**Land Adjacent to Haremuir, Benholm,
Johnshaven, Aberdeenshire, DD10 0HX
Report on Level 1 Standing Building Survey
Aberdeenshire planning application APP/2017/3248**

**Alison Cameron
Cameron Archaeology
19 April 2018**

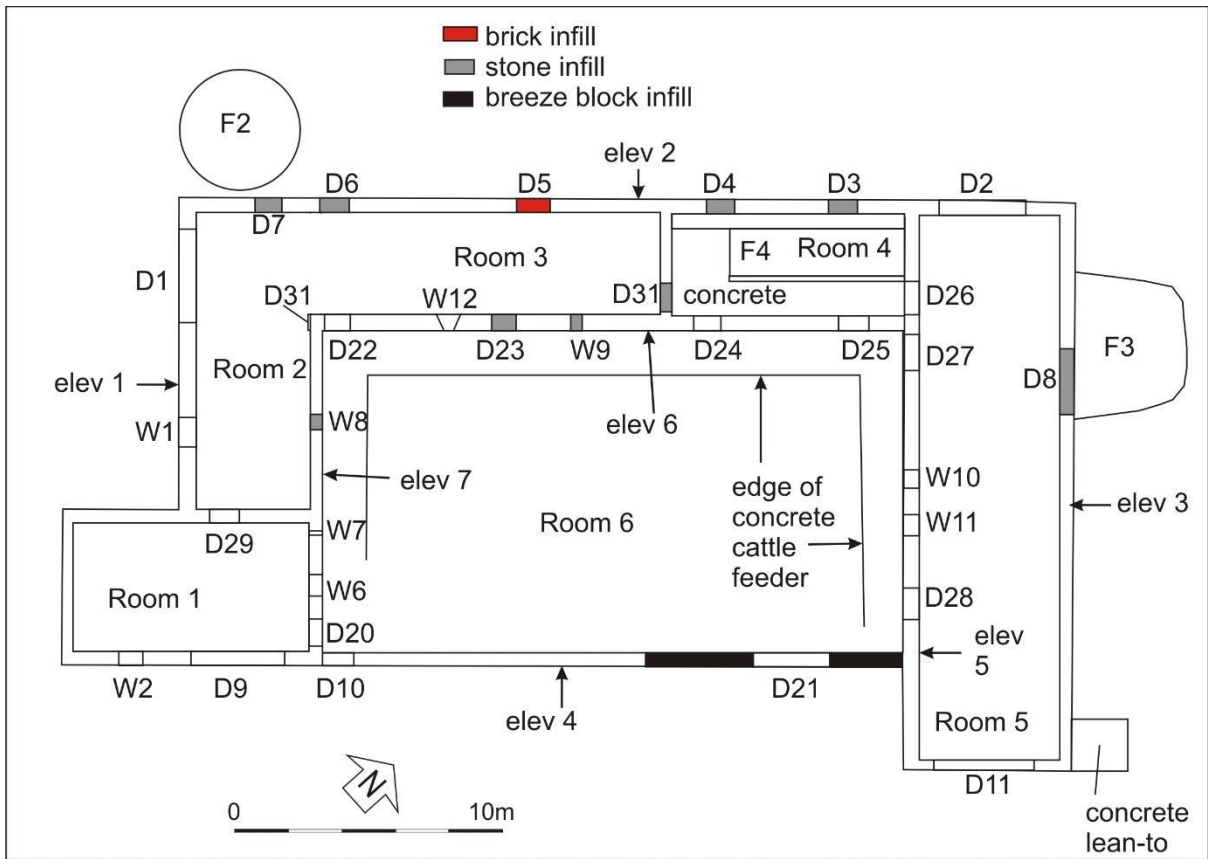
Illus 3 Plan of building annotated with numbers used in this survey and showing locations of elevation drawings

A level 1 standing building survey was carried out on 9 April 2018. No plans or elevations were available, and these were therefore all hand-drawn on site (Illus 3-5). The farm is 37.5m SW-NE and 21m NW-SE. It is mostly constructed of grey and red sandstone rubble and pecked grey sandstone for most of the jambs, lintels and sills.

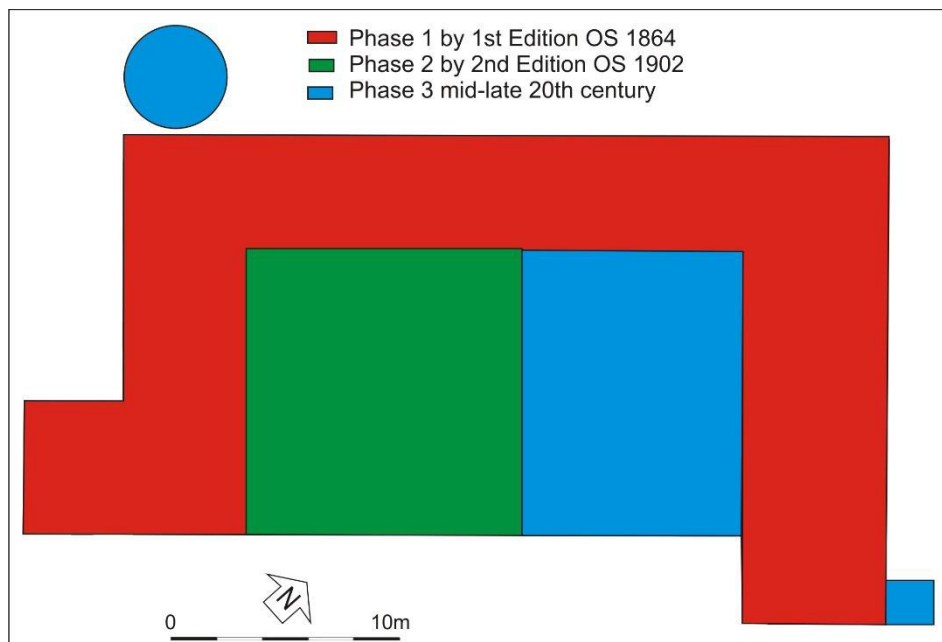
Illus 16 Phase plan

A Level 1 standing building survey was carried out on 9 April 2018. Three main phases of development of the farm were recorded (Illus 15). In Phase 1 which probably dates to the early 19th-century a C-shaped steading was constructed around a central courtyard which was enclosed over the following two phases. Doors and windows were blocked as the use of the building changed from a mill in Room 2 to full agricultural use. Room 4 is the only one without a concrete floor and this room retains the waterwashed cobble surface which would have originally floored all the areas in use for housing animals.

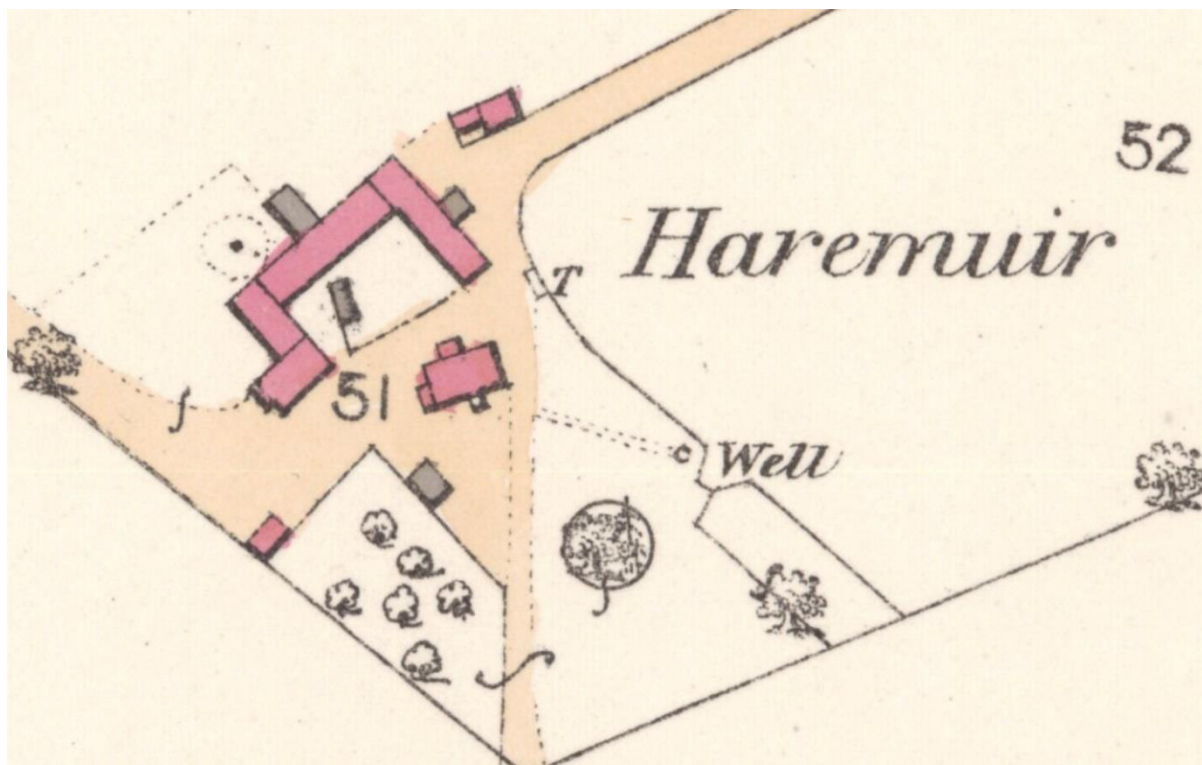
Illus 17 First Edition Ordnance Survey map (copyright National Library of Scotland)
Kincardineshire XXIV.8 (Benholm) Survey date: 1864 Publication date: 1866

Haremuir is not on the Aberdeenshire Sites and Monuments Record or the National Monuments Record. On the First Edition map (Illus 17) the building is a C-shaped steading on a NE-SW axis with small building at 90 degrees to the SE end of the SW wing, a small unroofed building off the NW wing and similar off the NE wing. There is a small unroofed building in the centre of the courtyard. There is a circular horsemill attached to the NW of the building. By the Second Edition (Illus 18) part of the courtyard has been infilled and the exterior rooms, including the horsemill, have been removed. By the date of the Third Edition (Illus 19) a building has been added on to the NE of the building.
