Mill of Lethnot, Edzell, Brechin, DD2 7UG
Report on Level 2 Standing Building Survey

Alison Cameron
Cameron Archaeology
17 April 2018

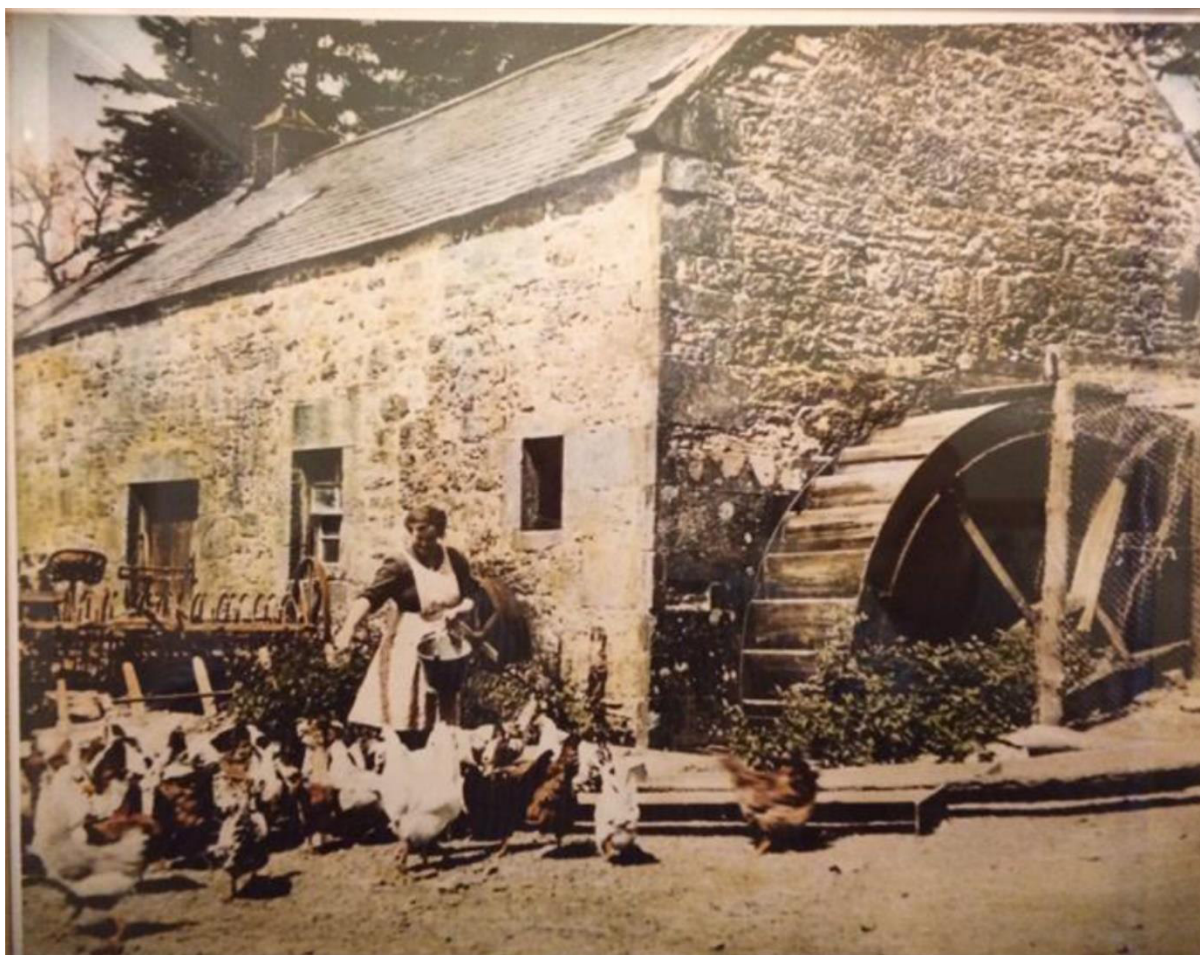
Illus 2 Photograph of mill with wheel *in situ*; copyright unknown, print belongs to a neighbour of current owner; facing N

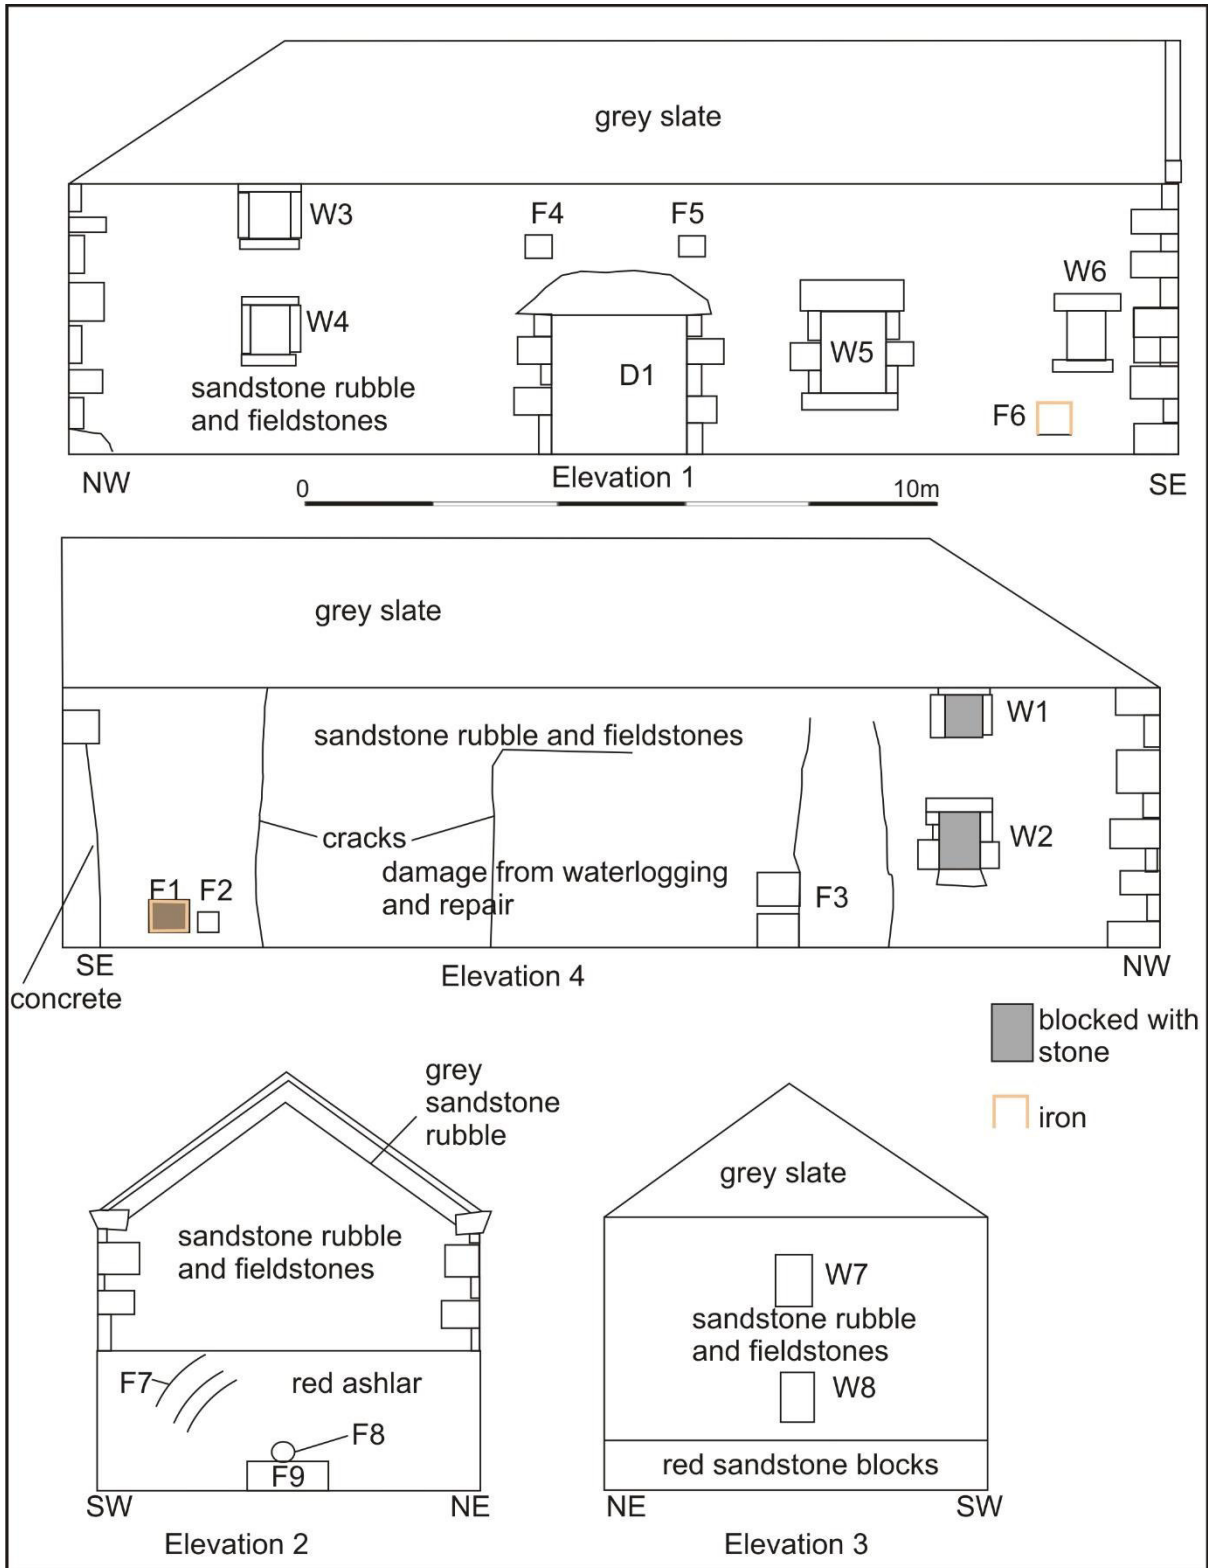
Illus 5 Elevations 1-4

Room 1 is 9 x 4m in size on the ground floor. It is likely that Rooms 1 and 2 were originally one room as the internal dividing wall is not tied in to the main walls (Illus 9). The NE wall of this room is slightly bowed as it has had historical water damage and has been repaired several times (Illus 5).
