**Inverharroch, Lower Cabrach, Huntly,  
Moray, AB54 4EU  
Level 1 Standing Building Survey  
Moray Council 17/01020/APP**

**Alison Cameron  
Cameron Archaeology Ltd  
1 October 2018**

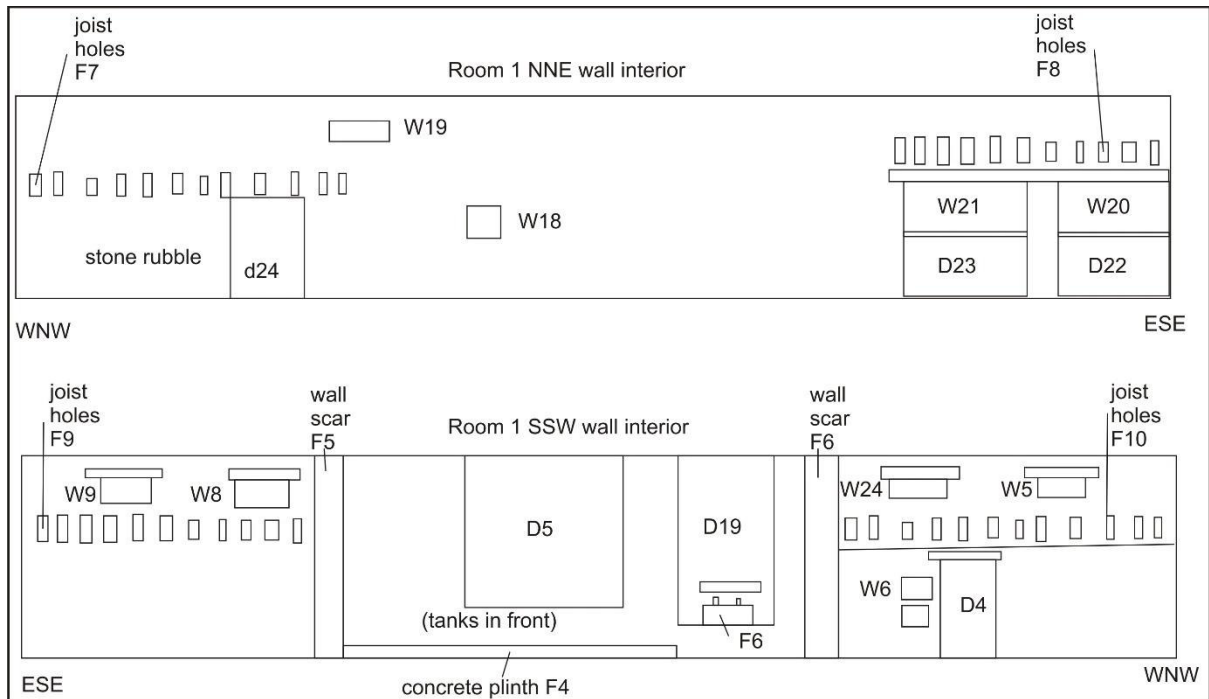
Illus 11 Room 1 internal elevations

Room 1 on the S side of the courtyard is 22m long and 6m wide with walls 0.6m thick, (Illus 11-14). It is constructed of red and grey granite, fieldstone, quartz with grey granite window and door jambs, sills and lintels and originally had two storeys. There are two cart doors (D22 and D23; Illus 10) both 2.2m wide and 2.1m high and later blocked with stone and small windows formed instead (W20, W21). There are blocked windows on the S wall (W8, W9, W6) and apertures W6 which is the likely location of the drive shaft from the former horse mill (recorded on the First Edition OS map; Illus 42). There is now a concrete plinth on the S wall (F4) but previously there had been a large door in the centre of the S wall (D5). The large doors in the W and E gables (D3 and D18) were increased in size in the 1960s for access by tractors and the walls repaired with concrete blocks.

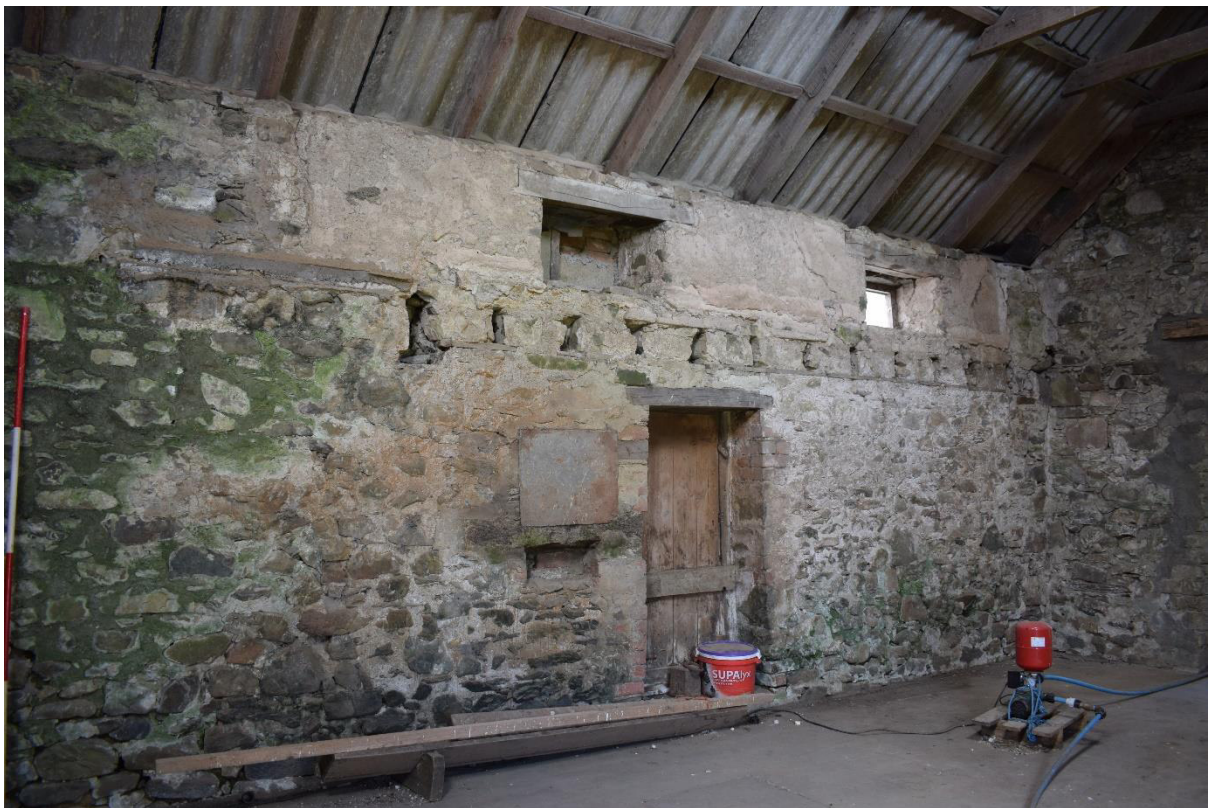
Illus 14 Room 1 S wall W end with D4 (centre) W6 (left) W24 and W5 (top); facing SW

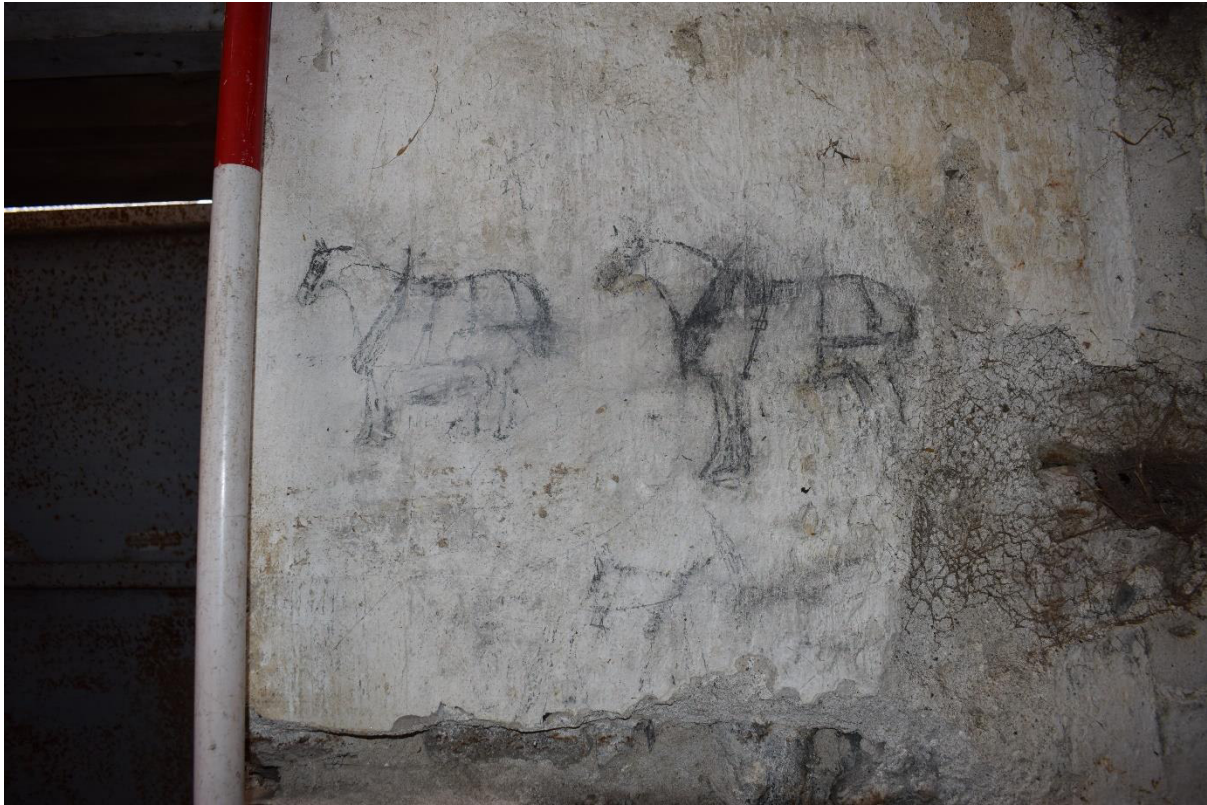
Illus 17 Pencil drawings on plaster between D17 and W12 showing horses; facing S

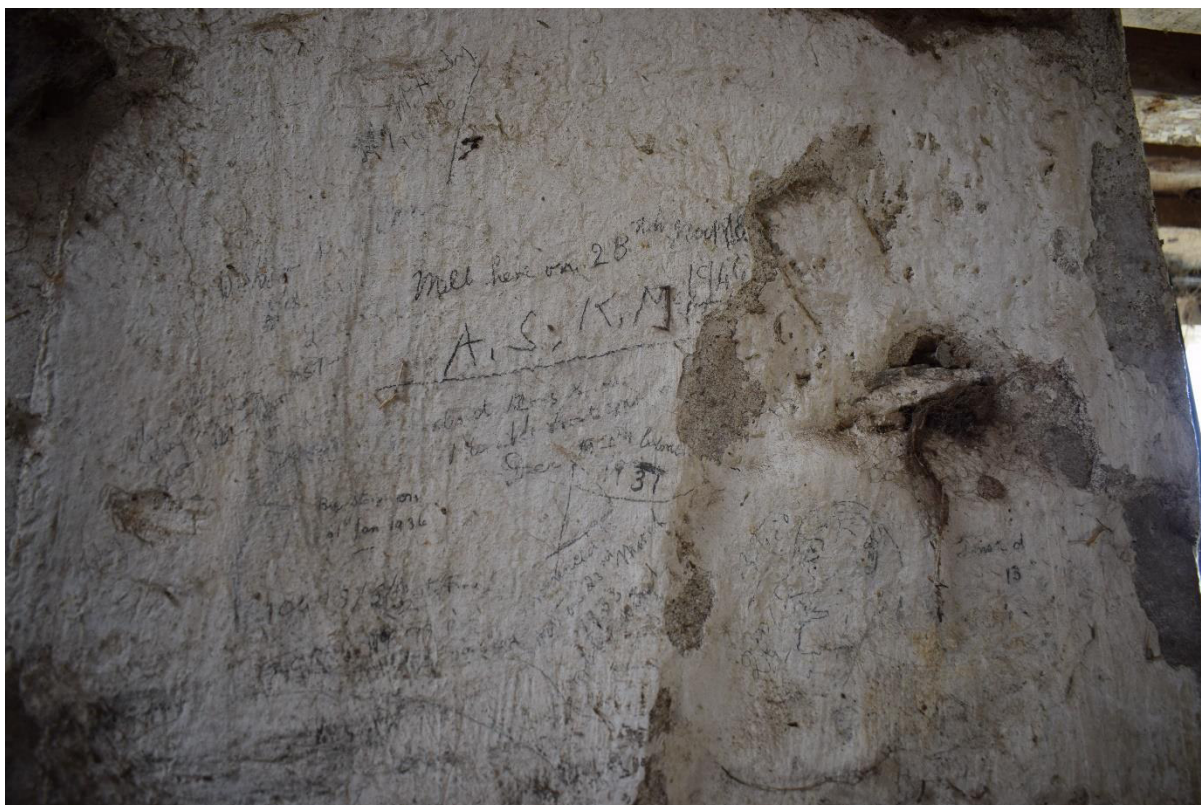
Illus 18 Pencil graffiti on plaster between D17 and W12 showing profile of a man and dates of the birth of horses, names and dates; facing S

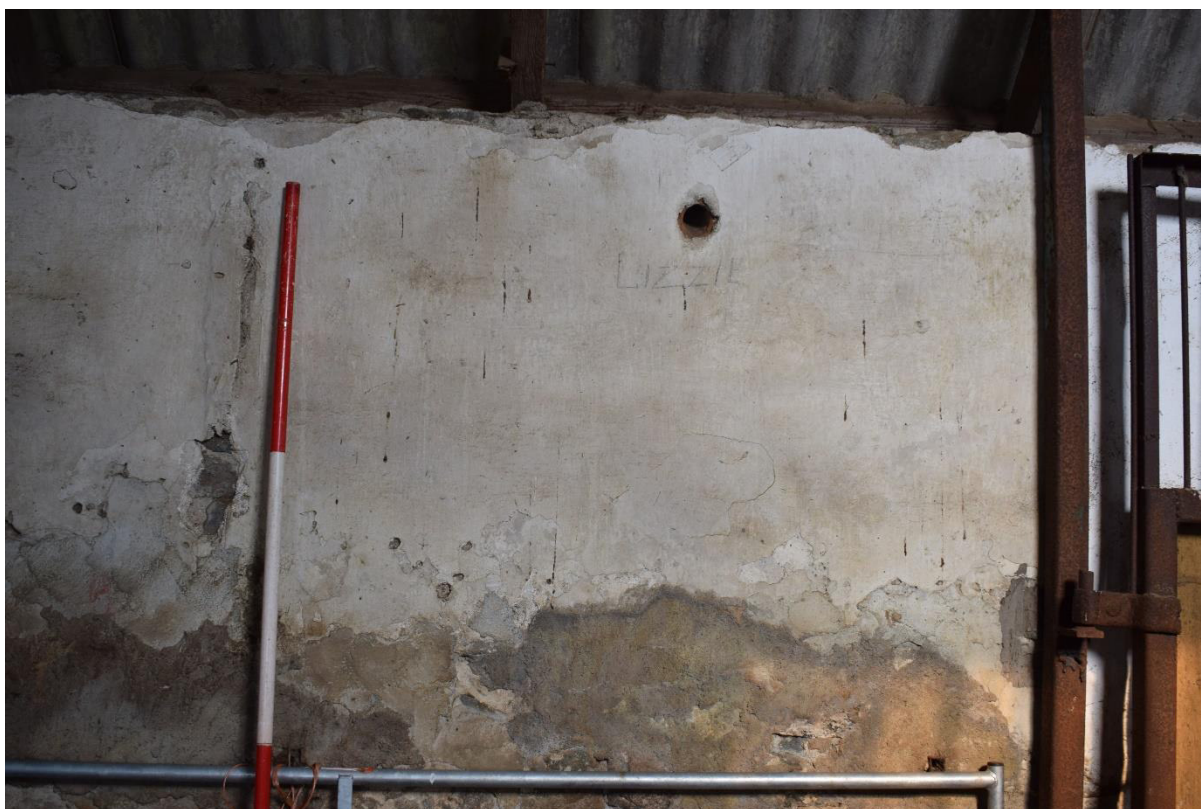
Illus 19 Pencil written horse name 'LIZZIE' above one of the stalls; facing N

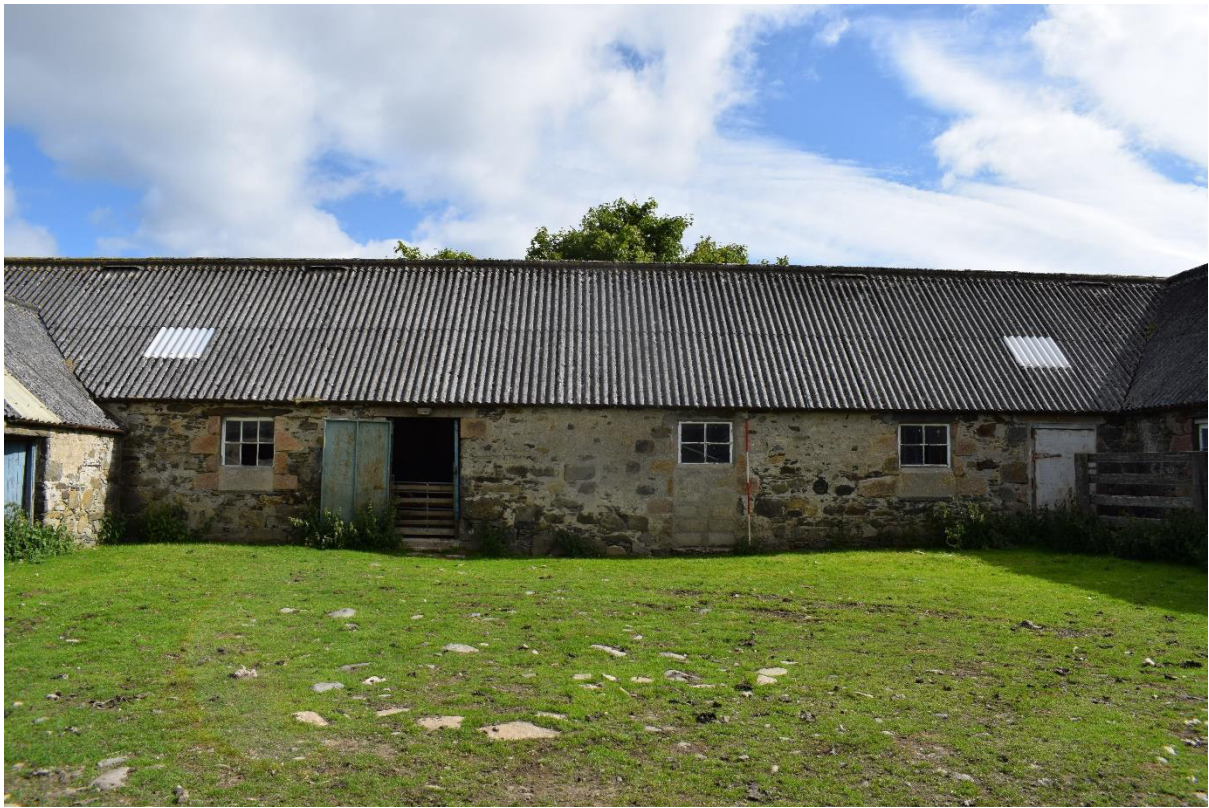
Room 3 forms the N edge of the courtyard 32m long and 6m wide (Illus 17-20). It has doors and windows on to the courtyard and a window on the N wall but the exterior of this room is not accessible because of the steep slope down to the N. The WNW gable wall has been rebuilt in concrete blocks when forming large door D1. There is pencil graffiti on the white plaster on the S wall of this room between D17 and W12 (Illus 17-18) and horses names over the former stalls E of W13 (Illus 19). There are small bore drainage pipes set into the N wall which have been inserted for ventilation.

Illus 20 Room 3 S wall W10, D15, D16/W11, W12 and D17; facing NNE

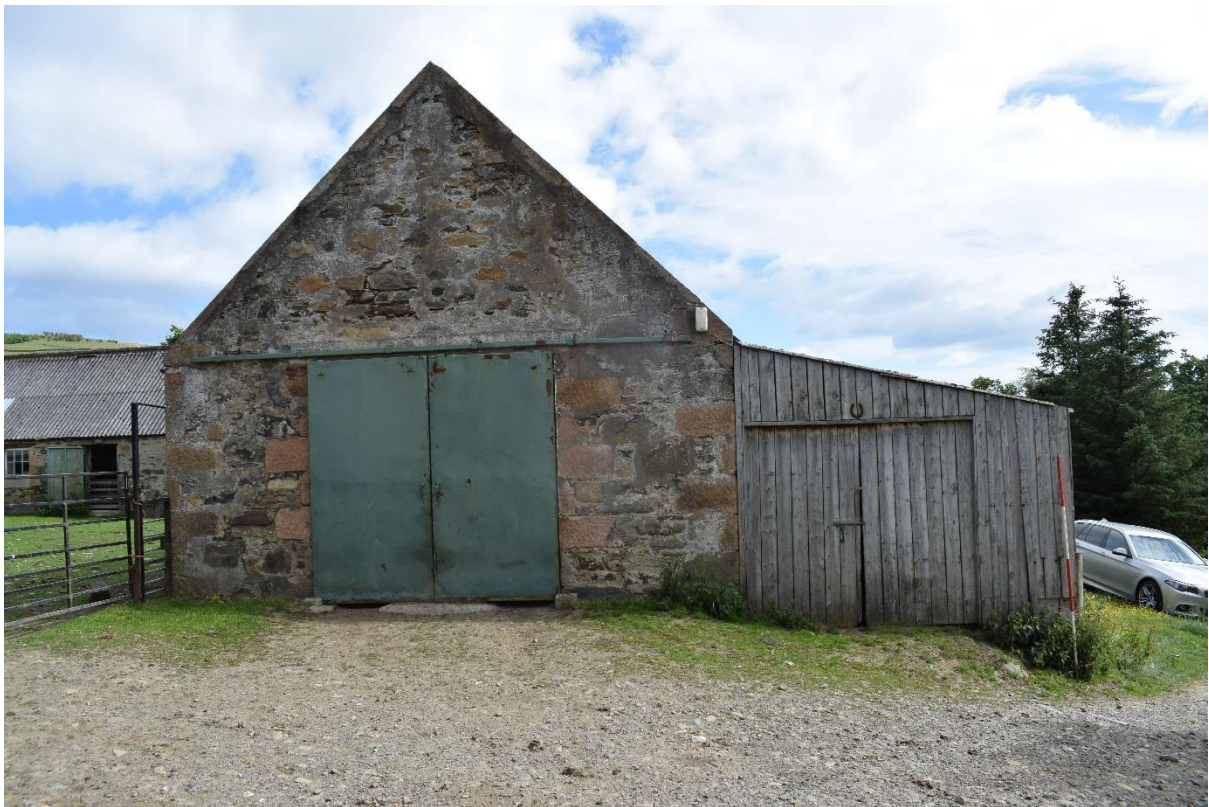
Illus 21 Room 4 S gable (left) with D6 and Room 5 S gable (right) D7; facing NNE

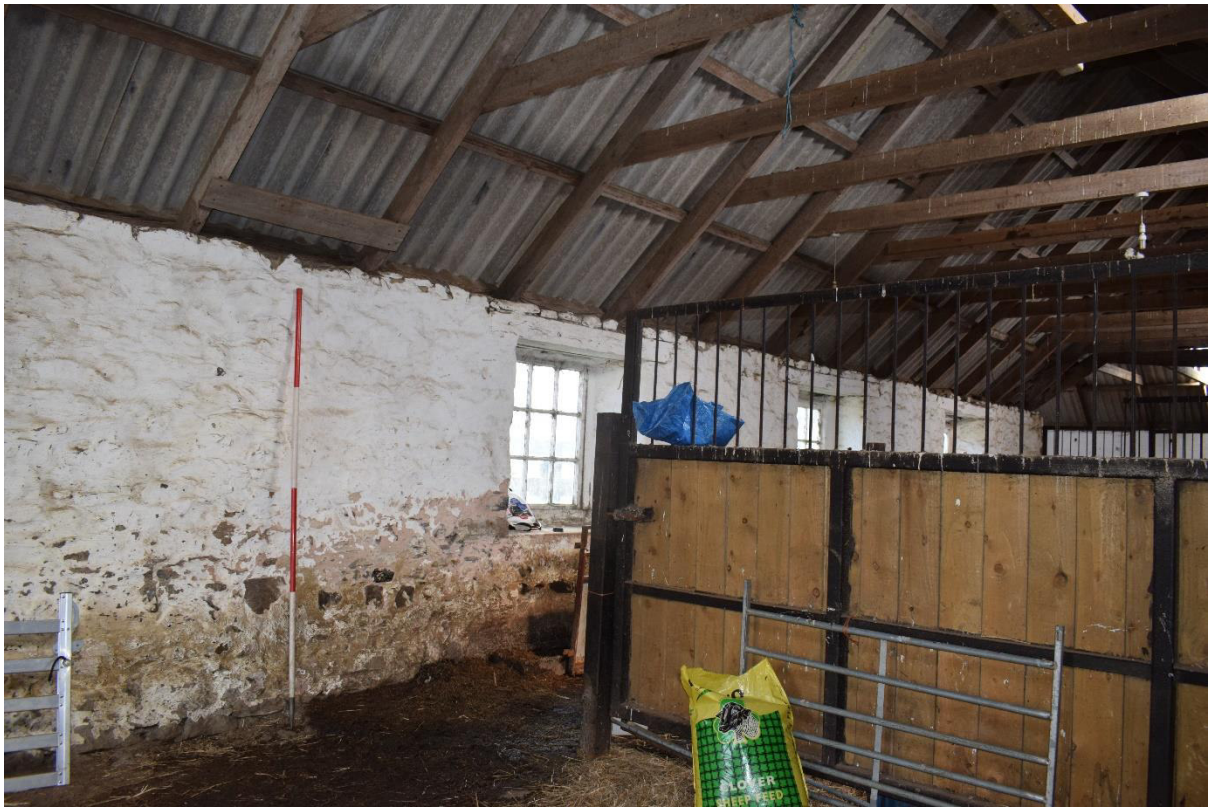
Illus 22 Room 4 W wall W23, D26, W22; facing NNW

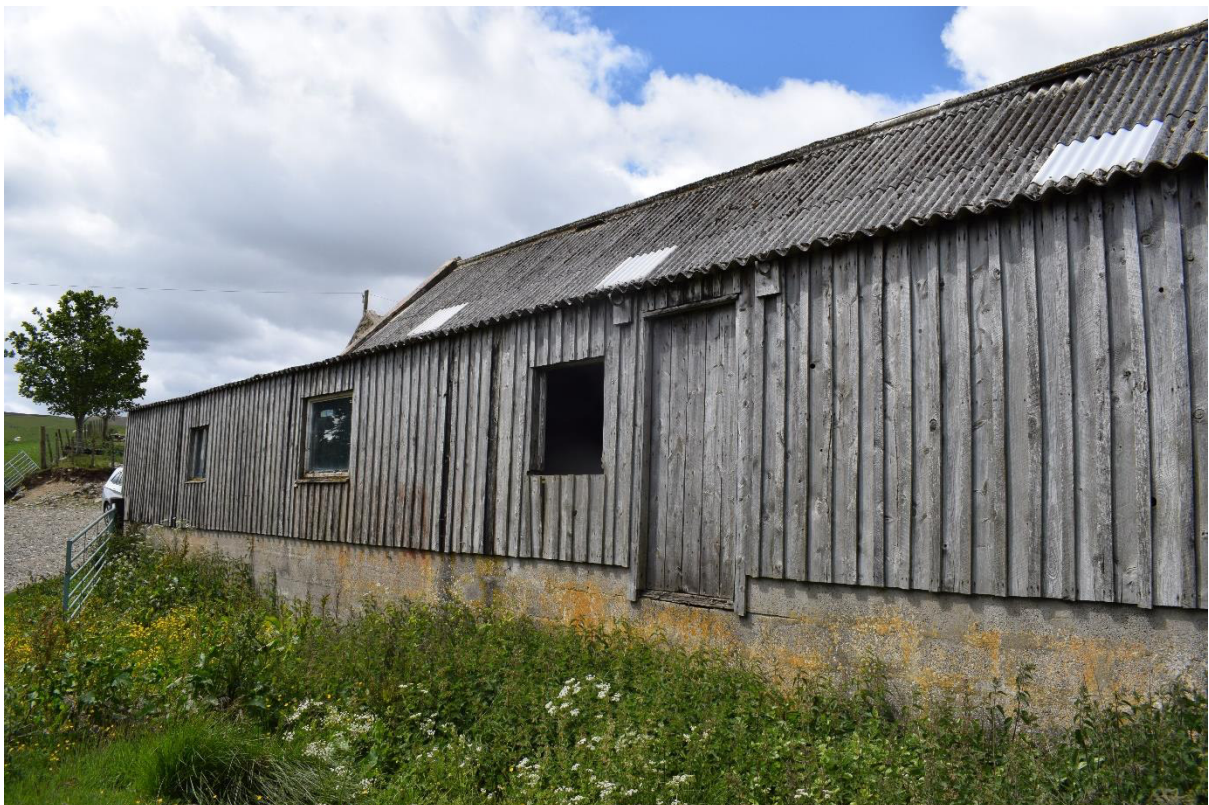
Room 4 forms the E edge of the courtyard and is 6m wide and 15m long (Illus 21-22). Room 5 is a wooden lean-to on the E side of Room 4 with an asbestos sheet roof (Illus 23). It is 4m wide with a door at the S end and windows in the E wall.

Illus 23 Room 5 E wall W14, W15, W16; facing SW

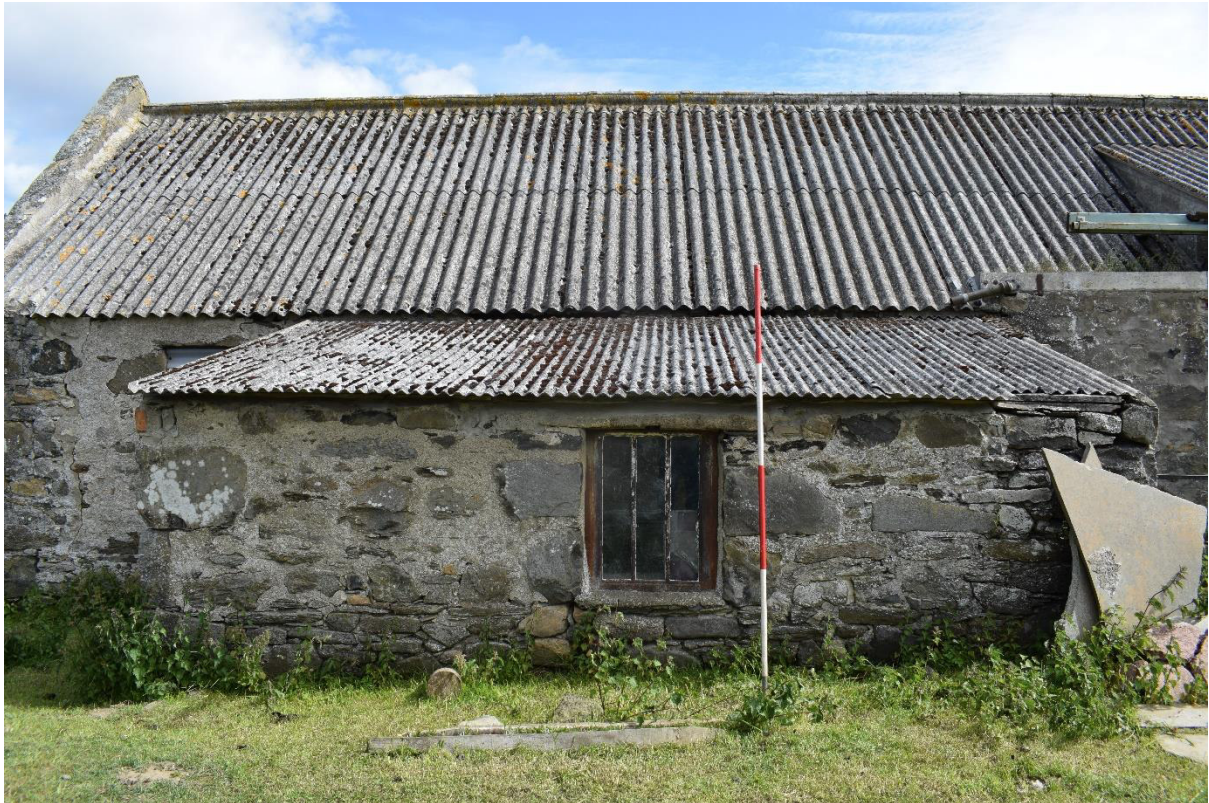
Room 6 is a later addition onto the S wall of Room 1 (Illus 24). It has a door in the W wall (D27), windows on the E and S walls and a blocked window on the E wall. It is presumably for an engine for the mill after the horse-mill went out of use and the concrete base, F11 (Illus 25) is probably the base for an engine to drive the mill.

Illus 24 Room 6 S wall W6 (left) W7 (centre); facing NNE

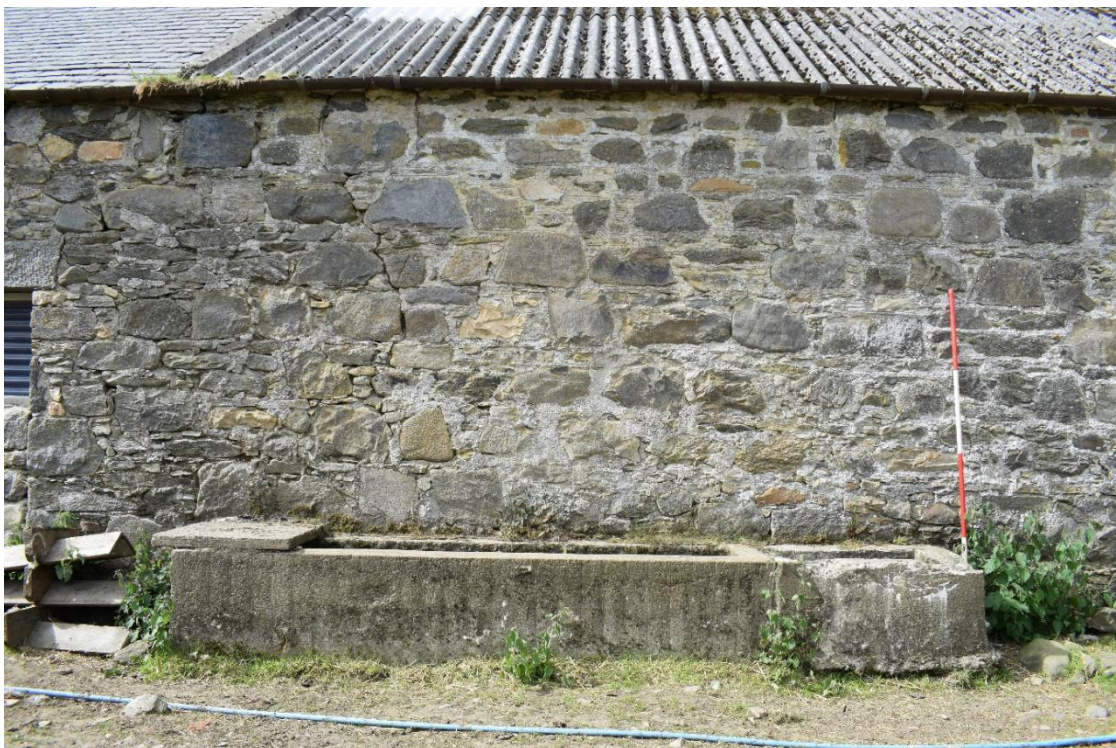
Illus 27 Concrete trough F3; facing SSW

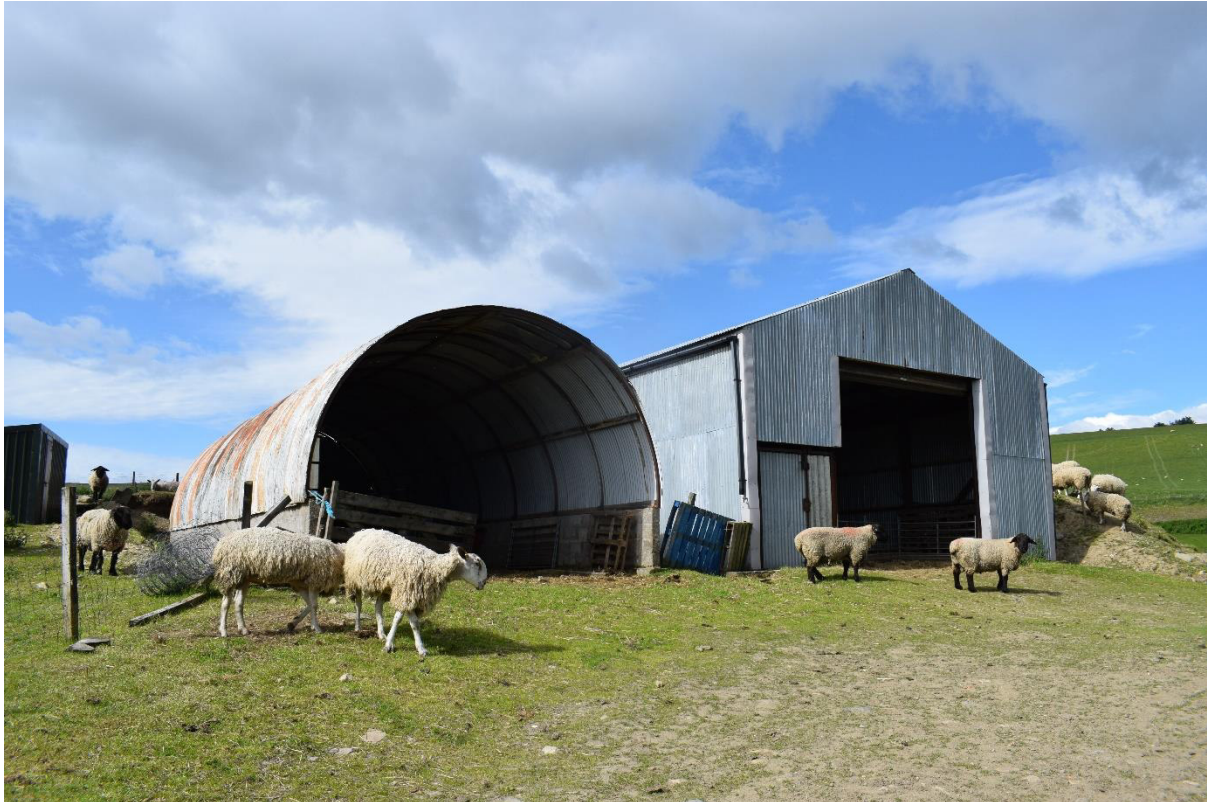
Structure 2 is a rectangular modern metal Dutch barn constructed in the 1980s (Illus 28). It is to be demolished for this development.

Illus 28 Structure 3 (left) and Structure 2 (right)

Structure 3 (Illus 28) is a Nissen-style corrugated iron Dutch barn which was purchased by the farm from Dallochty after WW2 (Derek McBain, tenant farmer). It is to be demolished for this development.

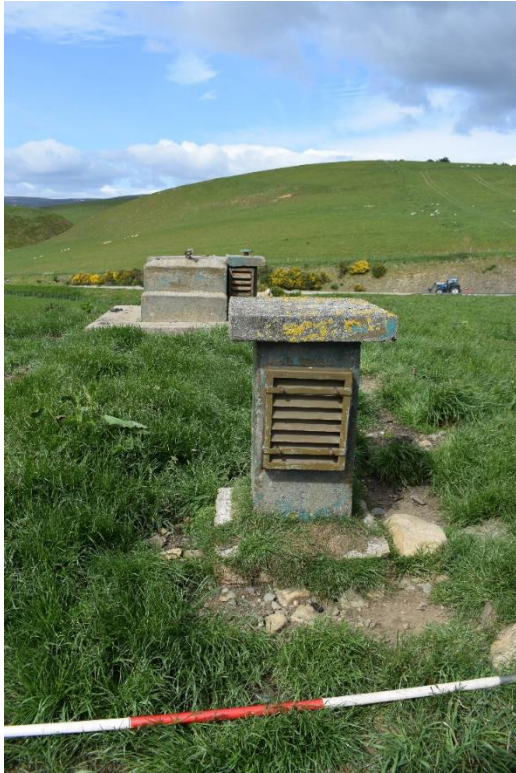
surface is an air vent (F1) a brick and concrete plinth 0.7 x 0.7m in size with a concrete a concrete cap with cast iron vents (Illus 32), F2 a ground zero indicator (GZI) and F3 a bomb power indicator (BPI) which would have connected to a gauge within the Post and access F4 with a concrete cap, concrete step (F7) and a cast-iron hatch (F8). There is a cast iron ladder F6 vertically down the S wall of the concrete shaft (Illus 33) which is 0.61 x 0.61m in size and 4.3m deep. Below the shaft is a sump 0.7m deep with a cast iron grill over the top. At the bottom of the shaft is a small room (Room 2) which would have had a composting chemical toilet but this has been replaced with a bucket toilet.

Illus 32 Structure 7 Vent F1 (foreground) with access shaft F8 (background); facing W

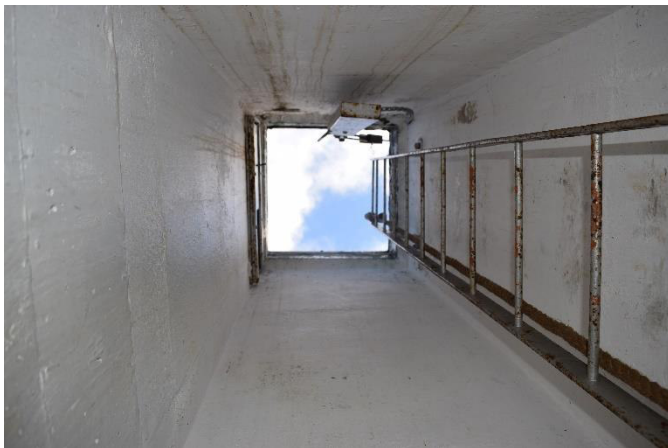
Illus 33 Structure 7 Entrance shaft F8; facing E

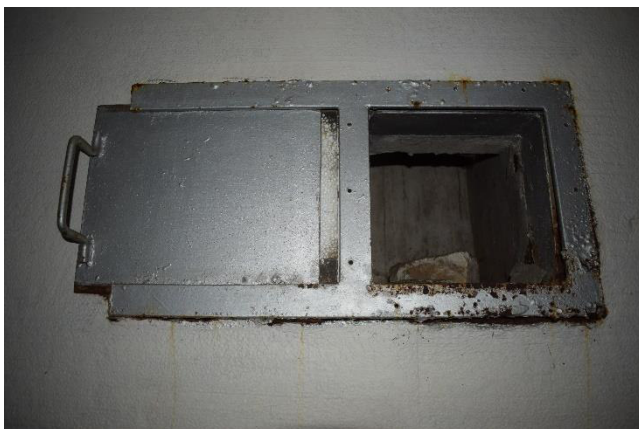
The main room (Room 1) is 4.6m long, 2.3m wide and 2.2m high. It has a replacement carpet on the floor and original polystyrene panelling on the walls and ceiling. There is a door (D1) in the W wall and vent F1 (Illus 34) on the E wall linking to the vent on the ground above. The vent in the concrete wall is 0.63 x 0.32m in size and 0.42m deep; the structure is built from concrete blocks and these can be seen within vent F1. On the N wall is wiring in ducts which are probably original and wiring for the bomb power indicator and there are two original power switches on this wall (Illus 34).

Illus 34 Structure 7 Vent F1 on E wall Room 1; facing E

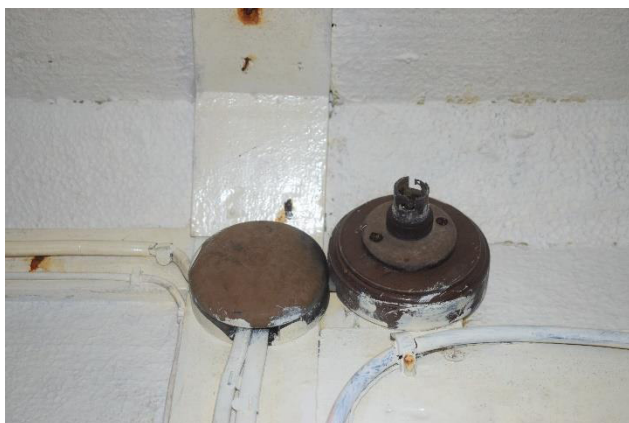
Illus 35 Structure 7 Room 1 N wall original electrical fittings

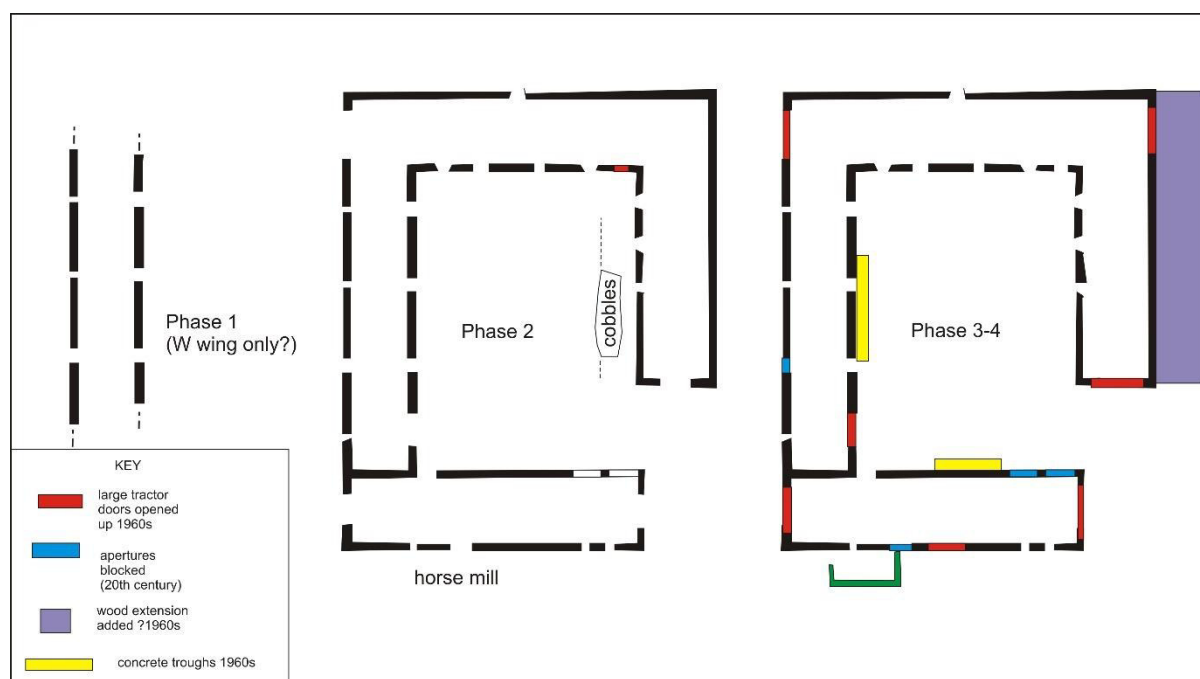
A level 1 standing building survey was carried out on 19-20 June and 28 September 2018. At least 4 main phases of development of the farm were recorded. The earliest phase of the building is probably the W wing (Illus 36); the N, E and S wings appear to have been added at a later date enclosing the central courtyard and these are complete by 1868, the First edition OS survey map (Illus 42). The First and Second OS map-s show small extensions on the E side of the farm but these have since been demolished and a wooden extension built. Large tractor doors have been added to several rooms around the 1960s and several apertures blocked. Room 3 had been subdivided with a bothy in the centre, cattle on a cobbled floor to the W and stalls for horses to the E but these were then knocked into one room when it as converted into cattle cubicles.

Illus 36 Plan showing main phases of development of the building (from copyright LDN Architects)

It is recommended that no further archaeological work is required during the current planning application.
