**Bogendollo House, Fettercairn,
Laurencekirk, AB30 1DL
Report on Level 1 Standing Building Survey**

Aberdeenshire Council planning application APP 2014/0183

**Alison Cameron
Cameron Archaeology
8 January 2019**

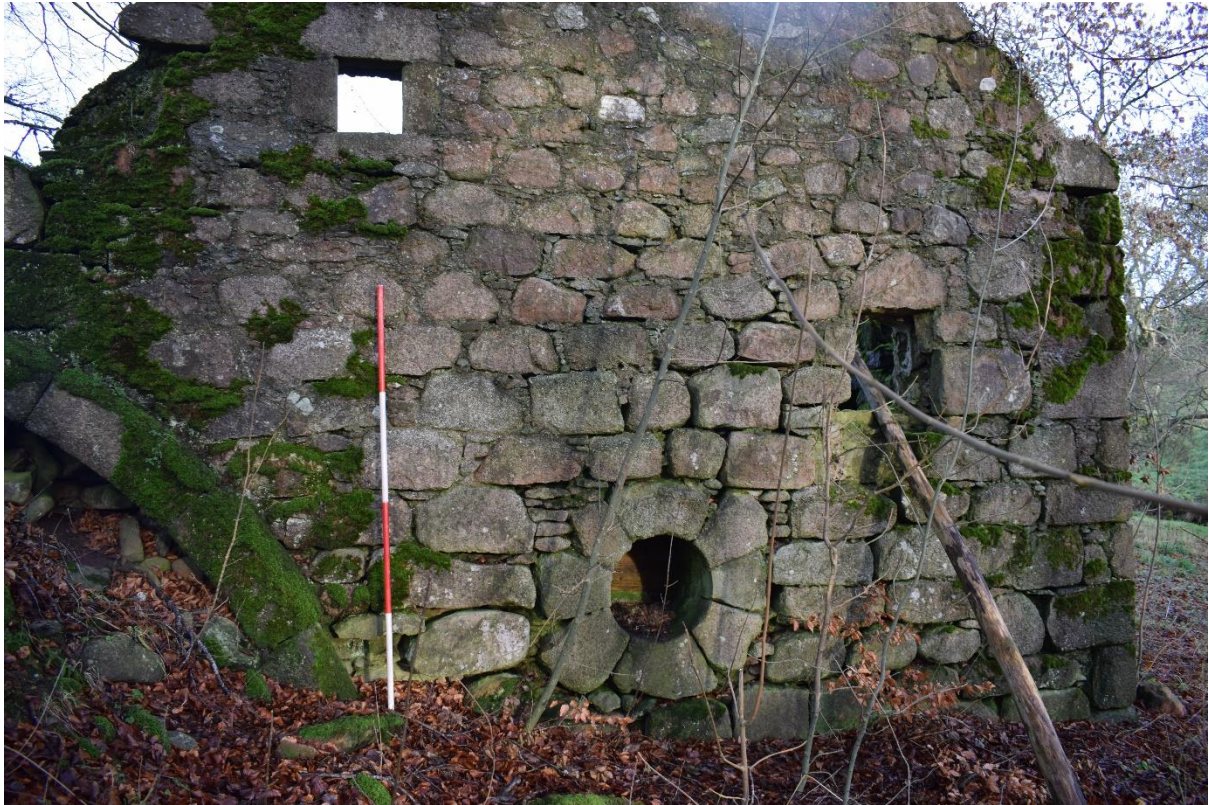
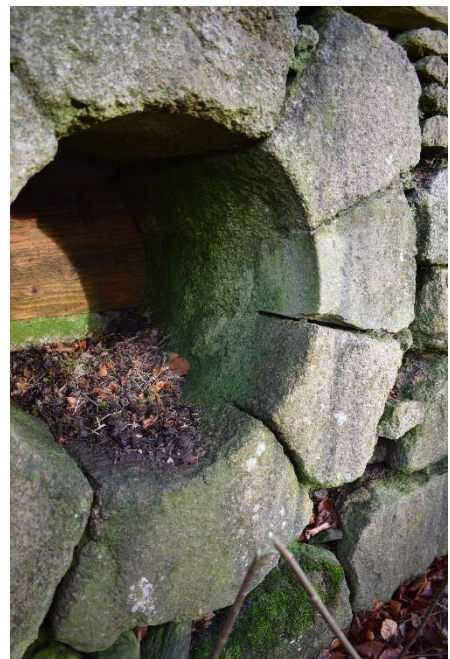
Cover: top Building 3 S gable; facing N. Bottom: Building 3 aperture for water mill wheel; facing NE

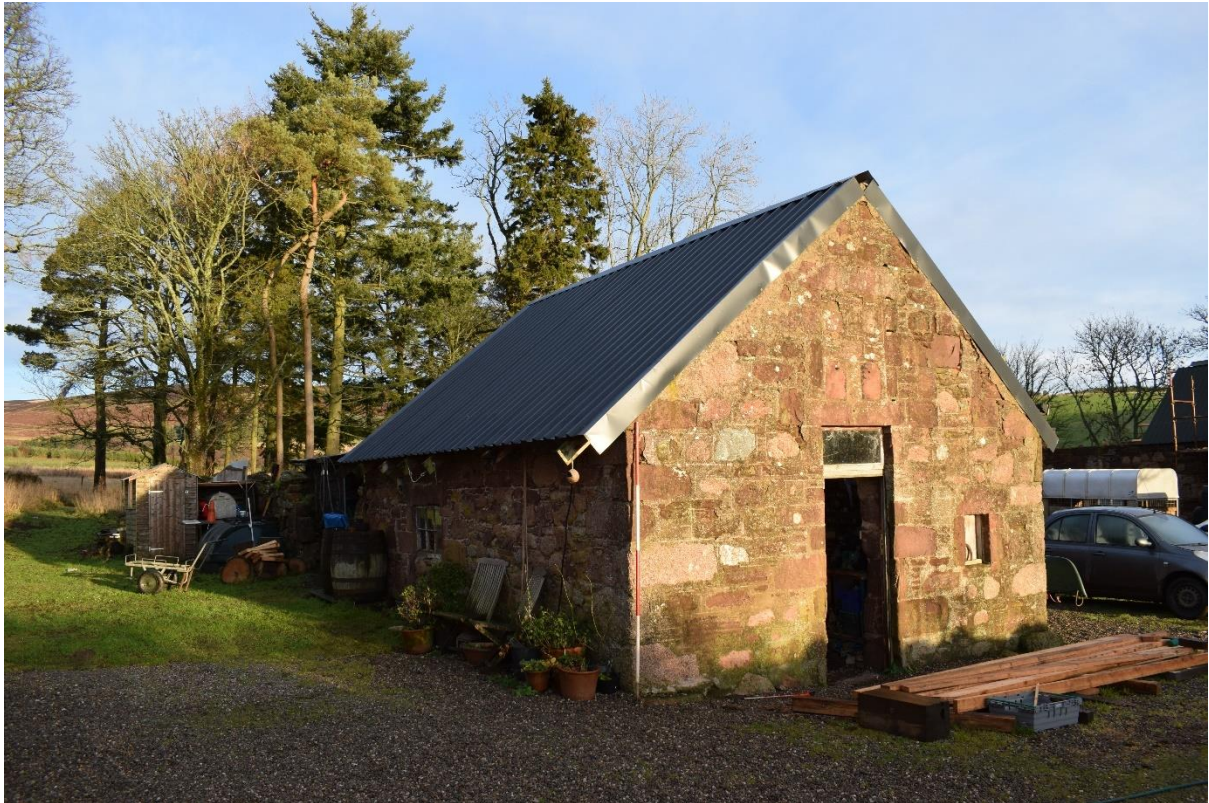
Illus 10 Building 2 Room 3; facing NE

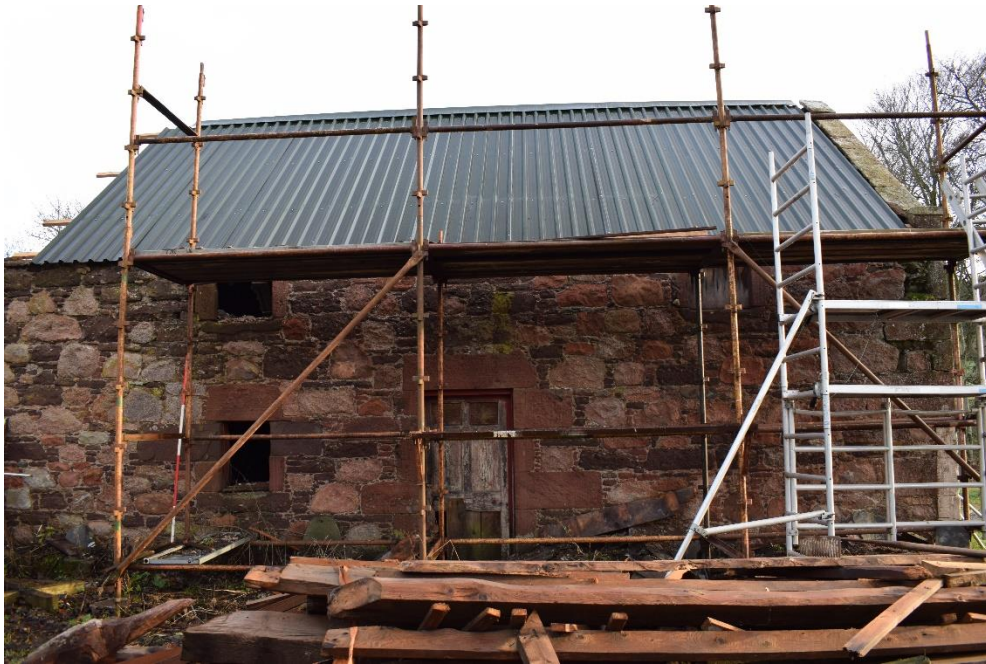
floor may have been accommodation for staff. There is also a first-floor door in the N gable (D14; Illus 17). Room 8 has no interior access but has central door (D12) and windows W8, W9 and W10 (Illus 14) and ground floor door (D3) on the S gable with upper door D14.

Illus 14 Room 8 W façade; facing E

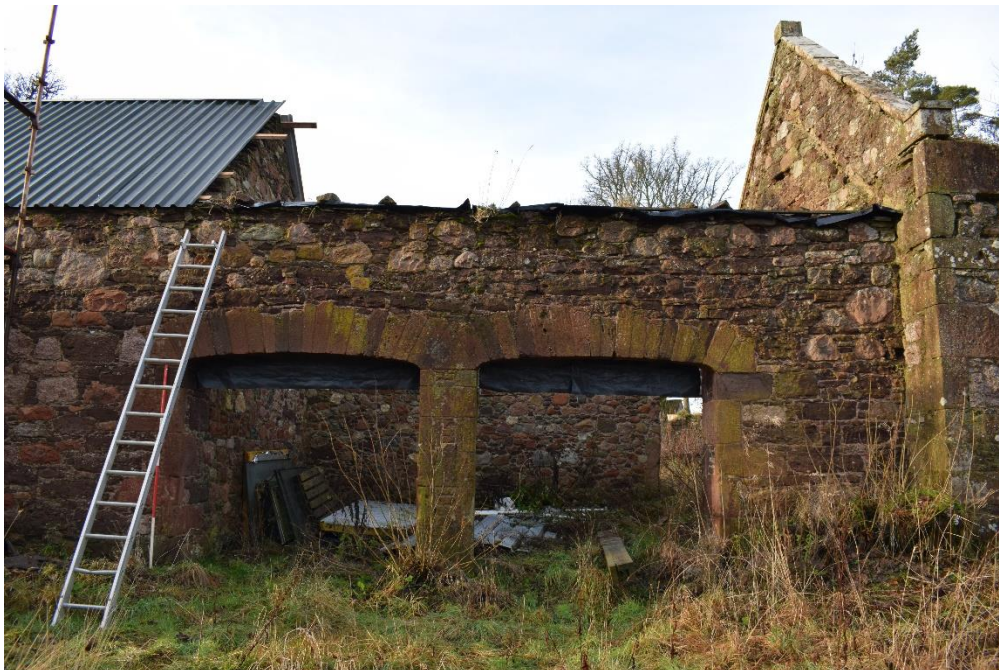
Illus 15 Room 7 E wall cart doors D4 (left) D5 (right); facing W

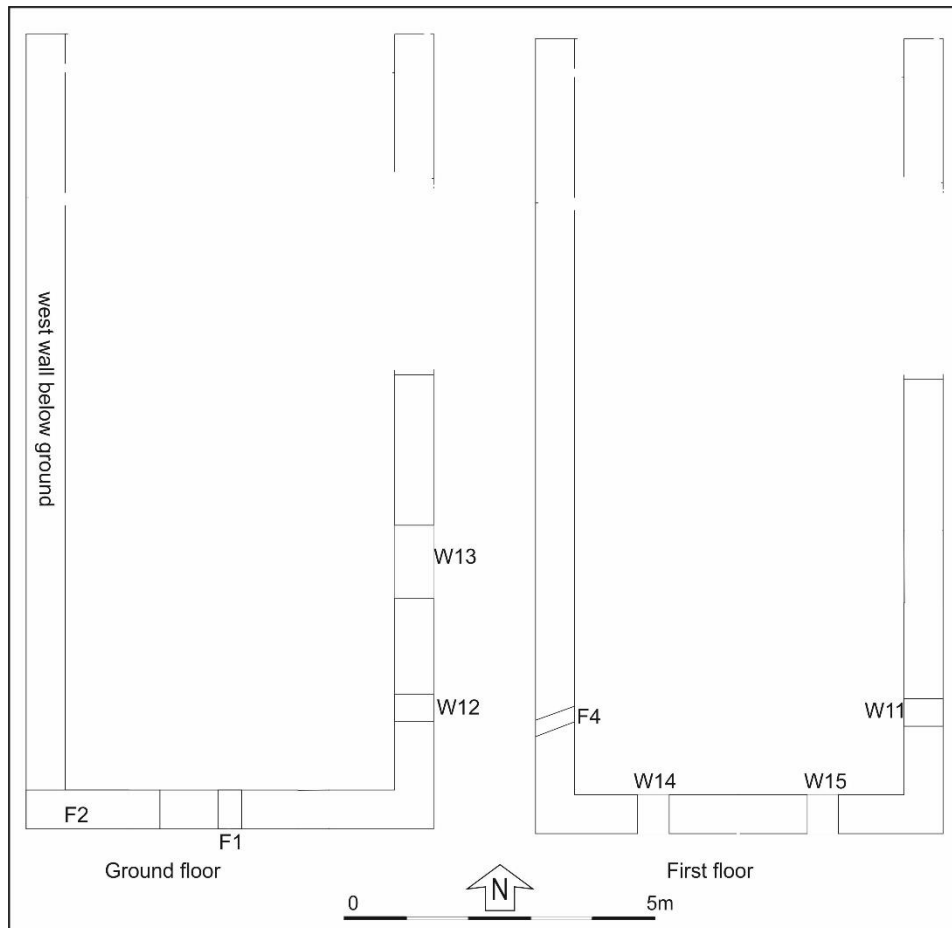
Illus 19 Building 3 plans annotated with numbers used in this survey (Copyright Daniel Herrera Gutierrez-Avellanosa)

Building 3 is 12 x 6.2m in size and constructed of fieldstones and is in poor condition apart from the S gable. The E wall survives to c3m high whilst much of the W wall is now below ground level; there was a mill pond to the W of the building on the 1st Edition OS map (Illus 26) and this is infilled and trees planted by the 2nd Edition OS map (Illus 27).

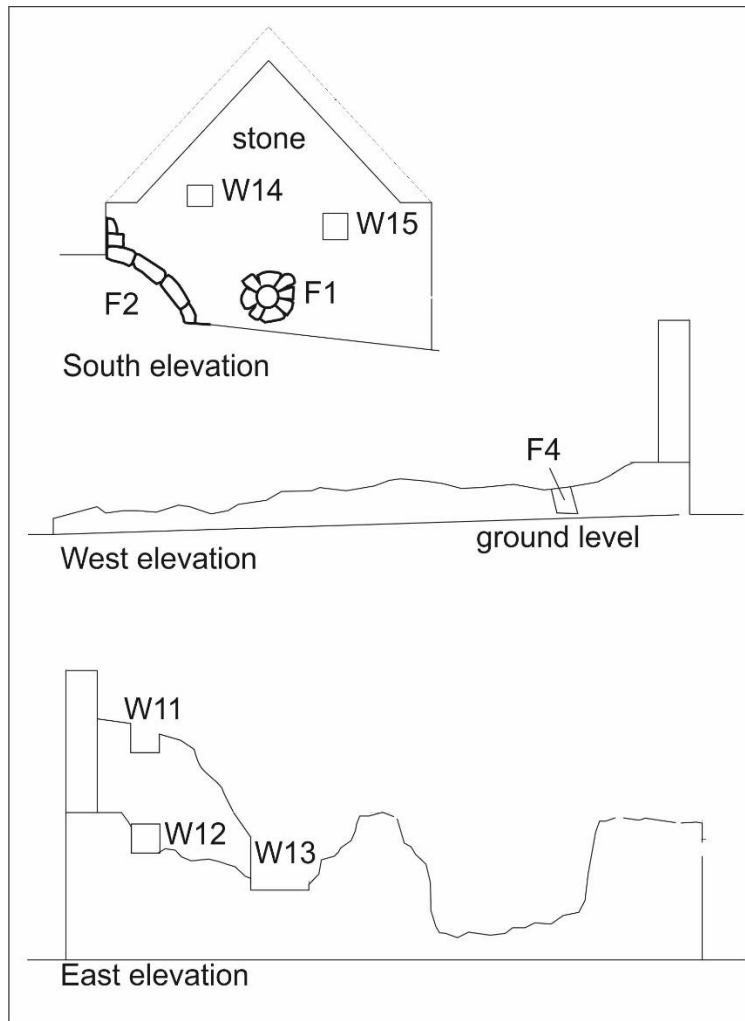
Illus 20 Building 3 elevations annotated with numbers used in this survey (Copyright Daniel Herrera Gutierrez-Avellanosa)

Three windows partially survive in the E wall including W12 which has been repaired or replaced with concrete surround (Illus 20, 21). There is an aperture in the W wall (F4), possibly for ventilation. The S gable is the most complete wall (Illus 20, 22) and it has two upper windows (W14 and W15) and a circular aperture (F1) which is 0.53m diameter. The wall thickness at F1 is 0.67m and F1 is constructed of granite blocks (Illus 20, 23). F1 is the aperture for the drive shaft for the waterwheel; there is no trace of the wheel and the wheel pit has been infilled. F2 is an arch of worked granite boulders; it is 1.9m W-E and 1.6m high. This is the channel through which the water flowed from the mill pond, under the SW corner of the building and along the S side of the building to power the waterwheel. This area has been infilled.
