**Land At Smiddyhill, Udney, Ellon,
Aberdeenshire, AB41 6SY**

Report on Level 1 Standing Building Survey

Aberdeenshire Planning application APP/2019/1064

**Alison Cameron
Cameron Archaeology
14 July 2019**

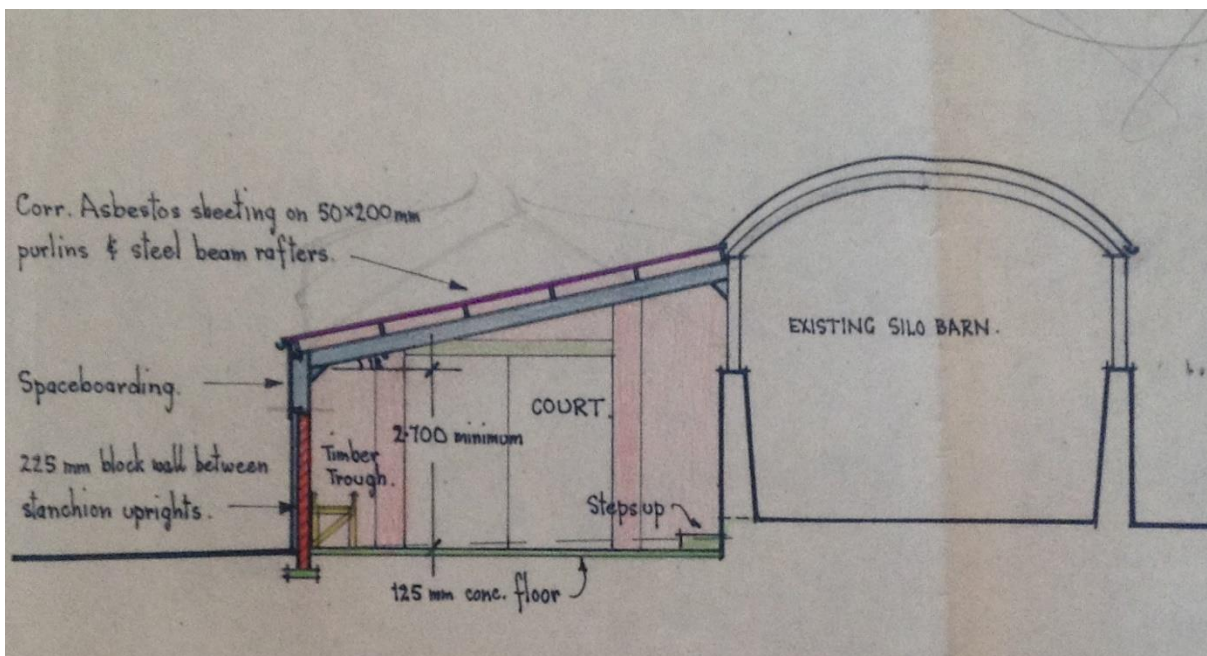
Illus 4 Cross section drawing showing N half of Building 2 (cattle court; left) added to Building 1 the existing silo barn (right) (courtesy of Isobel Milne)

Building 1 is 33m long and 5.7m wide constructed of concrete blocks (Illus 3, 5) with a curved metal roof and corrugated metal walled first floor. It was a silo barn (Illus 4) and was constructed by A&J Main & Co Ltd, Glasgow and London (Illus 6).

Building 2 was built by the Taylor family as a cattle court (Illus 4). It is 26.8m long and 18.2m wide and constructed of concrete blocks with asbestos roof and large metal doors in the WNW wall (D24; Illus 5) and ESE wall (D23).

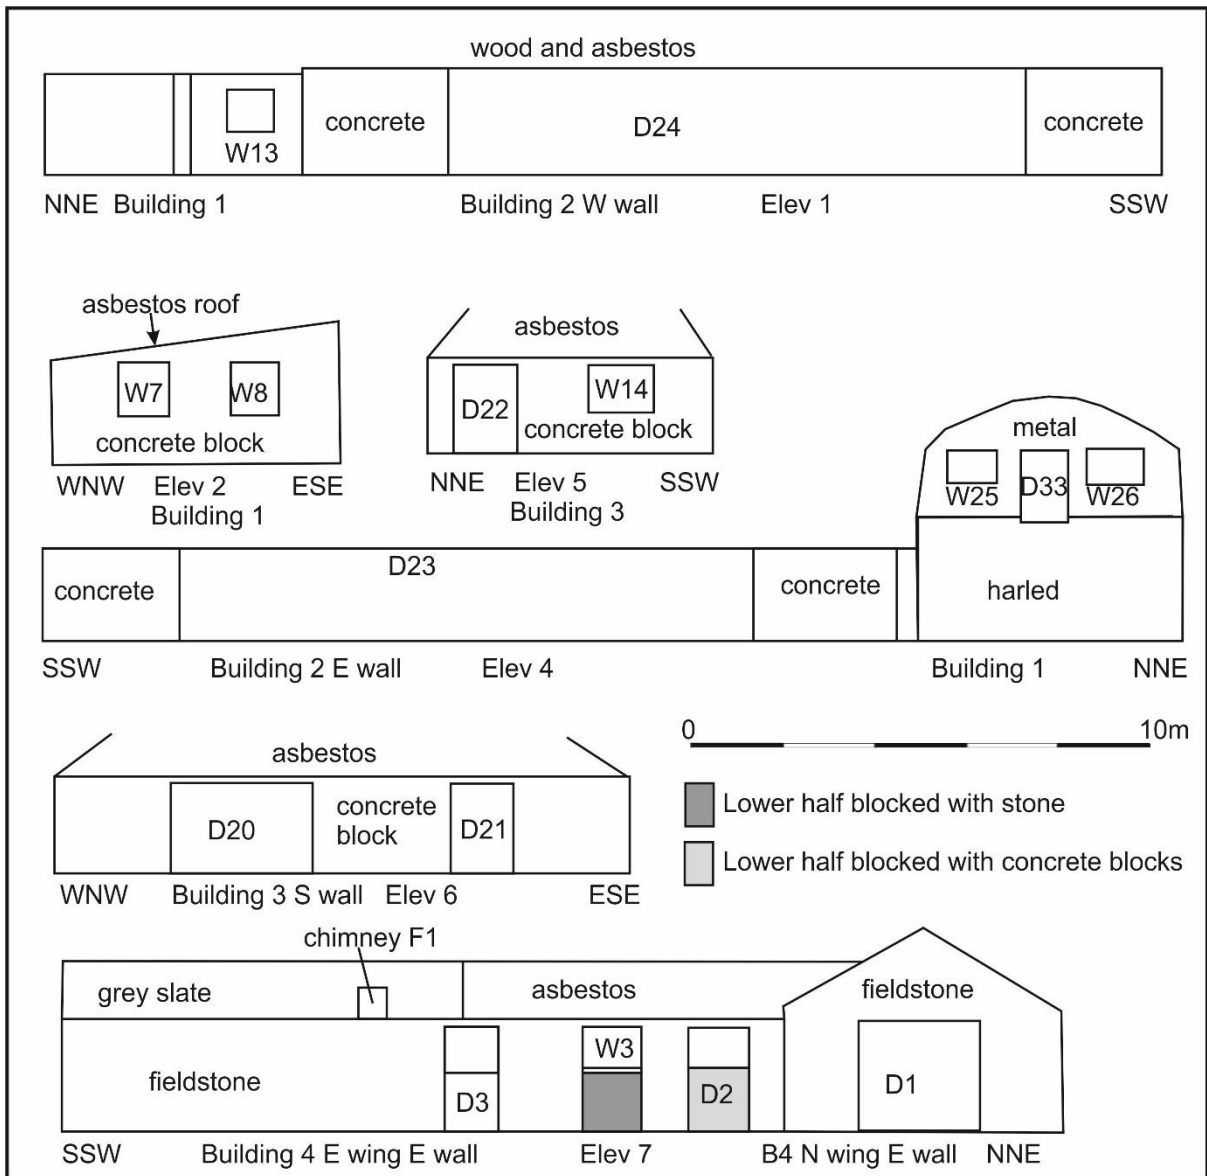
Illus 5 Elevations 1-2, 4-7 annotated with numbers used in this survey

There is a chimney on the exterior of the SE wall (F1; Illus 5 Elev 7) and a concrete scar on the interior where a fireplace and flue have been blocked. These may have been added when this end of the wing was converted into a cartshed, possibly to house a cartman.

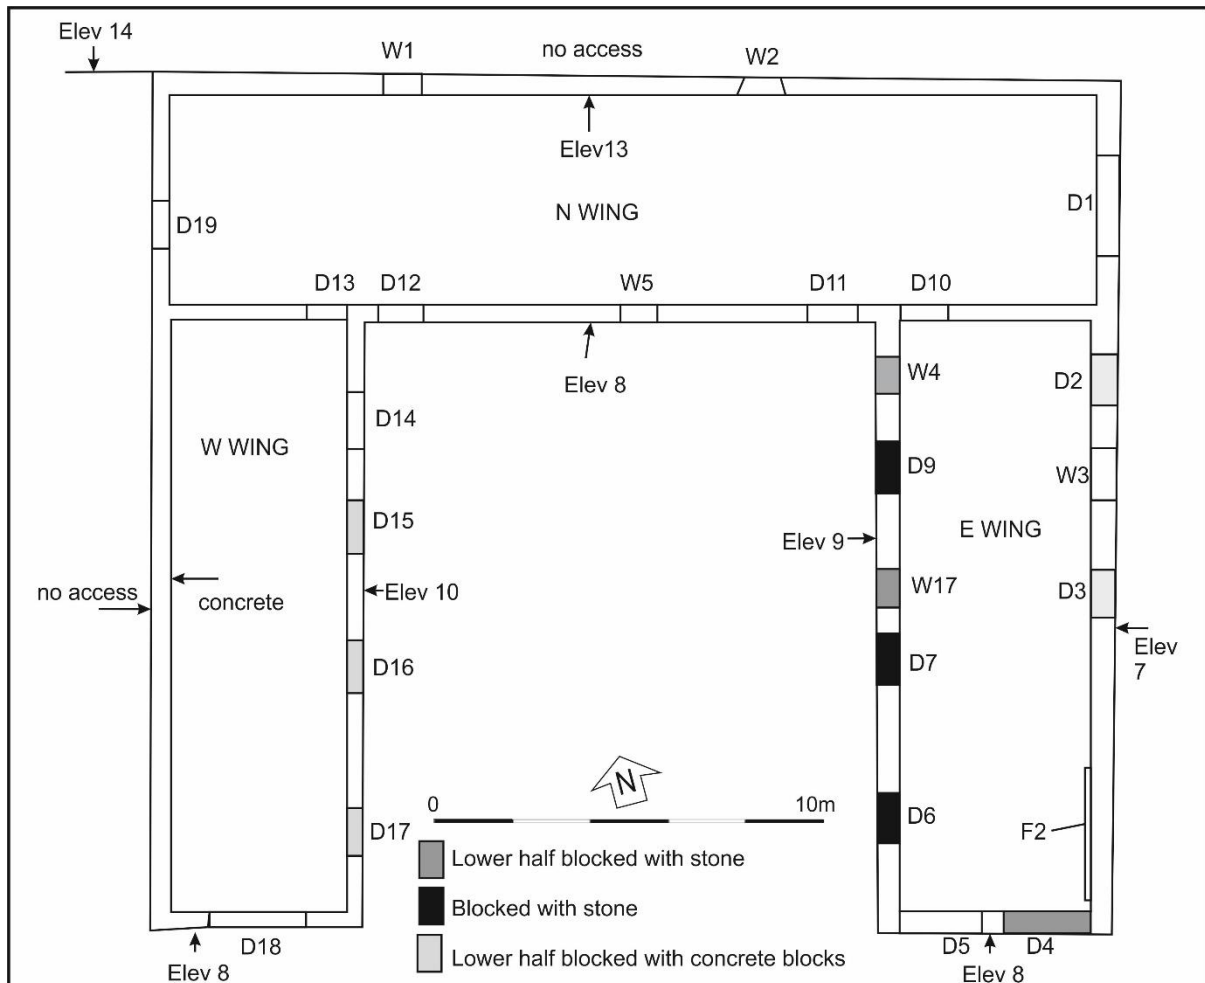
Illus 9 Plan of Building 4 annotated with numbers used in this survey

Building 4 is the earlier fieldstone steading constructed in a C shape with W wing 15 x 5.5m, N wing 24 x 6.2m and E wing 15.5 x 6.2m in size around a central courtyard (Illus 9) with access from the S. The original apertures are in granite but many of the doors have been blocked with stone and concrete blocks and some lintels and sills replaced in concrete (see Illus 18). The interiors have all been lined with concrete for housing cattle and there are concrete floors throughout. The original roofs have been grey slate but many have been replaced with asbestos roofs, including the NNE end of the E wing (Illus 18).

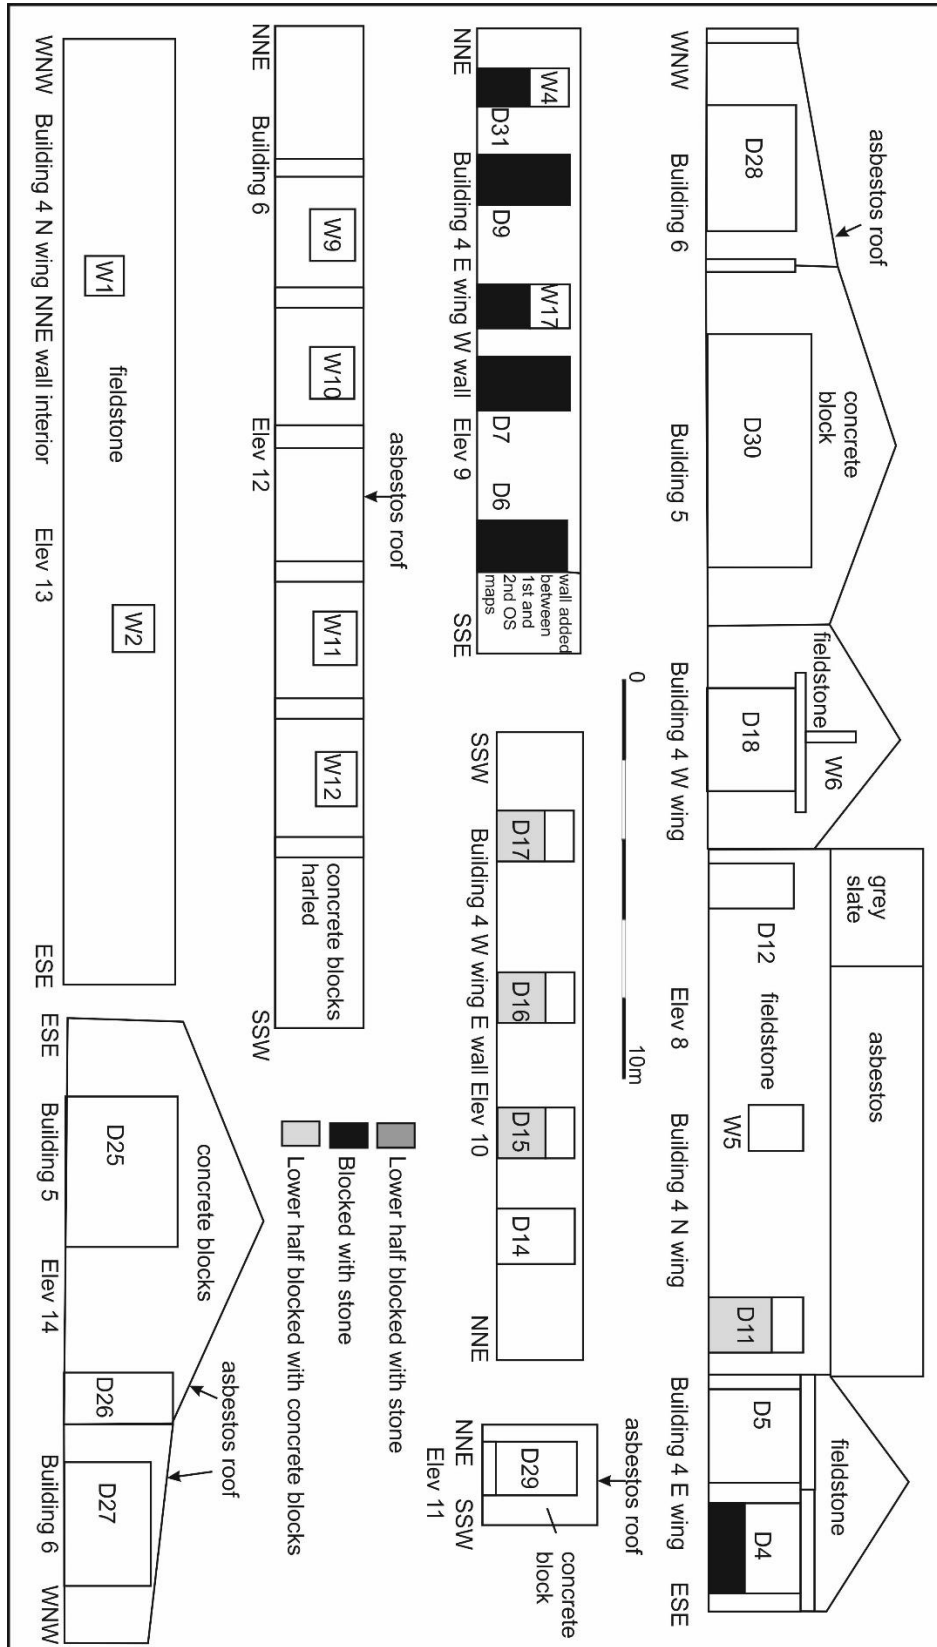
Illus 10 Elevations 8-14 annotated with numbers used in this survey

The W wing has a large door in the SSW wall (D18; Illus 11) and the wing had 4 doors on the ESE wall to access the courtyard (D14-17; Illus 12); three were later converted to windows (Illus 10, 12). A door (D13) has been broken through into the N wing but this is not an original door and has not been faced. It is roofed in grey slate.

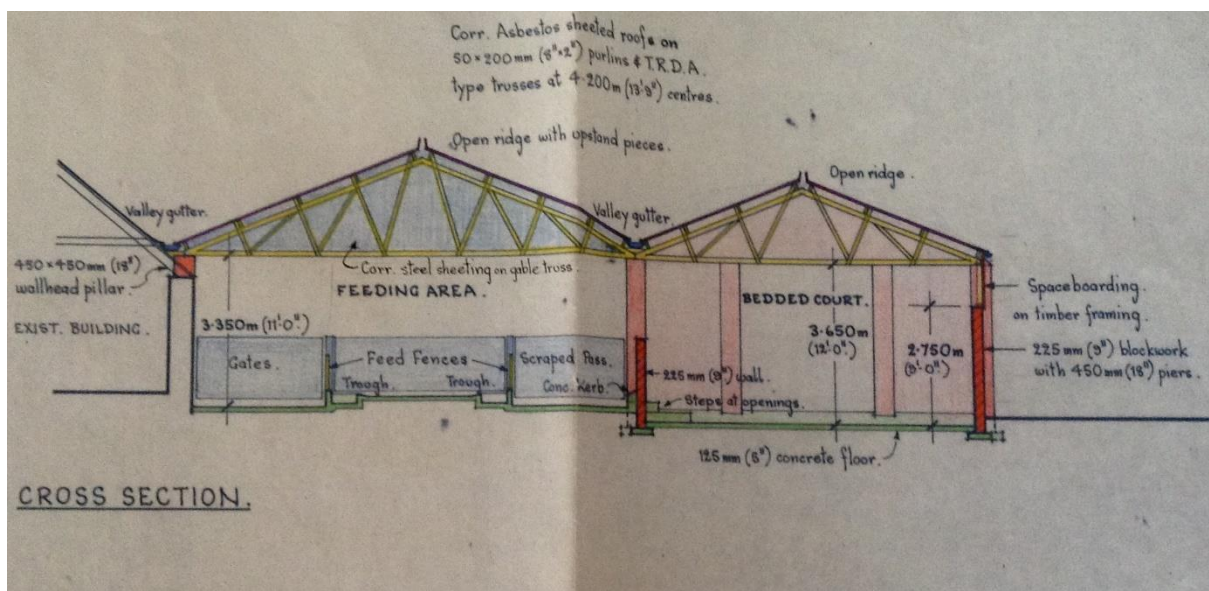
Illus 20 Cross section drawing showing Building 5 (feeding area; centre) added to 'existing building (Building 4, left) and Building 6 bedded court (right) (courtesy of Isobel Milne)

Building 5 was built by the Taylor family as a feeding court (Illus 20). It is 10m wide and 22.5m long and constructed of concrete blocks with asbestos roof, now collapsing (Illus 21-2). There was no access to the interior.

Building 6 was built by the Taylor family as a feeding court (Illus 20). It is 5.5m wide and 25m long and constructed of concrete blocks with asbestos roof, now collapsing (Illus 23-5). There was no access to the interior.

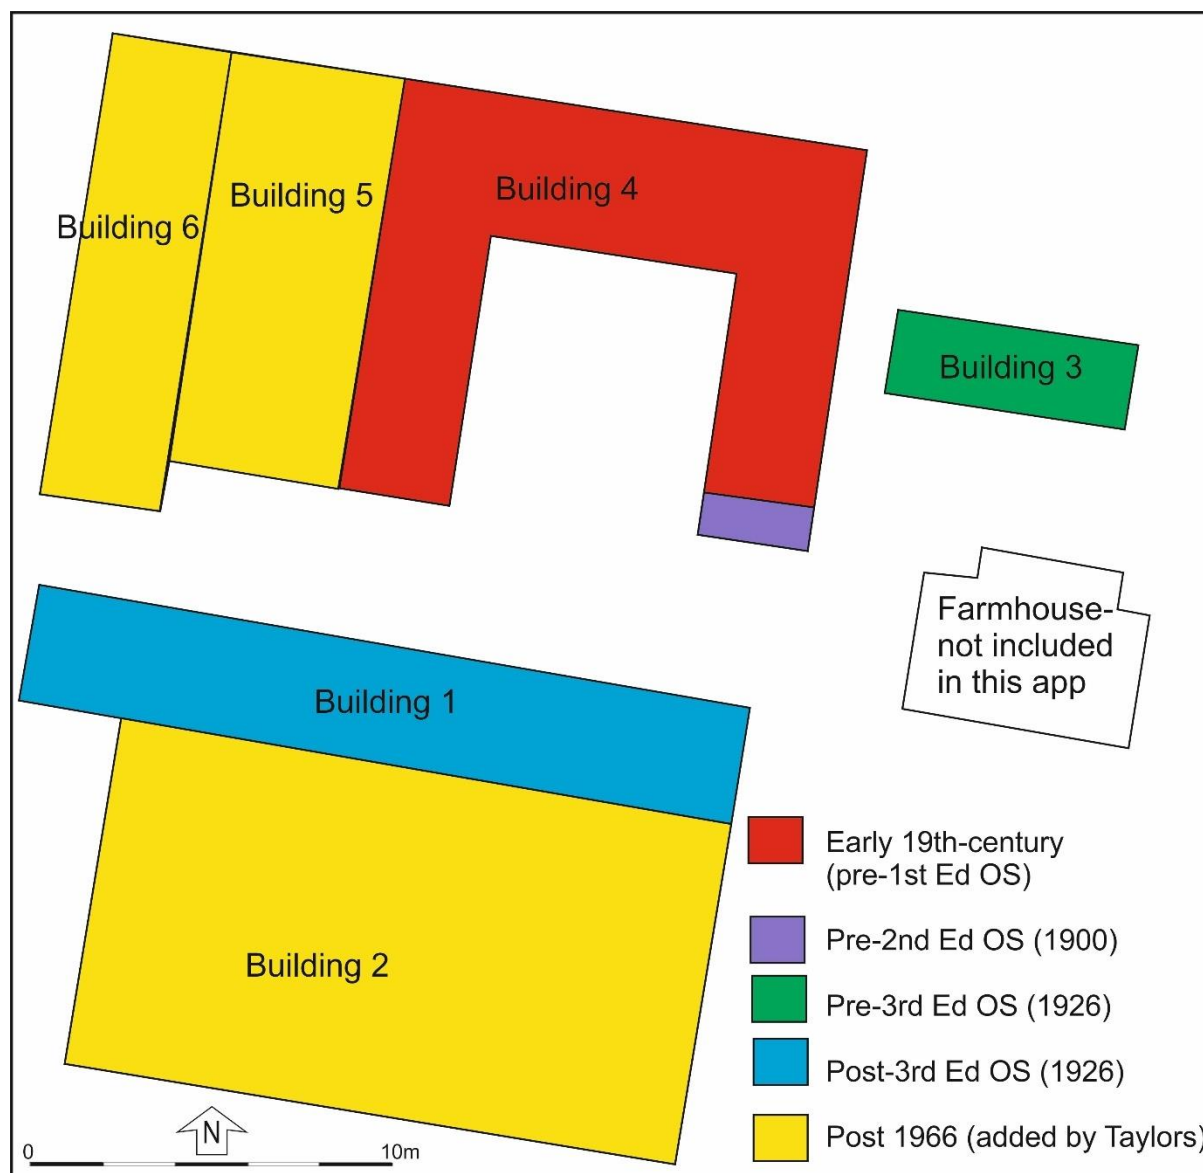
Illus 27 Phase plan

A Level 1 standing building survey was carried out on 11 July 2019. At least 5 phases of building were record including a C-shaped early 19th-century steading around a central courtyard (Building 4) which was extended to create a cartshed prior to the 2nd Edition OS map. Building 3 was constructed pre-1926 and Building 1 probably constructed in the mid 20th-century as a silo barn. Post-1966 additions include Buildings 2, 5 and 6.

It is recommended that no further archaeological work is required during the current planning application.
