Site At Burnside of Kirkbuddo, by Forfar, DD8 2NR
Report on Level 1 Standing Building Survey

Angus Council Planning Ref : 20/00201/FULL

Alison Cameron
Cameron Archaeology
21 July 2020

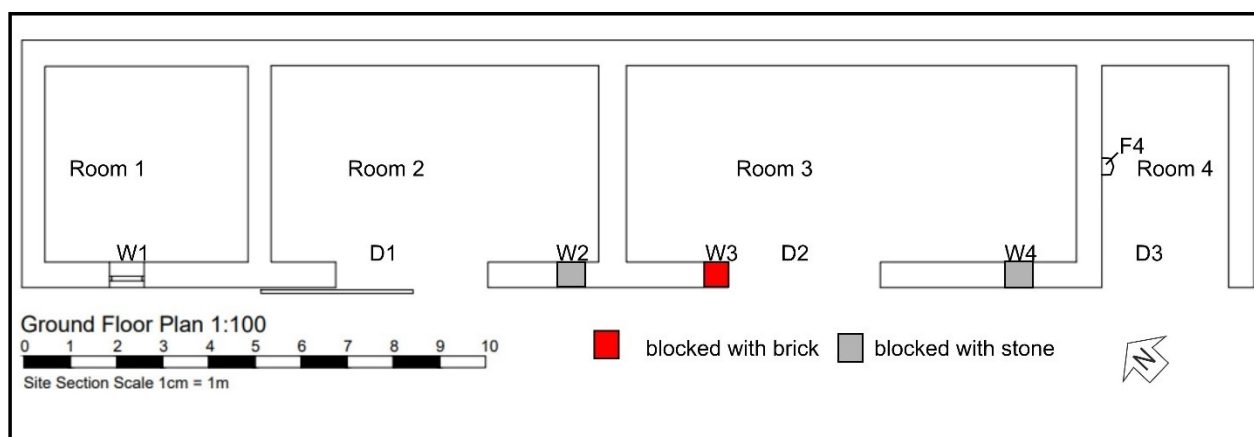
Illus 2 Plan annotated with numbers used in this survey (copyright AB Roger & Young)

The building is 26.7m long and 5.3m wide. It is constructed of quarried sandstone and was built in one phase. There are 4 rooms: Rooms 1 and 2 are not accessible and have a grey slate roof. Room 3 is mostly not accessible as the corrugated metal roof has slipped to the NE (Illus 7). Room 4 is 5.3 x 2.8m in size and is overgrown and unroofed. Room 1 has a rotten wooden floor and a fireplace on the NW wall under brick chimney F1. There is also a brick chimney above the gable between Rooms 1 and 2 and a stone chimney above the SE gable of Room 2. The chimney which had stood above the SE gable of Room 3 has now fallen. There is a stone standing proud from the NW wall of Room 4 (F4) but the room is completely overgrown with rubble on the floor and it is not possible to tell what this stone was associated with.

There are windows on the SW façade: W1 in Room 1 (Illus 4), W2 in Room 2 (Illus 5) and W4 (Illus 6) in Room 3 both blocked with stone and a possible blocked window W3 which has been infilled with brick and now forms the NW jamb of D2. D1 is inaccessible behind a rusted metal door and D3 may have been smaller but there is now no evidence of jambs on the SW wall of Room 4 (Illus 8).
