**Steading 60 Metres North East Of Islabank House,  
Coupar Angus  
Data Structure Report, Historic Building Survey**

**Perth and Kinross Council 20/00282/FLL**

**Alison Cameron  
Cameron Archaeology  
24 September 2020**

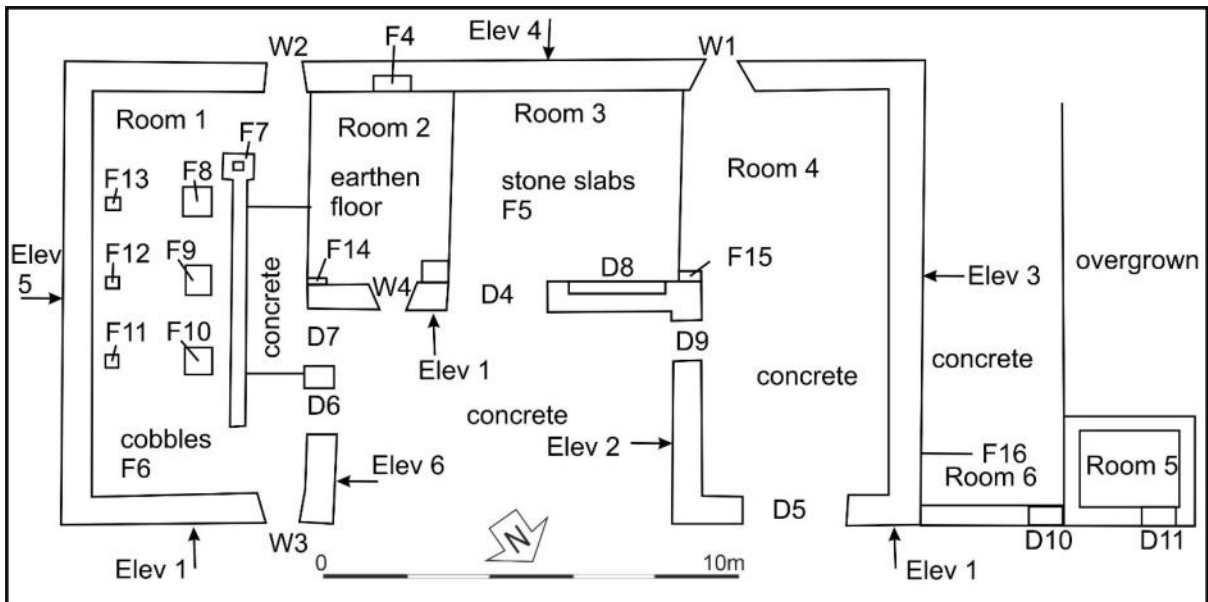
Illus 4 Plan of steading annotated with numbers used in this survey (redrawn from copyright The Building Workshop)

The steading consists of 6 rooms: Room 1 was stabling for animals. There is a window on the SW wall (W2) and one on the NE wall (W3) and two doors (D6, D7) on the NW wall to access the building from the courtyard. It has plastered walls and a waterwashed cobble floor (F6; Illus 9, 10) with a concrete drain F7 and stone blocks with post-holes for the uprights for stalls (F8-F13) in two lines of three. F8, 9 and 10 are 0.65x0.67m in size with a hole c0.25m diameter. F11, 12 and 13 are 0.4x0.4m in size with a hole 0.15m diameter. There are scars on the SE wall where the stalls have been removed (Illus 8). There is a concrete floor on the NW side of the room inside door D7.

The walls of Room 2 have been removed but it was a small wood-paneled room with fireplace (F4) on the SW wall (Illus 11); F4 has a sandstone surround and is 0.92mx0.92m in size and 0.42m deep. There is a window on the NE wall of Room 2 and there is now an earthen floor; the room was presumably used as a bothy for staff. Room 3 has also had the walls removed and has stone slabs (max 0.5 x 0.8m in size) on the floor (Illus 12) and originally had two cart doors on the NE wall. D4 is still open but the lintel has been replaced with a steel beam covered with concrete to mimic the tooled sandstone and the jambs replaced so its original width cannot be determined. D8 has been infilled with concrete blocks which have also been covered with textured concrete to mimic tooled sandstone. These two large doors suggest that Room 3 was a garage for vehicles. Room 4 has a concrete floor and plastered wall and has a window W1 on the SW wall, large door D5 on the NE wall and smaller door on the SE wall. The room may have been divided but has been in general agricultural use.

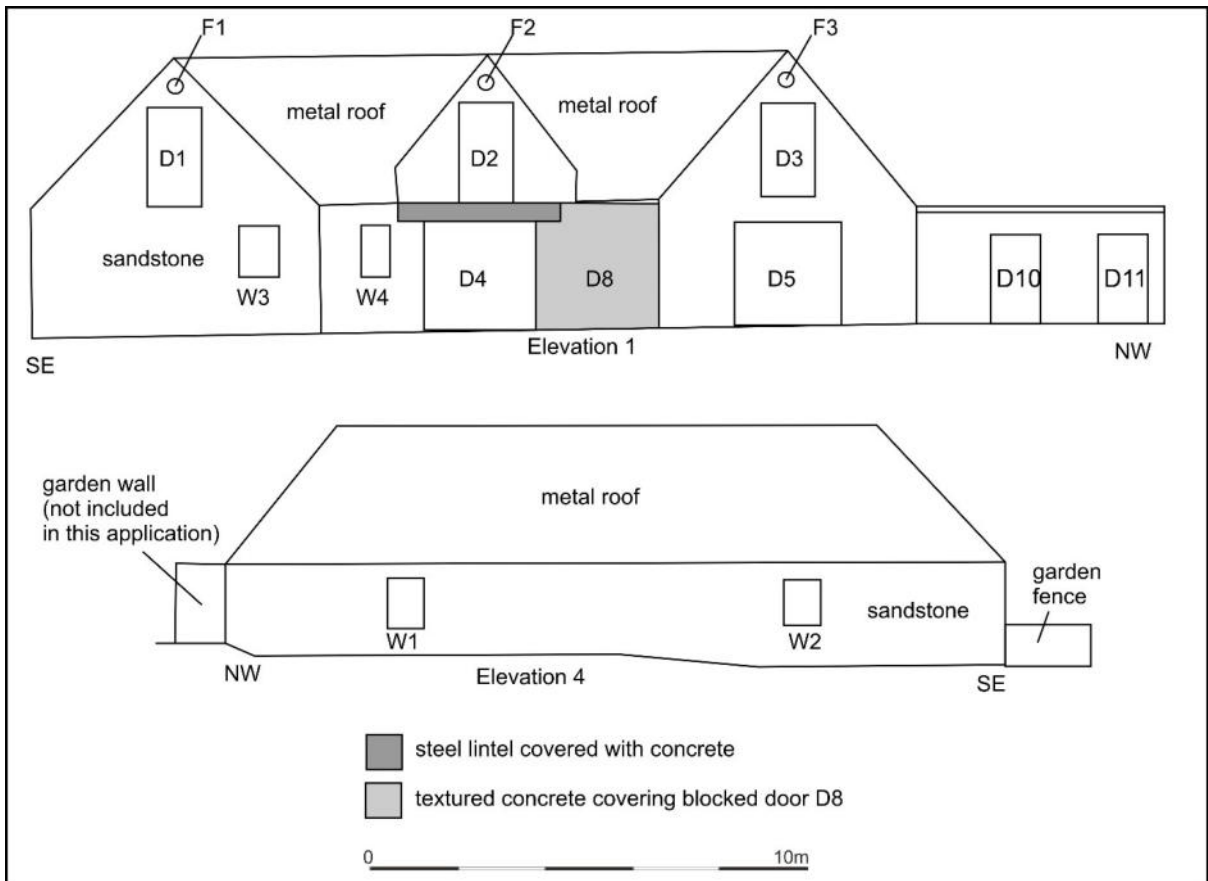
Illus 5 Elevations of steading annotated with numbers used in this survey (redrawn from copyright The Building Workshop)

The upper floors are not present but there are joists where the floor has been removed. On the first floor there are 3 doors on the NE elevation (D1-3) each with a small circular ventilation hole above (F1-3; Illus 7).
