**Land To The North East Of East Kinharrachie Farm,
Kinharrachie, Ellon, Aberdeenshire, AB41 8PQ**

Report on Level 2 Standing Building Survey

**Alison Cameron
Cameron Archaeology
15 February 2022**

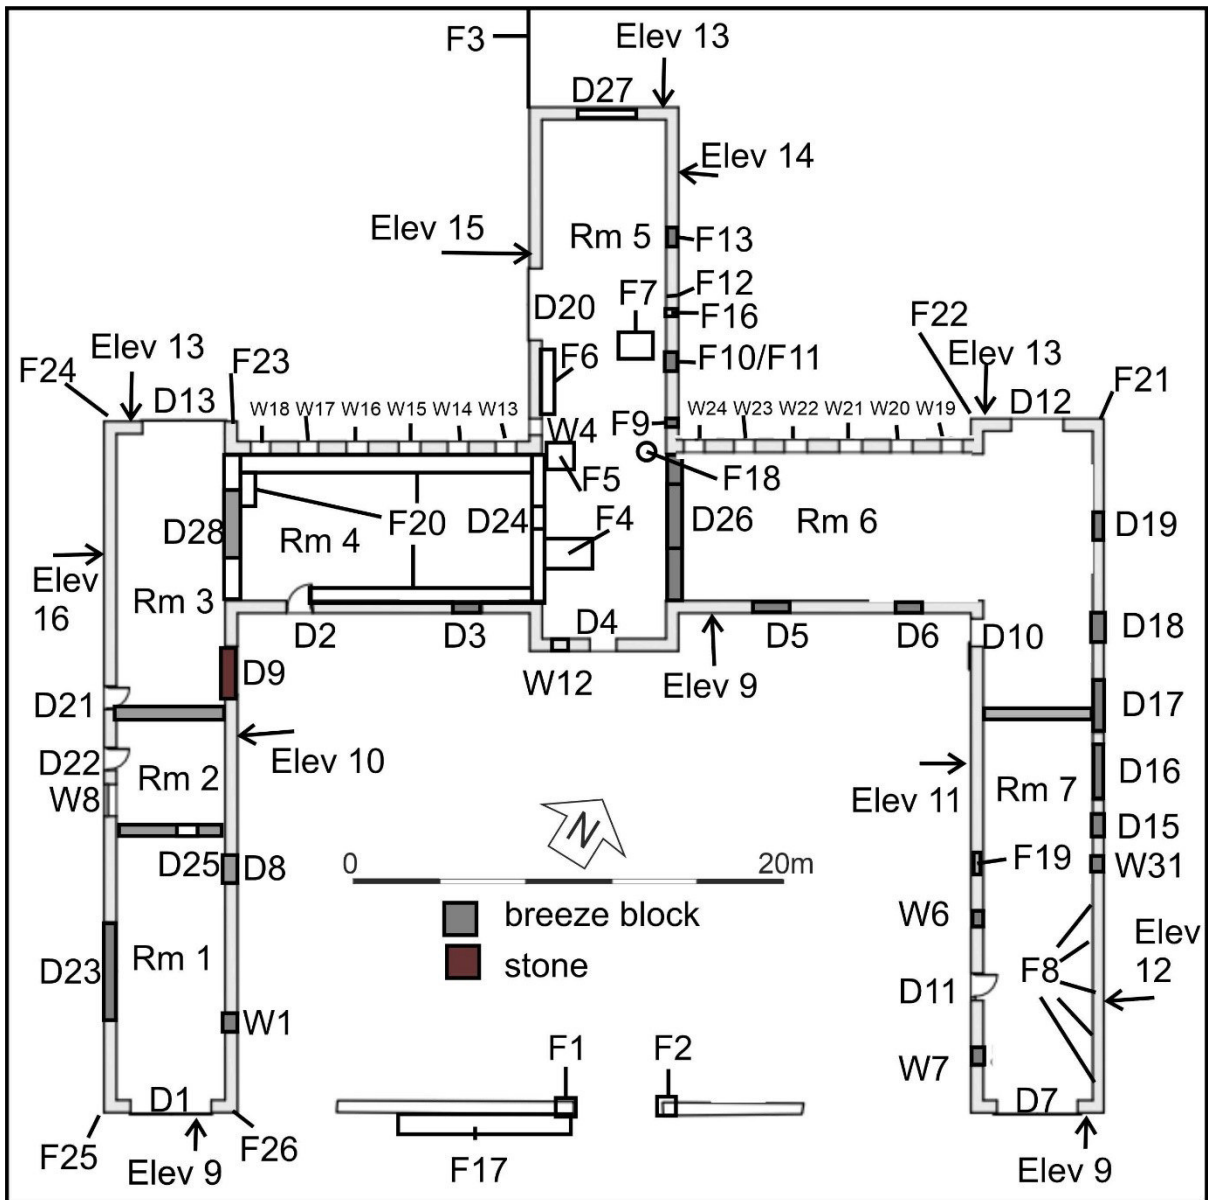
Illus 3 Building 1 ground floor plan annotated with numbers used in this survey (copyright Annie Kenyon Architects)

Room 1 at the SSE end of the WSW wing is 5.05x12m in size with cart door D23 on the WSW wall, D8 and W1 on the ENE wall (all blocked with breeze blocks in Phase 2; Illus 3). There is a breeze block partition wall forming the NNW wall of this room with modern door D25 into Room 2. Room 2 is a modern division 5.05x3.35 which was an office for the security company which most recently occupied the site. There is a door D22 and window W8 in the WSW wall. There is a breeze block division between Rooms 2 and 3 with no access. There are stone skewputts on the SSE gable (F25, F26). D1 is a rebuilt cart door in the SSE gable.

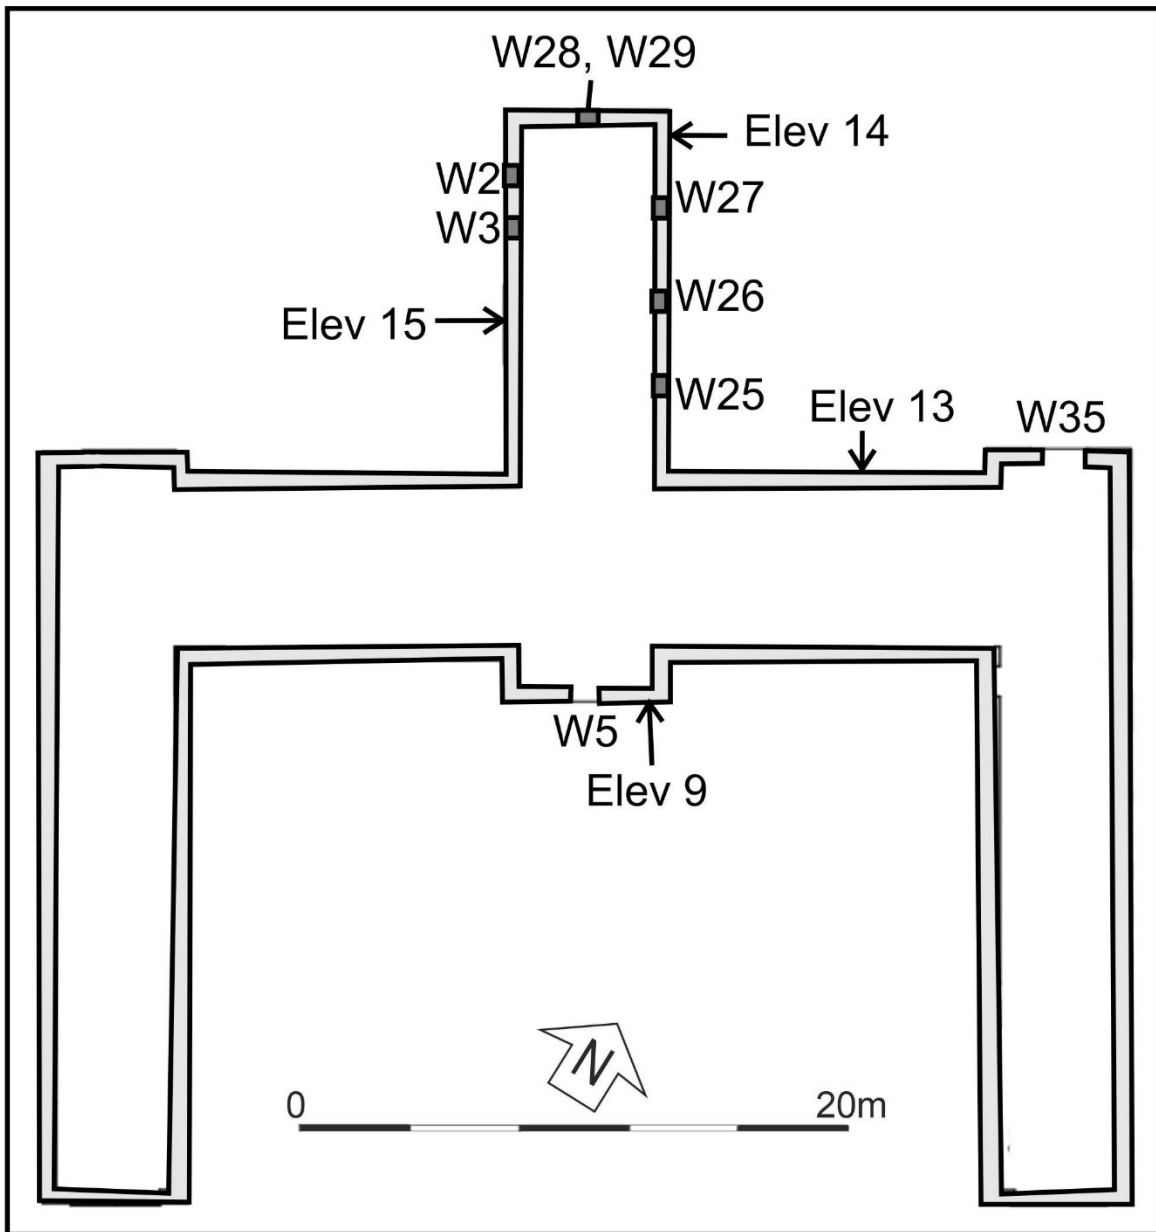
Illus 4 Building 1 first floor annotated with numbers used in this survey (copyright Annie Kenyon Architects)

Room 7 in the ENE wing is 5m wide and 17.93m long and is divided from Room 6 with a breeze block wall. The ENE walls of Rooms 6 and 7 have a series of doors infilled with breeze blocks – D19, D18, D15 and cart doors D17 and D16 and also window W31; Illus 4. Room 7 has a large cart door (D1) in the SSE gable but this has been altered in the 20th century with breeze blocks. There is D11 and windows W6 and W7 as well as fireplace F19 on the WSW wall, all filled with breeze blocks except D11. The SSE end of the ENE wall shows scars in the plaster (F8) where five animal stalls were sited which have been removed indicating housing for animals. There is a modern cart door on the SSE gable (D7).

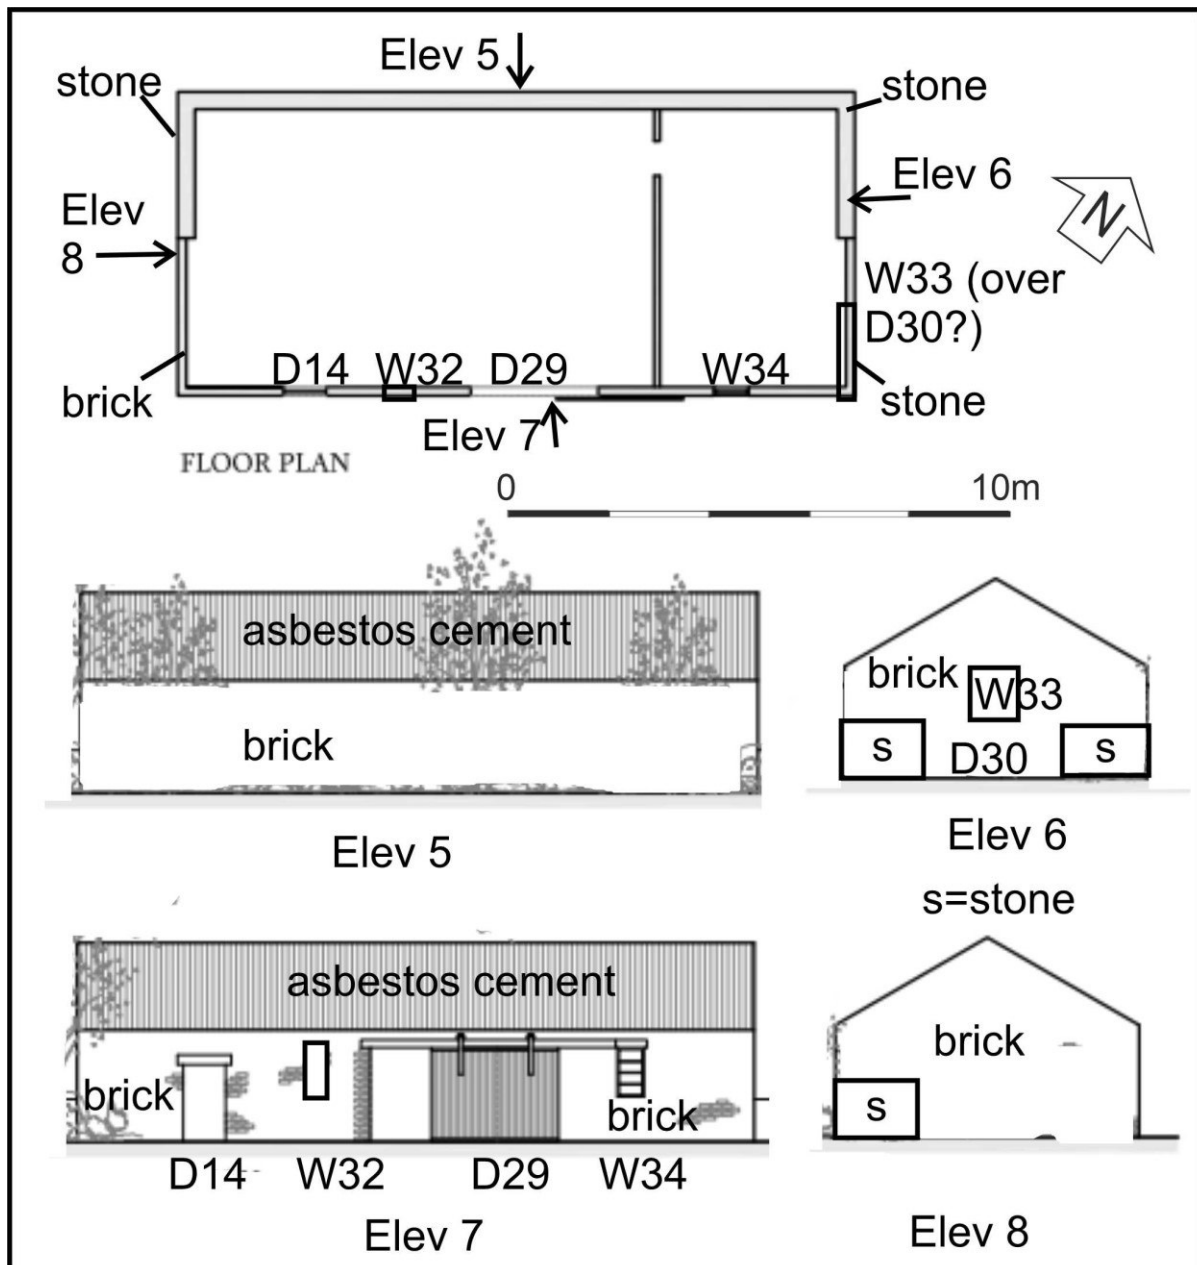
Illus 27 Building 2 plan and elevations annotated with numbers used in this survey (copyright Annie Kenyon Architects)

Building 2 (Illus 27) is 17.25m long and 7.68m wide with a Phase 1 fieldstone rubble core (Illus 30). The stone building was constructed between 1899 and 1924; there is a scar in the SE corner where a garden wall was demolished. The ENE wall has a gap 3.33m wide between the stone core and this may have represented a door (D30). No other Phase 1 apertures survive.

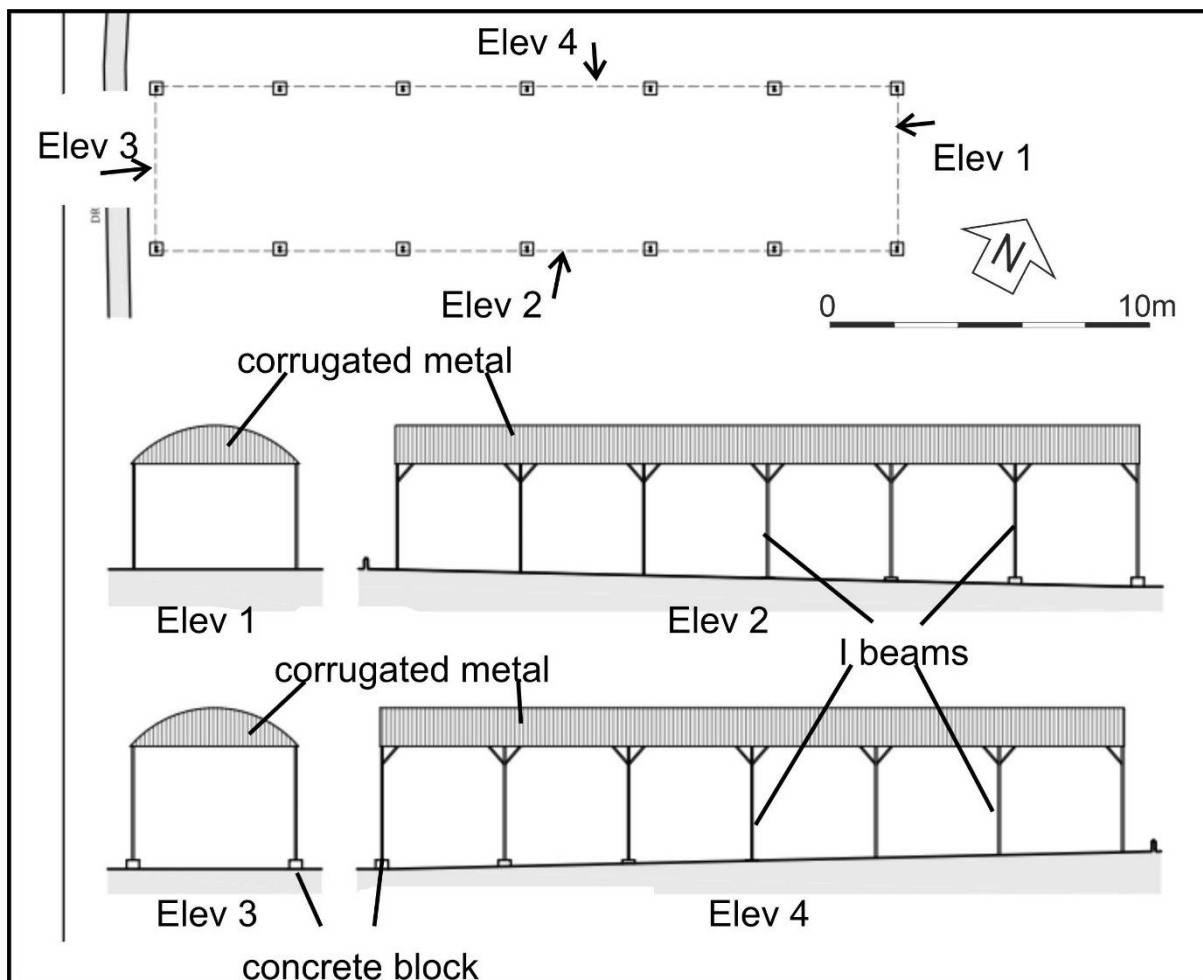
Illus 32 Building 3 plan and elevations annotated with numbers used in this survey (copyright Annie Kenyon Architects)

Building 3 is a Dutch barn 5.84m wide, 4.2m high and 29.19m long. Cast iron I beams are set on concrete block foundations 0.46x0.44x0.33m high. The I-beams and 0.15x0.08m in size and the roof is arched corrugated metal. The building has an earthen floor.

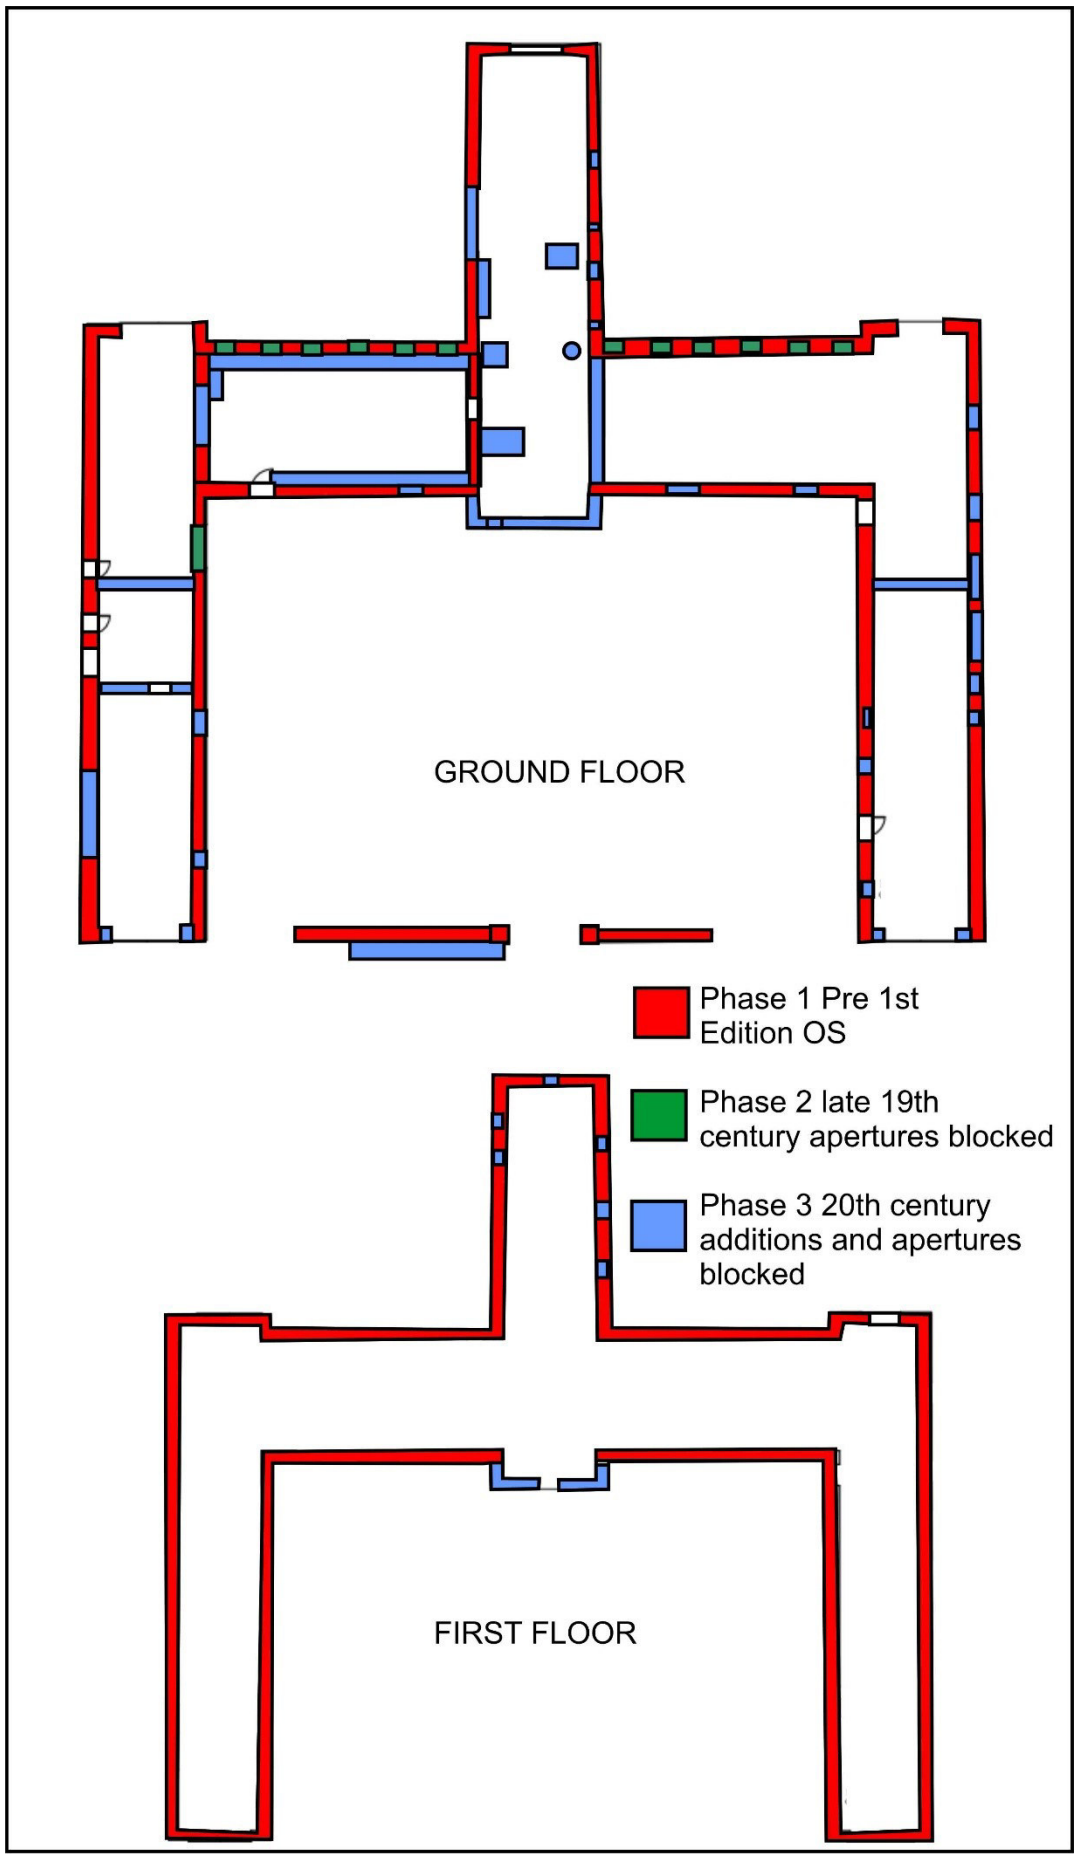
Illus 34 Phase plan ground and first floors (from copyright Annie Kenyon Architects)

A Level 2 standing building survey was carried out on 11 February 2022; a phase plan is shown in Illus 34. The U-shaped steading has been in use as a mill with extensive lade and millponds (all now infilled). There is evidence of the location of the waterwheel and apertures for connecting to interior mechanisms. There are hoppers within the central section of the mill suggesting that it was in use as a mill until recent times. The wings were both converted for animal use with concrete floors and walls, troughs and animal stalls and then areas of the WSW wing were in use as an office. Building 2 has a stone core of a building seen on the 3rd Edition OS map with a brick superstructure and Building 3 is a Dutch barn.

It is recommended that no further archaeological work is required during the current planning application.
