STANDING BUILDING SURVEY  
PARK HOUSE,  
120 WESTBURN ROAD, ABERDEEN

CAMERON  
ARCHAEOLOGY

20 July 2010

# Standing Building Survey

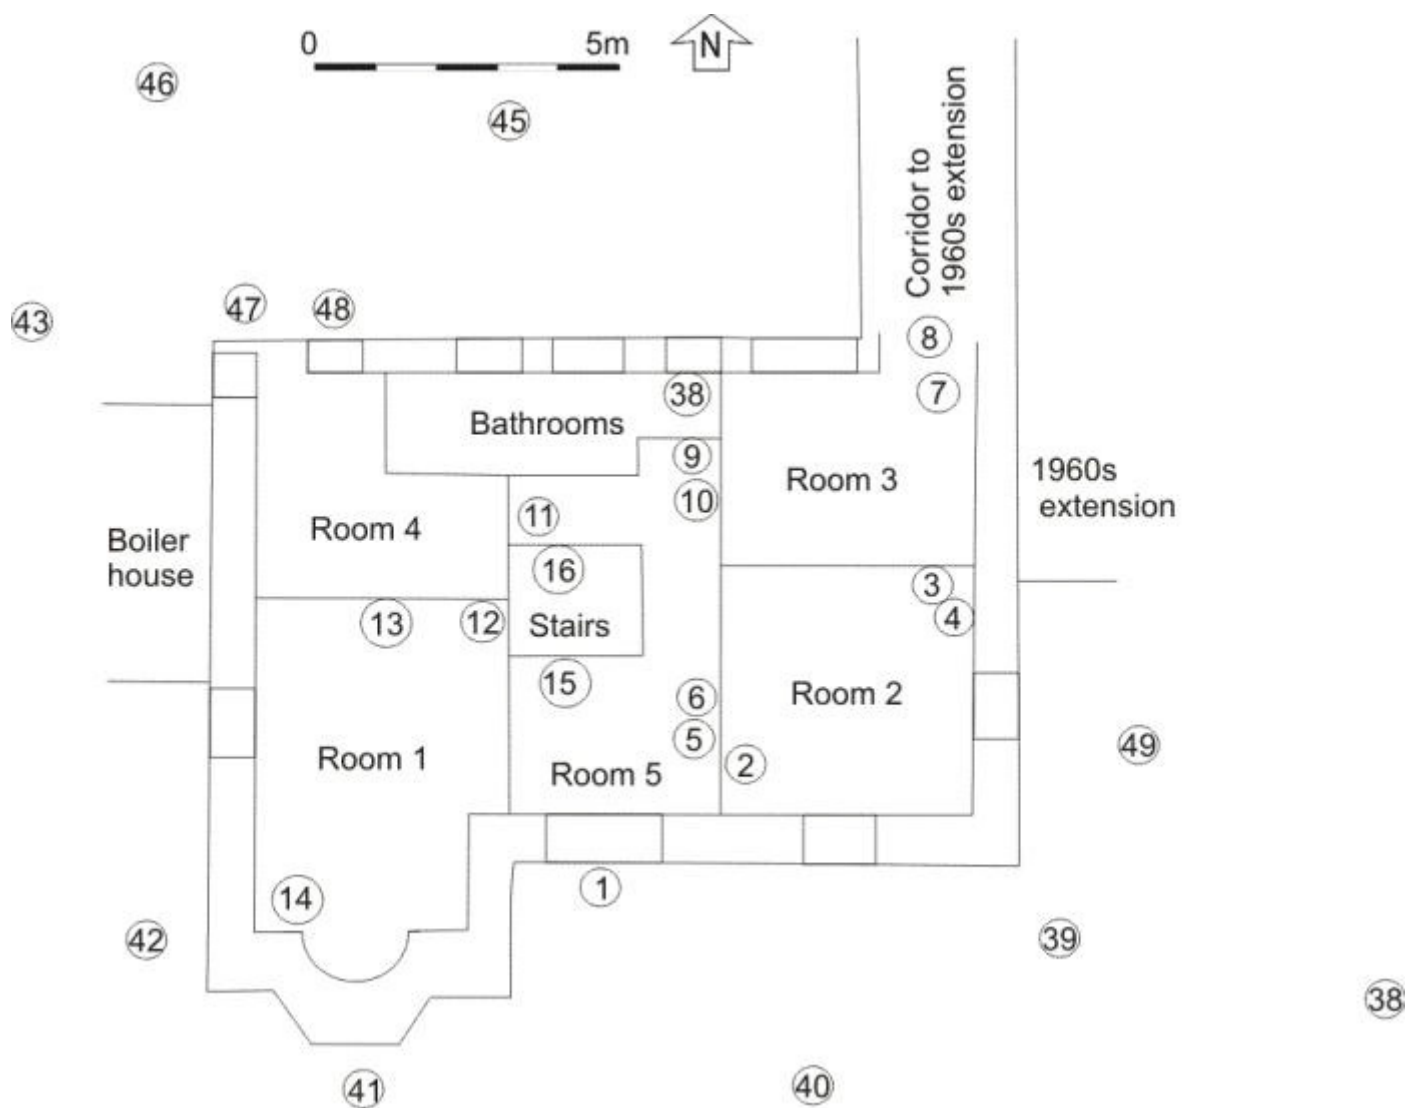
III 9 Ground floor plan showing photography locations (see Appendix 3)

The house is of a traditional type with two large reception rooms at the front of the ground floor and two smaller family rooms at the rear. Rooms 1, 2 and 3 have original cornices; Room 4 has been altered presumably in the 1960s and the cornice removed at that time. The house has a central stairwell with an original wooden handrail and cast iron balluster. No original fireplaces are present as all have been removed to install modern heating.

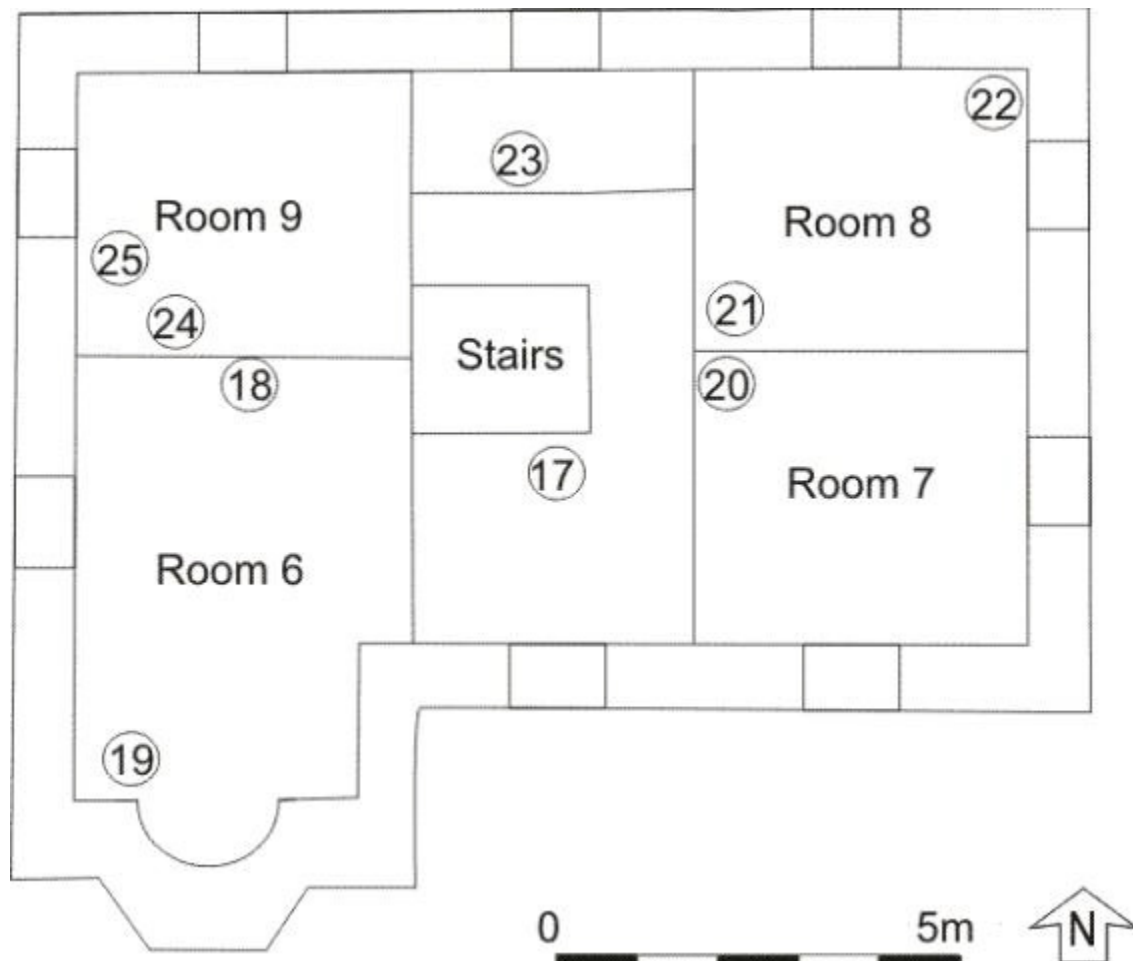
III 12 First floor plan showing photography locations (see Appendix 3)

The first floor follows a similar layout to the ground floor with Room 6 being of a similar grand style to Room 1 but without the cornice. Rooms 7, 8 and 9 all have original corncicing. In Room 9 plaster has been removed from one wall and and the original lathe and plaster construction can be seen.

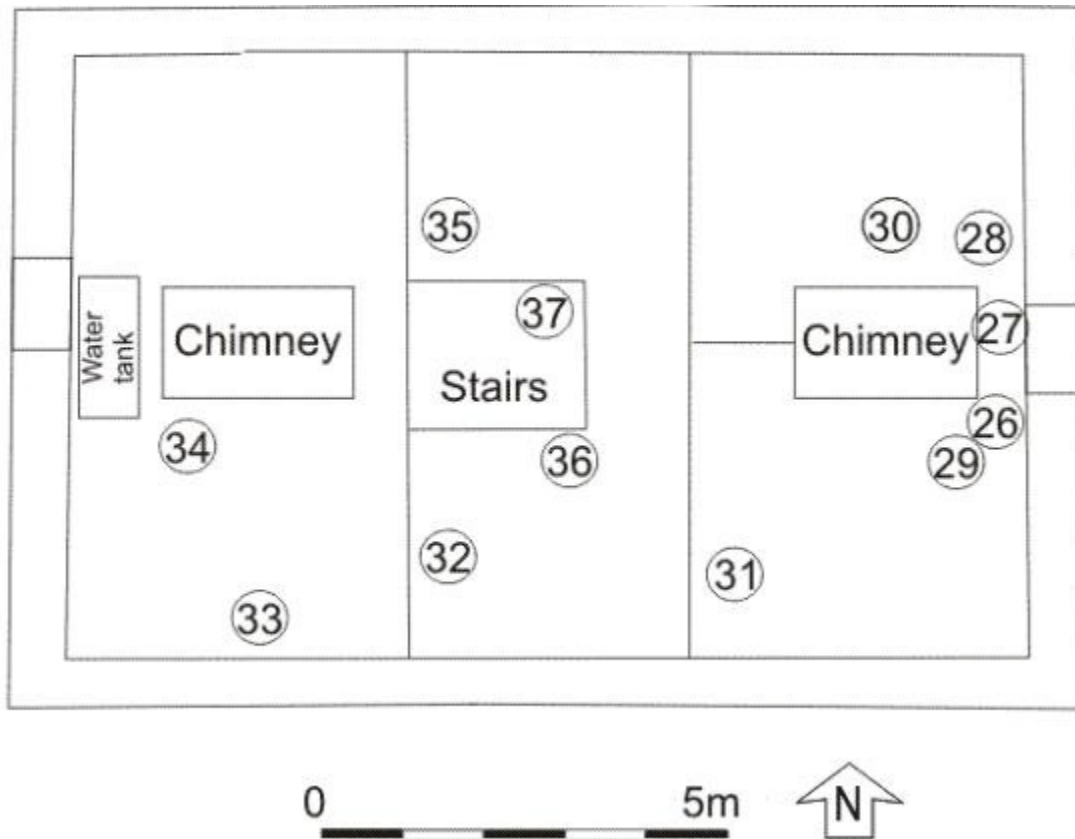
III 13 Eaves and attic floor plan showing photography locations (see Appendix 3)

The roof space and eaves contain two chimney breasts and water tank. The walls have been plastered and there is no access to examine the structure of the roof. Arched windows in the west and east gables allow light into this space.
