STANDING BUILDING SURVEY,
FARM STEADINGS, PITTODRIE HOUSE
HOTEL, ABERDEENSHIRE, AB51 5HS

CAMERON ARCHAEOLOGY
17 December 2010

SUMMARY

A standing building survey was carried out on farm steadings at Pittodrie House Hotel prior to demolition of derelict buildings and conversion of part of the complex into timeshare facilities.

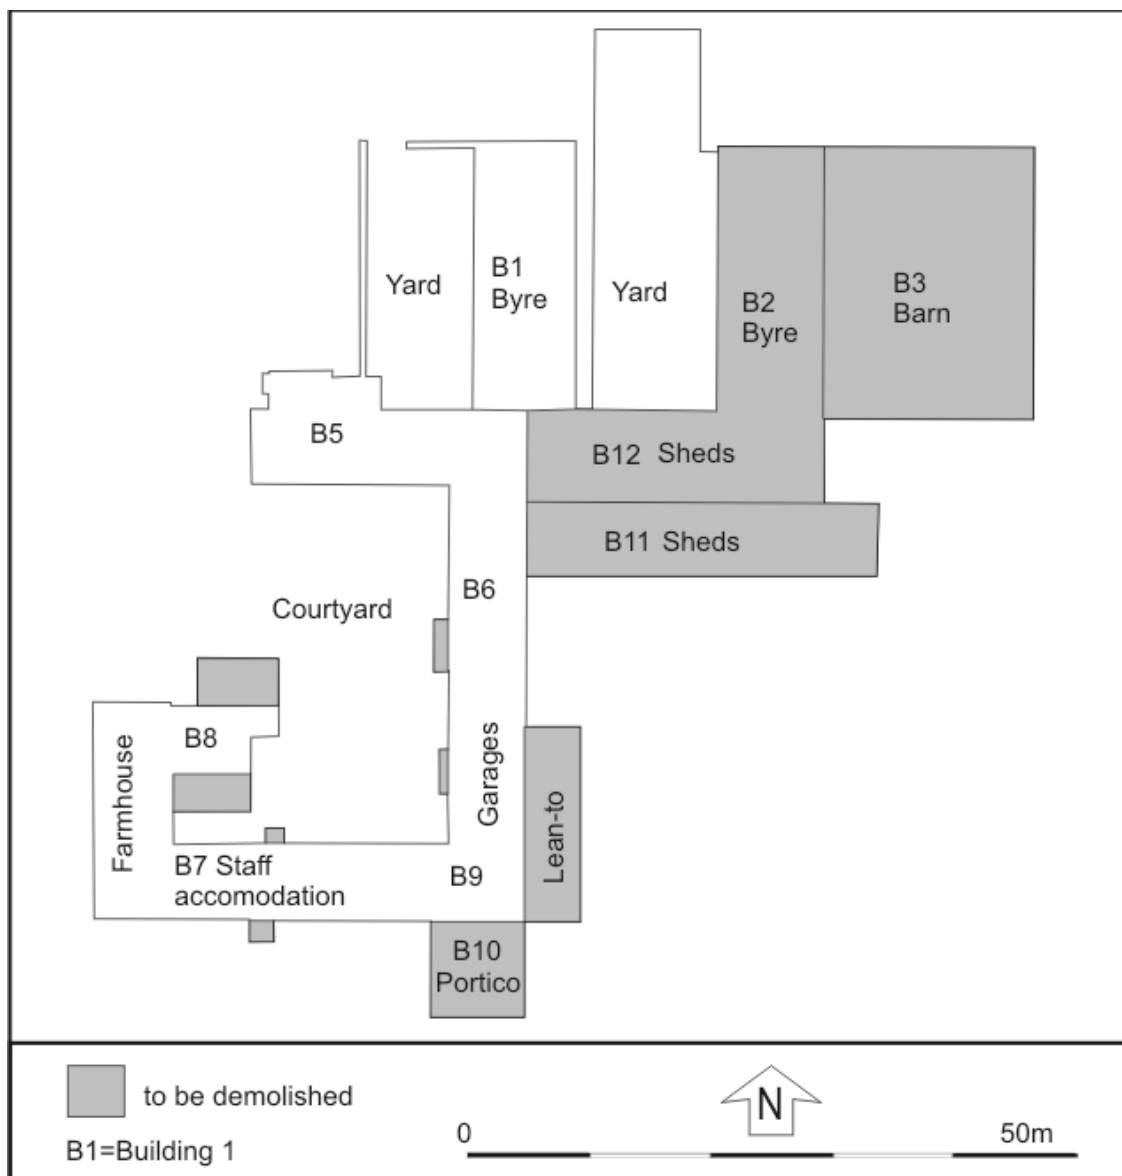
III 3 Survey building numbers and buildings to be demolished

A standing building was carried out on 9th December 2010 (III 3). The snow was lying up to 1m deep on the site and banked up against the buildings and on the roofs. Some of the buildings were inaccessible either because of the snow (B5) or because they were in a state of collapse (B2, B3). B7 is in use as staff accommodation and was therefore not accessed. Buildings B6, B8 and B9 had been heavily modernised internally during the late 20th century.

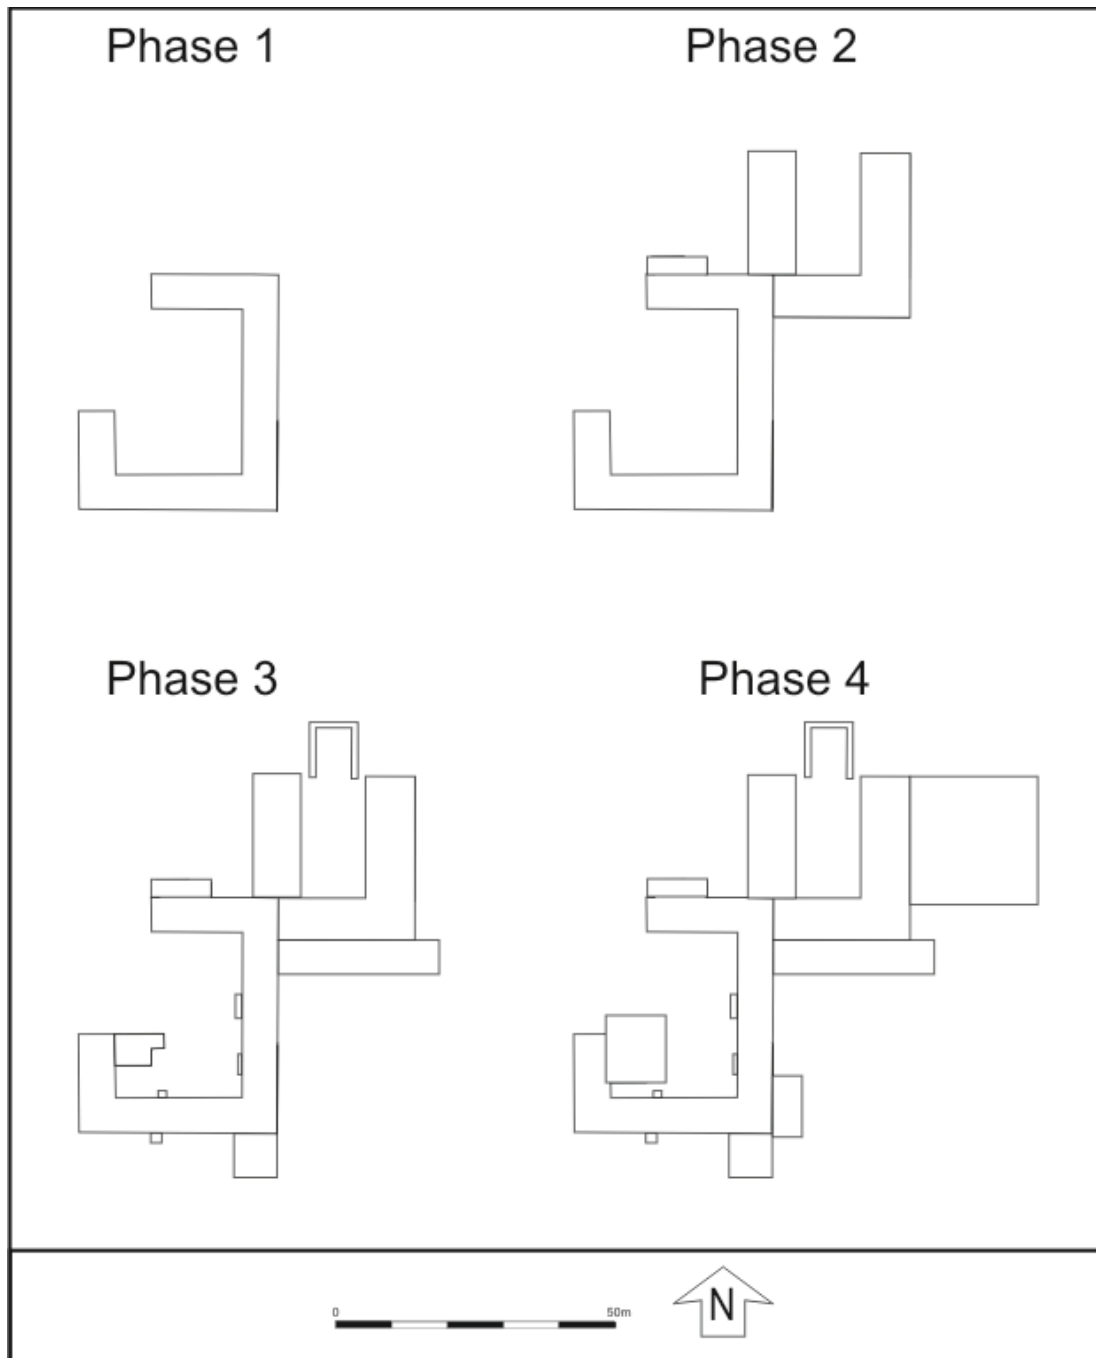
Ill 26 Phase plan showing approximate building phases

The standing building survey was hampered by ruinous buildings and snow. All the buildings were photographed in their current condition and a phase plan has been prepared (Ill 26).

Although some of the buildings are ruinous and were not fully accessible and all were covered with snow, the earlier phases of the building were thoroughly recorded and the buildings to be demolished were adequately recorded. It is recommended that no further work is required during the current development but the final decision remains with Moira Greig, Aberdeenshire Council.
