Kennall Vale, Ponsanooth, Cornwall

Archaeological management and interpretation

Client	Conserving Cornwall's Past
Report Number	2011R021
Date	May 2011
Status	Final
Report author(s)	Ann Preston-Jones
Checked by	Peter Rose
Approved by	Peter Rose

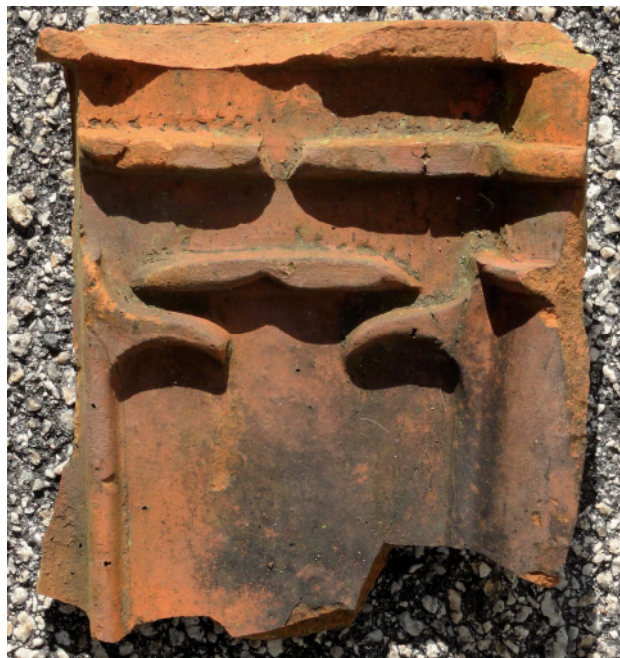
Fig 12 Pan tile from ground adjacent to cask house

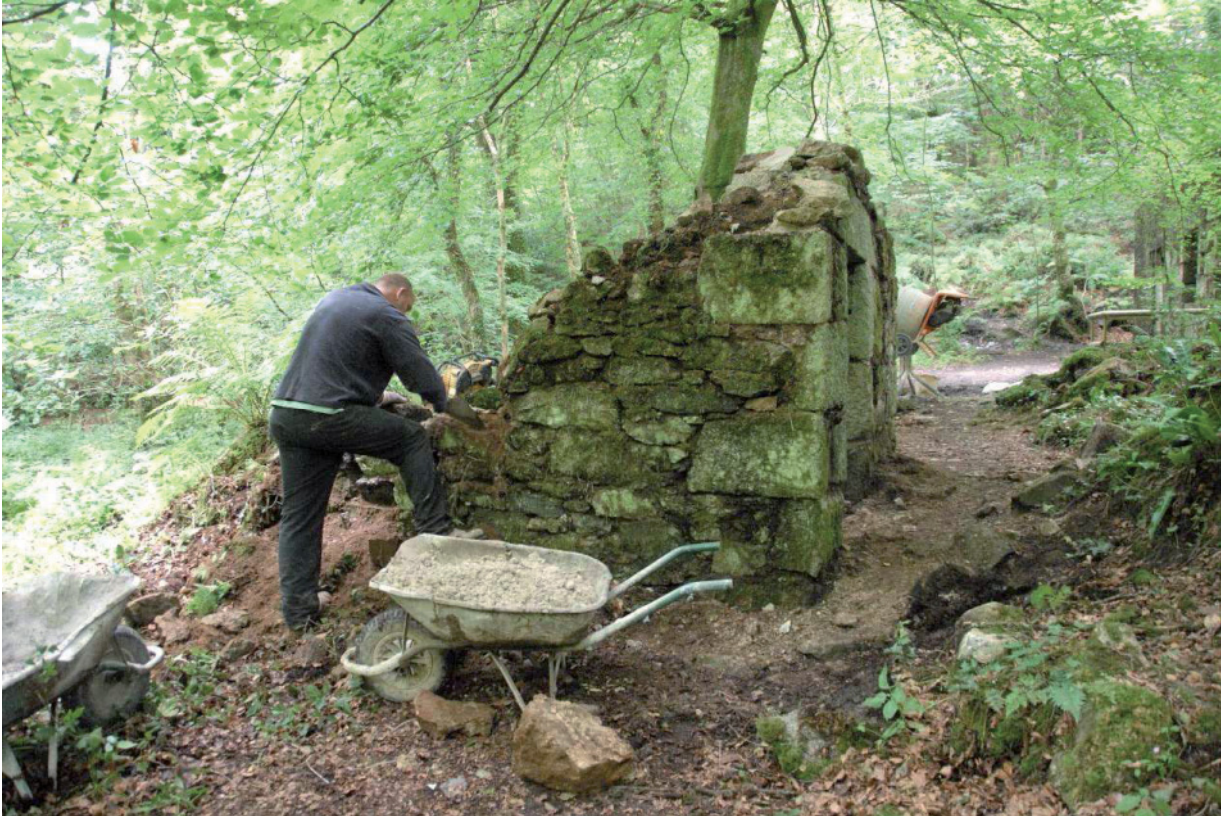
Fig 13 Work in progress on cask house

The repair work was carried out in July 2009, under the supervision of Adam Sharpe of Historic Environment (Fig 13).

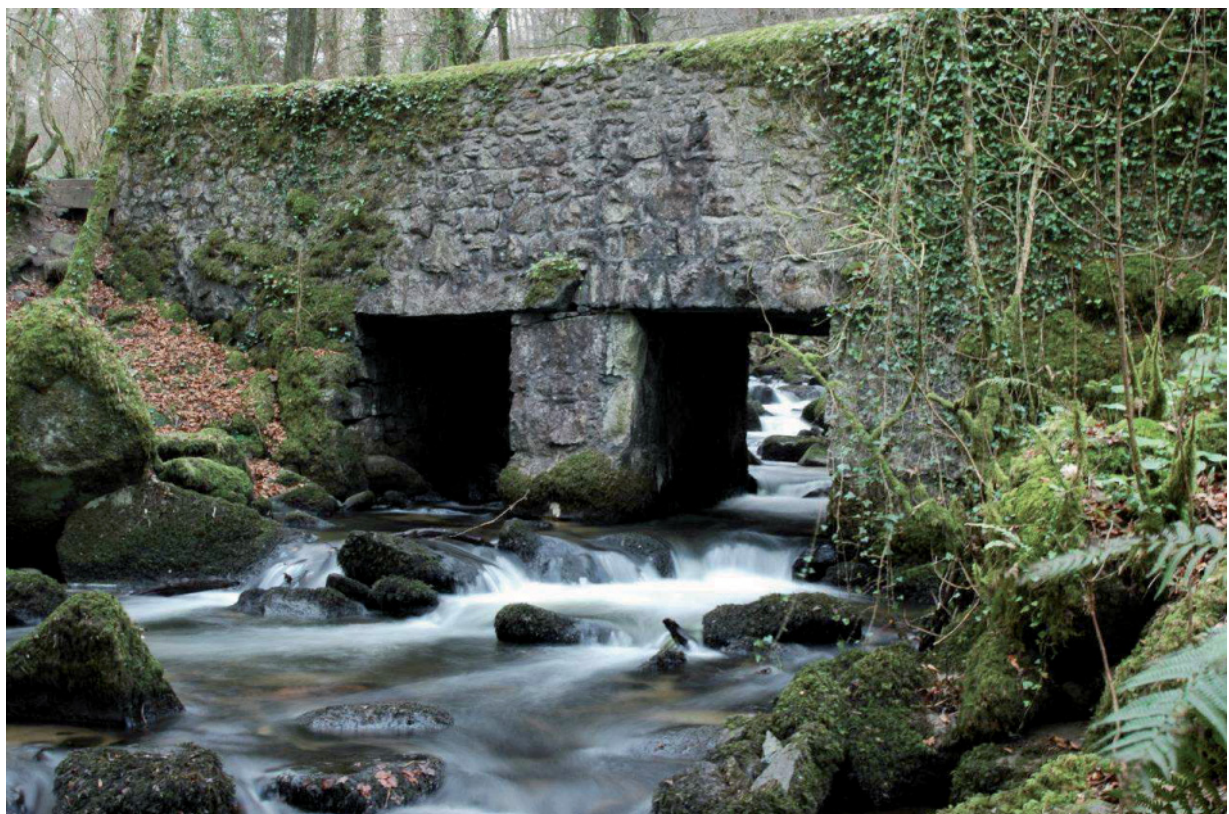
Dating from the 1844 extension of the gunpowder works, this bridge was built to link the original lower works with the newly-developed complex. It is a two-span bridge constructed of granite lintels laid across stone piers, with a parapet of very roughly coursed granite rubble (Figs 16 and 17).

Fig 16 East face of bridge at west end of reserve

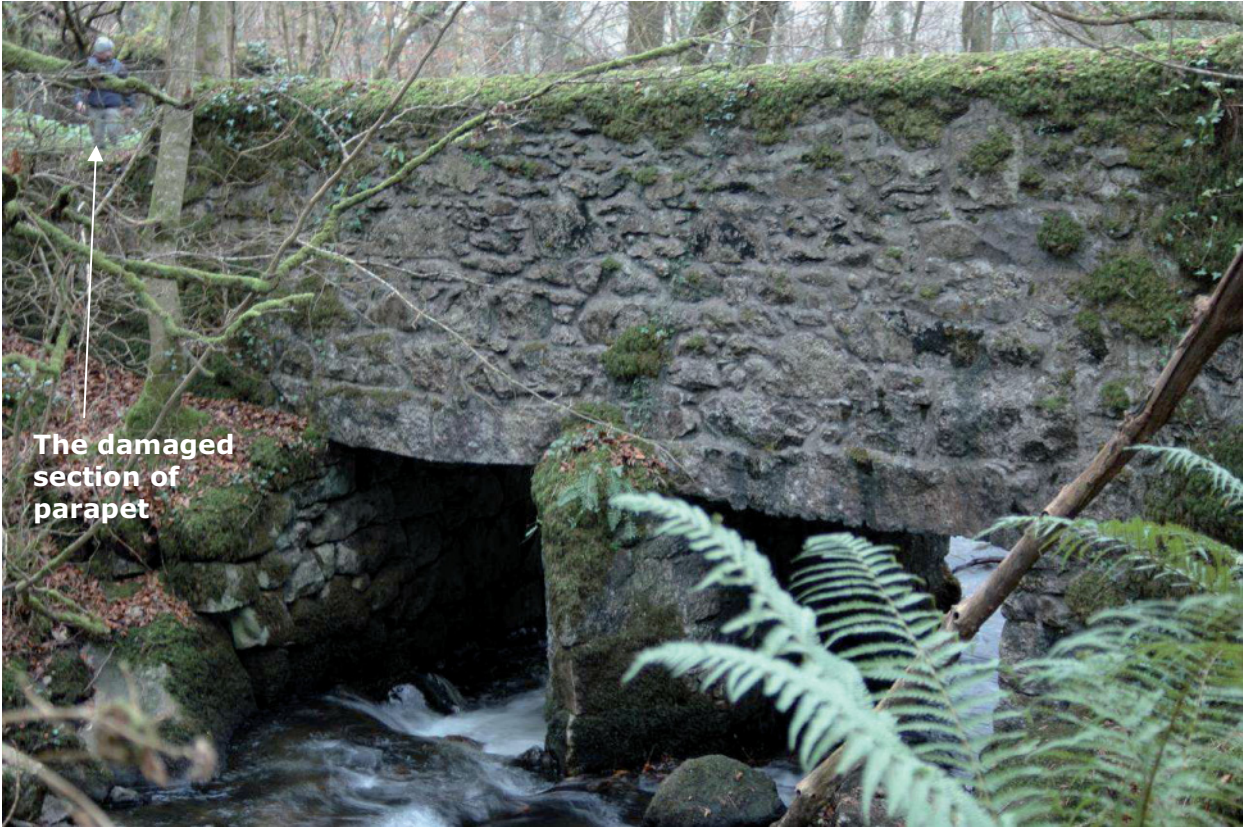
Fig 17 West face of bridge

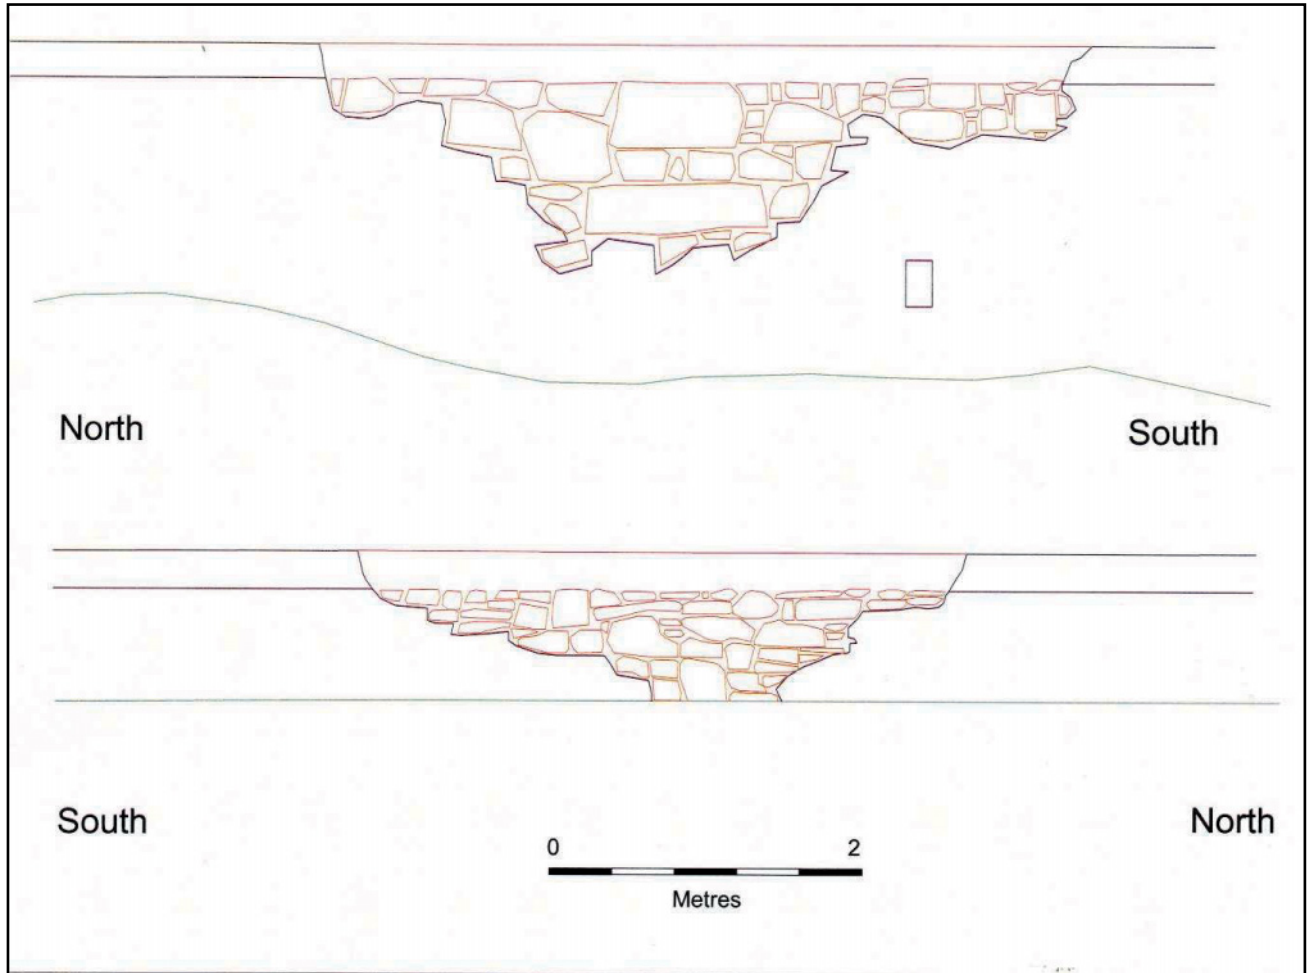
Damage to the parapet of the bridge appears to have taken place before 1999 (Herring 2000, 37), but has never been deemed a priority for repair. However, in December 2008, CWT suggested that it should be repaired, since the damage at this point facilitates access to a 1-metre diameter hole in the ground immediately to the west, where the roof of a culverted section of leat has collapsed, leaving exposed a drop of nearly two metres into the leat below (Fig 18).

The damage affects a four-metre length of the parapet on the causeway leading to the bridge, not the bridge itself (see Figs 19, 20). Lumps of moss-covered masonry lie on the ground to either side of the bridge.

Fig 19 Elevations of the western parapet of the bridge, drawn by Adam Sharpe: above, the exterior face and below, the interior

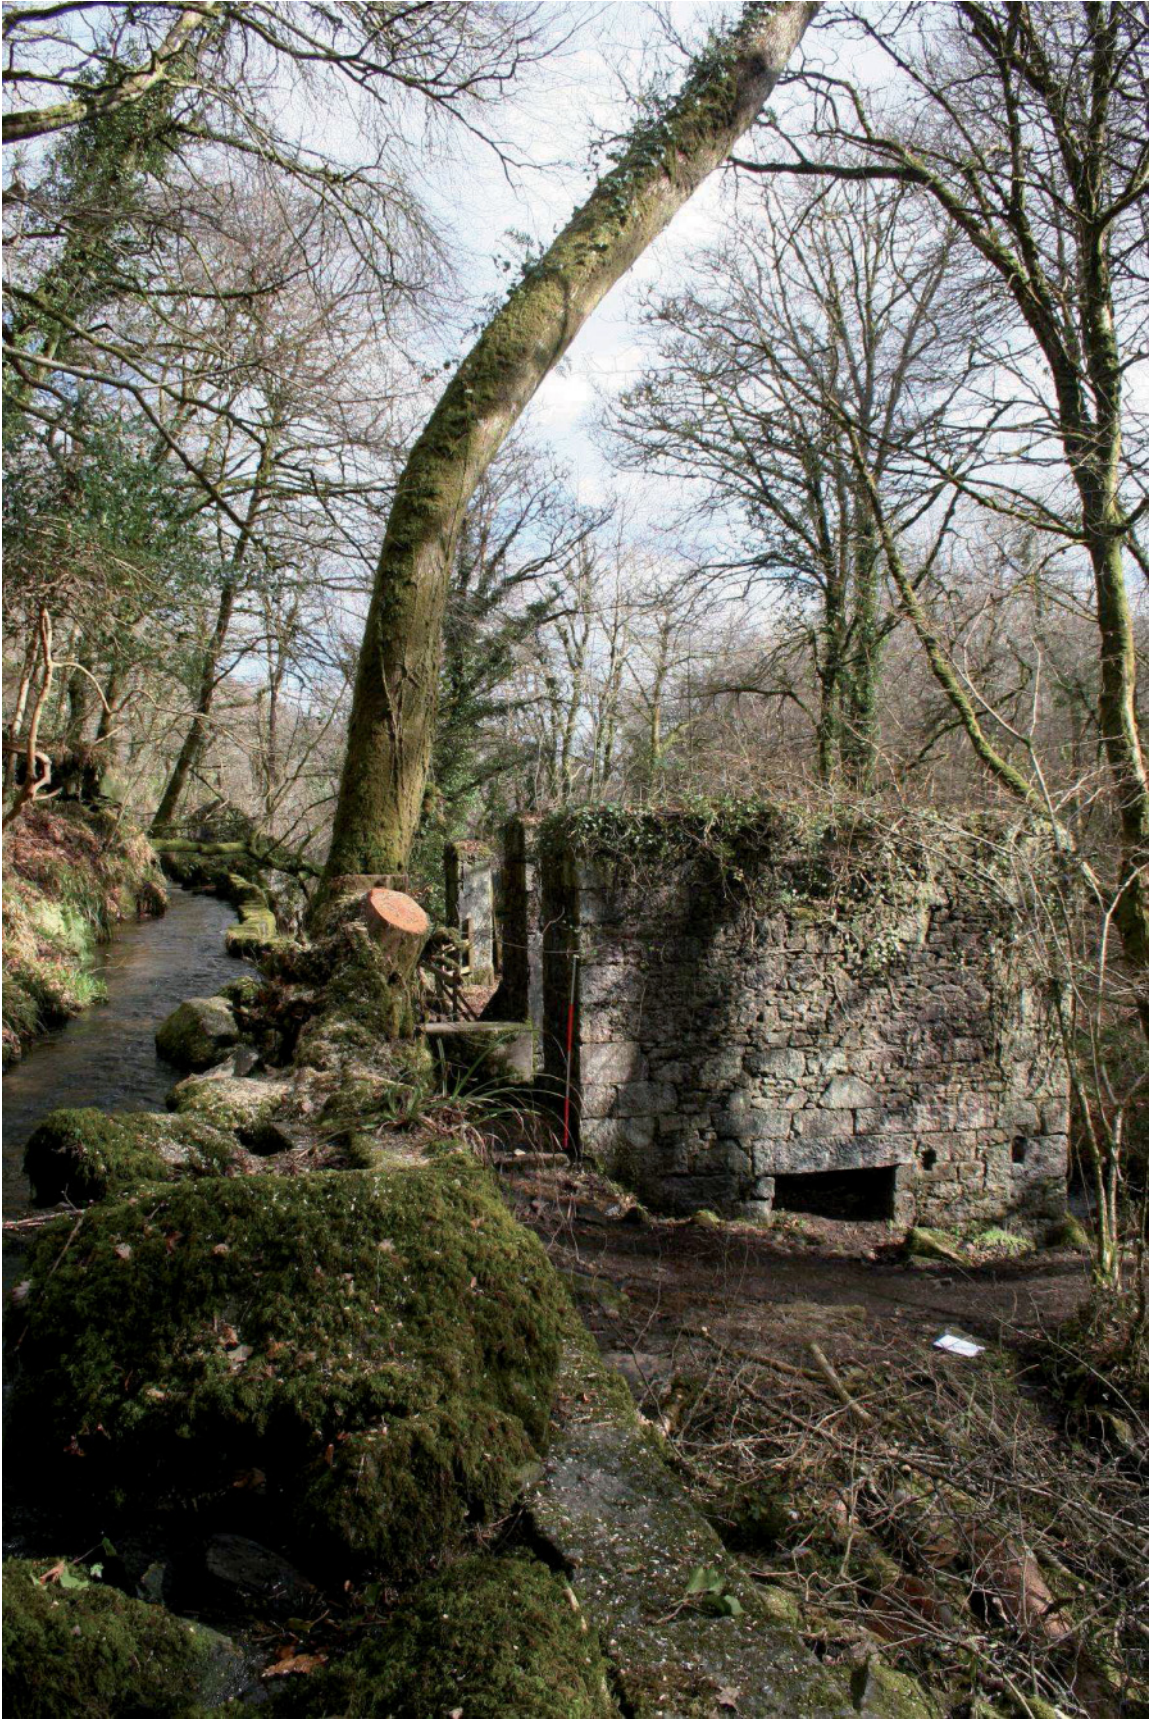
Fig 26 Tree work in progress: one tree has been felled and the other leaning tree is about to go

After much debate on the best use of the limited funding available, it was decided that four trees should be felled as a matter of priority. These were chosen by Nick Marriott, the CWT reserve officer, following survey and discussion with local tree surgeon Aldous George of Up-A-Tree.com. The position of these trees is shown in Fig 24; one example is illustrated in Fig 25. The trees are all rooted into walls and structures: one into a bridge abutment, one into a blast wall, and two into the walls of leats. One, growing in a very inaccessible position in a blast wall, was felled and the stump treated with herbicide to prevent re-growth; the others were cut but not treated, to encourage coppicing, thus making them more stable and less likely to fall but avoiding the risk of masonry collapsing as the roots rot away (Fig 26).
