# **Barn at Lower Cory, Morwenstow, Cornwall**

## **Historic Building Record**

2011R067

Barn at Lower Cory, Morwenstow, Cornwall,  
Historic Building Record

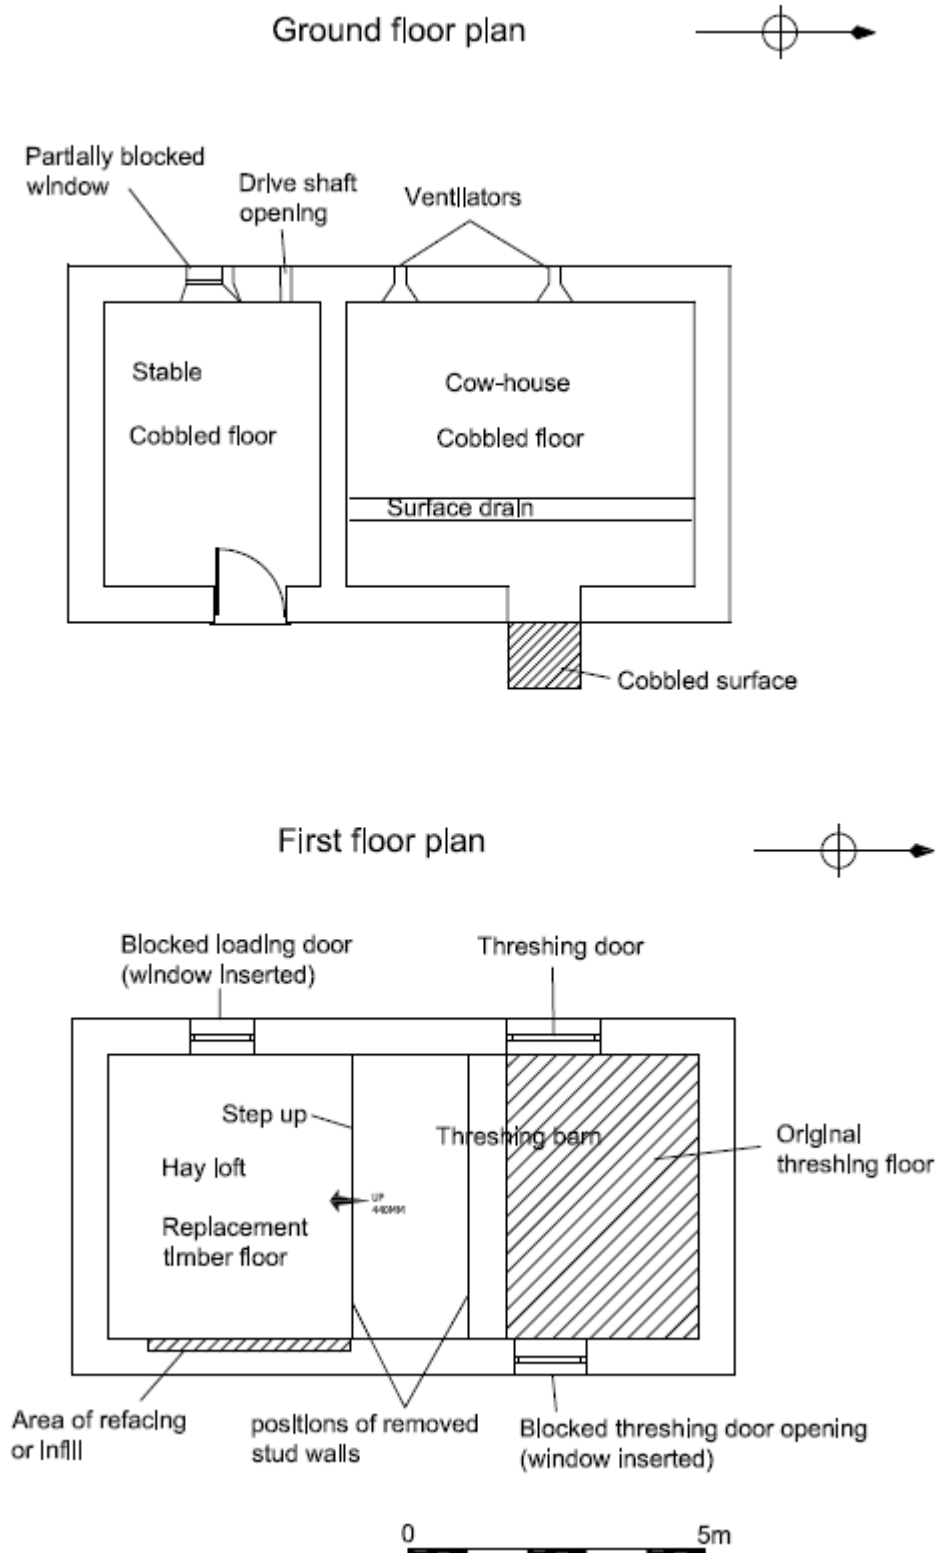
Fig 20: Annotated ground floor and first floor plans

Although now a single open room space the first floor was originally partitioned with stud walls to form two, if not three, rooms all open to the roof space. The northern room is the former threshing barn with its threshing floor still intact. The boards measure 0.35m wide and extend from the north wall as far as a line between the southern jambs of the two opposing threshing doors where the threshing took place. The opposing doors were designed to create and control a draught for winnowing (removing the chaff). To the south of this, but still within the threshing barn, the boards are narrow, probably late 19<sup>th</sup> century replacements in an area which is likely to have been used for storage. It is possible that this narrow area was partitioned off to form a separate room since there are signs of removed stud walls either side of the central bay (see Fig 20). Around the walls within the whole of this area there is a timber skirting approximately 0.2m high; a typical feature of a threshing barn. In the north-east corner of the floor a slot has been cut in recent years (Mr Axworthy pers comm.). The area of the threshing barn and storage area measures 5.8m north-south where as the area of the hay loft at the southern end of the first floor measures 4.1m north-south.

The hay loft area was once partitioned off from the room(s) to the north with a timber stud wall and there are indications that there was a door at the west end of this partition wall. The floor of the hay loft lies 0.45m above that of the threshing barn. This appears to be an original part of the building design to allow extra head room in the stable below. The joists and boards here are late 19<sup>th</sup> or 20<sup>th</sup> century replacements and the original floor may have been approximately 0.1m higher since a floor ledge survives in the south wall 0.1m higher than the present floor level. In the west wall is the original (blocked) loading door and in the south-west corner an opening in the floor giving access to the stable below.

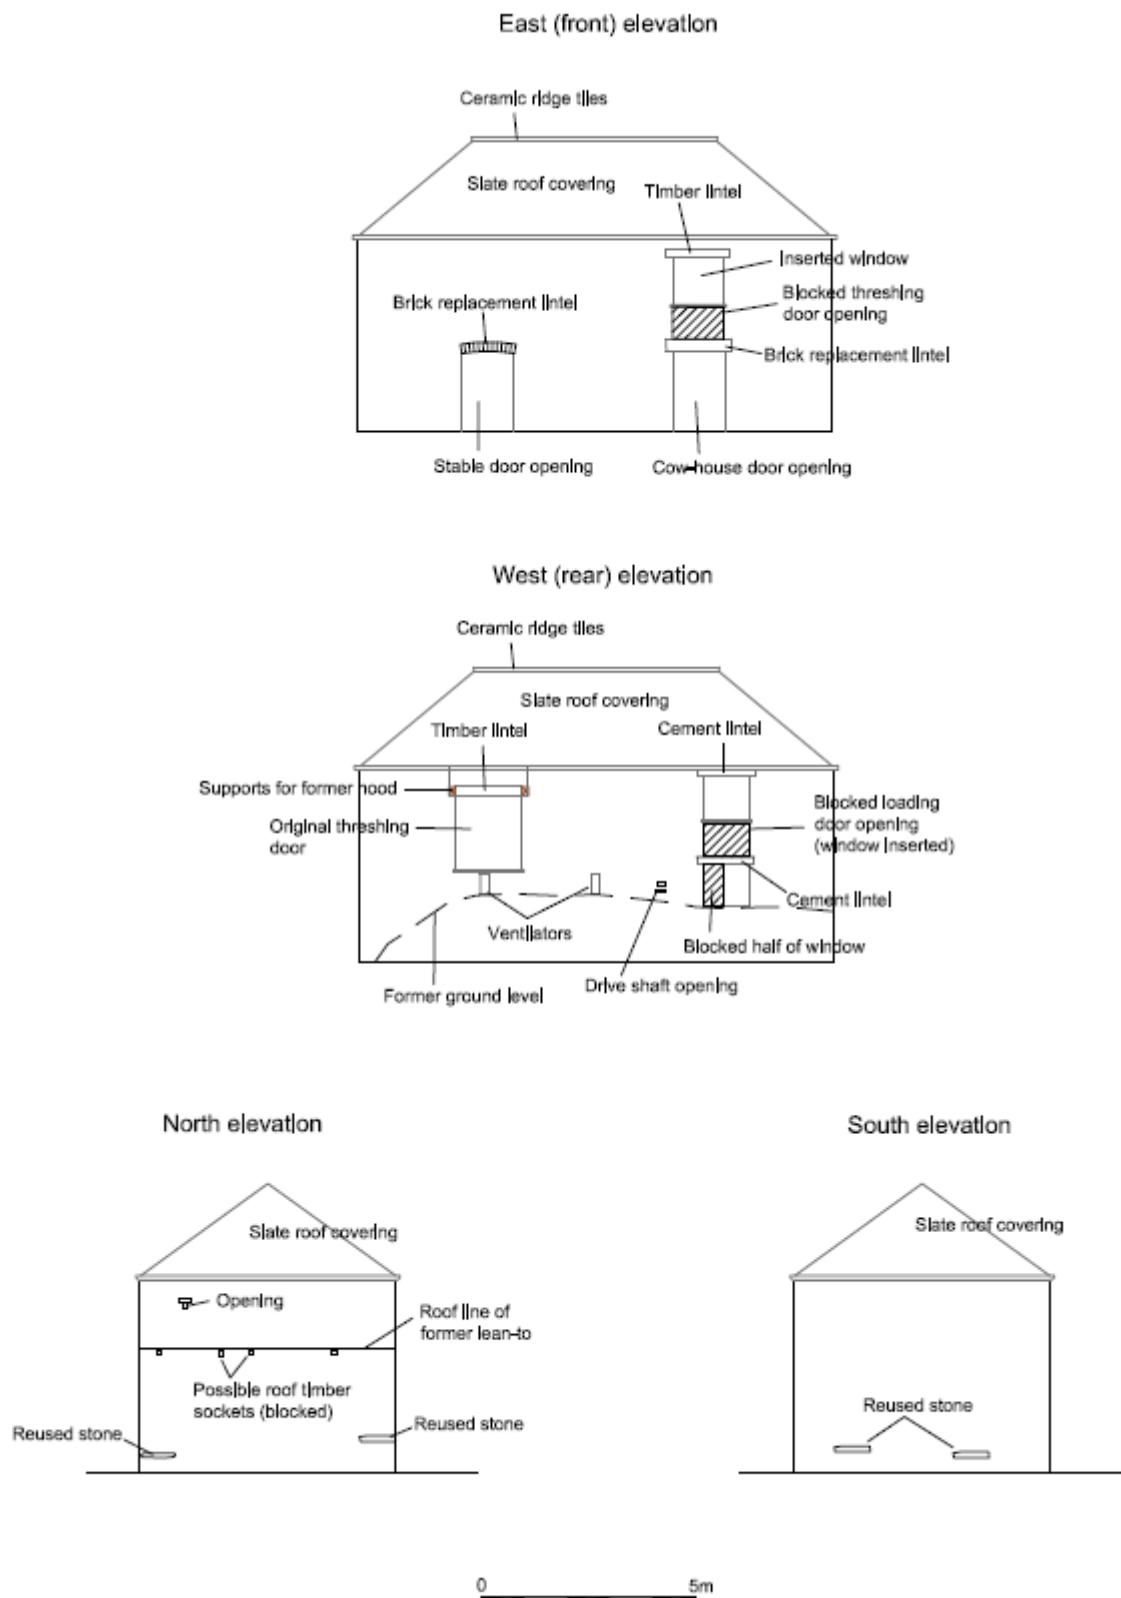
*Fig 21: Annotated elevations*

The north wall is constructed from sandstone rubble bonded with lime mortar. Towards the base of the north elevation are two reused worn slate blocks (possibly former steps). In this elevation the position of the roof line of the now demolished lean-to (former piggery) is visible. Above this at first floor level in the eastern half of the wall is a small opening (possibly a pigeon hole).

The south wall is constructed from sandstone rubble bonded with lime mortar. Towards the base of the north elevation are two reused worn slate blocks (possibly former steps). There are no openings or other features of note in this wall.
