Lambessow barn, St Clement, Cornwall

Historic Building Record

2011R079

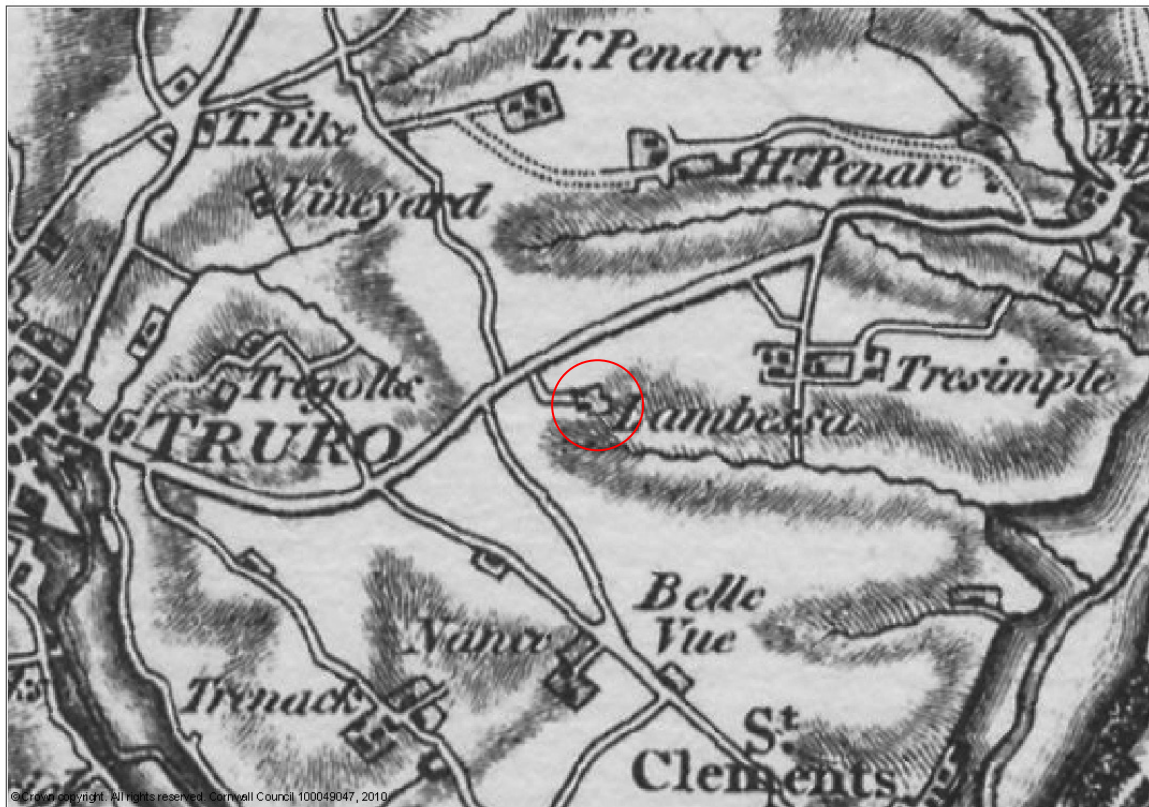
Fig 3: OS Surveyors' Drawing of c1809

The barn appears to be first shown on the OS Surveyor's Drawing of c1809 (Fig 3). Lambessow is not depicted on the Tithe map of c1840 because it was exempt from tithes, being part of the Duchy. The first reliable depiction of the barn is on the First Edition OS 25 inch scale map of c1880 (Fig 4) on which it is shown as the L-shaped building that exists today with the addition of a horse engine house adjoining the north-east elevation. It is shown again on the Second Edition OS 25 Inch scale map of c1907 (Fig 5) by which time the horse-engine house had been demolished. Both the First and Second Edition OS maps indicate that the remains of a Duchy prison were present at Lambessow in the late 19th and early 20th centuries but do not indicate the precise location. It is possible the prison existed in a wing of the house (since demolished) but also possible that it existed on or close to the site of the barn. It is possible (although unproven) that some of the earlier fabric of the existing barn may be associated with the prison.

The building certainly pre-dates the 1880 OS map and appears to be shown on the c1809 OS Surveyor's drawing (see Figs 3 and 4). The present building (phase 3 remodelling) was designed as a multi-purpose farm building (chall barn). In the past forty years the building has been used for storage only.

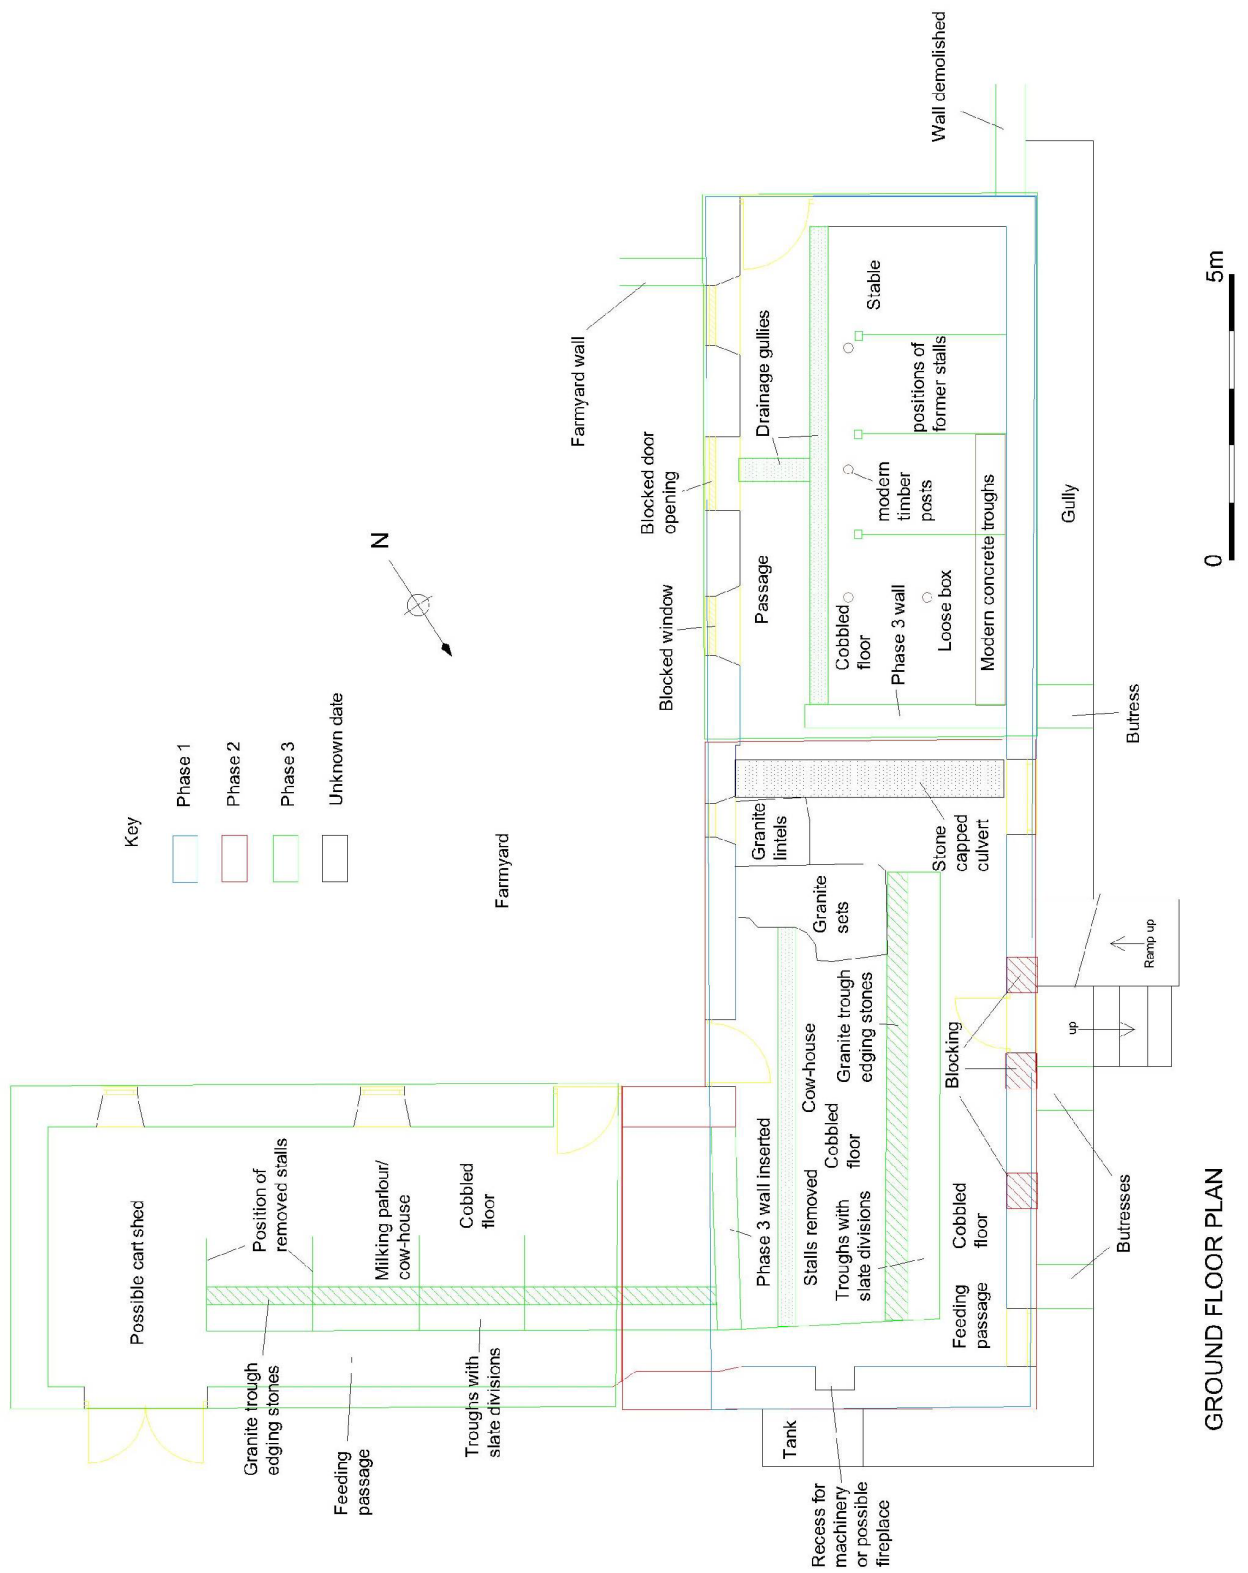
Fig 24: Annotated Ground floor plan showing construction phases

The floor in the stables is part of the phase 3 remodelling and comprises slate and granite cobbles with integral drainage gullies. The sockets to support the original stalls (now removed) can be seen in the floor and would have formed three stalls with a loose box at the north-east end of the room. The floor above the area of the stalls has since been removed and 20th century timber supports inserted. A cement rendered trough has also been inserted in the 20th century along the north-west wall after the removal of the stalls. The walls in the stable are white-washed. The two window openings and door opening in the south-east wall have reused moulded timber lintels.

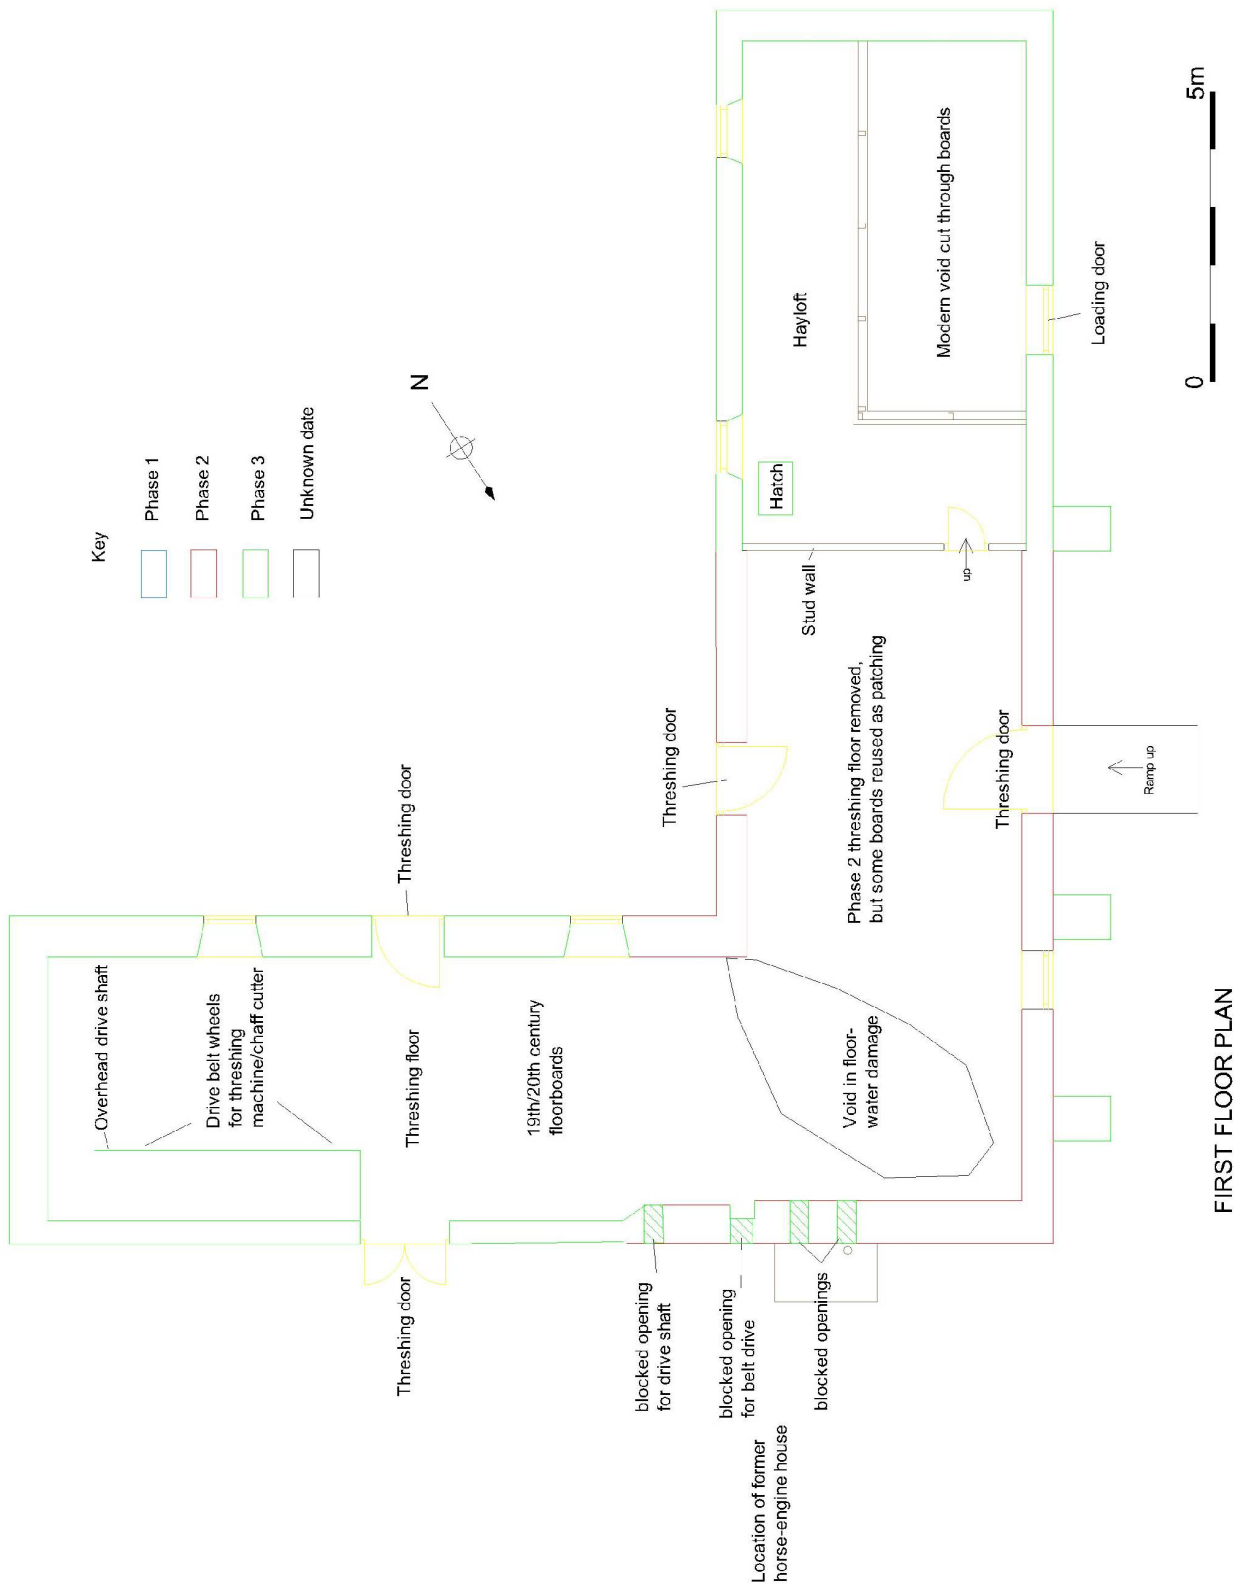
Fig 25: Annotated first floor plan showing construction phases

This room is located over the stable at the south-west end of the range. It is set at a slightly higher level than the rest of the first floor to allow more head room for the horses below. The floor joists and the room itself is part of the mid/late 19th century phase 3 remodelling although the boards are probably 20th century replacements. There

is a blocked hatch in the north-east corner of the room and a large part of the western half of the floor has been removed with a safety rail inserted at some point during the 20th century, and is now open to the ground floor. There is an original loading door in the north-west wall and the windows in the south-east wall retain their original frames and internal shutters. The timber planked partition wall dividing this room from the threshing floor to the north-east is a 20th century replacement of the original stud wall.
