Prince of Wales Mine, Harrowbarrow, Cornwall Report on building conservation works

Report on building conservation works (2007/8)

| Report Number | 2011R103 |
| Date | September 2011 |

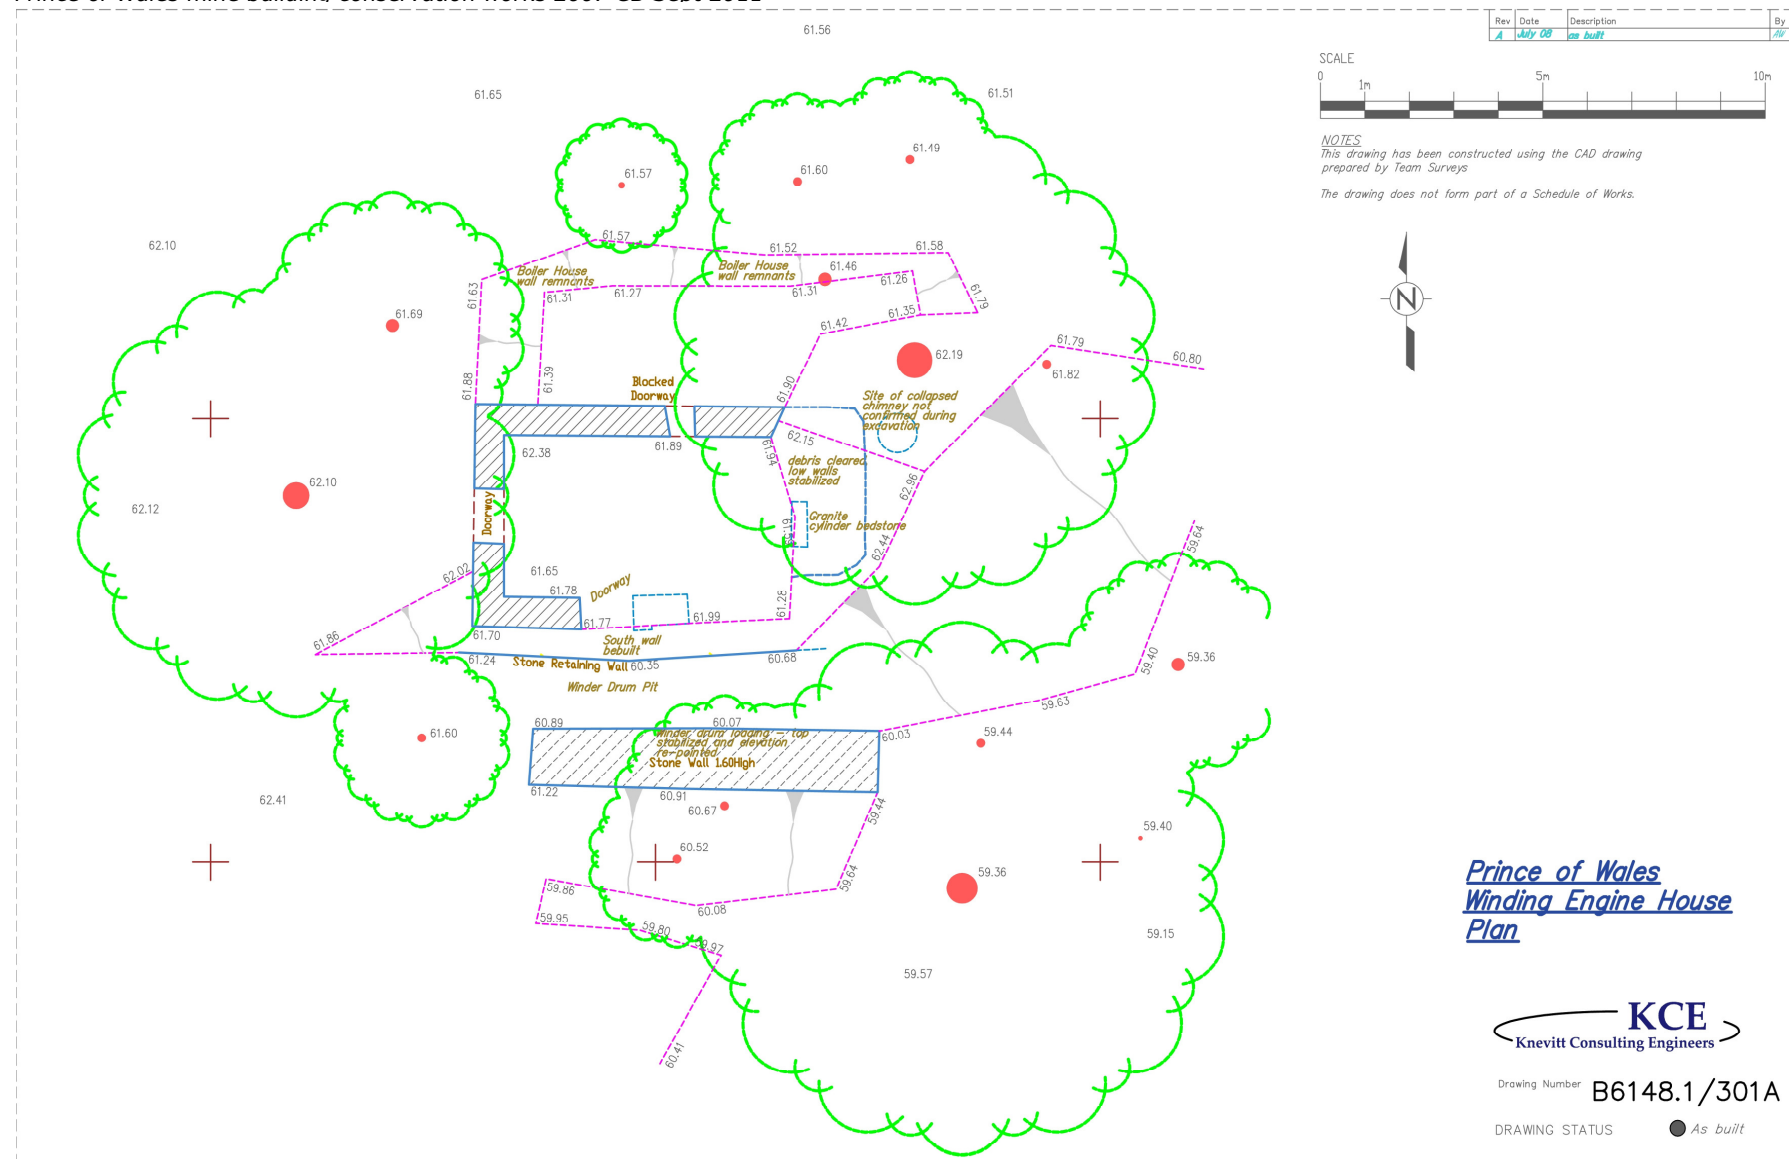
Figure 4 'As built' survey plan of the winding engine house, winder drum loadings/pit after works (Knevvitt Cons. Engs. 2008)

Figure 4 is an 'as-built' measured survey plan of the winder drum loadings, with annotations detailing the extent of the conservation works. By mid January 2008 all the major conservation works to winder drum loadings had been completed.

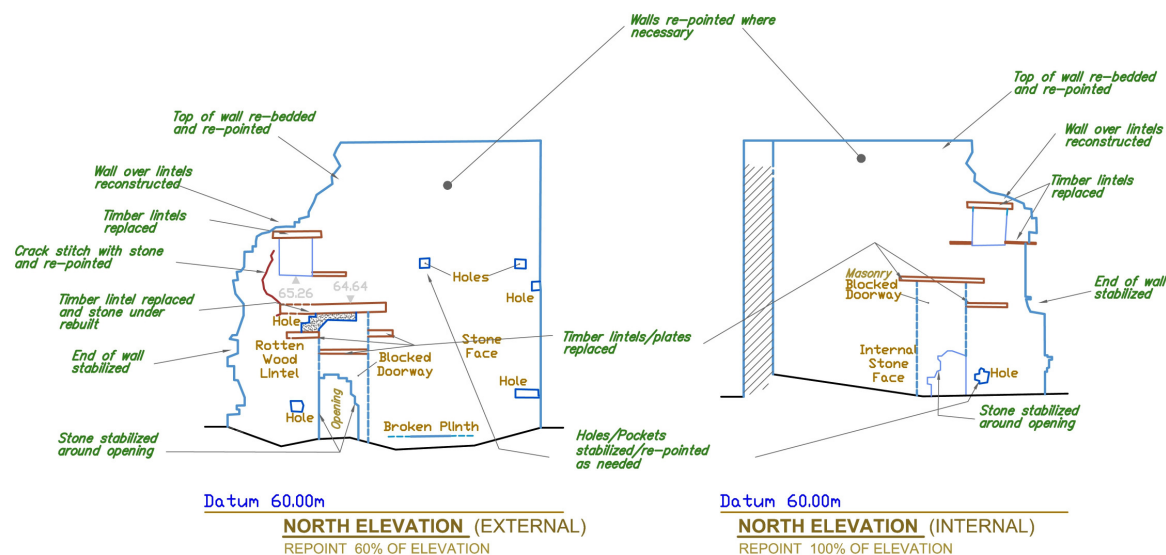
Figure 5 'As built' annotated North elevation survey of the winding engine house after works (Kneivt Cons. Engs. 2008)

Figures 5 to 7 are 'as-built' internal and external measured survey elevations of the engine house and a site plan (Fig 4). Each drawing has detailed annotations relating to the works that have been undertaken on each wall. Relevant representative photographs of the works are also reproduced in the text (Figs 8 and 9). By mid January 2008 all the major conservation works to the engine house (and adjacent winder drum loadings - see Section 4.2), had been completed, with the scaffolding removed a few weeks later.
