Kerris Cross, Paul, Cornwall

Conservation and repair

Client	English Heritage
Report Number	2011R105
Date	November 2011
Status	Final
Report author(s)	Ann Preston-Jones
Checked by	Andrew Young
Approved by	Andrew Young

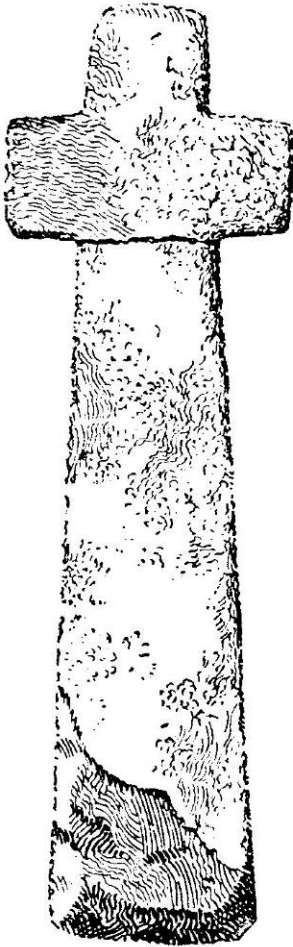
When recorded by AG Langdon prior to 1896 (1896, 202-3: Fig 6) the cross, which he calls Carlankan Cross, was lying on a waste piece of land at the bottom of the hill, on

The Kerris Cross is an undecorated latin cross with a total height (recorded by AG Langdon: see Fig 6) of 2.05m high, and 0.6 m wide across the arms. It has a strongly tapering shaft which is 0.29m wide at the neck and 0.45m at the bottom. Only 1.7 m of the shaft is now visible above ground. On the shaft are carved the letters L and A (Fig 7), perhaps representing a later use of the cross as a boundstone, and an Ordnance Survey benchmark. It is fractured just below the cross-arms. A square base is formed around the cross with blocks of granite filled in with earth and used as a small flower bed.

Fig 6 Drawing of the Kerris Cross by AG Langdon (1896)

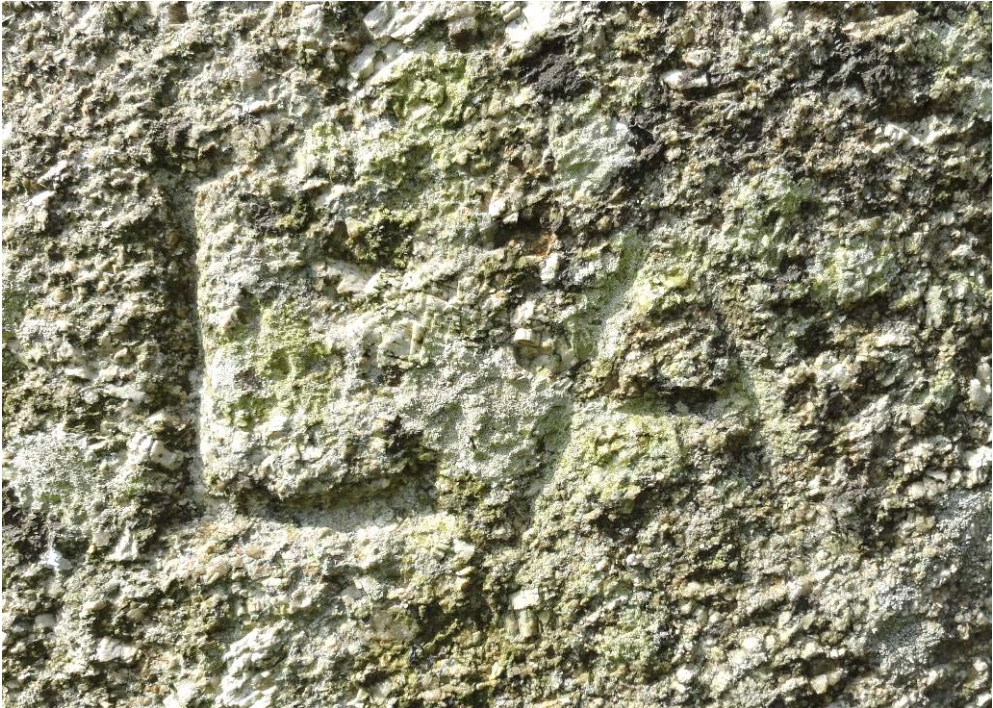
Fig 7 Letters L and A on the cross-shaft
