# The Samson Buildings Project 2006-7 Samson, Isles of Scilly

# Lichen Assessment, Archaeological Recording and Building Consolidation

March 2007

Report No: 2007R015

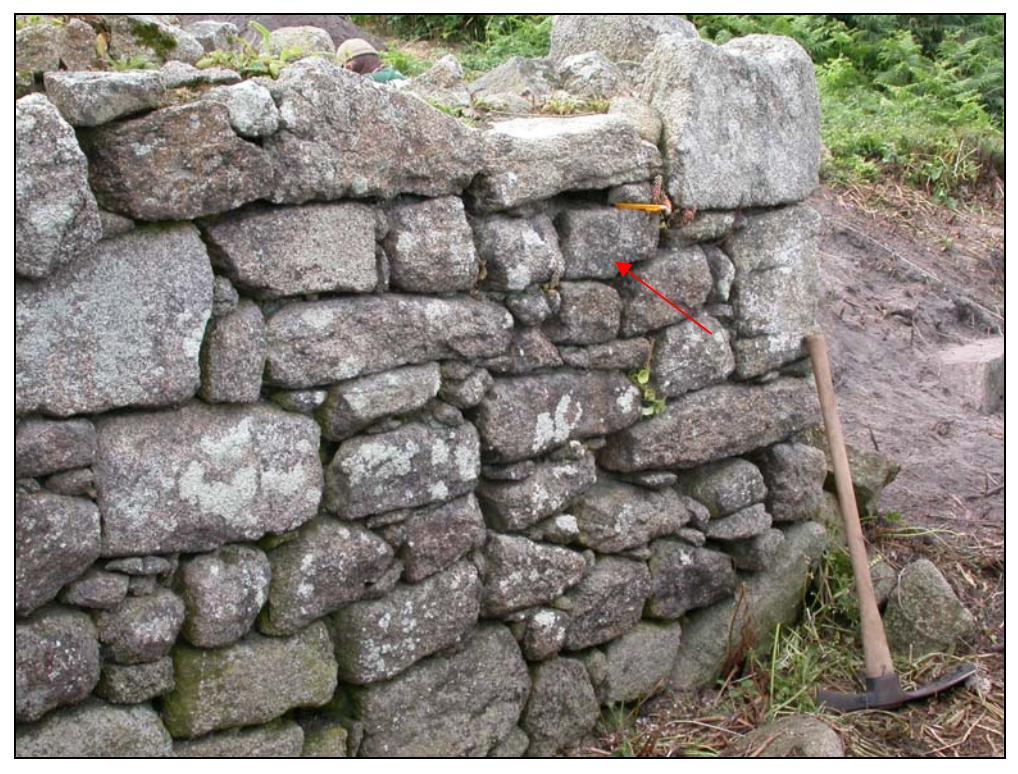
Fig 20 Building H, north wall, west end. The arrow indicates a stone supporting a good colony of Porina curnowii [RDB-NT; NR]

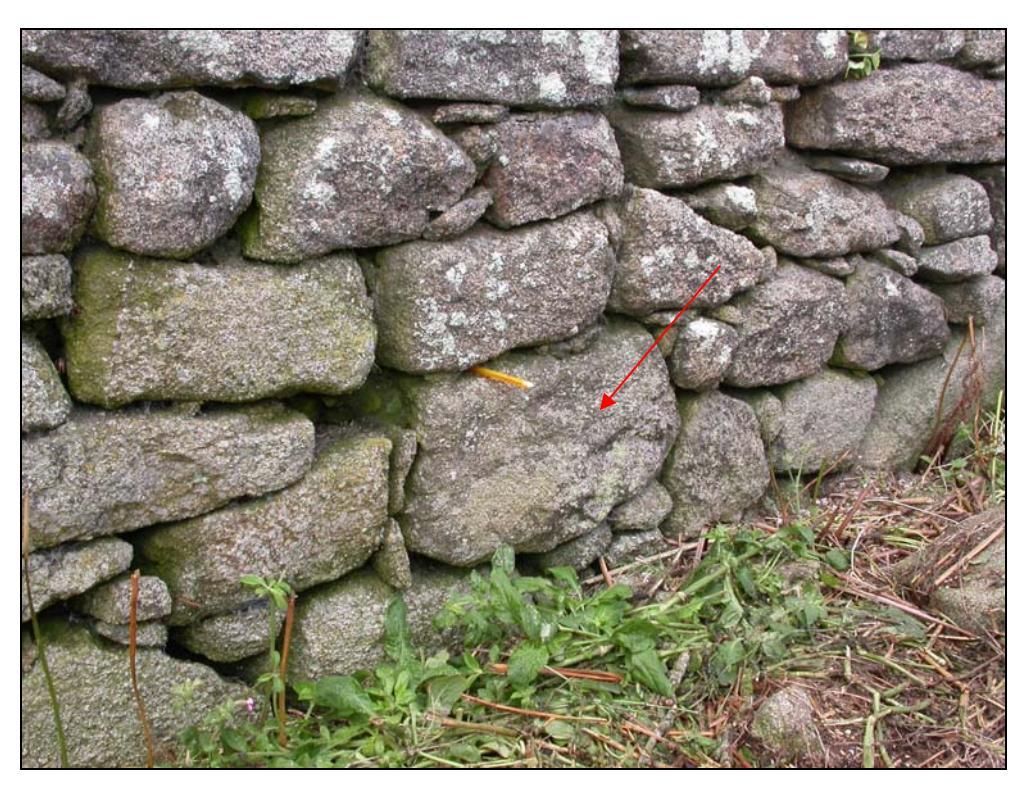
Fig 21 Building H, north wall, west end. The arrow indicates a large stone supporting a colony of Gyalecta jenensis var. macrospora [NR]

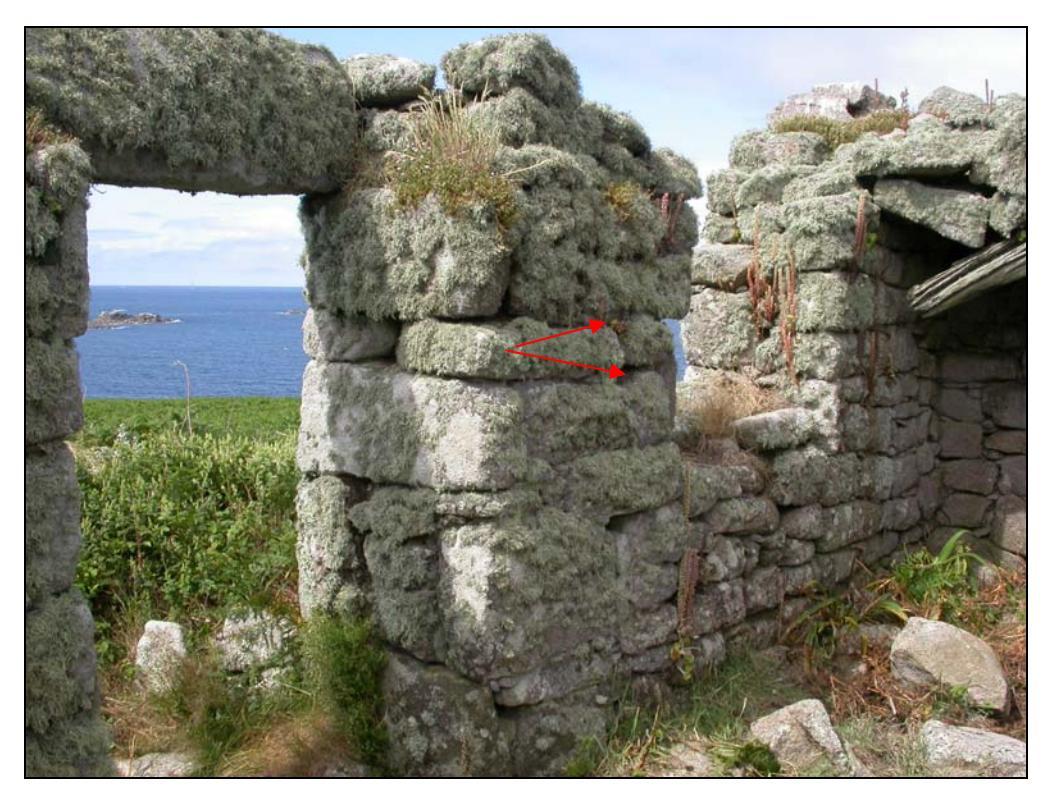
Fig 22 Inside of the south wall of building P. The arrow indicates the position of colonies of Caloplaca chrysophthalma [RDB-NT; NR] and Opegrapha areniseda [RDB-NT; NS] overgrowing ram between the stones

More difficult to deal with is the fact that two species of conservation interest, *Caloplaca chrysophthalma* and *Opegrapha areniseda*, are founding growing on the ram on the inside wall of building P (Figs 12, 22 and 23). This wall appears to be relatively stable, and therefore this area should not be re-mortared.

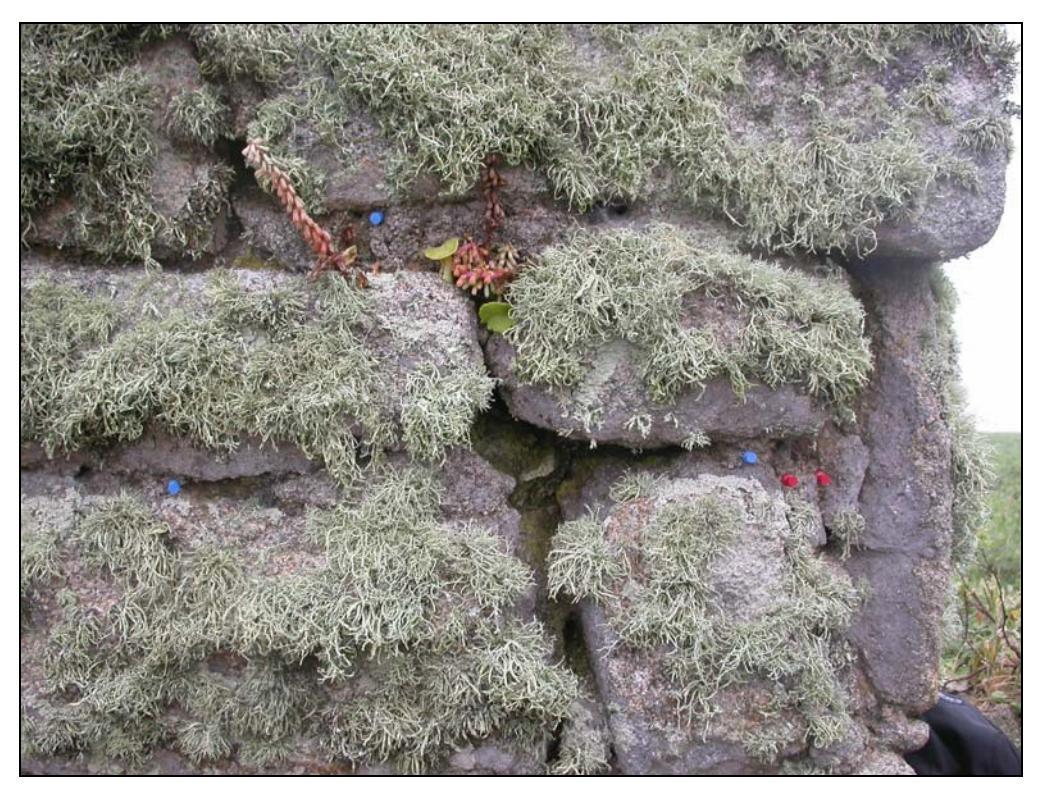
Fig 23 Close of the area shown in Fig 20. The blue pins show the location of the colonies of Opegrapha areniseda and the red pins Caloplaca chrysophthalma growing on the ram

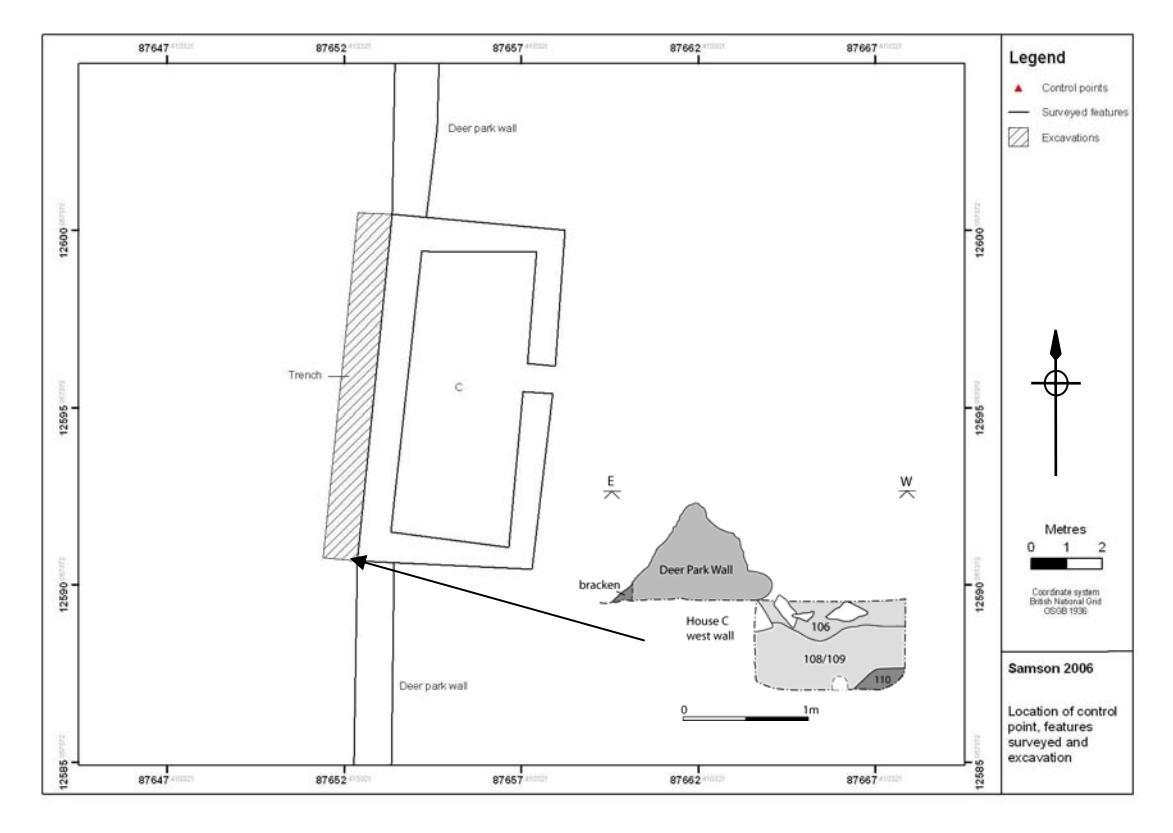
A trench 9.5m long by 1m wide by up to 1m deep was excavated along the exterior of the rear wall of House C in order to alleviate the pressure of windblown sand which was destabilising the wall (Fig 32). The only finds from the layers of sand, contexts (103) - (110) were a modern plastic bottle, shards of green bottle glass and a broken light bulb from the uppermost layer. These were kept for identification only and discarded. There were also a few tumbled stones from the wall.

Fig 32 EDM survey of House C, showing the location of the trench along the exterior of the west wall (HISAR), inset: north-facing section of the trench and profile of the deer park wall

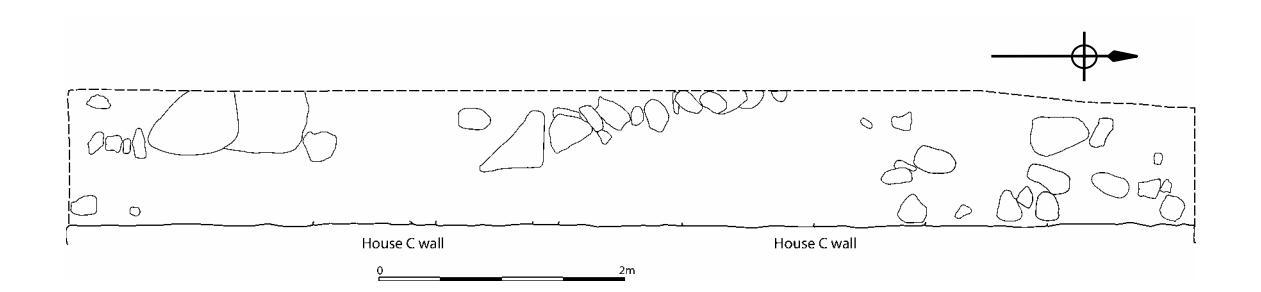
At a depth of 0.7m a north-west/south-east boulder wall was revealed [111] (Figs 33 and 34) The wall was one course high and one course wide, 6m long by 0.4m wide by 0.7m high, comprising one large granite boulder and an alignment of smaller stones. Interpreted as a possible field boundary, the wall evidently pre-dated the construction of House C and may have been prehistoric, although there was no dating evidence to confirm this.

Fig 33 Plan of trench alongside the exterior of the west wall of House C

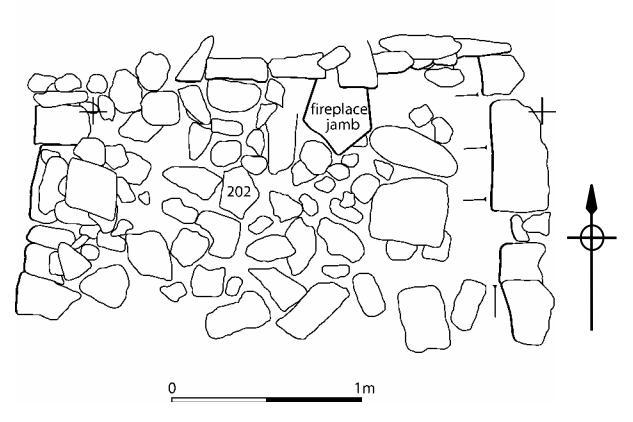
Fig 35 a) House F, plan of rubble at the north end

At the north end of the interior of House F it was necessary to remove a number of loose stones in a matrix of dark greyish rooty brown sandy clay (201) and some underlying tumbled stones in a similar matrix (202) in order to clarify the interior structure of the gable wall and enable recording prior to conservation work (Fig 35).

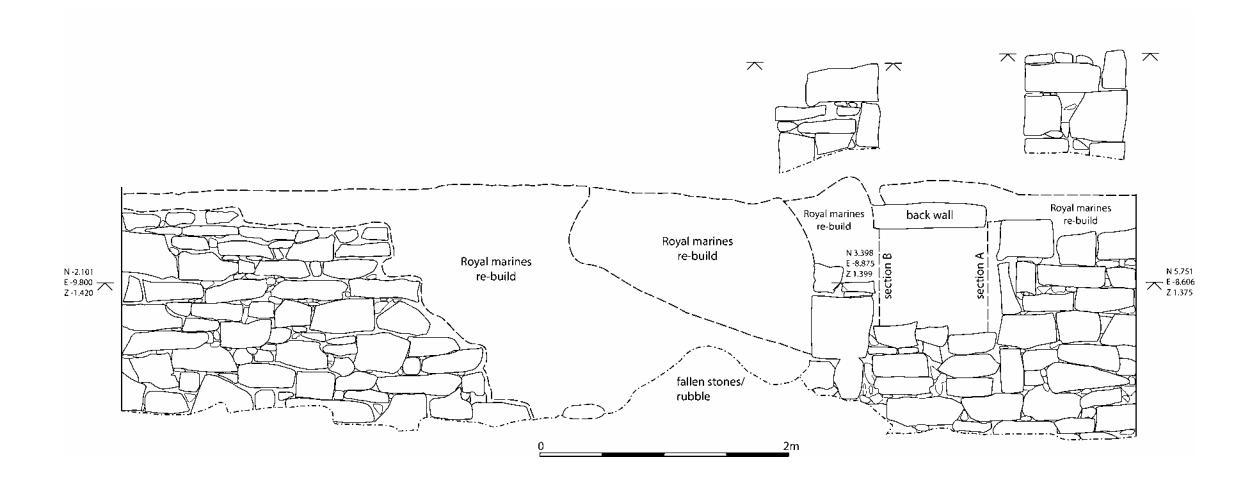
Fig 42 Elevation of interior of west wall House C, prior to consolidation work (HISAR)

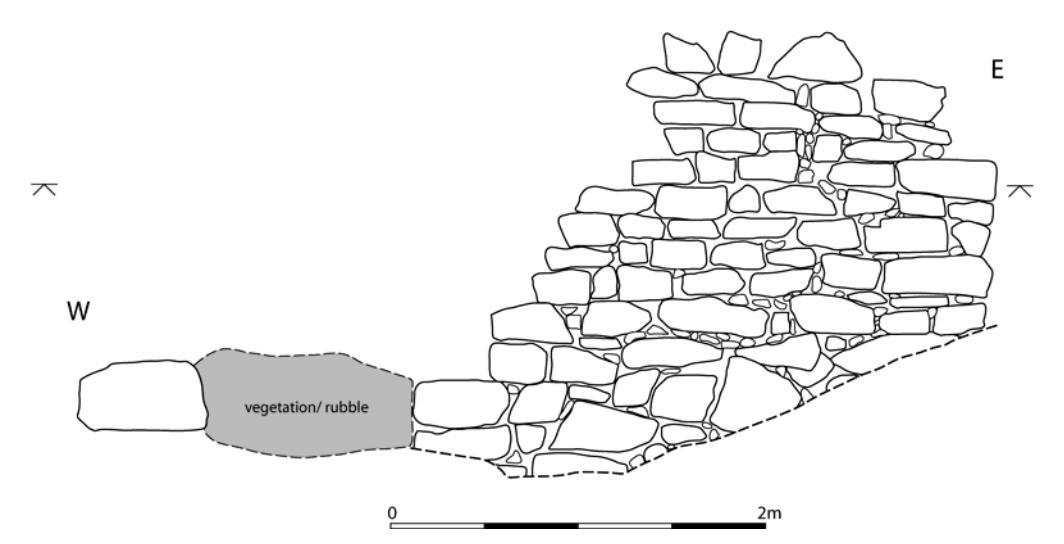
Fig 43 Exterior of north wall of House F prior to consolidation work (HISAR)

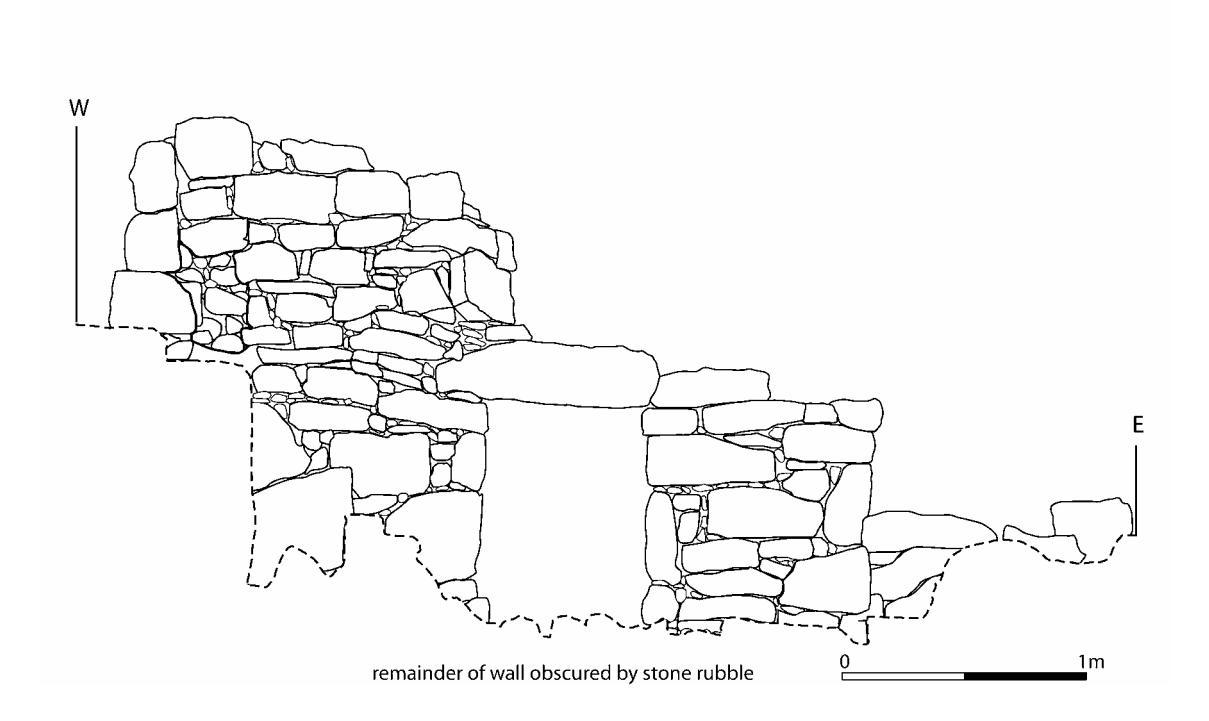
Fig 45 Interior of north wall, House N prior to consolidation (HISAR)

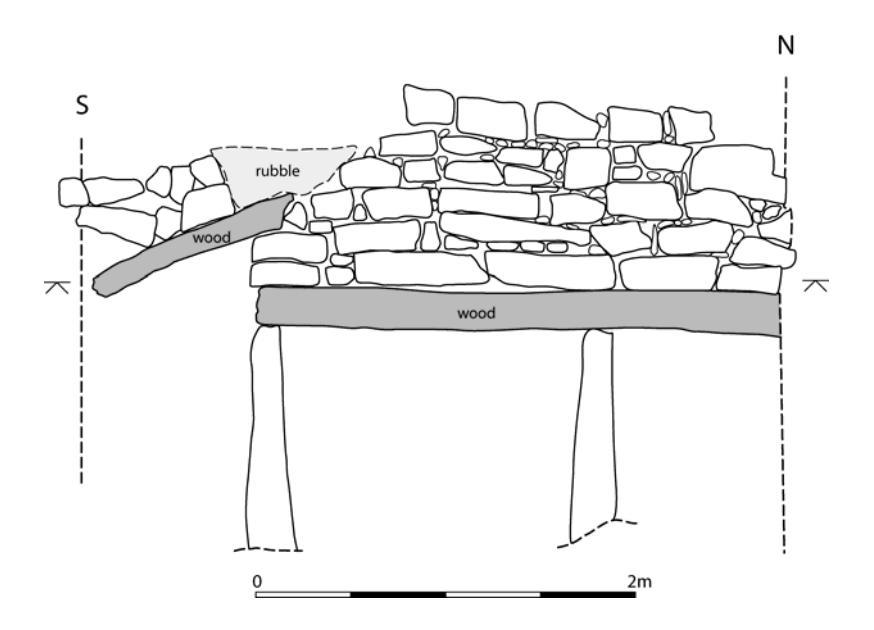
Fig 46 Interior of west wall of House P prior to consolidation (HISAR)

In Building P, oak lintels (re-used ships' timbers) that support considerable weight of masonry were reinforced by the addition of stainless steel bar to the underside of the lintels together with threaded bar passed through small-bore holes drilled in the lintels to support the underside of the stones above and held in place by locked nuts clasping the bar. The timber was treated with clear preservative to try to arrest the spread of rot but further work must be carried out on the wall tops to minimise water penetration to the lintels. All stainless steel that was left visible was painted with matt black paint to minimise its visual presence.

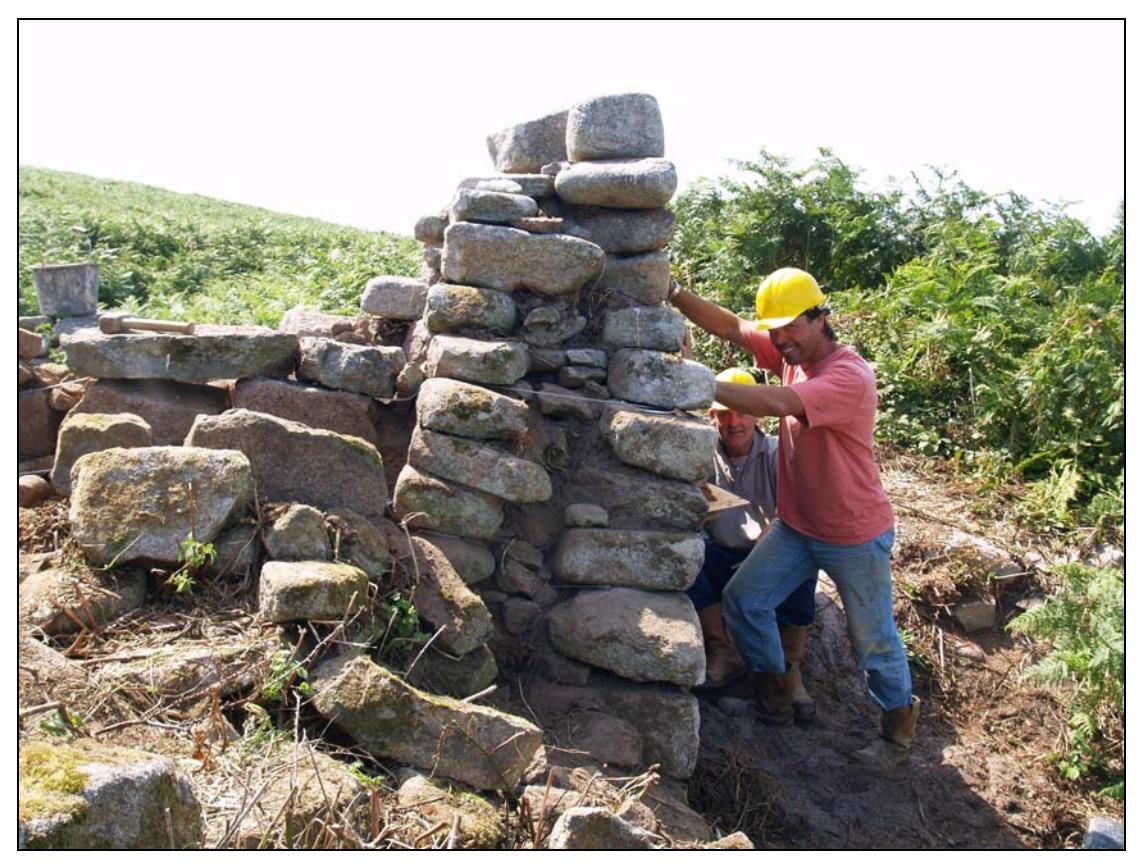
This building is one that has previously not received the attention it deserves. It had been identified as an 'animal house', not incorrectly because this had been its last use. However, this building is now recognised as a dwelling house with the upper part of a chimney breast visible in its north gable end. The position of this feature just above present floor level suggests that the original floor level of the house lies about 2m below the present floor level. Unfortunately, the pressure of the in-fill material has caused the gable end to lean outwards to an alarming angle. Its condition was such that total collapse was a real possibility and it therefore also represented a real danger to visitors to the buildings. To stabilise this situation was therefore an absolute priority and this involved considerable invention.

Fig 51 House F during repairs with Todd Stevens (rear left) and James Fletcher (photo: Eric Berry)

Stainless steel cables were let into the horizontal joints of the stonework at two critical levels, designed to have maximum restraint effect with minimum intervention. The cables were let into the external face of the north gable end and returned at a distance of about 2m to the external faces of the east and west walls. The poor condition of the upper part of the east wall presented a particular difficulty and some of the tumble had to be recorded prior to removal in order to get at masonry joints that were at the right level for the stainless-steel reinforcement. When the target section of the east wall was revealed vegetation had disturbed much of the stonework and the earth mortar had been converted to topsoil. Consequently, to enable secure anchorage for the cable it was necessary to remove some of the stonework and re-bed in lime mortar with the stones returned to their

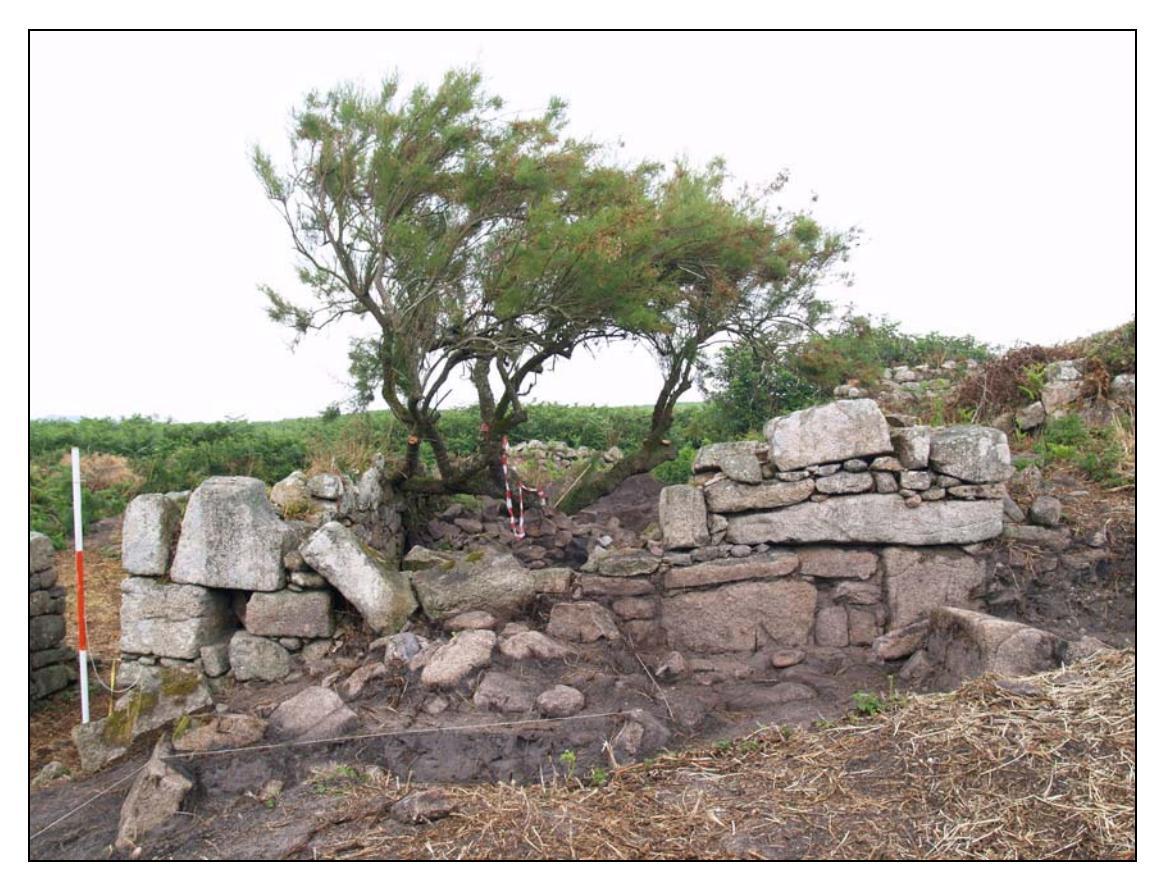
Fig 54 Building H during excavation and following pruning of Tamarisk 'tree' (photo: Eric Berry)

Some of the branches of the tamarisk tree were cut back to enable excavation and the large branch bearing on the east wall of House G was also cut off in order to prevent further damage to the wall and also to open up the pathway between Houses G and H and so reducing the need for visitors to clamber over buildings at this point.

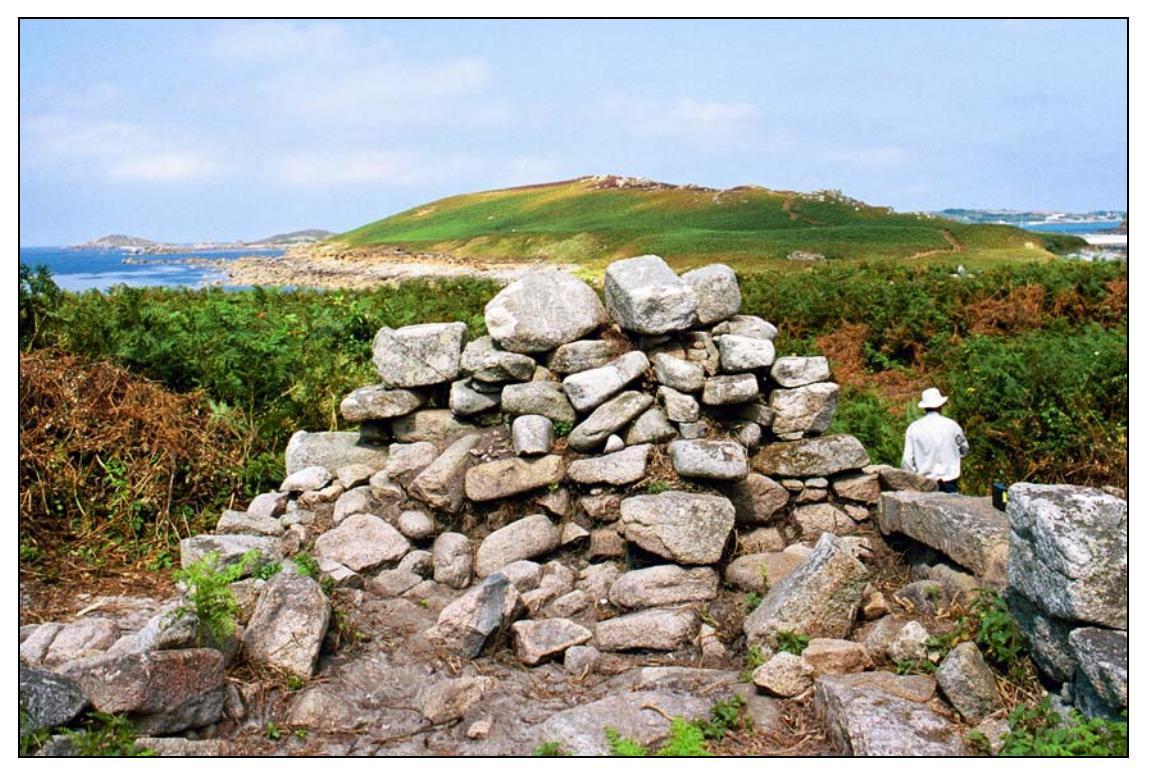
Fig 67 House F, north end: potential for further archaeology and analysis (photo: Eric Berry)

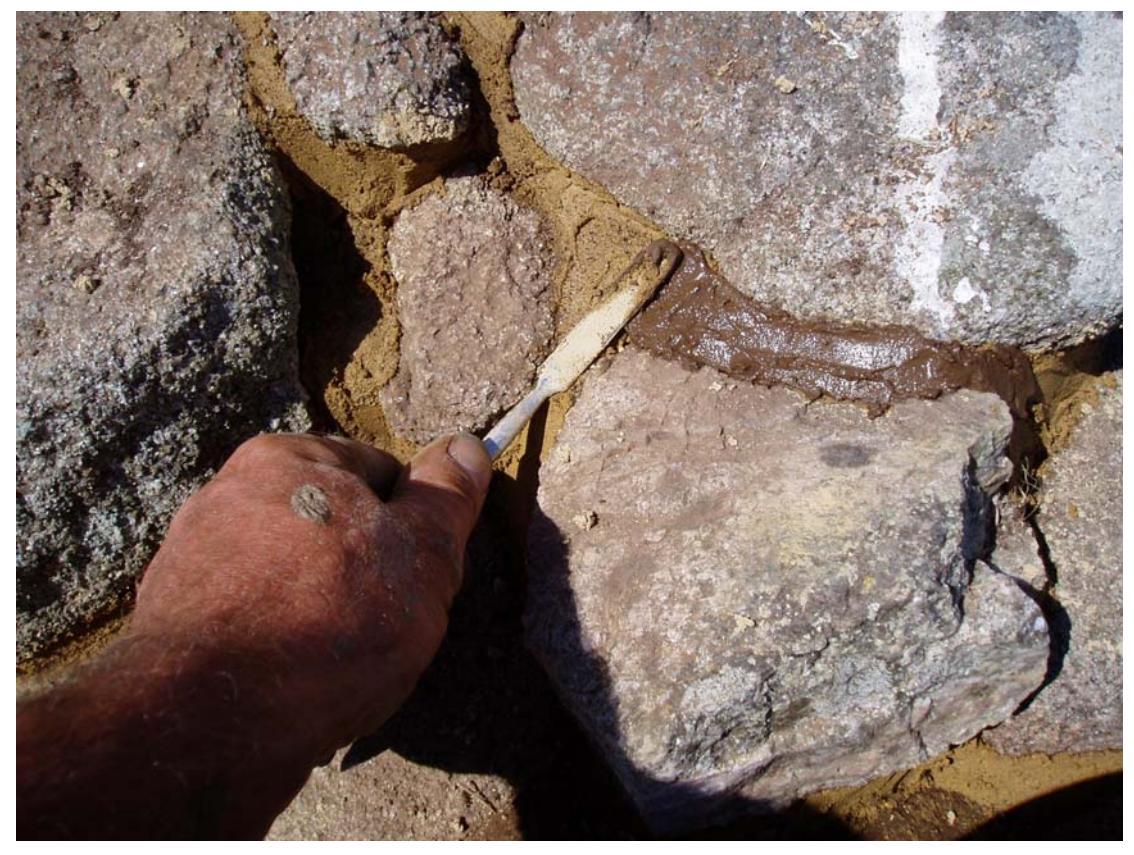
Fig 72 Covering the new, still damp, lime mortar with wet ram mud

Material to make the ram mud was gathered from the sub soil cliff face areas of the island. No ram was taken from the cliff face itself as there was found to be enough material that had fallen naturally from the ram cliff face sub soil layer. This was found in sizable lumps among the rocks along the rocky shore line. The lumps were then simply pounded with a heavy lump hammer and mixed with water into a bucket to make the mud. The best consistency we found to be like that of melted chocolate as it did not stick as well if either drier or wetter than that. Furthermore, it also adhered better if the lime mortar was damp. A good thick coat of ram was applied so that it could be beaten back with a stiff brush when dry, a process that made it look more naturally weathered.

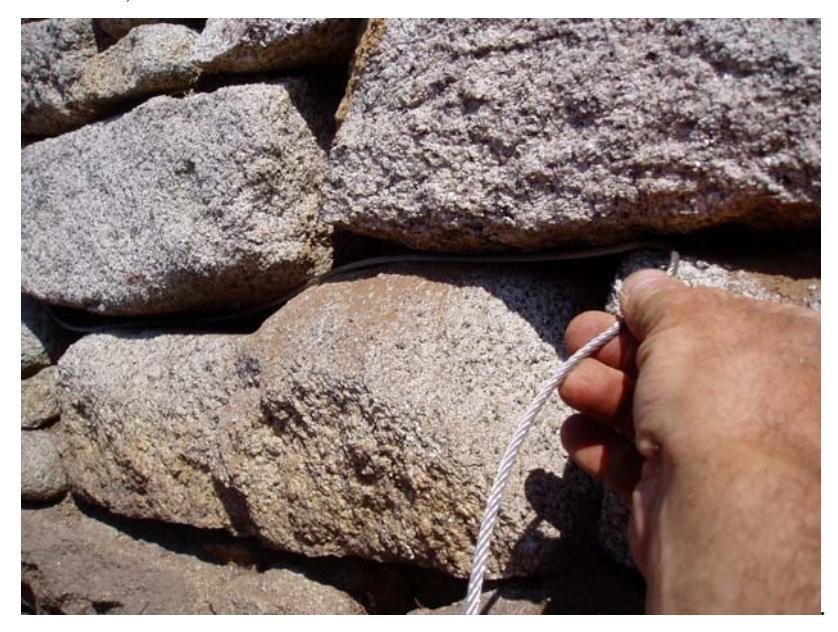
Fig 73 Feeding stainless steel cable into the joints

Walls that were found to be in serious danger of collapse were reinforced with stainless steel cable which we forced between the stones and into the joints. The best routes chosen for this were where heavy stones could carry the small looser ones and\or where the longest continuous run of steel cable could be achieved. Occasionally a small amount of leverage with a thin bolster chisel was used to enable the stones to be lifted gently, thus creating a good bearing or purchase on the cable or to allow the cable to be forced well into the joints.

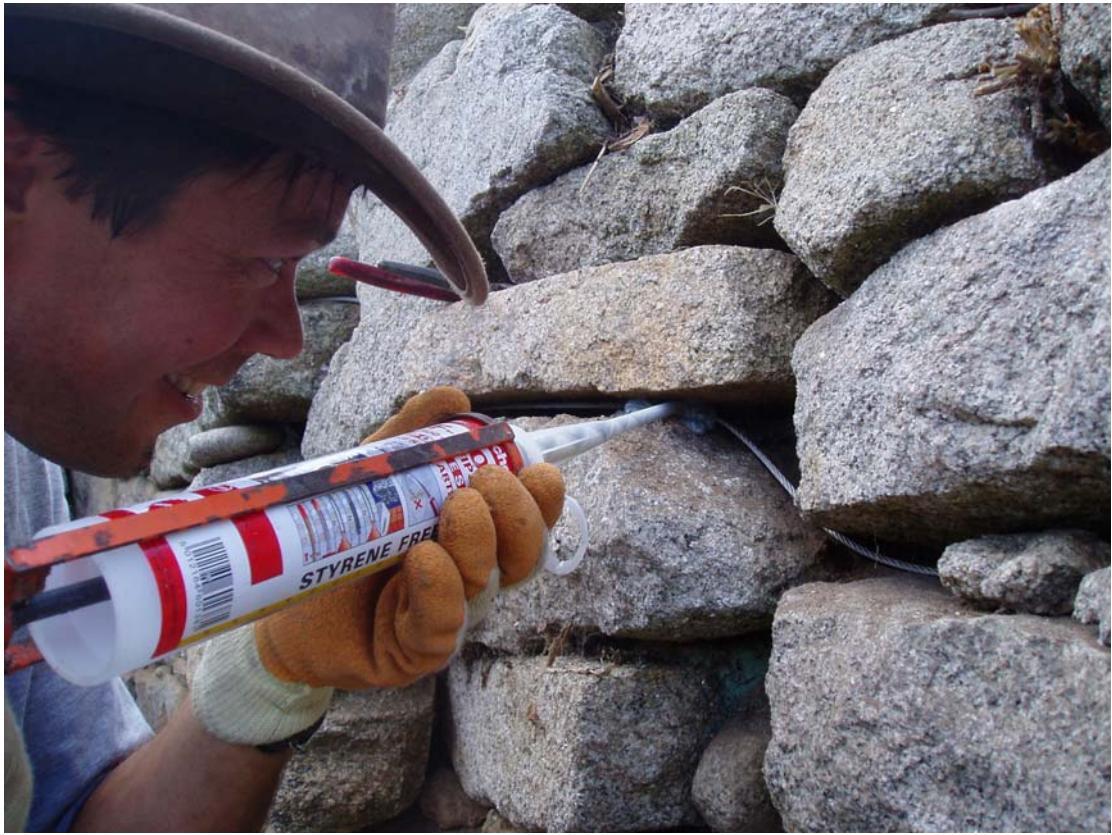
Fig 74 Injecting the resin

Resin was then injected into tight joints were the steel cable was pinched by the stones. The resin was then allowed to set hard before pointing over with lime mortar and ram mud.

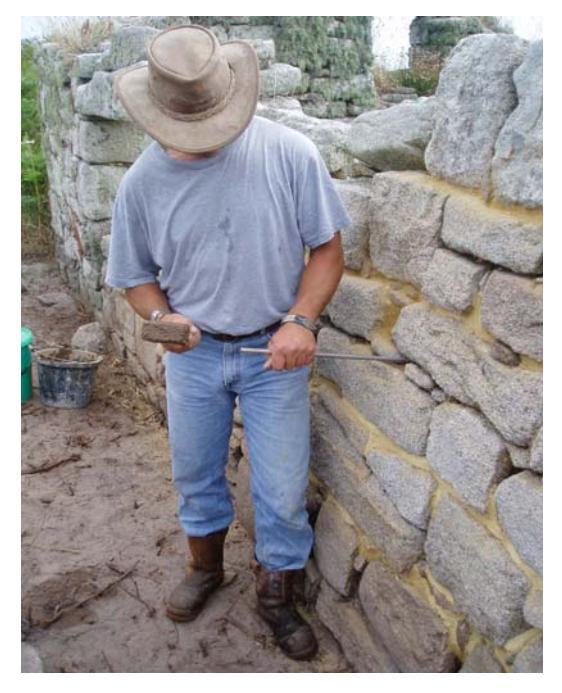
Fig 75 James gingerly taps a rod into position on building C

In many cases stainless steel rods were forced through gaps found in the walls (vertically and horizontally) to reinforce them. The rods were also then pointed over to hide them from view.

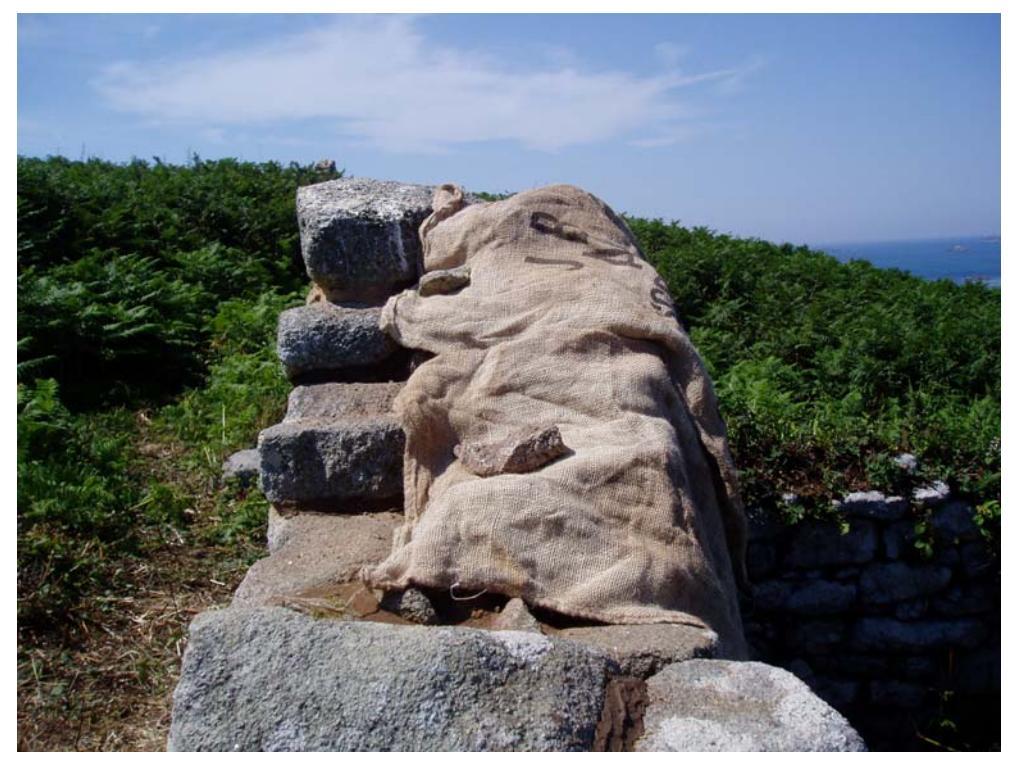
Fig 76 Damp Hessian covering on building O.

To prevent cracking the new lime mortar and ram mud pointing must not be allowed to dry too quickly, to counter this damp Hessian sacking was laid over the new work.

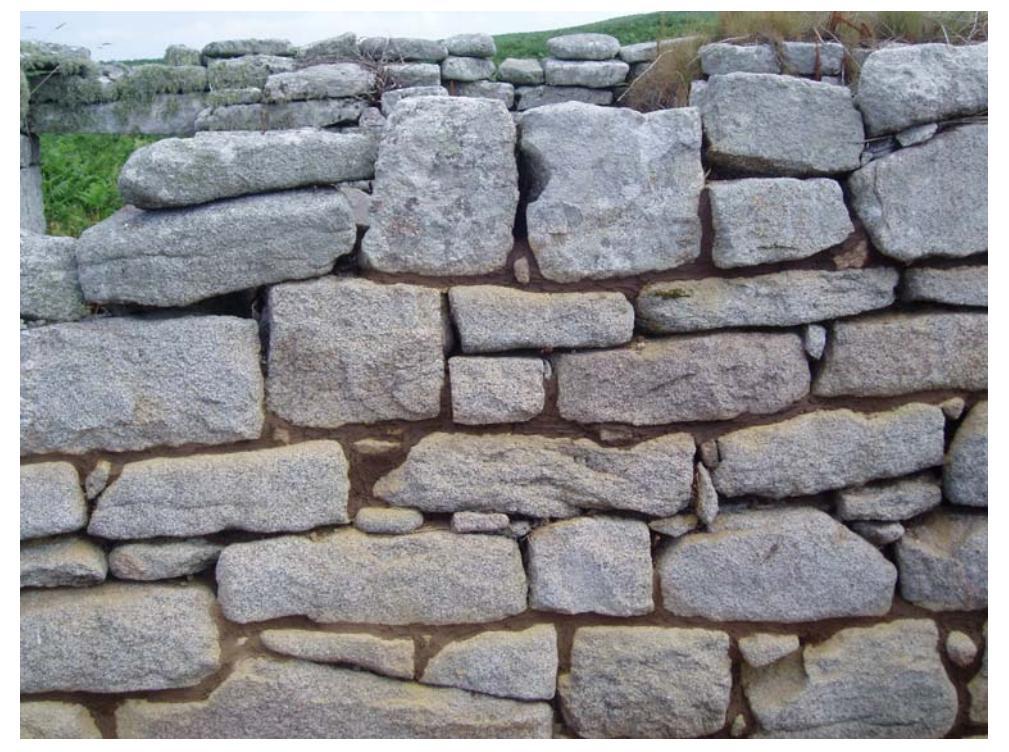
Fig 77 A consolidated wall after drying out on building C.

Once the new ram mud outer coating was dry it was distressed with a stiff brush. It was then washed with sea water. This gave the new pointing a more authentic weathered looking finish. All new pointing was then painted with a Lichen growth enticing medium ie horse manure solution.

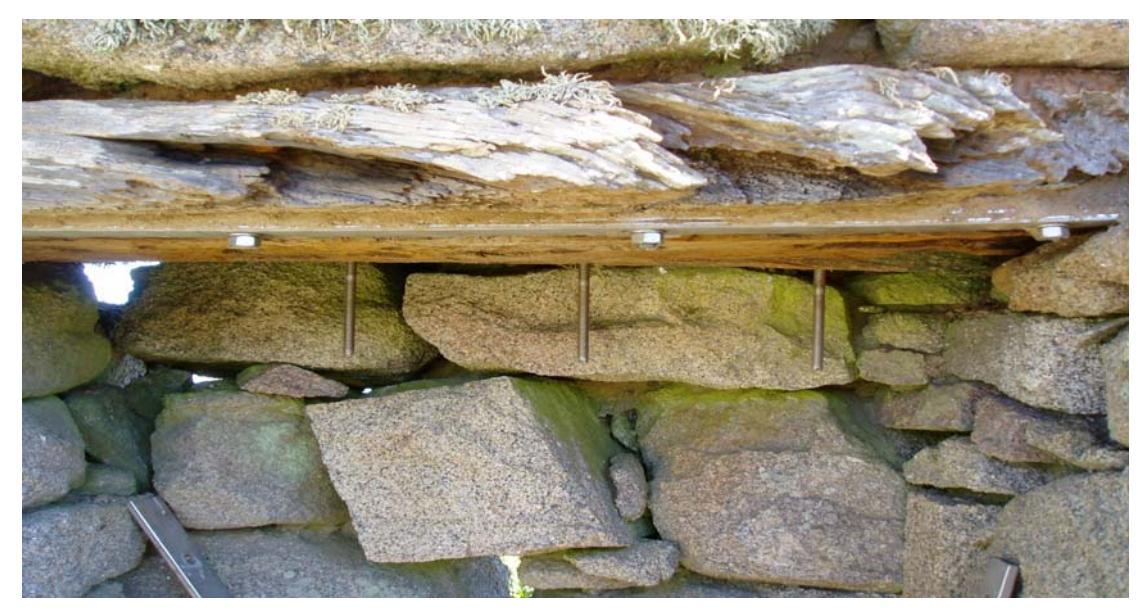
Fig 81 Another lintel in the process of being reinforced (Building P)

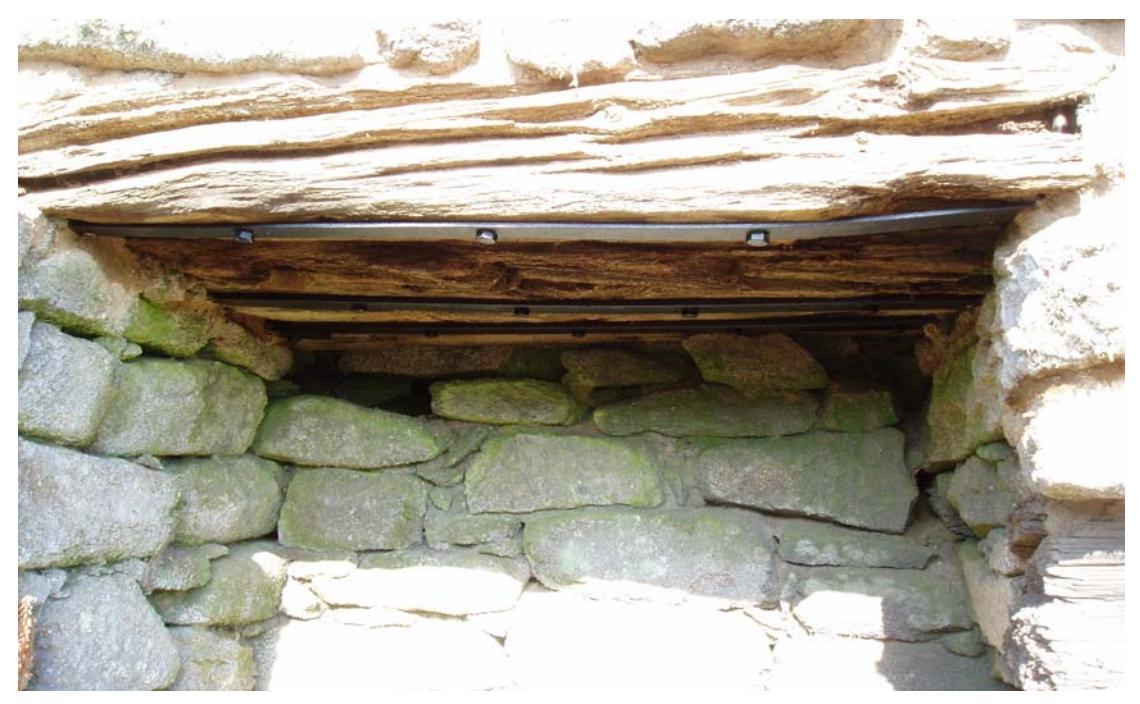
Fig 83 The painted finished article (Building P)

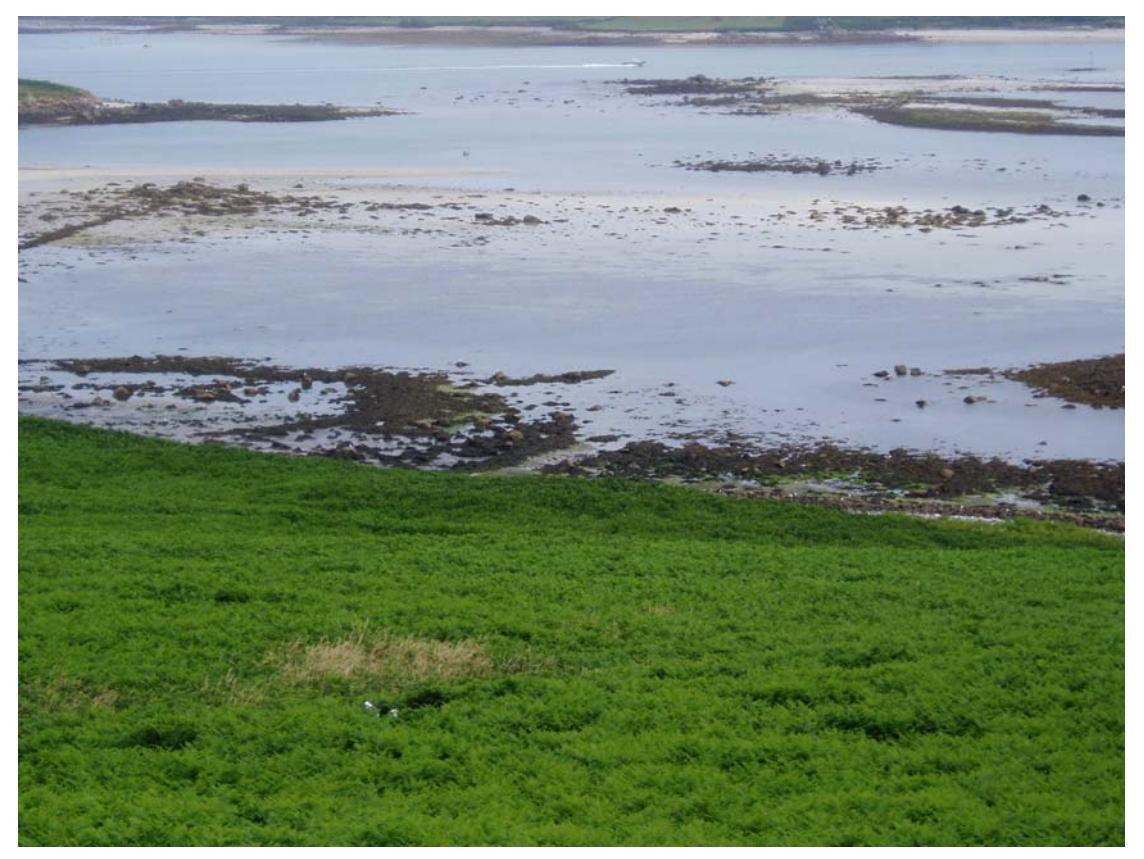
Fig 92 The same slipway half flooded (centre of picture).

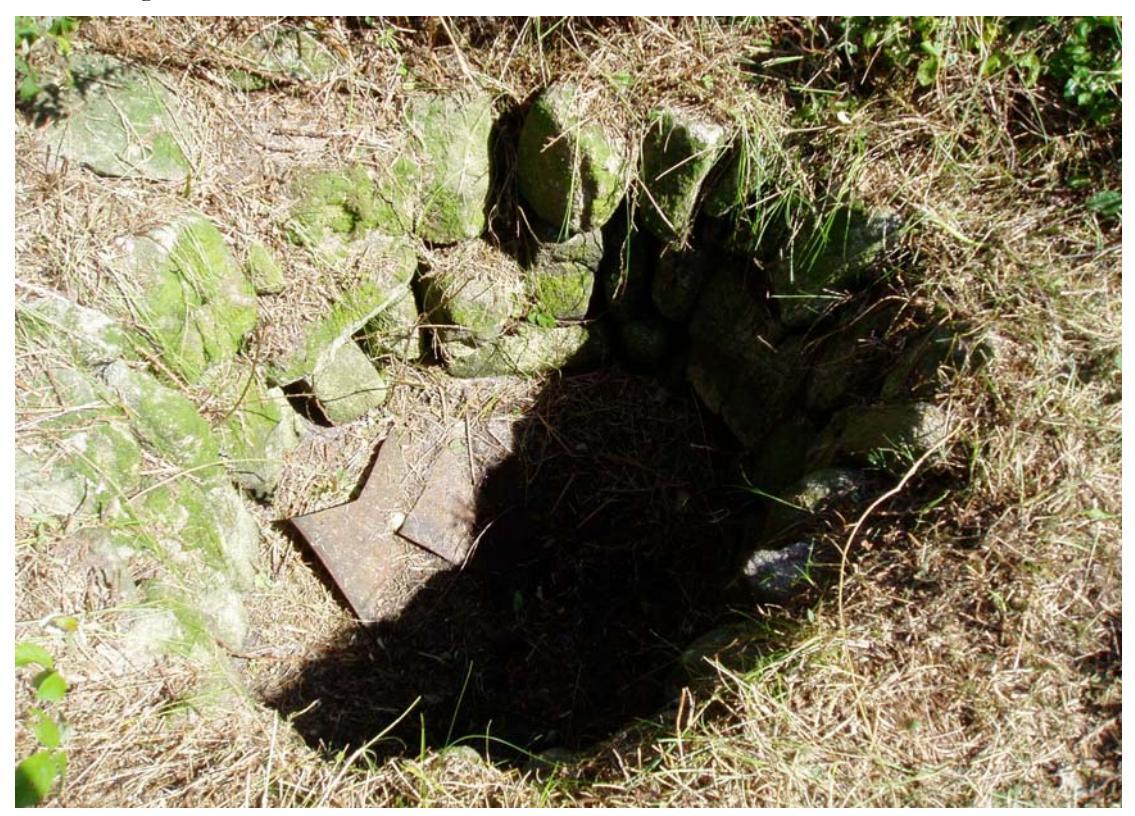
Below are a few (pre-recorded) features that are normally hidden from view The clearance of thick vegetation reveals the well below.

Fig 93 The well between the hills.

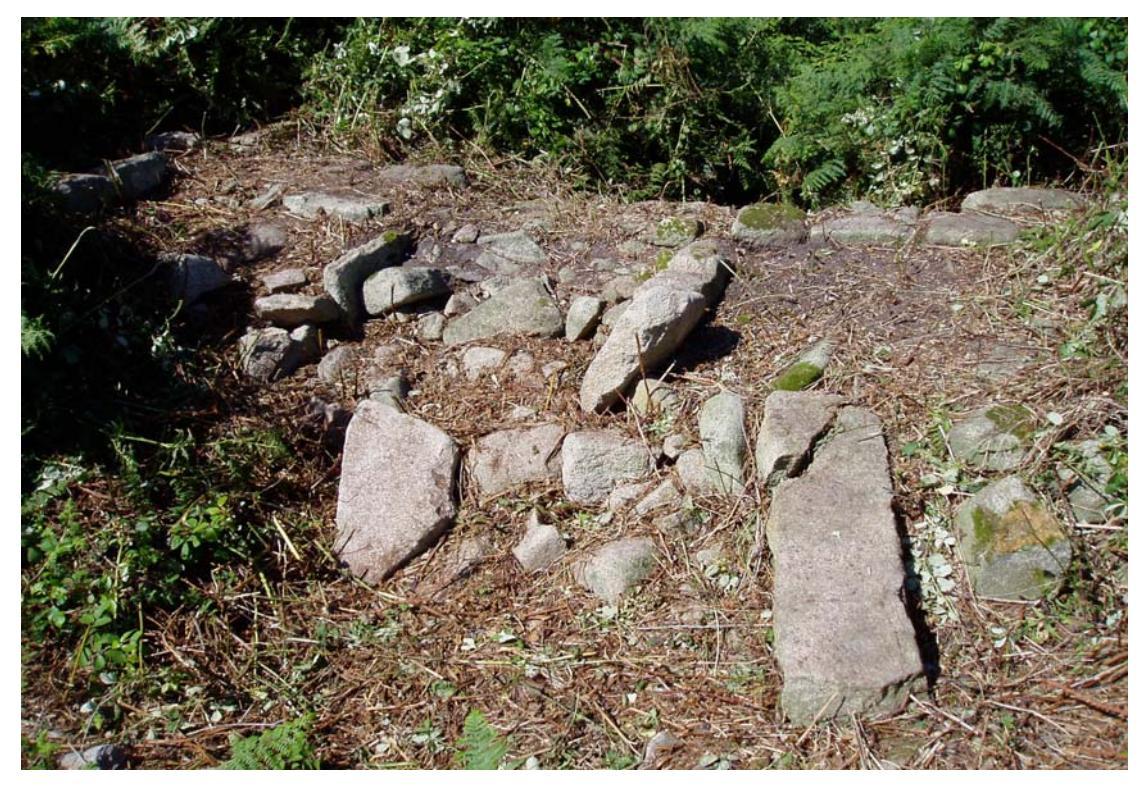
Fig 94 The remains of another cottage. Possible three section fireplace can be seen in the centre of the picture. A large door or window lintel lays on the right of the picture (Building E)

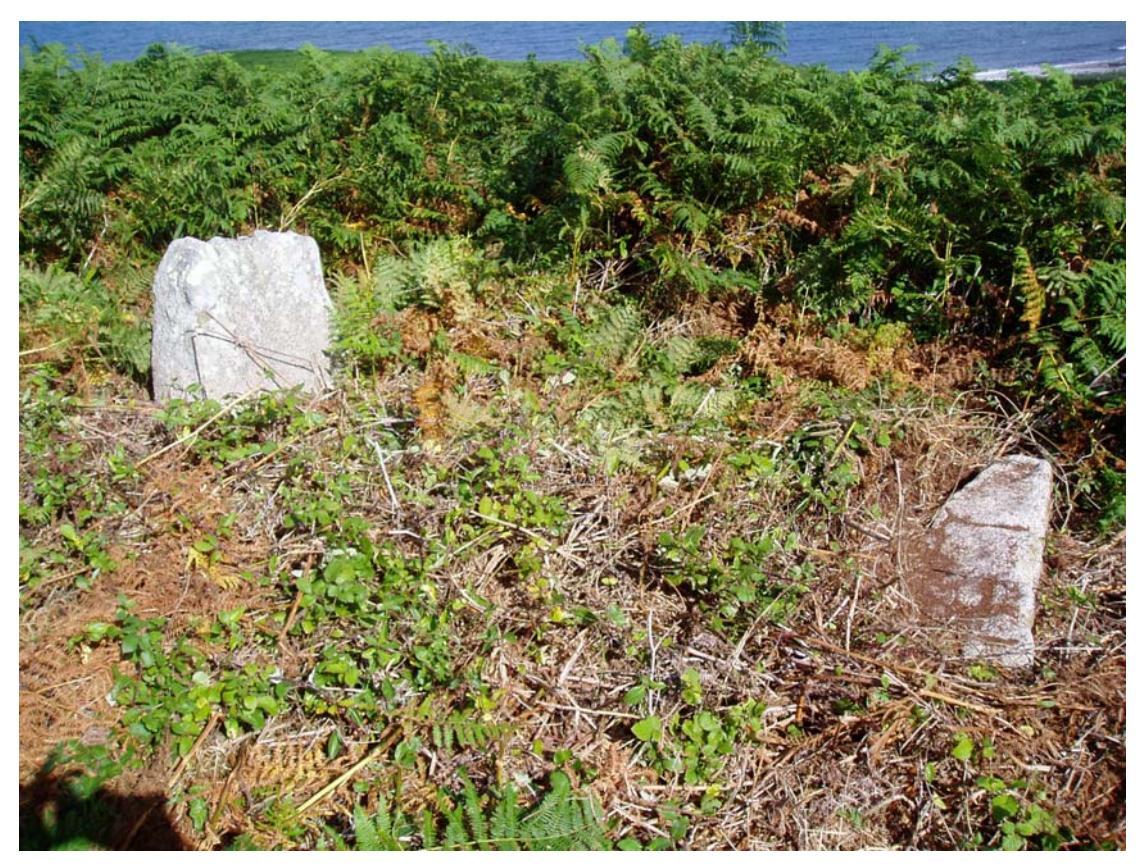
Fig 95 A possible grave at the summit of South Hill but this grave also has a foot stone
