# The Samson Buildings Project 2006-7 Samson, Isles of Scilly

# Lichen Assessment, Archaeological Recording and Building Consolidation

March 2007

Report No: 2007R015

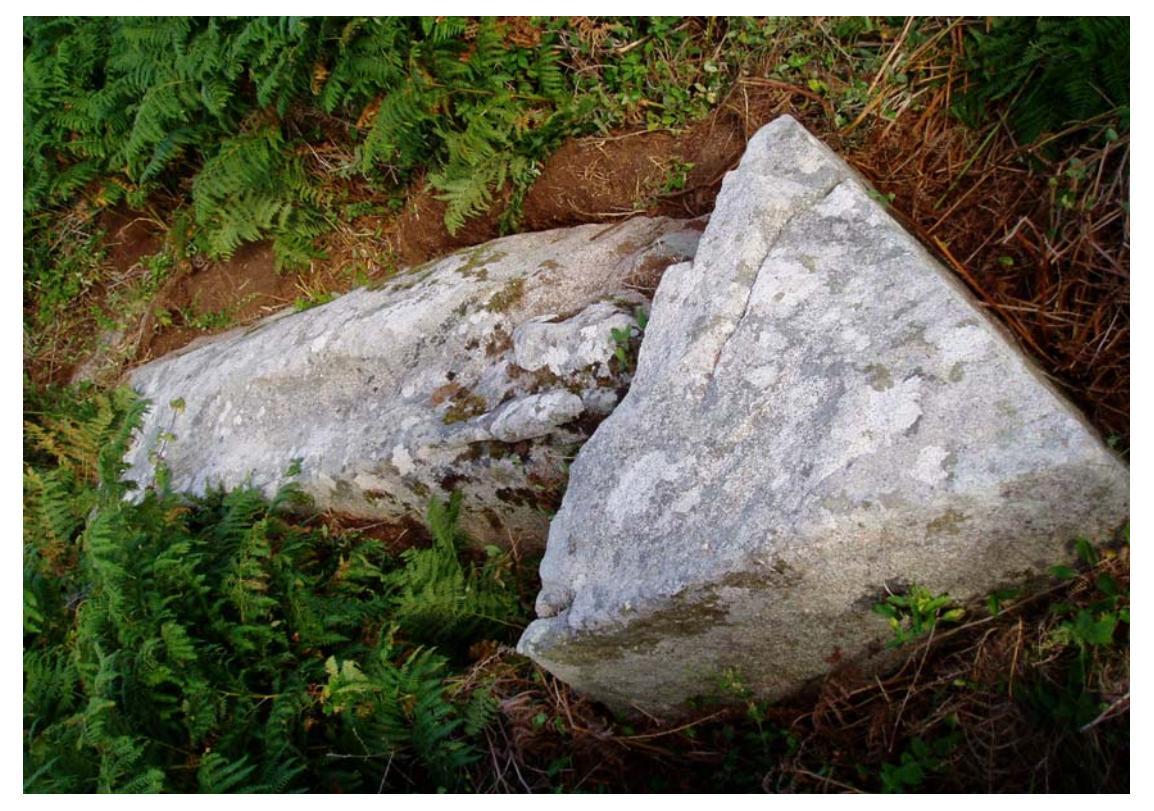
Fig 96 The great Arrow Stone also at the summit of South Hill could be natural but was a wonderful source of conjecture

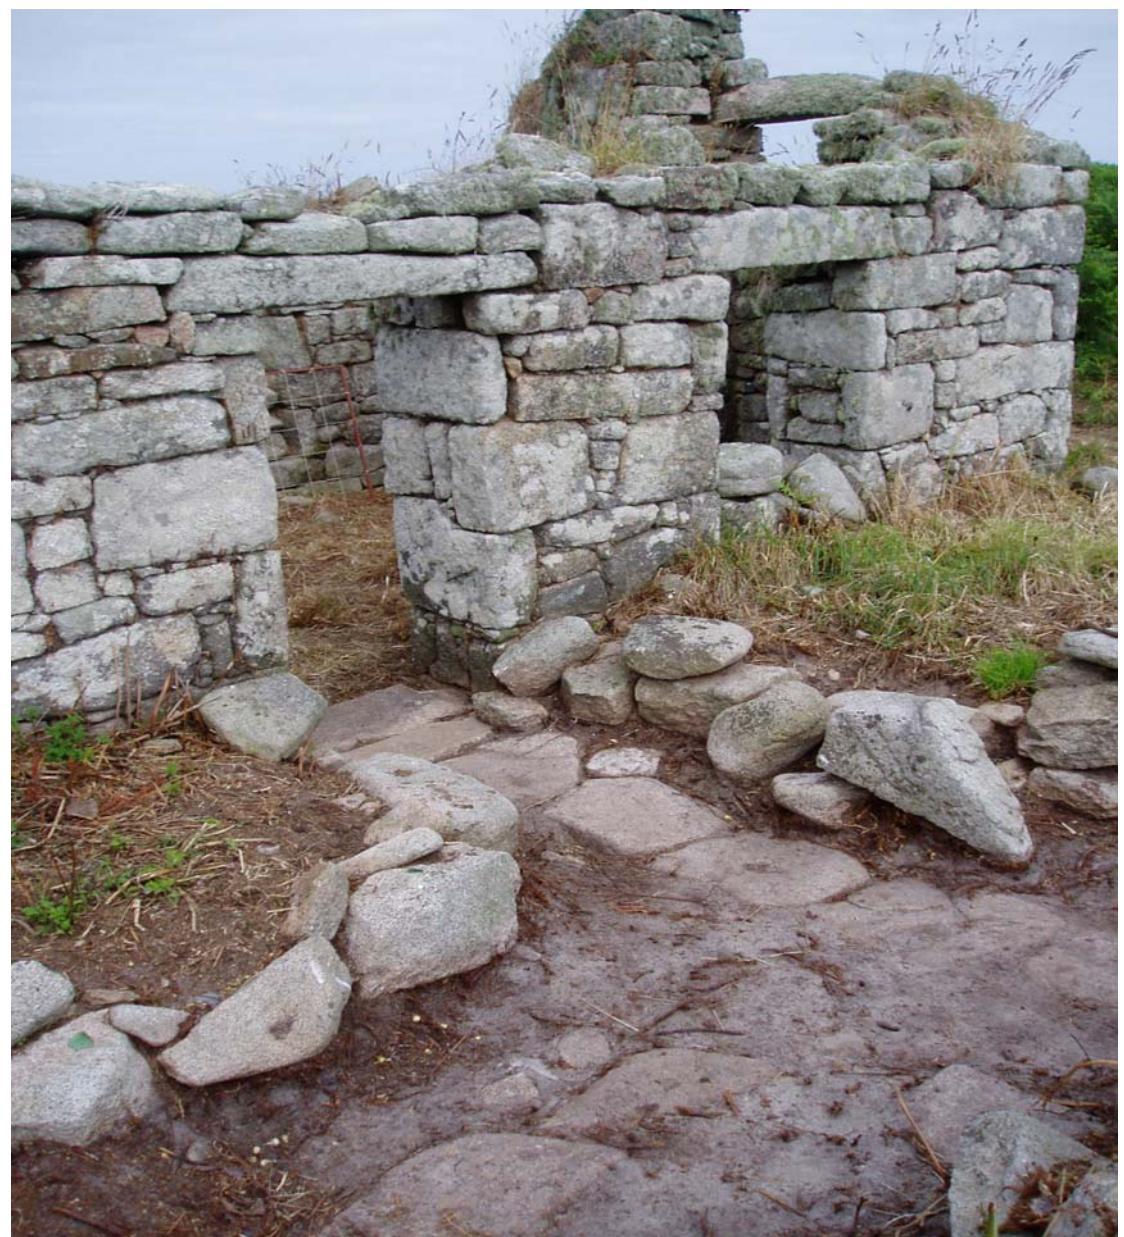
Fig 97 The flag stone path (House C)

Usually hidden by sand, the flag stone path, garden features and vegetable patch (not in shot) dispel any previous thoughts one may have of people living a lonely and bleak existence on Samson Island.
