Trevelgue Head Cliff Castle, Newquay, Cornwall

Management Works 2001-2004

Historic Environment Service (Projects)

A Report for Restormel Borough Council
and English Heritage

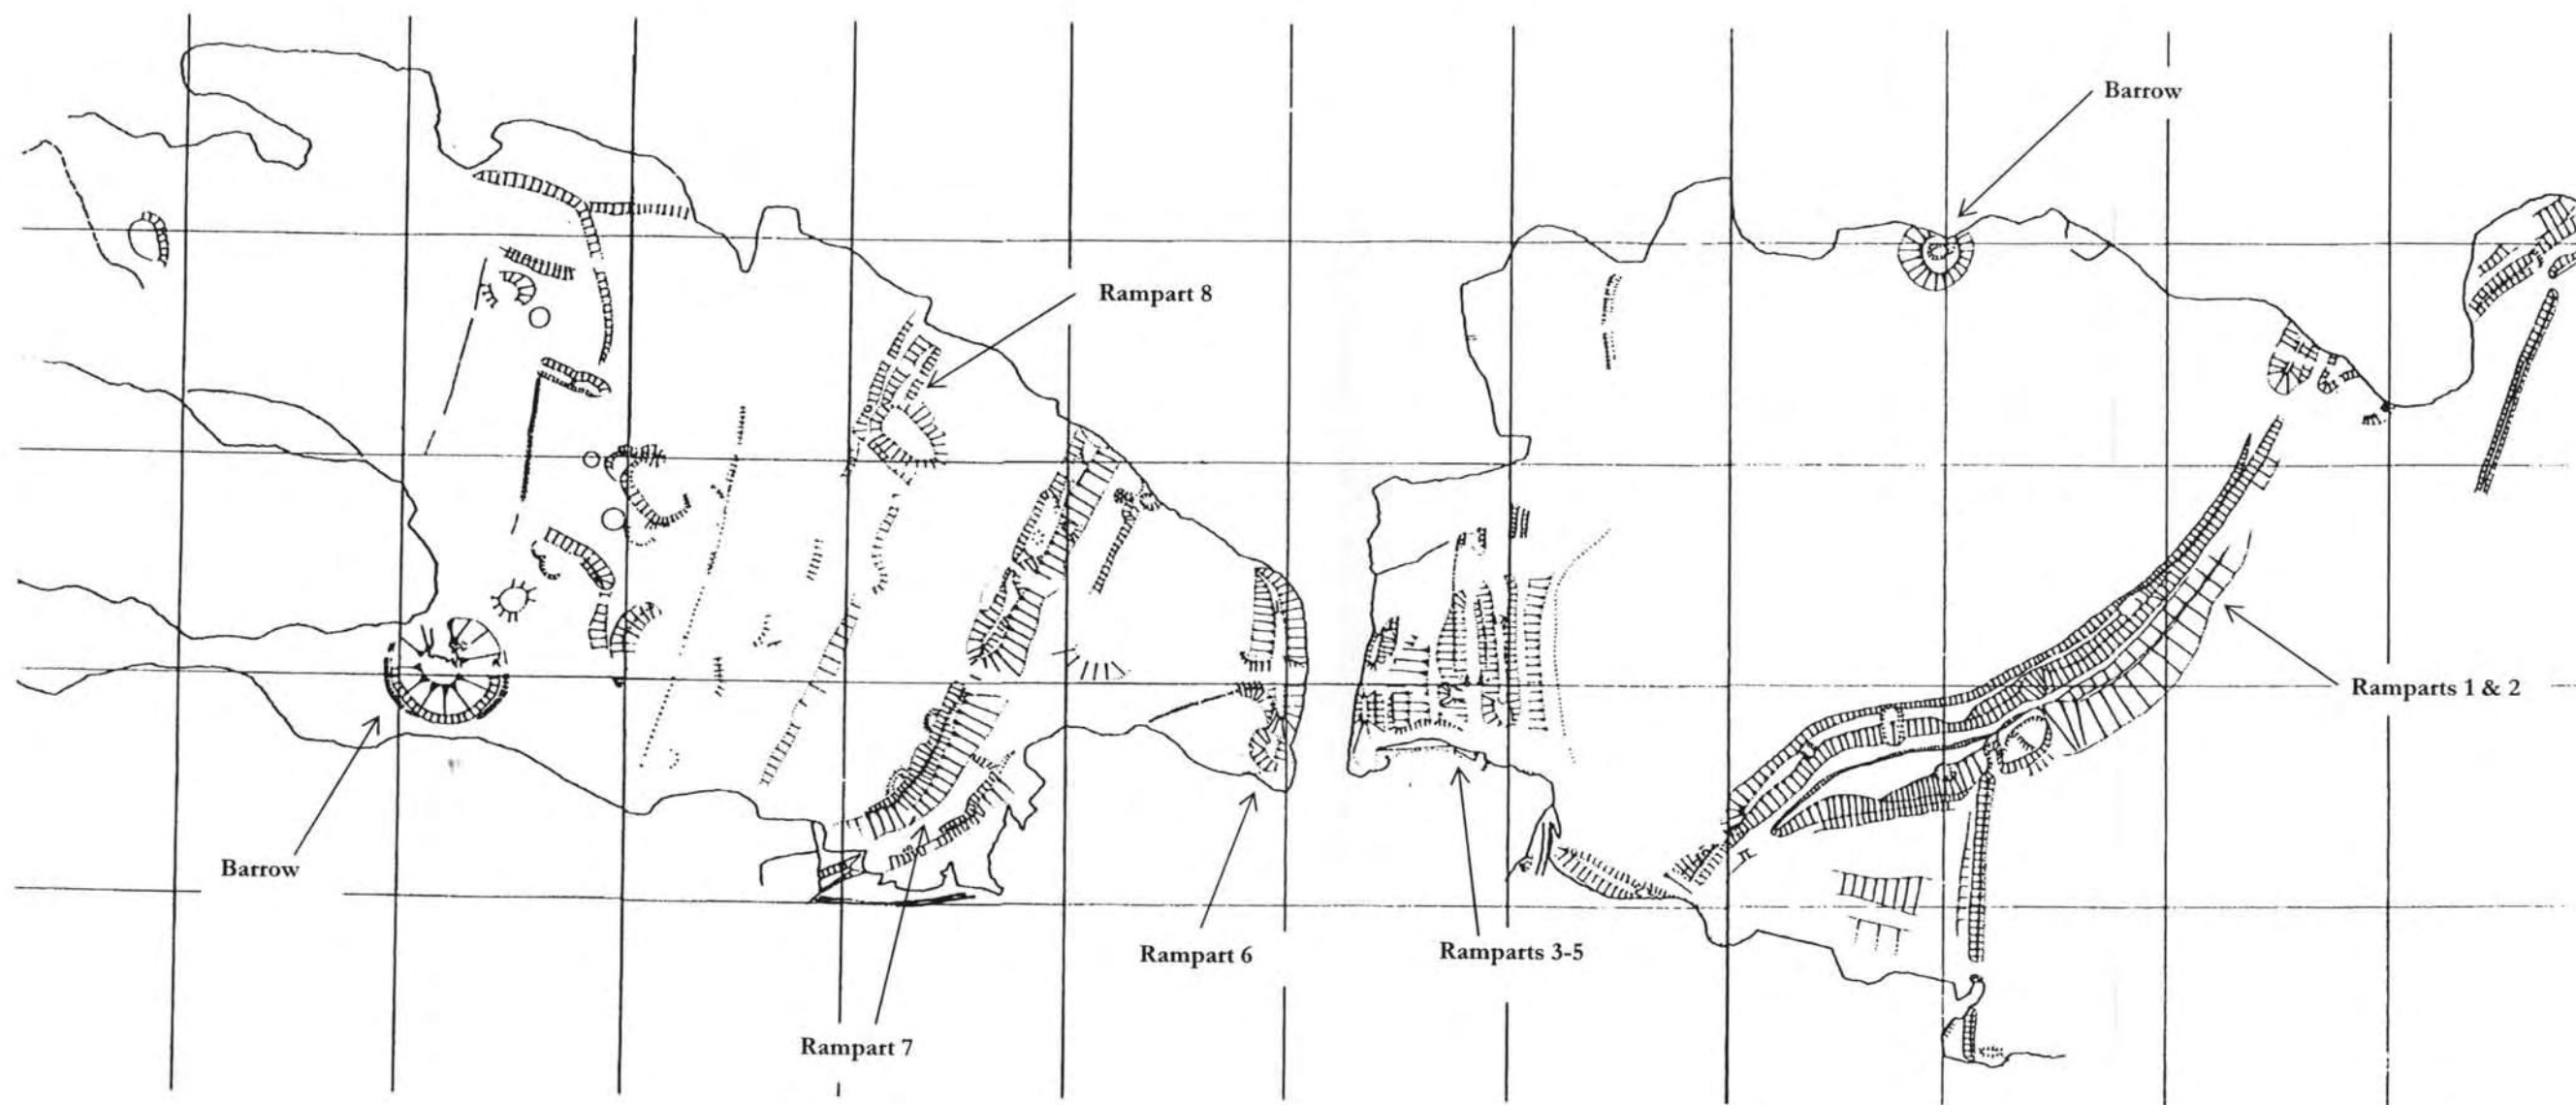
Figure 4 Location of erosion repair and footpath creation in seasons 1-3.

Season 1 (November 2001)
 Season 2 (Nov. 2002-March 2003)
 Season 3 (Nov. 2003-March 2004)
 Coloured broken lines shows new footpaths.

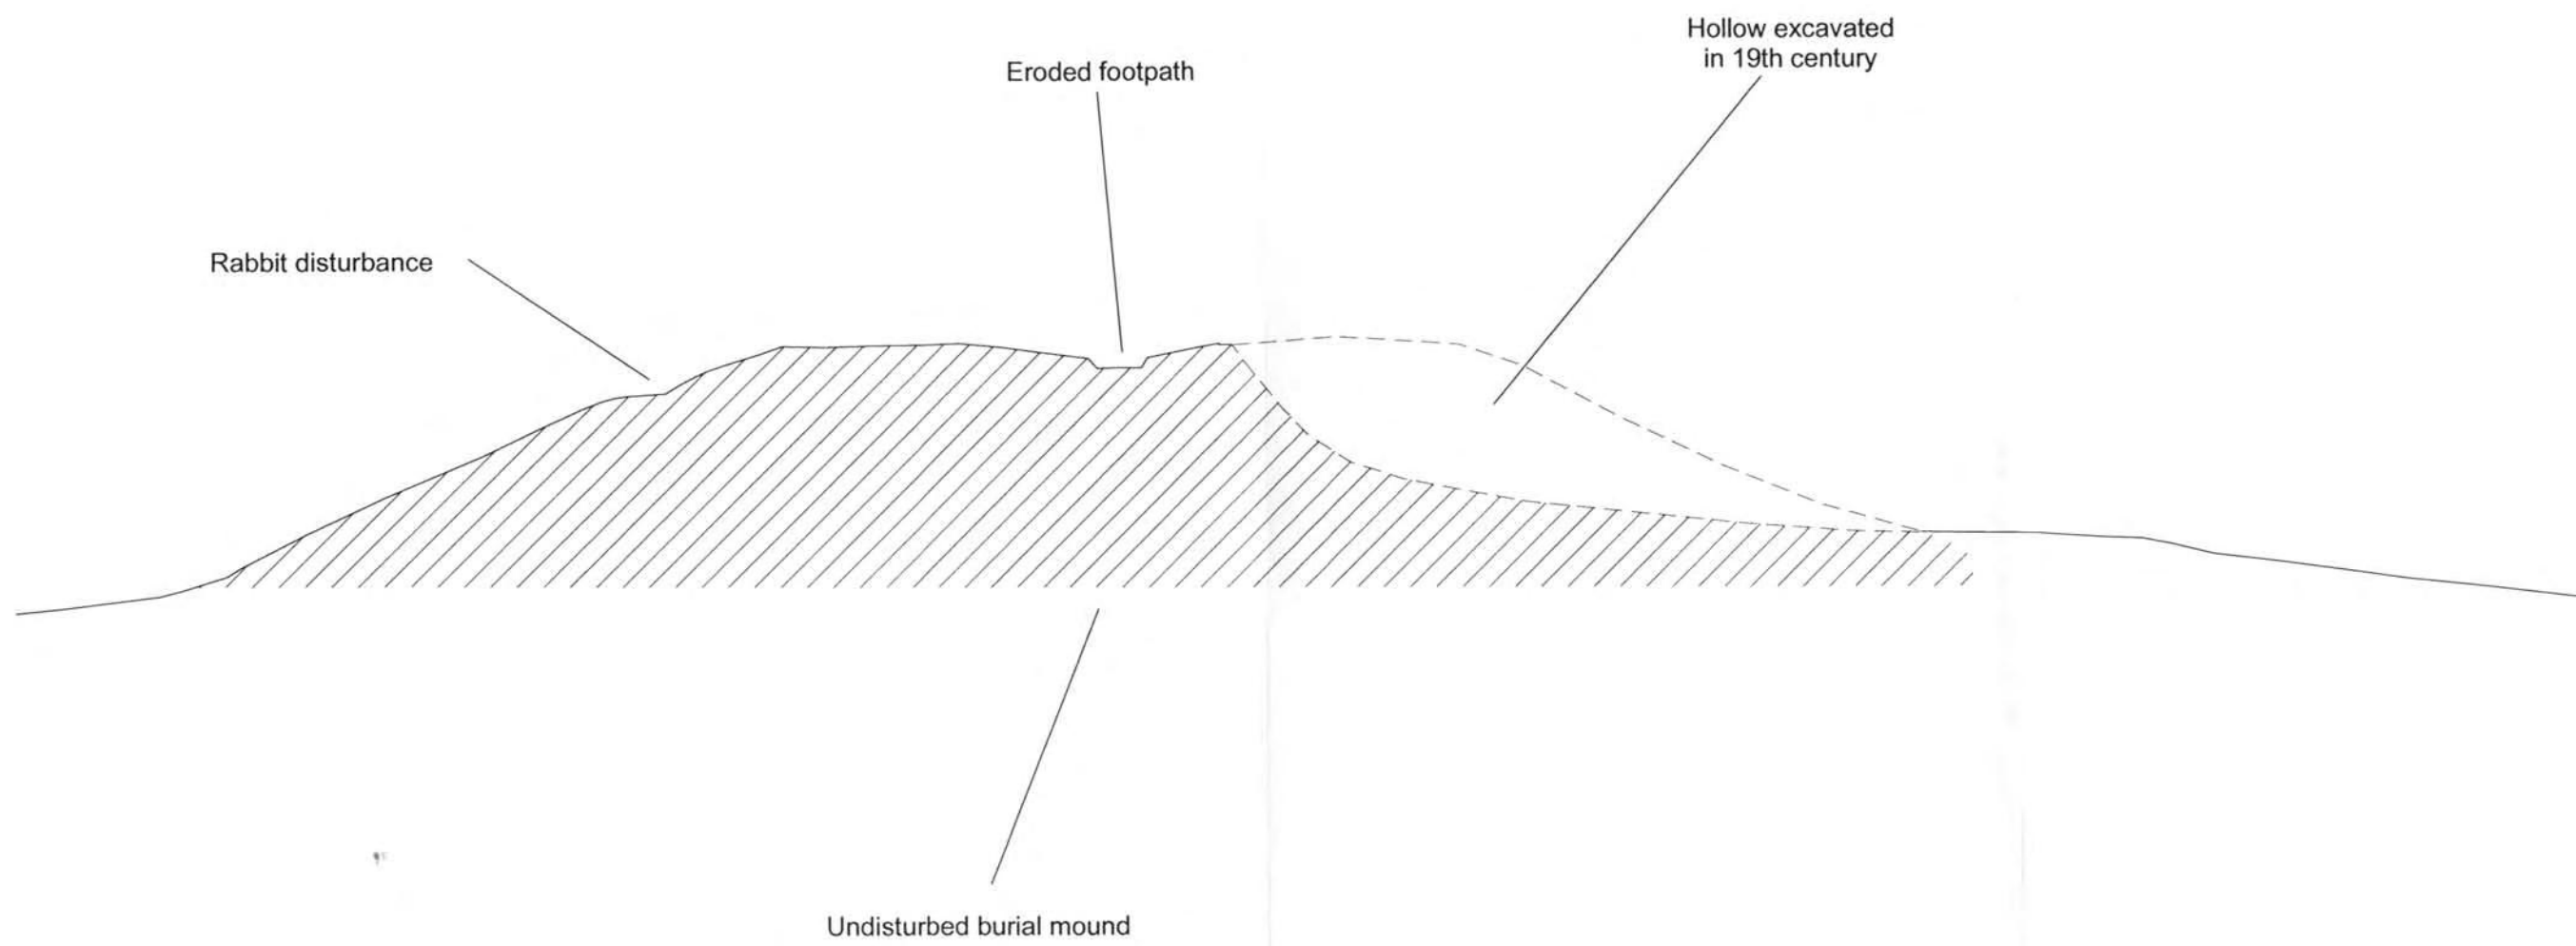
Fig. 9 Schematic east-facing section of Bronze Age barrow.

An EDM survey of the barrow was carried out in October 2003, in advance of the conservation works. The main areas of erosion within and over the barrow were recorded, as well as the areas of eroded path. Existing areas of grass cover and existing paths were also noted (Fig. 8) and a profile of the barrow was also constructed (Fig. 9). In comparison with the earlier 1983 survey, it showed that the surviving clumps of turf to the north of rampart 4 and to south of rampart 5 had been further eroded.
