Drakewalls Mine (east), St Ann's Chapel, Cornwall

Report on building conservation works

Report on building conservation works (2008)

Client	East Cornwall Regeneration Project
Report Number	2011R129
Date	December 2012
Status	Final
Report author	Colin Buck
Checked by	AJ
Approved by	AY

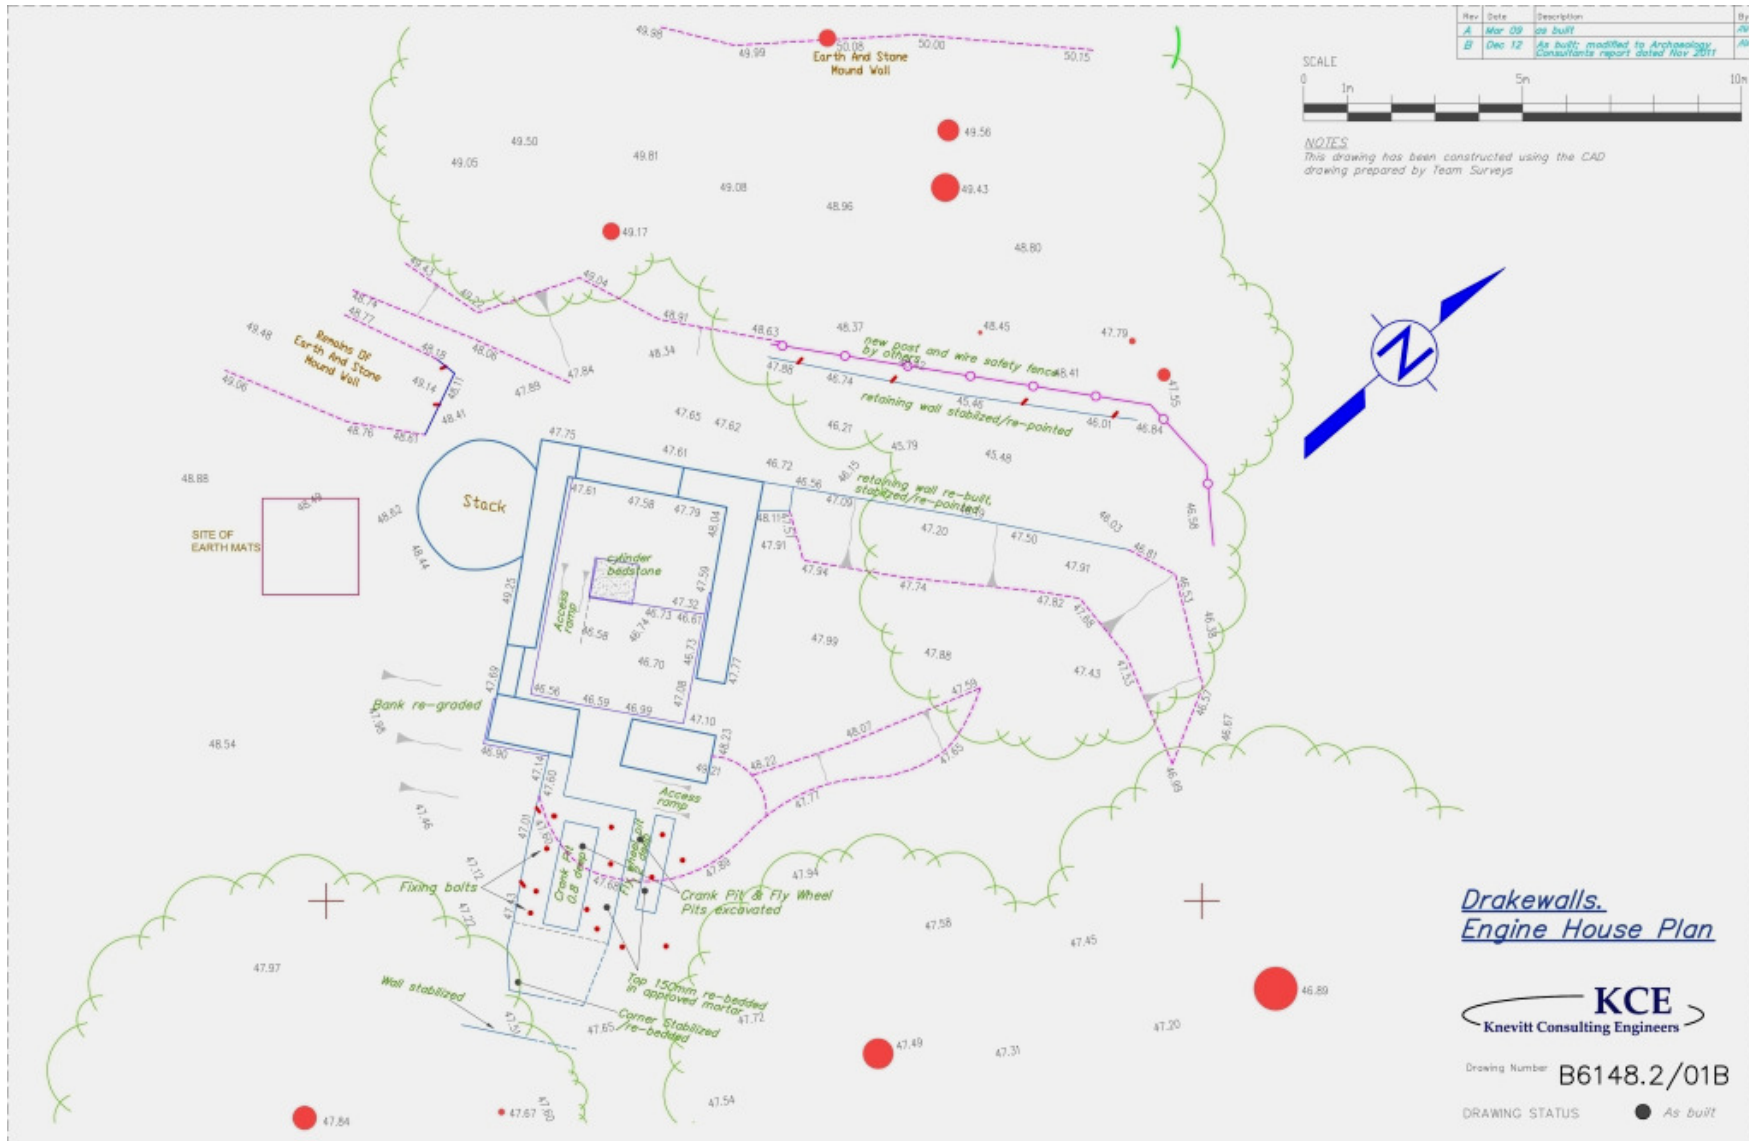
Figure 3 'As built' survey plan of the rotary engine (and boiler) house, flywheel loadings/crank pit after works (Knevvit Cons. Eng. 2008)

Figures 4, 7, 10 and 11 are 'as-built' internal and external measured survey elevations of the engine house and a site plan (Figure 3). Each drawing has detailed annotations relating to the works that have been undertaken on each wall. Relevant representative photographs of the works are also reproduced in the text (Figures 5-6, 8-9, and 12-15). By mid November 2008 all the major and minor conservation works to the engine house and adjacent loadings as an additional project (see Section 4.2), had been completed with the scaffolding removed in mid July 2008. During this period, the inside of the engine house had been cleared of rubble to allow safe public access, revealing an intact granite cylinder bedstone (1.0m X 1.1m and 0.3m thick), with four intact holes (near each corner) for the cylinder bolt tensioners. The cataract pit was not excavated; its rubble/earth infill was spread to allow safe public access through the engine house.

The masonry over the top of all the rotted timber lintels was carefully replaced with fallen stone from the building after new sections of tanalised Douglas Fir inserted to mimic the original timber specification. The top of the remaining walls were 'capped' and repointed. The walls were only repointed where there was a structural need to do so (mainly in the upper sections).

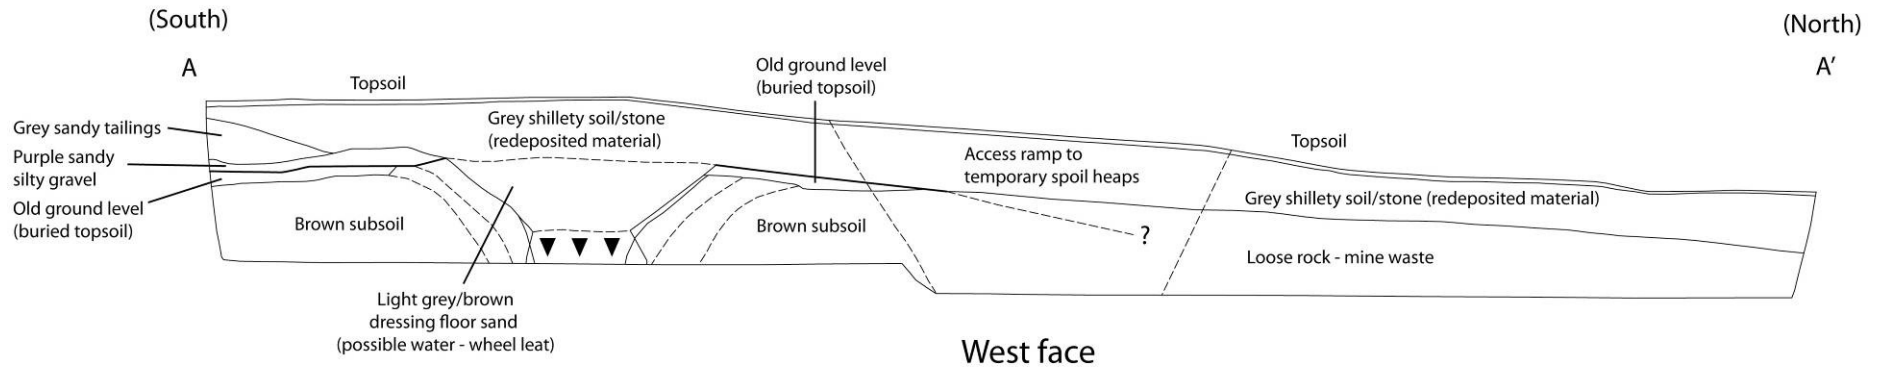
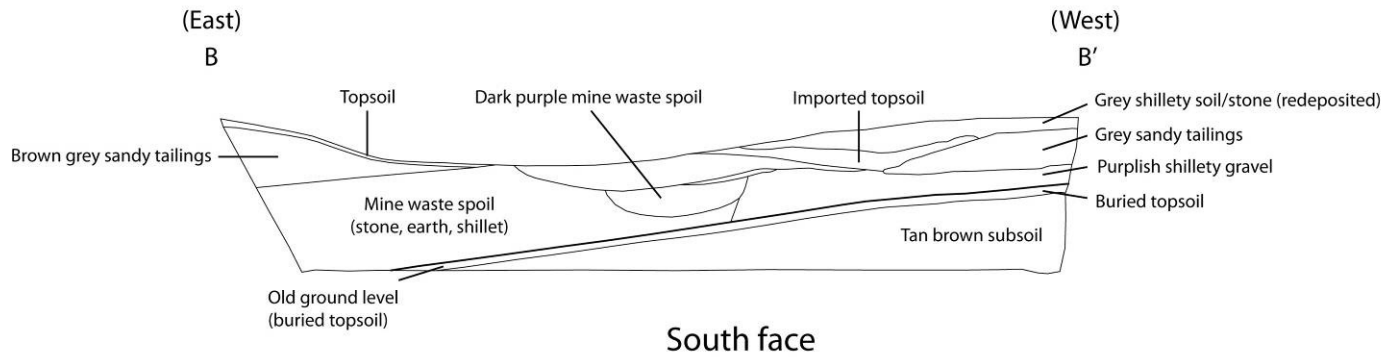
Figure 17 Section drawings A - A' and B - B'

The main significant archaeological feature is plainly visible in both Section A-A' and Figure 18. The light grey dressing floor sand material appears to have been deposited into a wide profile water leat which fed a water wheel sited in the area of the new car park (Section 4.7). An 1834 Tithe map showing the course of this leat is reproduced in Buck 2006, 11, Figure 6). The top of the leat cut is approximately 4.0m wide across its top, 2.0m deep and 1.5m wide across its excavation base. The remainder of the section show a variety of mine waste and sandy dressing floor tailings; visual below ground archaeological features for this part of the Drakewalls mine site, which in the mid 19th century once sited its dressing floors. Section B-B' is also a relatively standard profile for this part of the mine site, reflecting the site's topography and proximity to a large mine waste tip.

To summarise, the total depth of ground removed on the west side was approximately 2.8 to 3.0m below ground level, reducing from 0.3 to 1.5m on the east side. The north side was only 0.3 to 0.5m, and the south side only 1.5 to 3.0m below ground level. The excavation area was then levelled with a layer of '803'. The building was erected after the excavation footprint was deemed to be acceptable by the site building engineer (Mark Lovell Design Eng.) at the end of May 2008. Photographs were taken of this process, although the final stage is only shown in this report (Figure 21).

Given the depth and loose infilled leat material at the base of the foundation excavation, a decision was taken to further reduce (by an additional 0.8m), the depth of the building's footprint in order to entirely remove the leat's infill from the floor of the site. An access ramp had previously been excavated through the west side of Section A-A', in order to remove the surplus material to temporary dumps (see Figure 22), from which it was redistributed on site and then covered down with imported cleaner additional earth/stone, as the excavated material from both the building's footprint and the new car park excavations contained a degree of mine waste and metallic ore contamination.

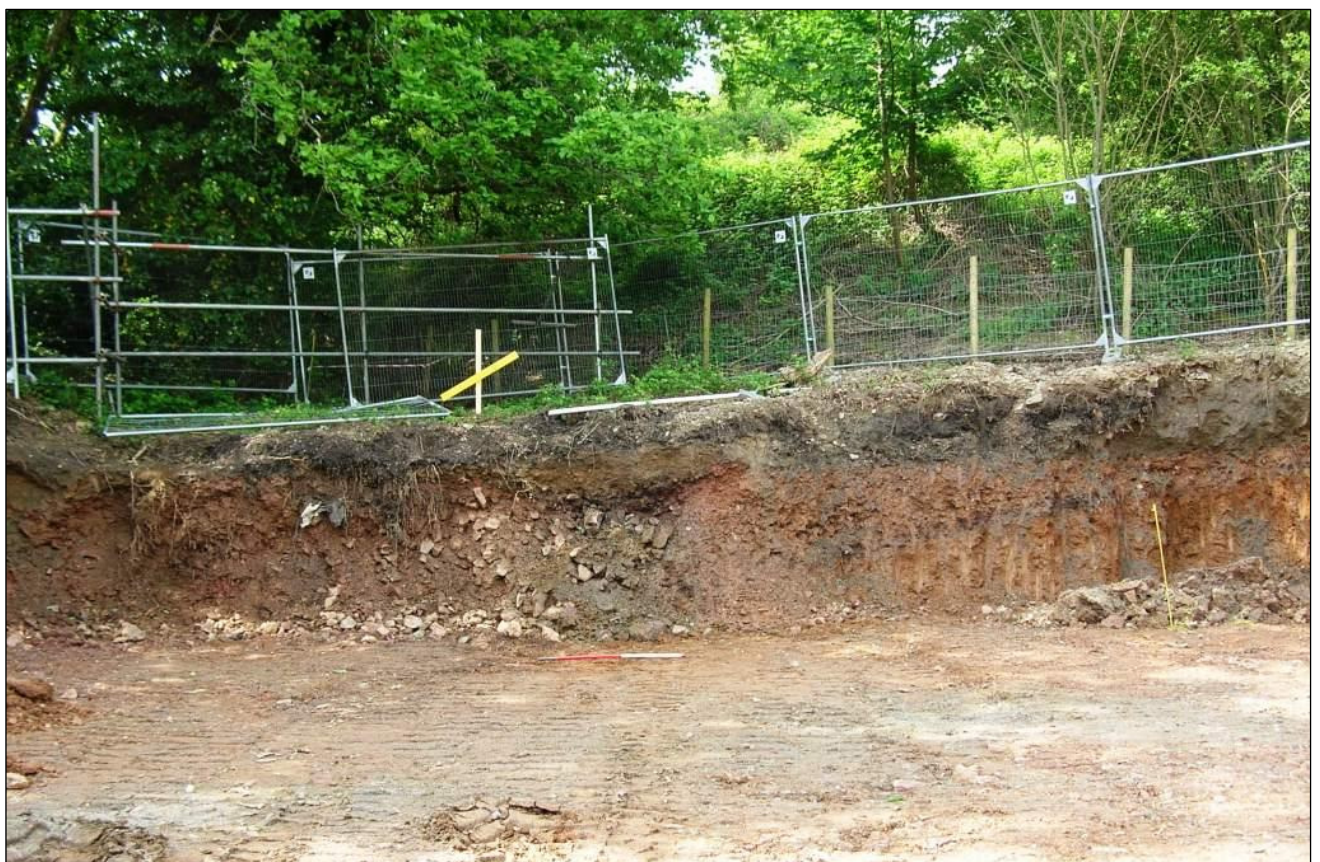
Figure 19 A view of Section B-B' from the north © CC HE Projects 2008

Site excavation started in early May 2008 (see Figure 20), with the final depth of footprint excavated by 21/05/2008. The site, as shown in detail on Figure 16, consisted of a rhomboid excavation, leaving a deeper section at the south west corner (Junction of Sections B' and A), to a depth of 2.3m, whilst the opposite corner was only excavated to a depth of 1.0m. Sections A-A' (south face) and B-B' (west face), are only shown in this report (as being representative of the soil profile and revealed archaeology). The illustrated sections are shown in Figure 17, with a photograph of each section reproduced as Figure 18 for Section A-A' (south half), and Figure 19 (Section B-B').

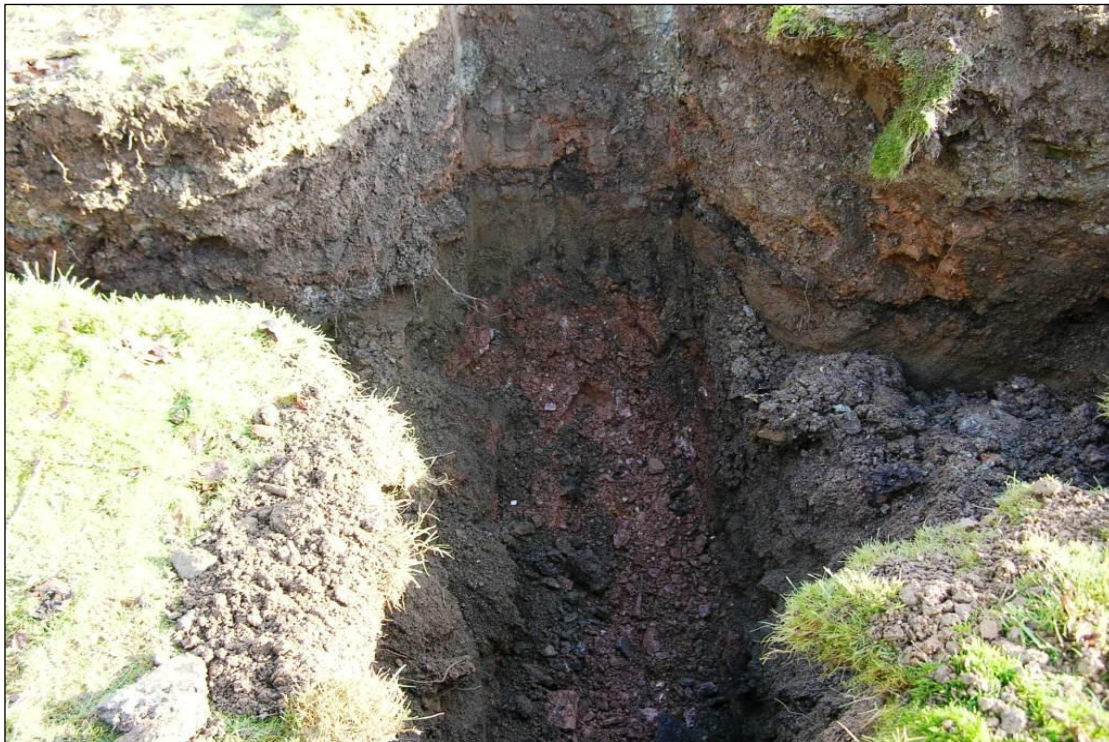
Figure 24 A view of excavated surface depression (from the north) © CC HE Projects 2009

During the excavation phase of the Tamar Valley Centre and the creation of temporary waste dumps (see Figure 22), a slight depression was observed. The site was temporarily fenced off during the site works. Sherrells Ltd (geotechnical mining engineers of Tavistock) were asked to undertake a small site investigation with a mini-digger. This took place on 13/01/2009. The small collapse was approximately 1.3m x 1.1m and 0.7m deep. It is sited 2.7m from the adjacent hedge encircling the south side of the gunnis (as shown on Figure 23). The feature was excavated to a depth of 1.5m and a length of 3.0m, with two trenches cut across the feature (see Figure 24). No definite conclusions were reached, except that it was probably a shallow pit or trench that had collapsed – possibly as a result of the previous landscaping works in 1995 that had covered a shallow void – which subsequently collapsed in late 2008. The site was backfilled.
