St. Ruan's Well, Grade, Cornwall

Conservation and Landscaping

March 2003

Report No: 2003RO27

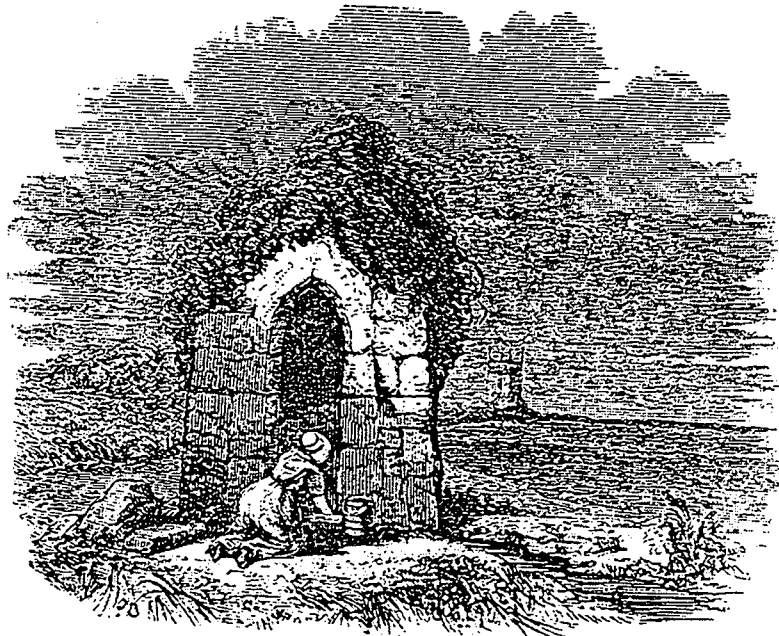
Figure 2. Illustration of the holy well from CA Johns (1848) *A Week at the Lizard*.

Johns refers in strongly derogatory terms to a restoration of the well in the mid 19th century. Both his illustration (Fig 2) and Blight's (Fig 3), which pre-date this 'restoration' show the roof thickly covered in vegetation and possibly higher than it is now. The restoration may have involved the removal of this growth and a reconstruction of the roof

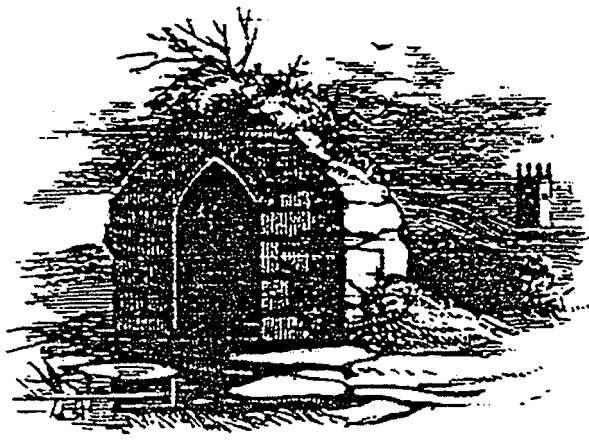
Figure 3 Illustration of the well by JT Blight, 1856

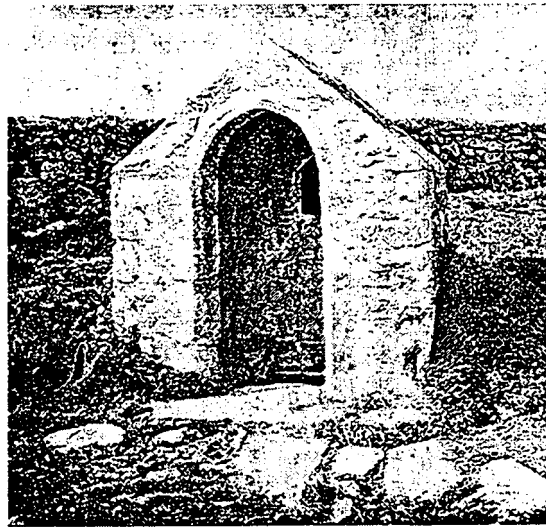
Figure 4. Photograph of the well in Qualler Cough (1894)

at a slightly lower level, for the illustration in Quiller Couch (Fig 4) shows a lower roof line and a complete absence of vegetation. Quiller Couch notes that the building was then in good condition. In 1916, Henderson (221, 224) observed that before restoration, the walls were 'without mortar and are still of the rudest description'; his description of the well, made when it was Scheduled just over ten years later, notes that the well had been repaired (conservatively) from time to time, but that the roof was 'in need of slight repair'. The photo of circa 1920 at the Royal Institution of Cornwall bears this out, in showing the stones of the roof without any mortar, although, as noted above, pointing can be seen on the front, particularly to the left of the door, the joints emphasised with incised lines. At this time, the well-house had a door, although it is not shown with one in any earlier illustrations, and has not now.

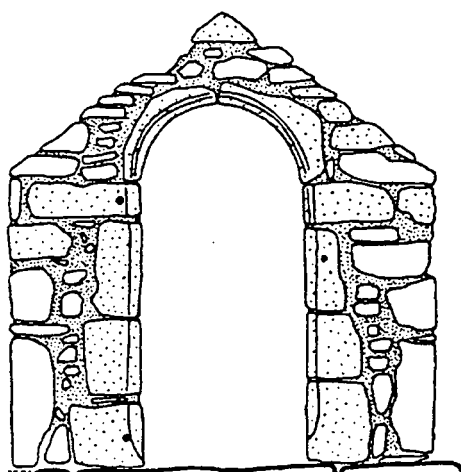
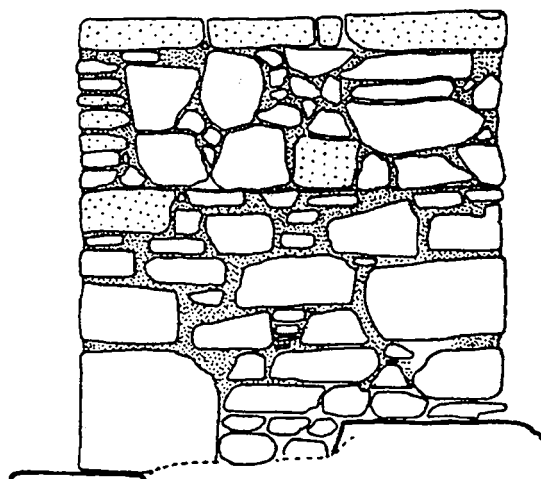
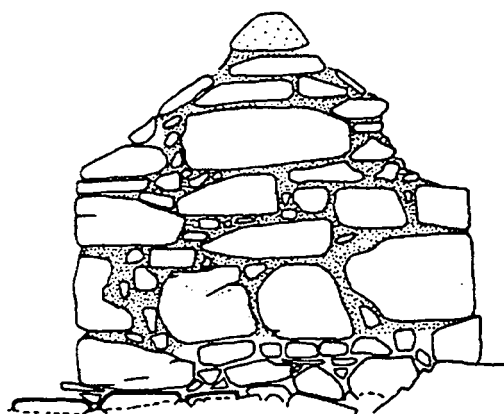
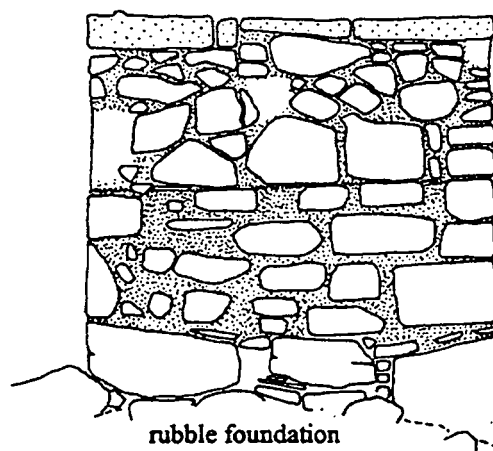
Figure 8. CAU's elevation drawings of St. Ruan's Well, Grade

On 27th July 2000, elevation drawings were made of St. Ruan's Well in Grade by Jo Sturges of Cornwall Archaeological Unit. These were made, at a scale of 1:20, to provide a basic record of the monument prior to the proposed conservation work, which was expected to involve the removal and replacement of stones, particularly in the roof. Only the exterior was drawn, as the interior was not likely to be affected by the conservation work. The drawings are shown in Fig 8.

north-west wall of the well-house and all of the internal faces of the building are founded on similar slabs of serpentine revealed after removal of a build-up of earth around the base of the building as a preliminary to the re-pointing. On the outside, on the west, this slab-foundation steps up by 0.2m, to fit with the natural slope of the land. In contrast, the south-west and south-east walls are set on rubble, one large chunk of stone having a drill-mark of early 19th century type in it (see the elevation drawings, Fig 8, and the plan, Fig 9).

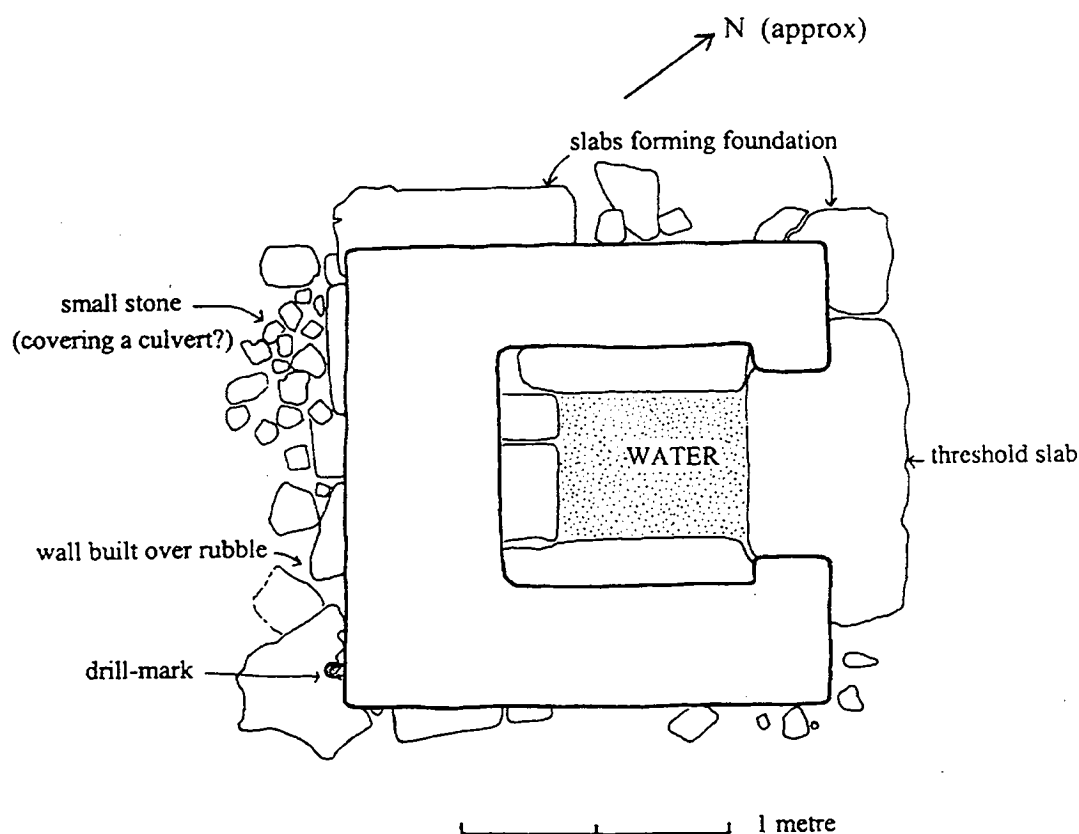
Figure 9. Plan of St. Ruan's Well, Grade

As noted above, a narrow (0.20m to 0.22m wide) sill of polished serpentine slabs surrounds the actual well basin, which measures 0.74m from front to back and is 0.54m wide. The basin is 0.45m deep, and full of incredibly cold, crystal-clear water. Its sides are undercut – by as much as 0.34m at the back – though whether this is the result of natural erosion, or because the well-house was originally constructed over a rough hollow, is uncertain. At 0.3m below water level, under the sill, is an iron pipe, to take the overflow away.

2. Beneath this build-up, larger earth-fast stones, supporting the structure, were found. The two contrasting types – the flat slabs and the rubble – have been described above, in section 4.1 and are shown in the plan, Fig 9.

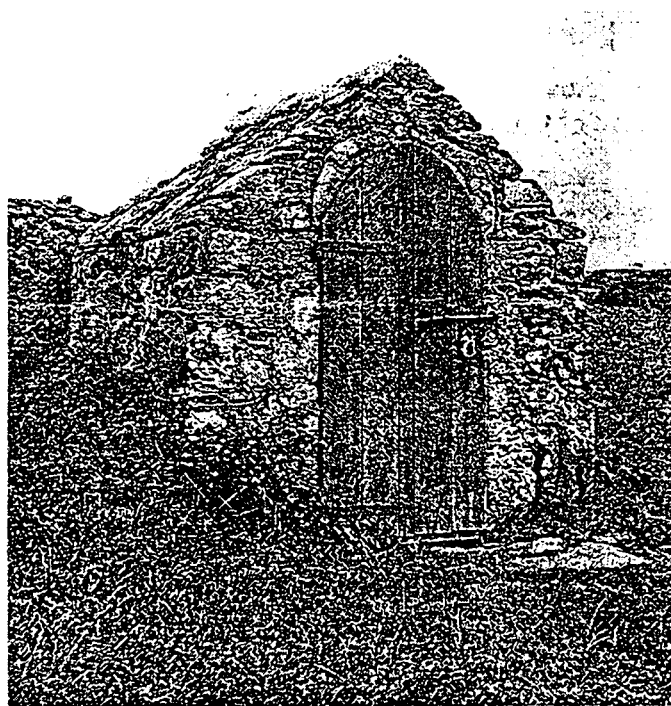
Figure 16. Undated photograph of the well with a wooden door

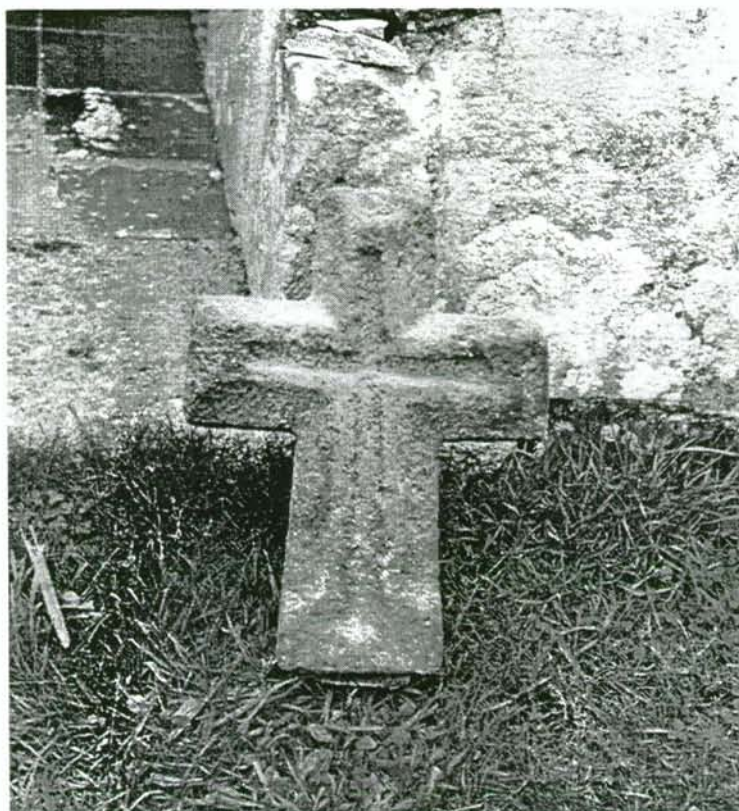
Until recently, the cross remained in safe-keeping, on the windowsill on the south side of the nave, in Grade Church. It is a latin cross 22cm across the arms, with chamfered angles forming an octagonal cross section, and a recessed cross carved on front and back. On the bottom is a small rounded tenon designed, in all probability, to fit the socket on the ridge of the well-house. The cross is carved of a fine-grained granite which is hardly weathered, so that it retains crisp angles and a fresh appearance. The degree of weathering, compared to the socket stone, suggests either that the cross, if medieval, has been stored under cover for most of its life, or that it was carved at a relatively late date to fit the existing socket. A possible context for this might have been the mid to late 19th century when, it was suggested in section 5.2, the socket could have been moved to the back of the building.

Sadly, the cross has been recently stolen, so details cannot be checked.

Figure 17. Gable cross from St. Ruan's Well, until recently at Grade Church

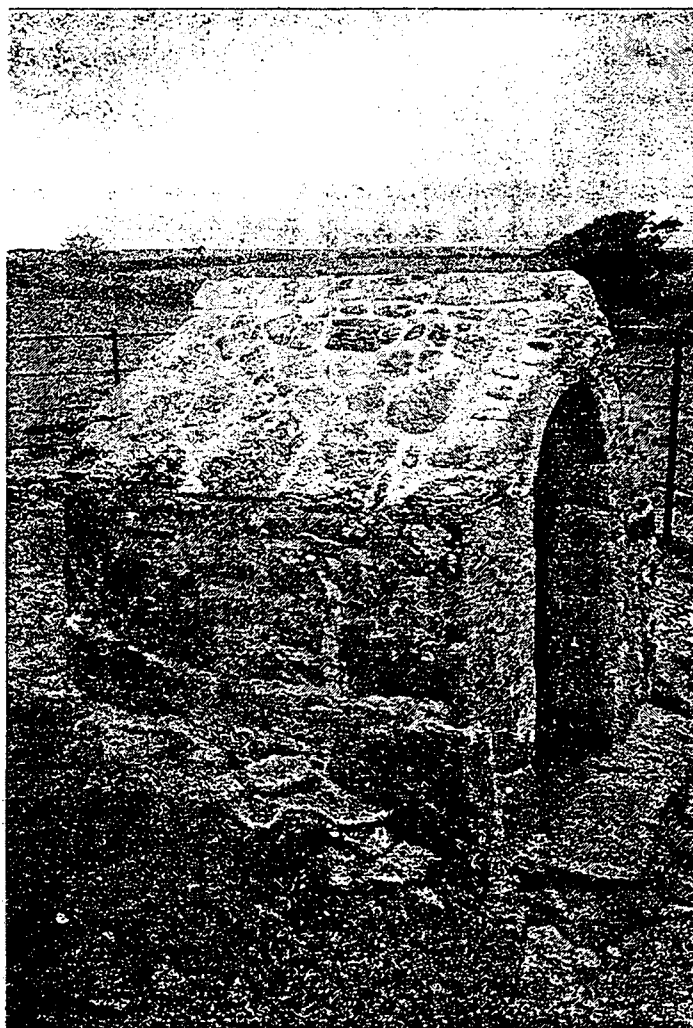
The Well after conservation. Summer/2001.
