Report No: 2014R052

# *Royal Anne* Galley Marine Environmental Assessment The Lizard, Cornwall

# **Phase 4: Inspection and Monitoring**

Client	English Heritage	
Report Number	2014R052	
Date	' September 2014	
Status	nal	
Report author(s)	Kevin Camidge and Charles Johns	
Checked by	Andy Jones	
Approved by	Ian Oxley & Mark Dunkley

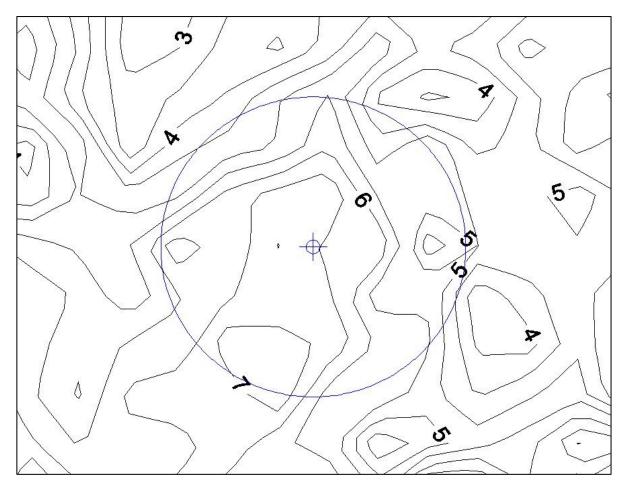
Fig 8 Contour plot of the area around the dispersal trial. The blue circle has a radius of 10m and is centred on the dispersal objects origin. The heights are in metres below chart datum. The contour vertical interval is 0.5m. Derived from Seastar bathymetric data collected September 2009 (RAG MEA stage II).

It has been suggested (EH comments on first draft report) that the differential movement of the two types of object (bricks and spheres) may have been caused by the spheres rolling downhill, while the bricks have reacted to water movements. This is an interesting idea. The impression given to the diver of the seabed in the area of the dispersal trial is that of a flat bottomed gulley. However, reference to the contour plot of the area (Fig 8) shows that the area where the majority of the spheres were observed in 2010 is in fact a shallow depression, while the majority of the bricks have 'travelled' uphill. This may account for the differentiation seen in 2010. By 2014 the spheres had all left the shallow depression and were all found (albeit only three of them) on higher parts of the seabed. We should perhaps be careful not to speculate too much on matters which are clearly the province of an oceanographer. It may be worth undertaking a small study of the data in collaboration with someone with expertise in the area of seabed sediment transport.

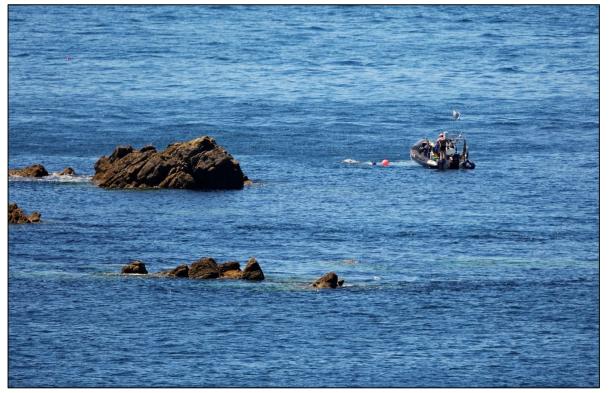
Fig 16 Diving on the Royal Anne Galley, 19 June 2014 —the buoy is attached to a shot weight positioned between guns 1 and 2 (photograph by Terence Thirlaway)
