KENNALL VALE GUNPOWDER WORKS, CORNWALL

Repair work to leat

July 2003

Report No: 2003R055

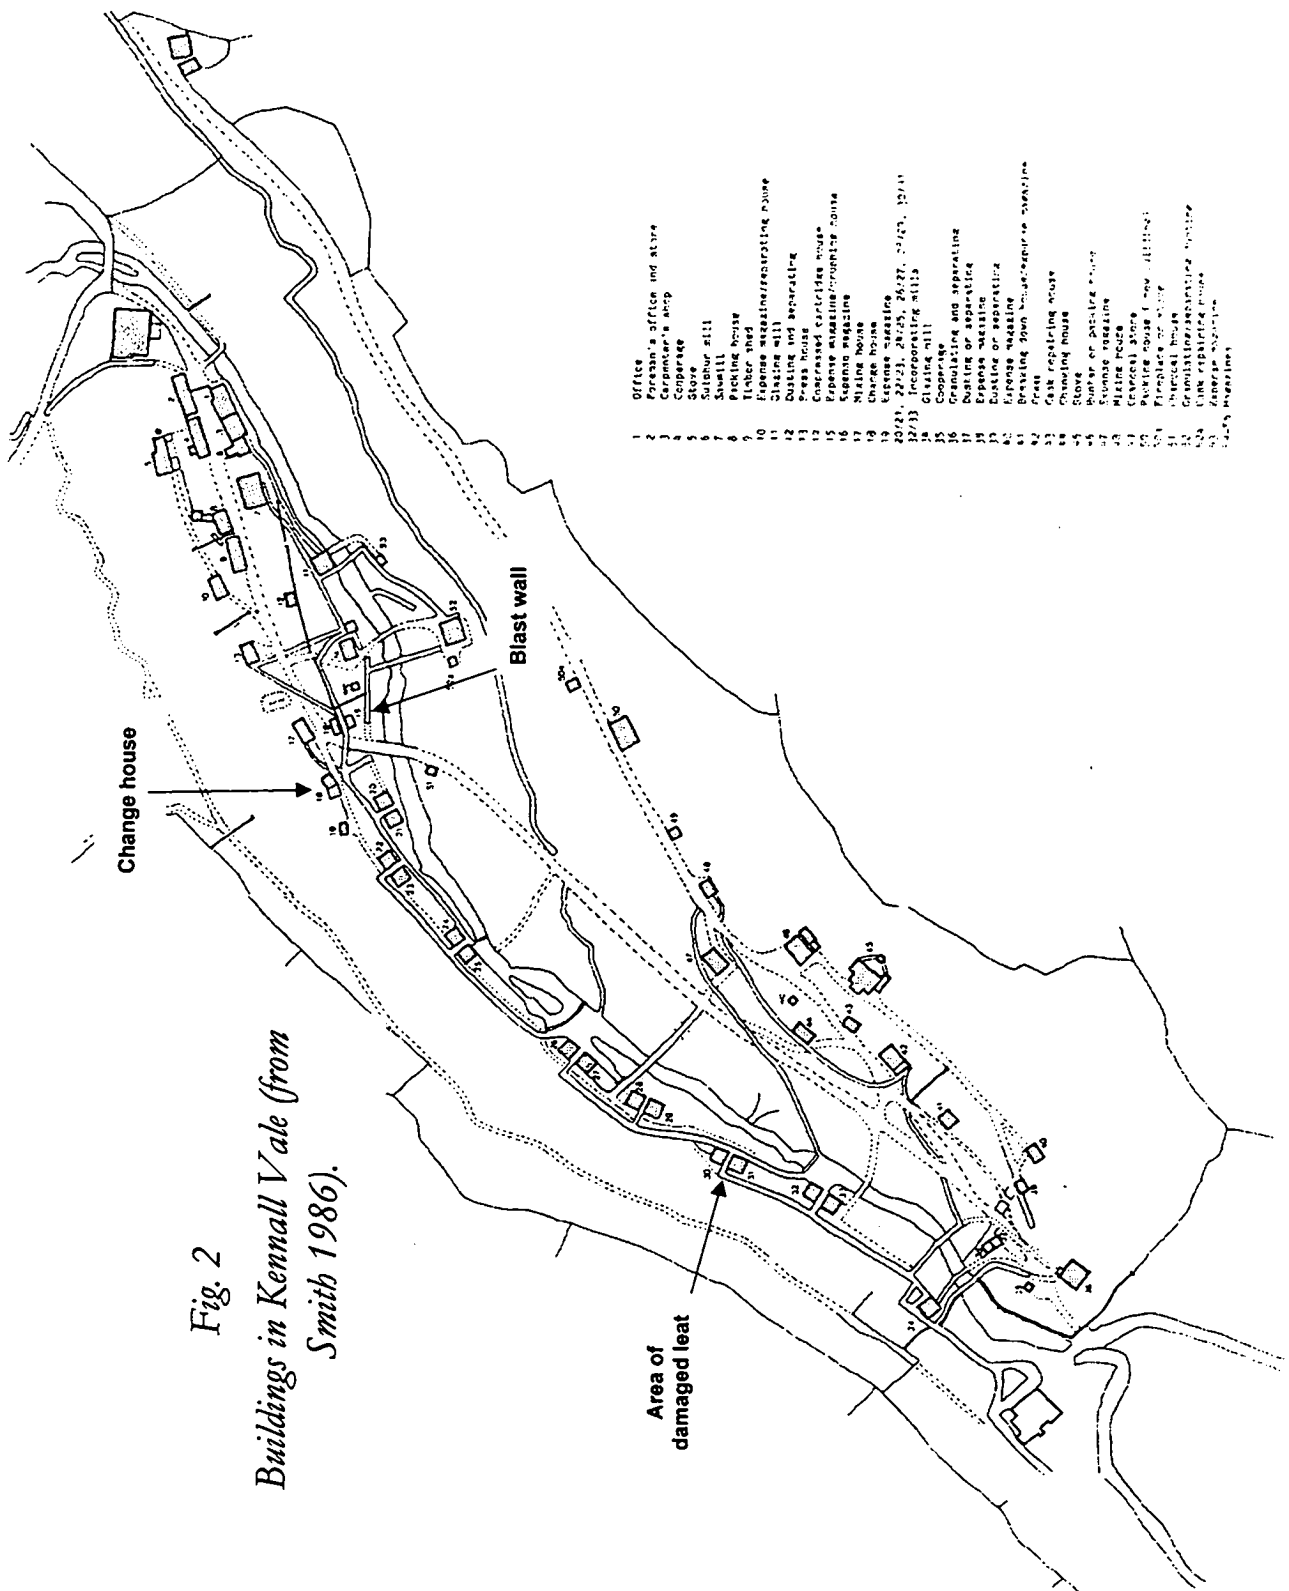
Fig. 2
Buildings in Kennall Vale (from
Smith 1986).

The damaged leat which was the subject of repair works is shown on the accompanying maps (see Figs. 2-4). It carries water to the second pair of incorporating mills (numbers 30 and 31) in CAU's survey (Smith 1986, fig 17). The leat is set on top of a rubblestone wall which is just under 2 metres high and built into the slope of the northern side of the valley. It supports a wall comprising two courses of large rectangular granite blocks which form the outer edge of the leat. There are two courses of red brick positioned on top of the walling for much of its length, the latter presumably relating to a heightening of the leat at some time.
