Wheal Call, Kenidjack, St. Just, Cornwall

Archaeological recording of the dressing floors prior to works

Client	The National Trust
Report Number	2012R014
Date	17 December 2012
Status	Final
Report author	Adam Sharpe BA MIfA
Checked by	Andy Jones
Approved by	Andrew Young MIfA, HE Projects Officer

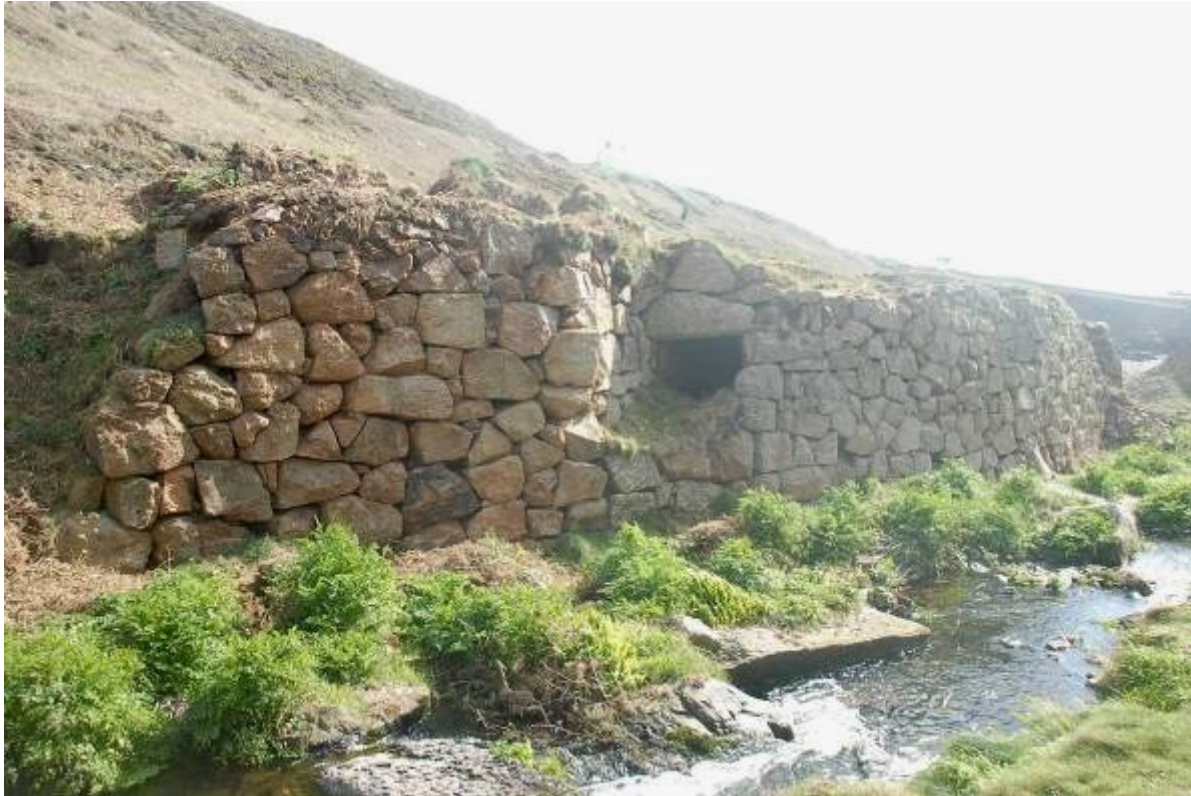
Fig 15. The dressing floor retaining wall from the north east, showing the entrance to the flatrod tunnel (centre).

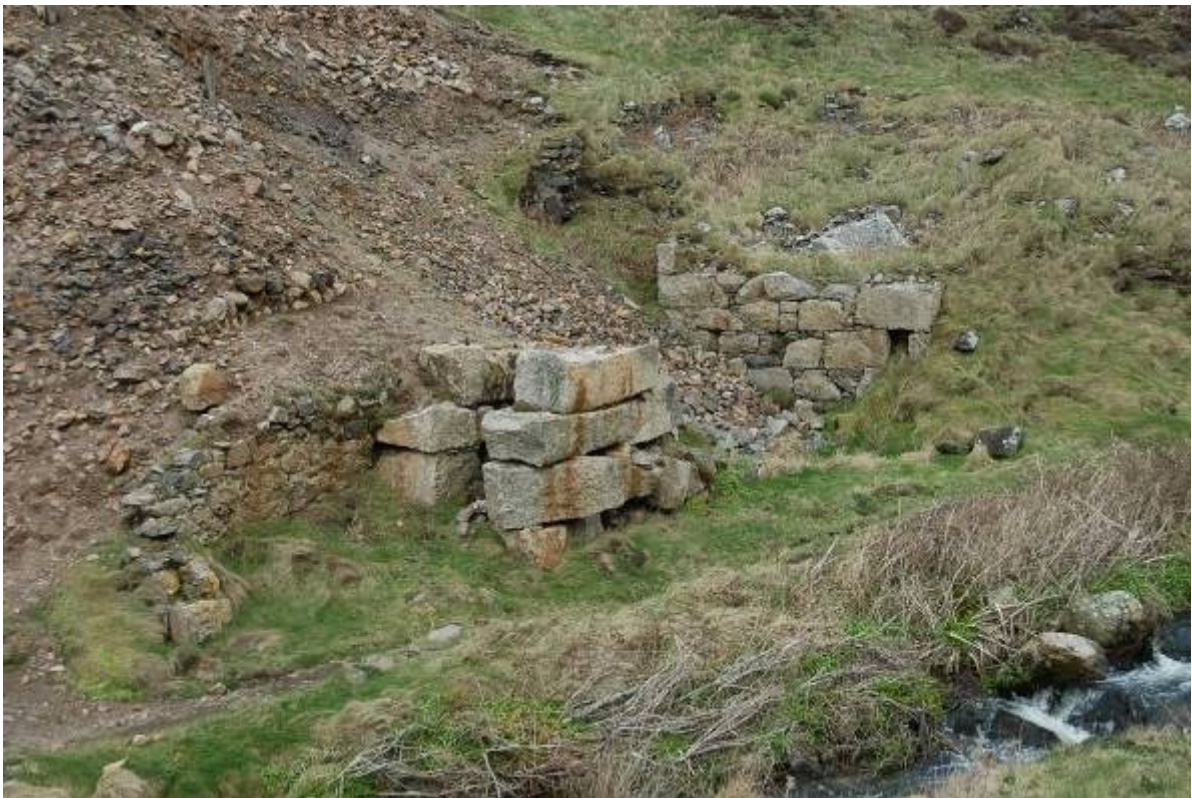
Fig 18. The angle bob loading adjacent to Engine Shaft (immediately to its right), with the remains of the pumping engine house bob wall to its right again.

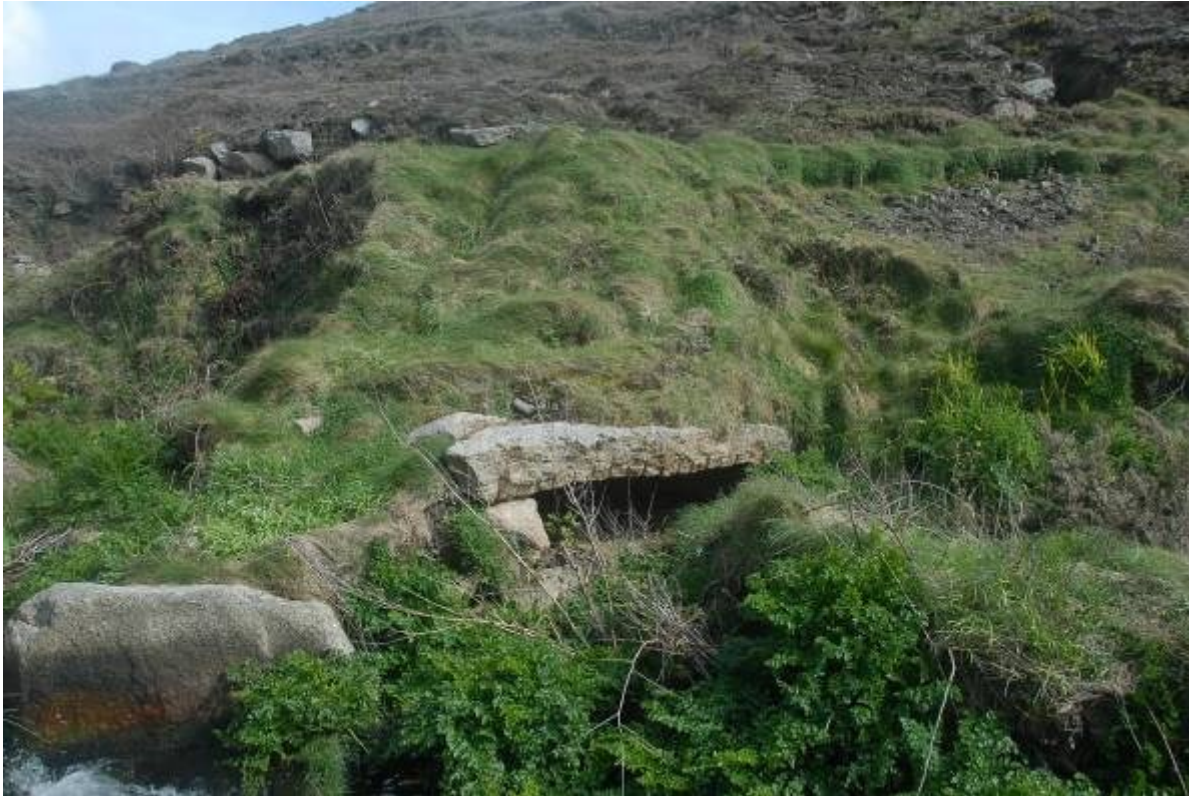
Fig 19. The entrance to the only surviving section of the culvert which originally carried the mine roadway across the valley from north to south.

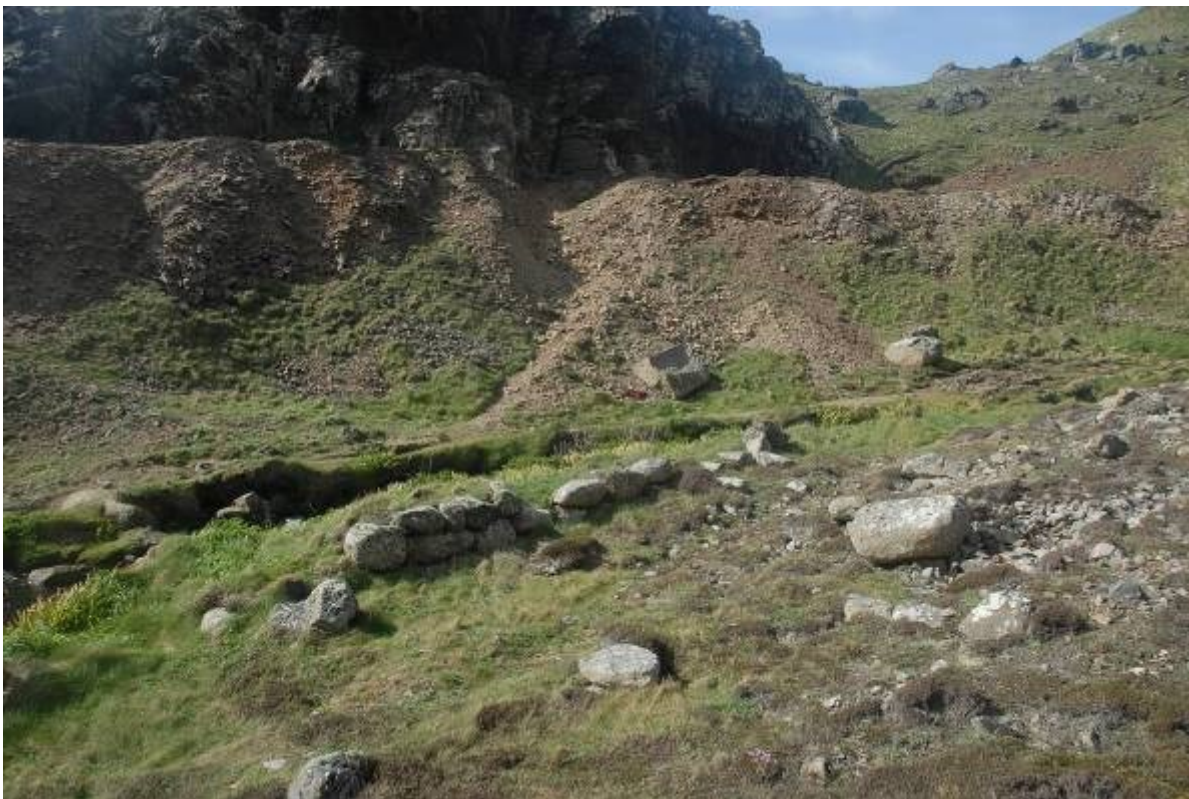
Fig 20. The boulder wall in this view probably served as an entraining wall for the stream, and continues the line of the dressing floor retaining wall to the east.

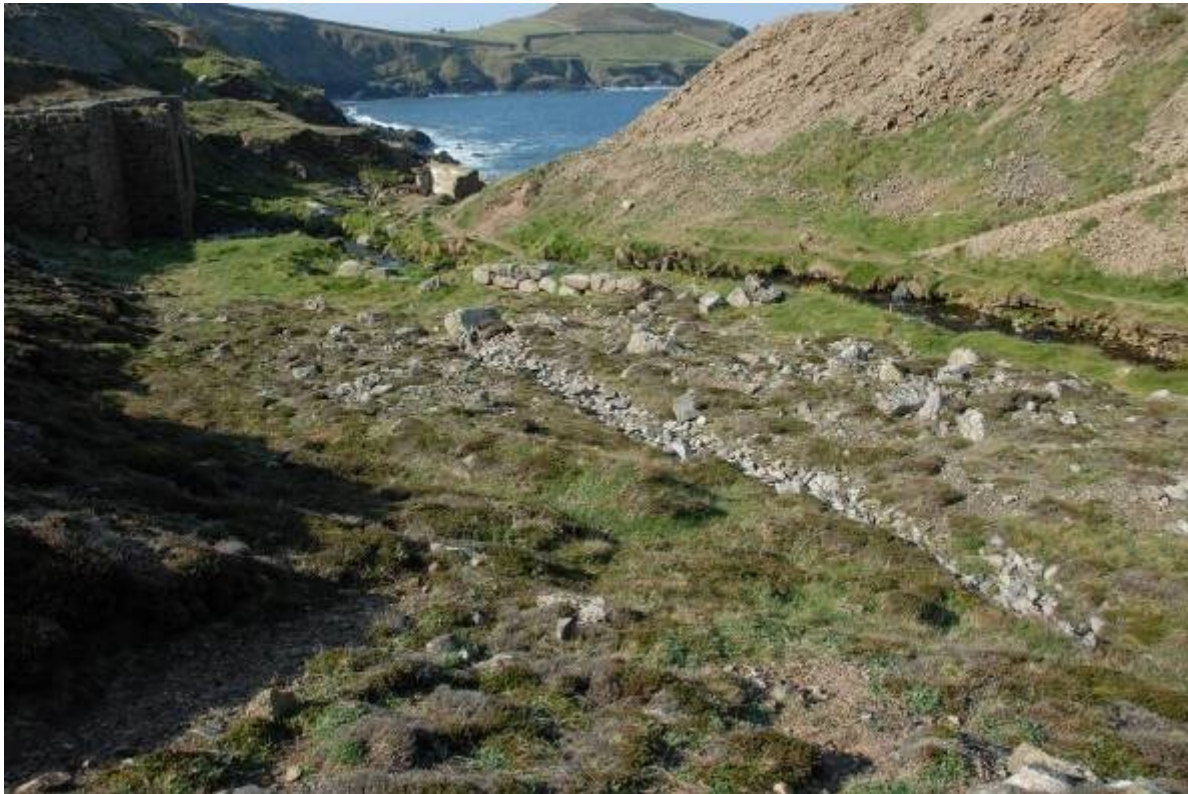
Fig 21. The stone filled trench (lower right to centre) in the lower part of the site which may have been a water channel.

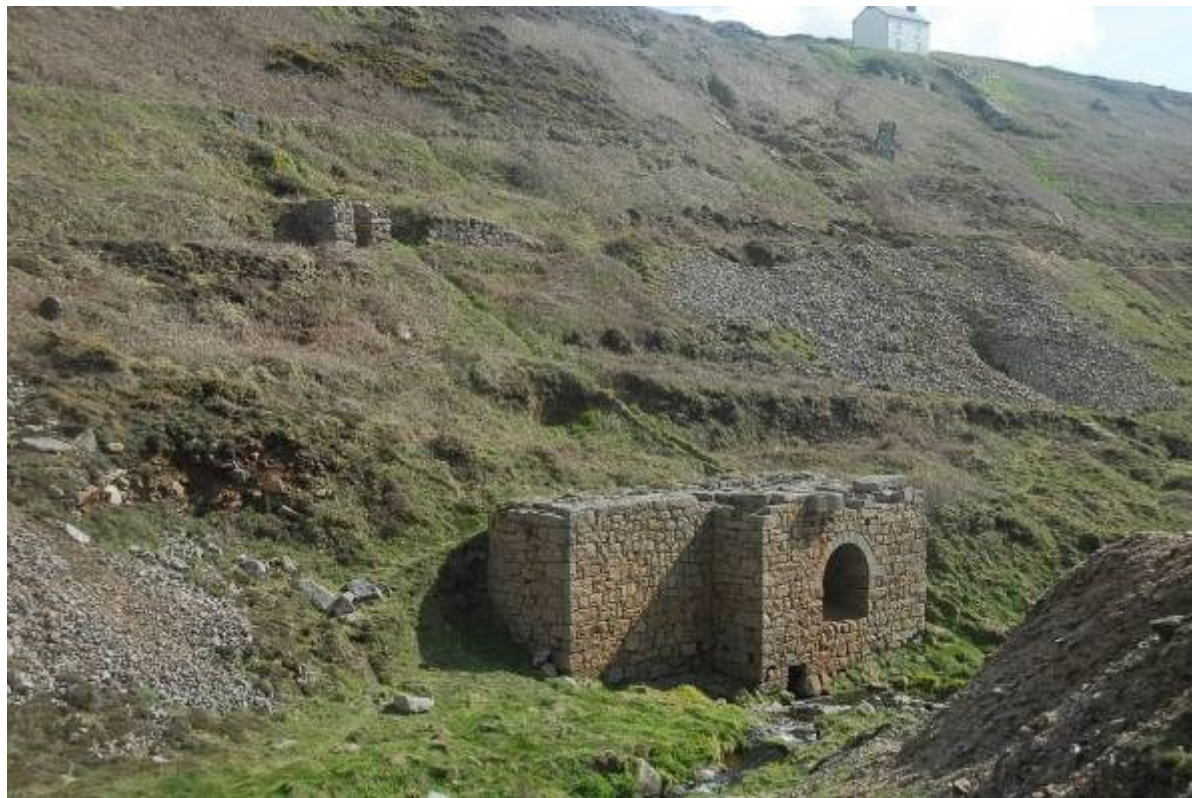
Fig 22. The free-standing pit for the Great Wheel which pumped Engine and Praze Shafts, with the pit for the winding water wheel and some of the mine leats clearly visible on the slopes above.

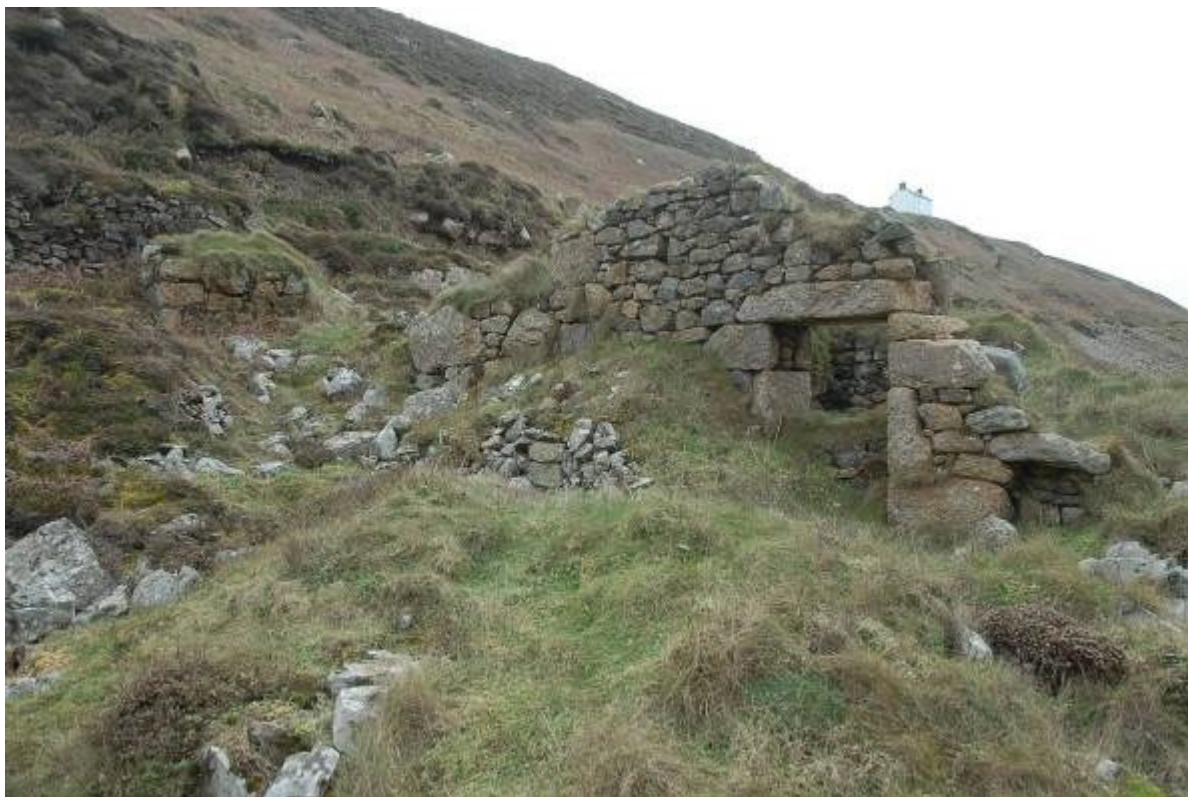
Fig 28. The eastern elevation of the reverberatory arsenic calciner, showing the part-blocked door, and the chimney stump (middle left).

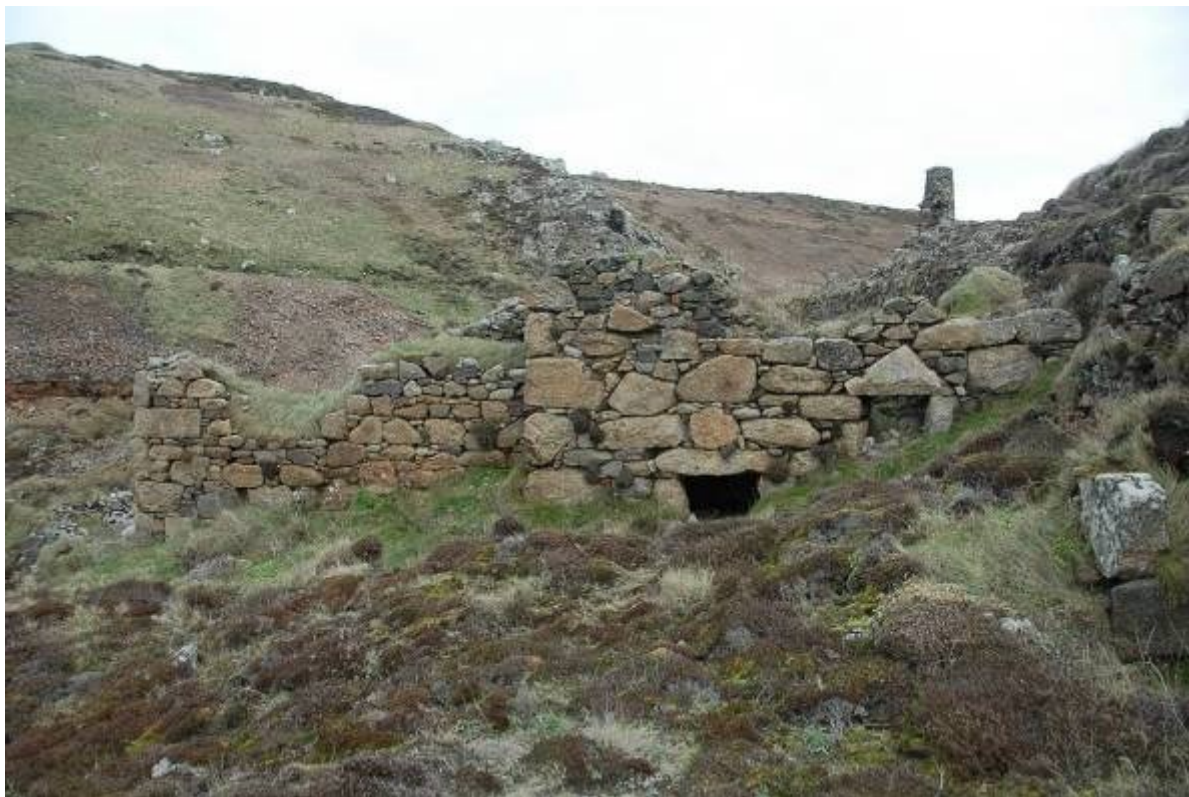
Fig 30. The reverberatory arsenic calciner from the west, showing the hearth opening (right) and discharge opening or wrinkle hole (left).

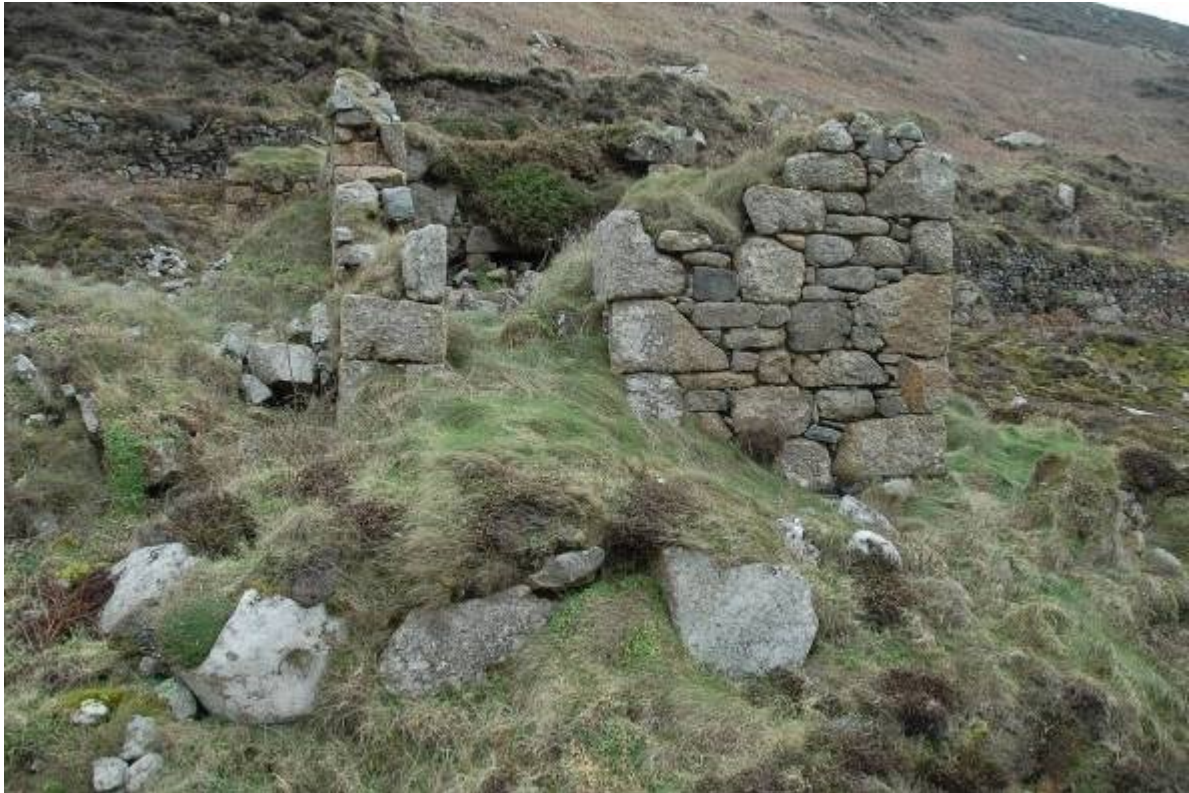
Fig 31. The northern elevation of the calciner, showing the offset doorway and the stamps mortarstone incorporated into the low wall in front (bottom left).

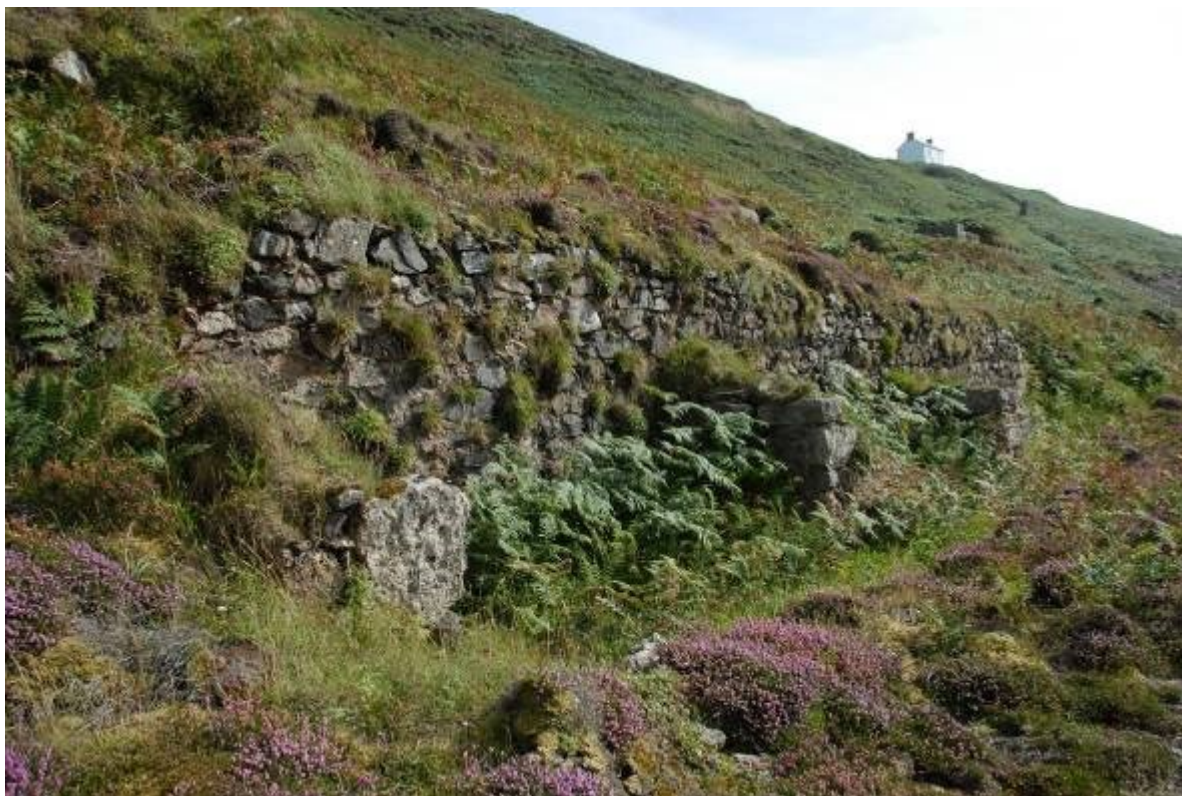
Fig 33. The buttressed wall immediately downslope from the arsenic calciner. The function of the buttresses is unknown.

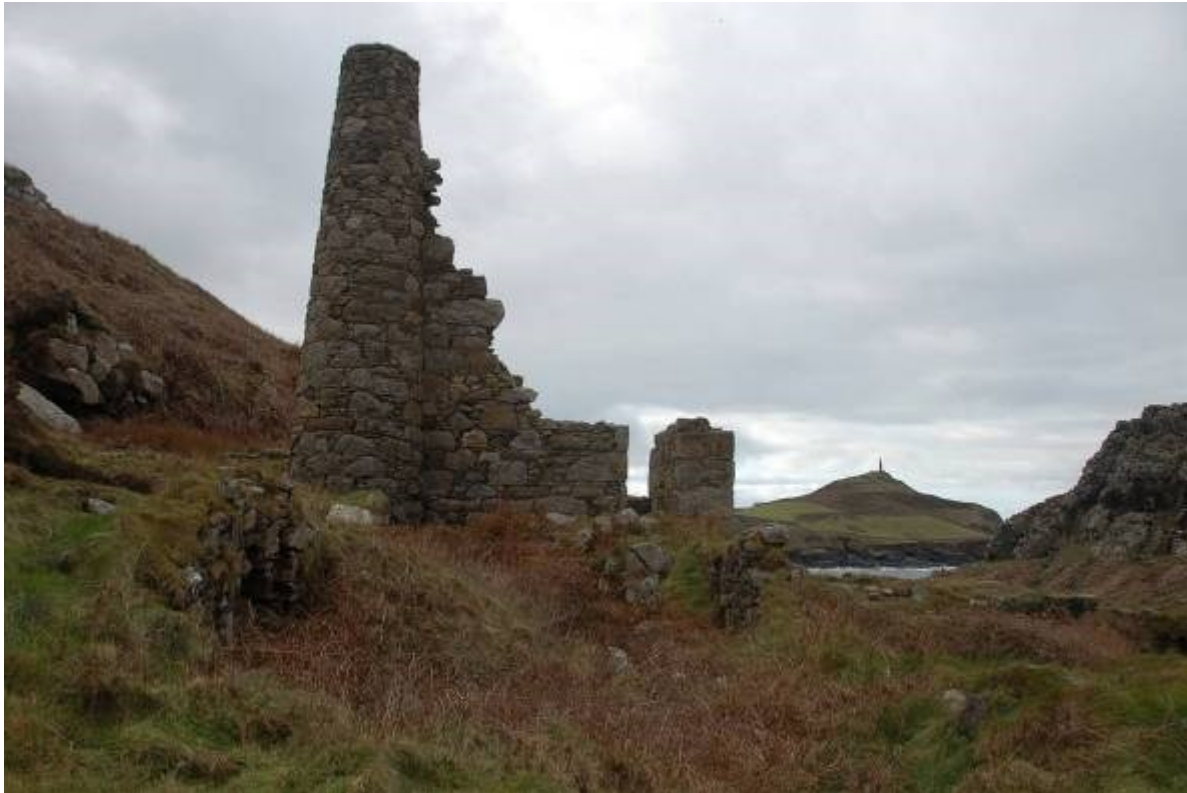
Fig 35. The stamps engine house from the east, with the remains of the boiler house walls in the foreground.

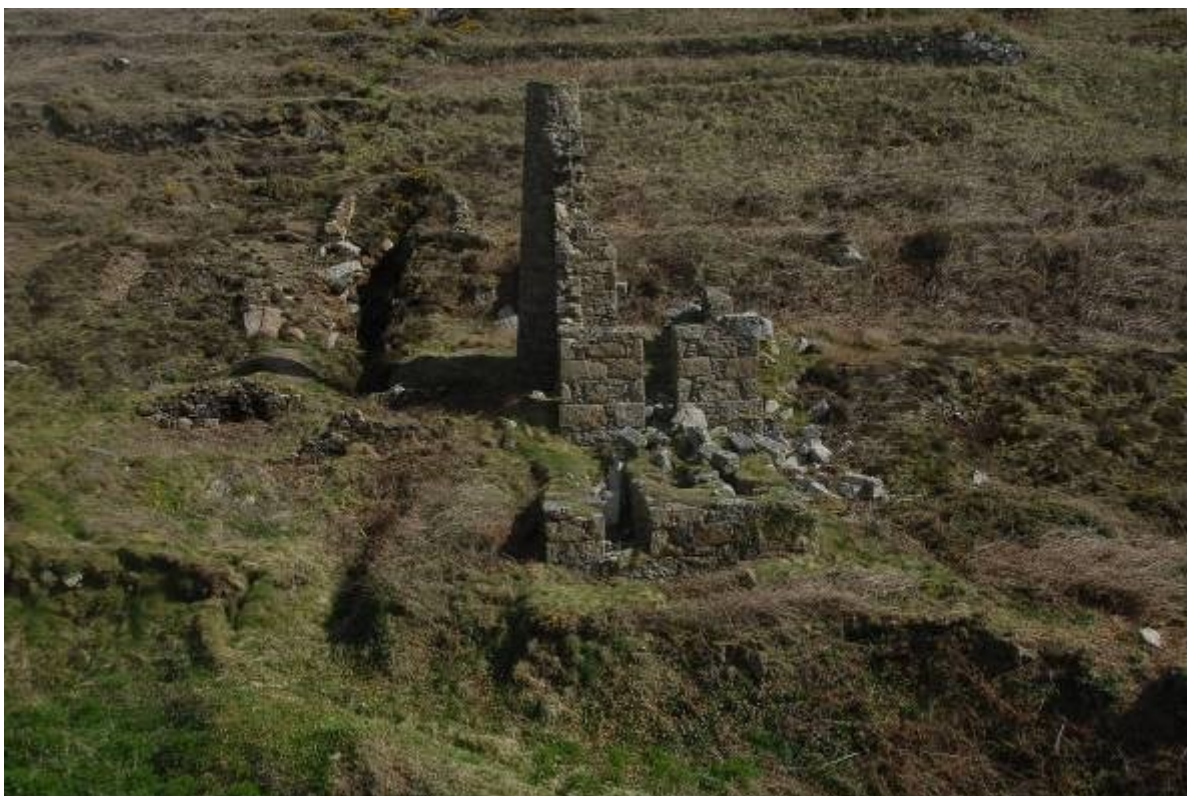
Fig 36. The stamps engine house from the north, showing the loadings to its north and workings on the outcrop of one of the Boswedden lodes to its left and running under its boiler house.

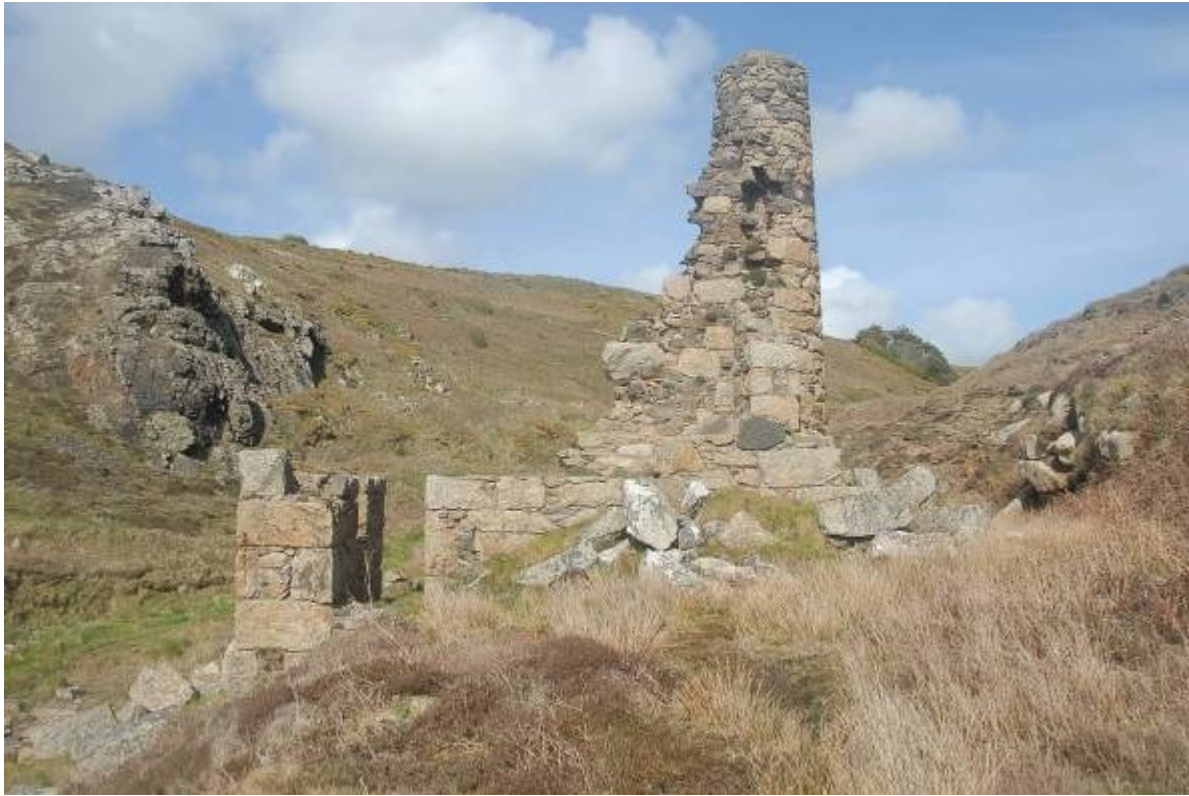
Fig 37. The stamps engine house from the west, showing the paired doorways behind the bob wall.

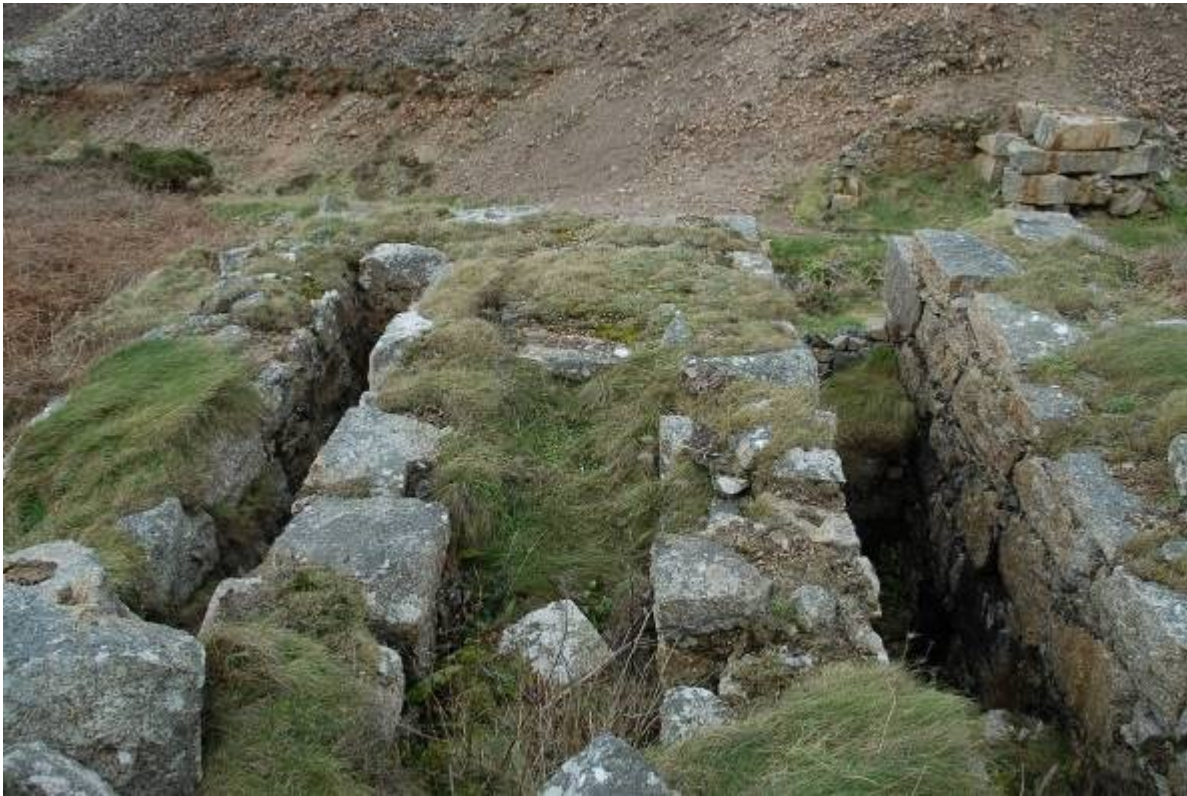
Fig 39. The paired flywheel slots and central crank slot in the loadings immediately to the north of the stamps engine house.

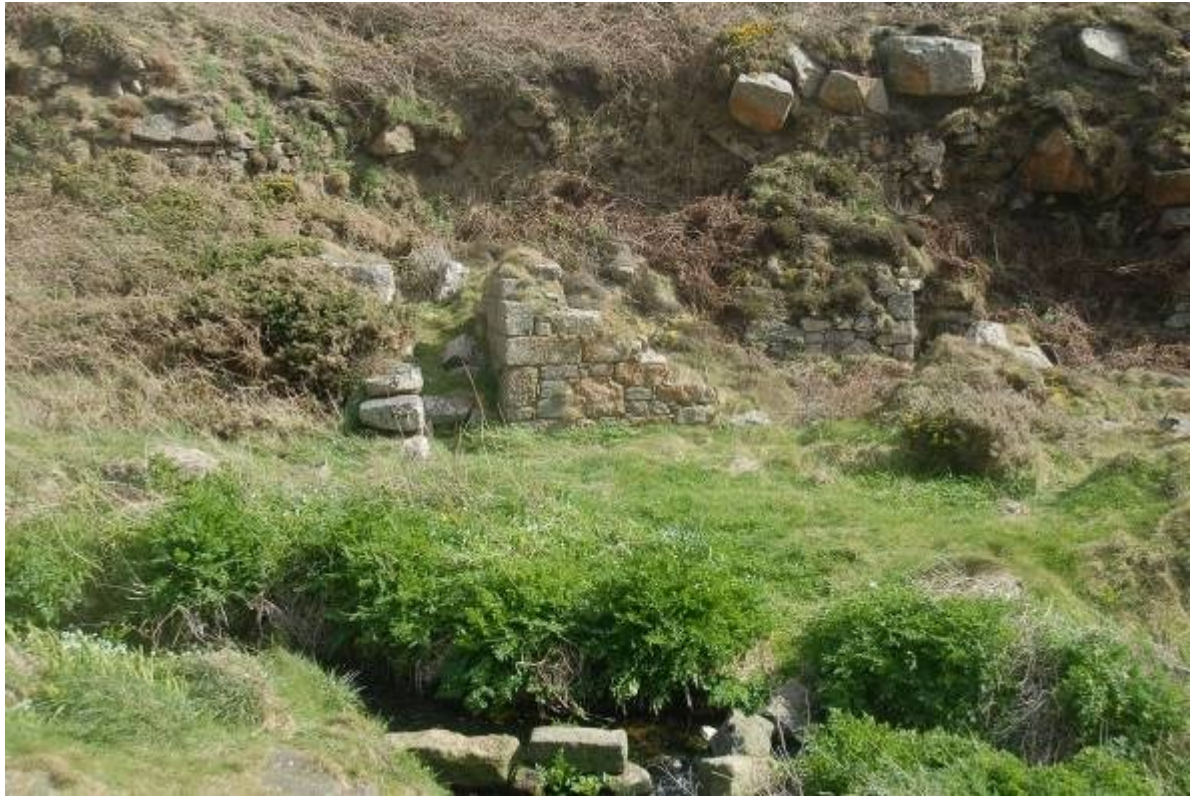
Fig 41. The wheelpit for a small and early set of water powered stamps just to the east of the steam stamps and their associated dressing floors.

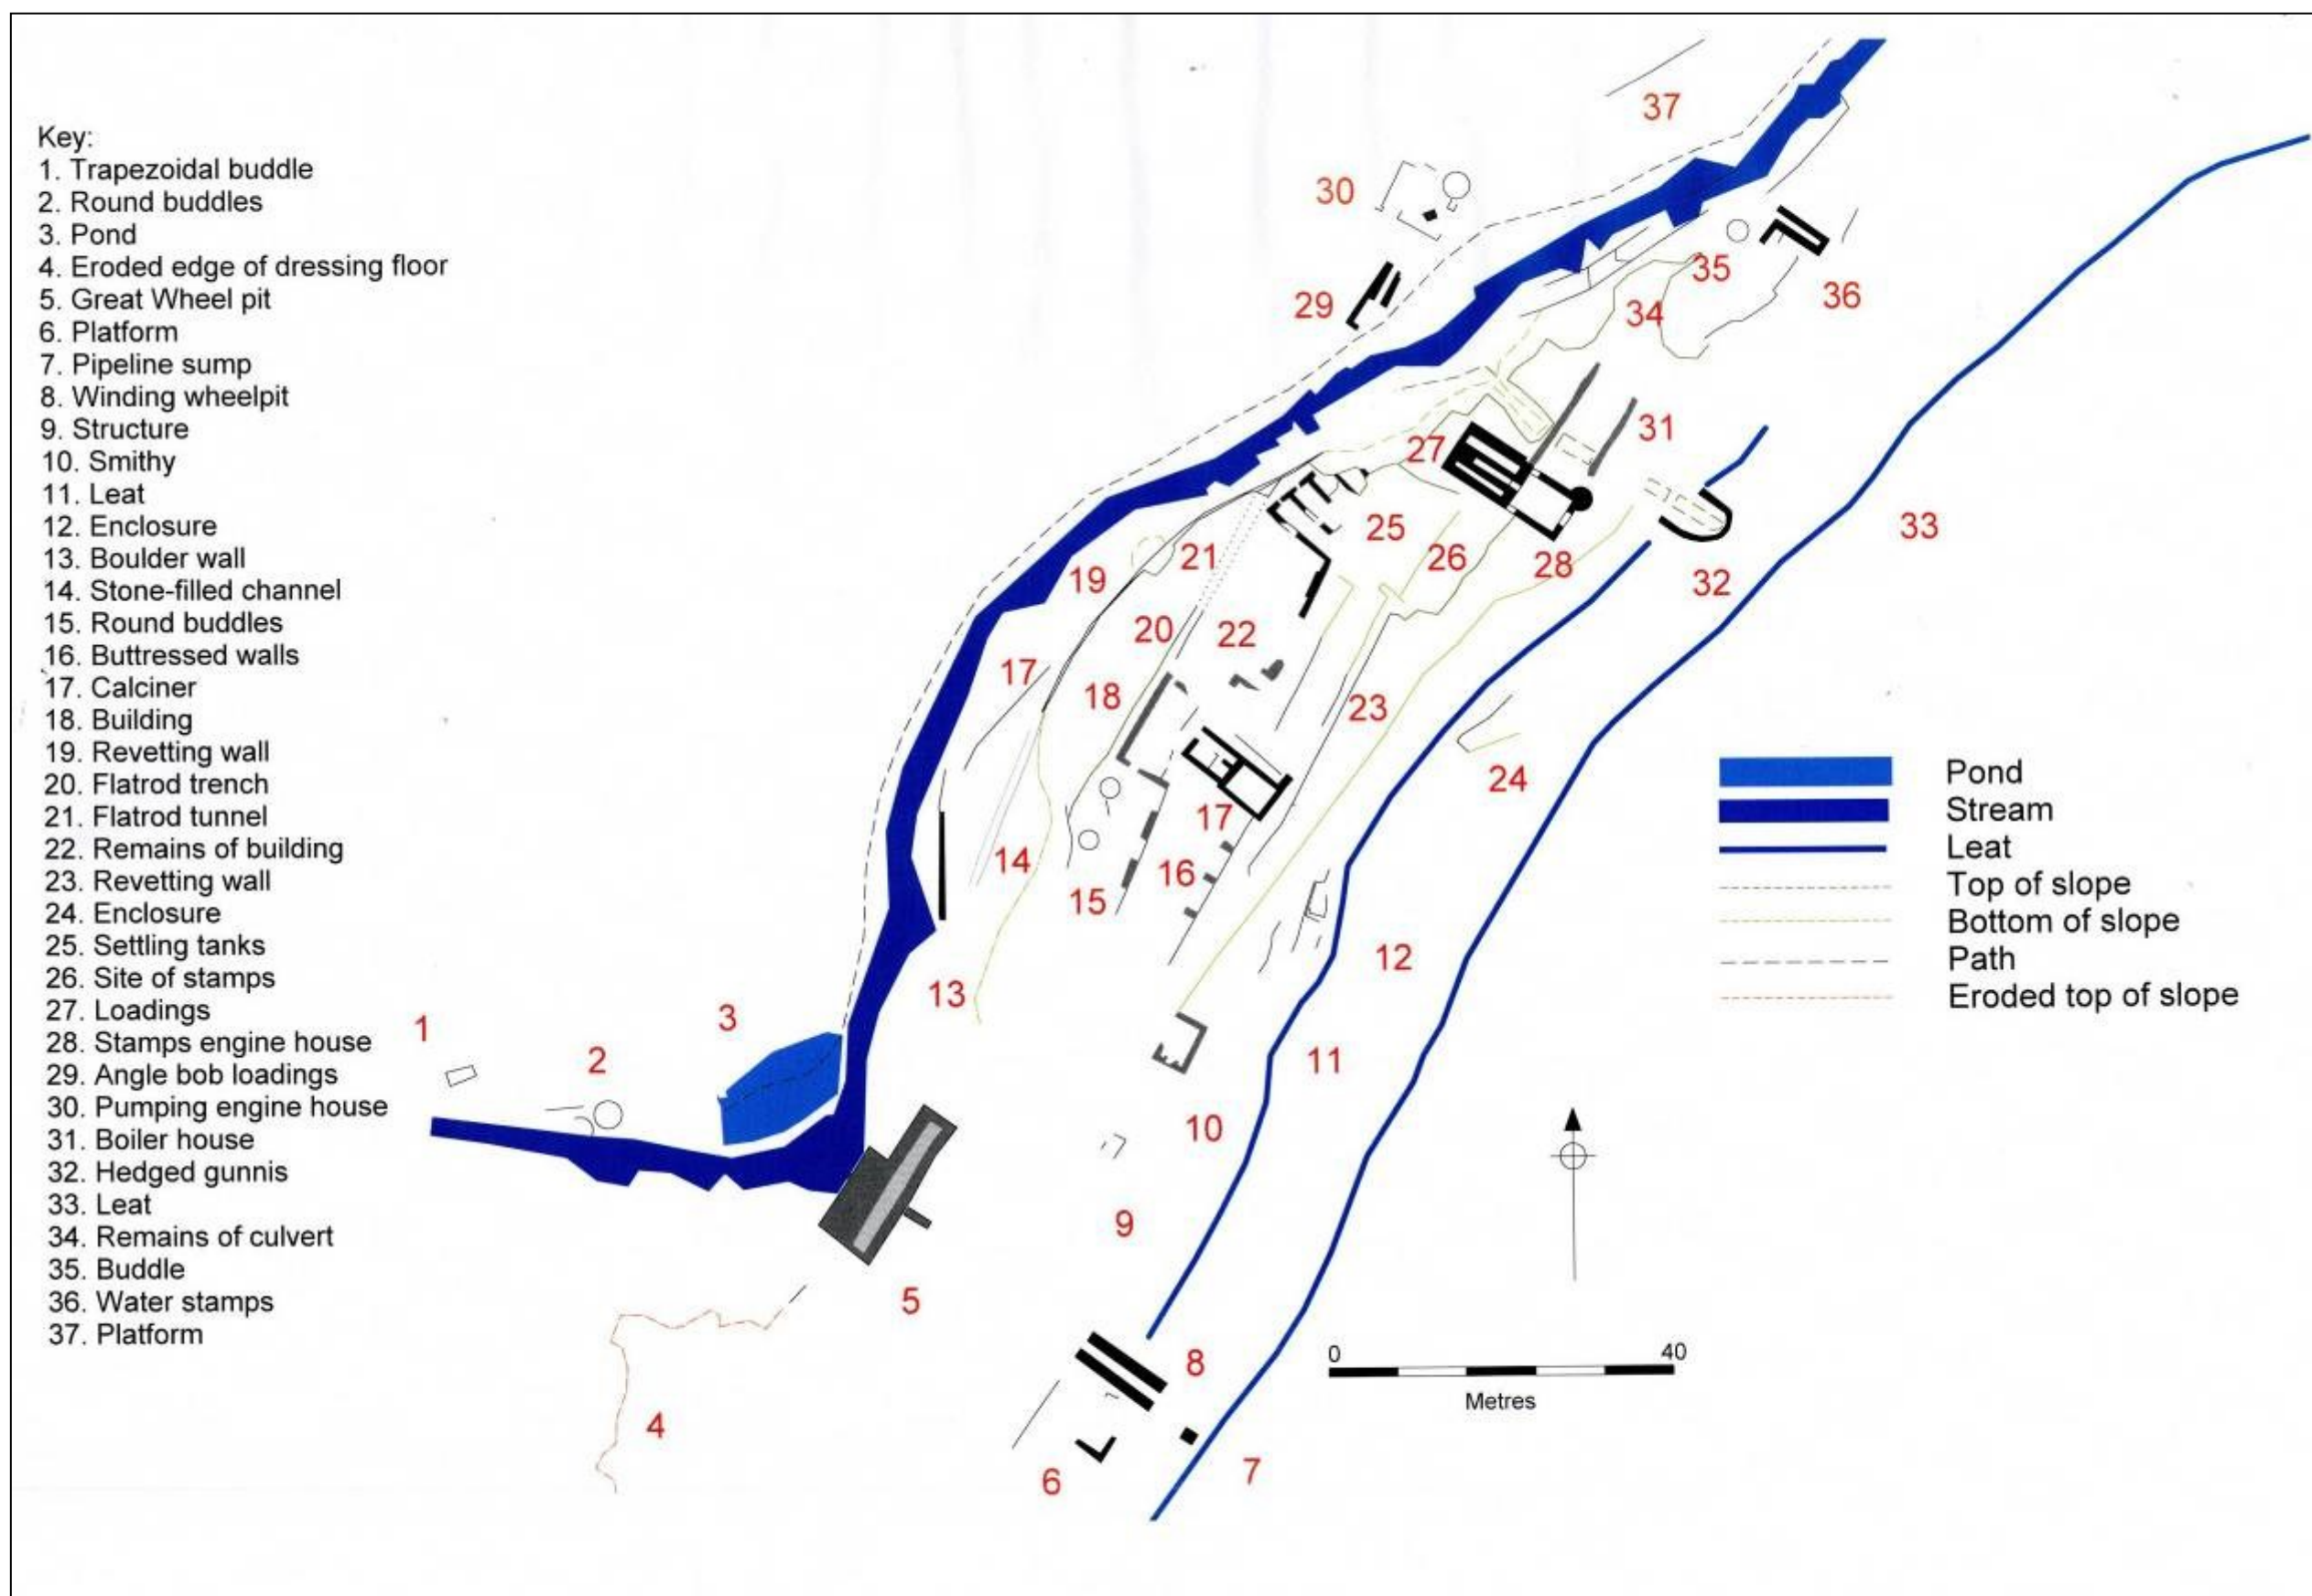
Fig 45. The 2012 survey of the Wheal Call dressing floors and adjacent features.

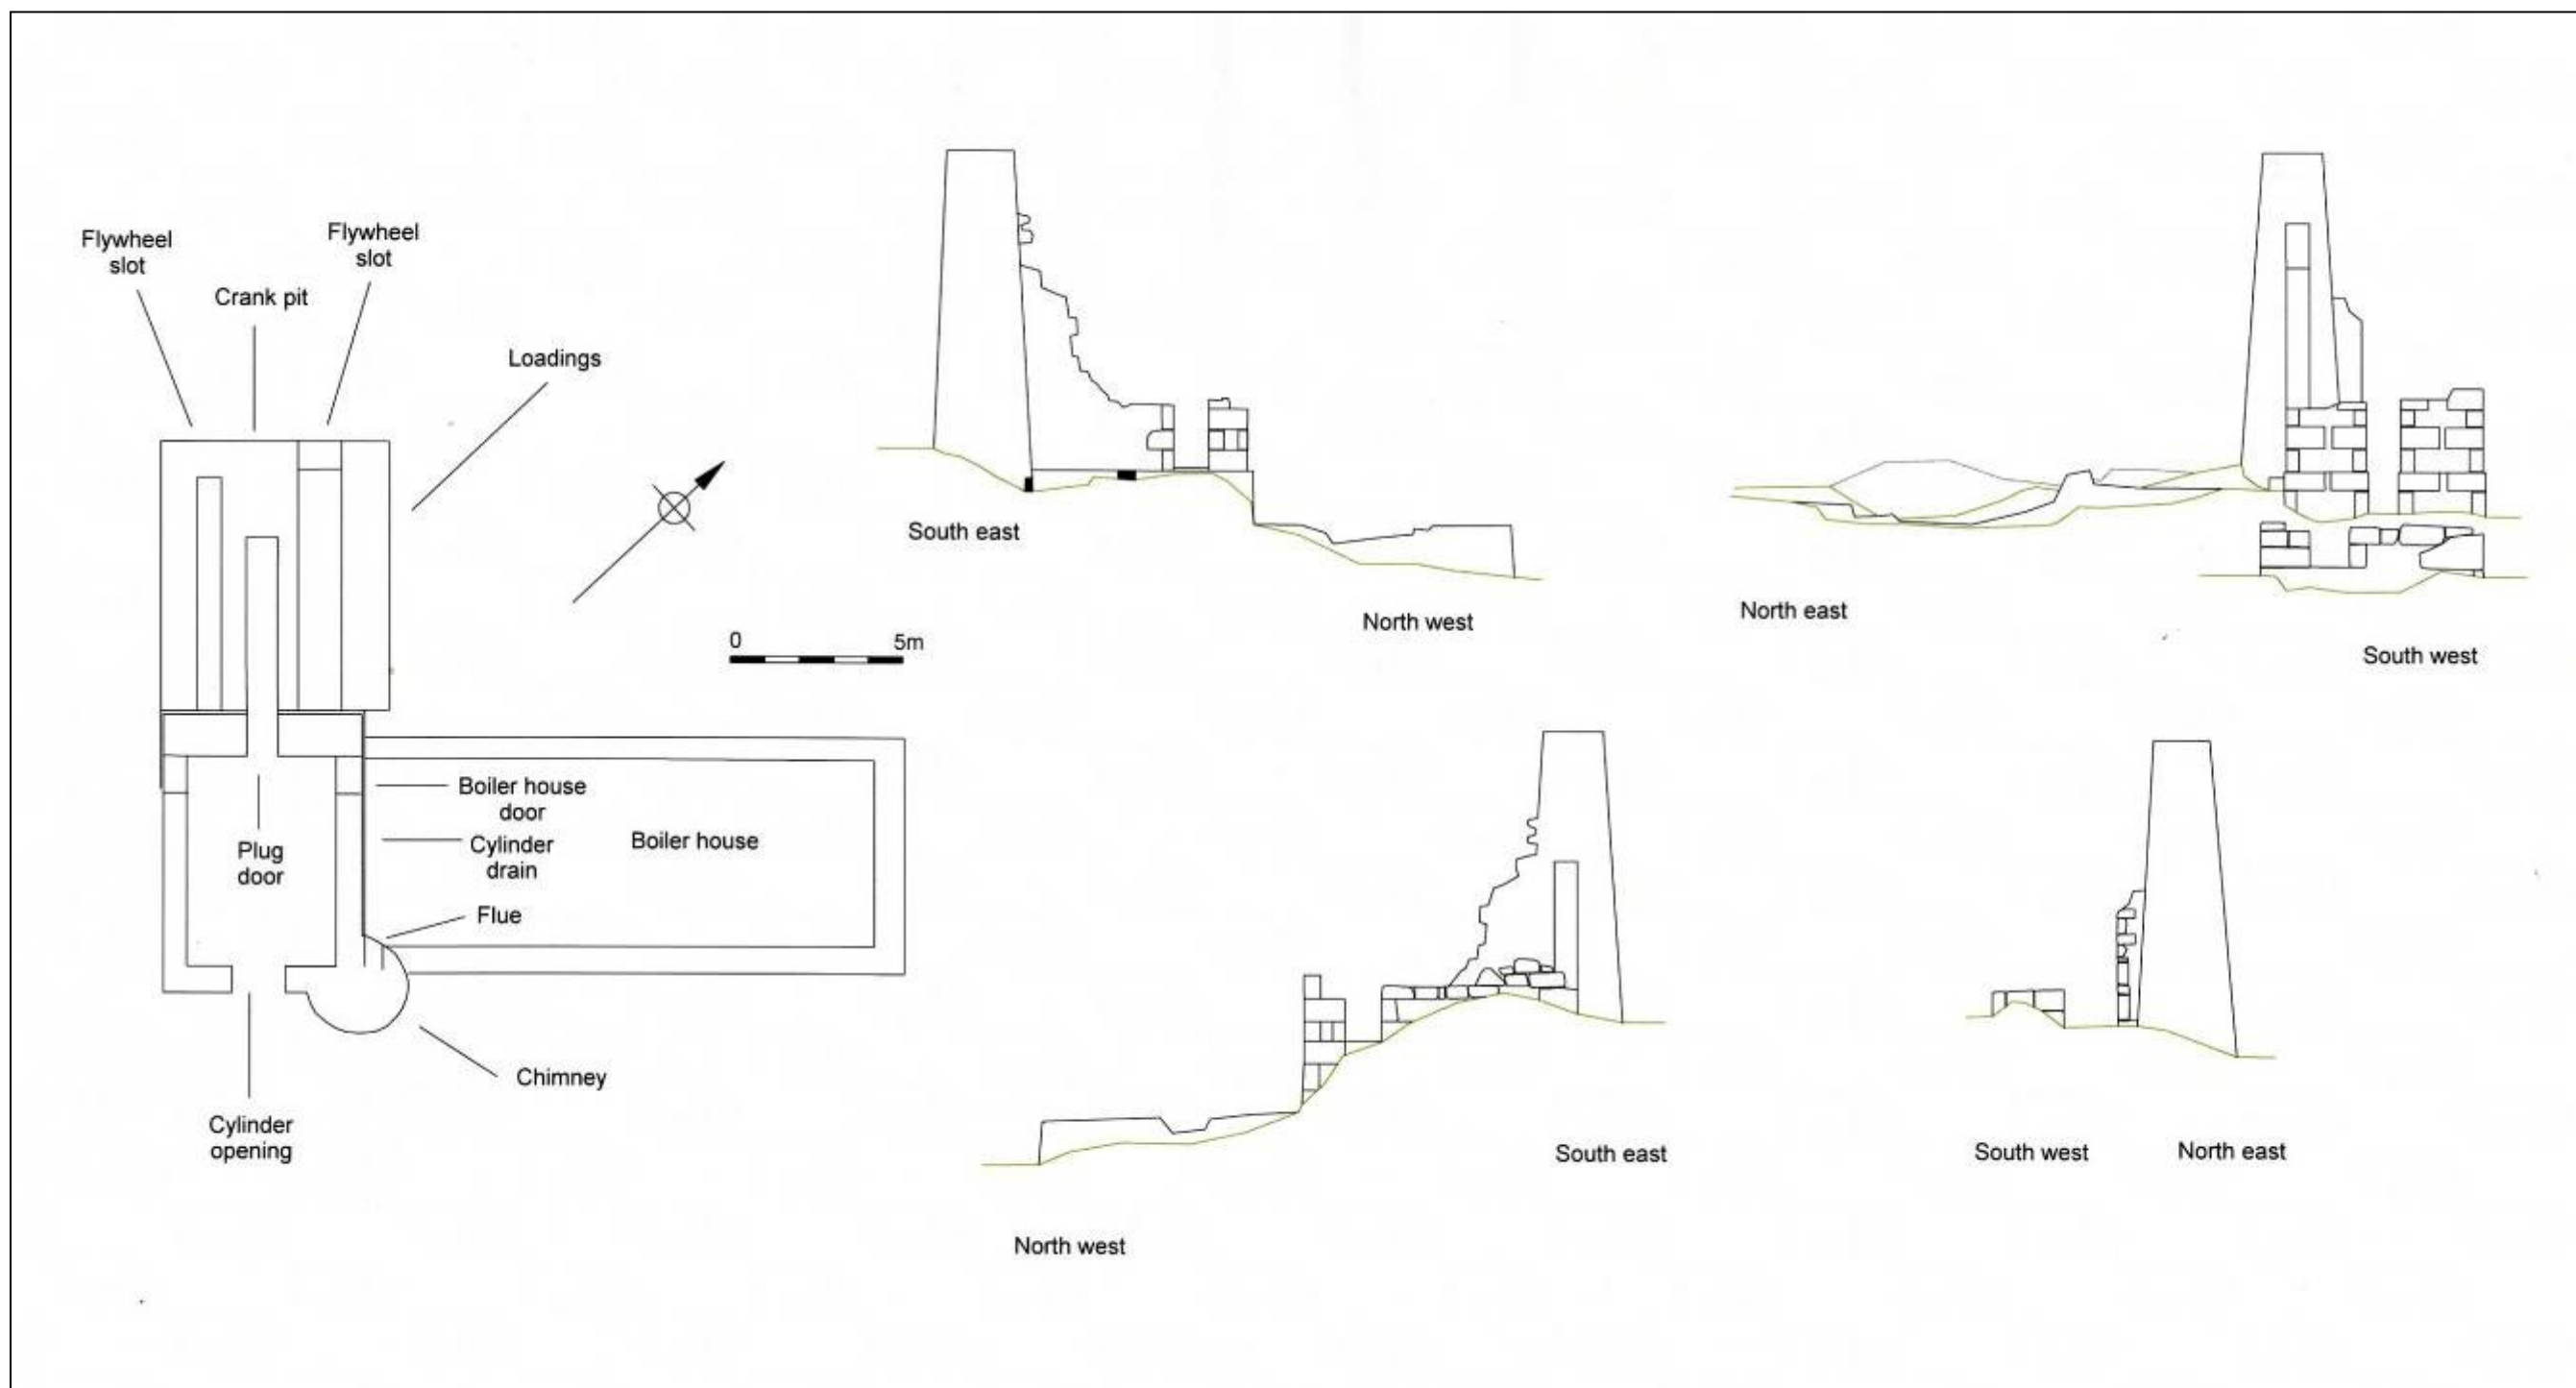
Fig 46. The 2012 survey of the ruins of the stamps engine house.
