Wheal Call, Kenidjack, St. Just, Cornwall

Archaeological recording of the dressing floors prior to works

Client	The National Trust
Report Number	2012R014
Date	17 December 2012
Status	Final
Report author	Adam Sharpe BA MIfA
Checked by	Andy Jones
Approved by	Andrew Young MIfA, HE Projects Officer

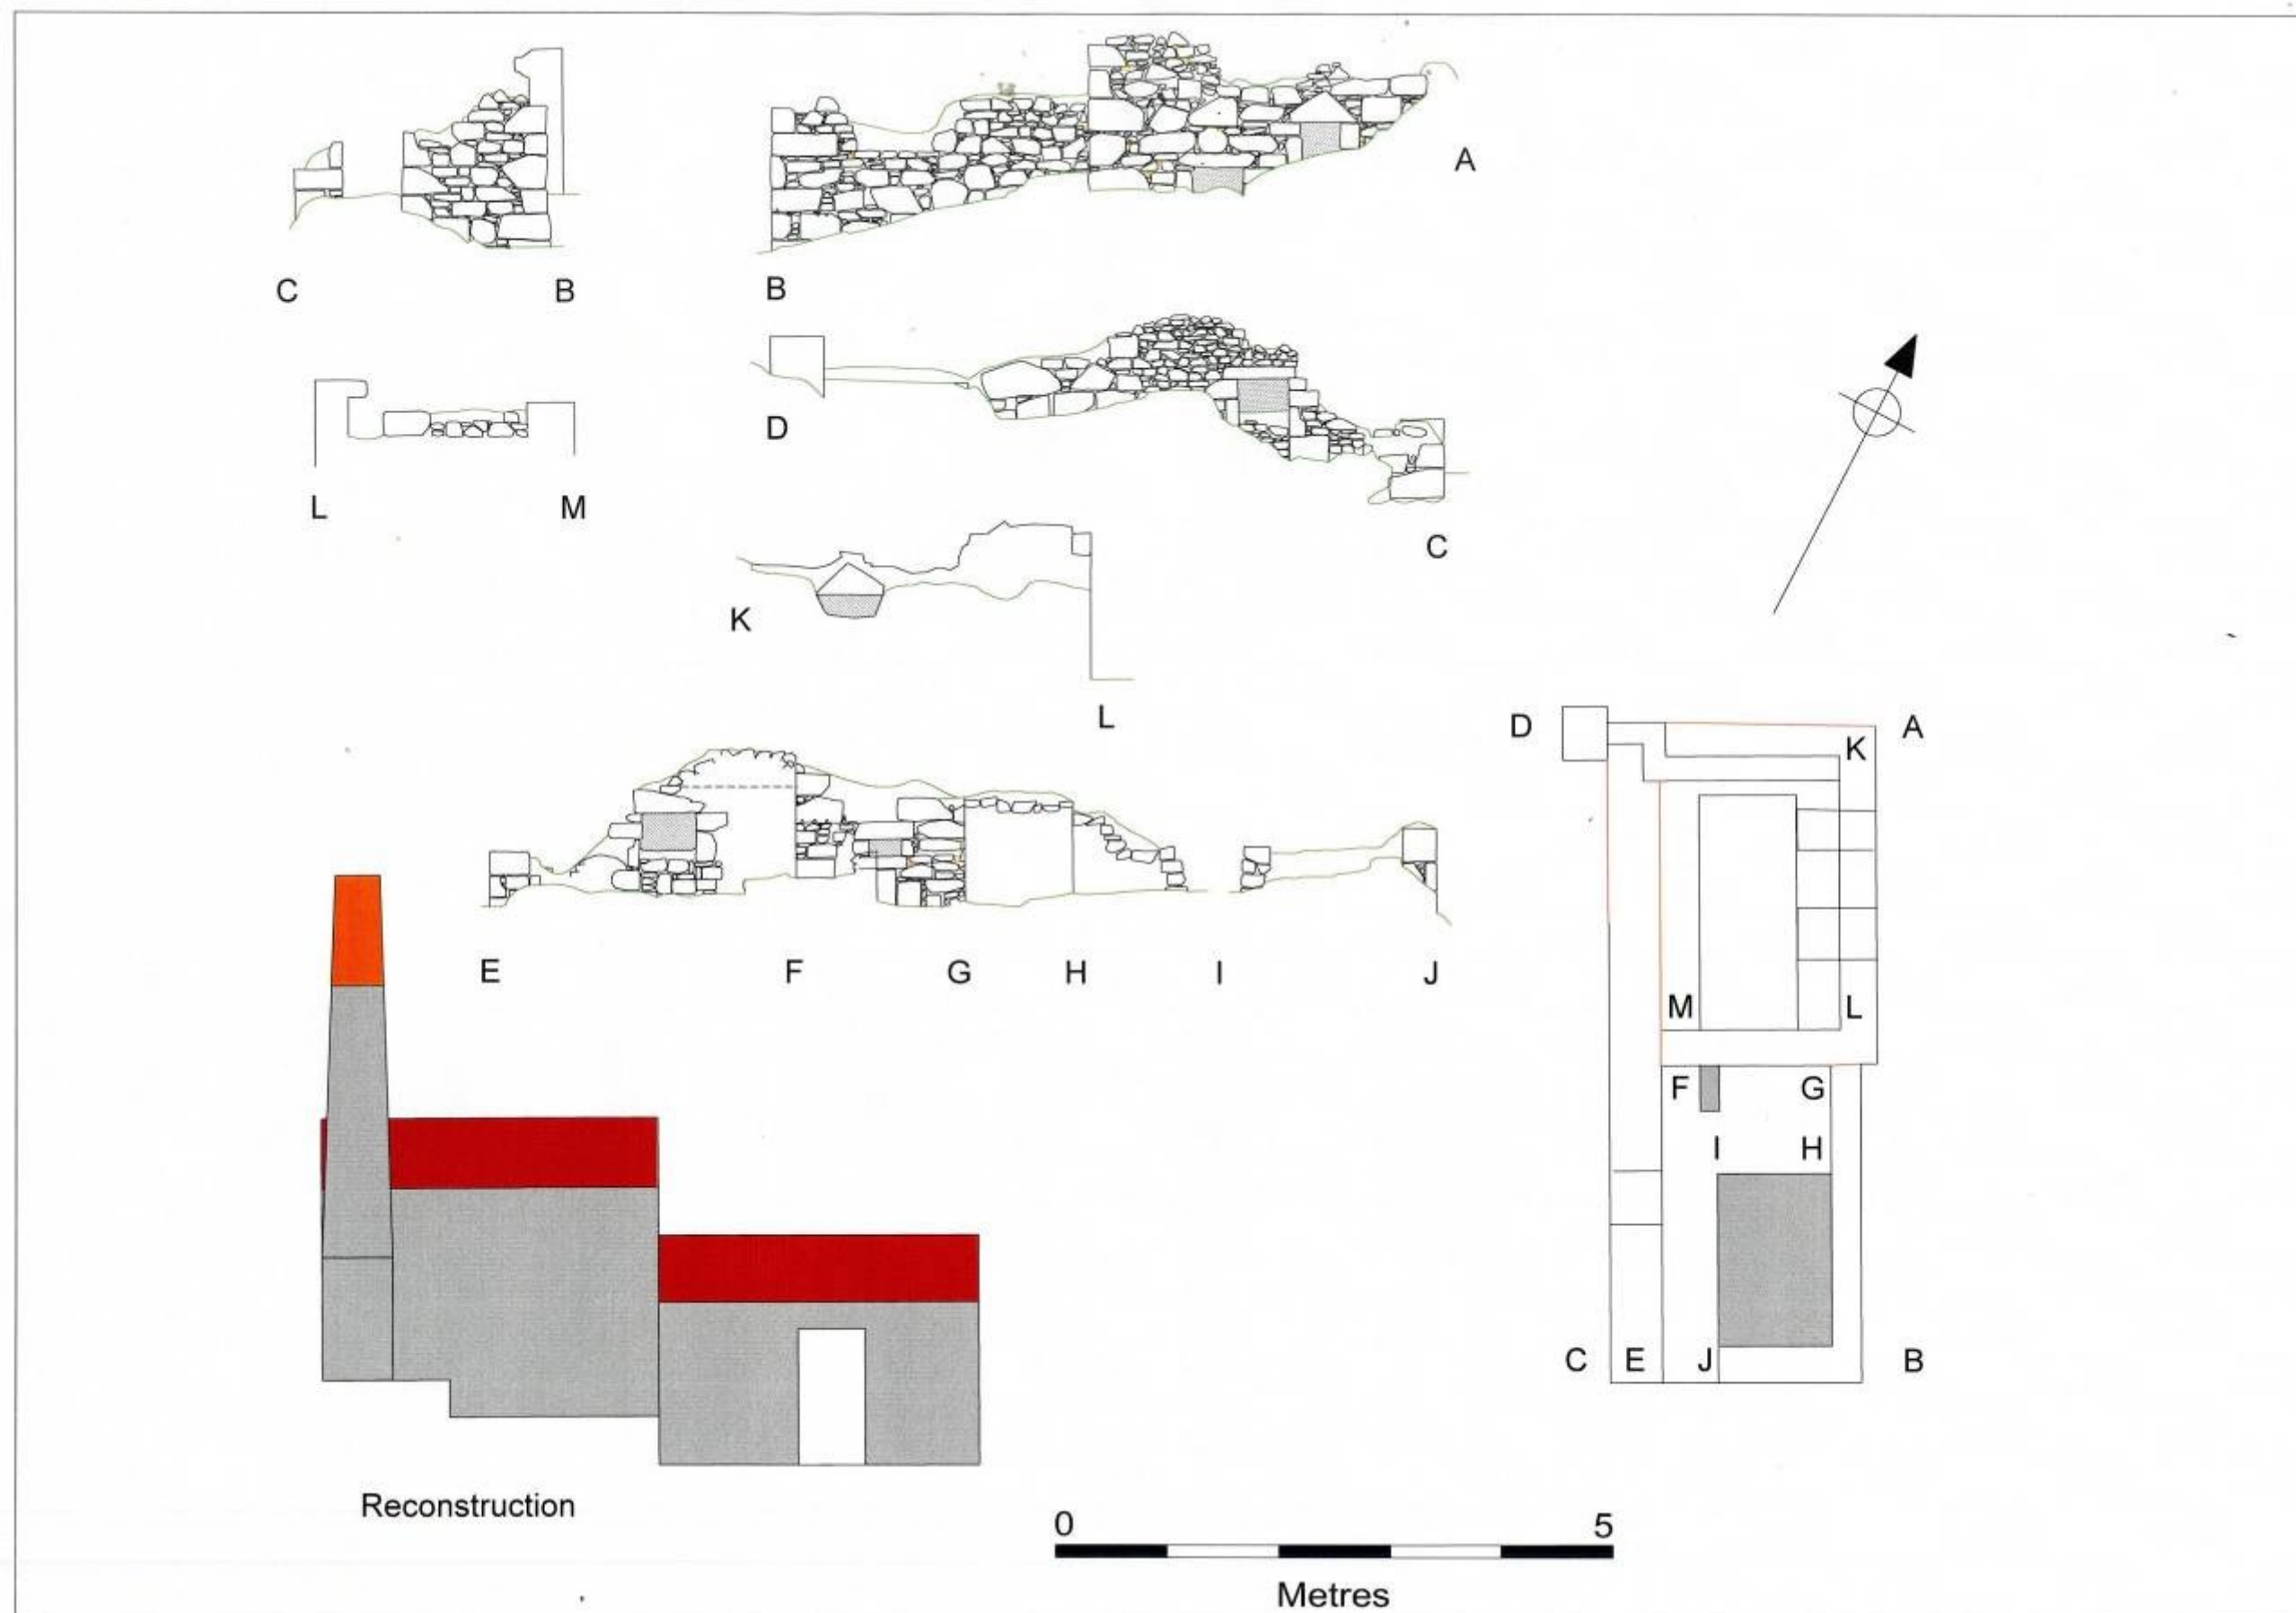
Fig 47. Plan and elevations of the Wheal Call reverberatory arsenic calciner, together with a reconstruction of its likely original appearance.
