# Castle-an-Dinas Mine, St Columb Major, Cornwall

## Archaeological assessment

<b>Client</b>	<b>Mr and Mrs David Chambers</b>
<b>Report Number</b>	<b>2012R087</b>
<b>Date</b>	<b>December 2012</b>
<b>Status</b>	<b>Final</b>
<b>Report authors</b>	<b>Colin Buck and Nigel Thomas</b>
<b>Checked by</b>	<b>Andy Jones</b>
<b>Approved by</b>	<b>Andrew Young</b>

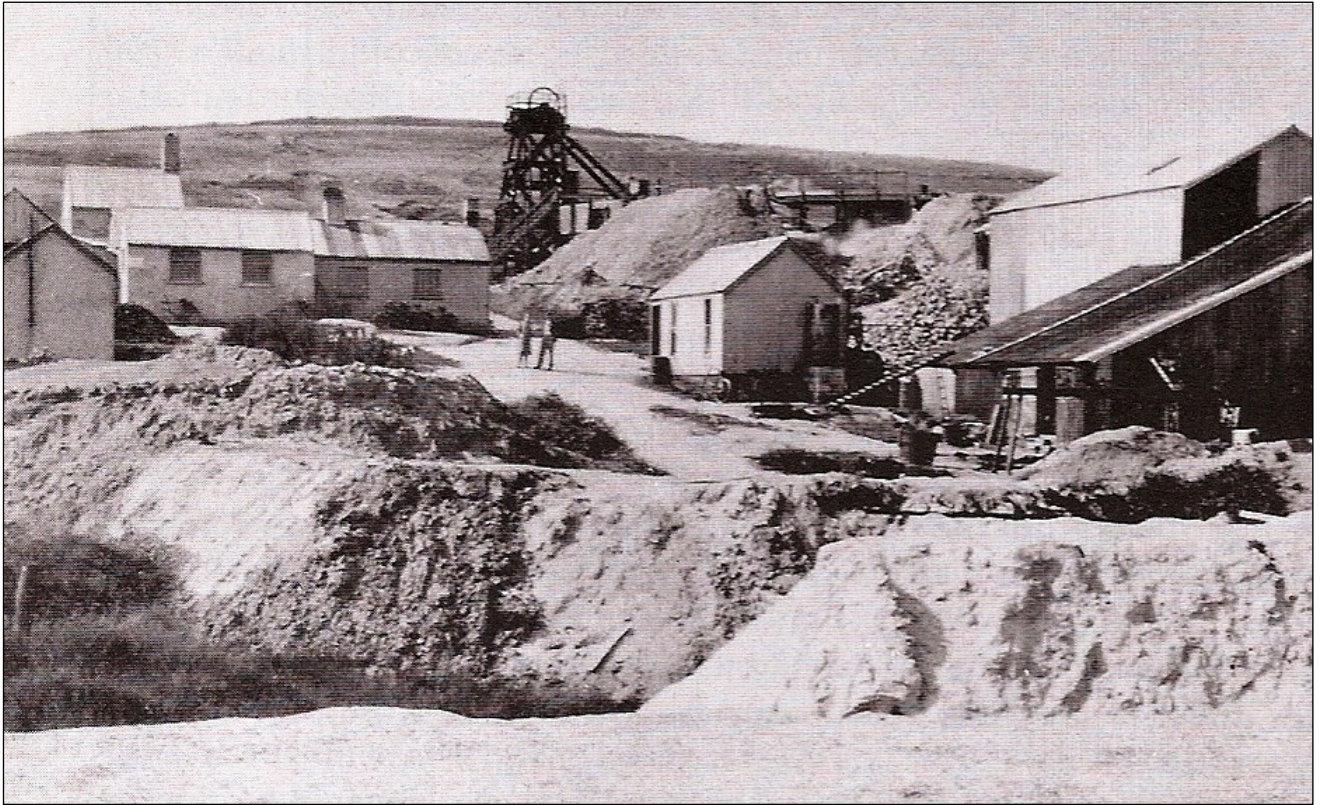
Figure 7 North Shaft complex in early 1940s (Reproduced with permission of Tony Brooks)

The roof and chimney (on the west gable end) of this building can be seen in Figure 7 (behind the Miners' Dry - Site 43). This was the smithy for the second phase of the mine's history (prior to construction of the South Shaft mine site from 1942).

Figure 7 shows the headgear timbers over the shaft – with a gangway from this to the adjacent ore bin and waste tip.

The northern gable end of this building is shown on the left side of Figure 7. It appears to have been constructed of concrete block with a corrugated steel roof.

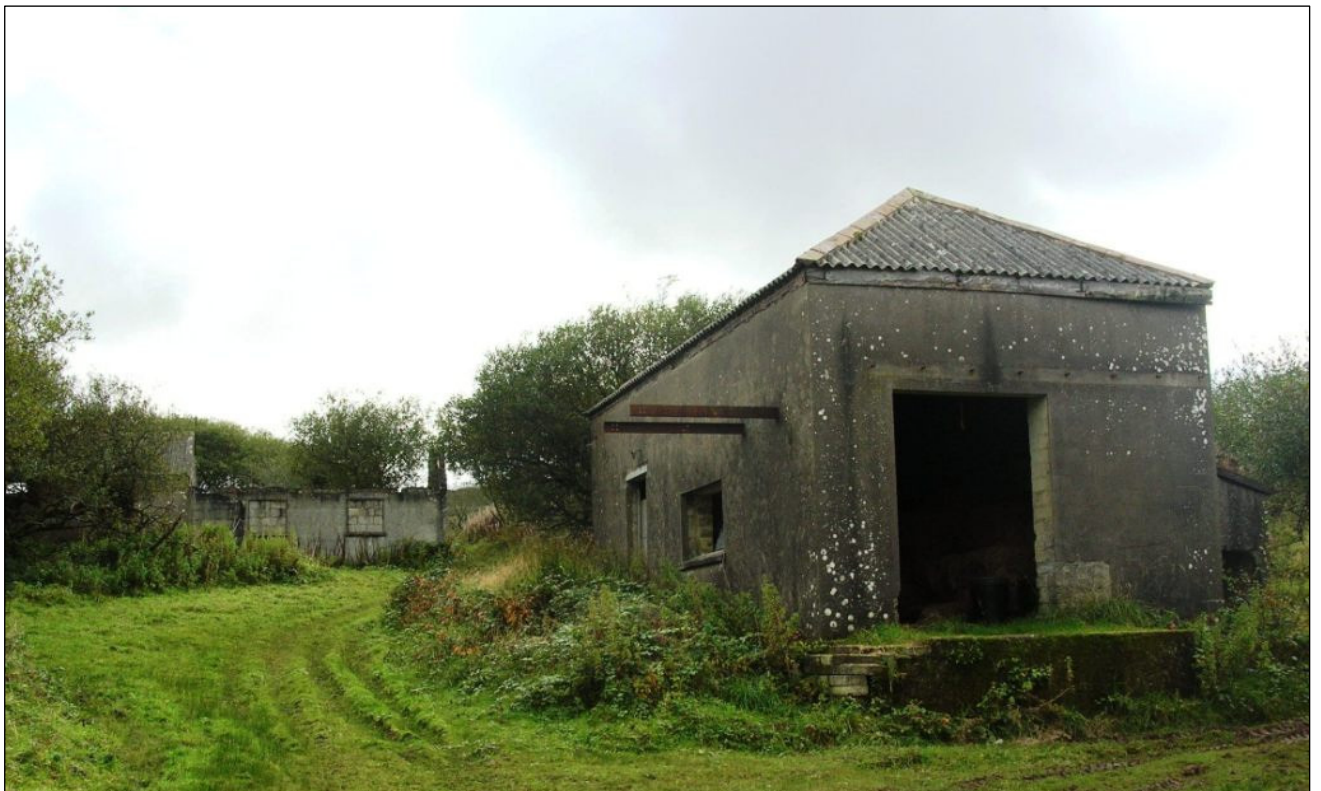
Figure 8 North Shaft complex in 2012. (Later) Diesel Mill engine house (Site 45) in foreground, Miners' Dry (Site 43) in background (© CC HE Projects)

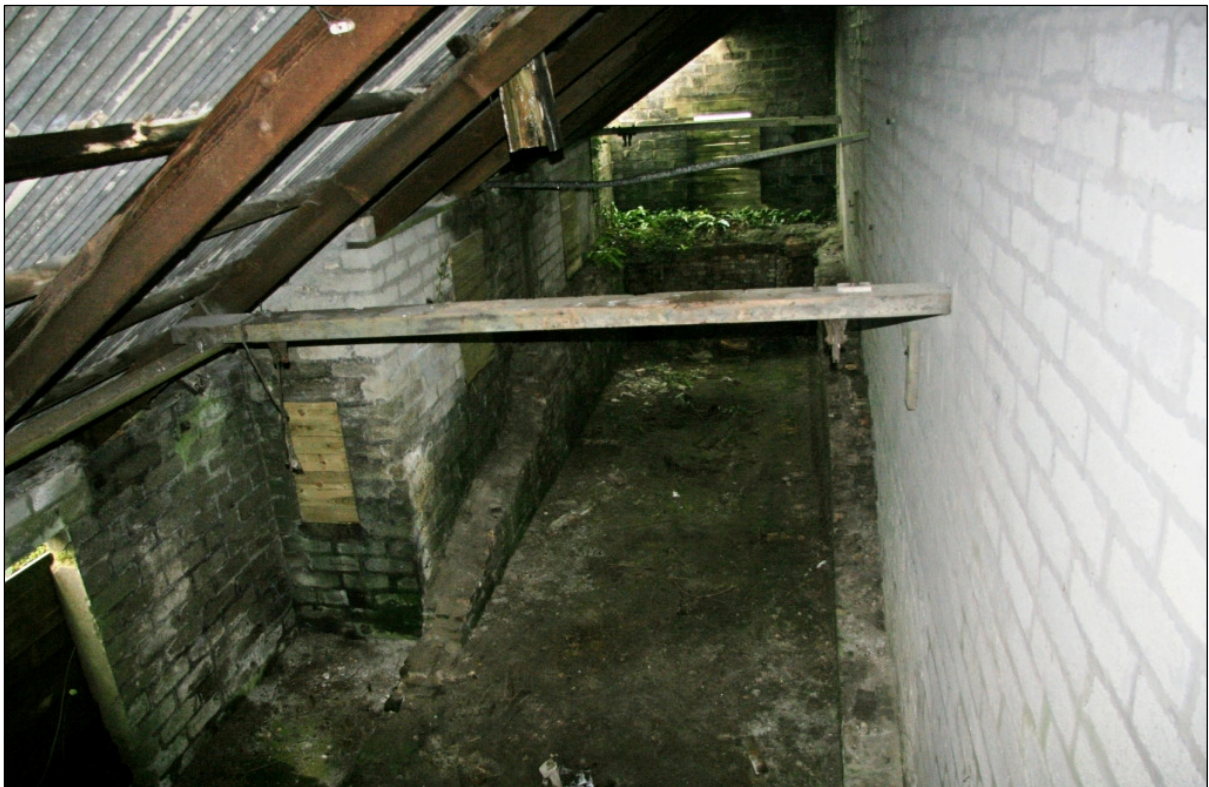
Figure 25 An internal view of the Boiler House (Site 3.2) from the north (© CC HE Projects)

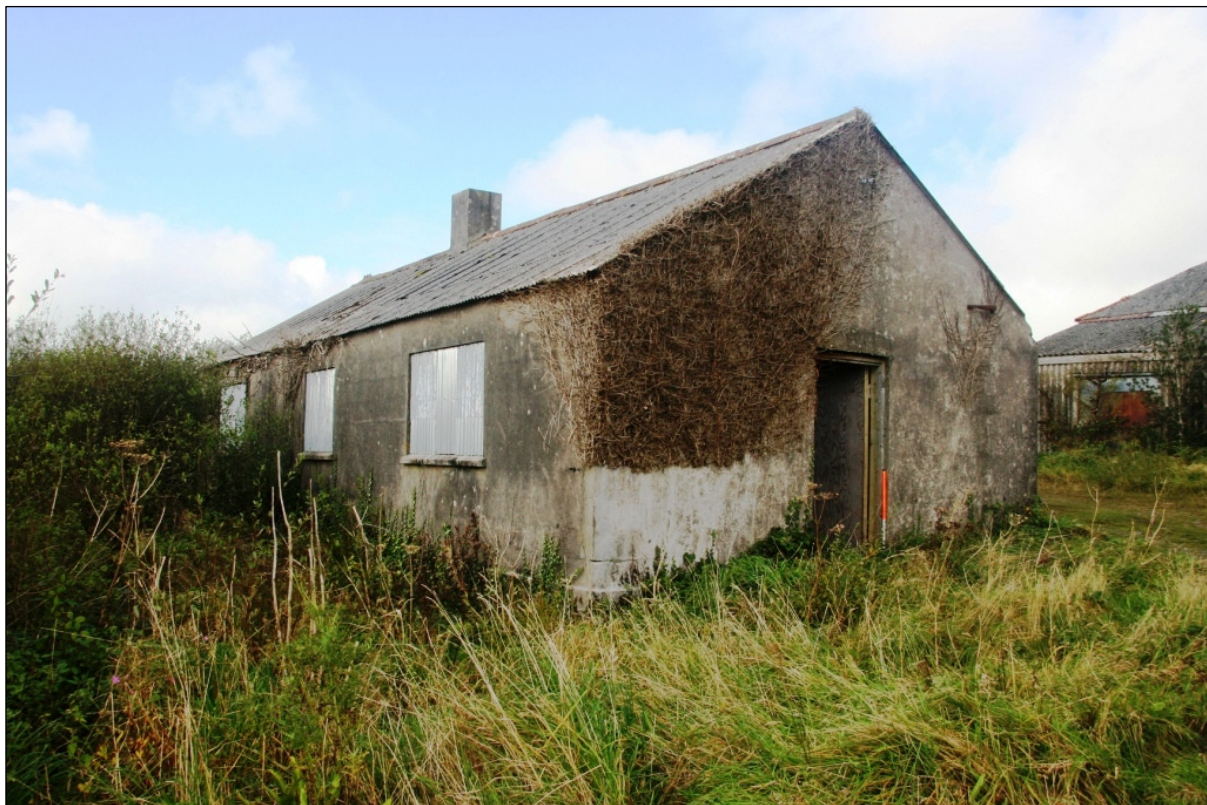
This building appears to be in relatively stable condition.

Figure 26 A view of the Carpenter's Shop (Site 5.1) and Forge (Site 5.2) from the west (© CC HE Projects)

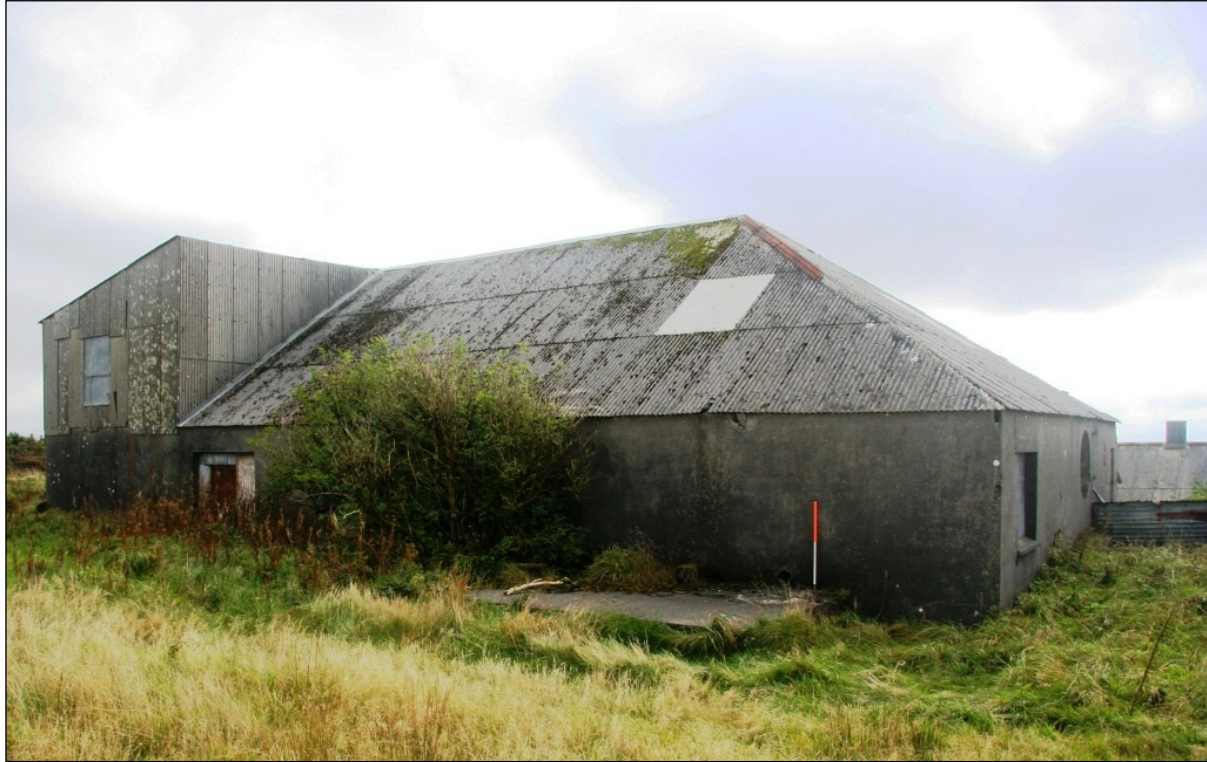
Figure 27 A view from the north of the diesel engine house (Site 7) © CC HE Projects

at the south west corner of the building. Insertion of this tall stanchion also involved cutting away part of the hipped roof timber.

A distinctive round opening is also extant in the west wall of the engine house. This has been cut through the original wall and part of its circumference infilled with additional mortar. Pintail hinges (and traces of a latch position) have also been added to the external side of the opening. Inside and below the opening is a pair of roughly built concrete block piers or buttresses. Neither the opening nor the buttresses appear in historic photos of the engine house (*cf* Bullen 2003, 68).
