**POLTESCO MILL**

**ARCHAEOLOGICAL ASSESSMENT  
AND  
INTERPRETIVE HISTORIC  
BUILDING SURVEY OF THE MILL**

**ARCHAEOLOGICAL ASSESSMENT  
AND  
INTERPRETIVE HISTORIC  
BUILDING SURVEY**

**HE Report No.**  
**2013R013**

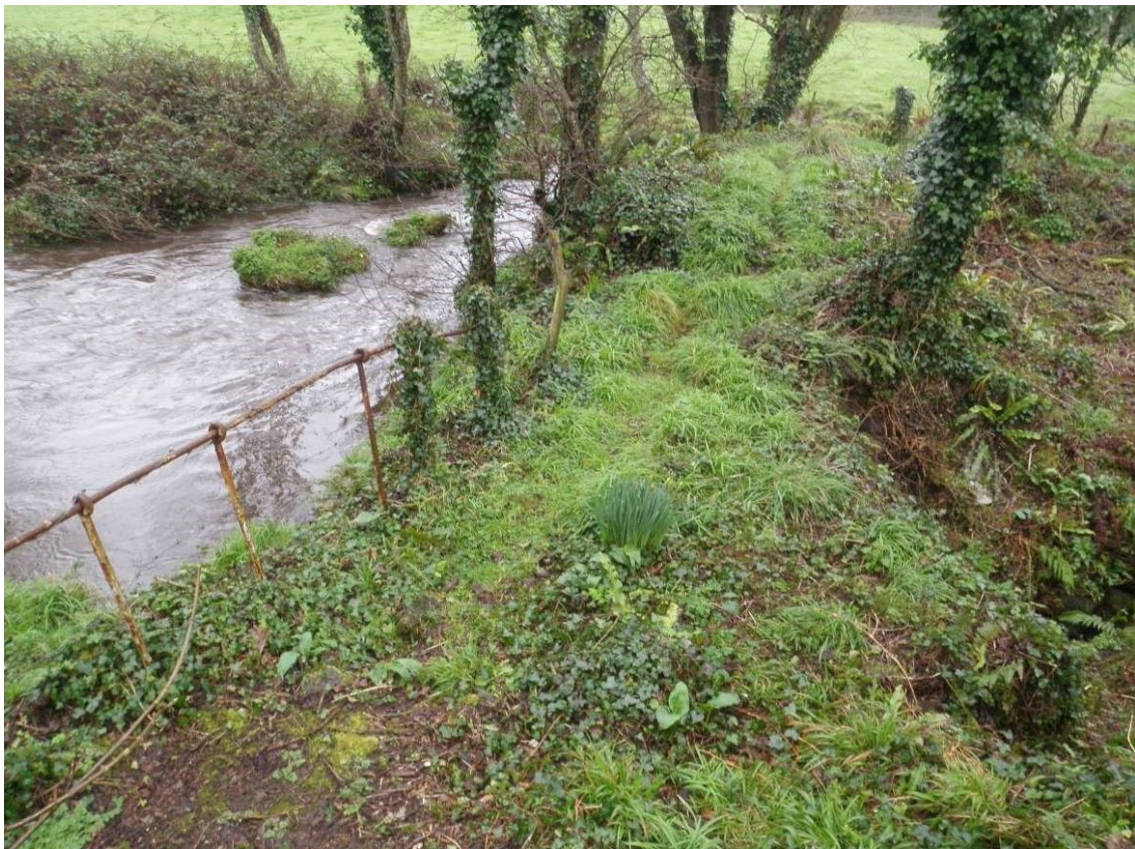
*Fig 41: Raised bank **92629** retaining north side of millpond. Taken at west end looking north*

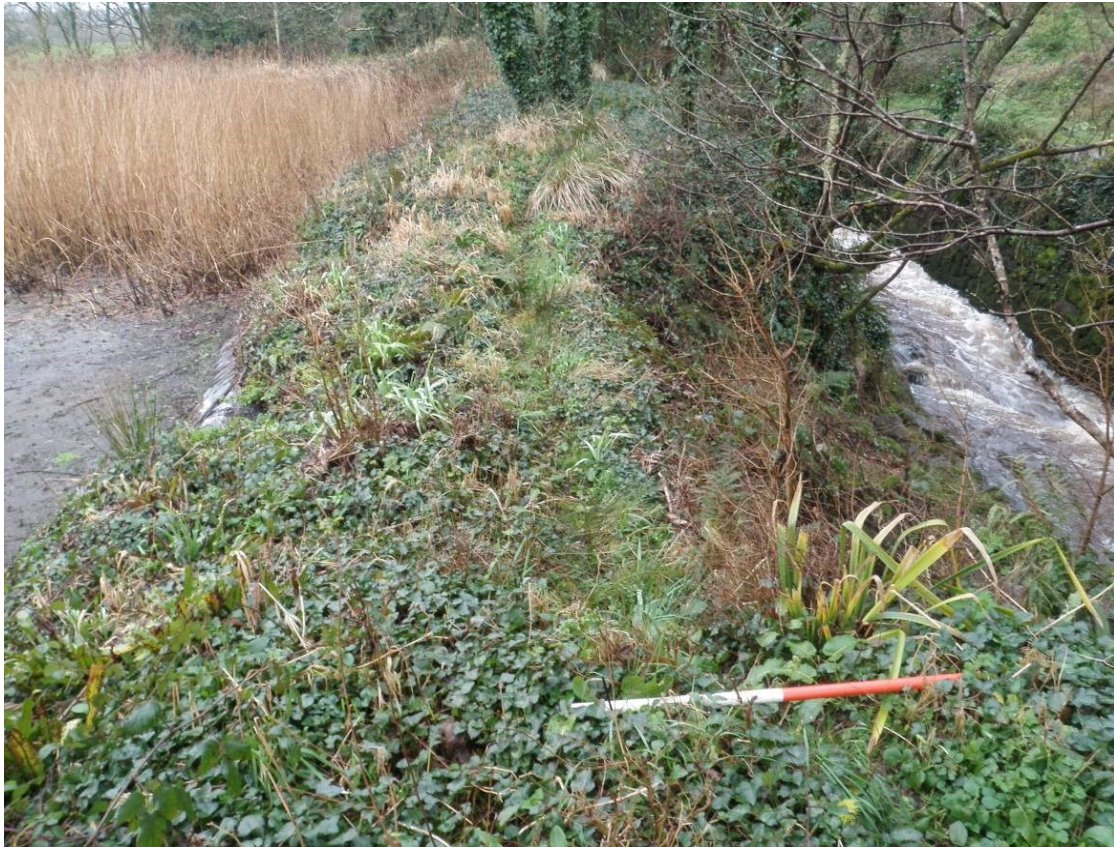
*Fig 42: Possible overflow **92631** in raised bank **92629** retaining north side of millpond.  
Taken looking north-west*

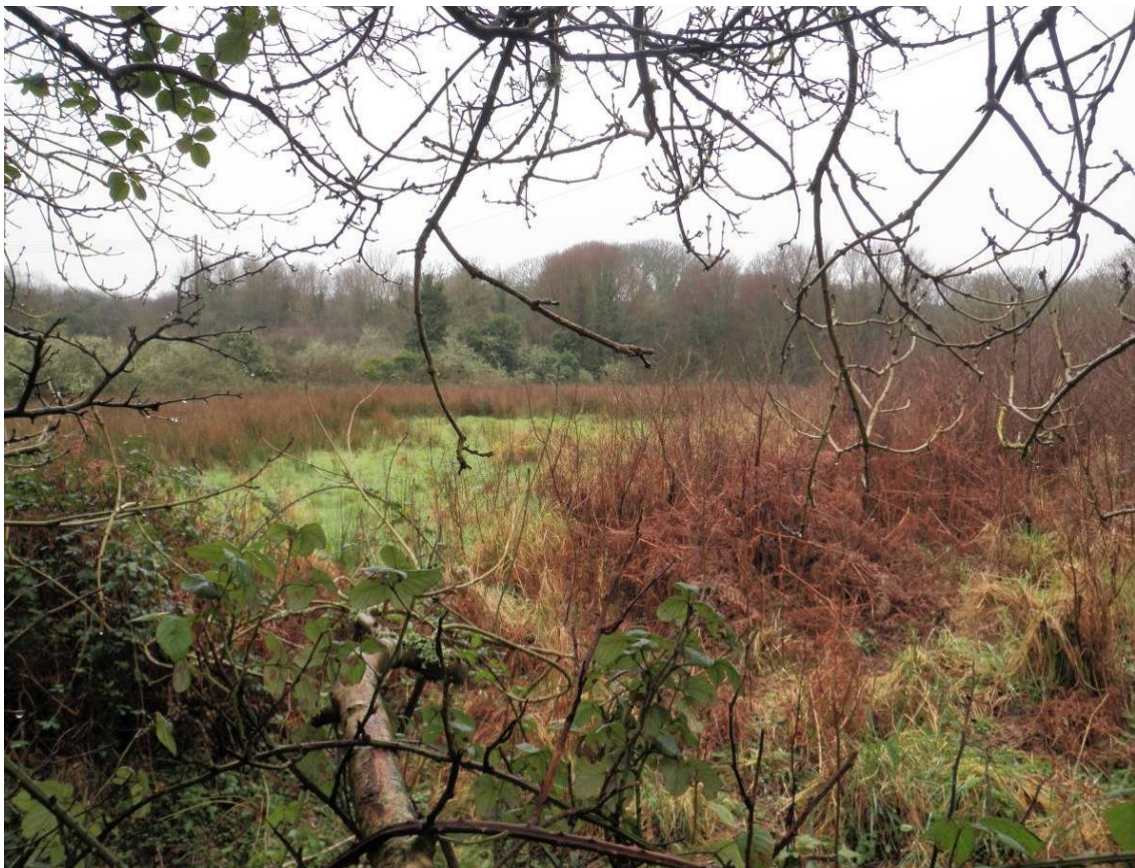
*Fig 43: Field **92632** looking south-west*

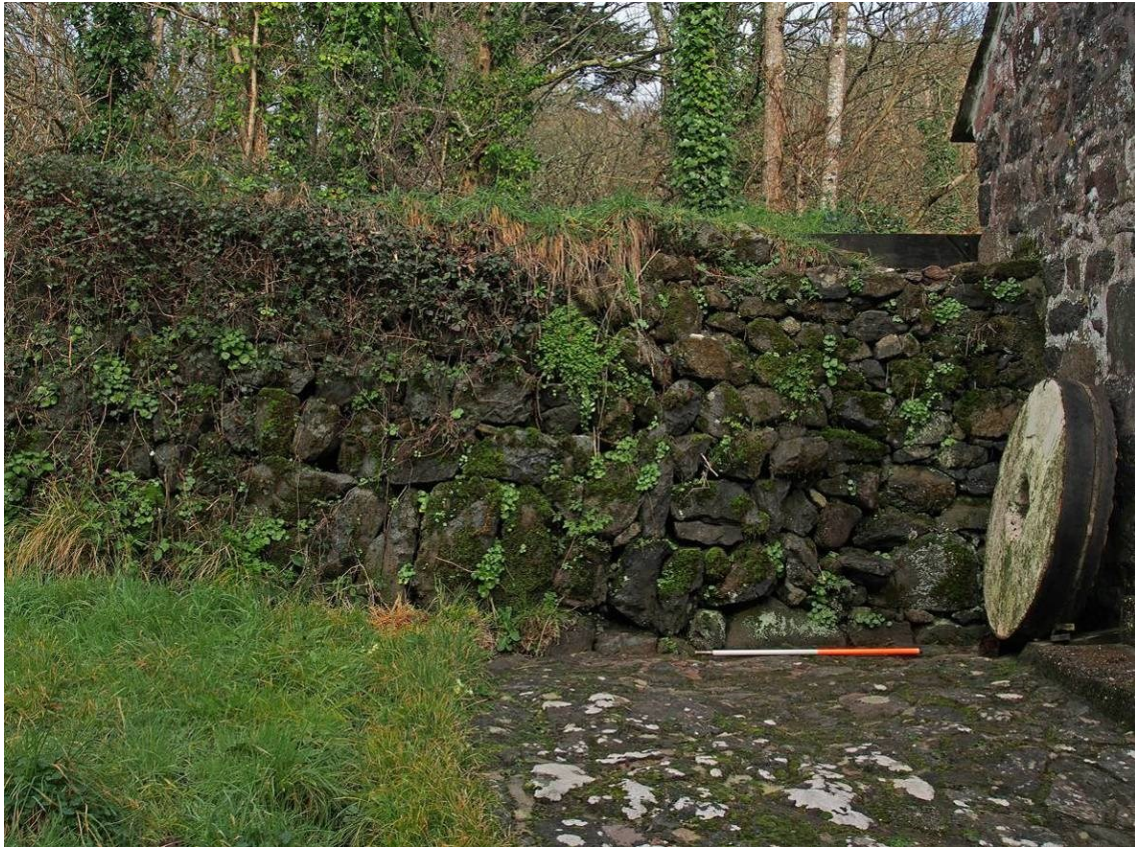
*Plate 11 The wall supporting the leat adjoining the mill building. A step-stile has been incorporated into a rebuilt section of the wall towards the right. This rebuild would appear to date from the time the mill was extended towards the SW*

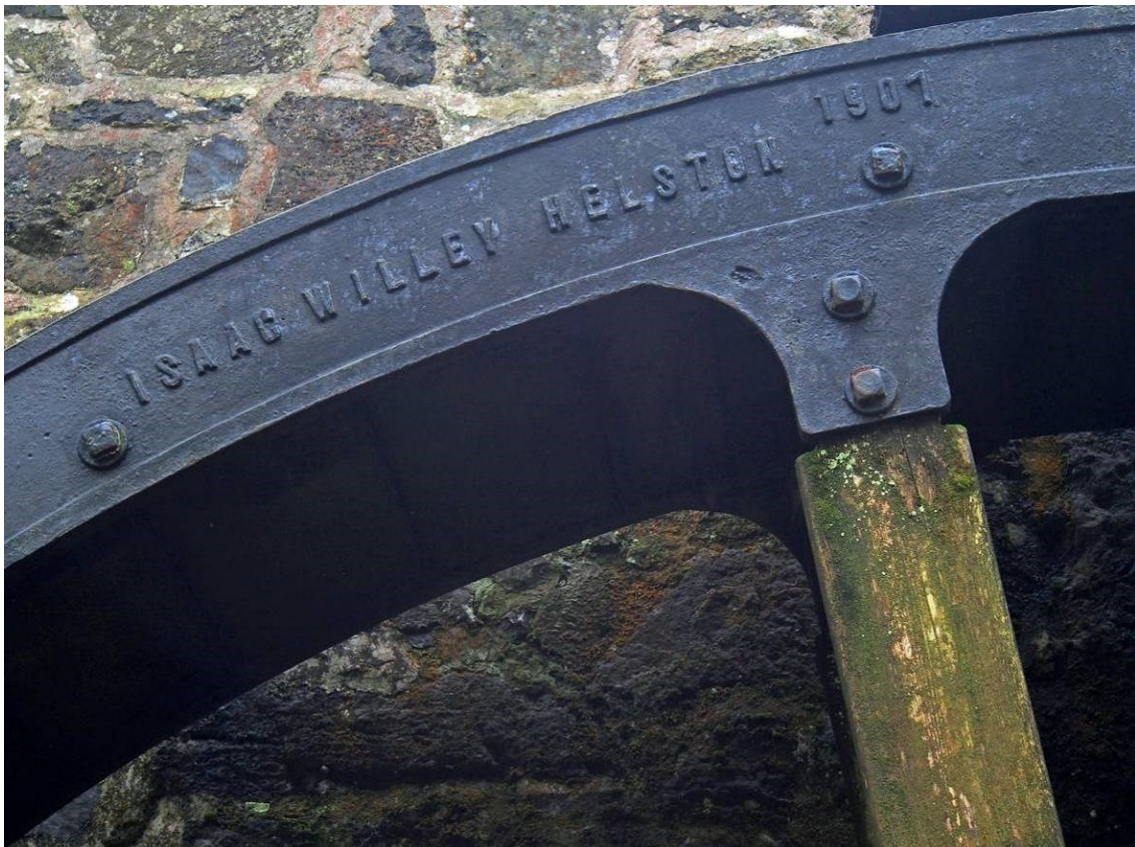
*Plate 12 Maker's name and date on the waterwheel*

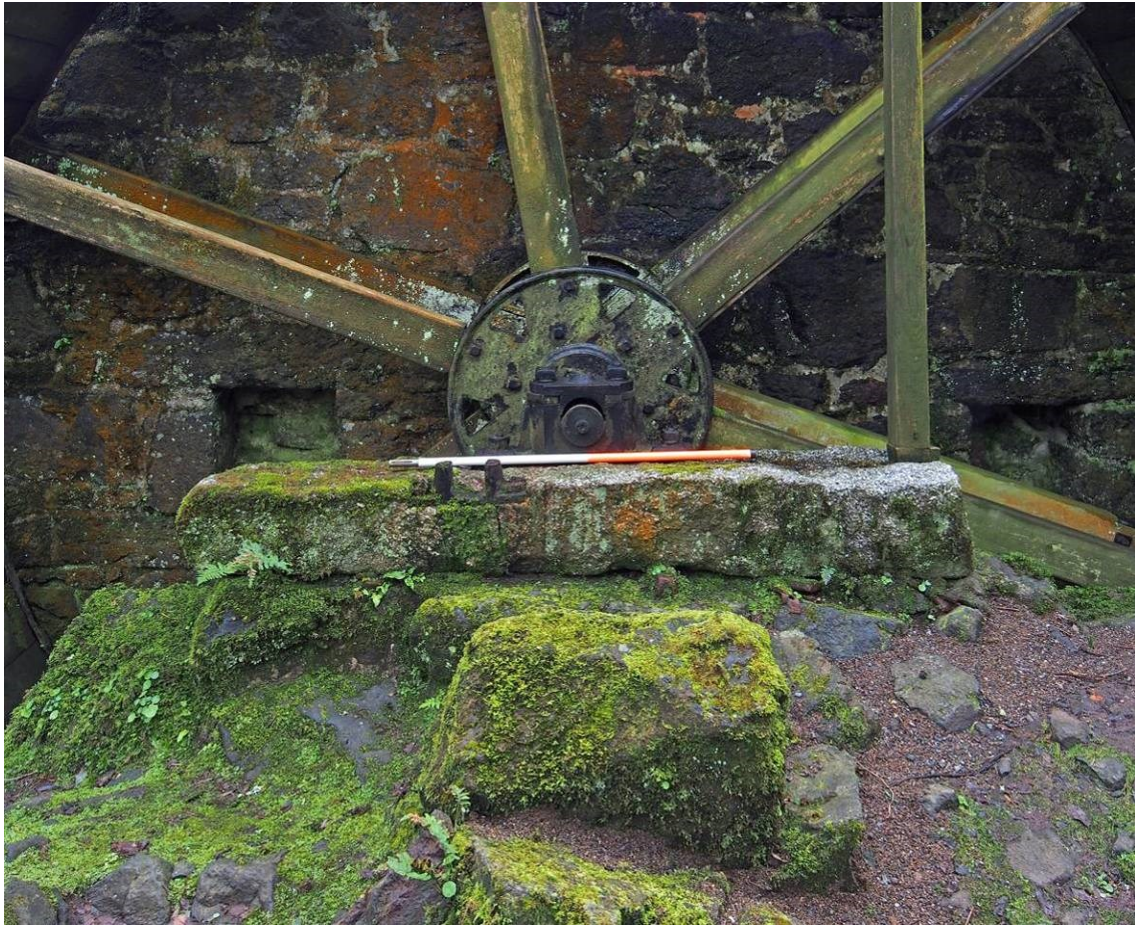
*Plate 13 Reused granite block supporting the bearings of the waterwheel. Note the earlier bracket position on the outside of the stone*

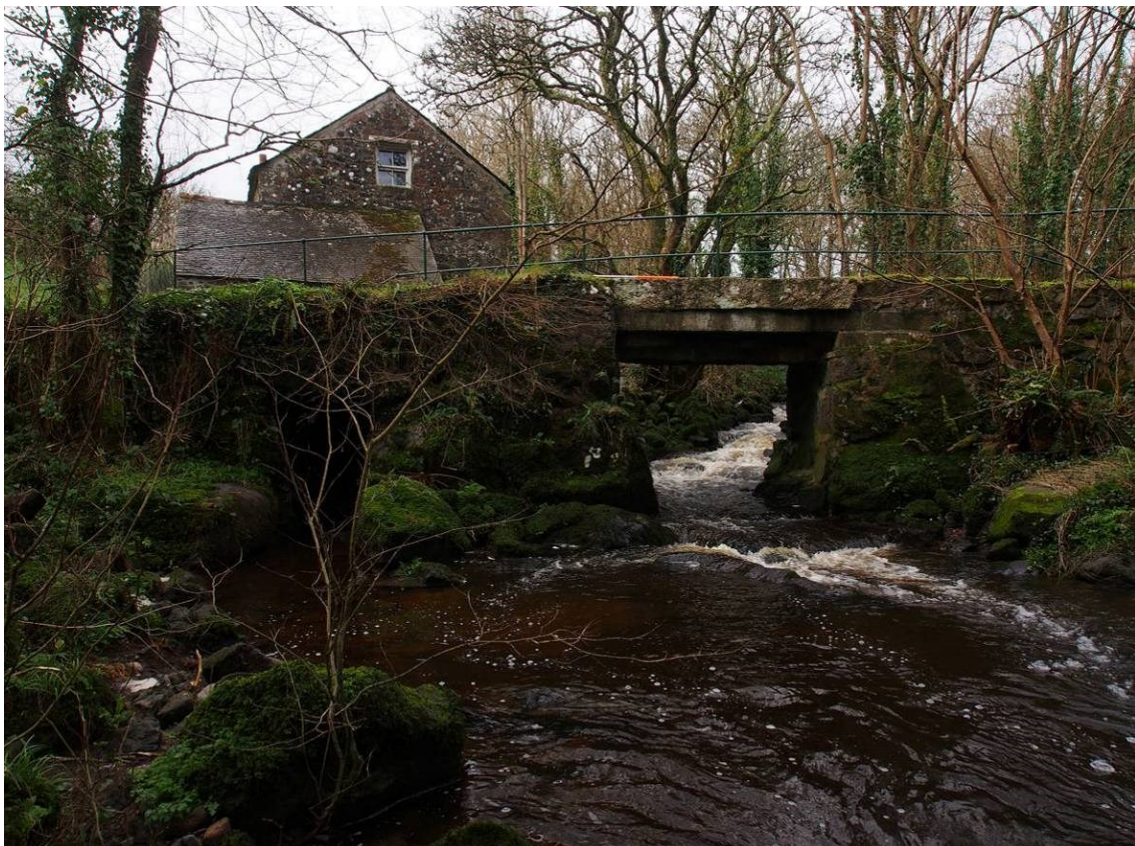
*Plate 15 View from below the bridge. The left hand (mill tailrace) opening appears to be the earlier part of the structure*

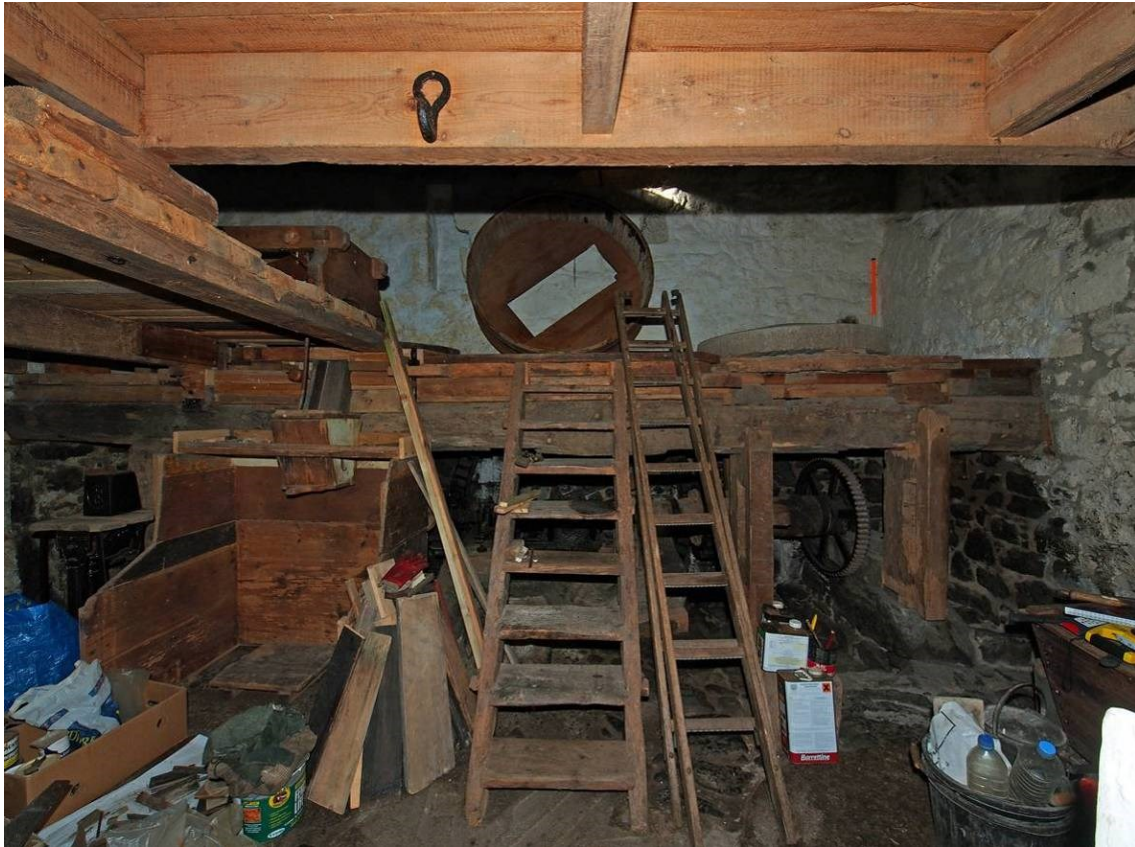
Access to the first floor is by a central (and substantial) ladder stair. This has the pleasant patina and wear of substantial use over the decades (Plate 25).

*Plate 25 Ladder to first floor (millstones visible towards upper right)*

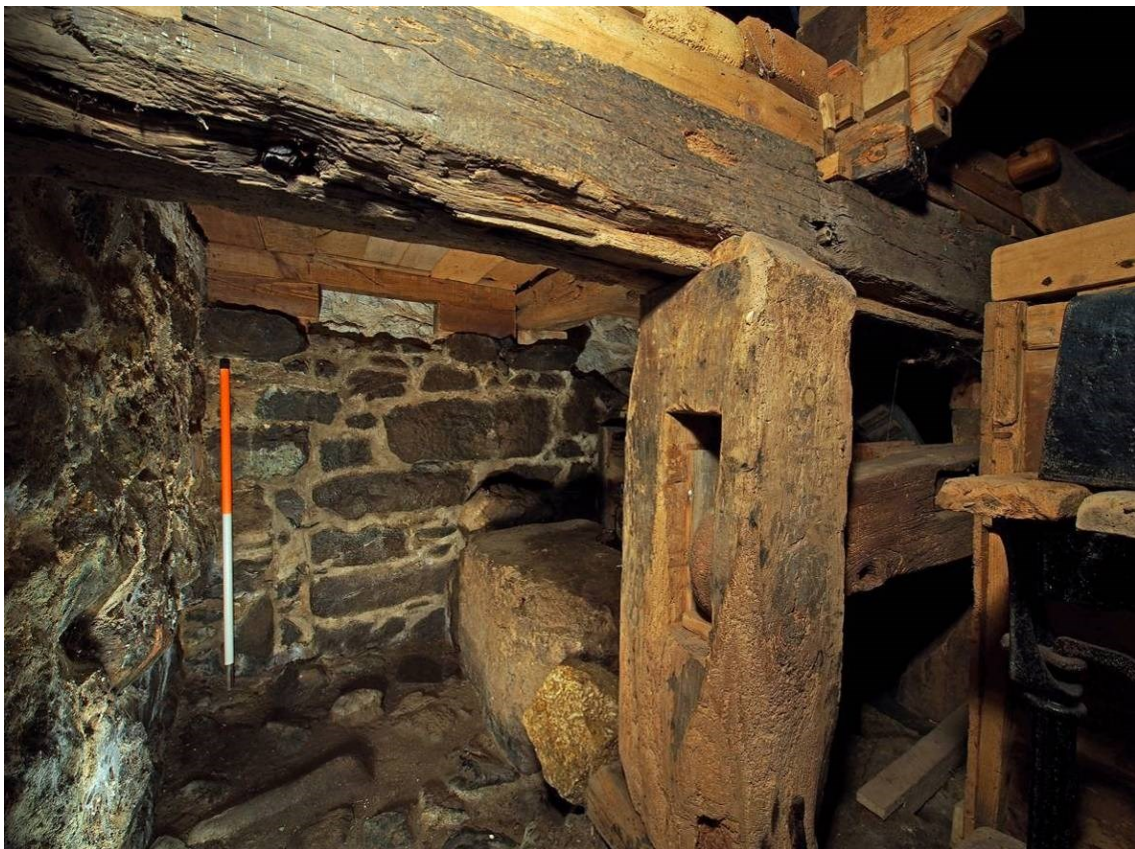
*Plate 28 Blocked vertical slot in NW corner hints at earlier arrangement of bridgework*

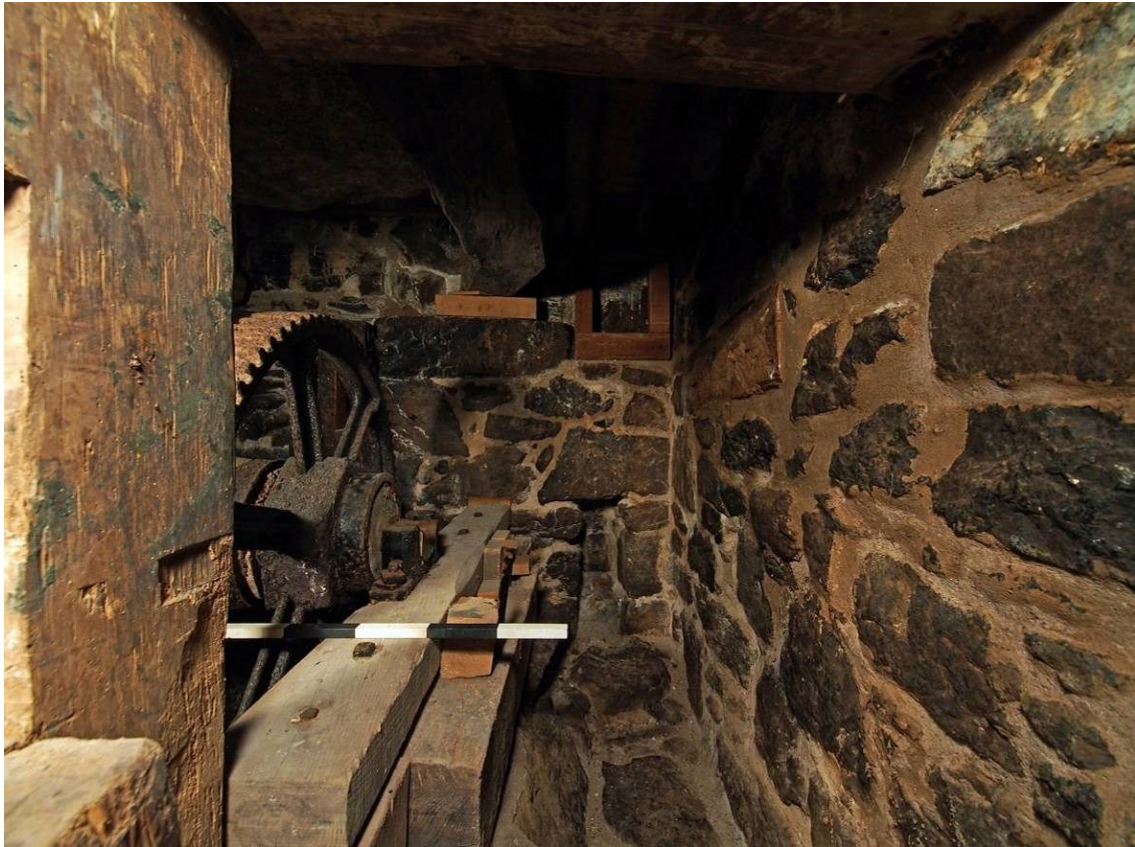
*Plate 29 Vertical slot in NE corner shows hints at earlier arrangement of bridgework*

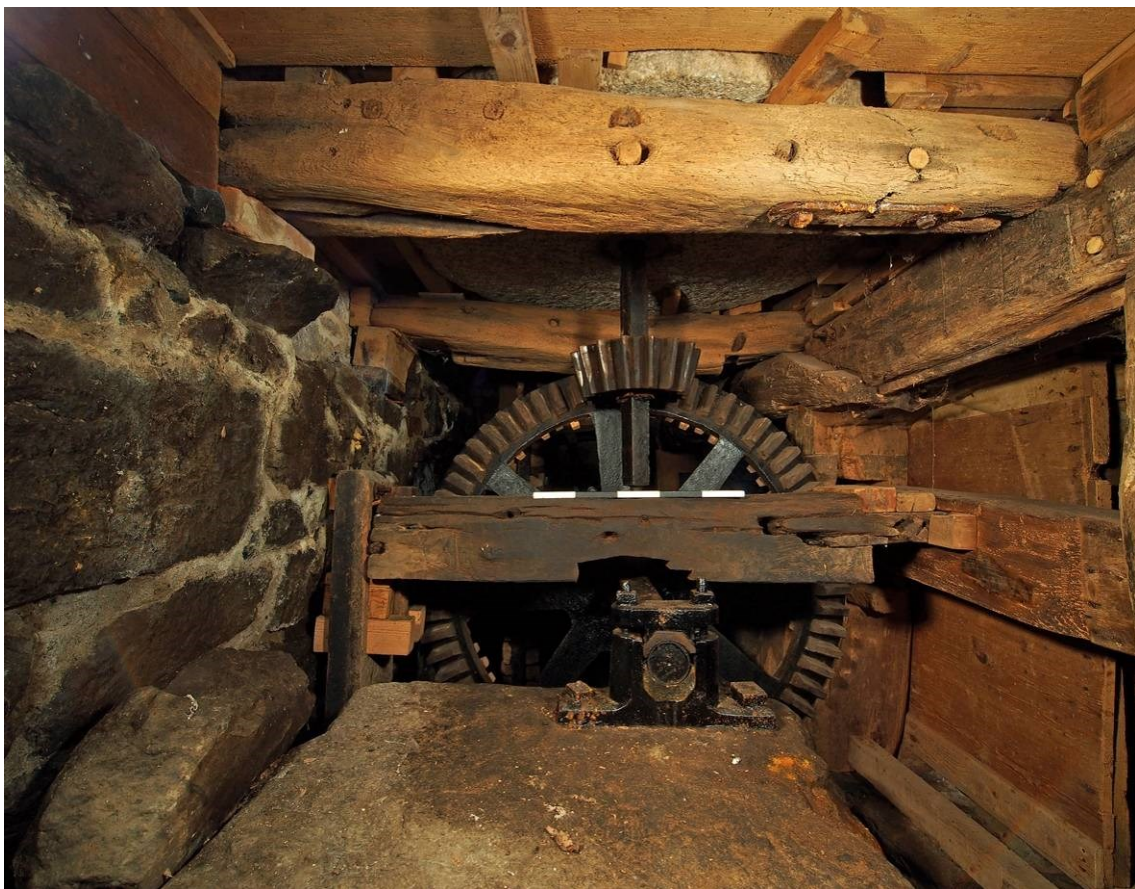
*Plate 30 Gearing to underside of millstones*

- Gearing to the NE set of stones
- Replacement (?) of the SW driven stone
- Reinstatement of the covers and hopper feeds to both sets of stones

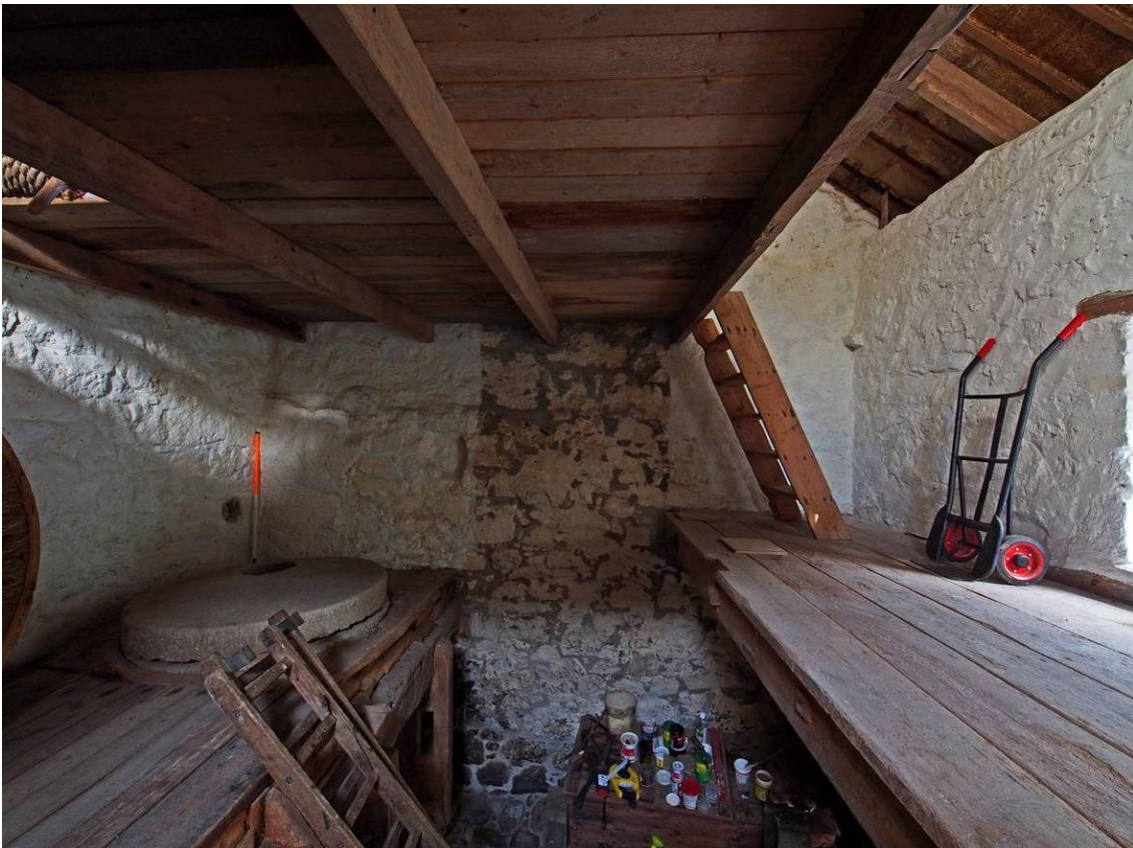
*Plate 32 View towards the NE wall at first floor level. Note the change in build and narrowed wall thickness (above the scale bar)*

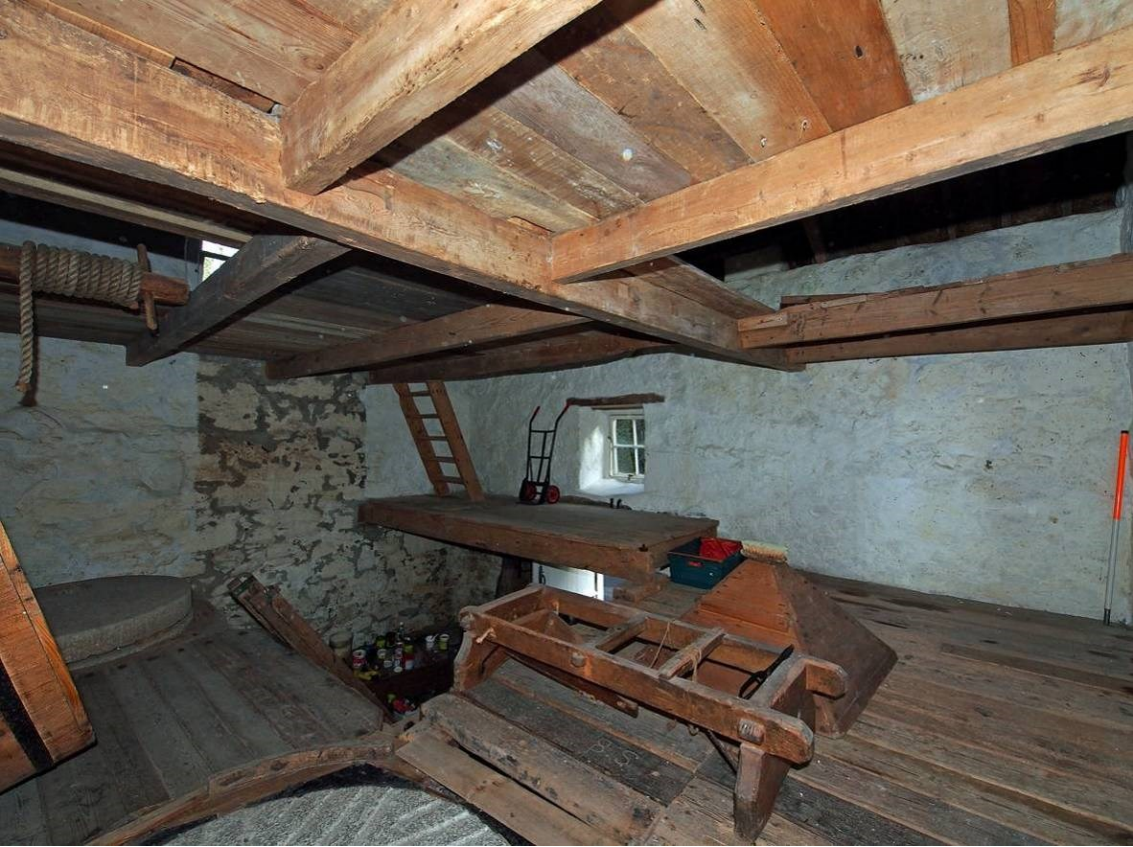
The remainder of the first floor comprises wooden planking of various widths and depths, parts having been replaced at various times (Plate 33).

*Plate 33 View of first floor looking E*

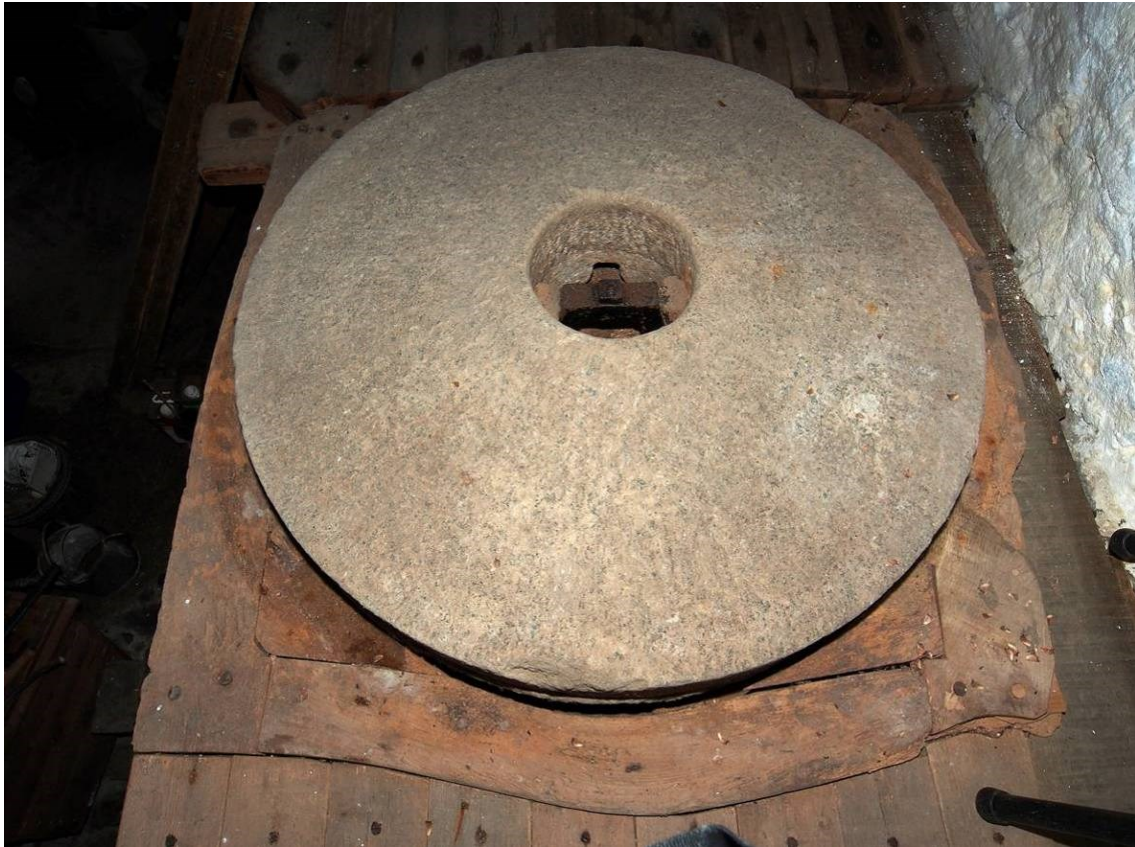
*Plate 37 The eastern millstones in situ*

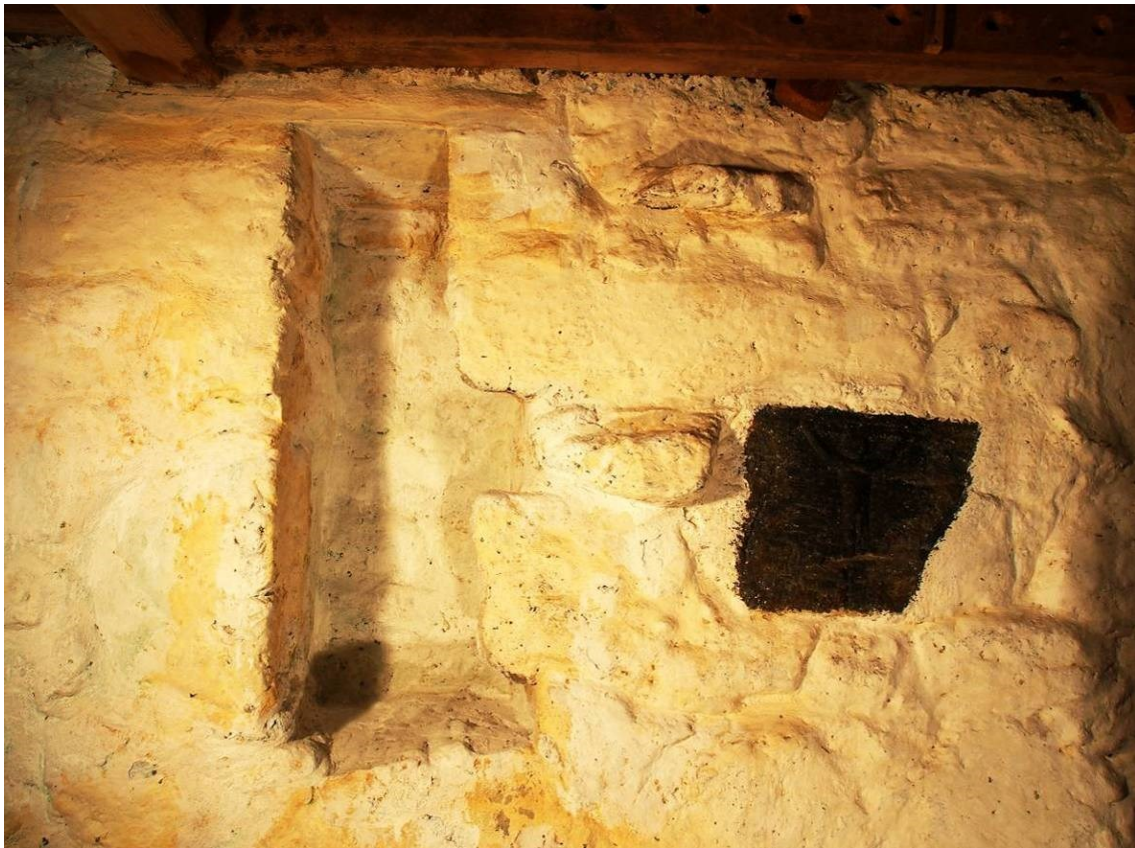
Within the rear wall is a vertical recess, together with two stones that protrude from the wall facing (Plate 38). To the right of the recess is a carving in shallow relief on serpentine stone, depicting a crucifixion (Plate 39). This is most likely of medieval date. A dated stone towards the centre of the elevation is inscribed 'WW 1867', recording modifications to the mill made by Mr. Wearne, the miller at the time. A stone at the far right of this wall is inscribed 'JJ', likely to be a 17<sup>th</sup> century mason's mark (Anthony Hitchens Unwin pers comm).

*Plate 38 Recess in NW wall on first floor, which appears to have been created from where the earlier SW wall formed a quoin. Note the stones protruding from the wall to the right*

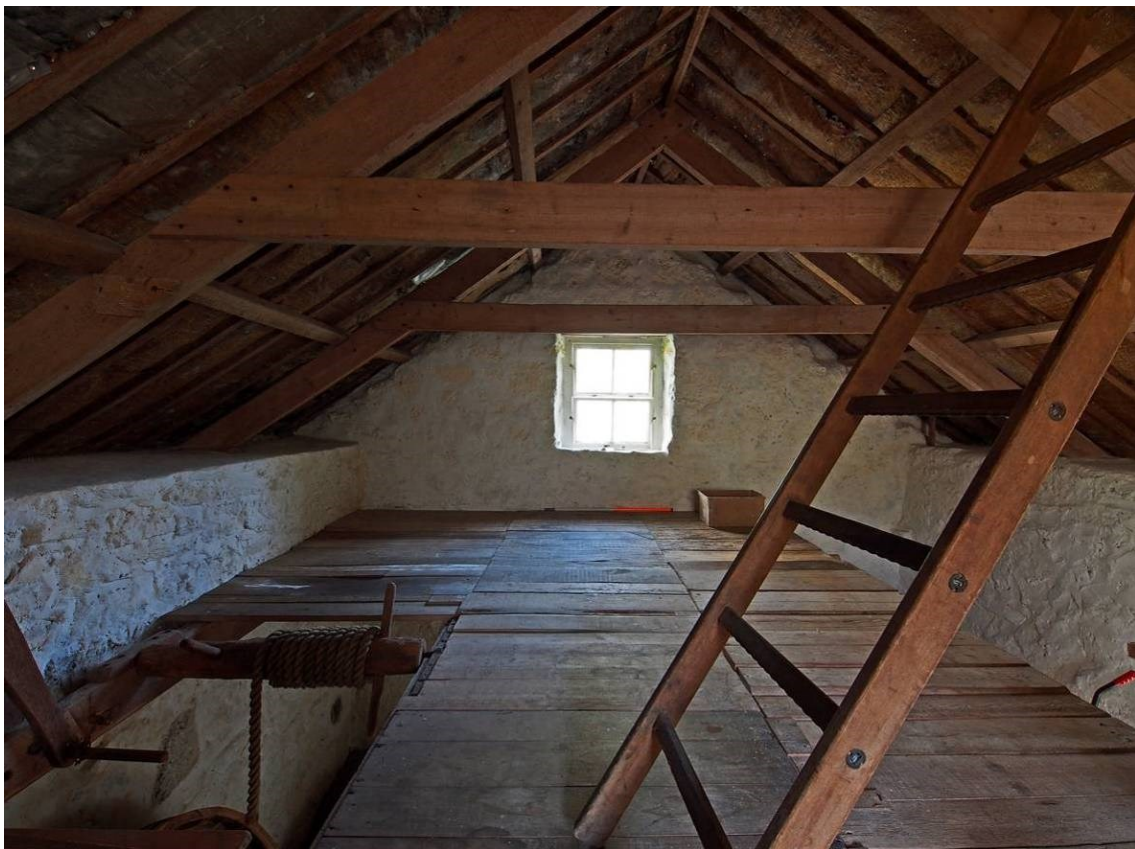
The roof structure comprises nailed A-frames supporting purlins and rafters (Plates 40 and 41). The covering is of scantle slate on laths (Plate 2); bituminous paper has also been added between the rafters. The ridge is of red clay tiles. Cement wash has been added in the later 20<sup>th</sup> century to try and prevent slate slippage. The slate covering is

A steep wooden ladder (later 20<sup>th</sup> century?) provides access to the loft area. The loft has windows in the two gable ends (see Exterior and Plates 40 and 41). The floor is of planks of differing widths. Almost central to the rear wall is an opening in the floor which has a horizontal capstan mounted between two joists (Plate 42). This is for lifting and maintenance of the millstones. Also in this area is the internal lever that operates the sluice on the launder outside, thereby controlling the flow of water over the wheel.

*Plate 40 View of the loft floor looking NE*

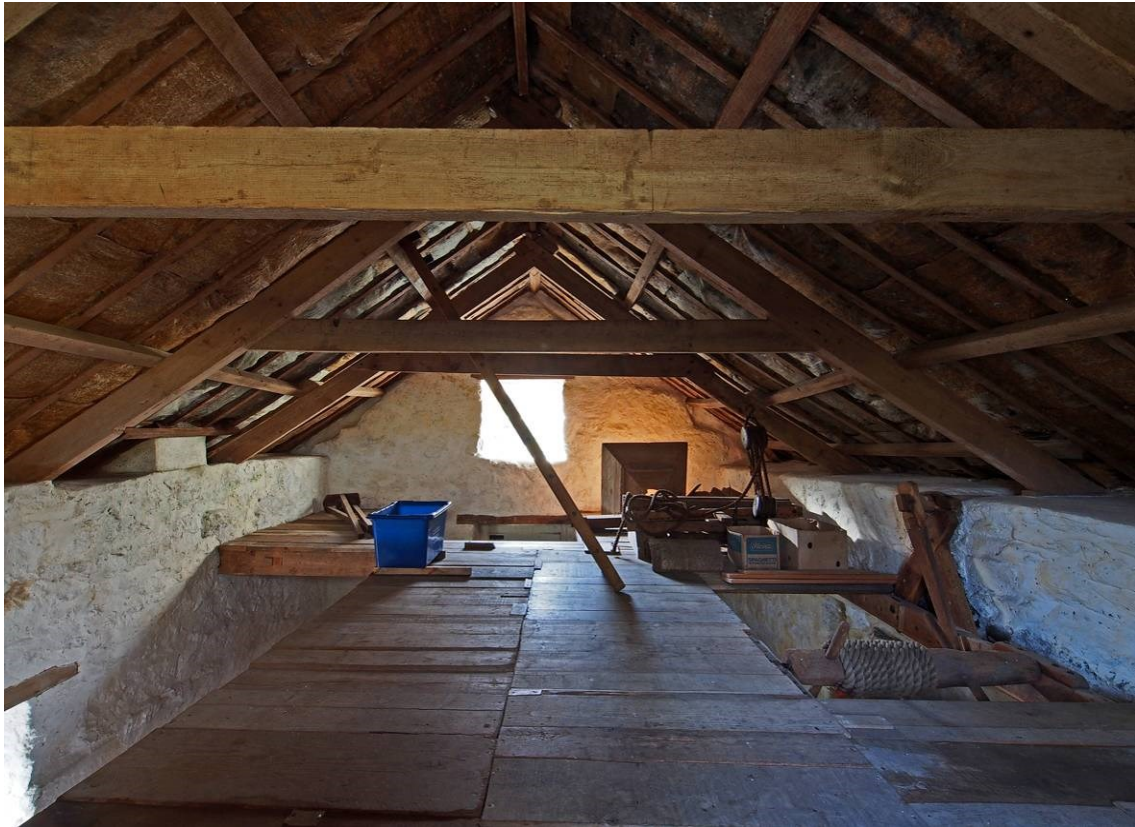
*Plate 41 View of the loft floor looking SW*

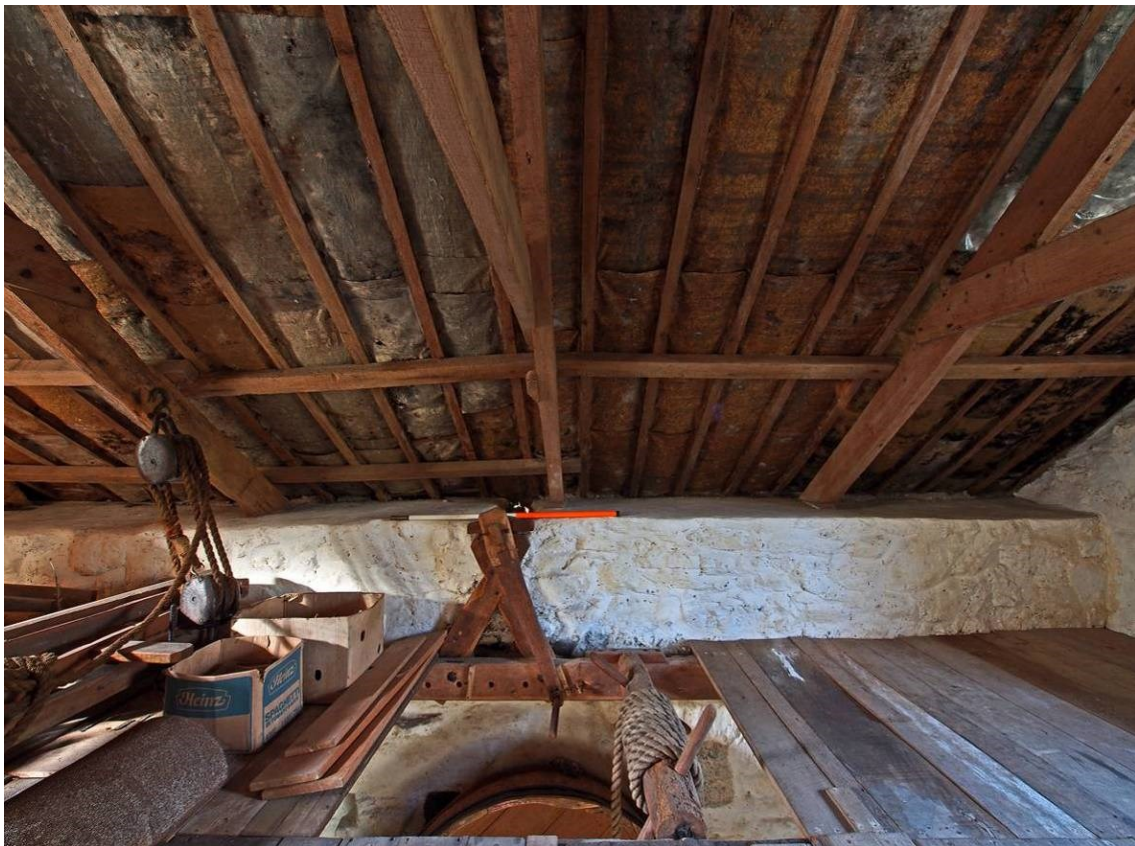
*Plate 42 View of the loft floor. Note the capstan for lifting the millstones (right of centre) and the wooden lever (centre, rear) for adjusting the sluice controlling the flow on the waterwheel*
