# **Structures at Taylor's and Davey's Shafts, Consolidated Mines, Gwennap, Cornwall**

## **Historic Environment consultancy during consolidation works**

<b>Client</b>	<b>Gwennap Parish Council</b>
<b>Report Number</b>	<b>2013R077</b>
<b>Date</b>	<b>24 October 2013</b>
<b>Status</b>	<b>Final</b>
<b>Report author</b>	<b>Adam Sharpe BA MIfA</b>
<b>Checked by</b>	<b>Dr. Andy Jones</b>
<b>Approved by</b>	<b>Andrew Young MIfA</b>

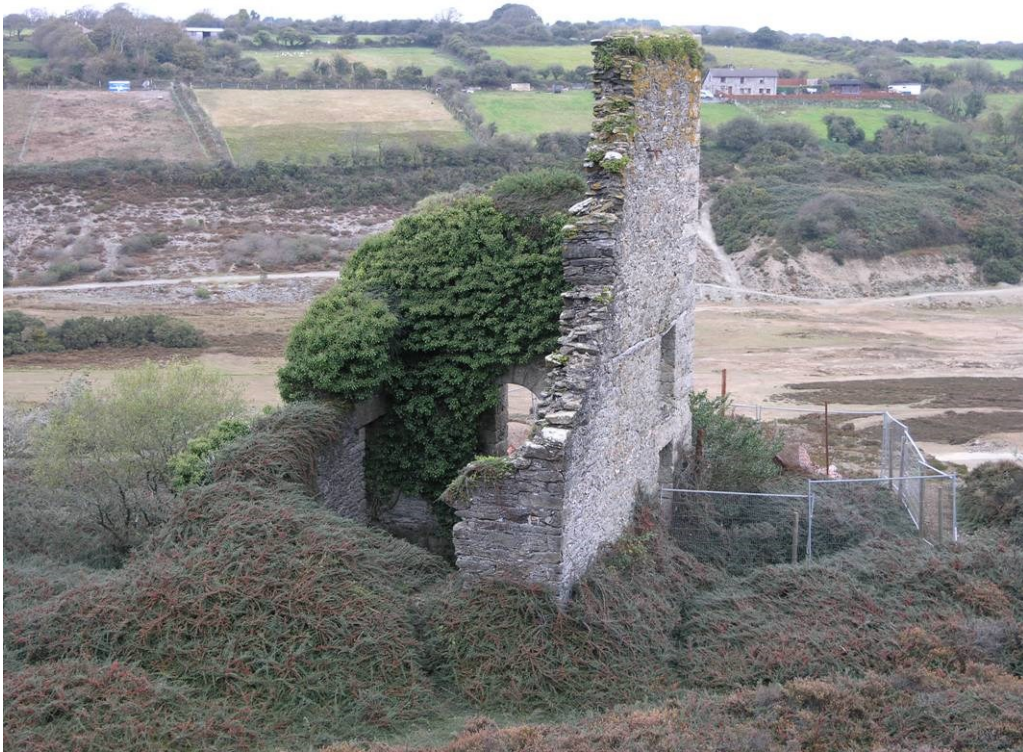
*Fig 9. Taylor's engine house from the south during 2009. The amount of masonry lost from the rear half of the engine house is apparent, as is the quantity of ivy cloaking the north western corner of the building and the cotoneaster around it.*

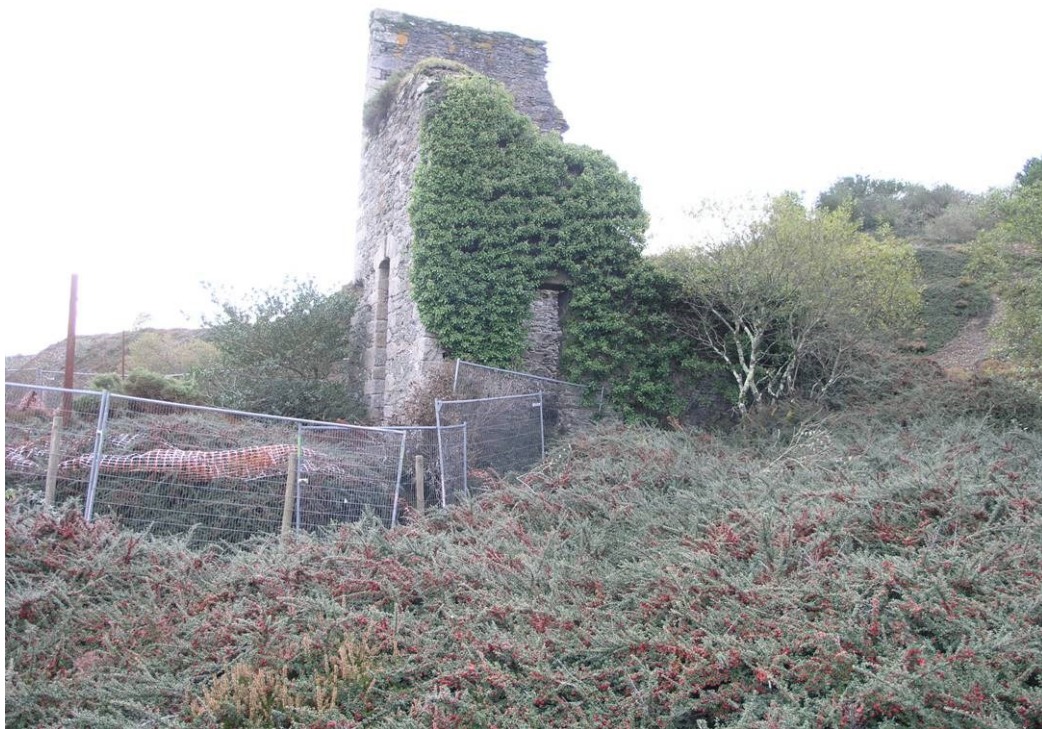
*Fig 10. Taylor's pumping engine house from the west in 2009, showing the boiler house door and the ivy cover which cloaked this elevation.*

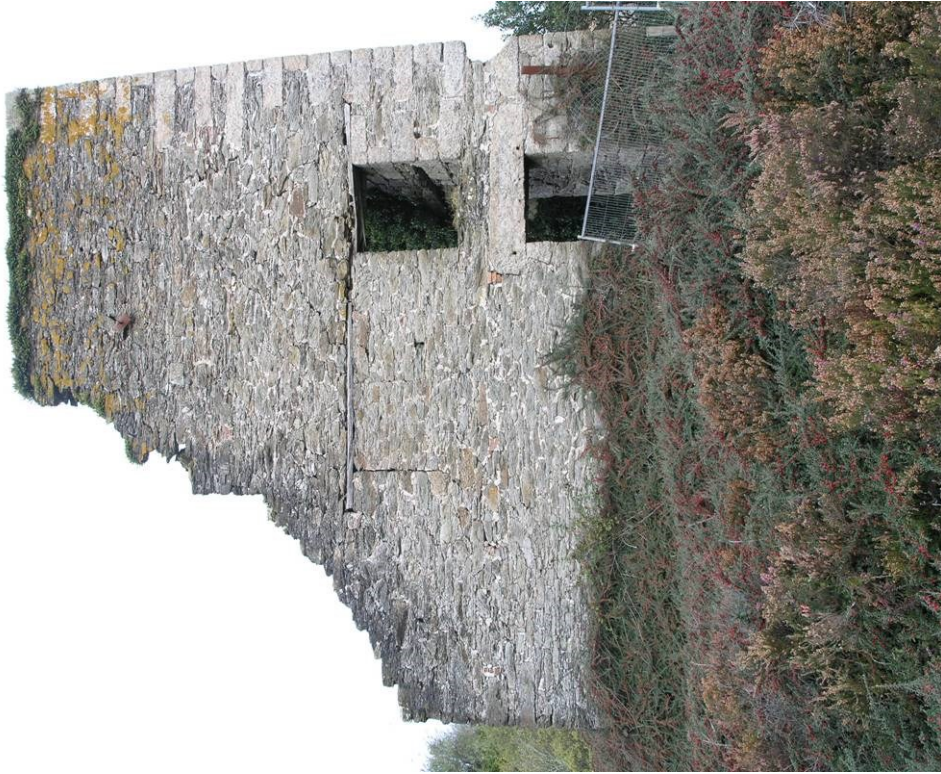
Fig 12. The eastern wall of Taylor's pumping engine house, showing the doorway and window above and blocked window to its rear, the longitudinal timber and (half-way up the rear edge of the surviving masonry) the remains of the girder opening.

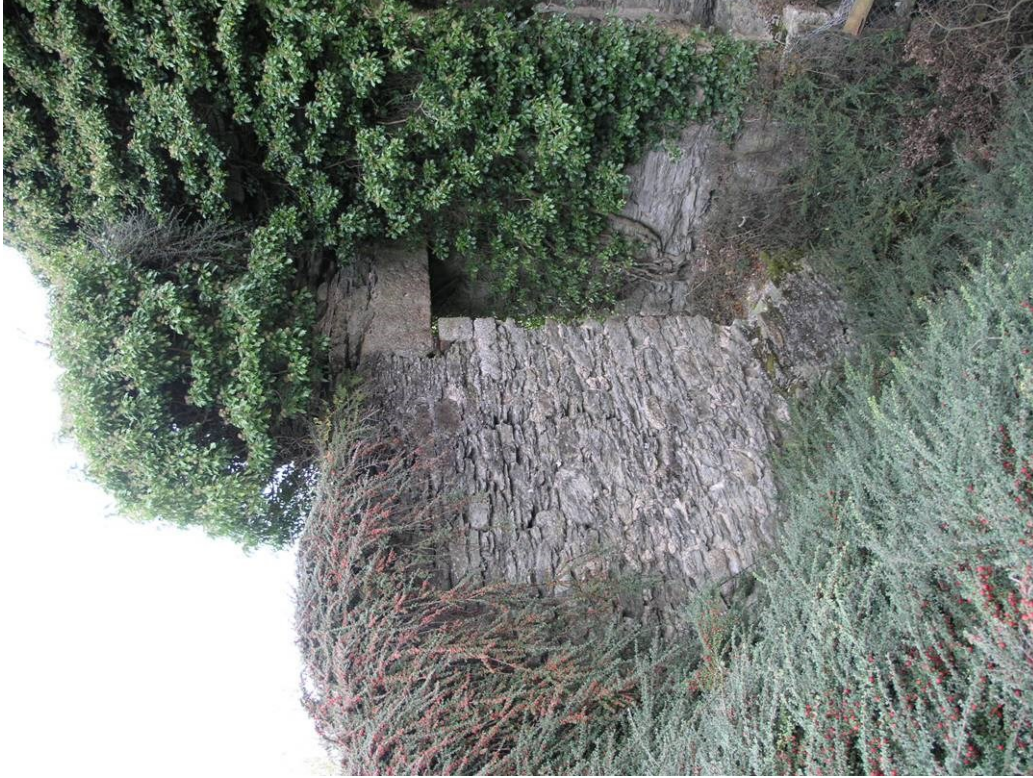
Fig 14. The internal elevation of the western wall, showing the boiler house door, the cotoneaster which cloaked the wall, and the tree ivy over the north-western corner of the building.

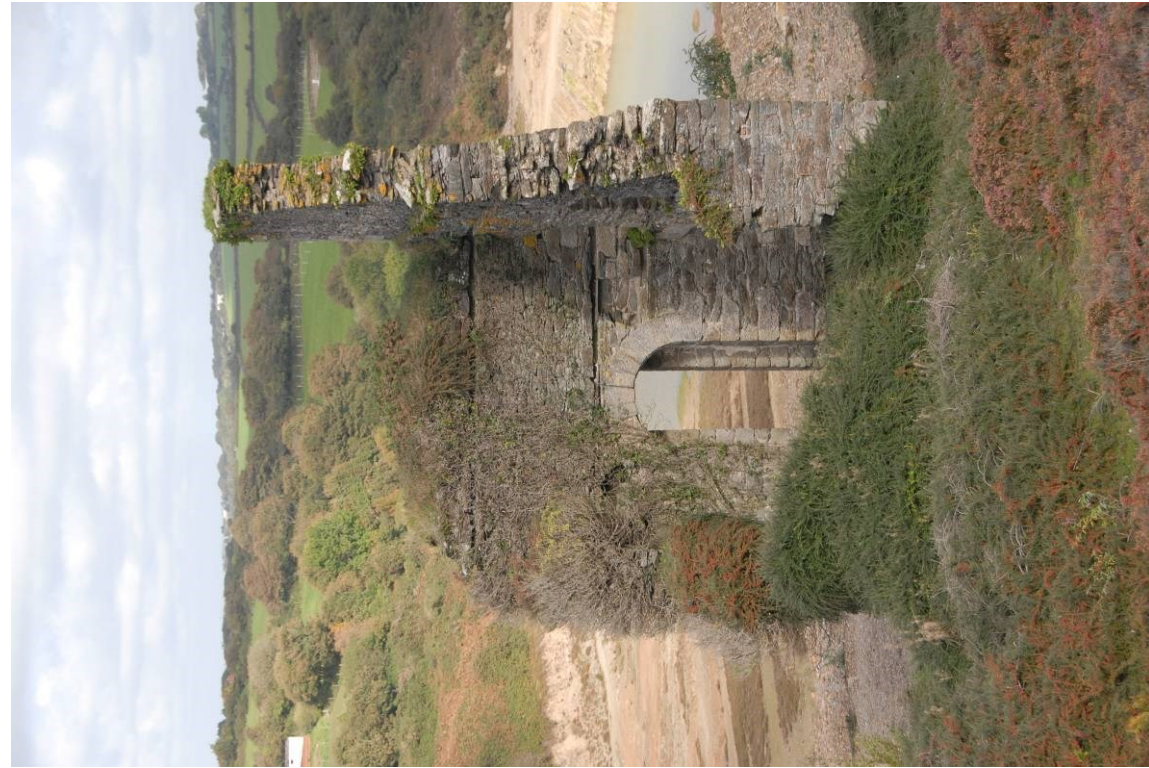
*Fig 15. Taylor's engine house from the south prior to works and once some of the ivy had died back.*

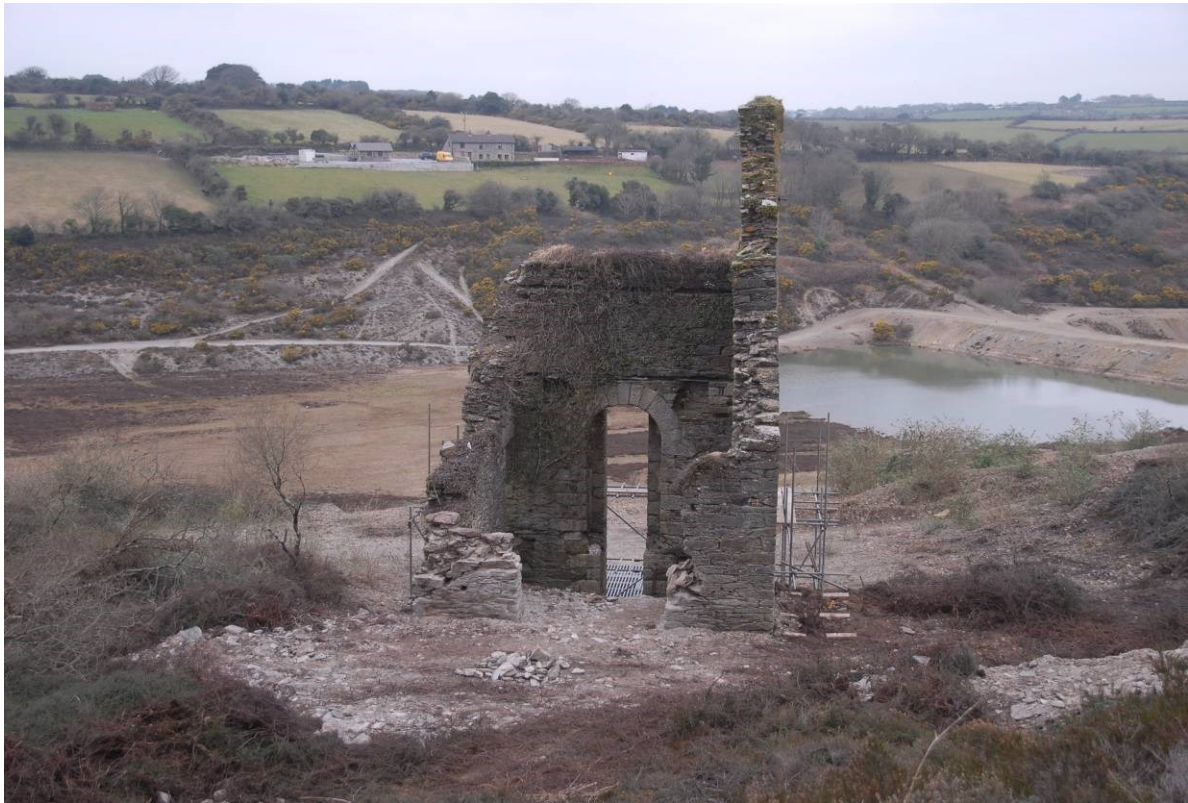
*Fig 19. Taylor's engine house from the south following the clearance of rubble and scrub, showing the newly-revealed cylinder doorway.*

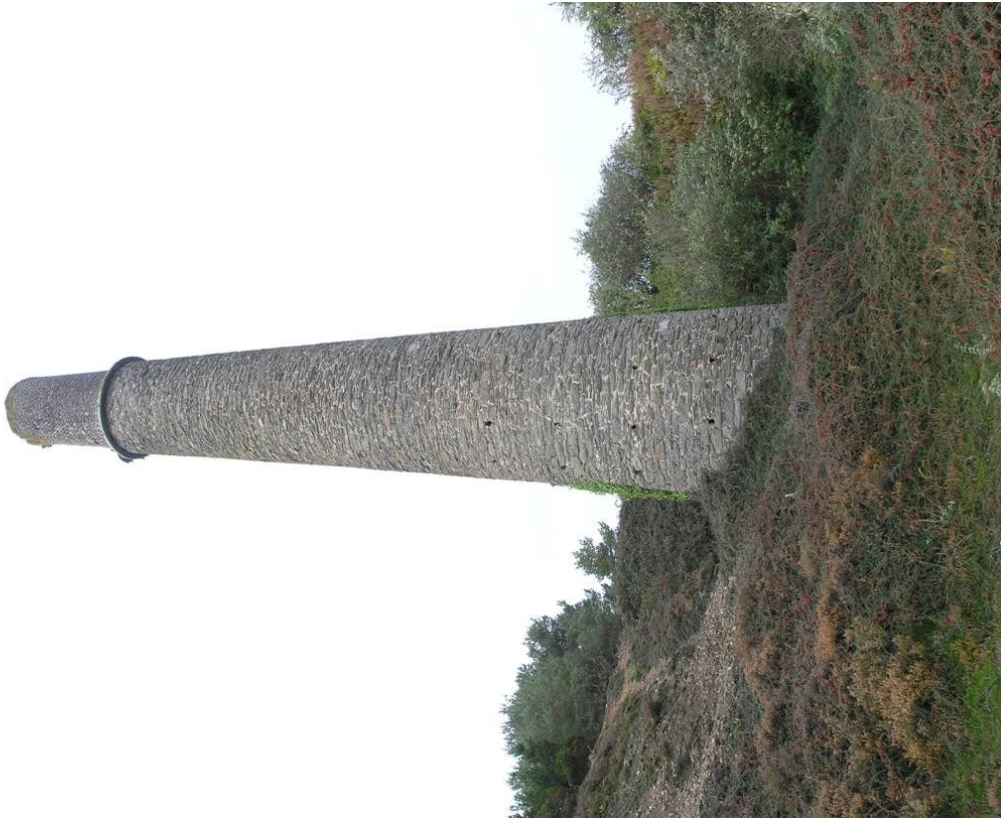
*Fig 35. Taylor's chimney from the north-east. The poor state of its brickwork was not particularly evident from this viewpoint.*

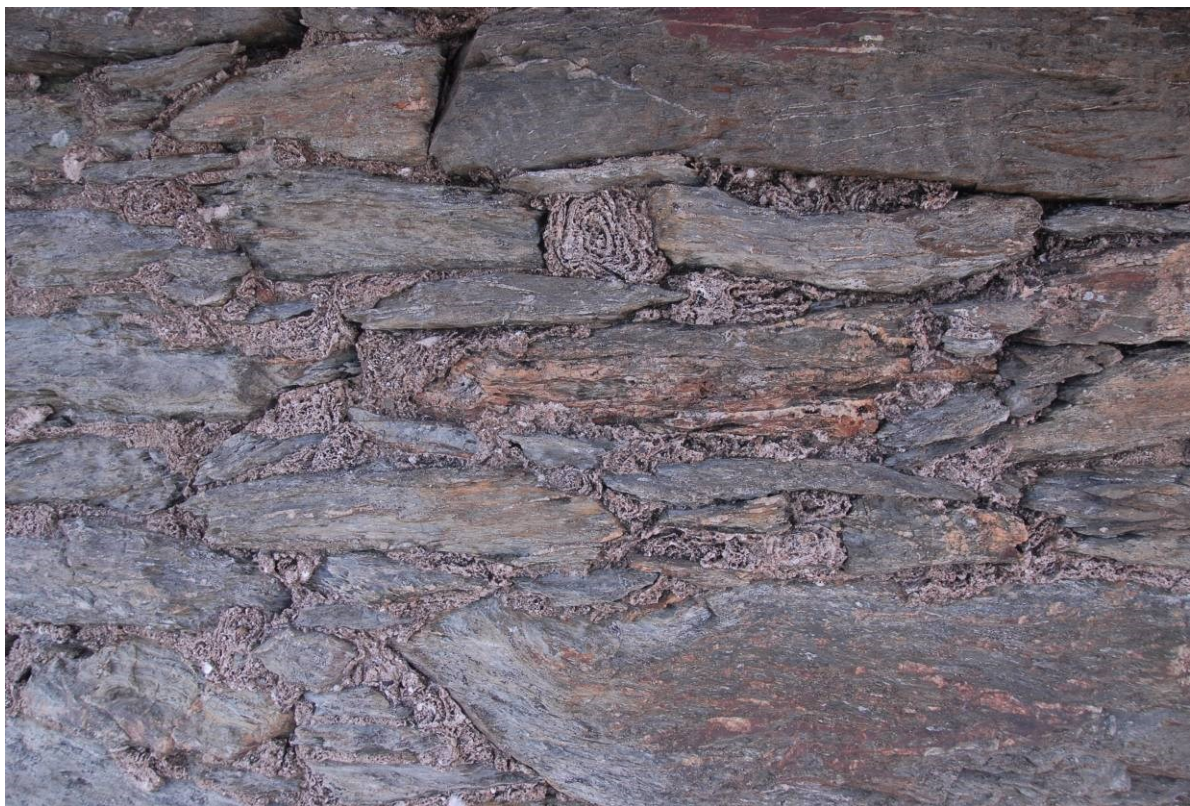
*Fig 42. Original pointing on the western elevation of the chimney had a characteristic weathering appearance. Much of this pointing was sound and could be left in place.*

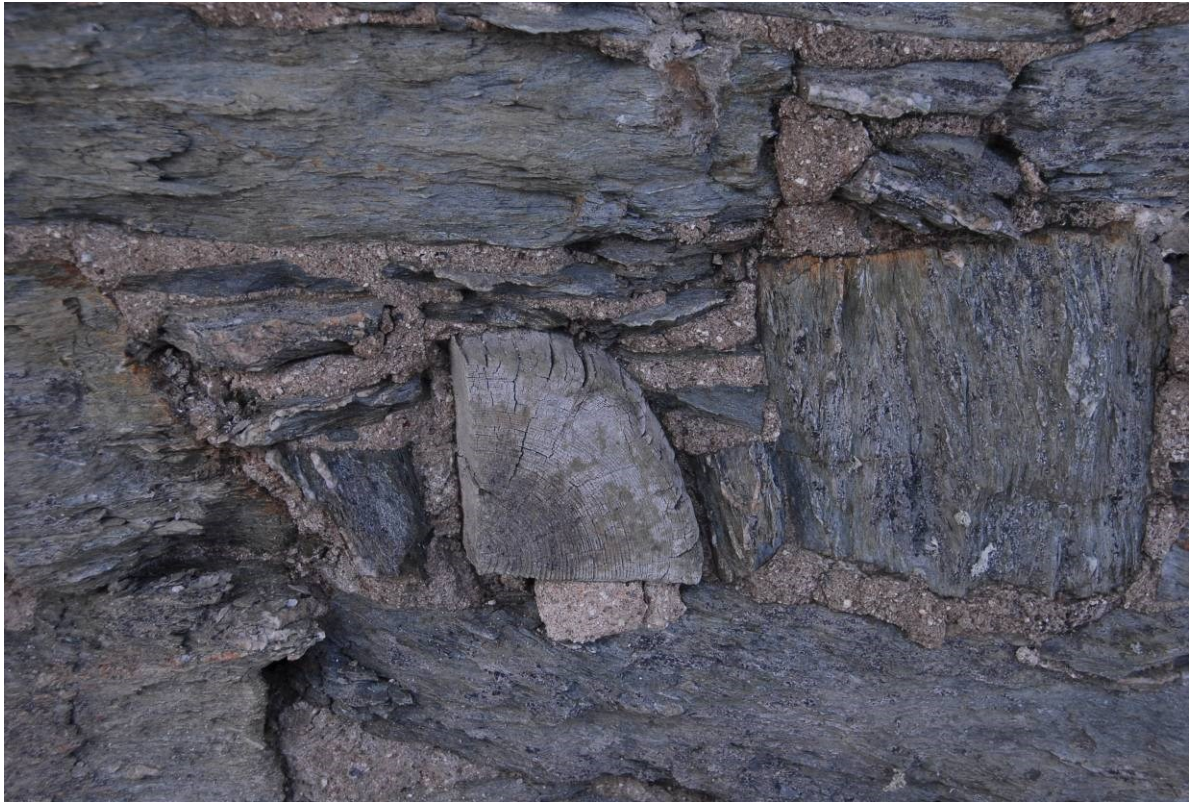
*Fig 43. A remnant cut off putlog in the face of the chimney. Note also the differential erosion which has occurred in the stonework of this structure.*

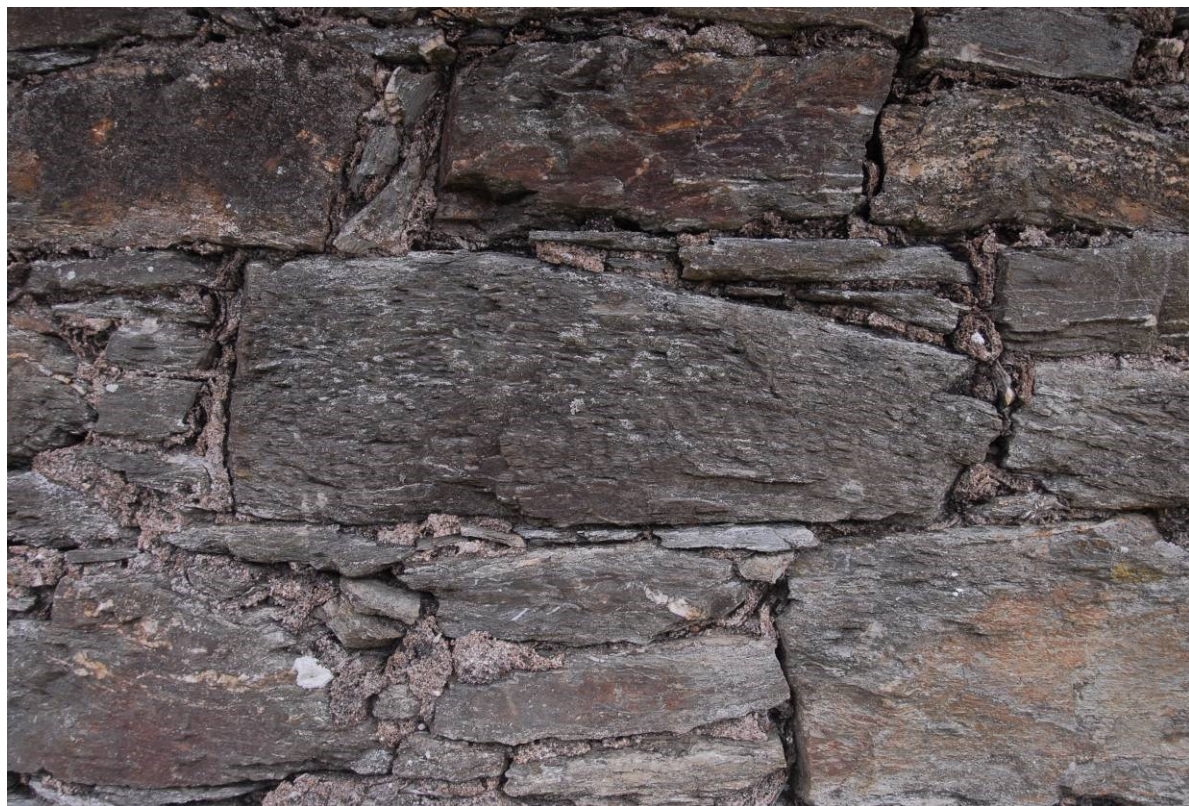
*Fig 46. Roughly coursed masonry on the chimney showing indications (centre stone) of final shaping in situ.*

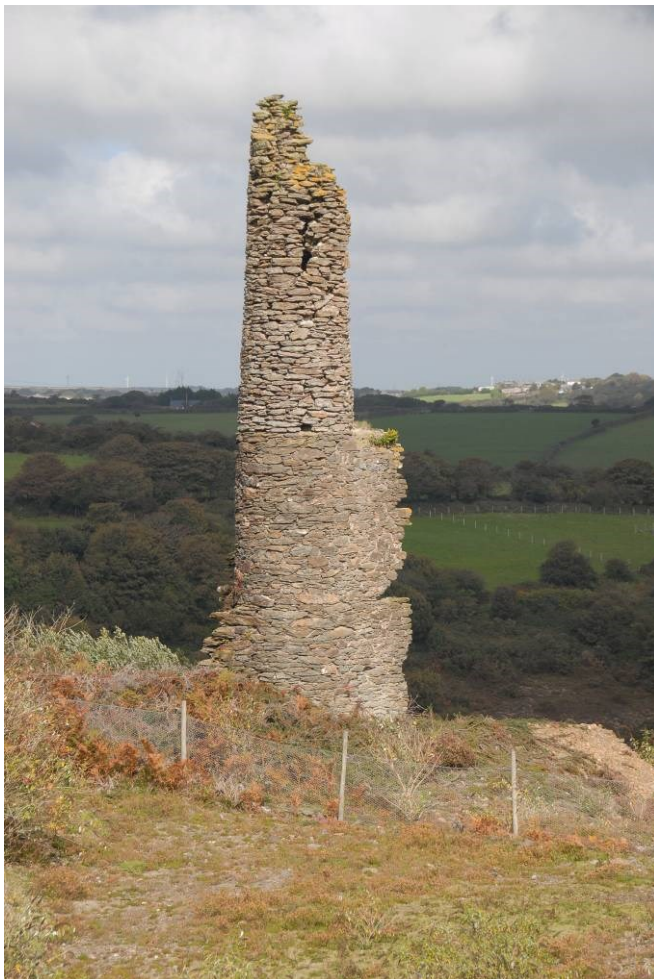
*Fig 50. Taylor's whim from the south east prior to works, showing the poor state of the upper part of the chimney and the small amount of the remainder of the building which survived.*

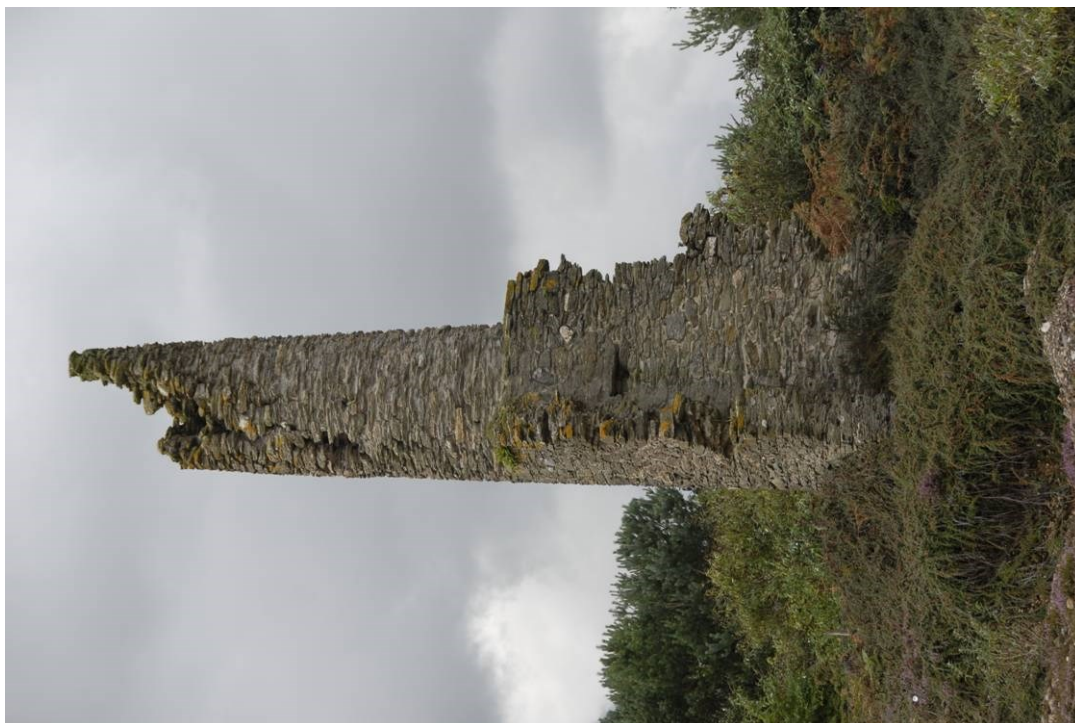
*Fig 51. Taylor's whim from the south east prior to work.*

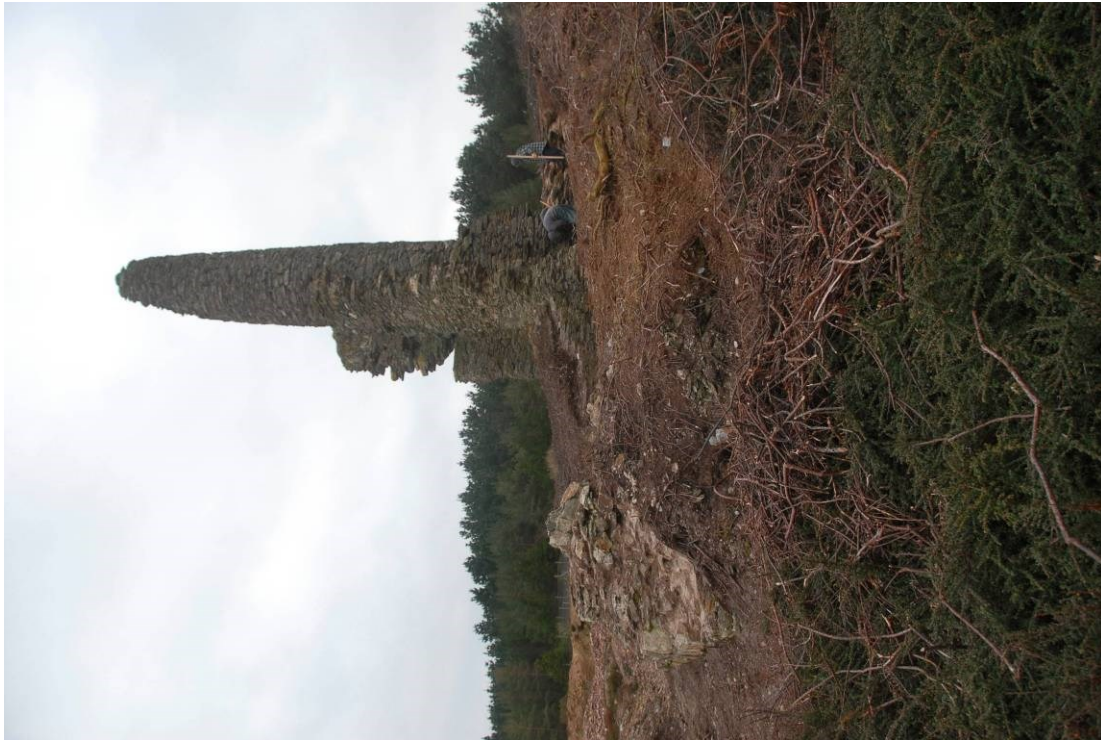
*Fig 53. Taylor's whim during preliminary vegetation clearance, showing the remains of the loadings (foreground left).*

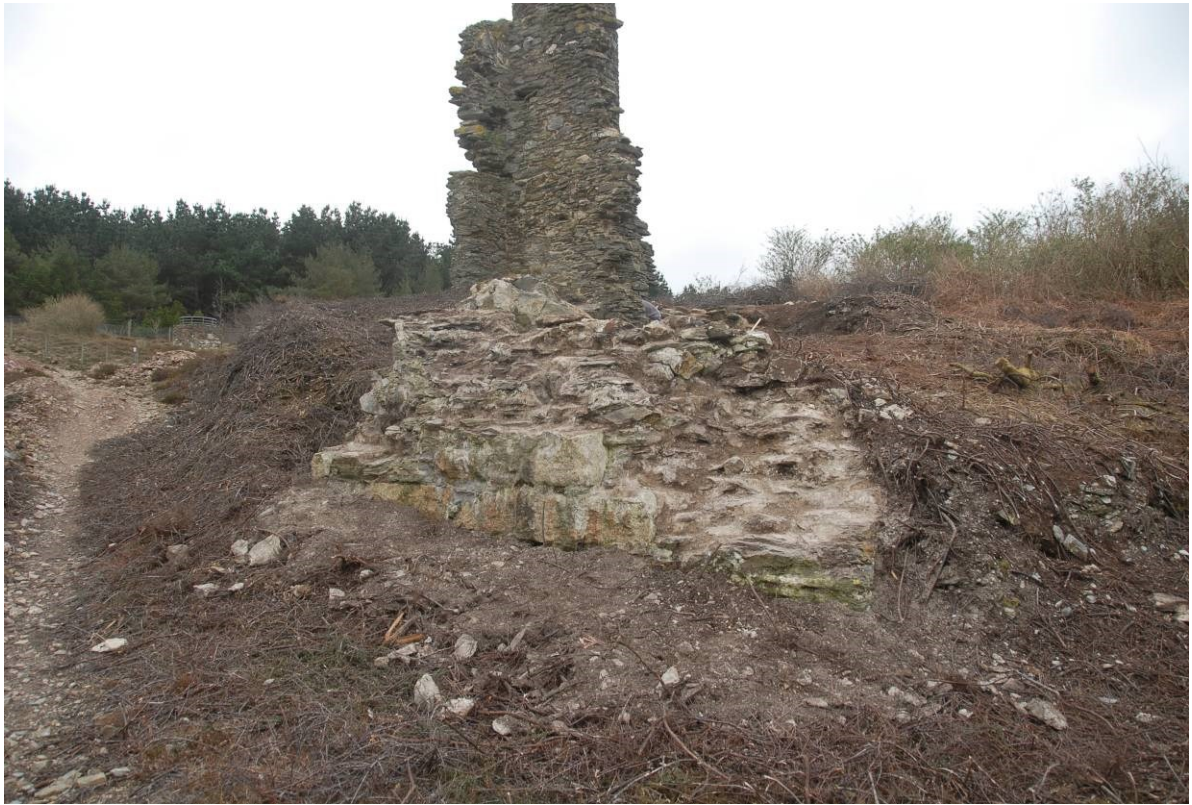
Thick mats of Cotoneaster surrounding the building and covering the whim loadings had been cut back (with some difficulty) during early 2013 to allow the survey of this building. Little more had been revealed other than some additional detail of the remains of the whim loadings (Fig 55) and parts of the upper sections of the boiler house walling. The latter proved to be rather poorly built, and it was decided not to expose them further, but to consolidate the limited amounts of masonry which protruded from the ground surface (Fig 56). Hand excavation also revealed further detail of the flue opening from the chimney into the boiler house (Fig 54).

*Fig 55. The whim loadings following the clearance of the dense Cotoneaster which formerly completely covered them.*

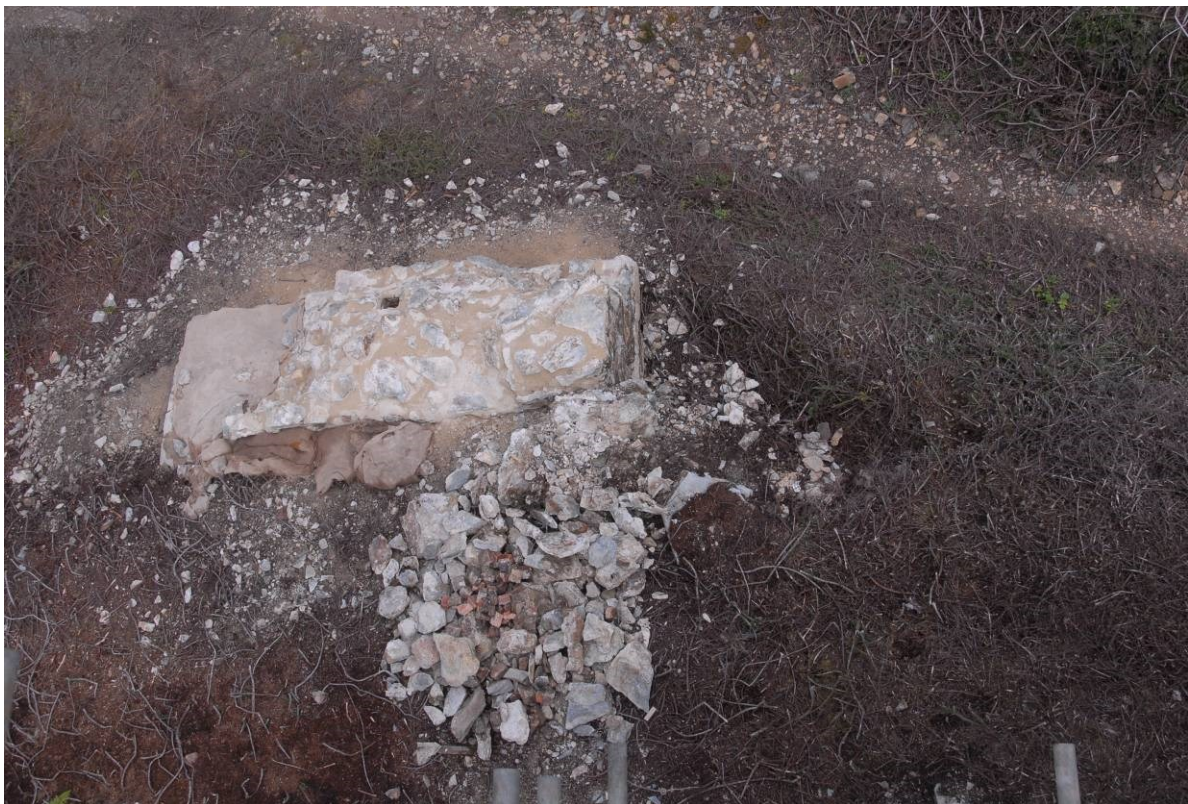
*Fig 62. Looking down from Taylor's whim scaffolding on the consolidated remains of the whim loading.*

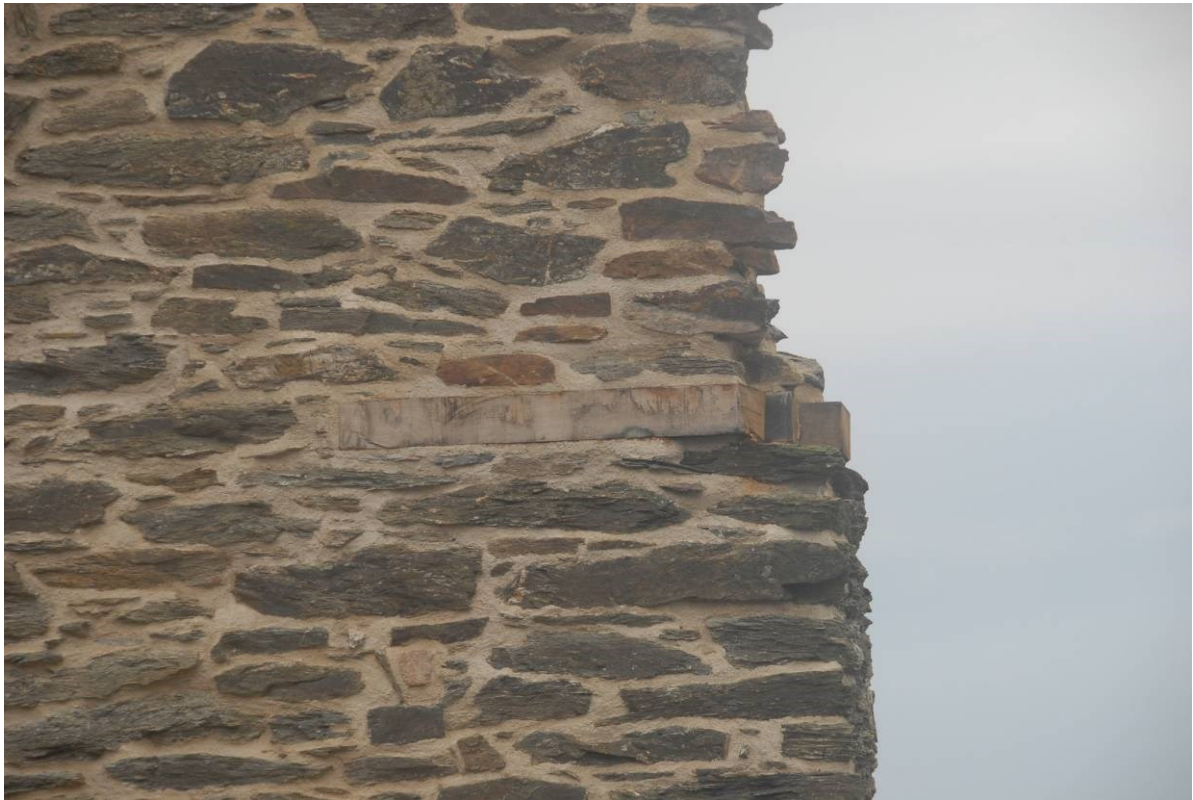
*Fig 63. The rebuilt eastern edge of the lower part of the southern wall of Taylor's whim, showing the oak lintel stubs incorporated to indicate the location of the former doorway.*

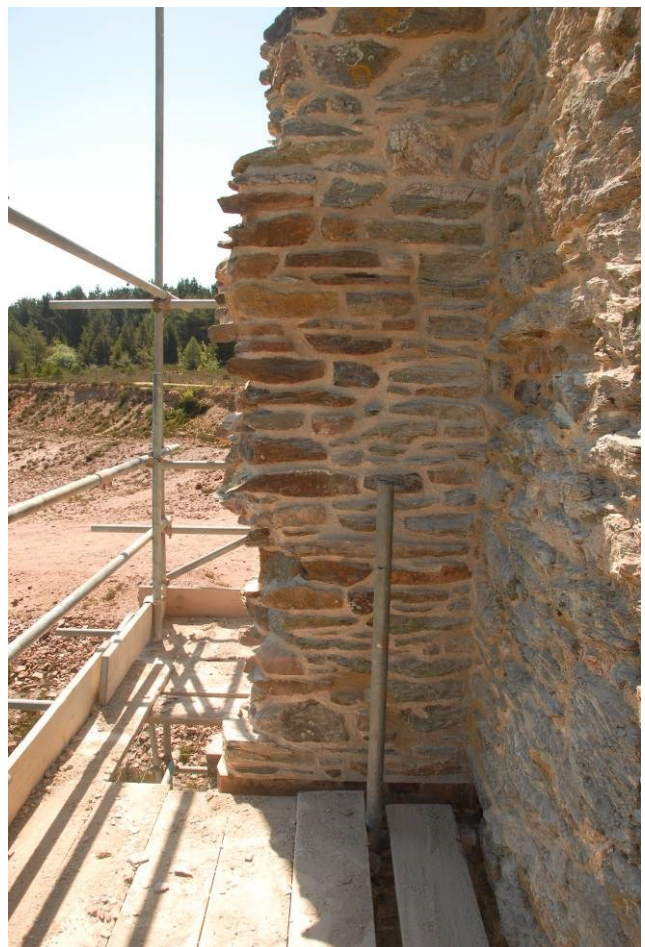
*Fig 64. The conserved upper section of the southern wall of Taylor's whim, seen from the north.*

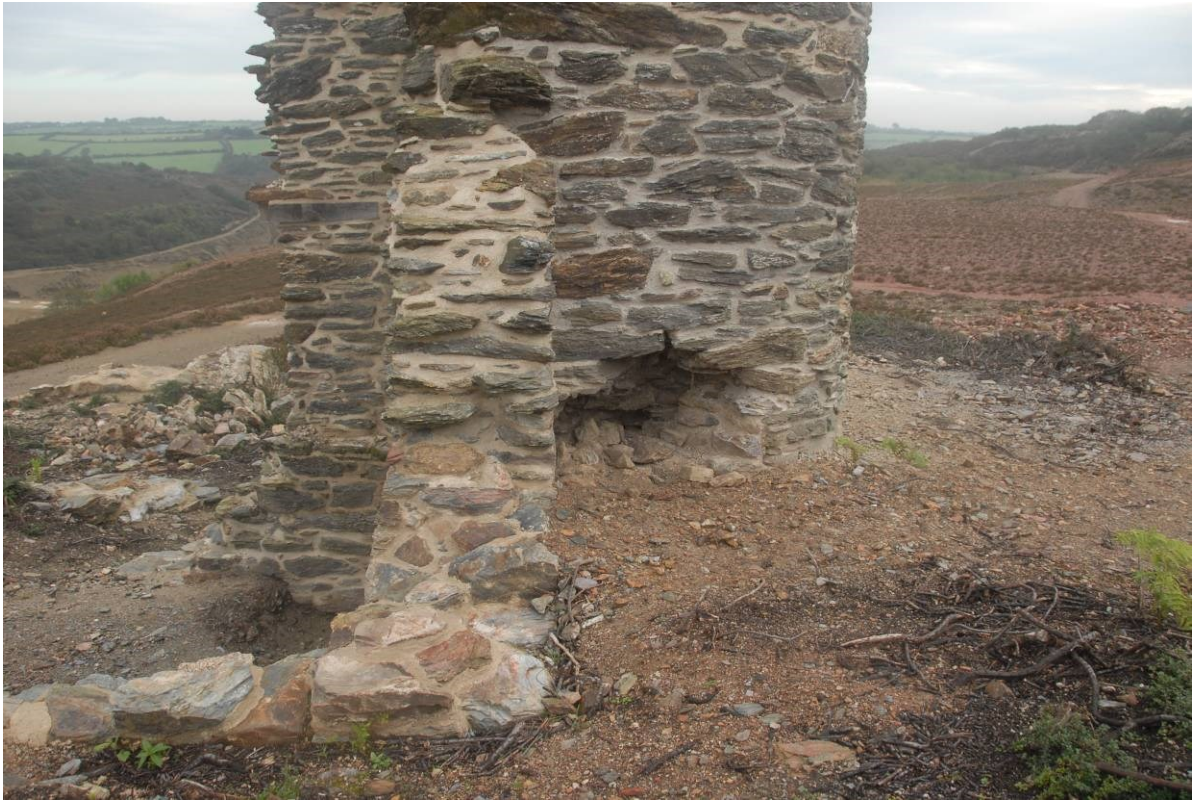
*Fig 65. The completed work to the lower section of the chimney and boiler house walls at Taylor's whim following the installation of the lightning conductor.*

Except where the original pointing was judged to be of serviceable quality and could be left in place, it was cut out to an average depth of 50mm and replaced. Broken wall ends were also repointed and wall tops lifted and reset in a lime based bedding mortar. Wall pockets were re-formed where required, and a section of new masonry was constructed to support an overhanging section of the eastern wall. Sections of oak were installed at the original locations of the lintels over the eastern doorway and the doorway into the boiler house at the northern end of the western wall (Fig 63). These were installed as stubs to indicate the locations of the original doors and assist with the interpretation of the building. Following limited hand excavation, it was possible to interpret the original form of the flue opening into the chimney from the boiler house. As most of the brickwork had been lost, destabilising the masonry above and leaving it unsupported, it was decided to re-form this brick arch-headed feature using salvaged bricks (Fig 66). The ash clearance opening on the southern side of the chimney was partially buried below ground level (Fig 65). This was more fully exposed during excavation for the installation of the lightning conductor and some limited degree of consolidation of this feature was undertaken.

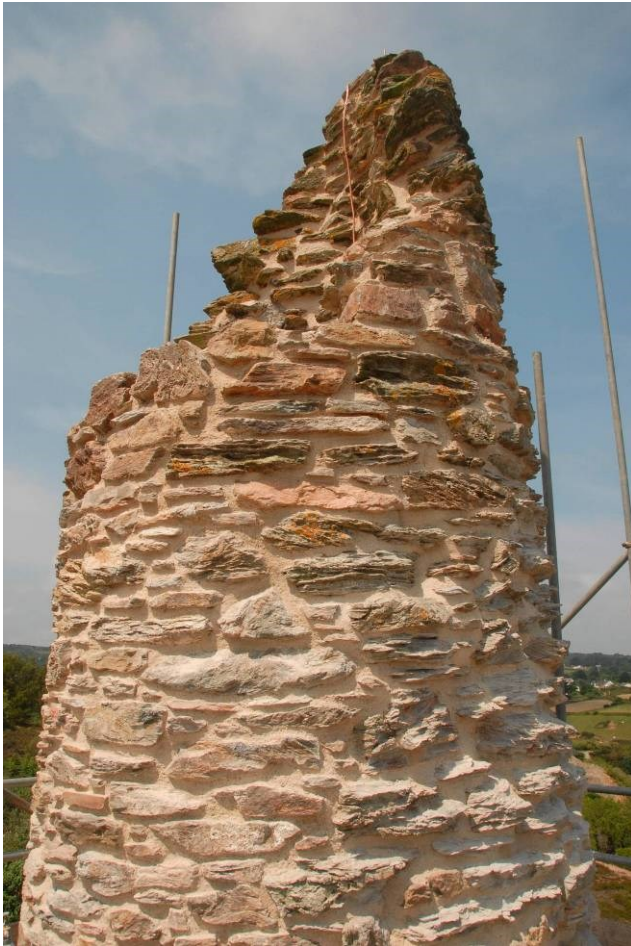
*Fig 67. The reconstructed upper section of Taylor's whim chimney with its unobtrusive lightning conductor.*

loss, and it was evident that solely repointing and adding in some lost stones would be insufficient to confer an adequate level of stability to the structure. Given the very unstable profile of the semi-collapsed upper section of the chimney, it was not possible for this to be exactly replicated during the rebuild; nevertheless a broken top was re-created which preserved its pre-consolidation appearance (Fig 67).

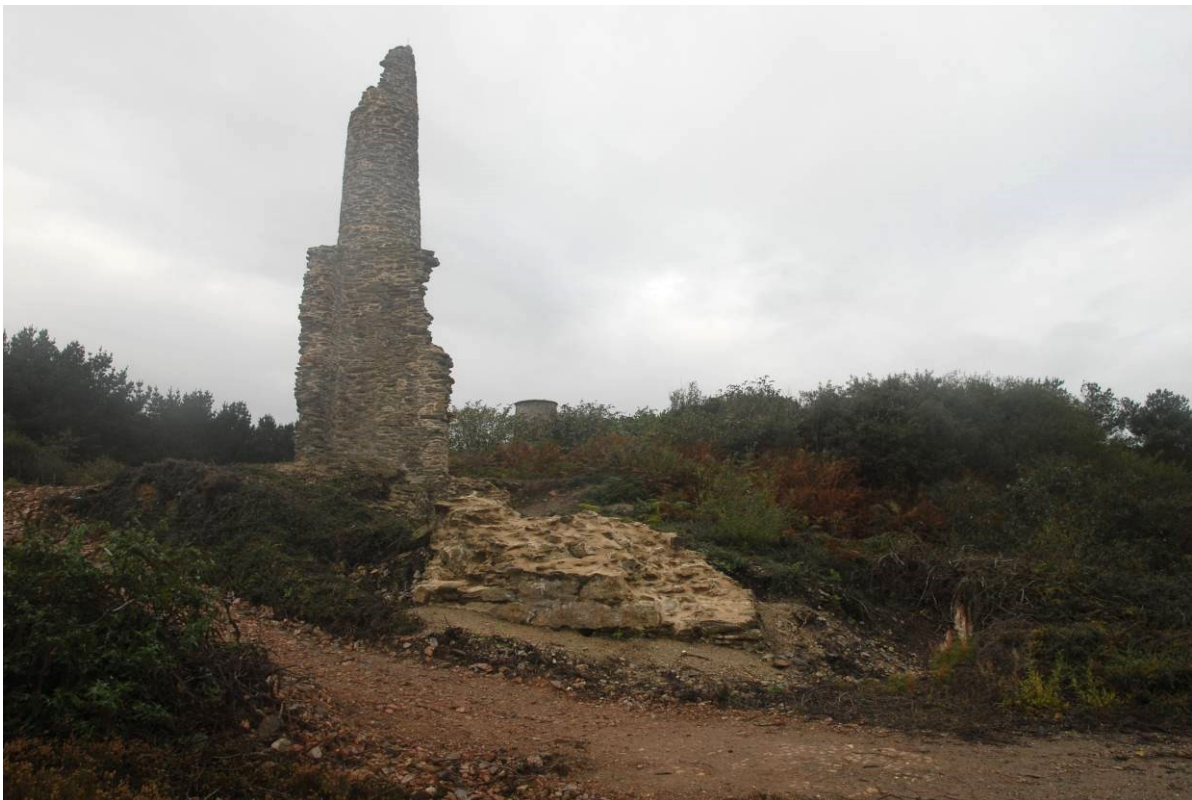
*Fig 68. The completed works to Taylor's whim, viewed from the east.*

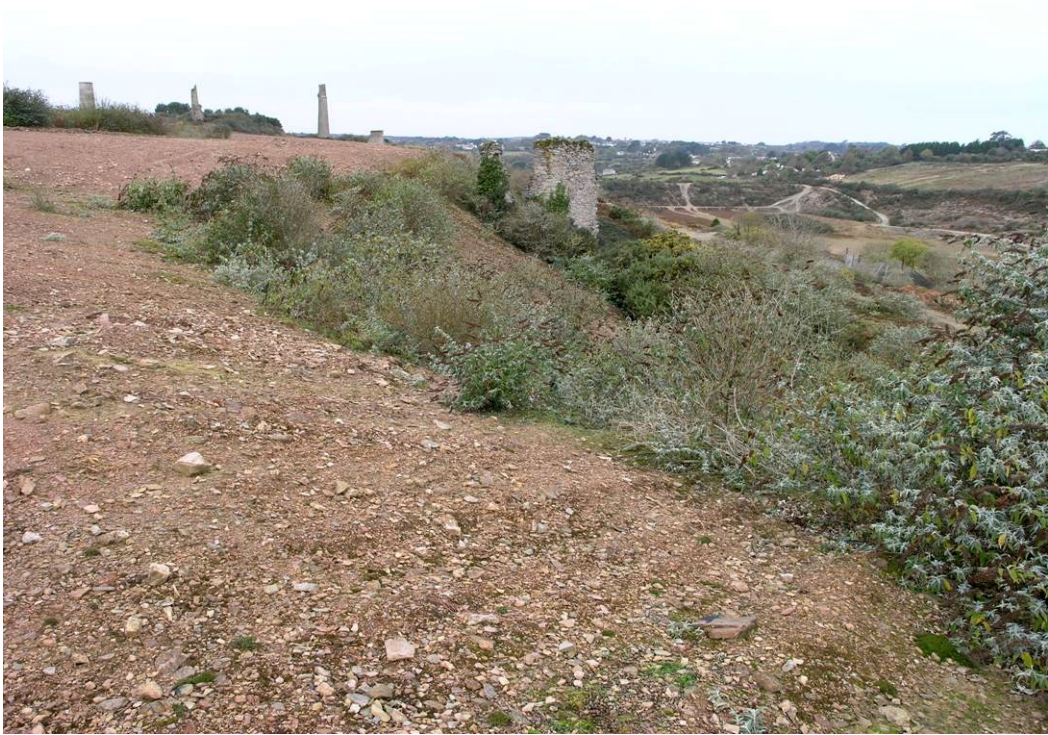
From near the base of the extensive dump of pink shillet produced as a result of Mount Wellington's quarrying operations to create tailings dam bunds and the landscaping of this upper valley side protrude the battered remains of a small and early (*circa* 1835) winding engine house (Fig 69). This measures approximately 6.0m x 5.3m in plan with walls 0.66m thick, the remains standing to a maximum of 5.5m high. The engine was probably started in the early 1830s, but was not listed as being at work in 1861 (Barton 1969), by when had probably become redundant. The 1878 OS mapping showed a structure measuring 10m x 5.36m in plan, with a detached chimney set 4.45m to its south, the location of this feature suggesting that the boiler house (which had already been demolished by that date) had been set on the eastern side of the engine house (Fig 4). The whim loadings would have been on the eastern side of the house, serving a major shaft to the north (one of a closely-set pair with Davy's Engine Shaft). The chimney appears to have been demolished between 1877 and 1907 (OS mapping evidence, Figs 4 and 5), though the engine house still survived at that date.

*Fig 69. Davey's whim engine house from the east prior to works, half buried by landscaped shillet.*

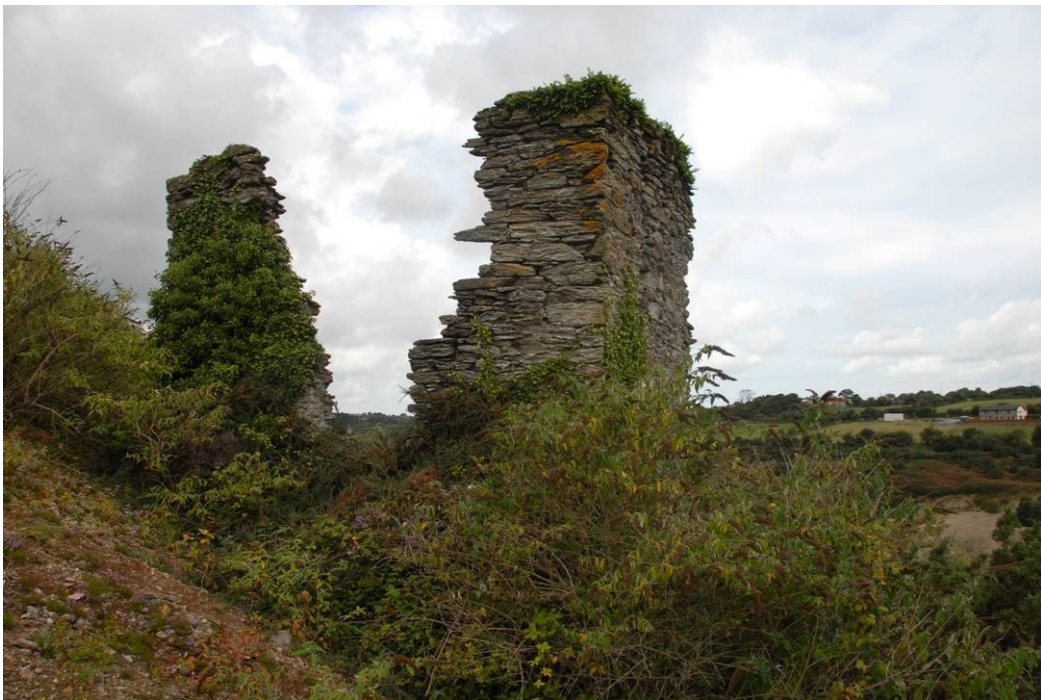
*Fig 70. The south eastern elevation of Davey's whim prior to works, showing the precarious and overgrown state of the building.*

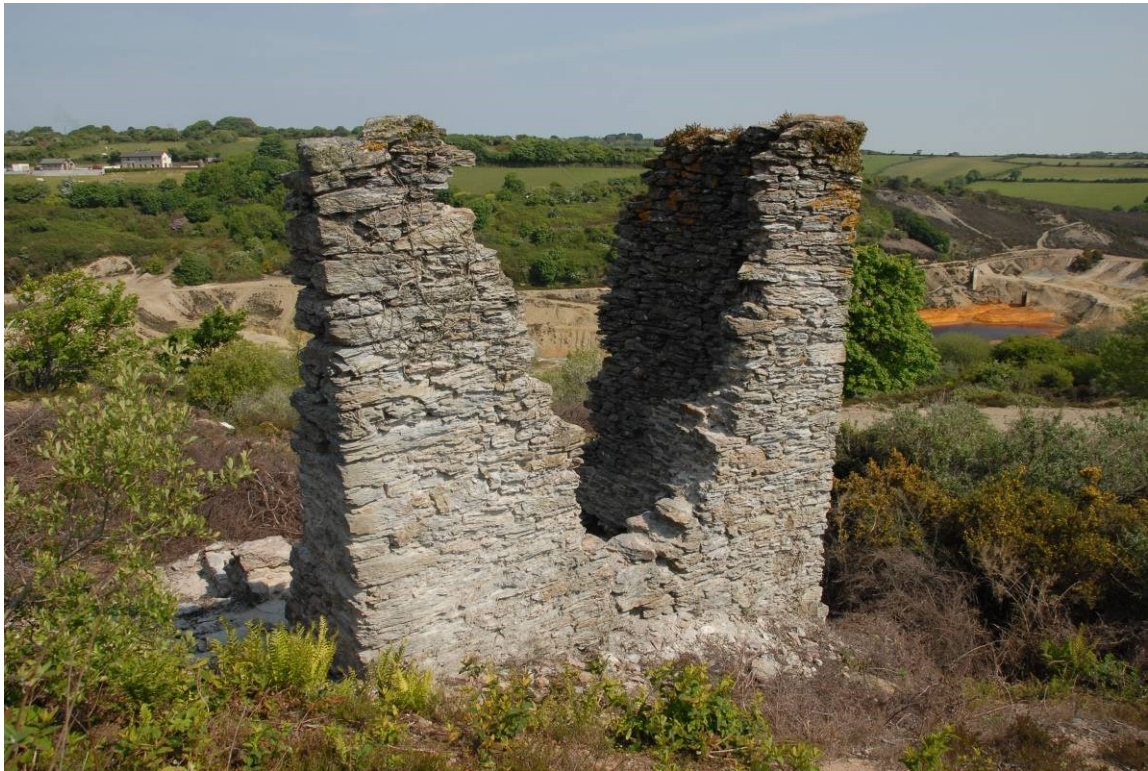
*Fig 71. The south eastern elevation of Davey's whim following the removal of ivy and other vegetation.*

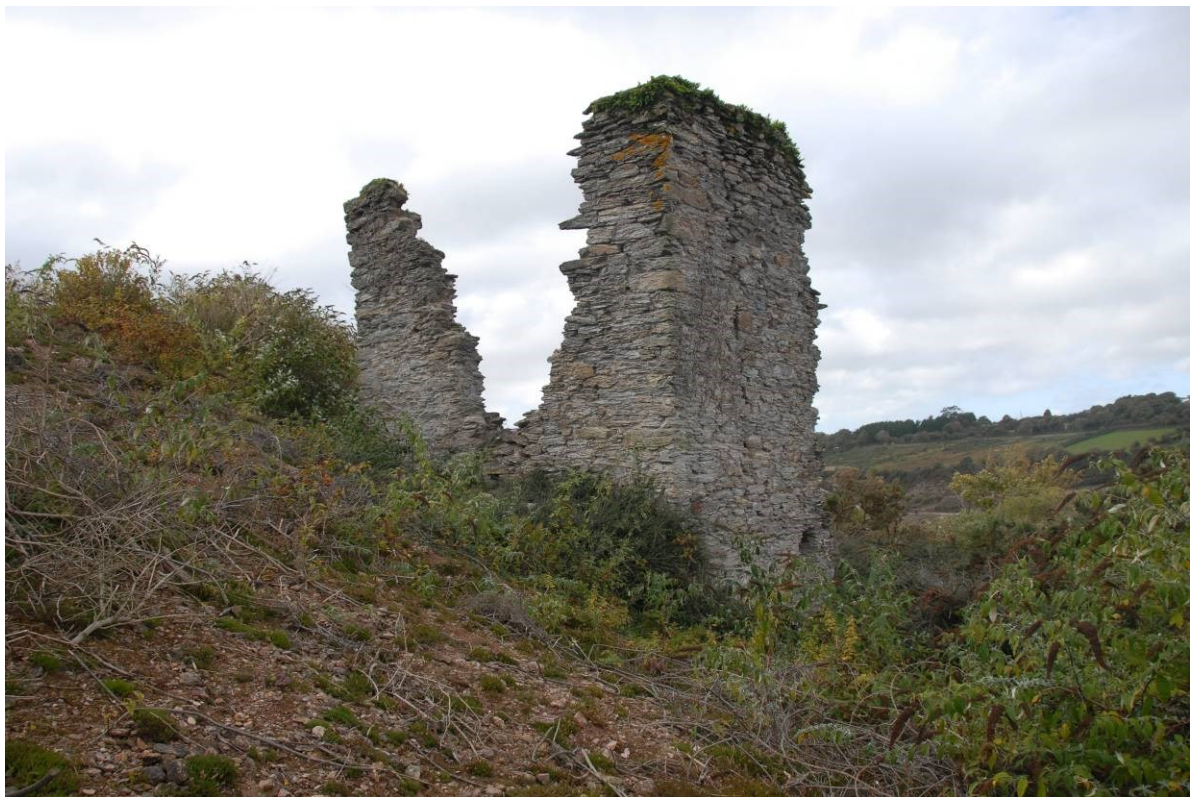
*Fig 72. Davey's whim from the east prior to works.*

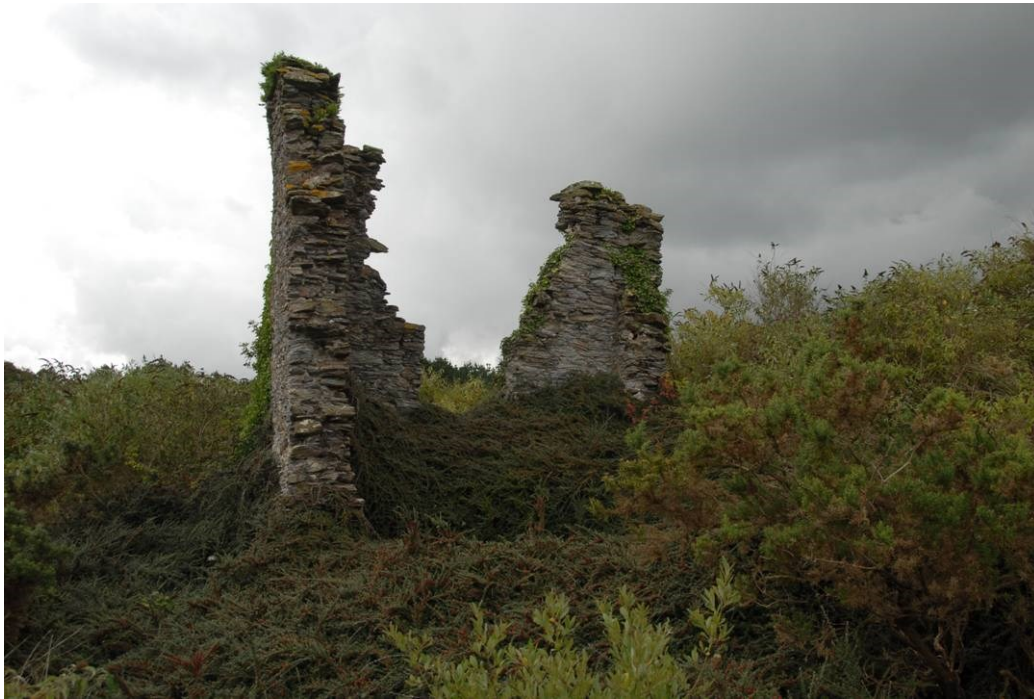
*Fig 73. Davey's whim from the north prior to works. Cotoneaster completely covered the cylinder plat. The splayed nature of the upper sections of the walls is clearly visible.*
