# **Structures at Taylor's and Davey's Shafts, Consolidated Mines, Gwennap, Cornwall**

## **Historic Environment consultancy during consolidation works**

<b>Client</b>	<b>Gwennap Parish Council</b>
<b>Report Number</b>	<b>2013R077</b>
<b>Date</b>	<b>24 October 2013</b>
<b>Status</b>	<b>Final</b>
<b>Report author</b>	<b>Adam Sharpe BA MIfA</b>
<b>Checked by</b>	<b>Dr. Andy Jones</b>
<b>Approved by</b>	<b>Andrew Young MIfA</b>

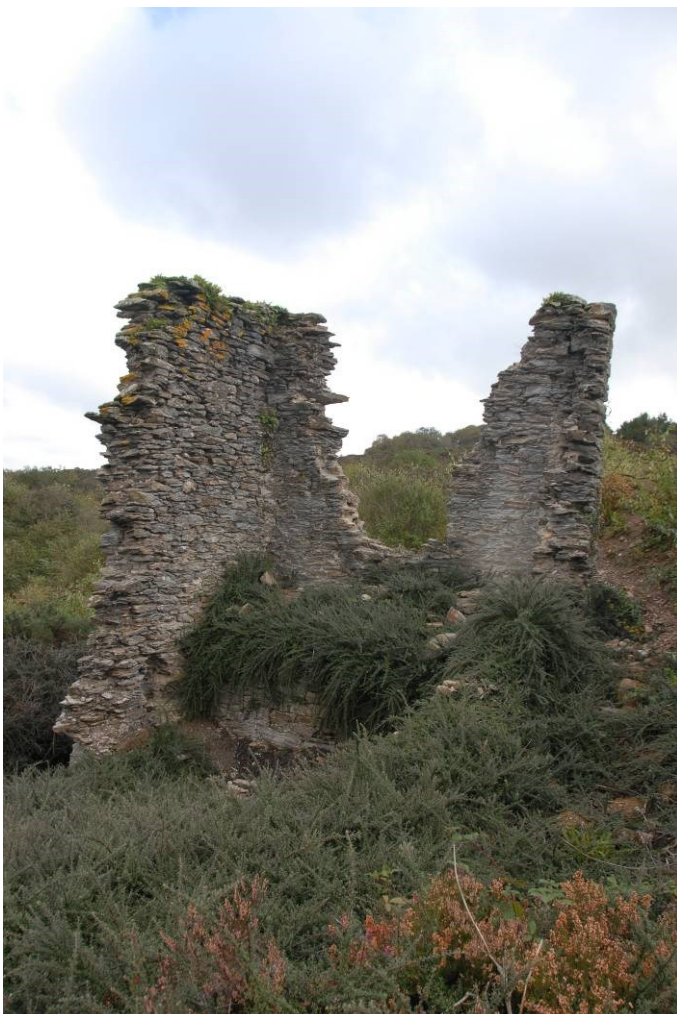
*Fig 74. Davey's whim from the north west prior to works, the image giving a clear indication of the challenges posed in the conservation of this building.*

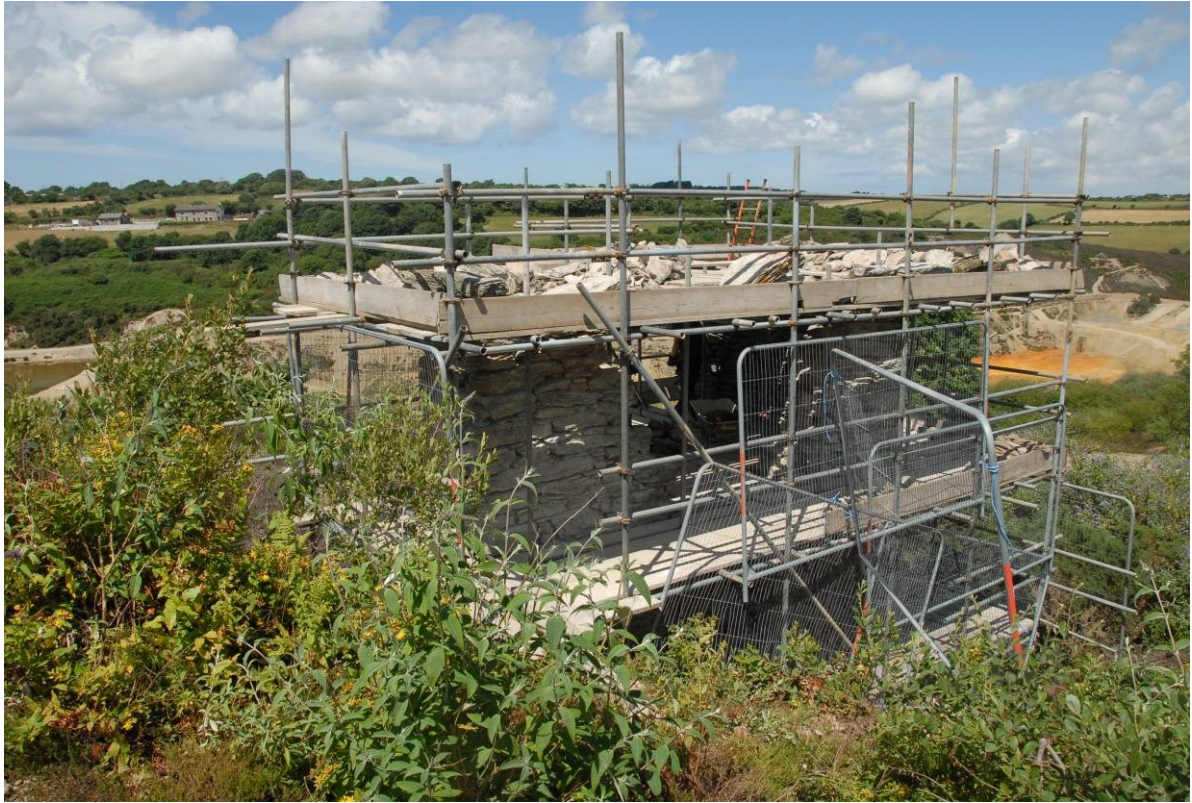
*Fig 75. Conservation works under way. The unstable stonework forming the wall peaks had been recorded and dismantled by this stage.*

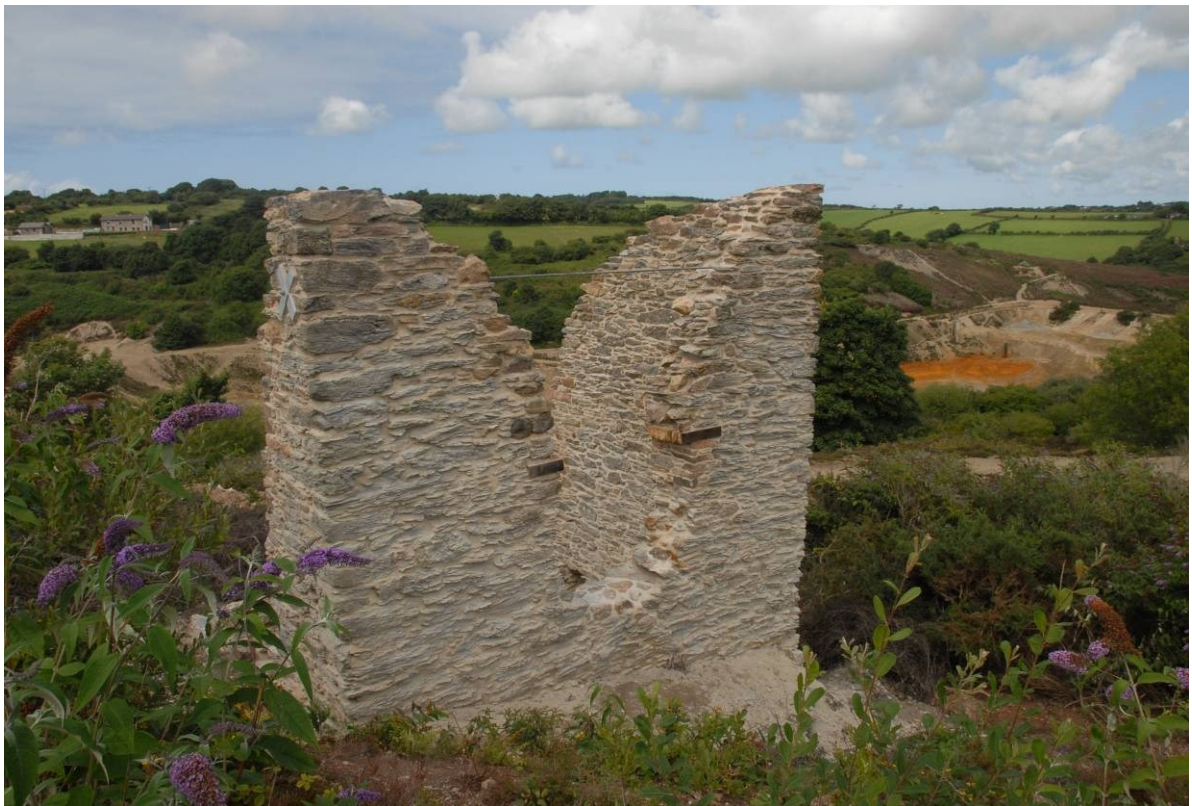
*Fig 78. The completed works to Davey's whim as seen from the south. Note the tie rod and pattress and the lintel stubs inserted into their original locations. Compare with Fig 71.*

As noted, the two side walls (to the south west and north east) were visibly bowing outwards. In order to arrest any further movement, a tie rod and crossed plate patresses were installed through the south eastern ends of these walls (Figs 77-78). These two side walls were 100% repointed internally and externally, stainless steel helicoil bedjoint reinforcement being installed to add further structural rigidity to the building. Broken wall ends were stabilised through full repointing and limited rebuilding where required on structural grounds. During the installation of the tie rod, the upper sections of the walls were dismantled and rebuilt in fresh bedding mortar (Fig 77). The decision was taken to reduce the height of the northern end of the north eastern wall to some degree during this operation given the poor quality of the stone used in the original construction, the need to utilise salvageable stone in the southern end of the building, and the unstable original profile of the northern end of this wall. The steam pipe entry opening and the cylinder drain opening were partly re-formed and rebuilt to stabilise them (Fig 79).

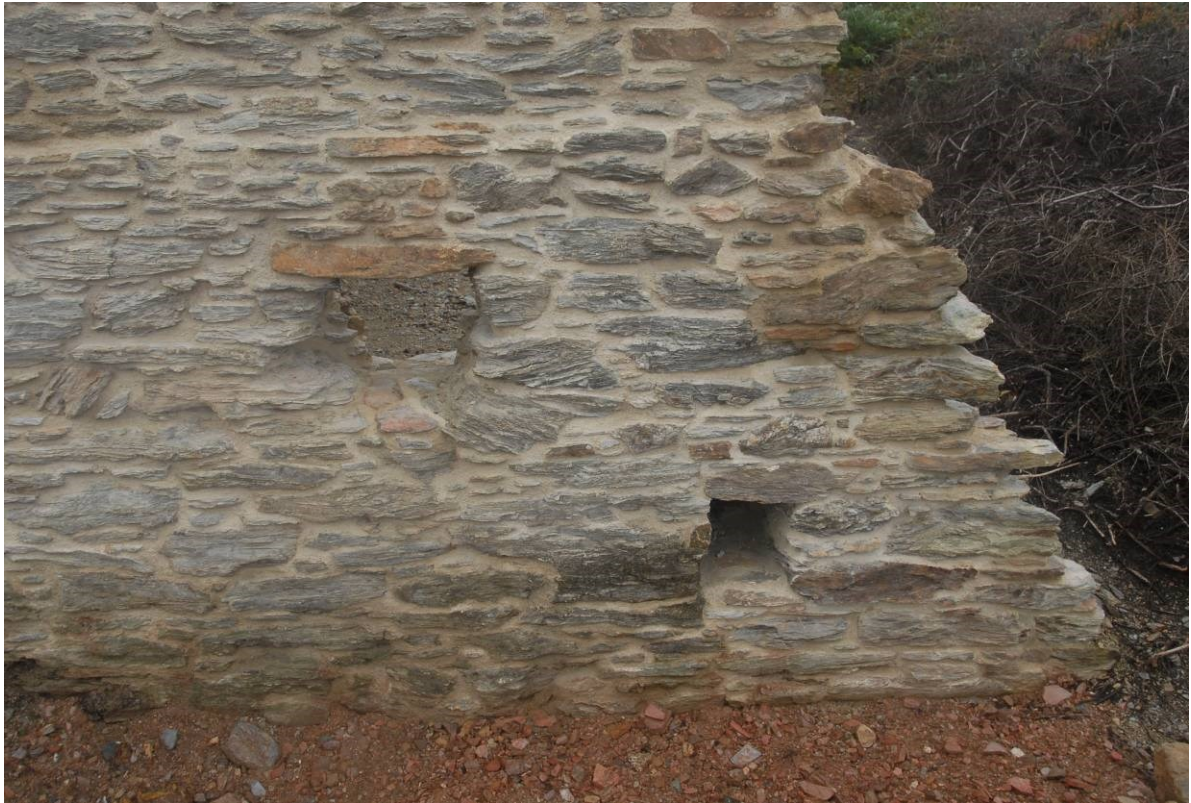
*Fig 79. The north eastern wall of Davey's whim, showing the steam pipe entry and cylinder drain openings.*

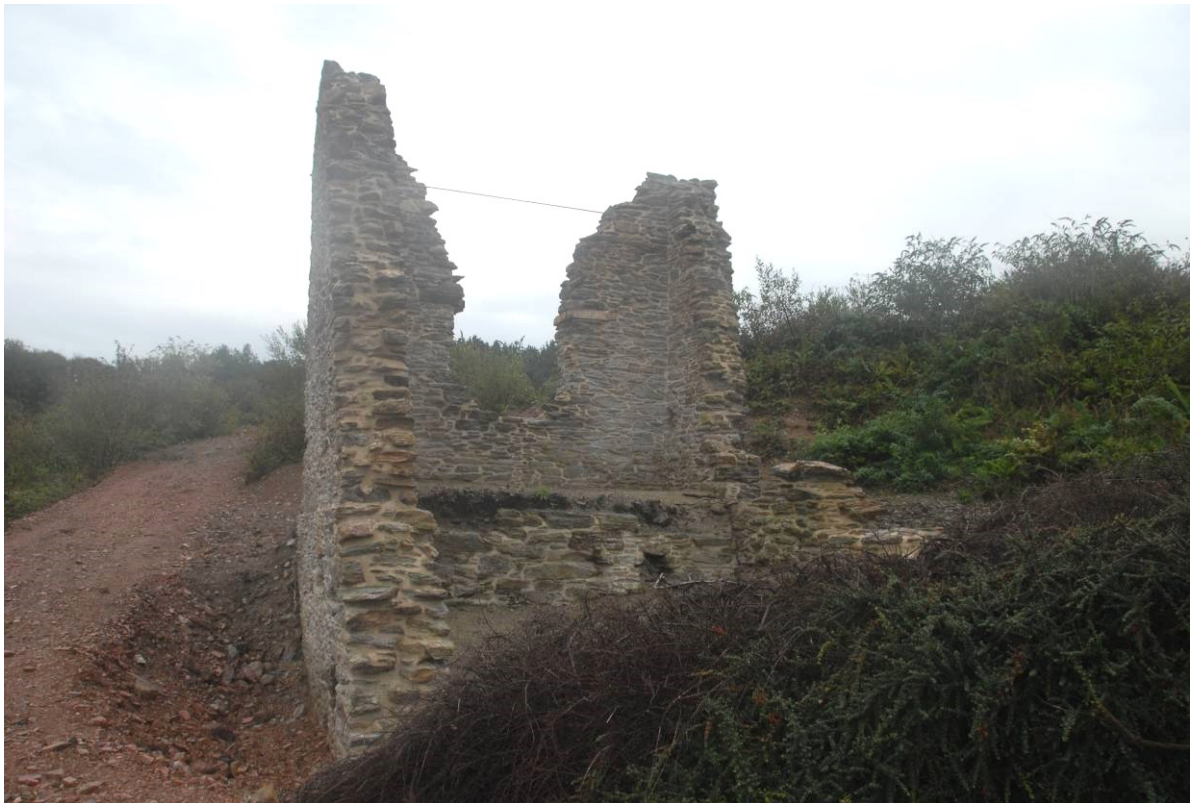
*Fig 80. Davey's whim from the north following the conservation works and the creation of the path route around the building. Compare with Fig 73.*

Within the building, the face of the cylinder plat was cleaned and repointed (Fig 80), an original opening in this structure being retained as found. The upper surface of the cylinder plat was left blanketed in soil and vegetation to protect it from water ingress, as no surviving stone surfacing was found here.

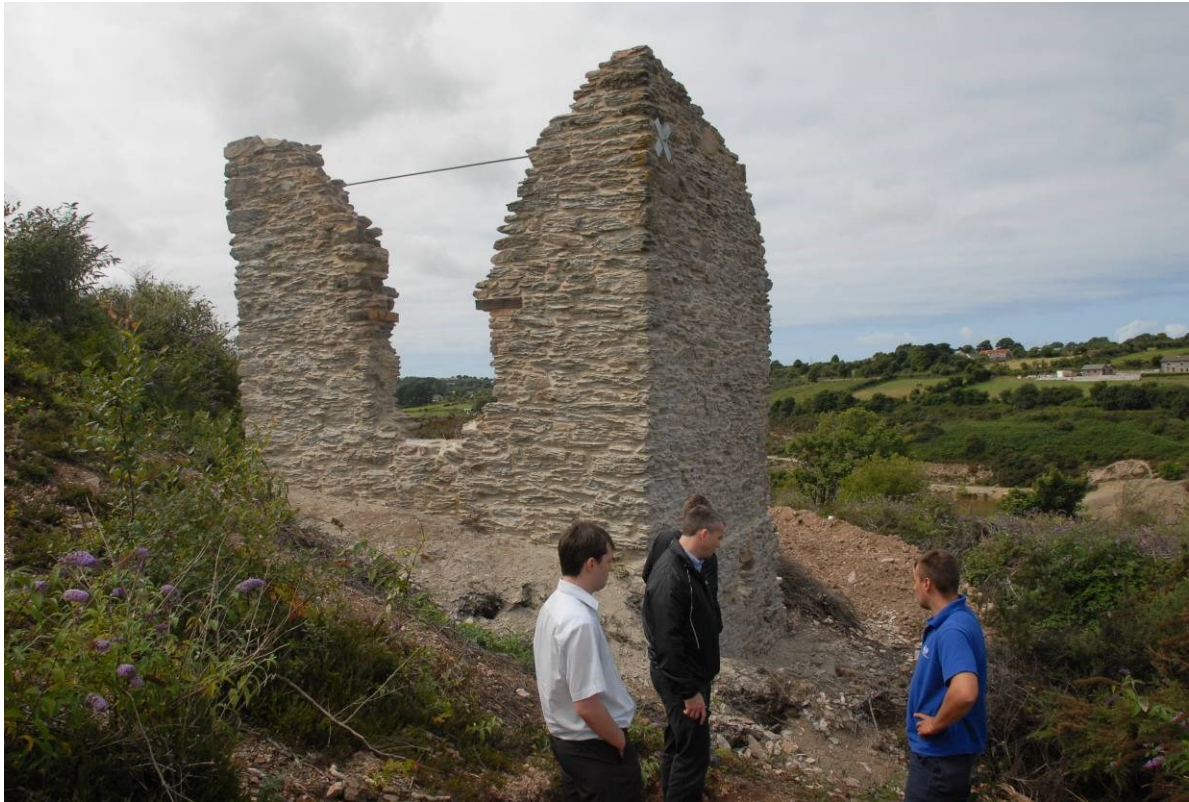
*Fig 81. The final site meeting at Davey's whim, during the path creation works which now link this building to the structures adjacent to Taylor's Shaft, and with the Mineral Tramways Coast to Coast Trail.*

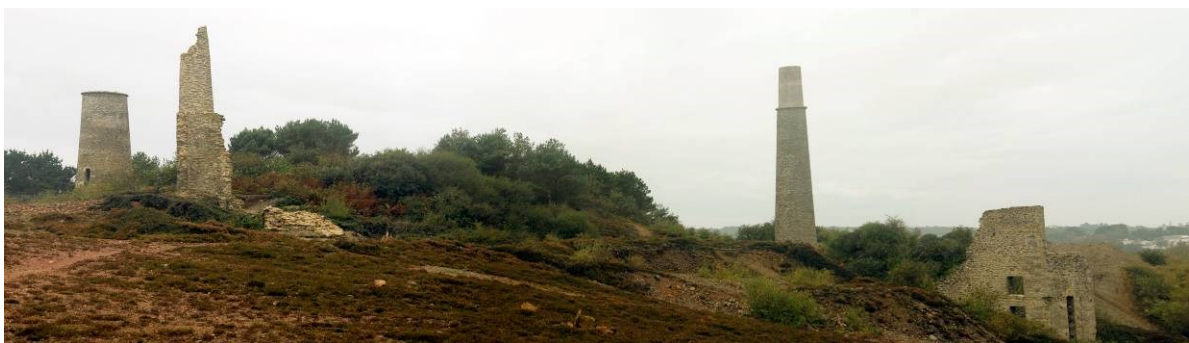
*Fig 82. A composite panoramic view of the Taylor's Shaft buildings from the east, showing (from left to right) the previously-conserved clock tower, Taylor's whim, Taylor's chimney and Taylor's pumping engine house.*
