New Cook's Kitchen Shaft, South Crofty and Chapple's Shaft, Cook's Kitchen, Pool, Cornwall

**Historic Environment Consultancy during
conservation works to structures**

Client	Cornwall Council
Report Number	2013R080
Date	04 February 2014
Status	Final
Report author	Adam Sharpe BA MIfA
Checked by	Dr. Andy Jones MA MiFA
Approved by	Andrew Young MIfA

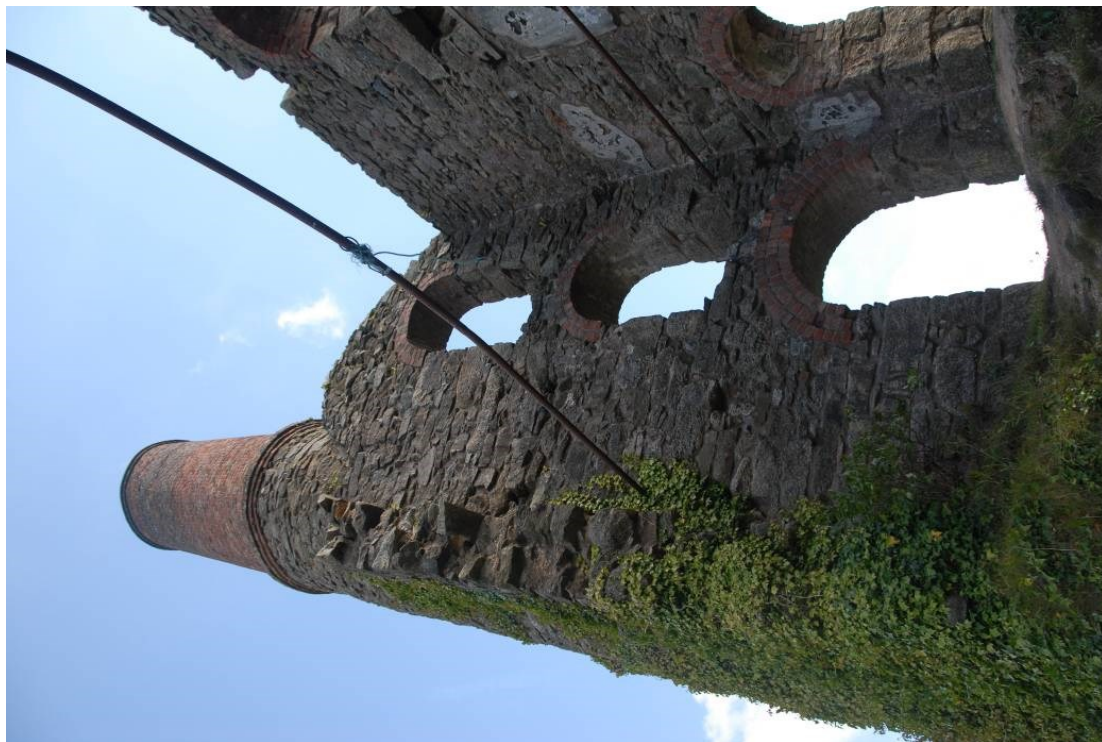
Fig 12. The internal elevation of the eastern wall of the whim engine house prior to works.

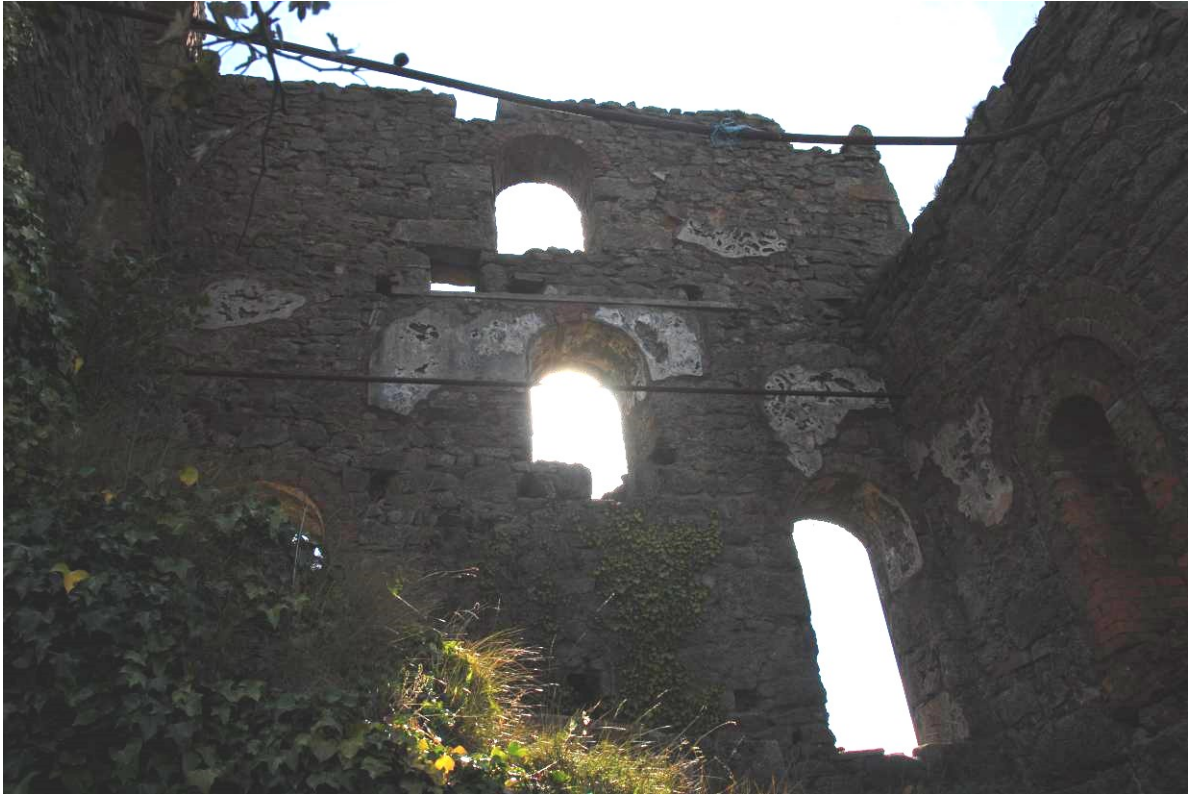
Fig 13. The internal elevation of the southern wall of the whim engine house, showing patches of remnant original plasterwork. Few of these could be saved.

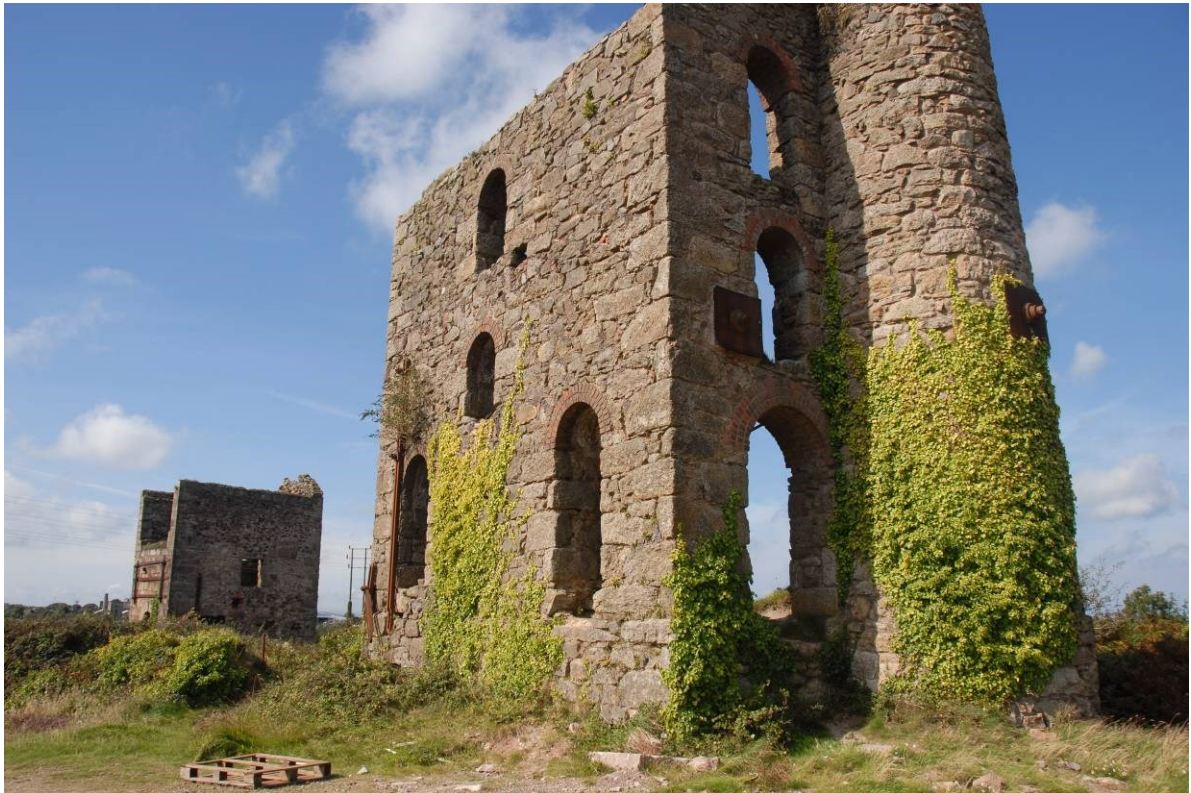
Fig 14. The whim engine house from the south east prior to works. Note the ivy which had begun to be established on the building and the tie rod through the chimney.

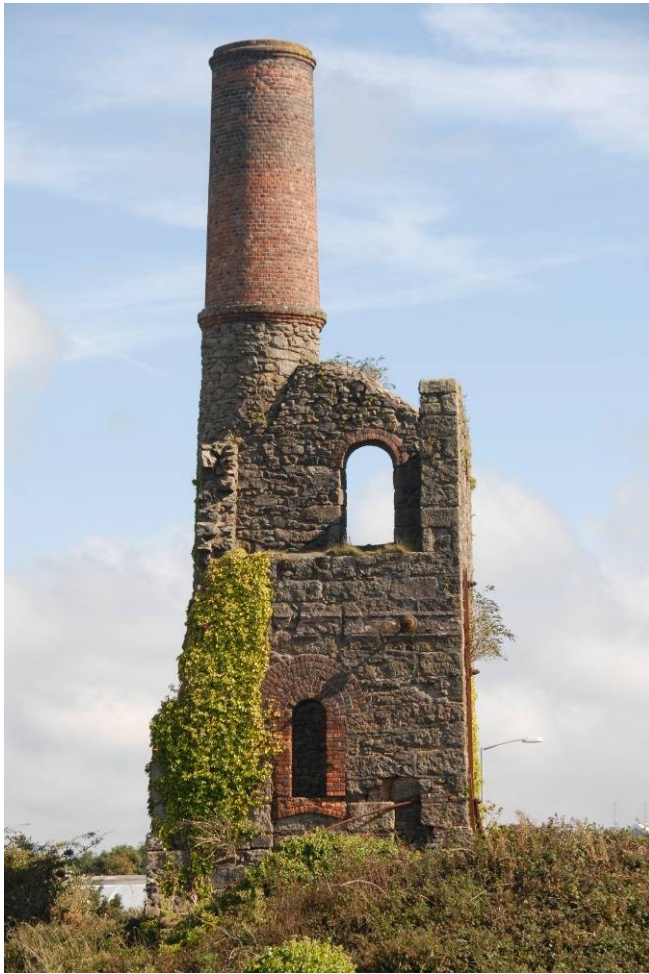
Fig 15. The whim engine house from the west prior to the start of works. Ivy covered the broken wall end of the return from the bob wall to the northern wall.

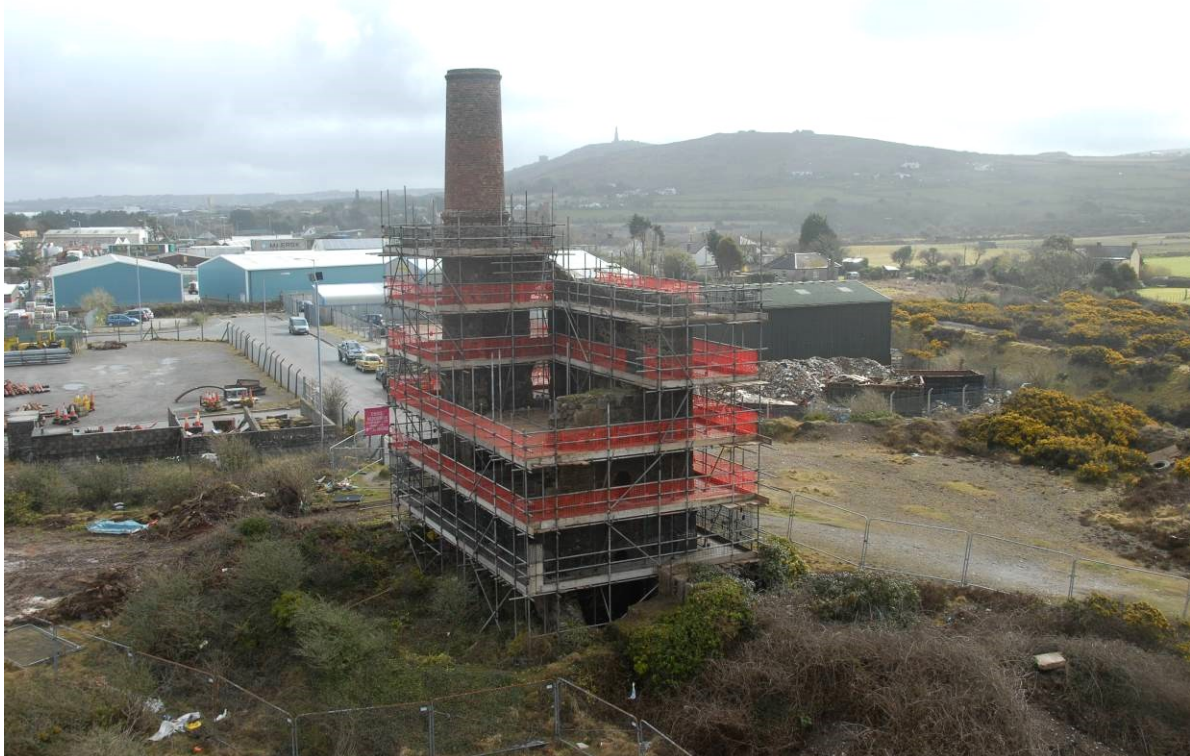
Fig 16. The scaffolding erected on the whim engine house. The brick section of the chimney was judged to be in good enough condition not to require re-pointing.

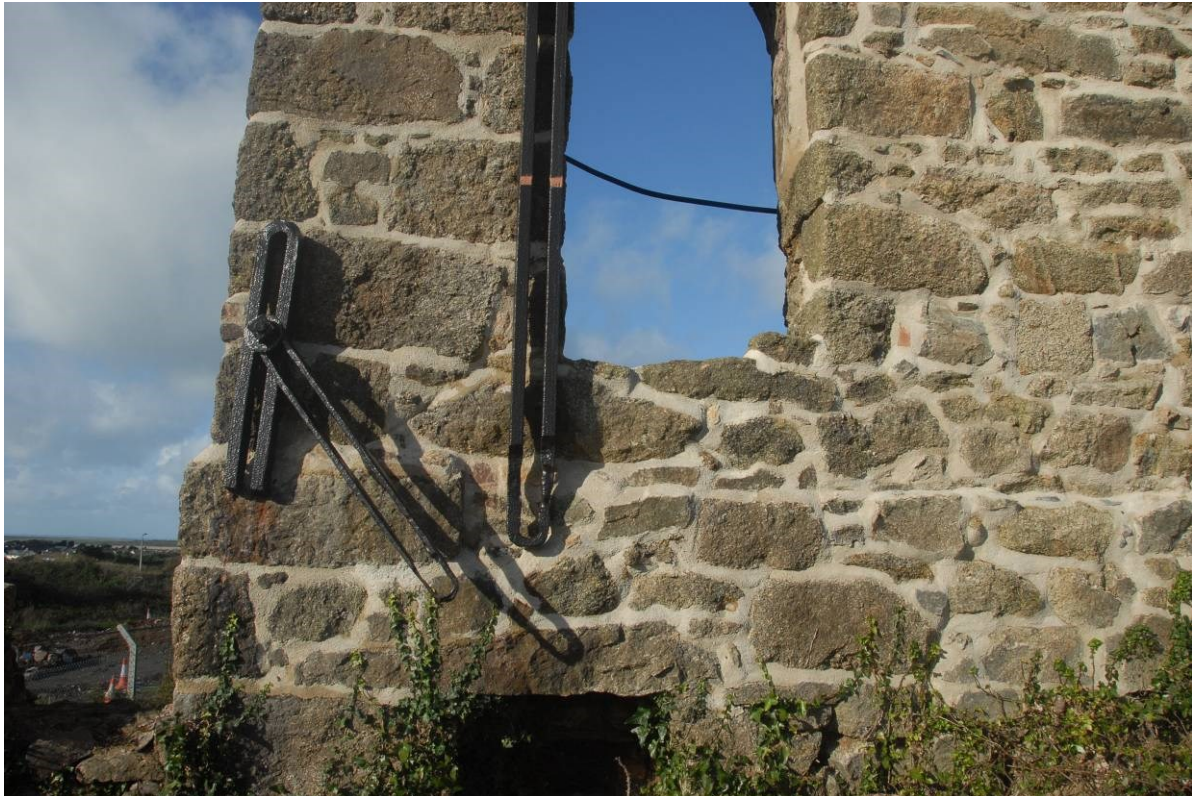
Fig 23. The lower part of the south-western corner of the conserved whim engine house, showing the finished pointing and painted ironwork.

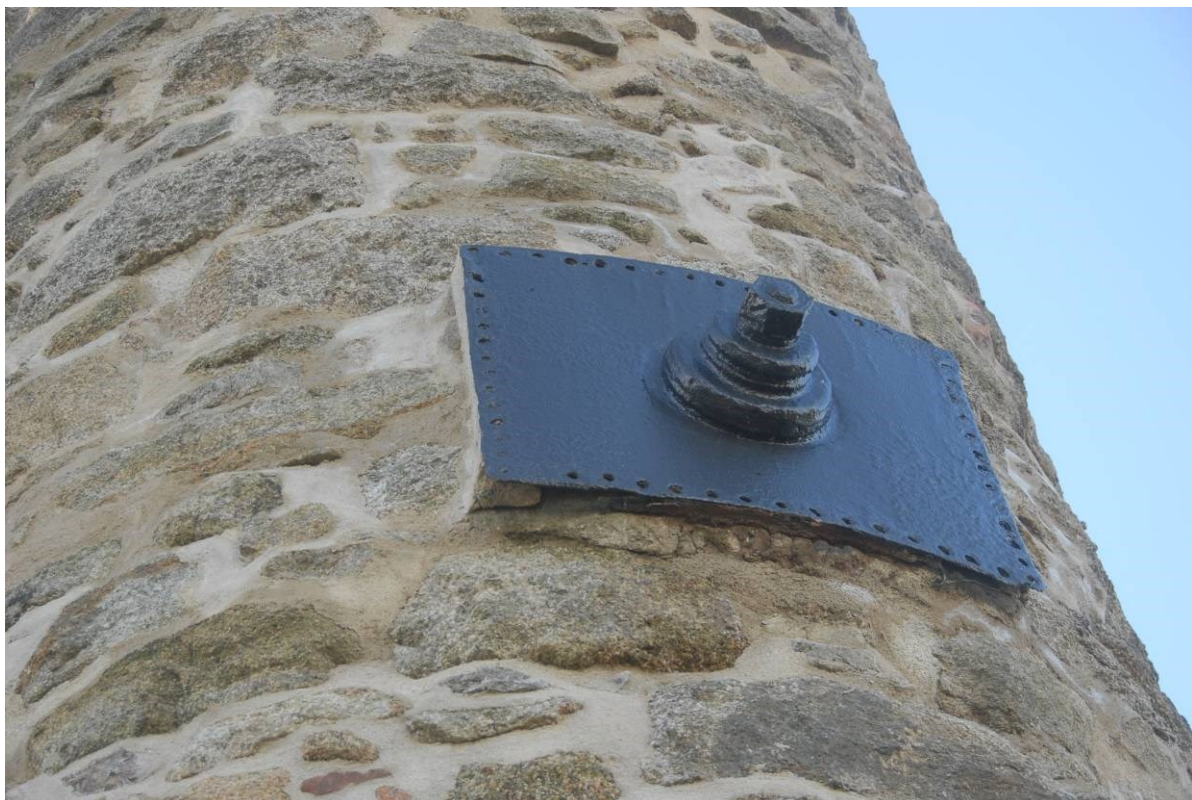
Fig 24. The original boiler plate pattress and tie rod inserted through the chimney of the whim engine house, cleaned, painted and pointed in.

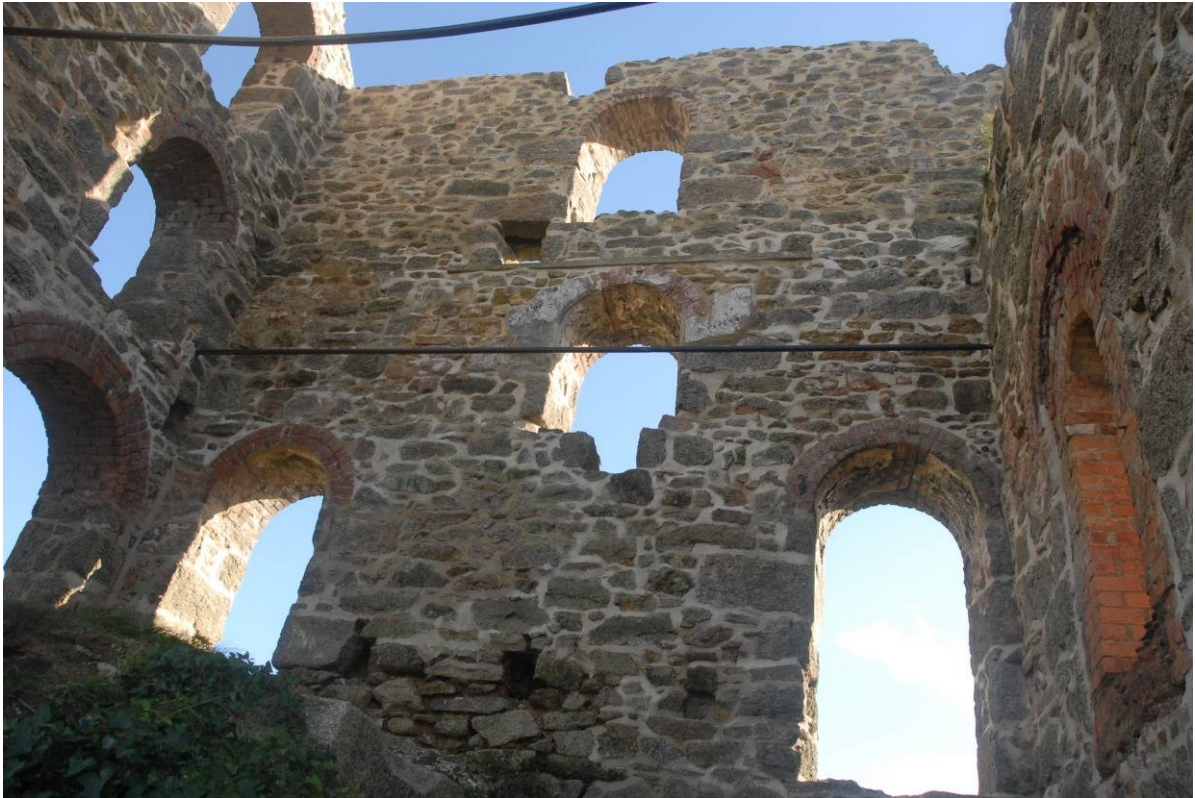
Fig 25. The internal elevation of the southern wall of the whim engine house following repointing.

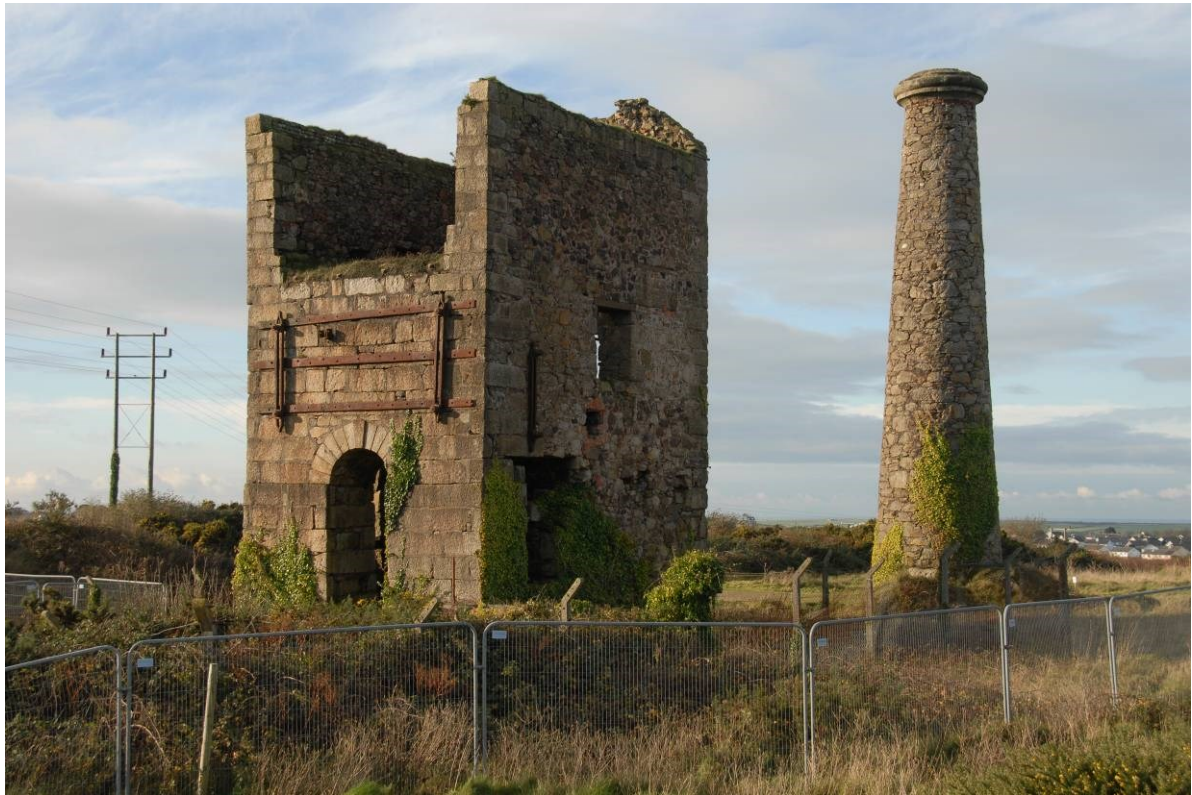
Fig 27. From the south east, there appeared to be few structural problems with the Chapple's Shaft pumping engine house. Note the tie rods and patress plates.

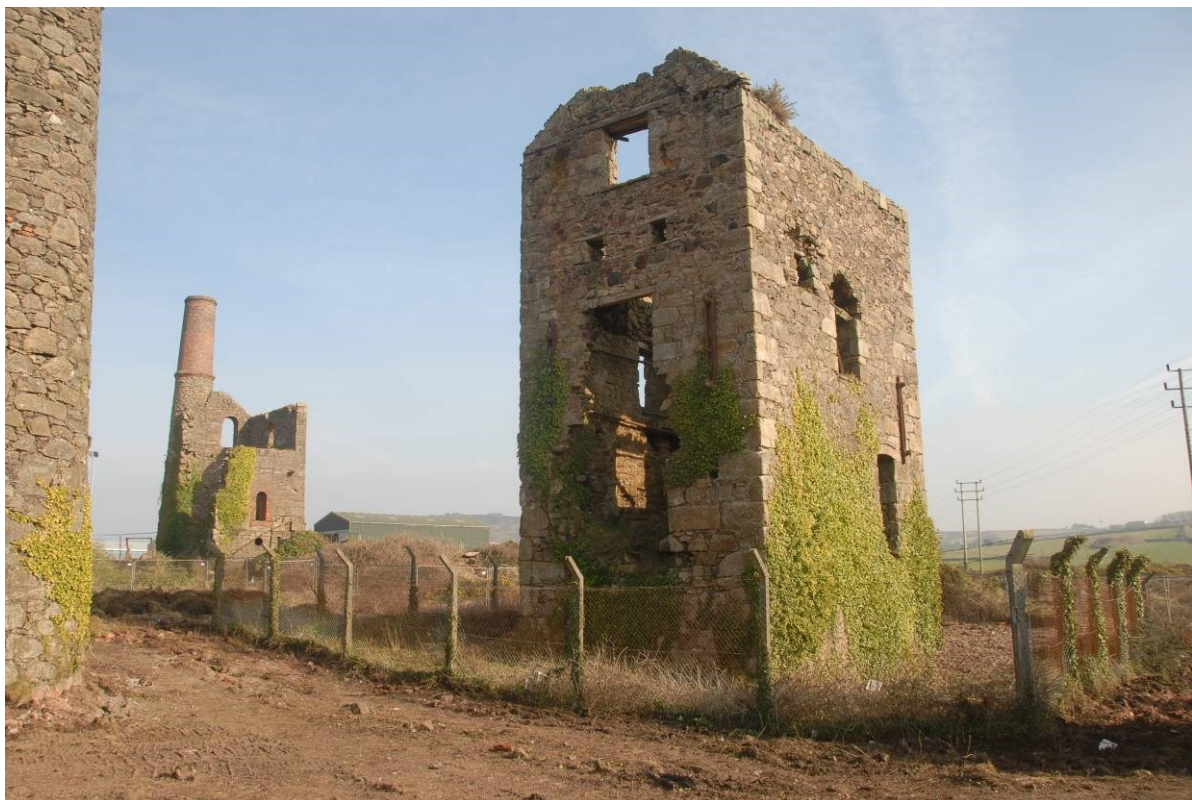
Fig 28. From the north west, it could be seen that the cylinder doorway and middle floor window on the northern elevation had coalesced due to the loss of lintels and supported stonework. The gable peak had also been lost

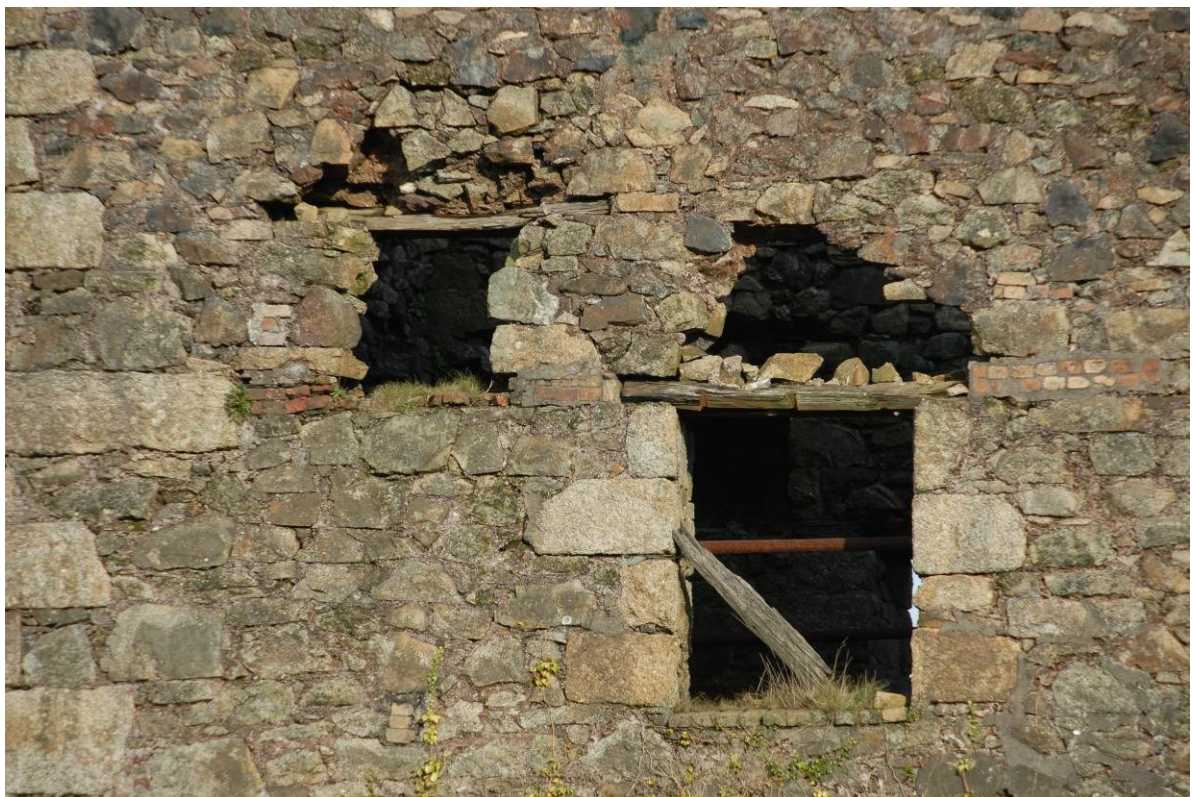
Fig 30. Clear indications of the problems experienced by this building in the form of failed timber lintels and the loss of supported stonework.

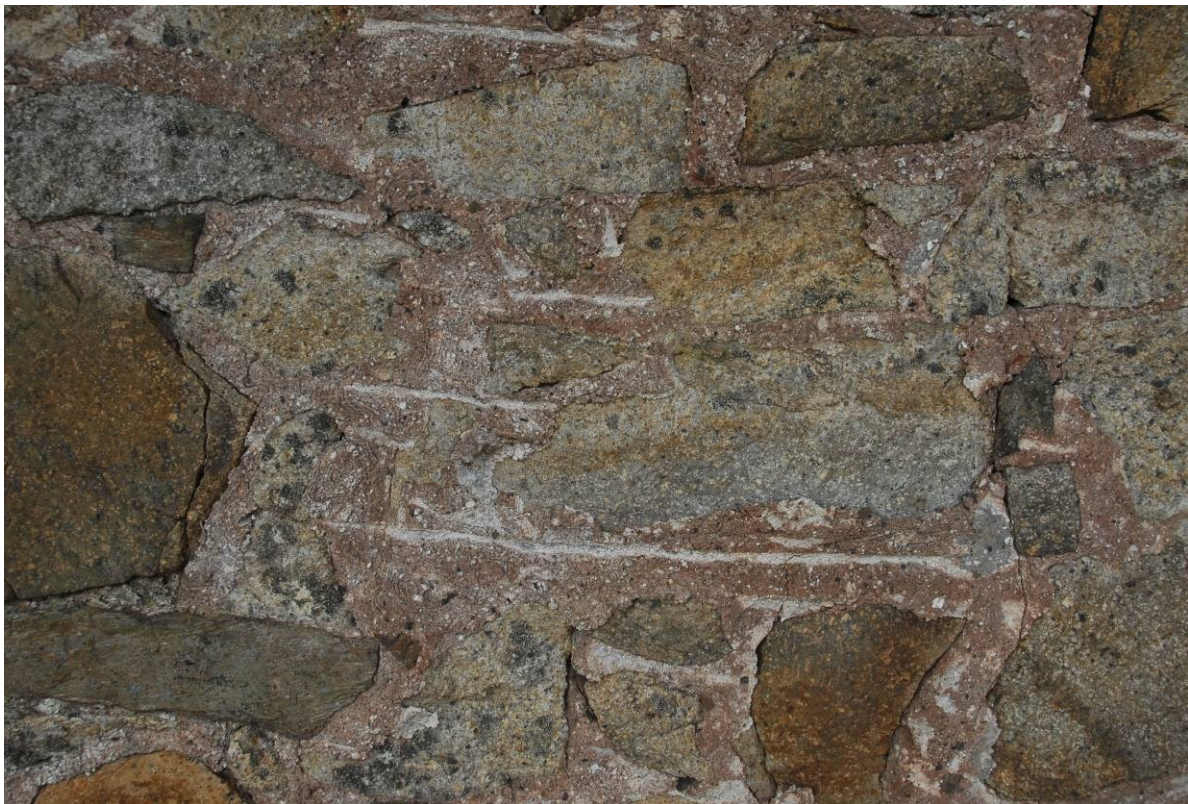
Fig 36. Remnant scribed pointing on the western side of the engine house was evidently used in part to disguise the poor quality of the stonework use in the build.

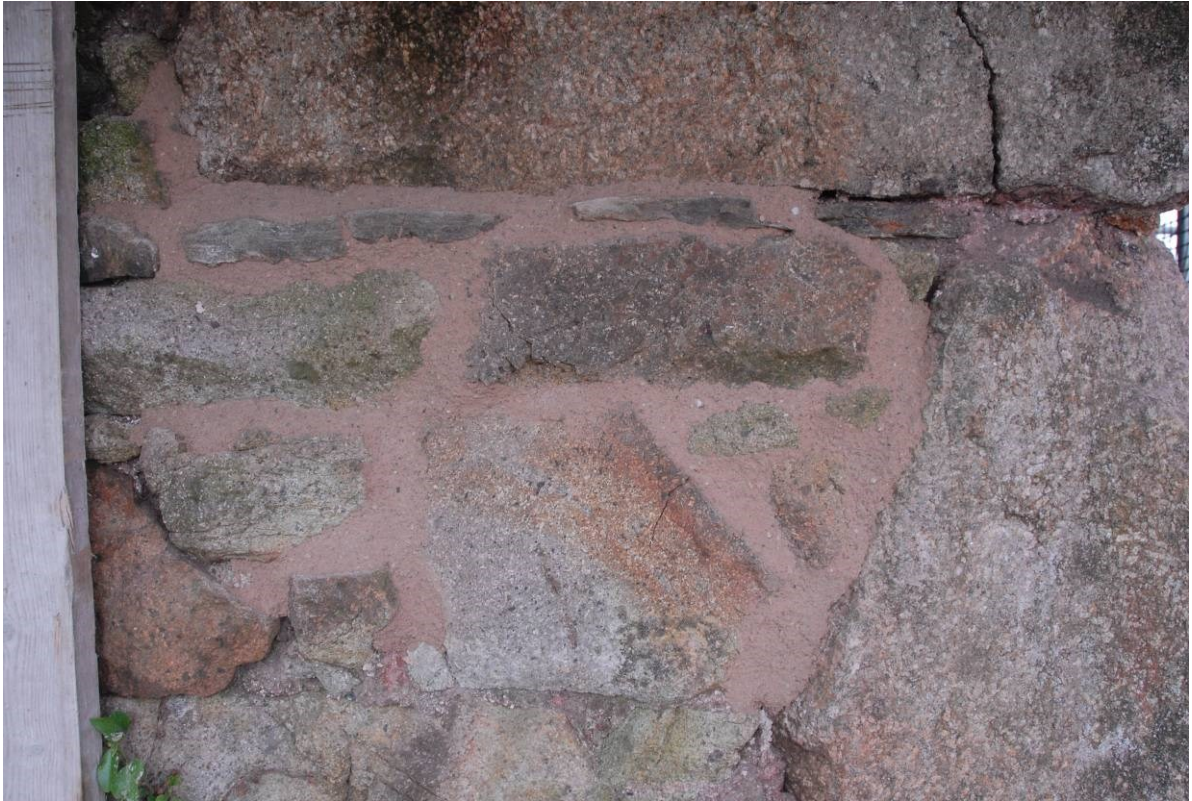
Fig 37. The pointing test panel showing a variation on the original mix, but incorporating 10% brick dust. This was judged to be unacceptably pink.

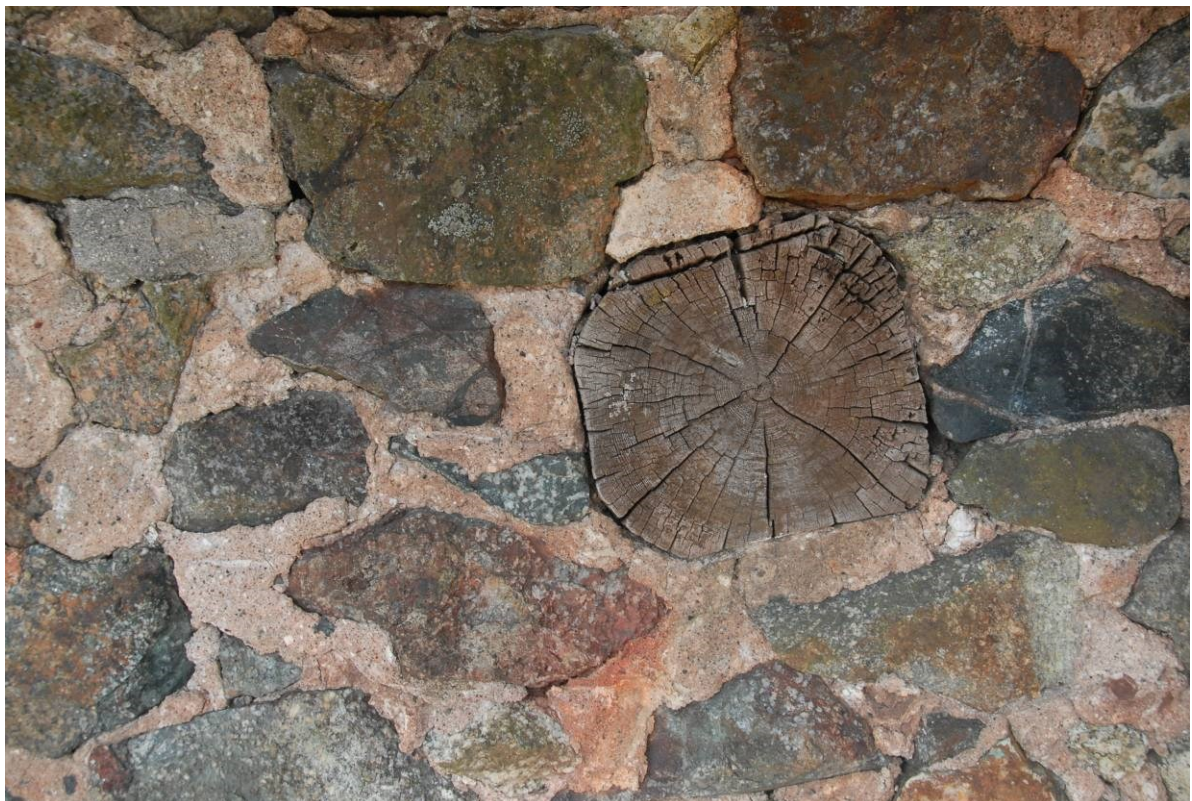
Fig 38. A sawn-off putlog left in the wall of the engine house. Note the generally poor quality and small size of the stone used in the construction.

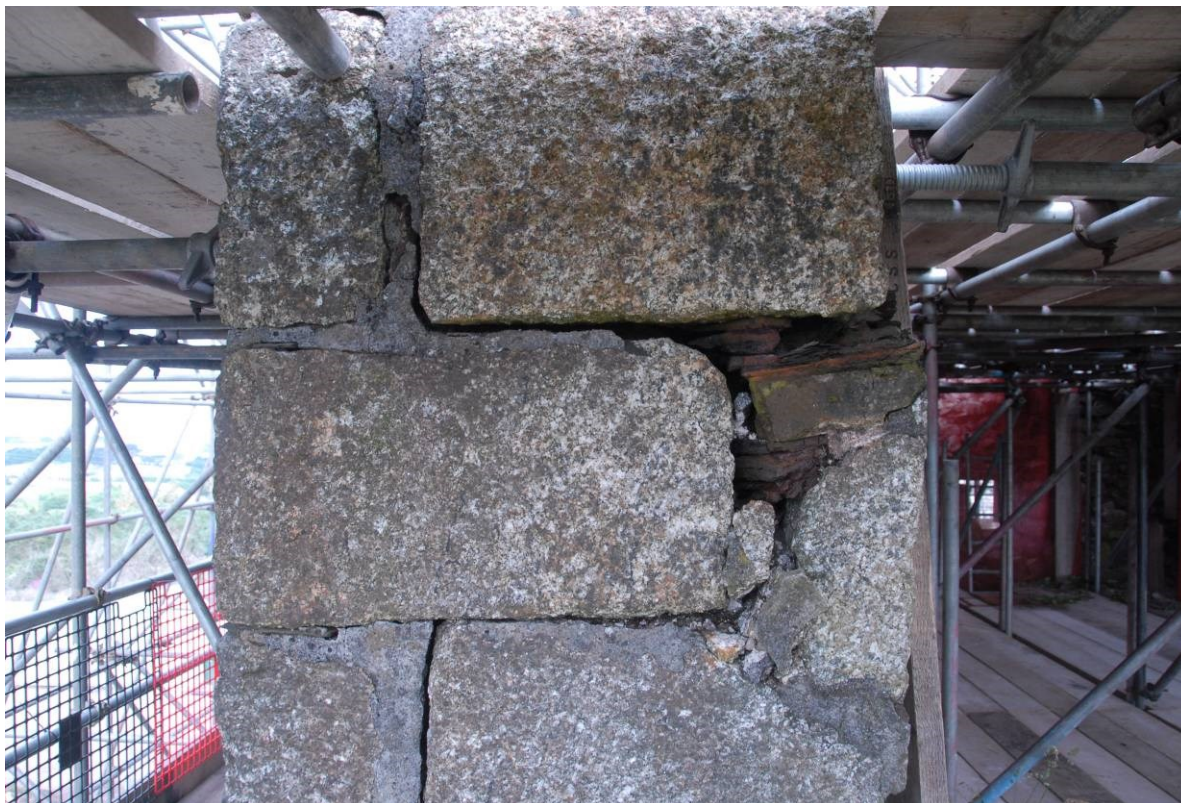
Fig 39. Incorporated pieces of rusted ironwork have jacked the quoins in this wall end severely. The ironwork was removed and the space filled with mortared stone.

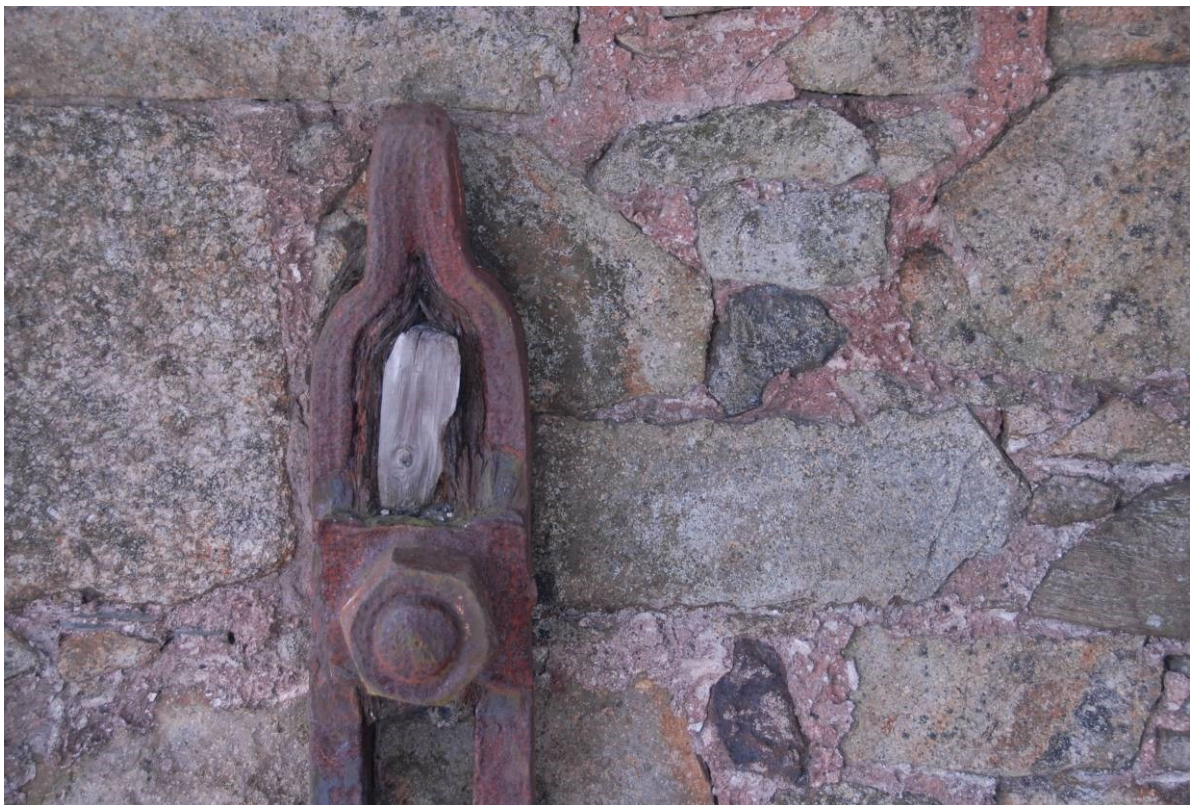
Fig 42. One of the blacksmith-made wrought iron pattrasses linking the tie bars through the engine house. The original function of the wooden plug inside the pattrass is unclear.

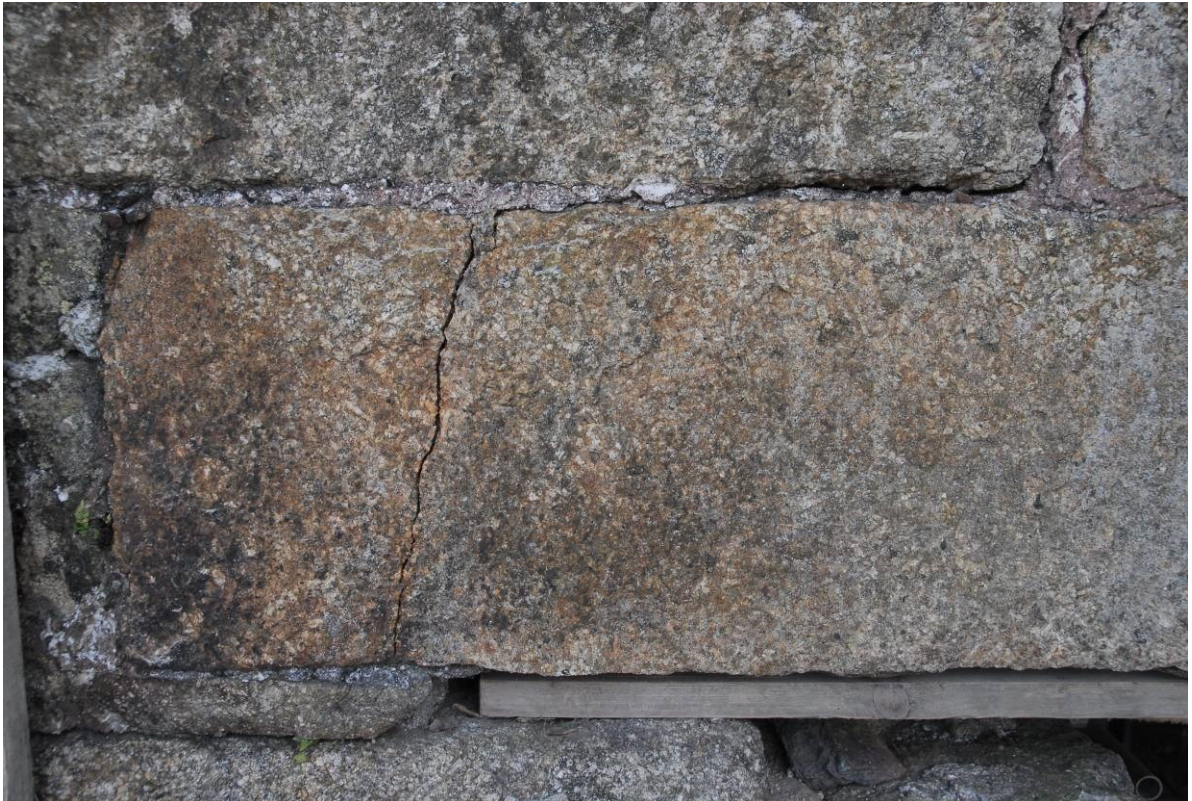
Fig 43. A granite lintel over the boiler house door which had sheared through, possibly as a result of stresses resulting from the racking of this wall.

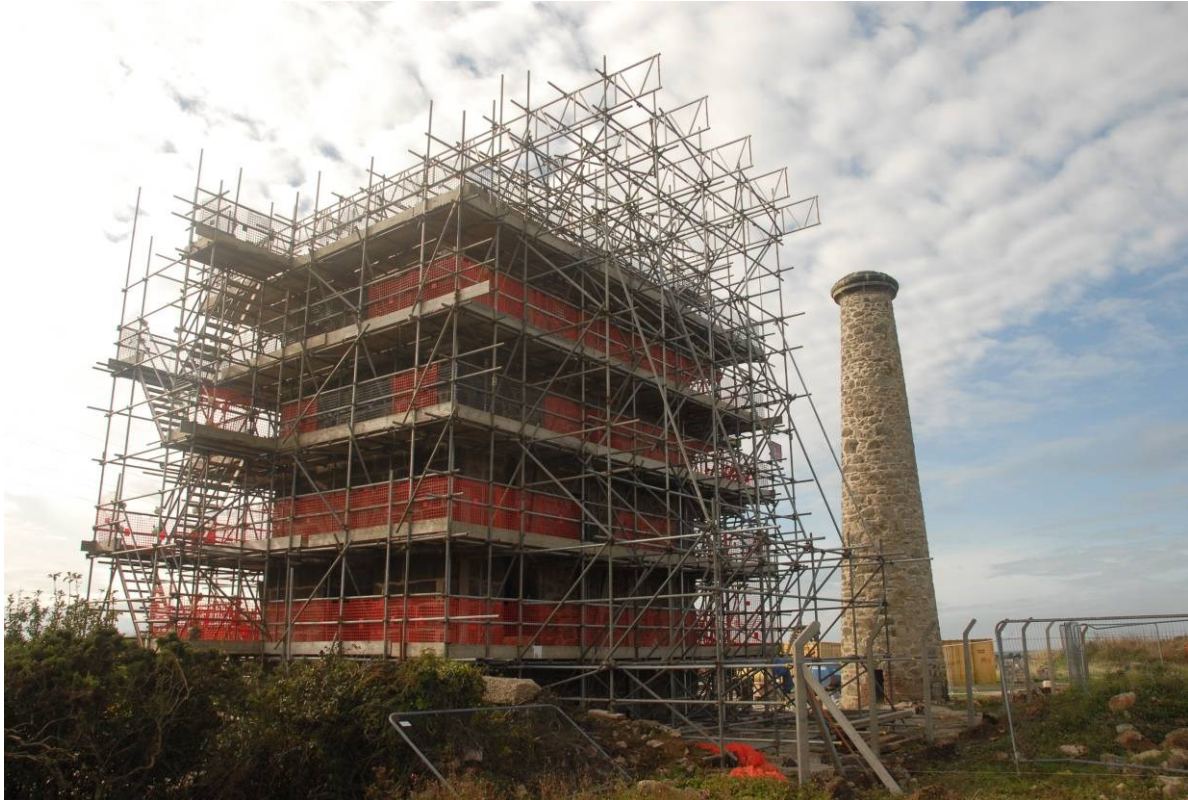
Fig 51. The complex scaffolding applied to the engine house. The internal scaffolding was suspended from the external scaffolding, whilst the two were braced against the walls to prevent any further movement of them.

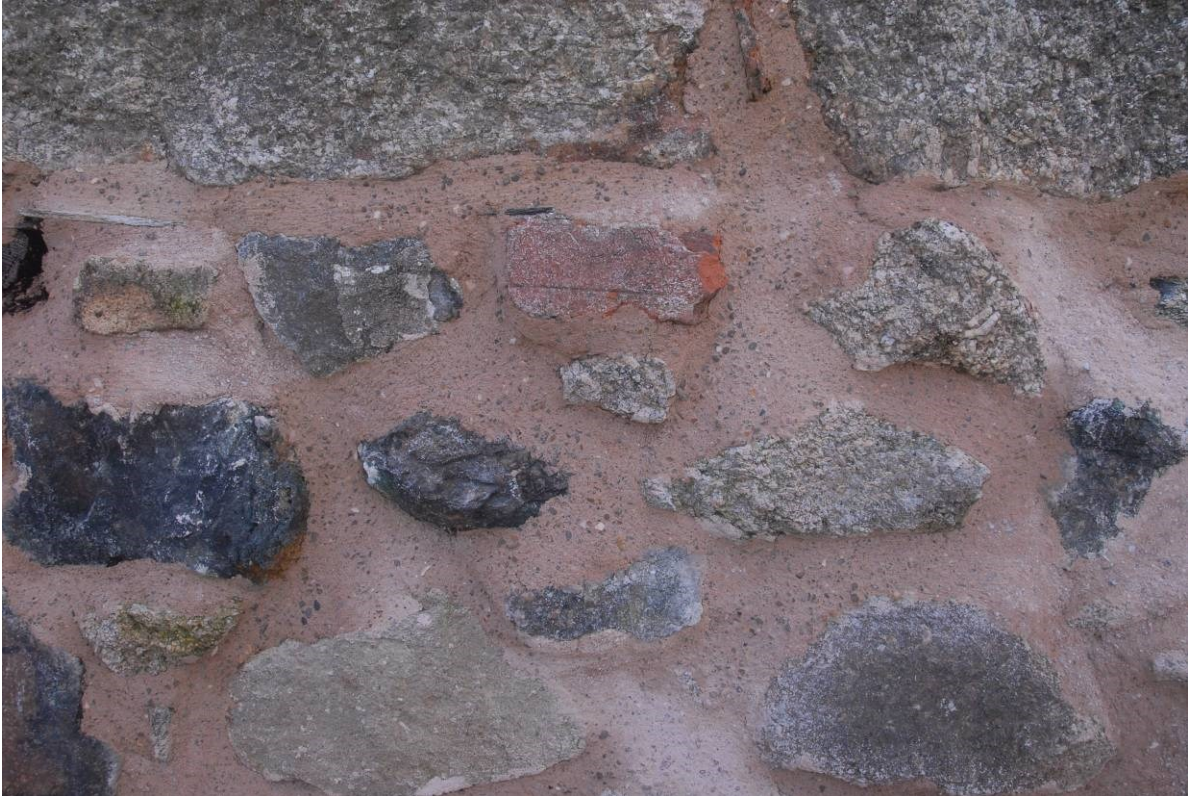
Fig 53. An example of the new pointing which had been allowed to cure for several weeks, showing its finished colour and texture.

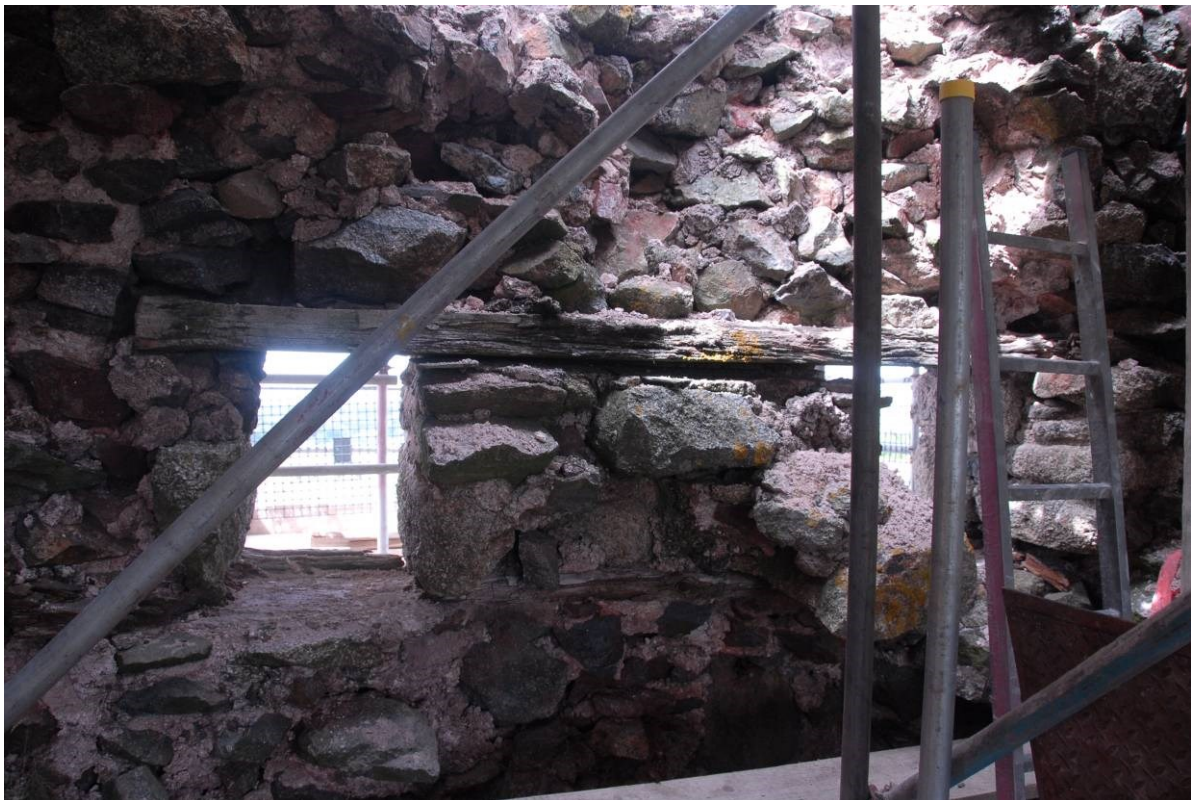
Fig 54. The internal elevation of the panel of masonry between the spring beam openings incorporated some large, cantilevered stones given the loss of the inner wall skin.

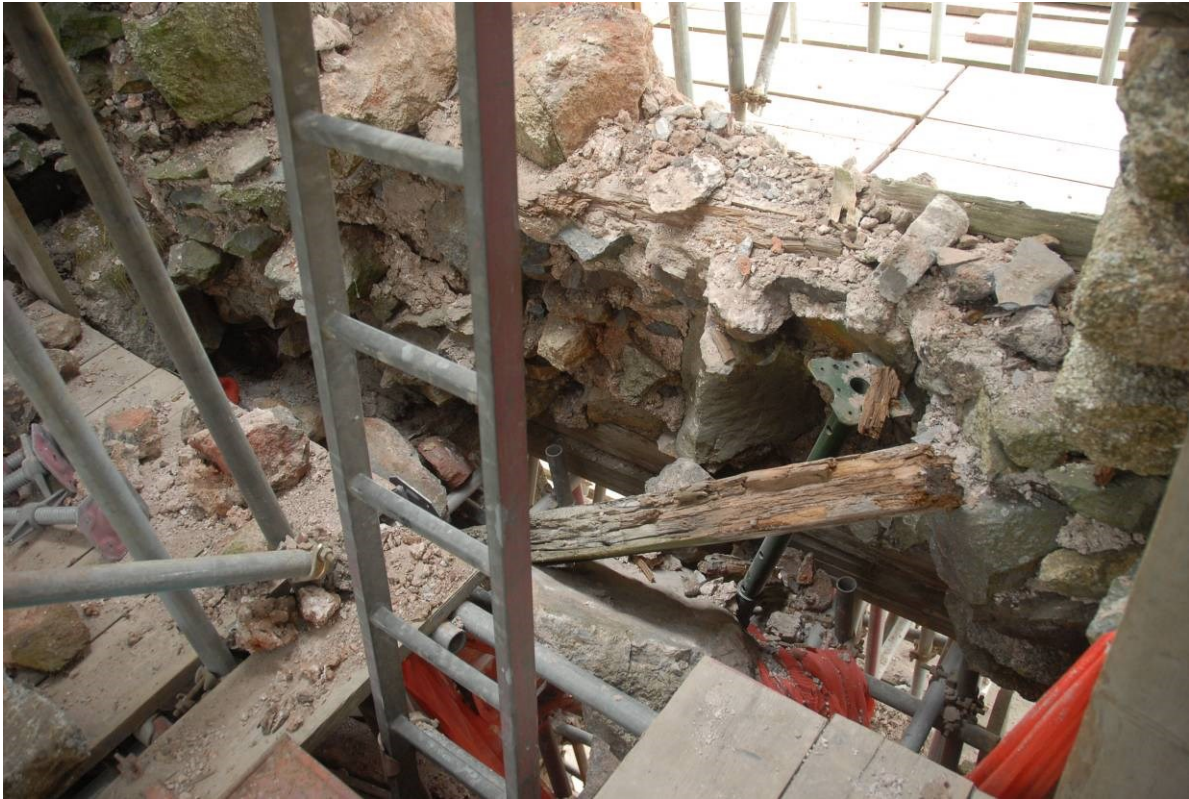
Fig 55. A collapse of the masonry panel between the spring beam openings occurred when one of the masons dislodged a large stone in this area. The extent of the ensuing collapse underscored the fragility of this part of the building.

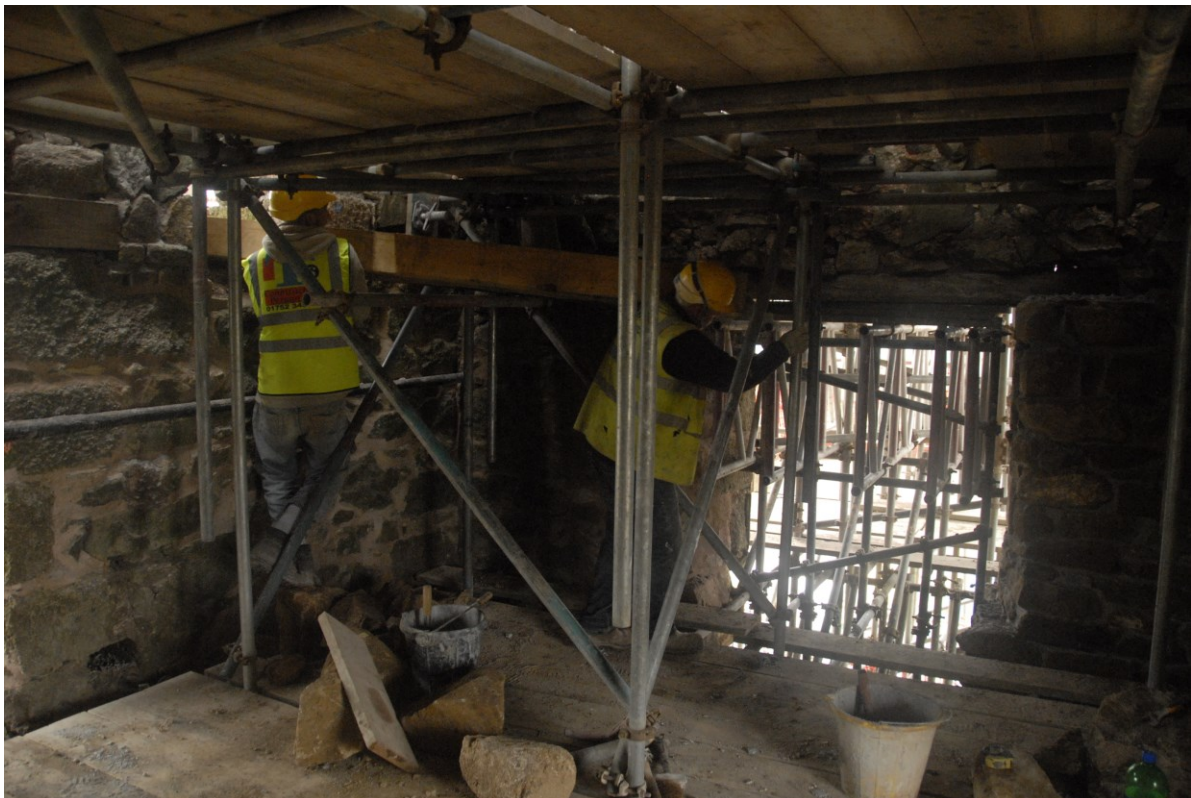
Fig 56. Installing one of the new lintels over the middle floor window – an awkward job given the weight of the oak timbers and the amount of scaffolding within the space nearby.

On the other elevations, all lost or failing timber lintels were replaced in oak and collapsed or collapsing stonework above them reinstated (Figs 30, 33-34, 47-48, 56, and 59). Badly corroded iron lintels over a small opening on the eastern side of the building were replaced in steel. Further corrosion of all exposed original metalwork was prevented by the application of a two coat epoxy paint (Fig 66). Sections of incorporated ironwork which had jacked the stonework (Fig 39) were removed, the gaps being infilled with small stone. All window cills were repaired in a cement-based screed, as originally constructed.

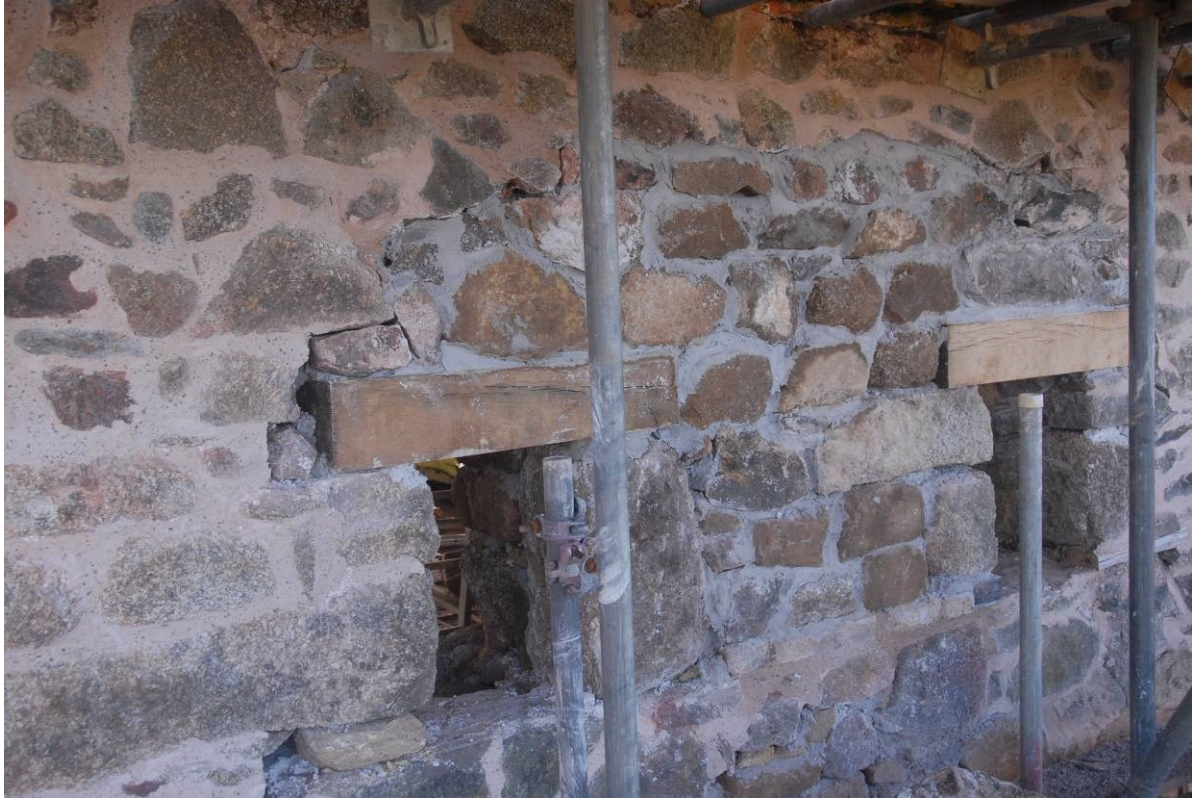
Fig 57. The reconstructed panel of masonry around the spring beam openings. As is evident, an unavoidable further collapse of masonry over this area occurred during this work.
