New Cook's Kitchen Shaft, South Crofty and Chapple's Shaft, Cook's Kitchen, Pool, Cornwall

**Historic Environment Consultancy during
conservation works to structures**

Client	Cornwall Council
Report Number	2013R080
Date	04 February 2014
Status	Final
Report author	Adam Sharpe BA MIfA
Checked by	Dr. Andy Jones MA MiFA
Approved by	Andrew Young MIfA

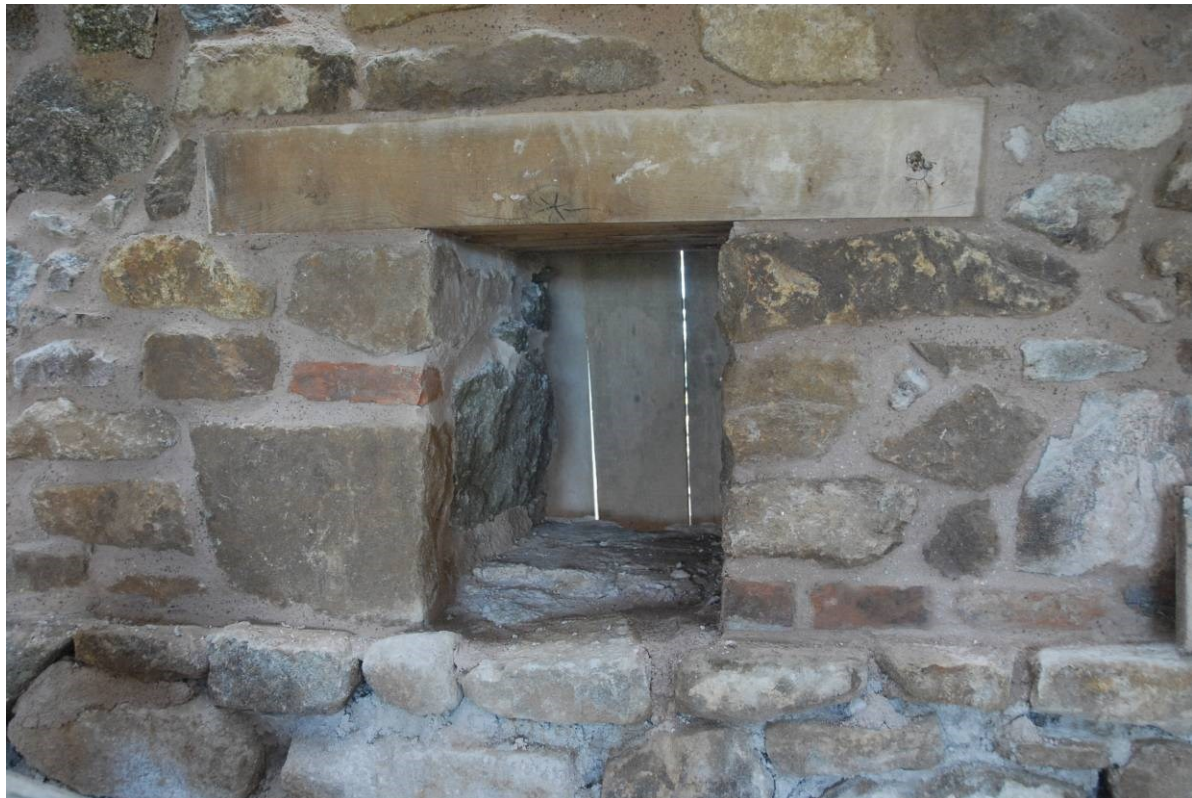
Fig 58. The internal elevation of one of the reconstructed spring beam openings.

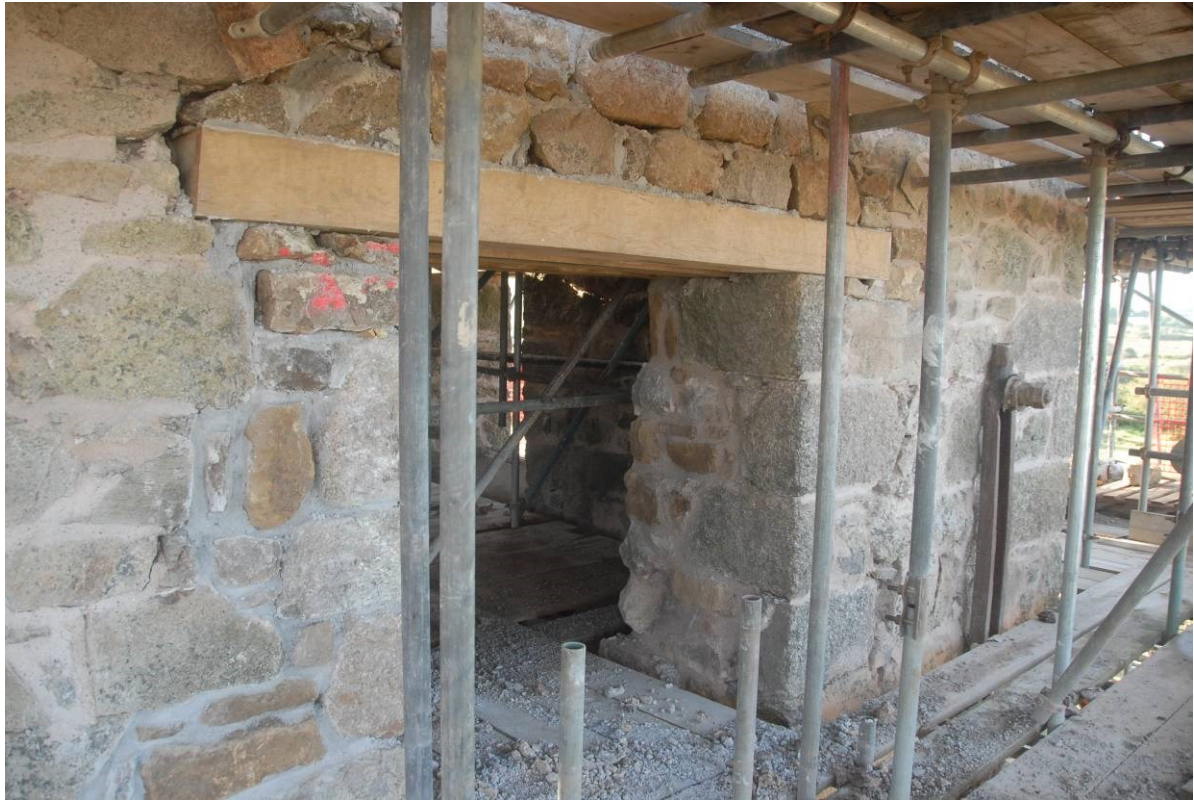
Fig 59. One of the new external lintels over a middle floor window opening prior to the completion of the repointing of the surrounding walling.

On the other elevations, all lost or failing timber lintels were replaced in oak and collapsed or collapsing stonework above them reinstated (Figs 30, 33-34, 47-48, 56, and 59). Badly corroded iron lintels over a small opening on the eastern side of the building were replaced in steel. Further corrosion of all exposed original metalwork was prevented by the application of a two coat epoxy paint (Fig 66). Sections of incorporated ironwork which had jacked the stonework (Fig 39) were removed, the gaps being infilled with small stone. All window cills were repaired in a cement-based screed, as originally constructed.

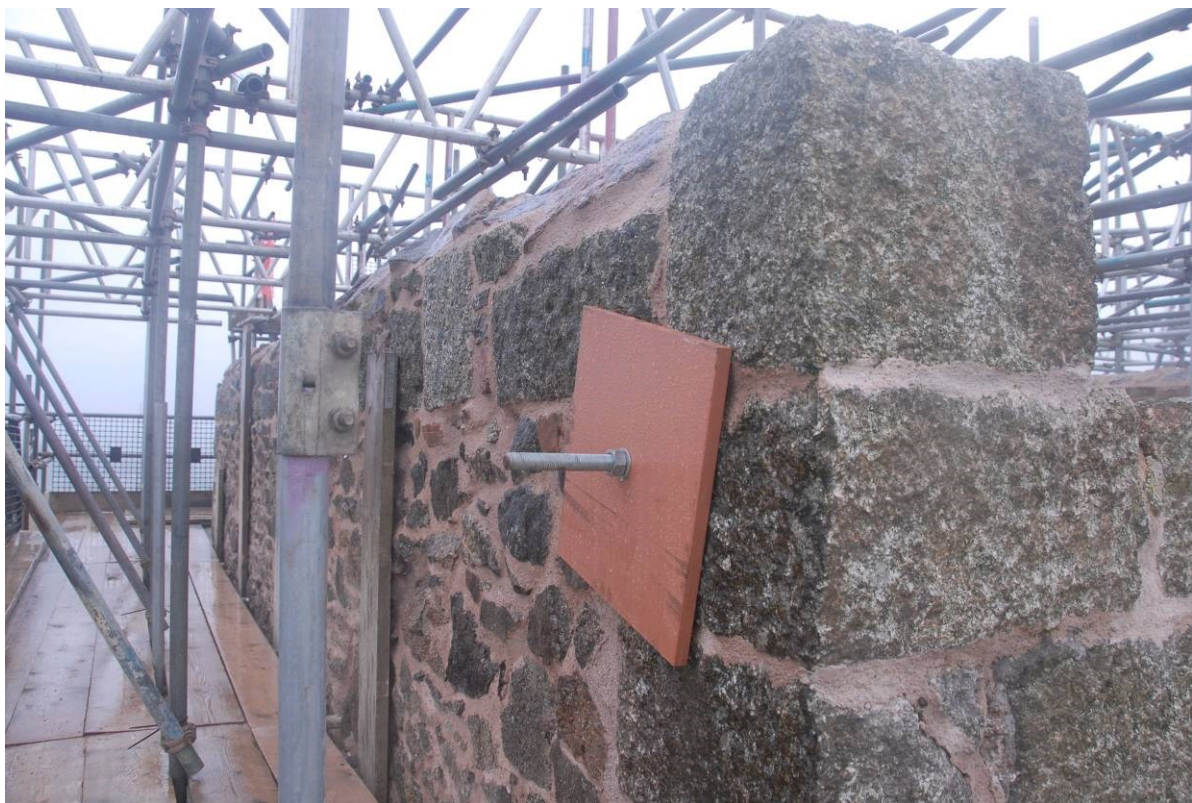
Fig 60. The patress plate on one of the new tie rods bracing the wing walls above bob wall height on the southern elevation.

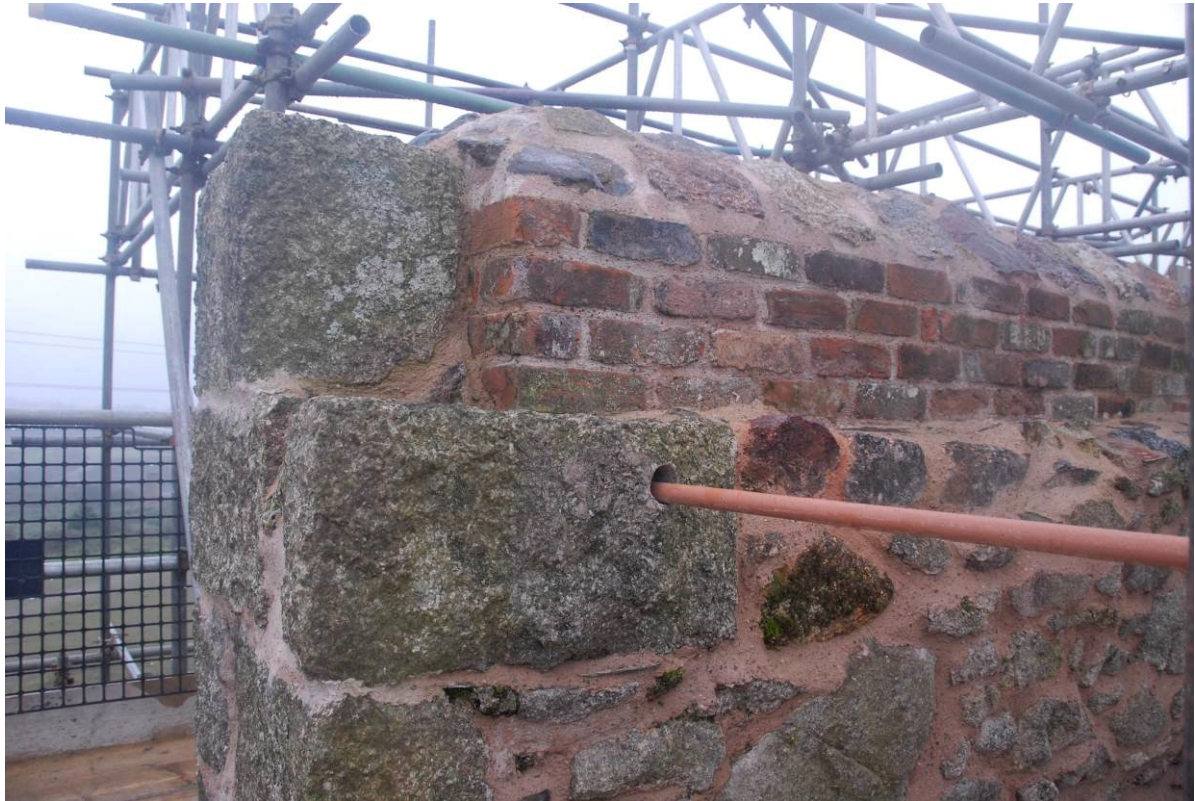
Fig 61. The new tie bars were drilled through the quoins at the leading edges of the walls, as seen here.

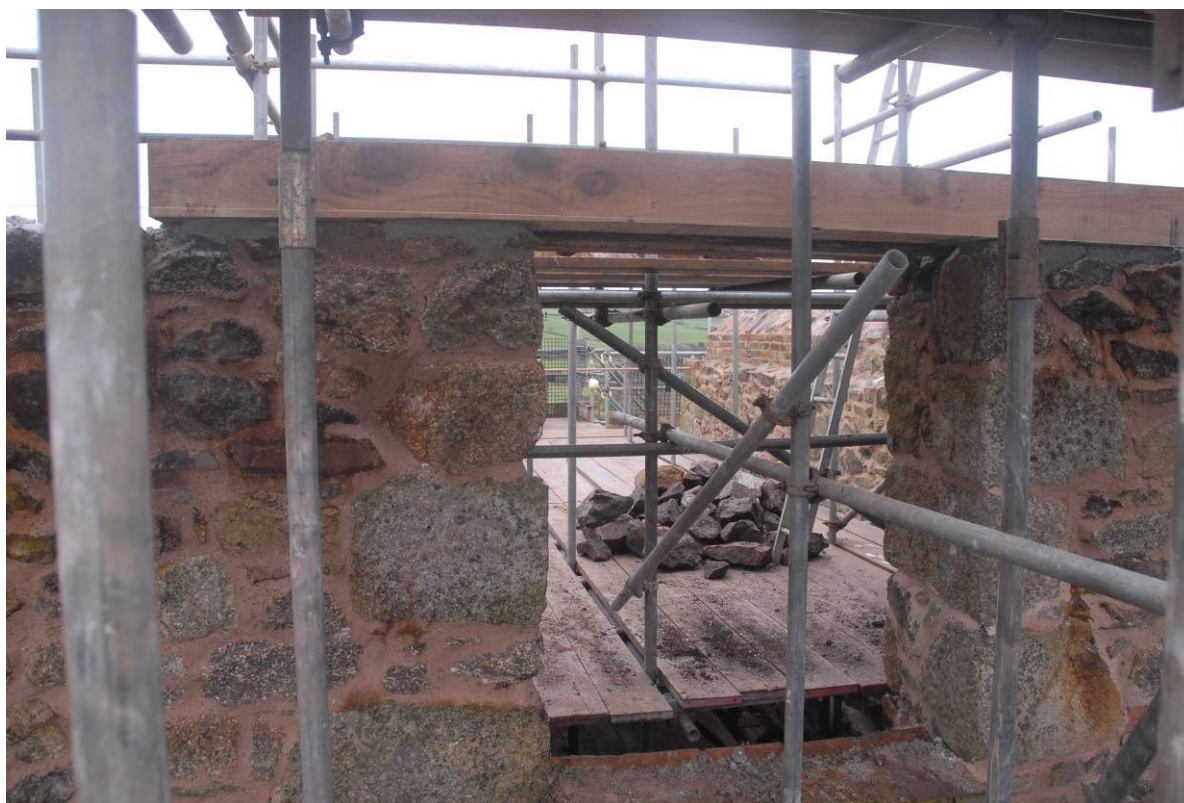
Fig 63. The new oak lintels installed over the bob loft (top floor) window.

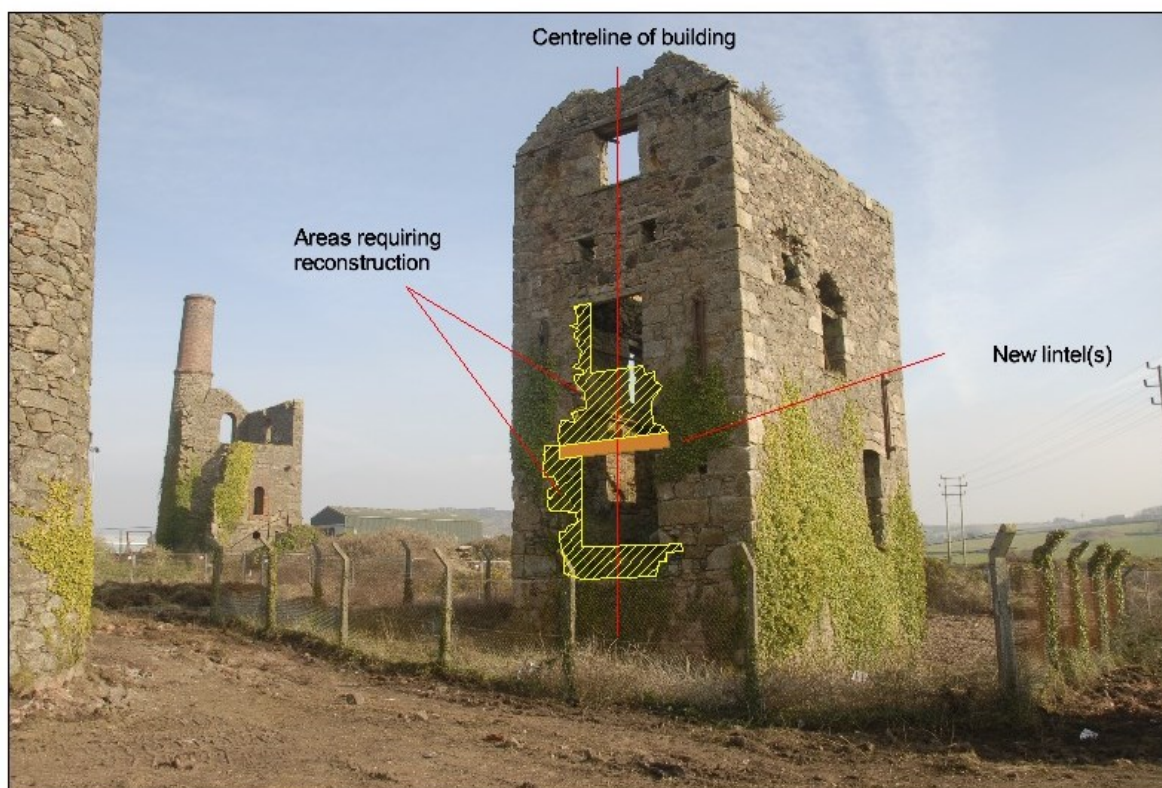
Fig 64. The HE Projects recommended reconstruction of the openings in the southern elevation of the pumping engine house. This approach was unfortunately rejected on cost grounds.

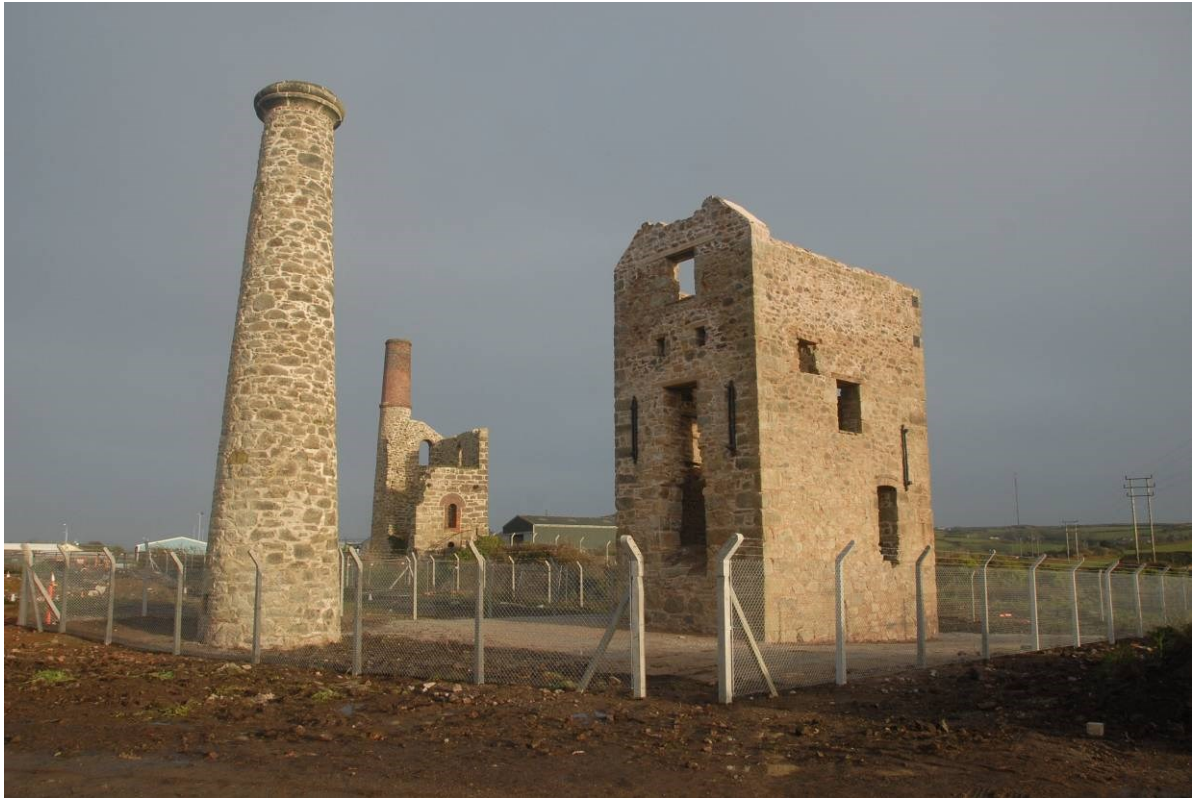
Fig 65. The completed works to the north elevation of Chapple's pumping engine house. Compare with Figure 28.

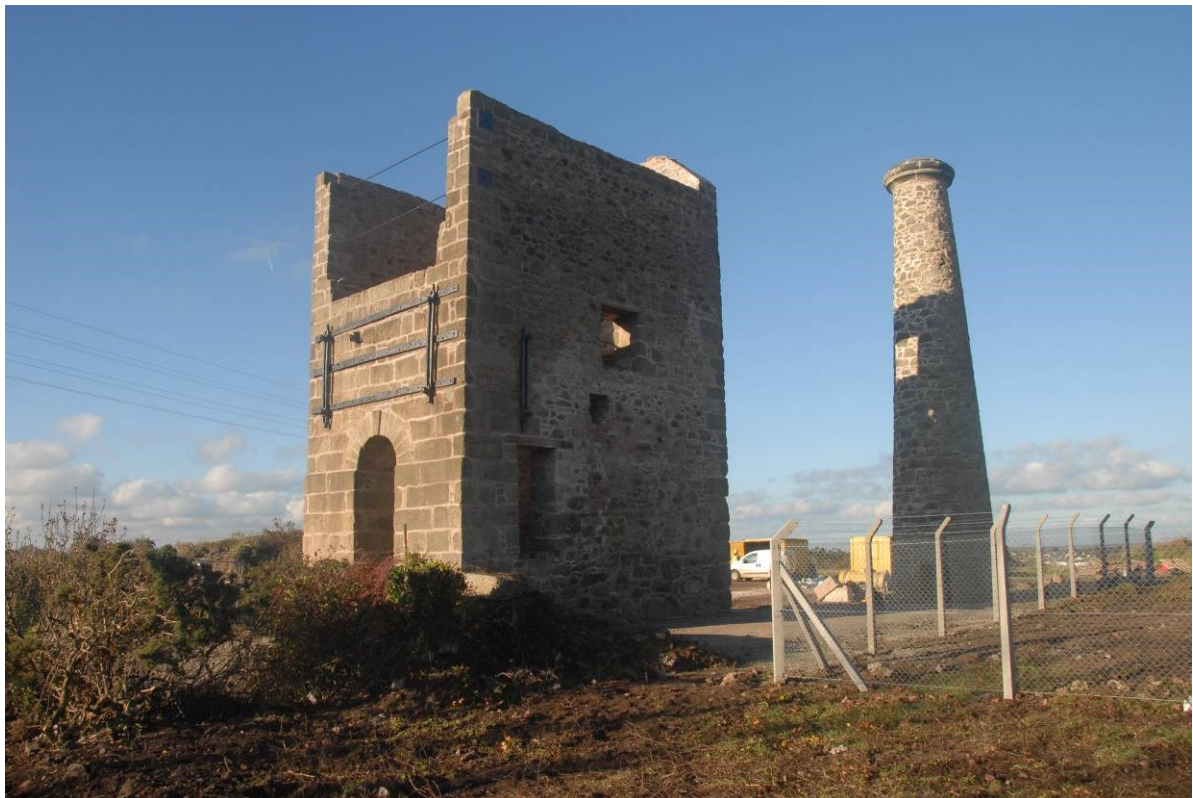
Fig 66. The completed works to Chapple's pumping engine house from the south east. Compare with Figure 27.

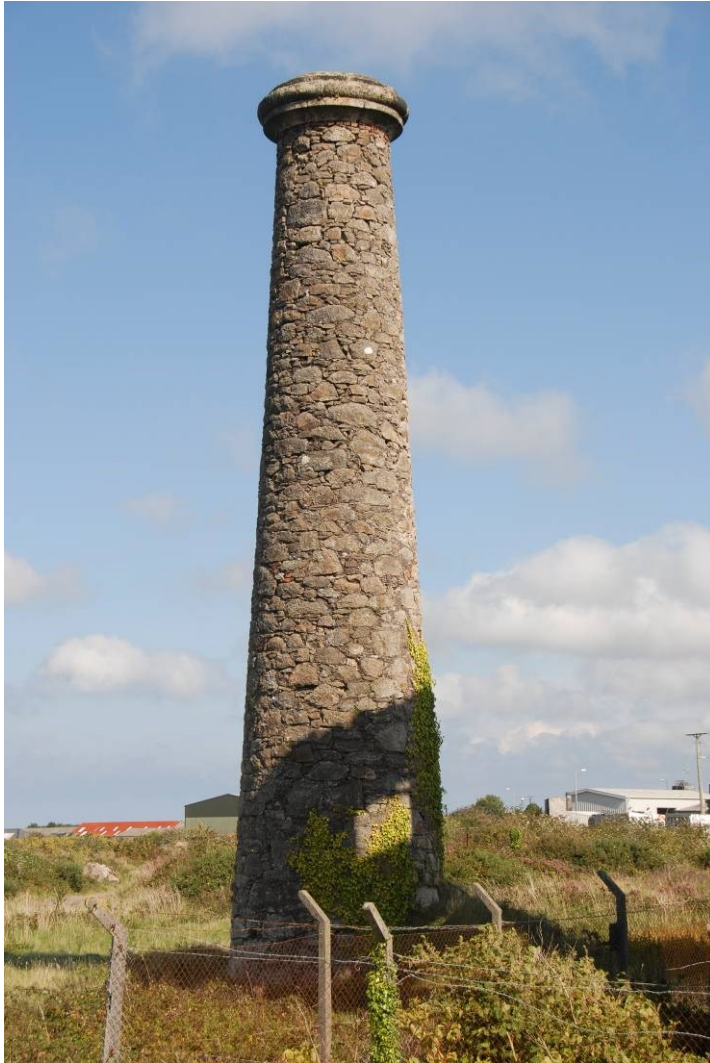
The now freestanding chimney is constructed of a mixture of granite and mine waste and stands to 14m high and is 3.0m in diameter at ground level (Fig 67). It has completely lost its upper brick section, and is now truncated at its granite drip ring (Fig 68). Inspection suggested that the chimney was in good condition, requiring little in the way of conservation work beyond re-pointing and the provision of lightning protection.

Fig 67. The free-standing pumping engine house chimney at Chapple's Shaft, Cook's Kitchen prior to works. The whole of the original brick capping has been lost.

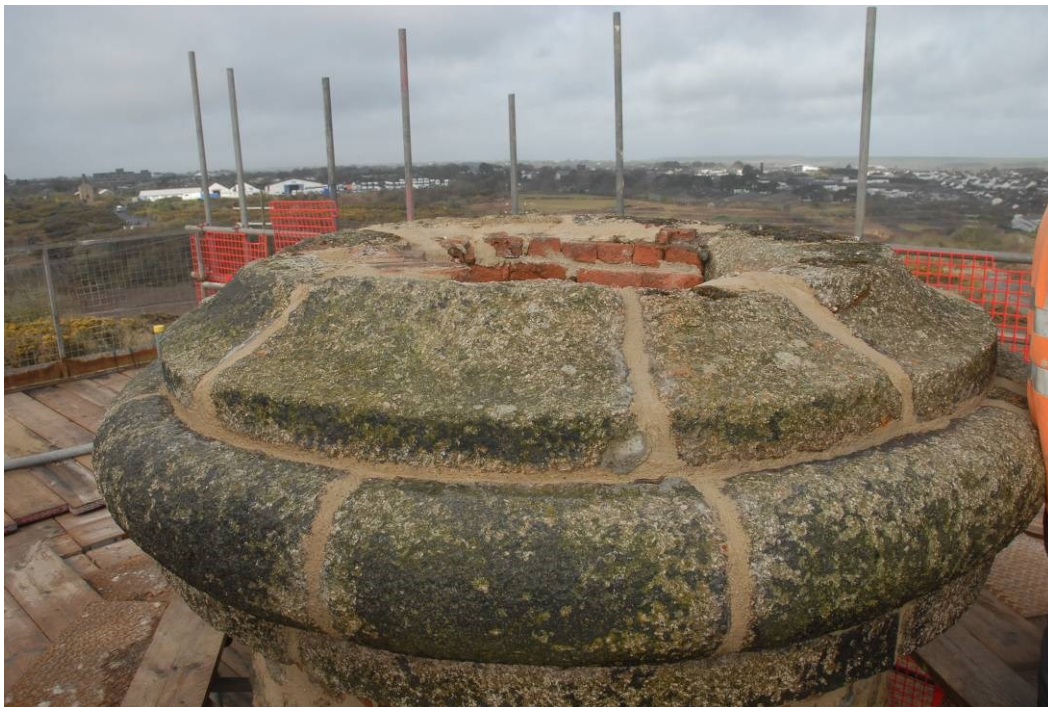
The upper section of the interior of the chimney had lost most of its pointing, as well as some of the rough masonry and brickwork which formed its inner face (Fig 68). The segmented shaped granite drip ring had been set on a single course of header bricks, possibly a decorative band but more likely a levelling layer; the drip ring was found to be in good condition, and did not need lifting and resetting. The top joints of the drip ring were pointed, as were the accessible more weathered vertical joints within its inner face (Fig 76).

Fig 68 (below). The moulded segmented granite drip ring now forming the upper part of the chimney, showing the brickwork which had been used to line part of its interior.

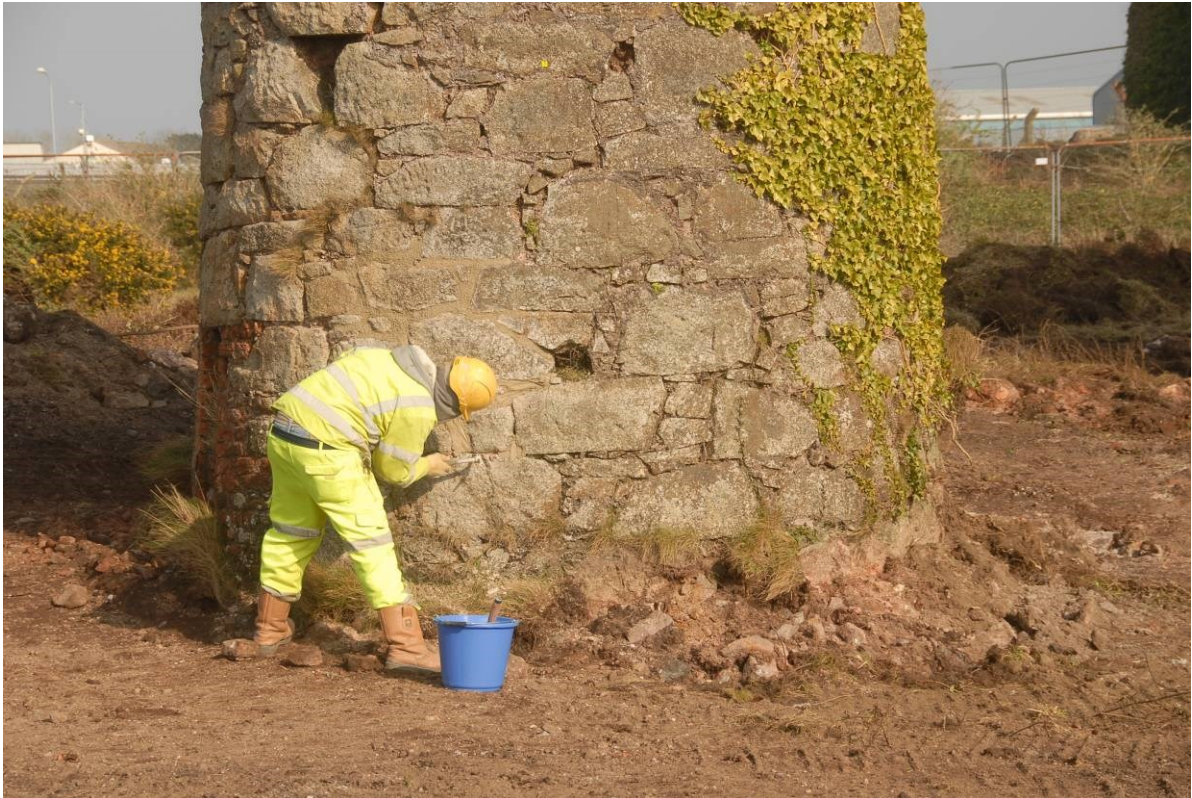
A mortar test panel based on 5 parts of CLS 11 sand and 2 parts of NHL 3.5 hydraulic lime was installed on the chimney near its base at an early stage in the project (Fig 69). This was left to cure and then inspected for colour and texture match with the original pointing. The chimney was then fully scaffolded and inspected in detail. Much of the pointing was found to be in fair condition, though it was decided to take the opportunity to replace almost all of it.

Fig 69. Applying a pointing text panel to the base of the chimney during the early stages of the project.

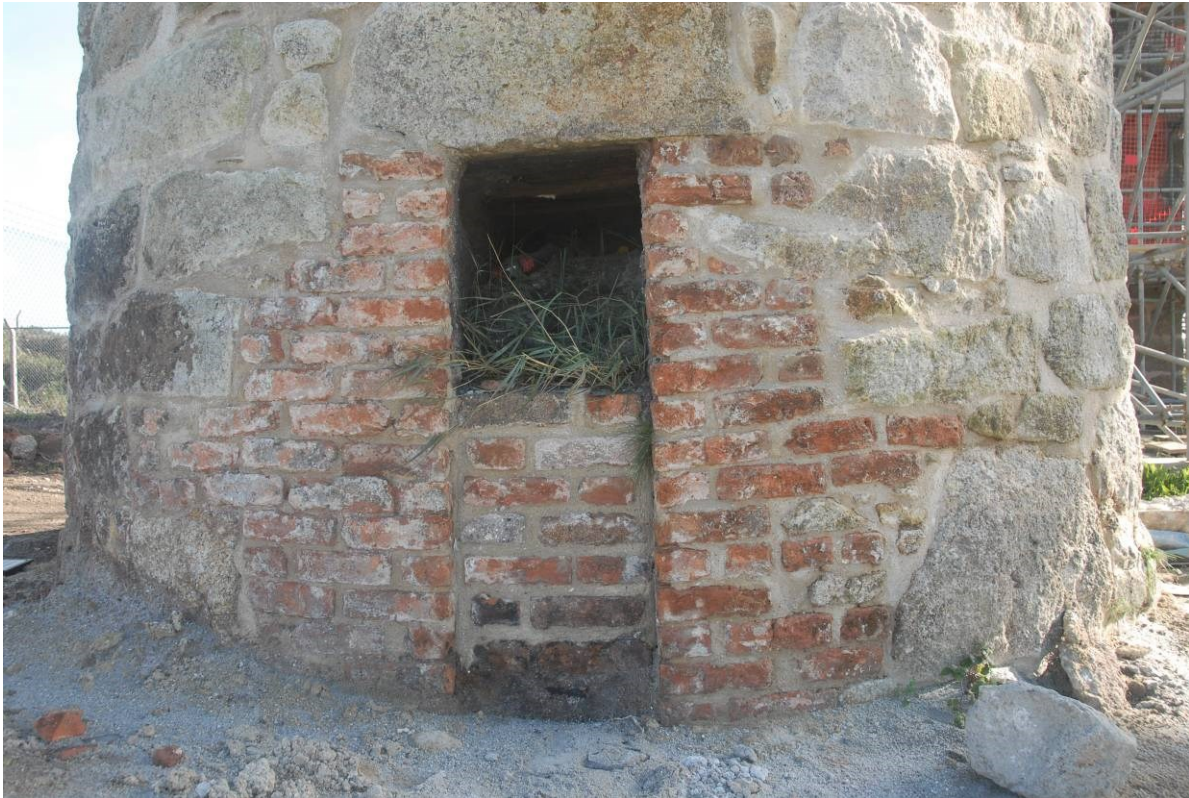
Three original openings into the chimney were found, to the north, south and east. That to the north was relatively small, measuring 1.27m high by 0.4m wide under a granite lintel, the opening being blocked with a brick panel for the lower 0.67m; it had brick reveals and sheet iron inner lintels and was found to be blocked with rubble 1.4m in from the outer face of the chimney (Fig 71). The function of this opening is uncertain. It may have been for access to the interior of the stack during ash cleaning operations, though it is paired with another opening to the south, this measuring 1.1m high and 0.4m wide. This again has a granite external lintel and sheet iron inner lintels, but is blocked by a panel of brickwork 1.0m in from the face of the stack (Fig 72). This, too, might have been an ash-cleaning opening, the access originally being from within the boiler house. The opening to the east where the boiler flues had led into the stack was considerably larger than the other two and had lost its lintel, leading to instability of the masonry over its location (Fig 73). The failing stonework was propped as a matter of urgency and was repaired once the scaffolding had been struck. The opening as found measured 2.0m high and was up to 1.5m wide, extending the full distance into the interior of the stack (1.0m). The opening was reinstated at 0.76m by 0.76m based on information on the size of the original suggested by flanking brickwork (Fig 72). This was capped with a second hand granite lintel measuring 1.15m by 0.12m which had been sourced by CORMAC and, on the advice of the site archaeologist, the opening was then blocked in with a two course depth of site-salvaged bricks to prevent the theft of the accessible exposed section of the lightning conductor tape, the bricks being tied into the chimney masonry using sections of stainless steel dowel (Figs 74-75).

Fig 71. The northern opening to the chimney, historically part closed with the lower brickwork panel.

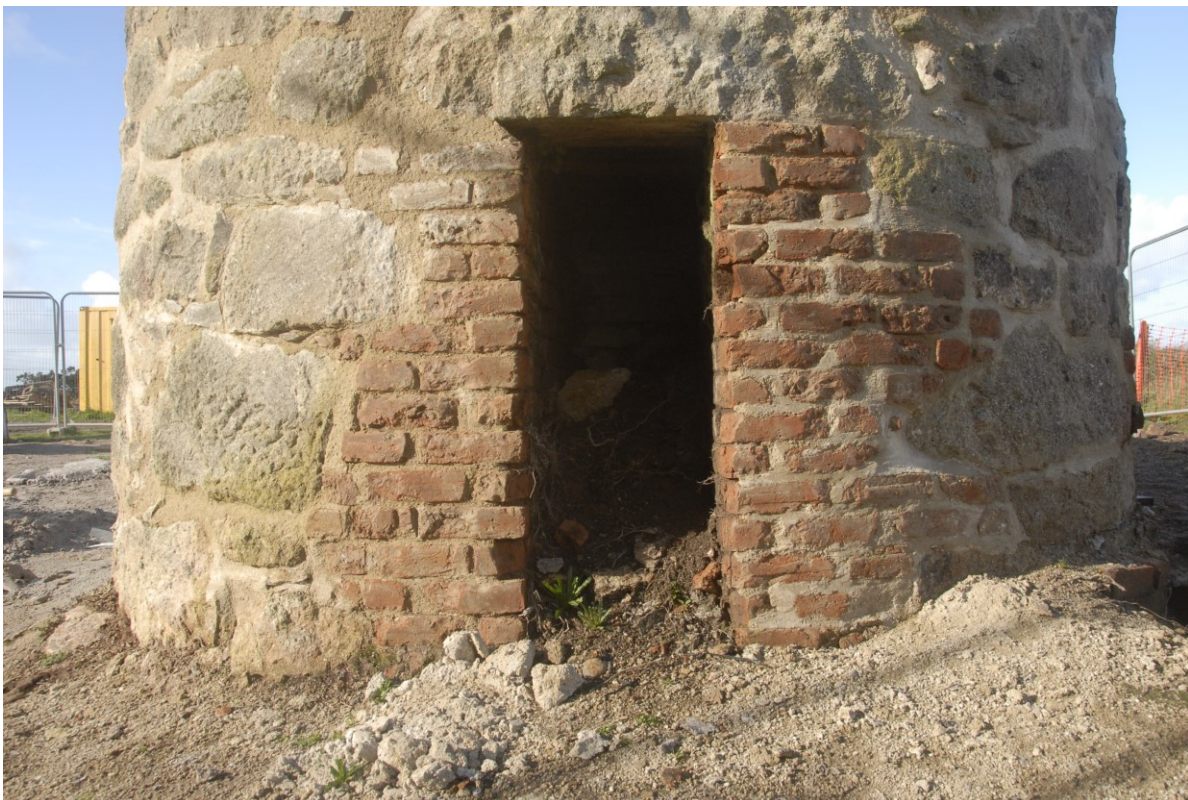
Fig 72. The southern opening into the chimney, in this case found to have been closed off one metre into the chimney by a brick panel.

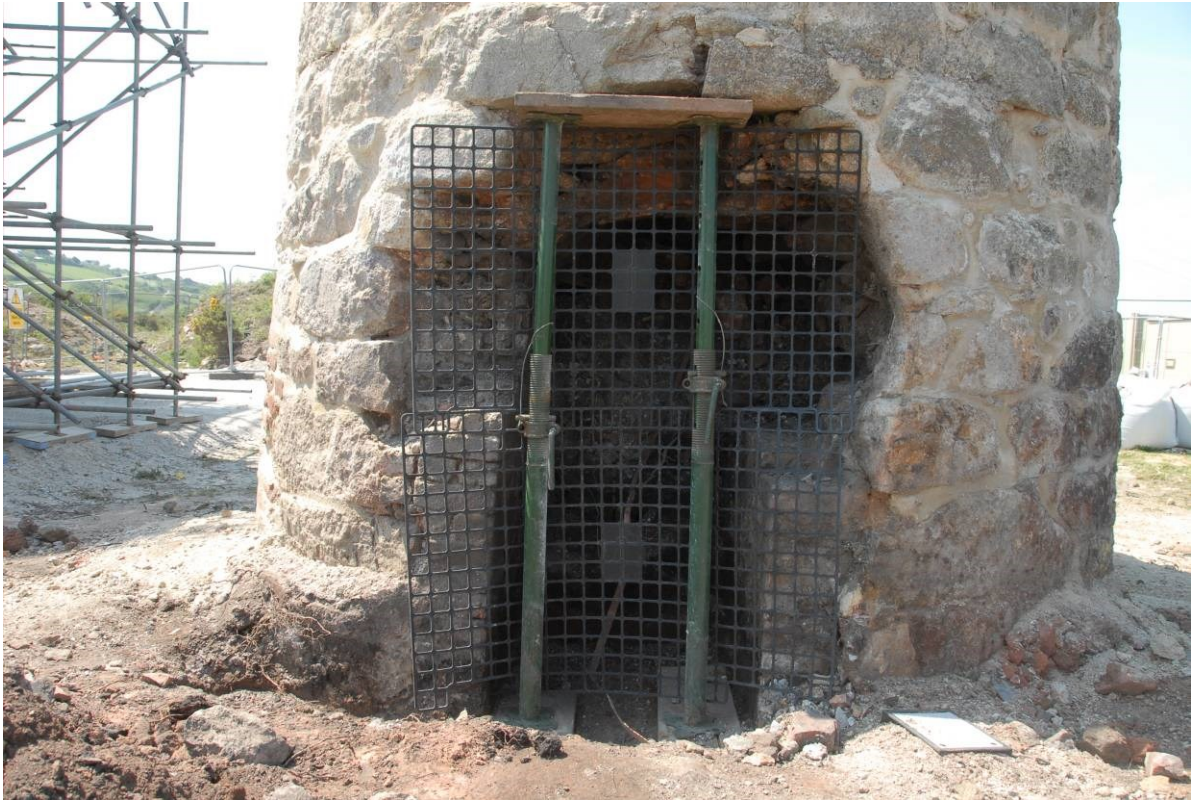
Fig 73. The eastern (flue) opening into the chimney as excavated and subsequently propped to prevent any further collapse of masonry.

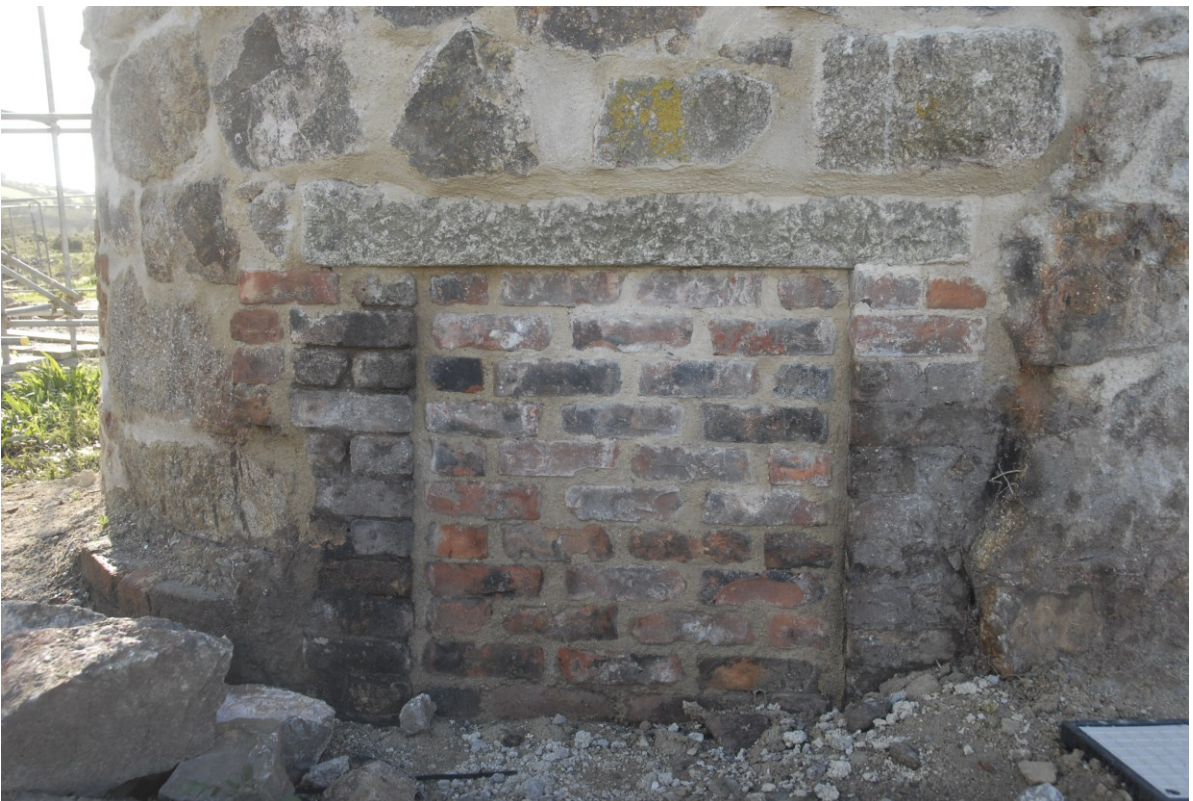
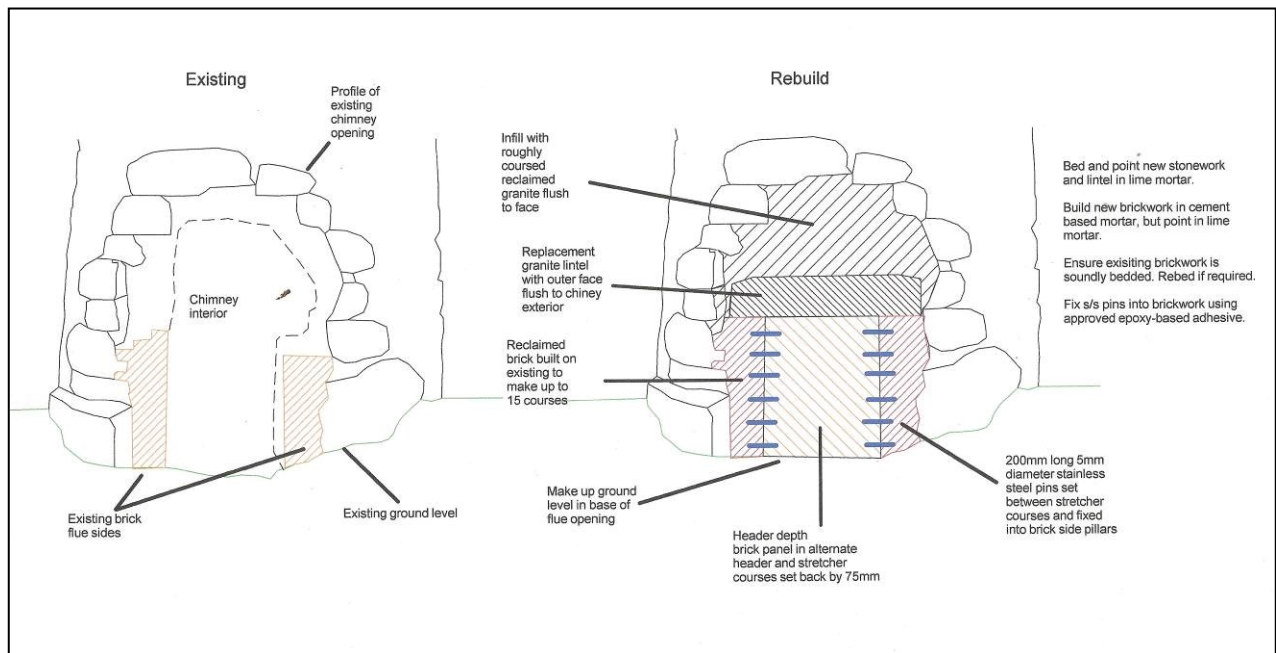
Fig 74. The reconstructed flue opening, utilising a re-used granite lintel and a recessed panel of site-won salvaged brick to close off access to the lightning conductor tape.

Fig 75. Detail of the method for rebuilding and infilling the flue opening to the chimney.

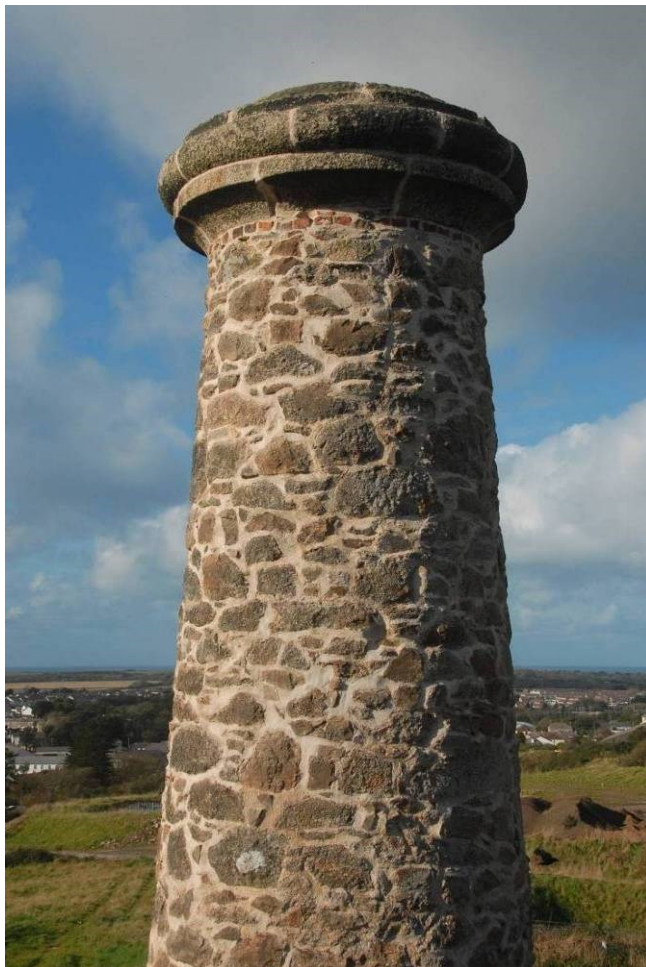
Fig 76. The upper section of the conserved chimney.

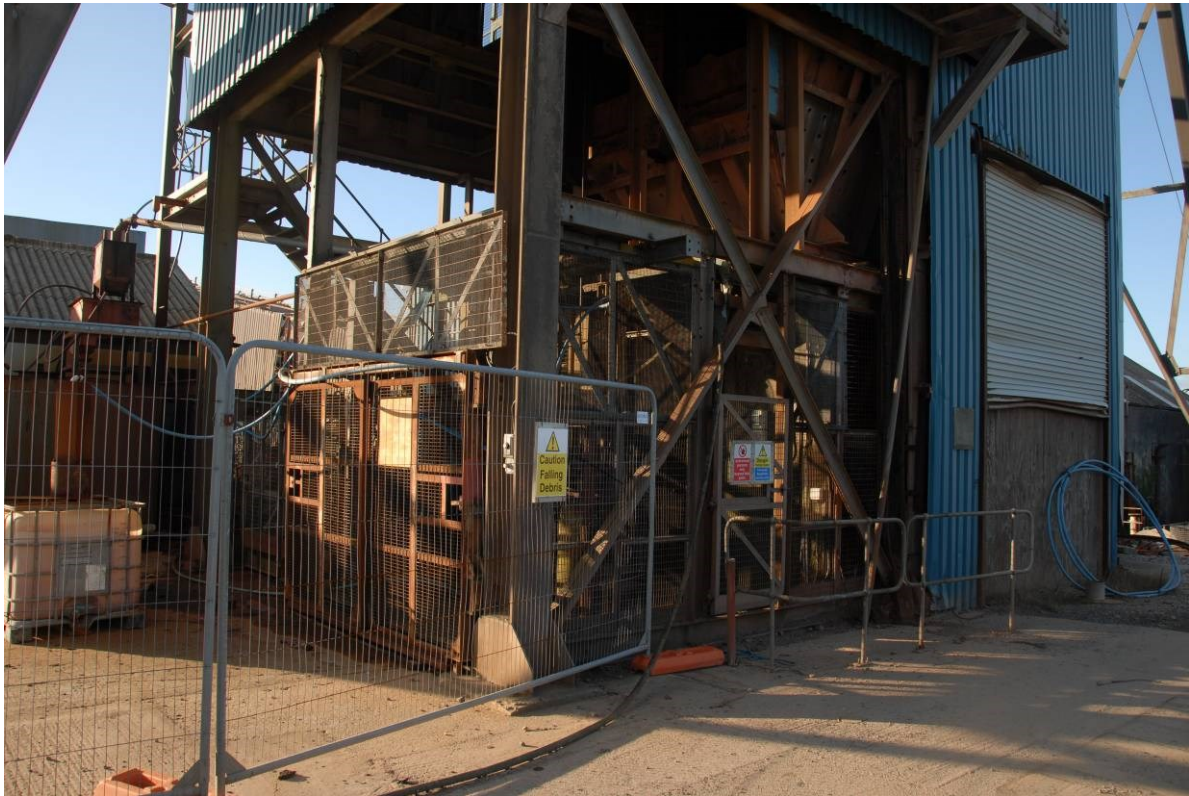
failed roller shutter door giving access to the conveyor house (Fig 83) cabling and hoses, together with other features relating to the operation of the shaft (see for example, Figs 80-84, 89-91), and the conveyor leading from the skip hoisting tippler station in the northern headframe to the coarse ore bins to the west (Fig 79). The conveyor structure was demolished in early 2013, leaving only a small section protruding from the base of the headframe, together with the vibrating feeder under the headframe (Figs 81, 85-88).

Fig 83. The eastern side of New Cook's Shaft headgear at ground level, showing (right) the defunct roller shutter door giving access to the end of the ore conveyor.

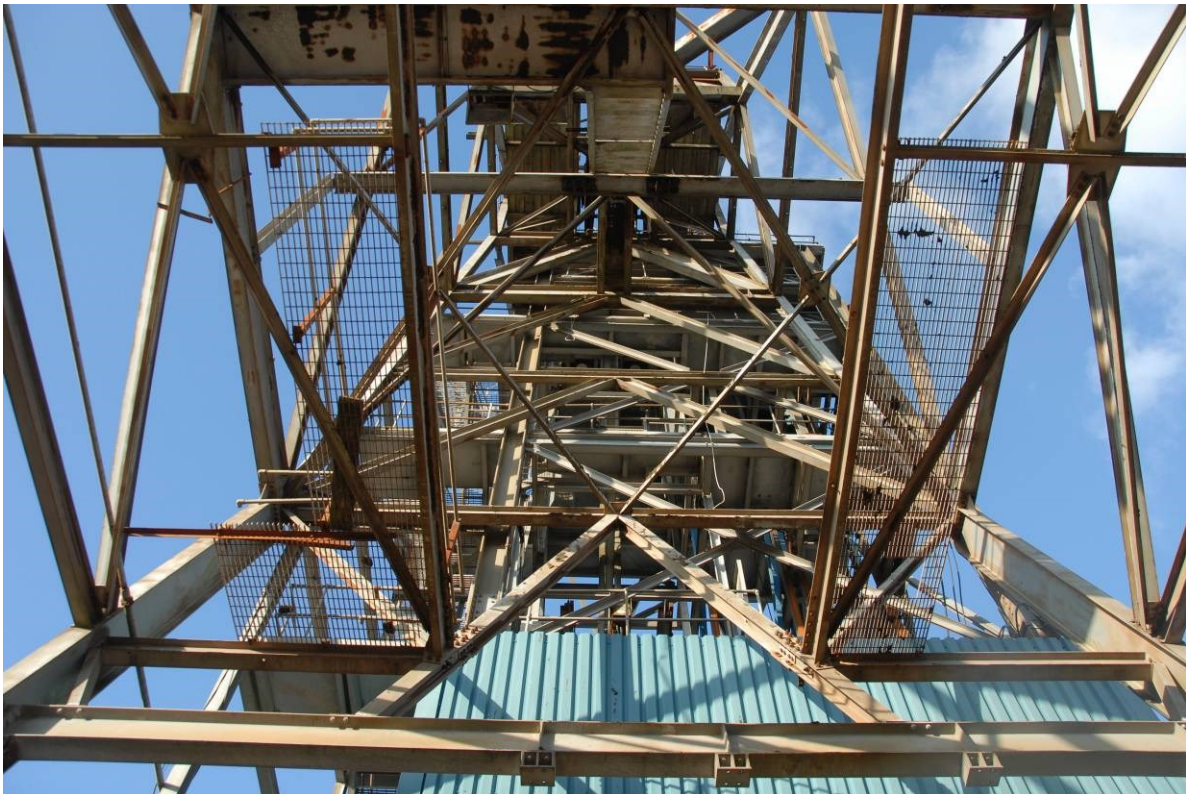
Exposed to the elements (including warm damp air rising up the shaft) for many years, the headframe had deteriorated significantly in places, its galvanised coating having deteriorated to the extent that a few structural members had corroded and would need replacement (Figs 97-99). The headframe also include some redundant features such as partial sections of walkways in the lower part of the southern headframe (Fig 92), a

Fig 92. Looking up inside the south headframe, showing some of the redundant walkways (left and right).

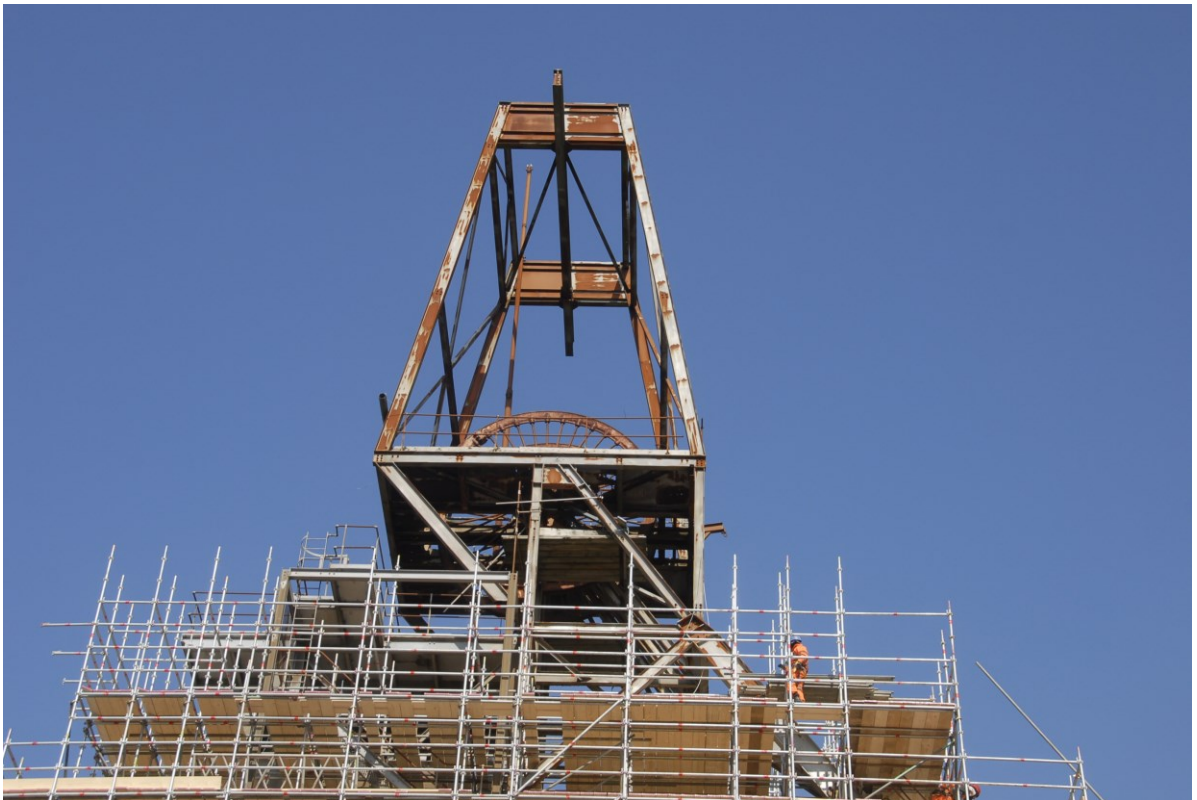
Fig 94. Detail of the sheave wheel maintenance gantry on the south headframe prior to its removal.

At an early stage in the project there had been some suggestions that the sheave wheel maintenance gantry (Fig 94) might not be re-set on top of the headframe, in part due to the budget being inadequate to cover the costs of reinstatement. Historic Environment argued that this important element of the headframe should be re-set if at all possible – such features are now exceptionally rare in Cornwall (the only examples being at Victory Shaft, Geevor and at New Cook's Shaft, South Crofty). In addition, the gantry formed part of the well-know profile of the headframe – the considerable additional height it conferred to the headframe also made this landmark feature visible from a far wider area of the surrounding landscape. In the event, funds to undertake the work were identified, the gantry was sheeted over, grit blasted and painted using a mobile access platform, and, following the stripping of the overall scaffold structure (Fig 113-114), the gantry was re-located on the 7th October 2013, the occasion being taken for a small-scale topping out ceremony attended by the project partners and the local Cornwall Councillor (Figs 127-132).

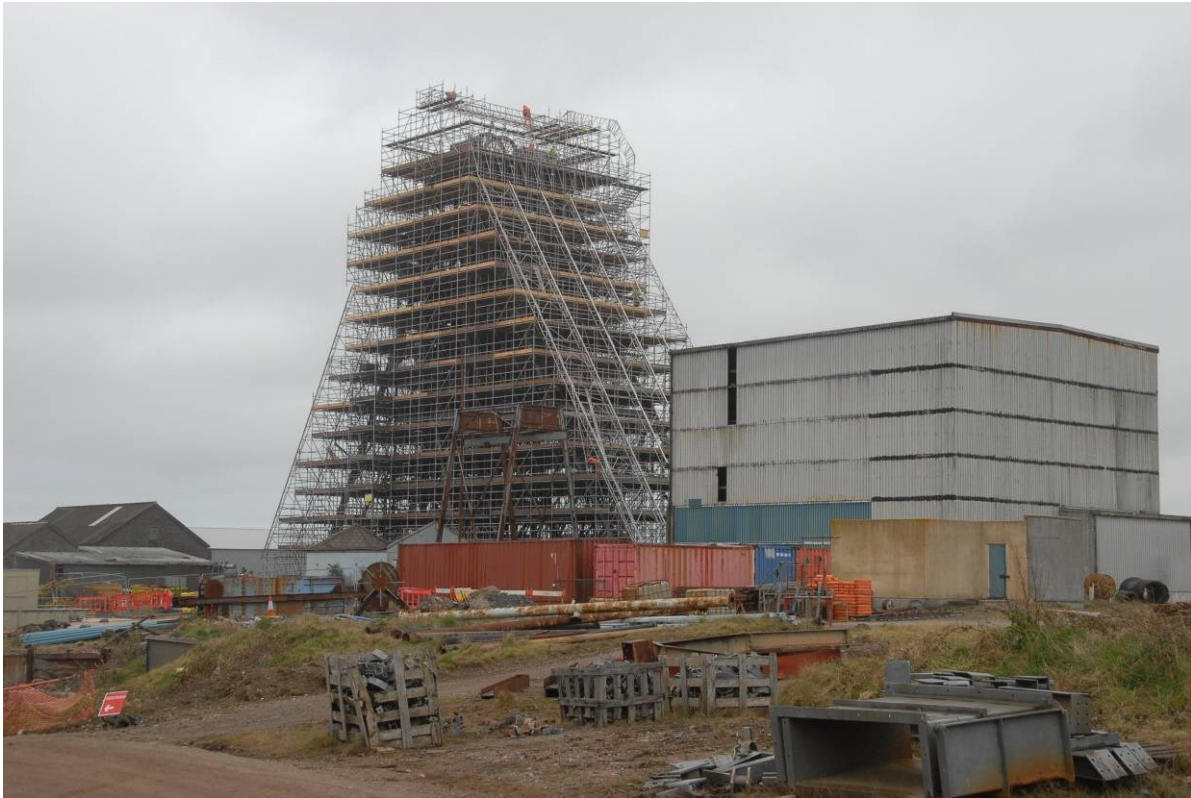
Fig 95. Scaffolding erection on the headframe at an advanced stage. The sheave wheel maintenance gantry had been craned off by this stage, and had been stored on the ground adjacent to the headframe.

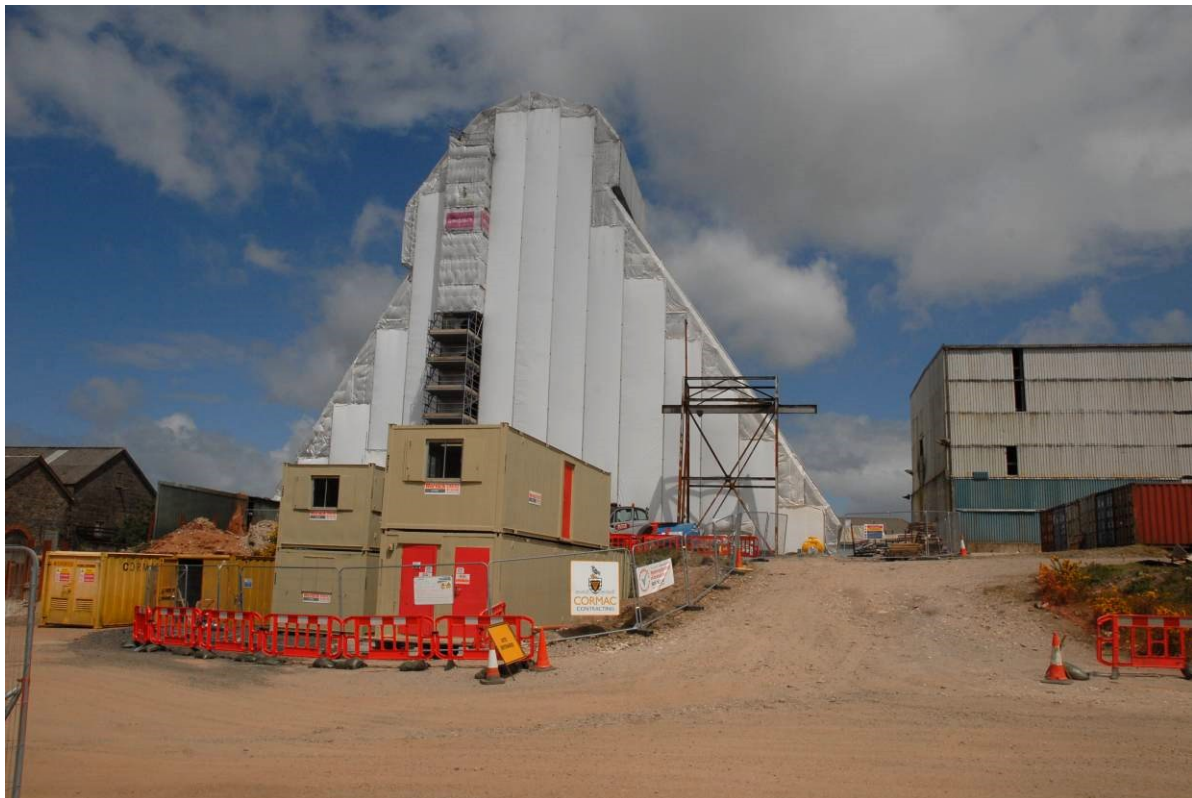
Fig 96. The fully sheeted scaffolding over the headframe, intended to reduce the noise impacts from grit blasting and to provide protected conditions for the subsequent painting activities.
