New Cook's Kitchen Shaft, South Crofty and Chapple's Shaft, Cook's Kitchen, Pool, Cornwall

**Historic Environment Consultancy during
conservation works to structures**

Client	Cornwall Council
Report Number	2013R080
Date	04 February 2014
Status	Final
Report author	Adam Sharpe BA MIfA
Checked by	Dr. Andy Jones MA MiFA
Approved by	Andrew Young MIfA

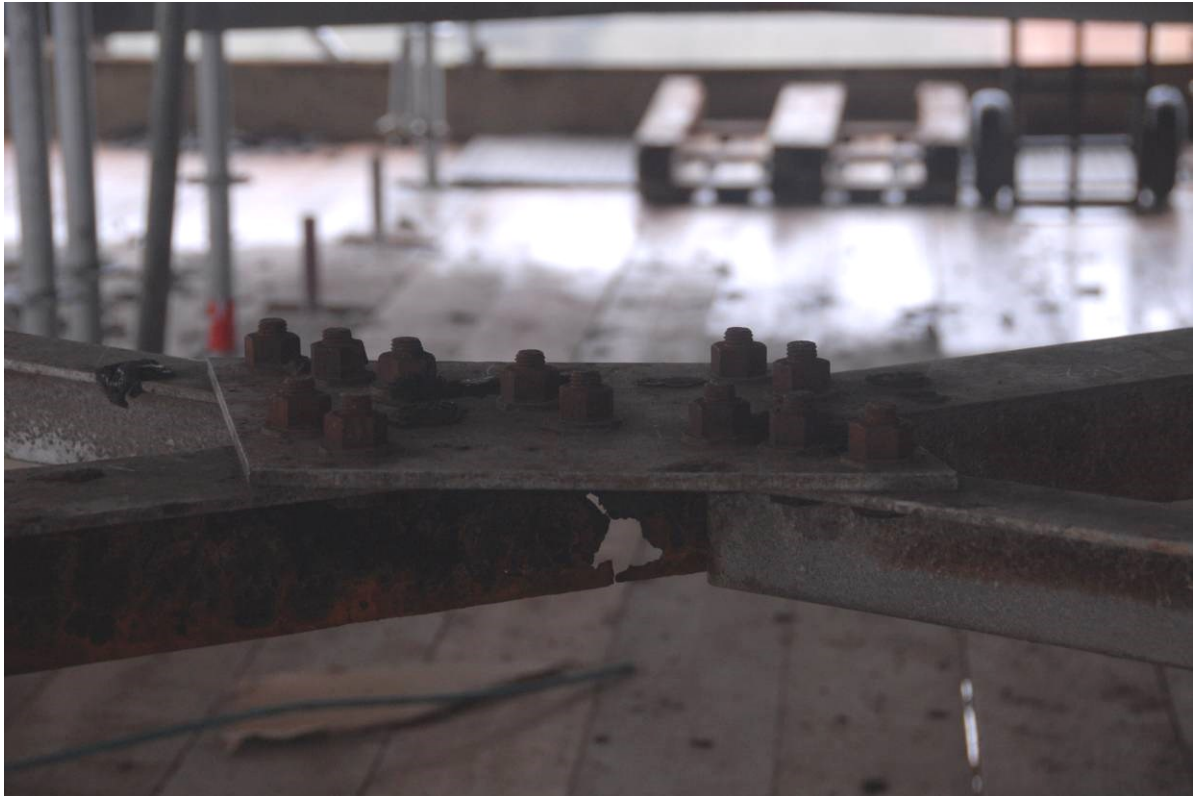
Fig 97. Corroded diagonal bracing members in the older south headframe. This steelwork was replaced.

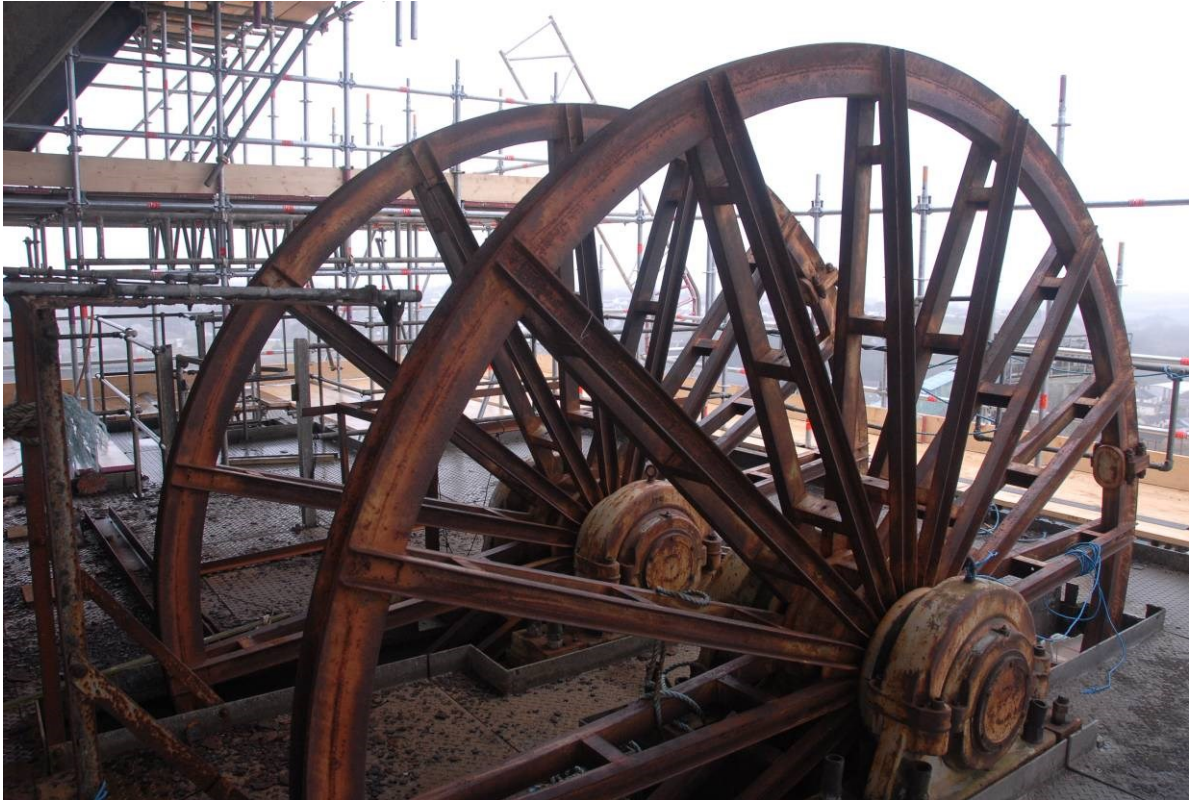
Fig 101. The built up steelwork construction north headgear sheave wheels prior to works.

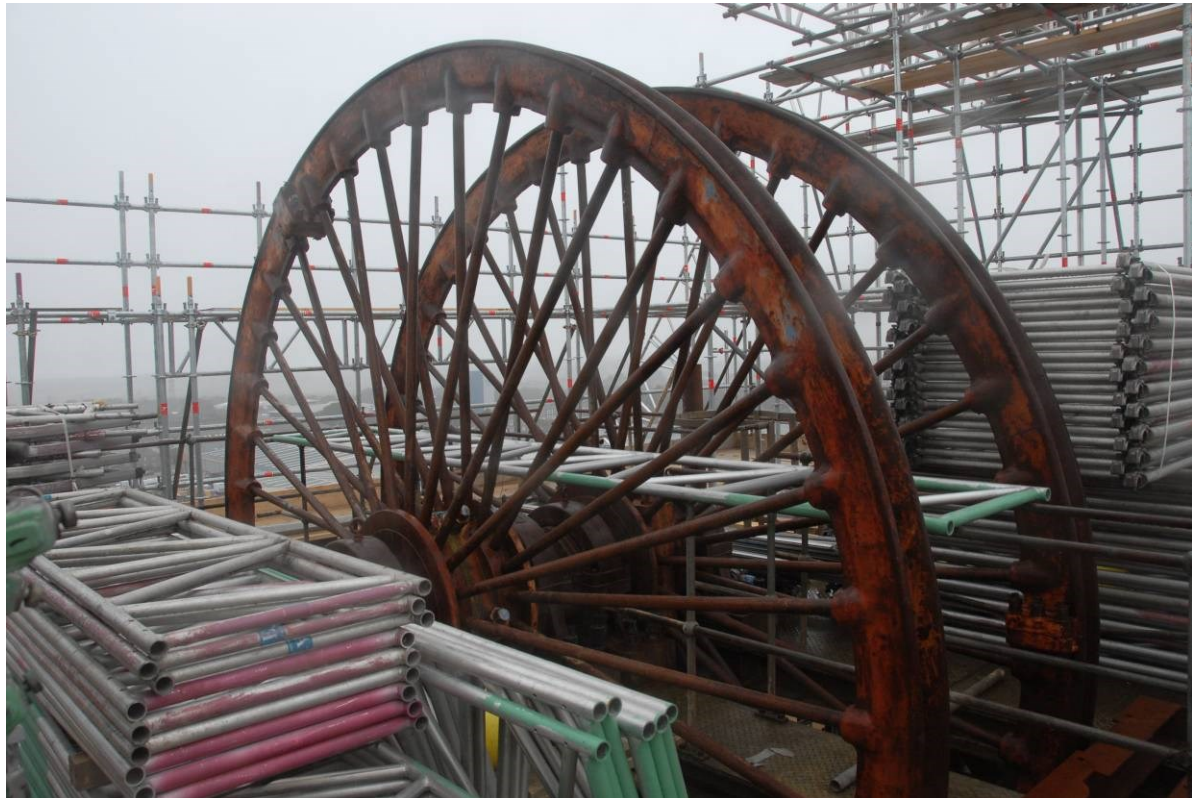
Fig 102. The older south headgear sheave wheels with their cast single piece rims prior to works.

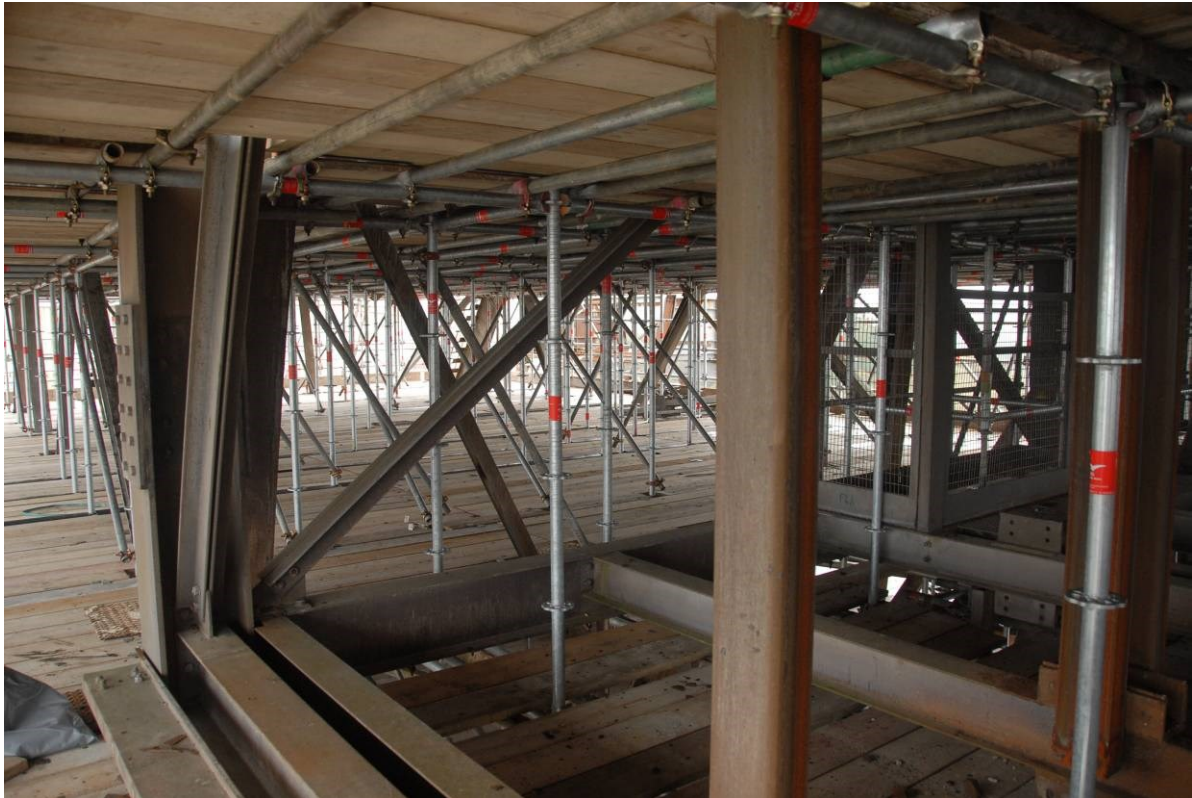
Fig 103. The central area of the headframe once scaffolding had been erected, but prior to grit blasting. Much of the steelwork was found to be in good condition.

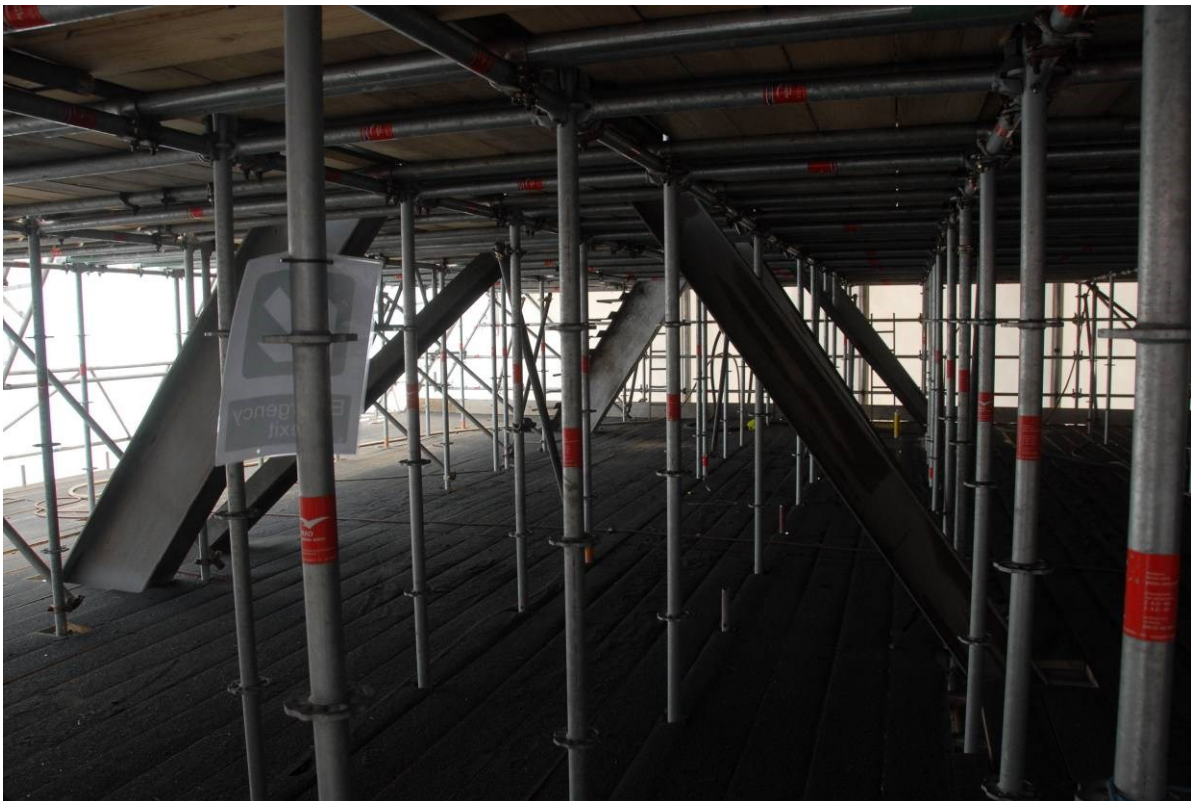
Fig 104. Within the south headframe following grit blasting. Recording this activity was impossible, given the high levels of noise and dust.

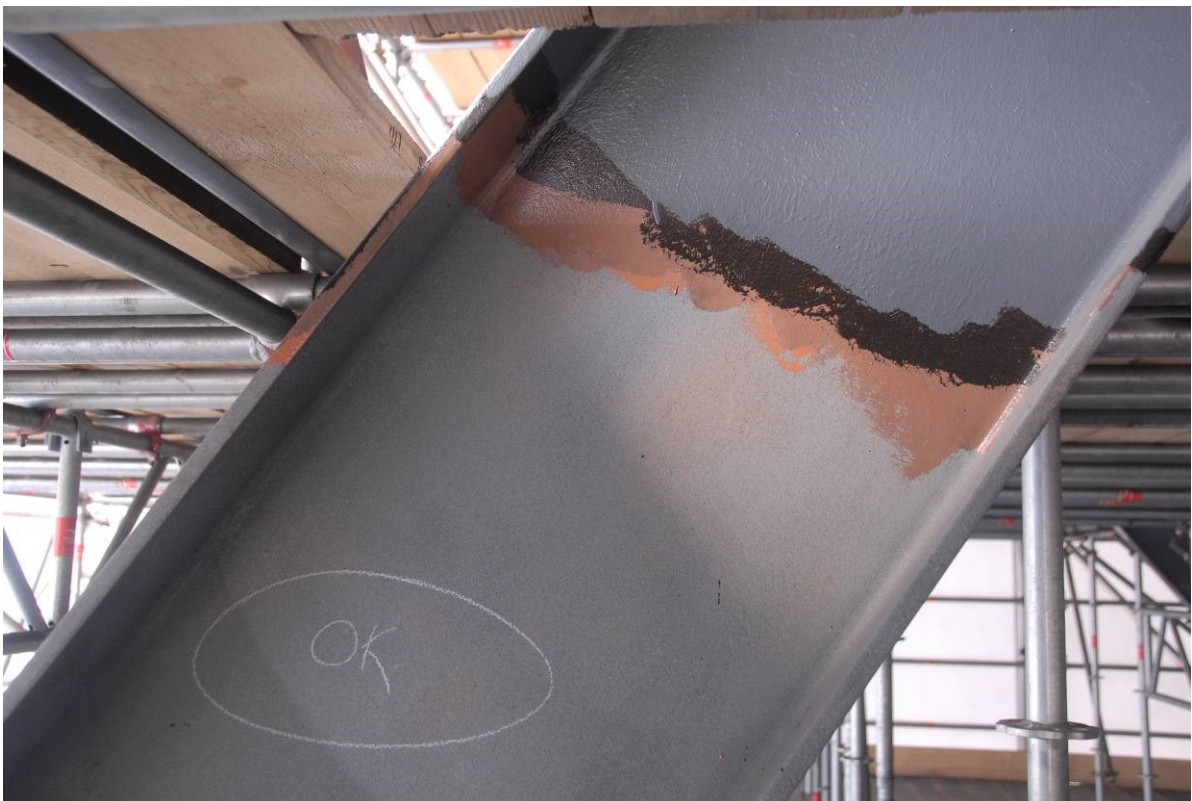
Fig 106. One of the south headframe raker legs showing (lower left) the grit blasted surface, (centre) the undercoat and mid coat) and upper right, the first of the paint top coats.

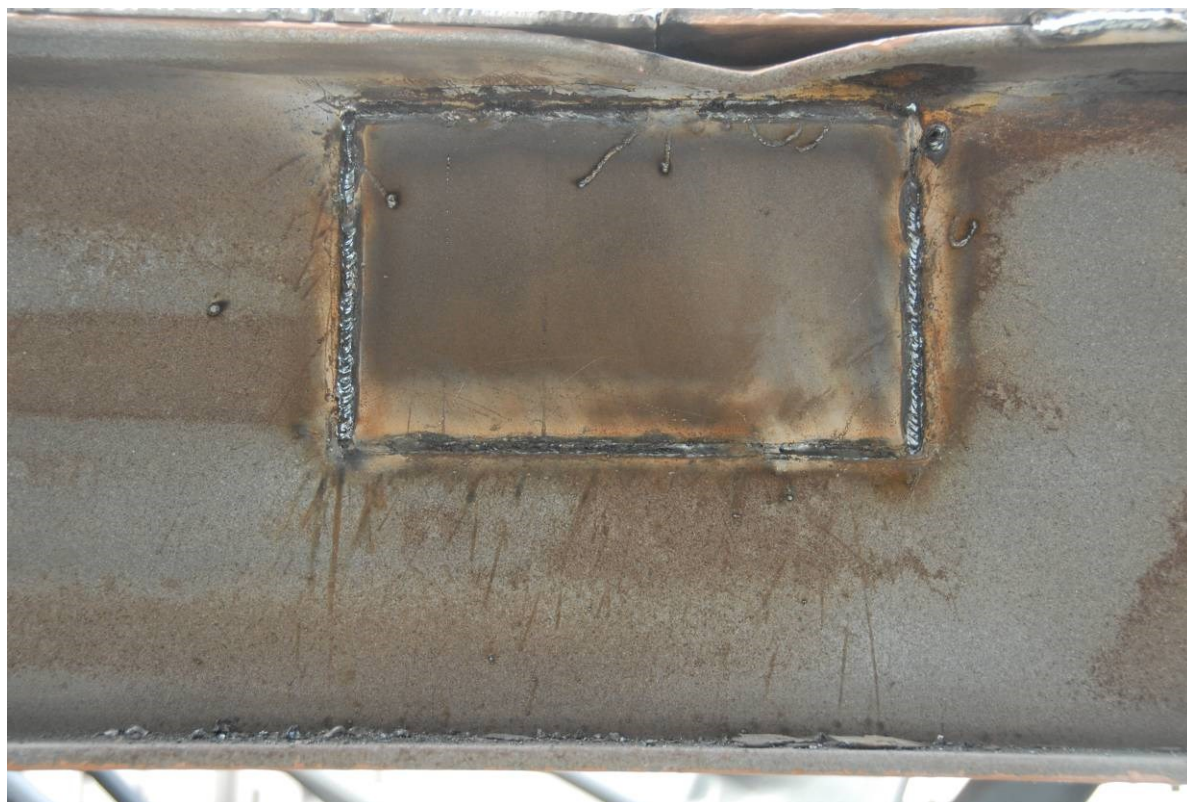
Fig 107. A plated patch on an area of corrosion on the web of a section of structural steel.

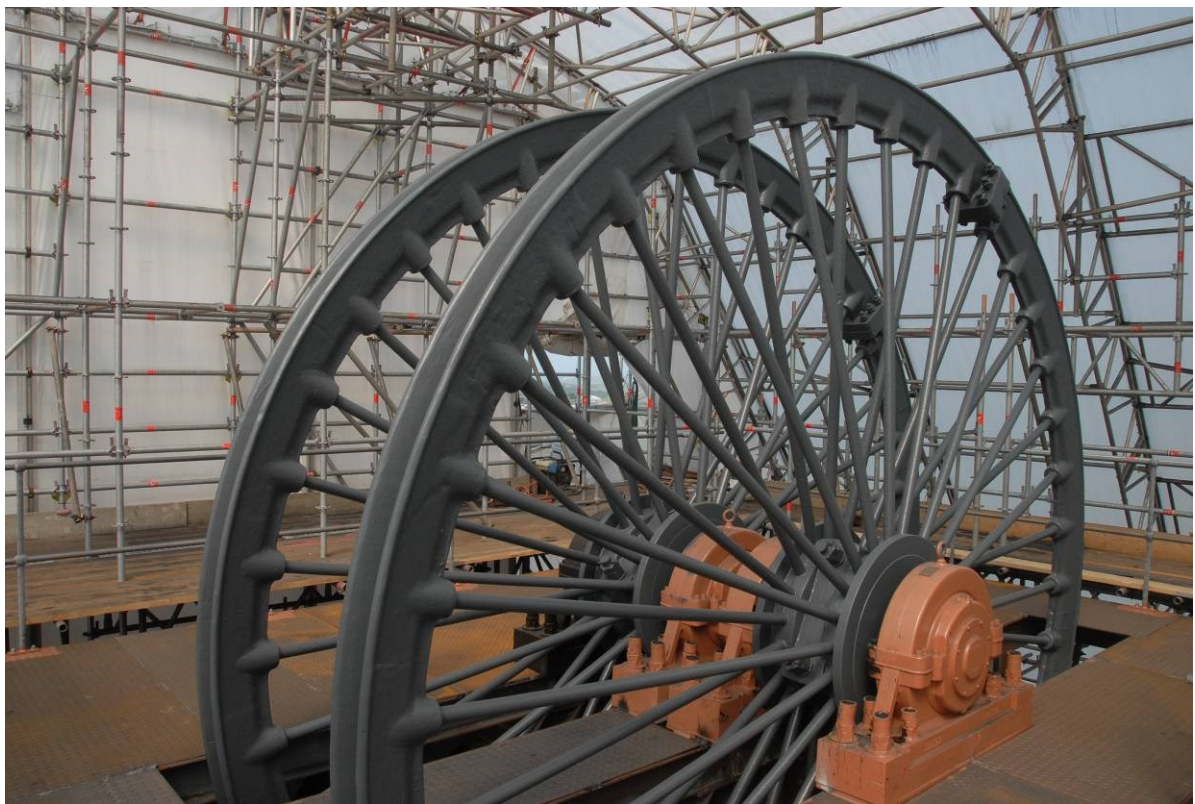
Fig 110. The south headgear sheave wheels in their grey top-coated finish.

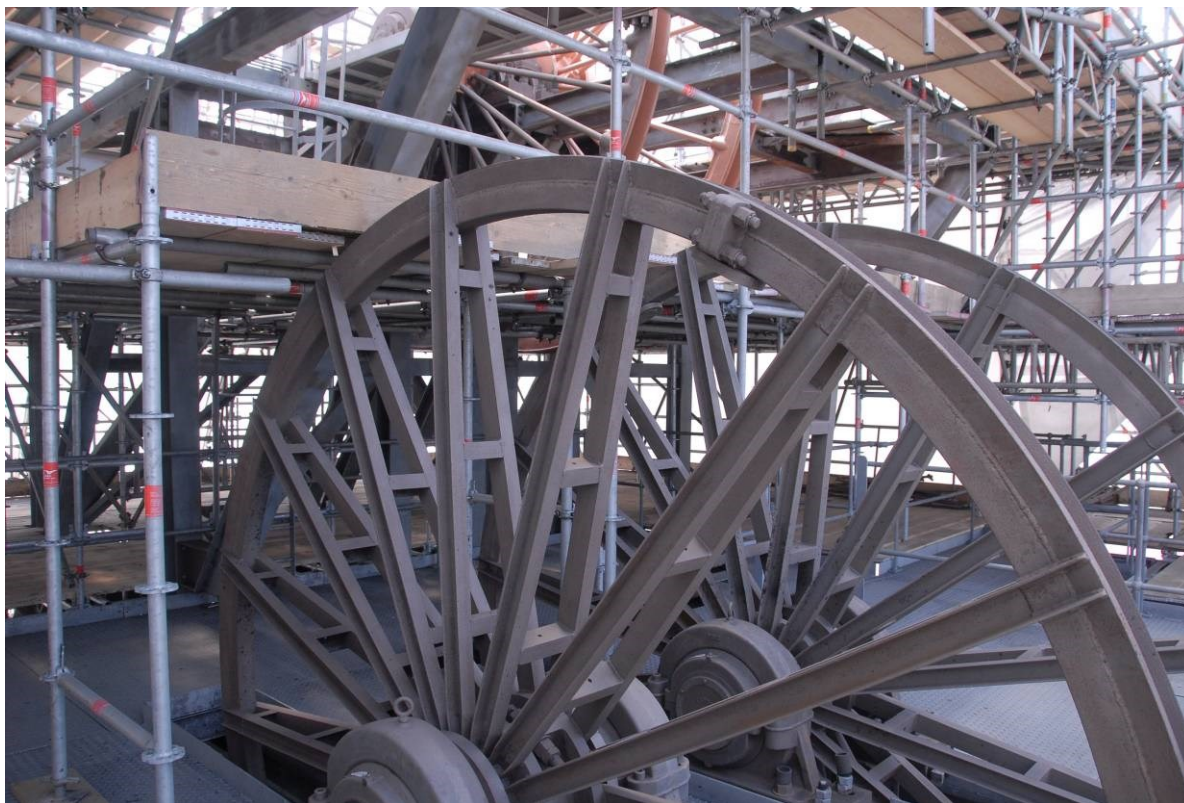
Fig 111. The north headgear sheave wheels following grit blasting.

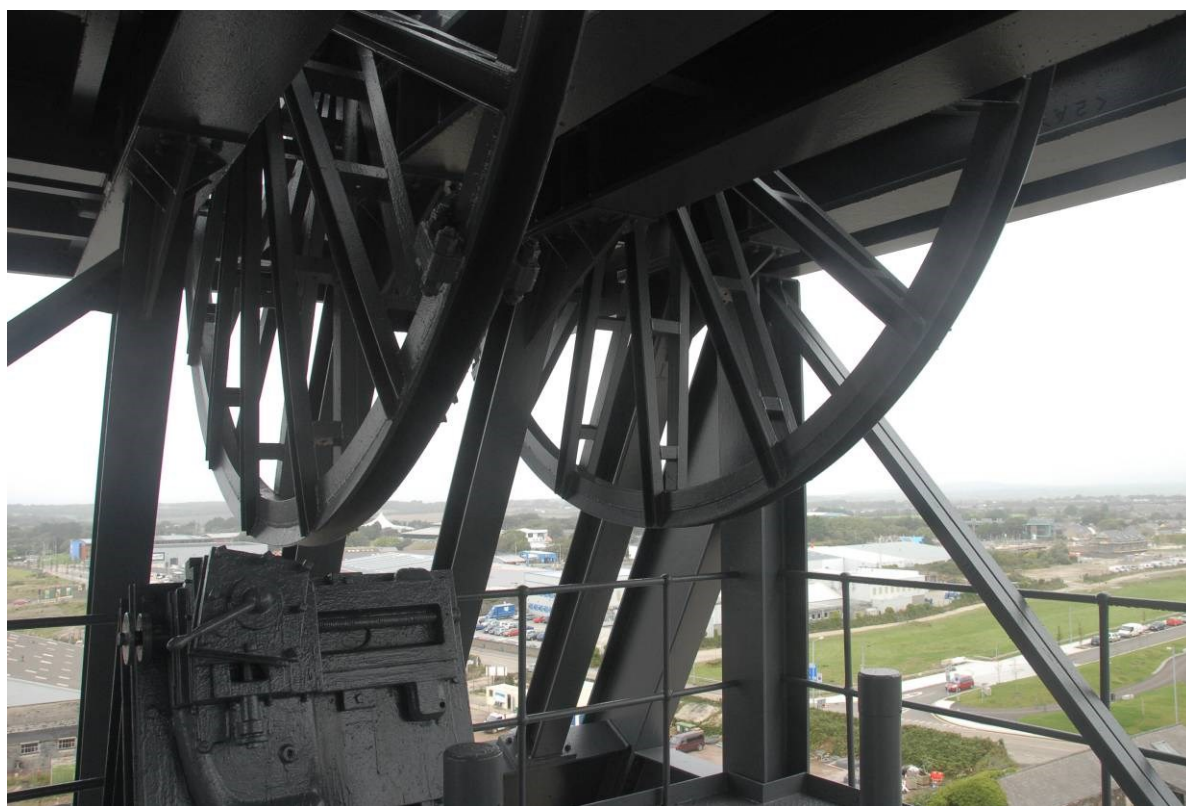
Fig 112. The north headgear sheave wheels following painting. Note the rope clamp (lower left) used when changing the winding ropes.

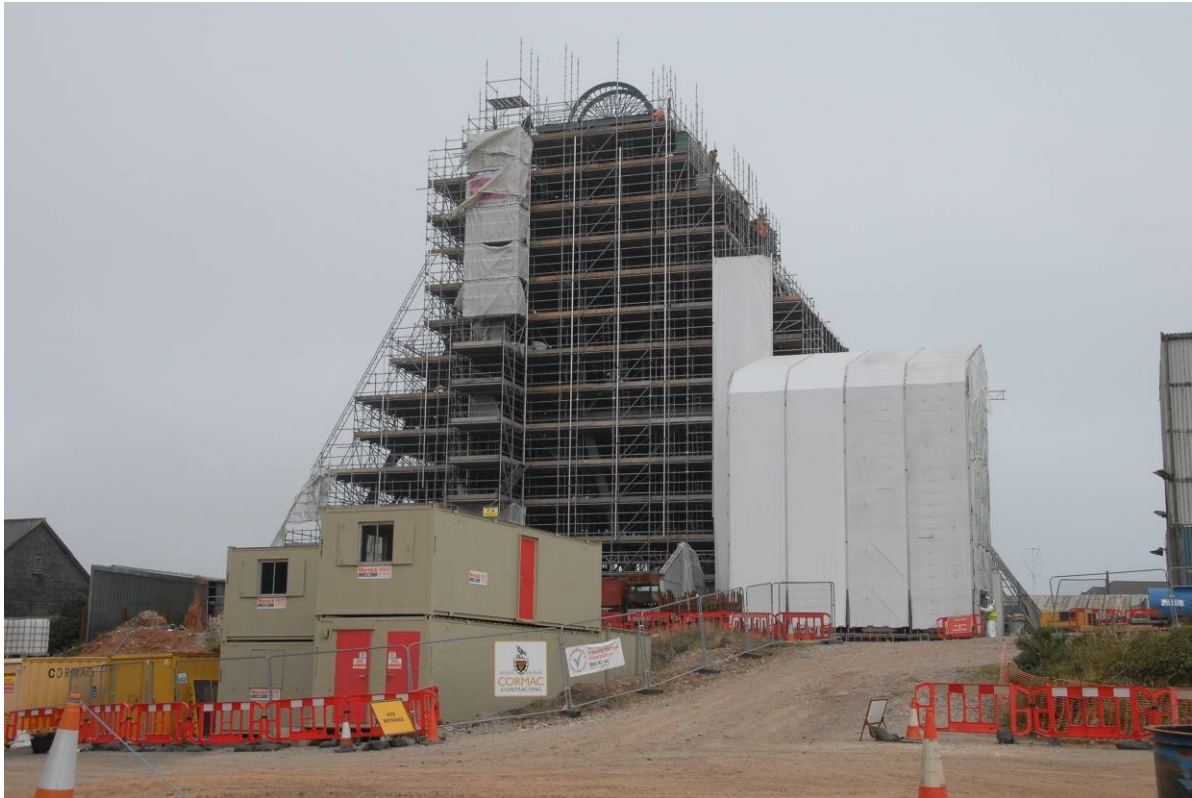
Fig 113. Stripping the headgear scaffolding under way, the sheeting having been removed. The sheeted structure in front covers the sheave wheel maintenance gantry, which was being painted at this time.

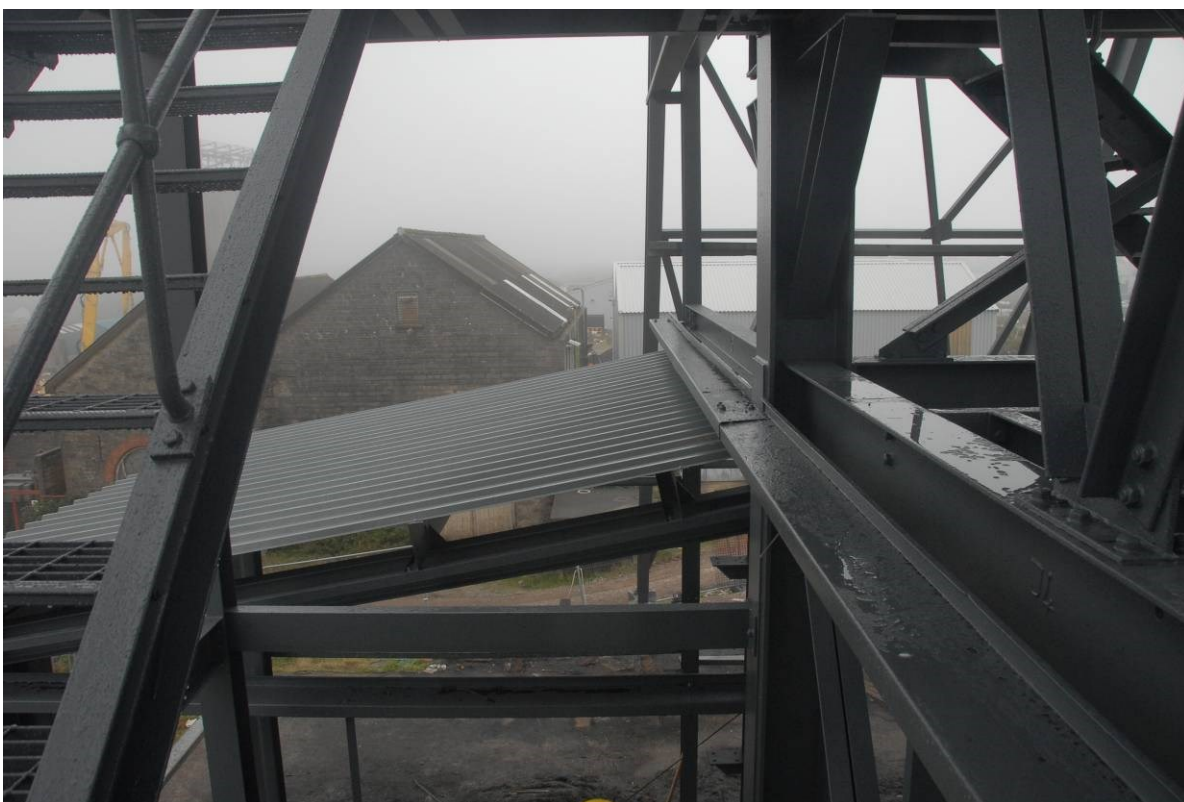
Fig 120. The replacement roofing under construction over the conveyor house in the north headframe.

The final works undertaken at the headframe were the removal of the temporary shaft cover, the reinstatement of the sheet steel cladding to the lower part of the headframe (Figs 120, 132-133), the installation of permanent lightning conductor protection and the enclosure of the headframe with a permanent security fence (Fig 136). It is anticipated that public access to the shaft and headframe will be assured in any future redevelopment of the South Crofty site.

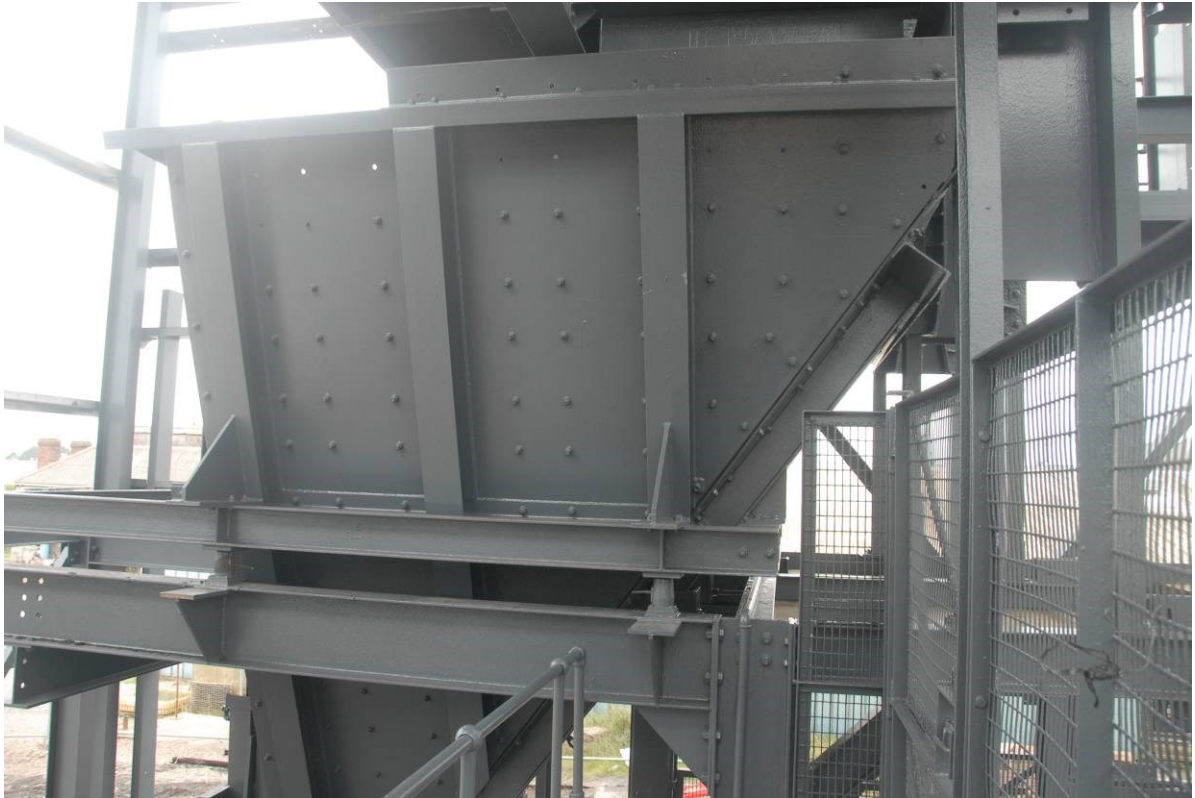
Fig 121. The grit blasted and painted conveyor feed hopper.

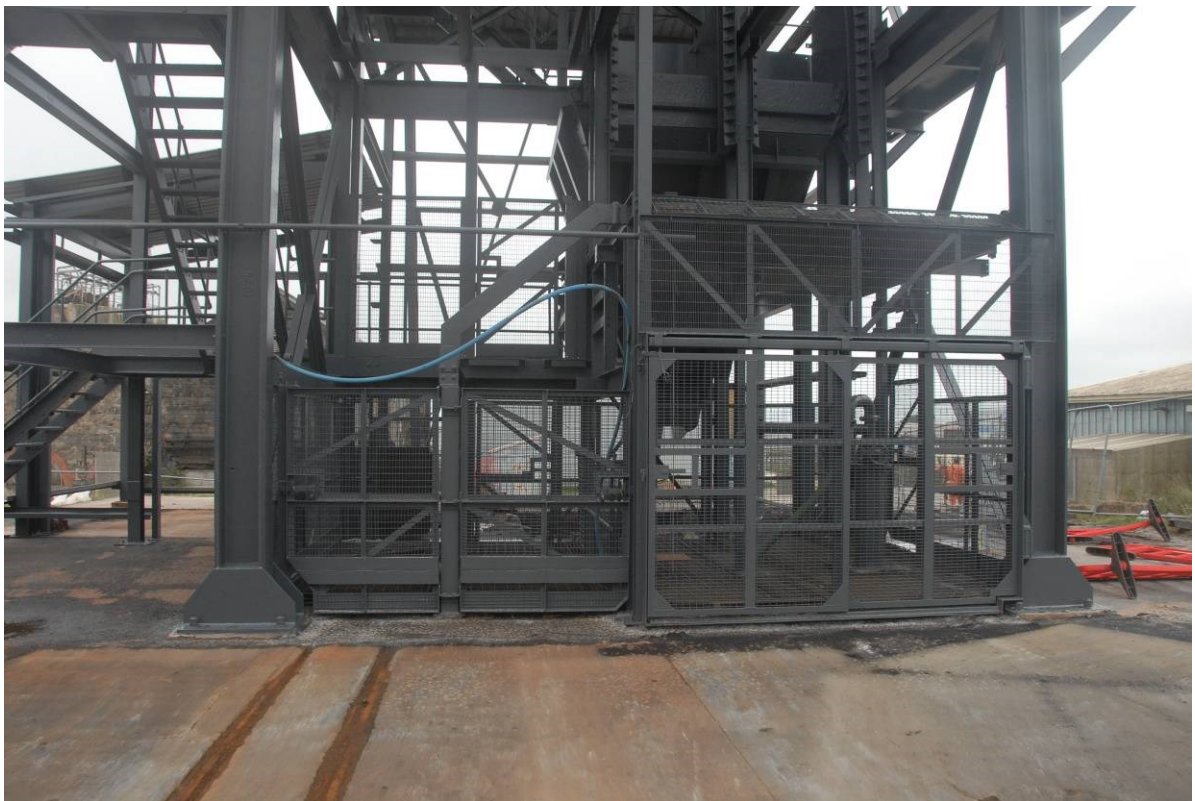
Fig 122. New Cook's Shaft surface shaft station from the south on completion of the works. Compare with Fig 83.

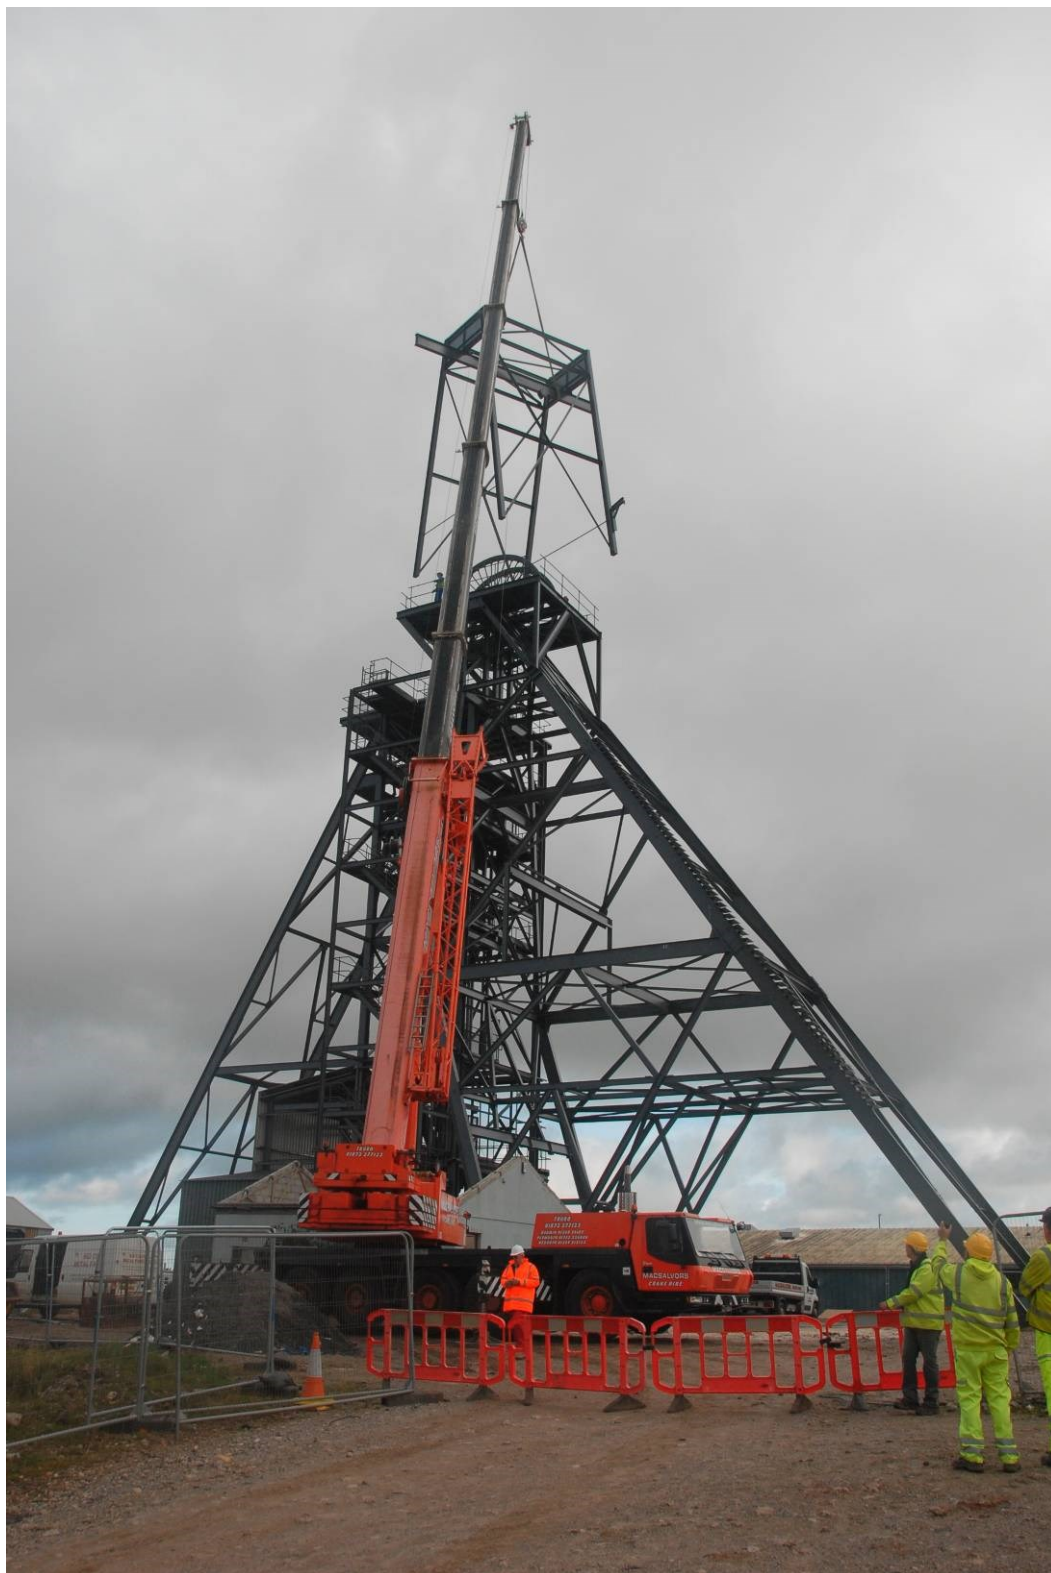
Fig 127. Craning on the sheave wheel maintenance gantry – a delicate operation, carried out with considerable skill by the crane driver.

At an early stage in the project there had been some suggestions that the sheave wheel maintenance gantry (Fig 94) might not be re-set on top of the headframe, in part due to the budget being inadequate to cover the costs of reinstatement. Historic Environment argued that this important element of the headframe should be re-set if at all possible – such features are now exceptionally rare in Cornwall (the only examples being at Victory Shaft, Geevor and at New Cook's Shaft, South Crofty). In addition, the gantry formed part of the well-know profile of the headframe – the considerable additional height it conferred to the headframe also made this landmark feature visible from a far wider area of the surrounding landscape. In the event, funds to undertake the work were identified, the gantry was sheeted over, grit blasted and painted using a mobile access platform, and, following the stripping of the overall scaffold structure (Fig 113-114), the gantry was re-located on the 7th October 2013, the occasion being taken for a small-scale topping out ceremony attended by the project partners and the local Cornwall Councillor (Figs 127-132).

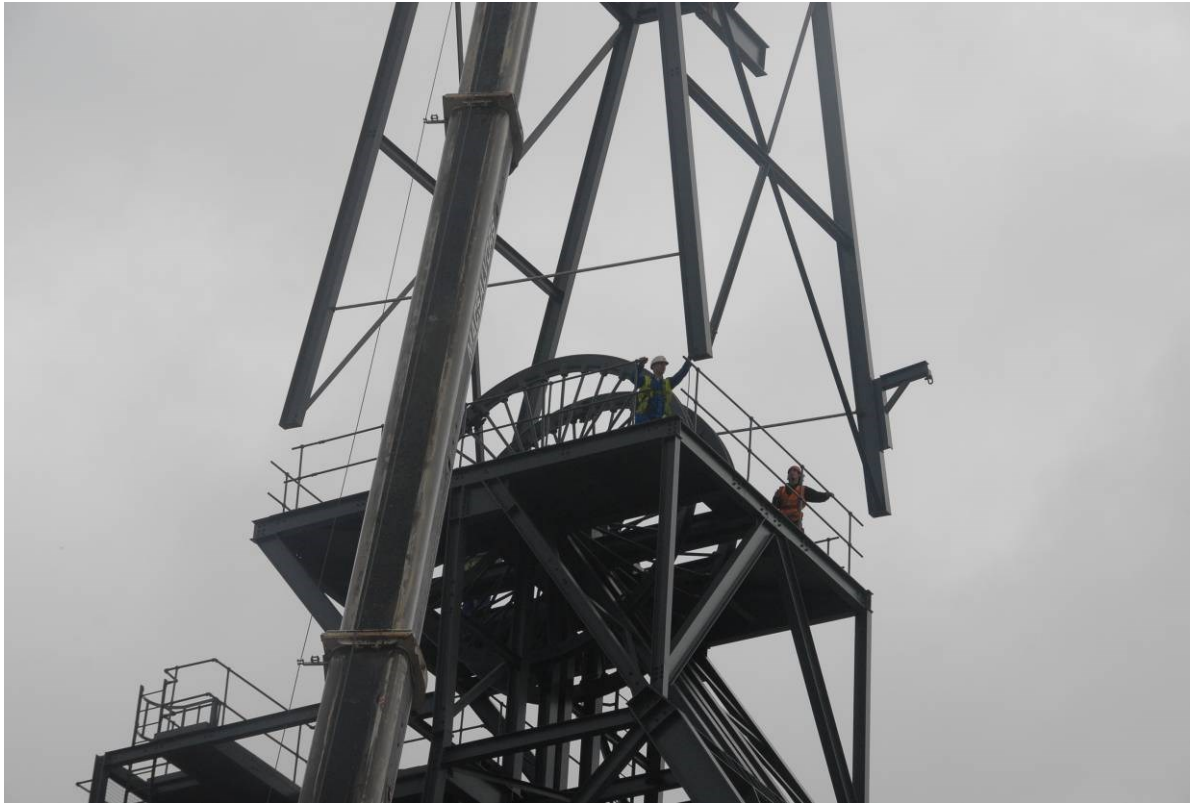
Fig 128. The final stages of craning on the sheave wheel maintenance gantry.

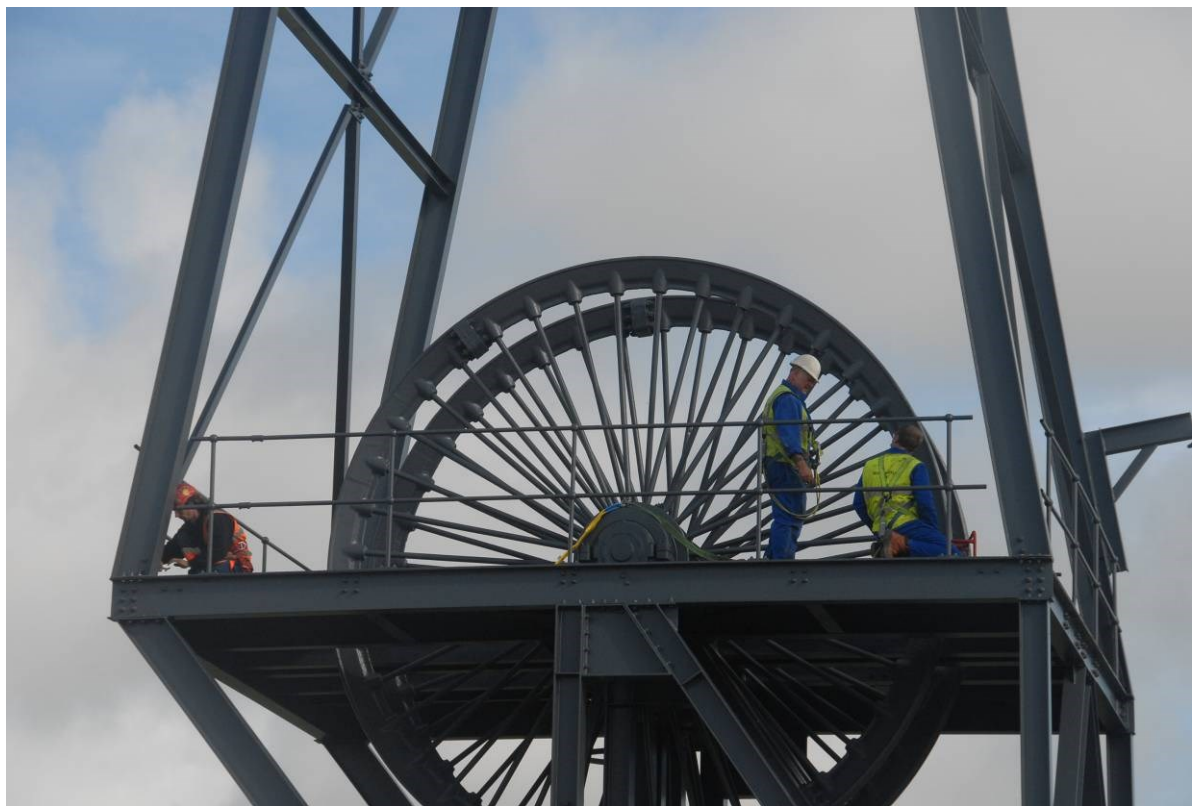
Fig 129. Bolting down the legs of the sheave wheel maintenance gantry.

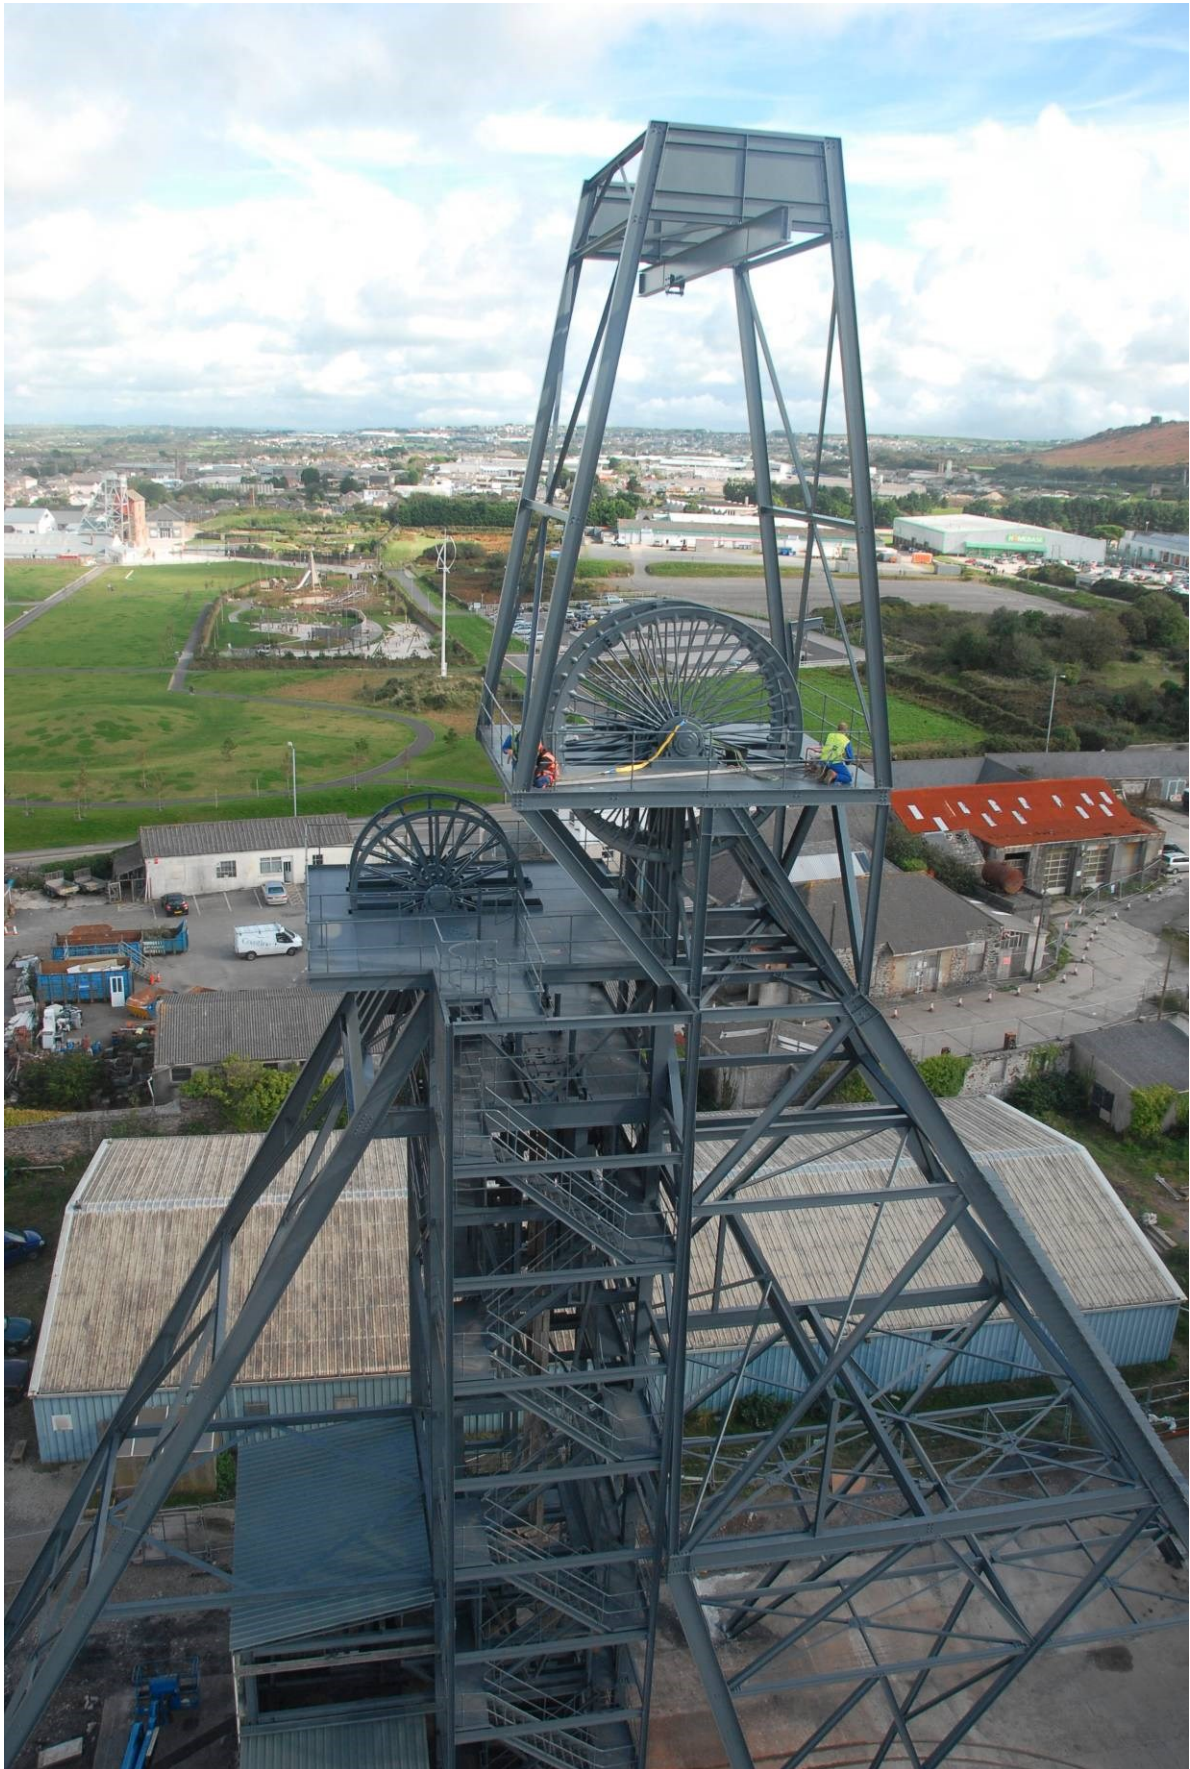
Fig 132. The completed headframe seen from the crane basket, with the landscape stretching out to Robinson's Shaft and Carn Brea in the background.

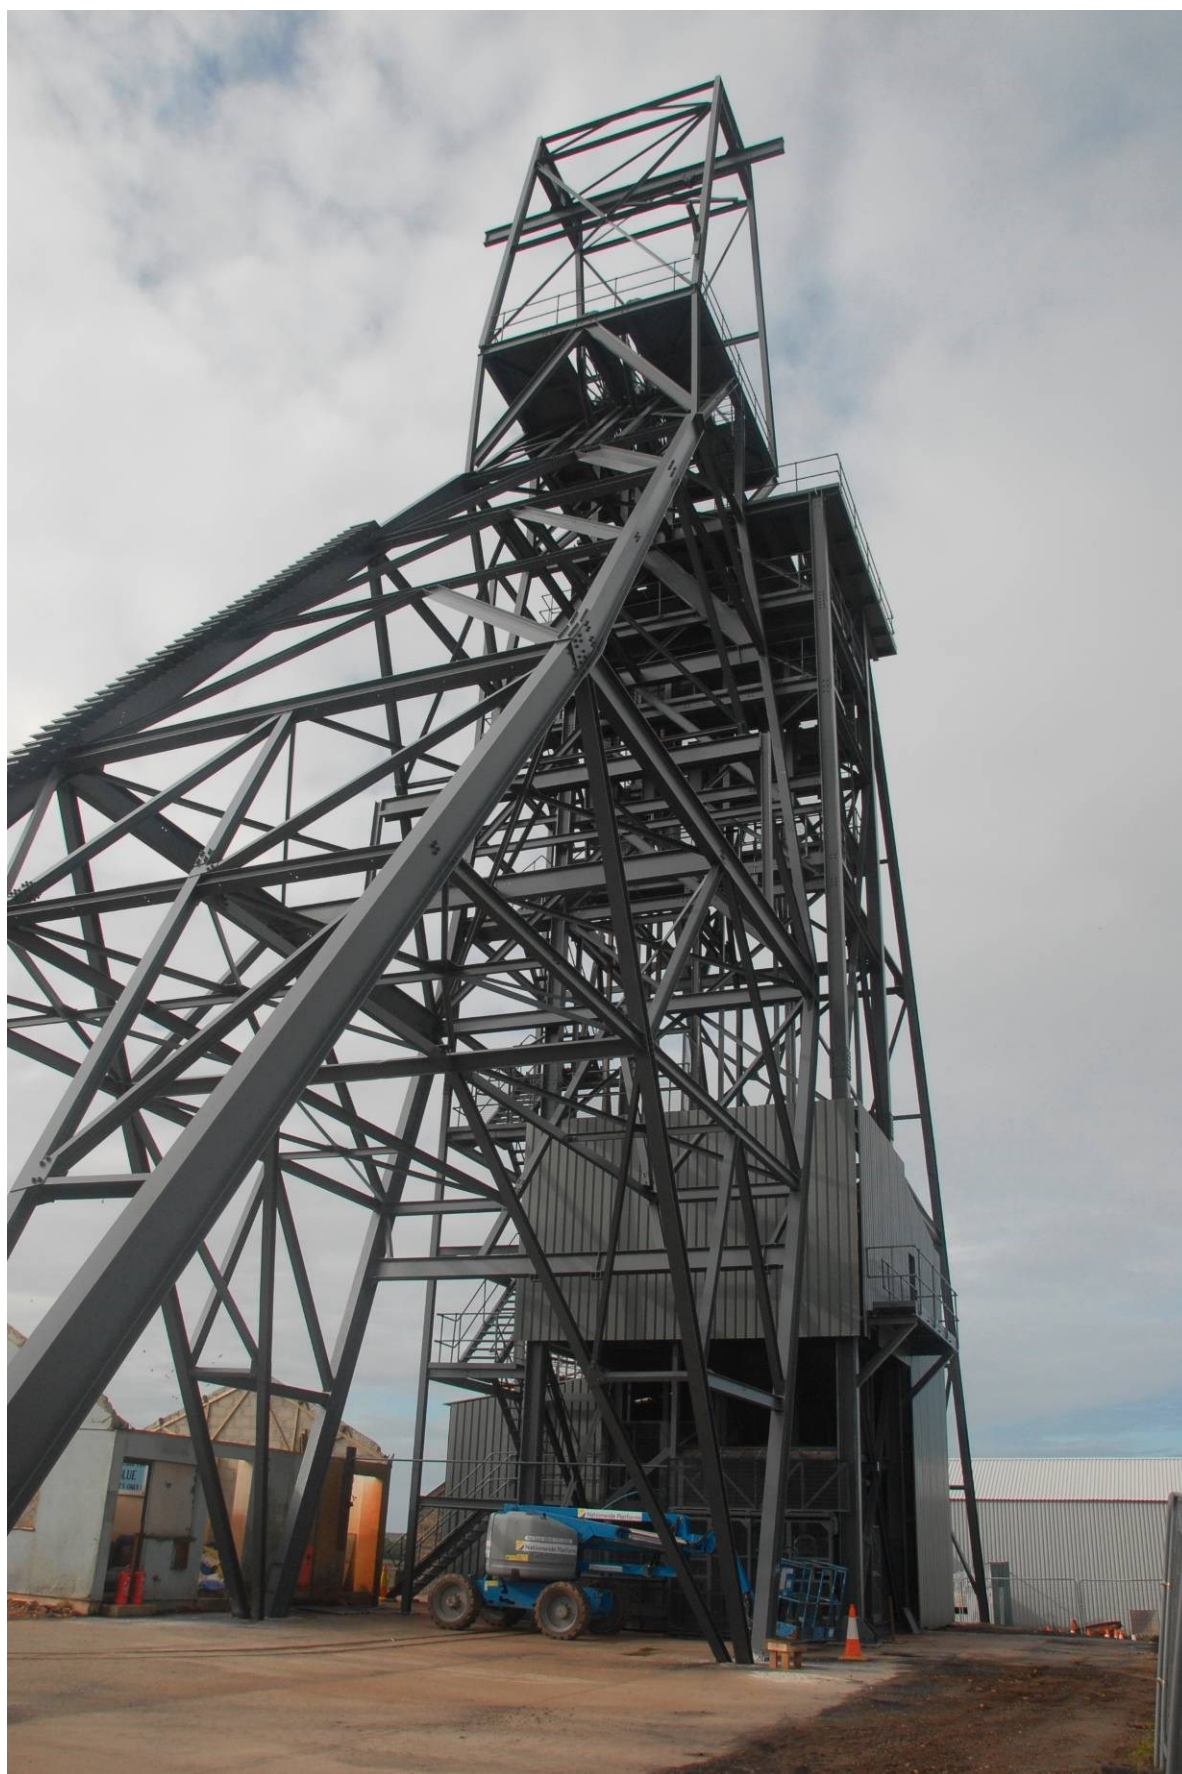
Fig 133. The completed headframe from the south east.
