New Cook's Kitchen Shaft, South Crofty and Chapple's Shaft, Cook's Kitchen, Pool, Cornwall

**Historic Environment Consultancy during
conservation works to structures**

Client	Cornwall Council
Report Number	2013R080
Date	04 February 2014
Status	Final
Report author	Adam Sharpe BA MIfA
Checked by	Dr. Andy Jones MA MiFA
Approved by	Andrew Young MIfA

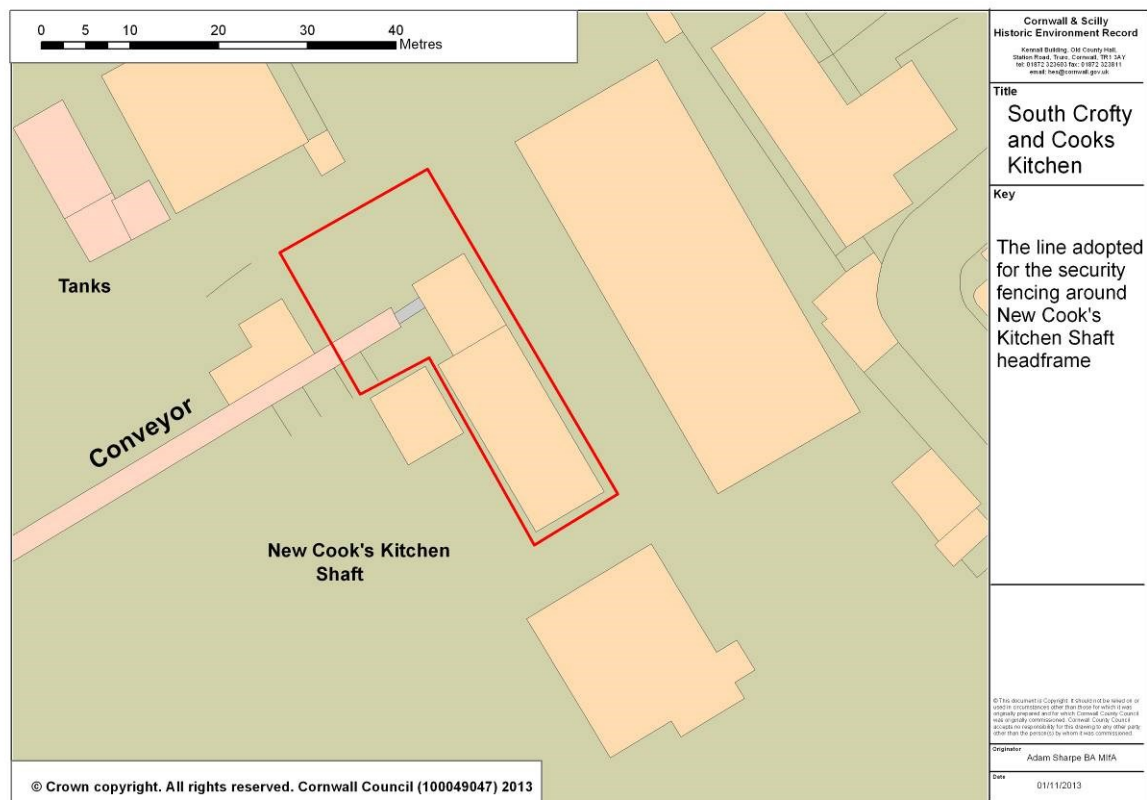
Fig 136. The line of the security fencing around New Cook's Kitchen headframe.

A second security fence, this time on galvanised steel posts, was erected around New Cook's headframe in order to secure both the headframe and shaft from unauthorised access (Fig 136). The majority of the fence run (to the east, south and west) was bolted down to the concrete pad surrounding the headframe. To the north, the original ground levels sloped down to the nearby mine roadway and were built up in reclaimed material revetted by large blocks of site-won granite. The fence posts in this area were concreted in place. There were no archaeological implications to this work.
