# **Tolgus Arsenic Works, Cornwall**

## **Report of archaeological management work**

### **Report of management work: roof repairs, scrub clearance and recording**

<b>Client</b>	<b>English Heritage, Cornwall Heritage Trust</b>
<b>Report Number</b>	<b>2014R048</b>
<b>Date</b>	<b>June 2014</b>
<b>Status</b>	<b>Final</b>
<b>Report author(s)</b>	<b>Ann Preston-Jones, Adam Sharpe</b>
<b>Checked by</b>	<b>Jacky Nowakowski</b>
<b>Approved by</b>	<b>Andrew Young</b>

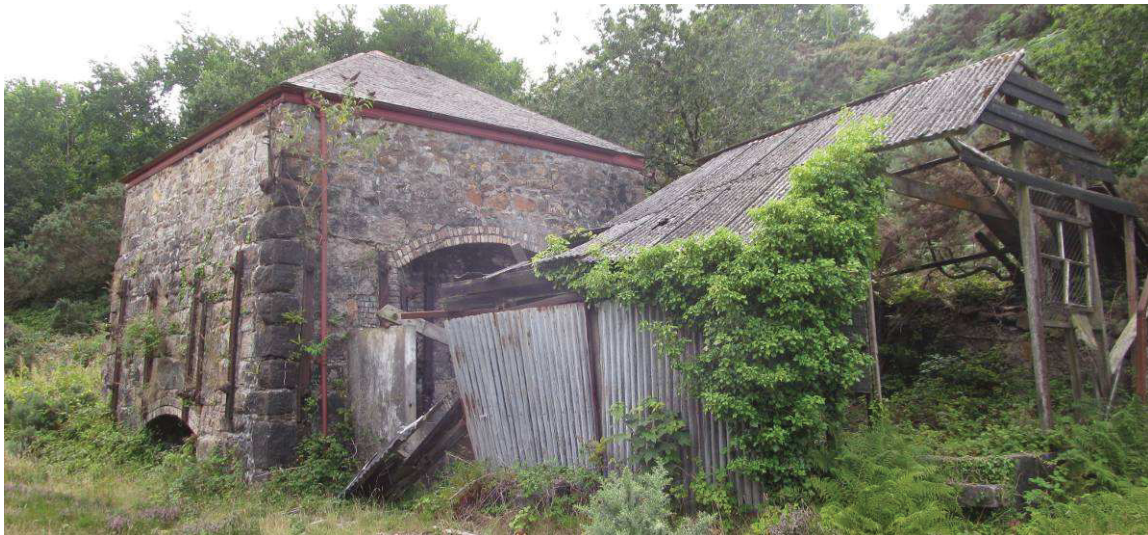
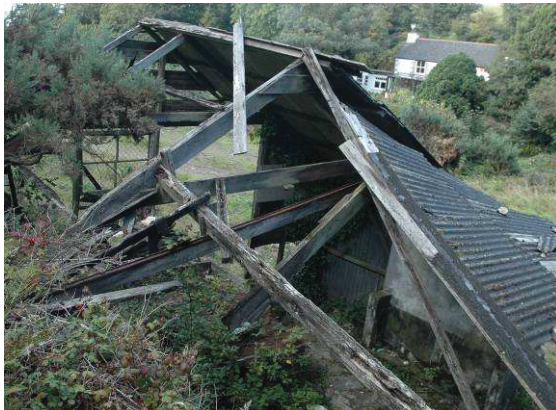
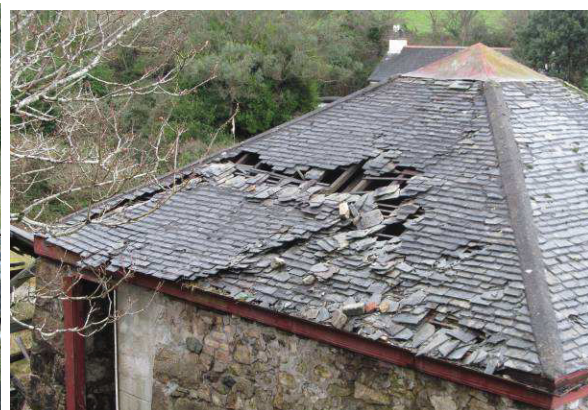
Three pictures illustrate the sorry state of the calciner and fuel store. Above is the site from the NE in 2013; below are views of the damaged roofs of the fuel store (left) and the calciner (right).
