Glasney College, Penryn, Cornwall

Report of conservation management work

Client	English Heritage, Cornwall Heritage Trust
Report Number	2014R012
Date	July 2014
Status	Final
Report author(s)	Ann Preston-Jones
Checked by	Jacky Nowakowski
Approved by	Andrew Young

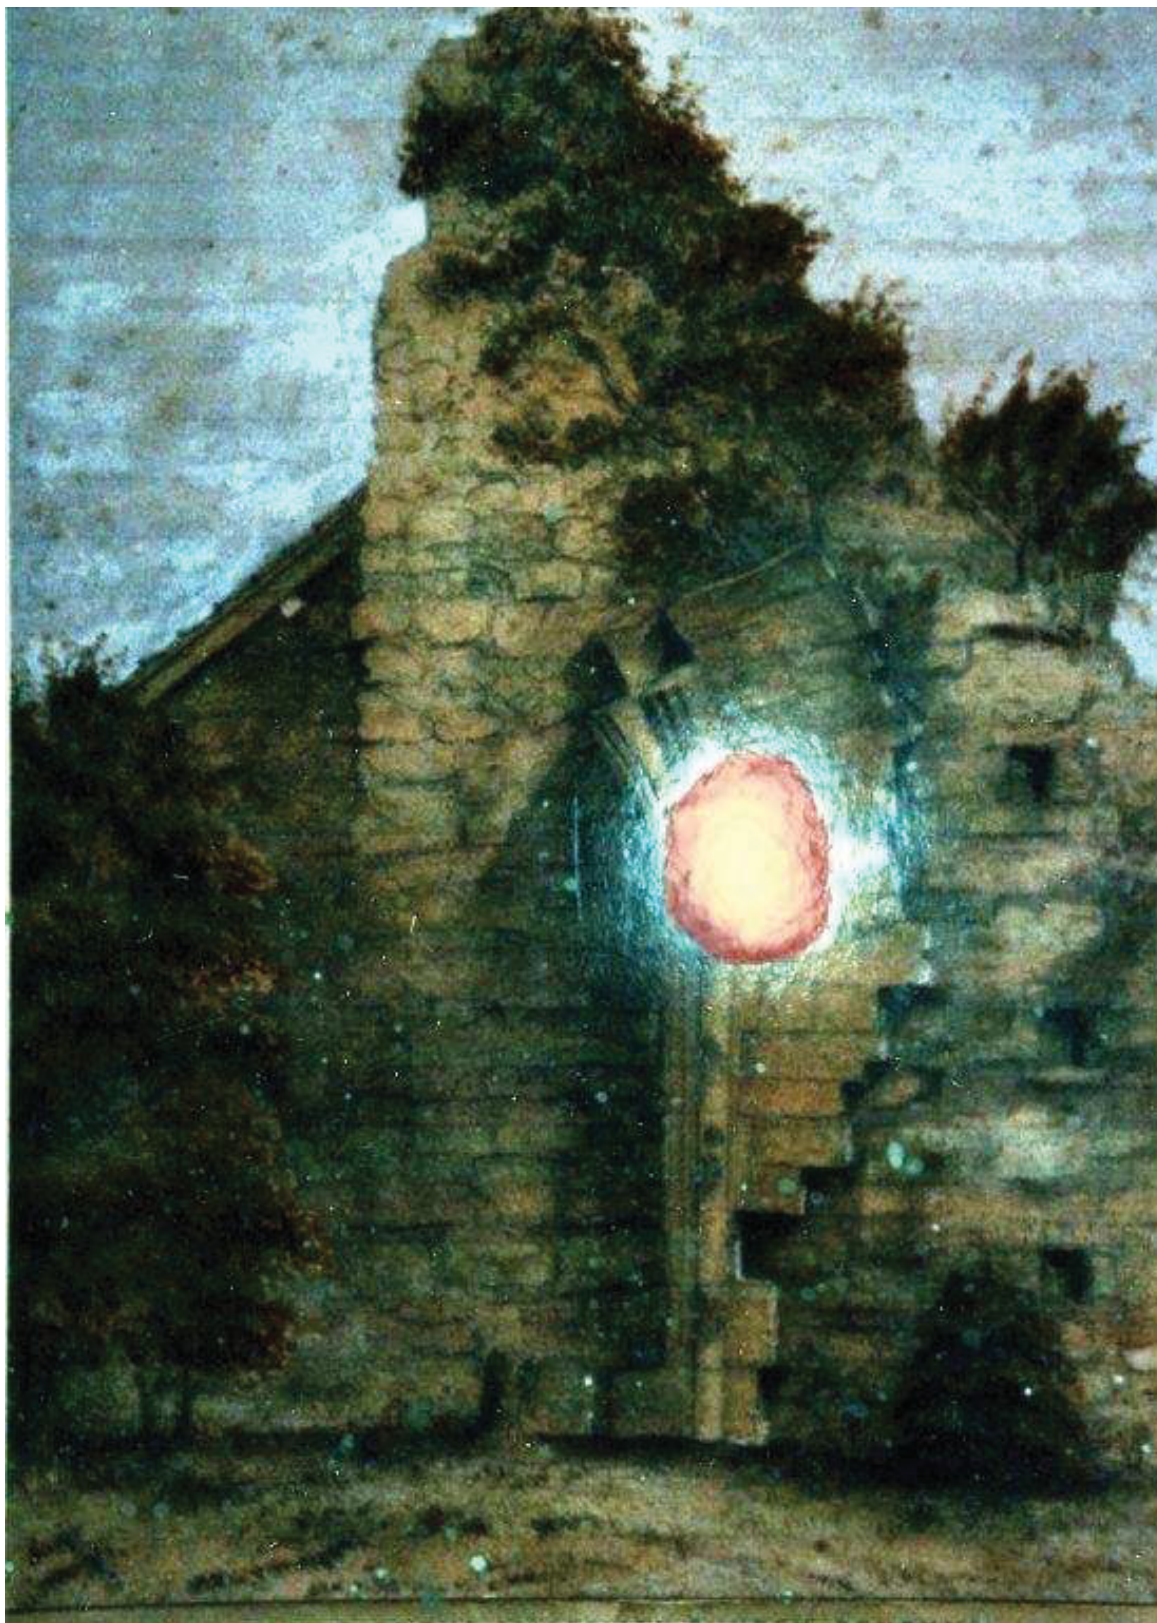
In the process of undertaking this work, three massive putlog holes in an approximately vertical line were 'rediscovered' in the west (corework) face on the wall. These holes are visible on early depictions of the wall (for example Fig 7) but had become lost to sight beneath the vegetation which has enveloped the wall in recent years. One had had the stove pipe inserted in it. All - especially the bottom one - had proved a route for the penetration of ivy.

Fig 7 Nineteenth century depiction of the ruined college wall and former cottage, image courtesy of Barry Searle. Note the putlog holes can be seen in the wall face on the right

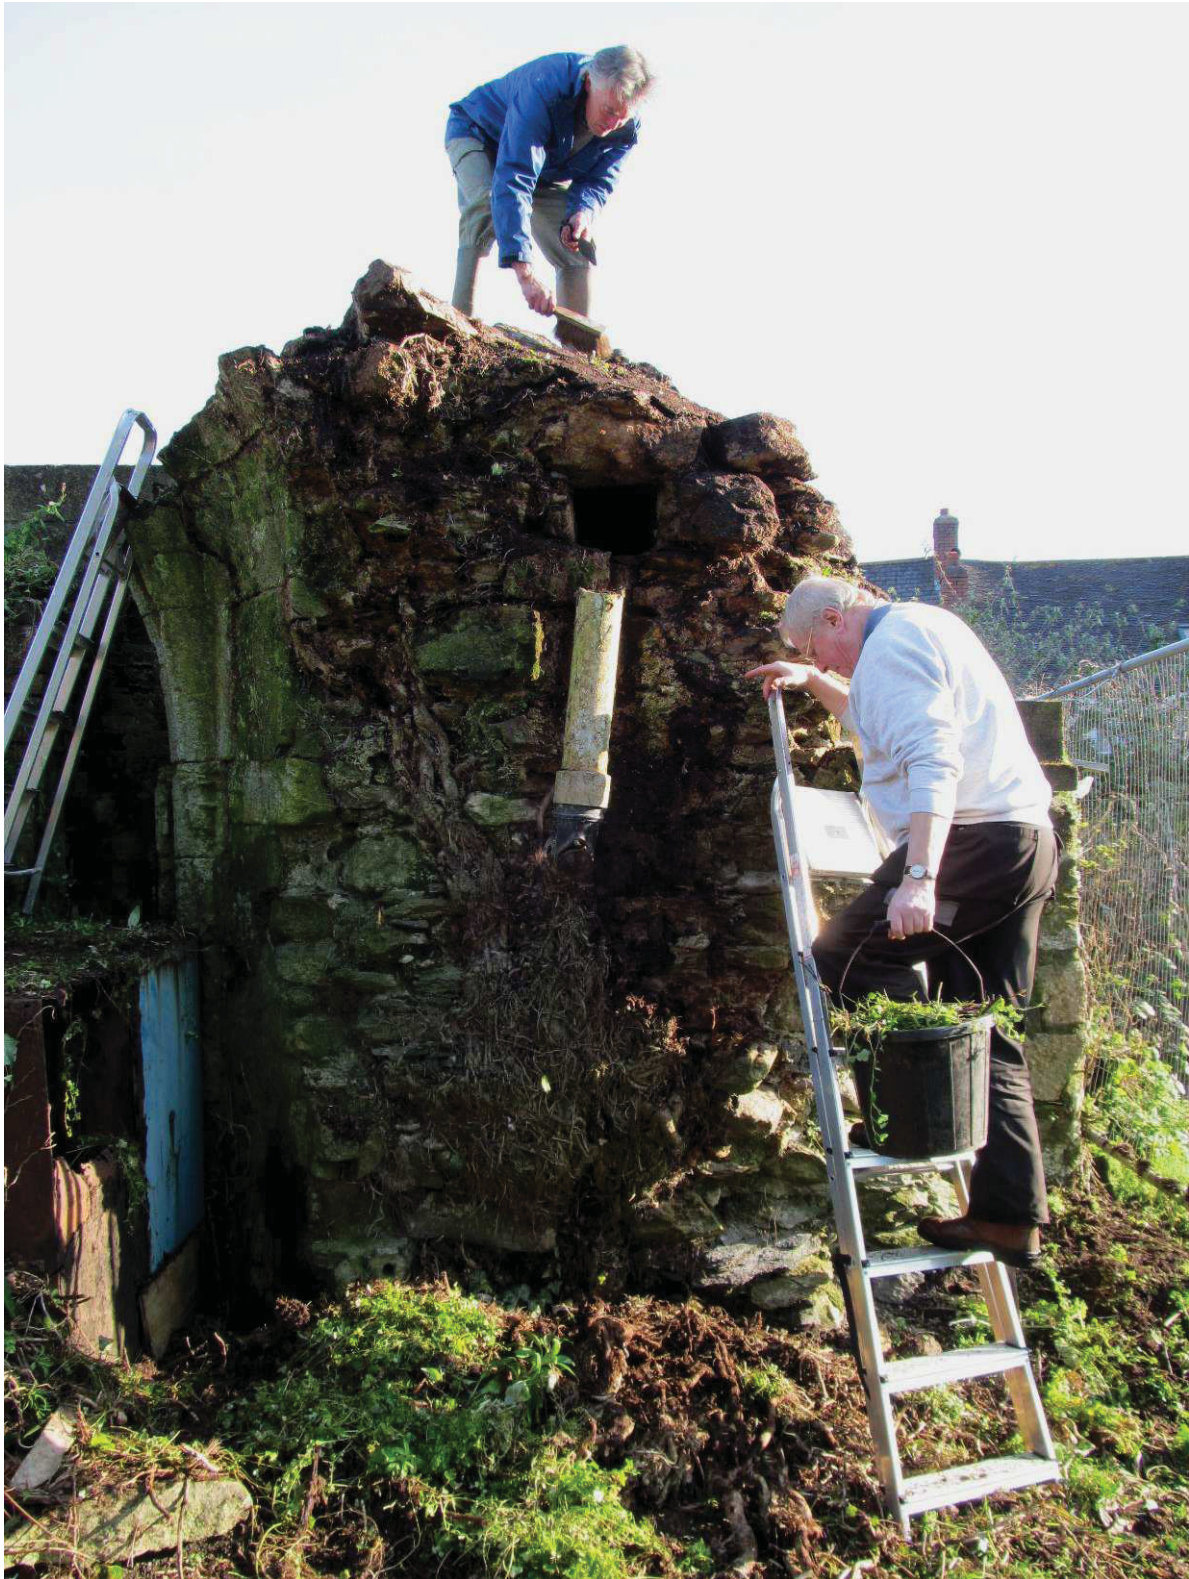
Fig 10 Volunteers John Kirby and Alex Hooper clearing vegetation from the ruined wall in January 2013. The stove pipe is clear and above it, one of the three putlog holes seen in Fig 7 has re-emerged

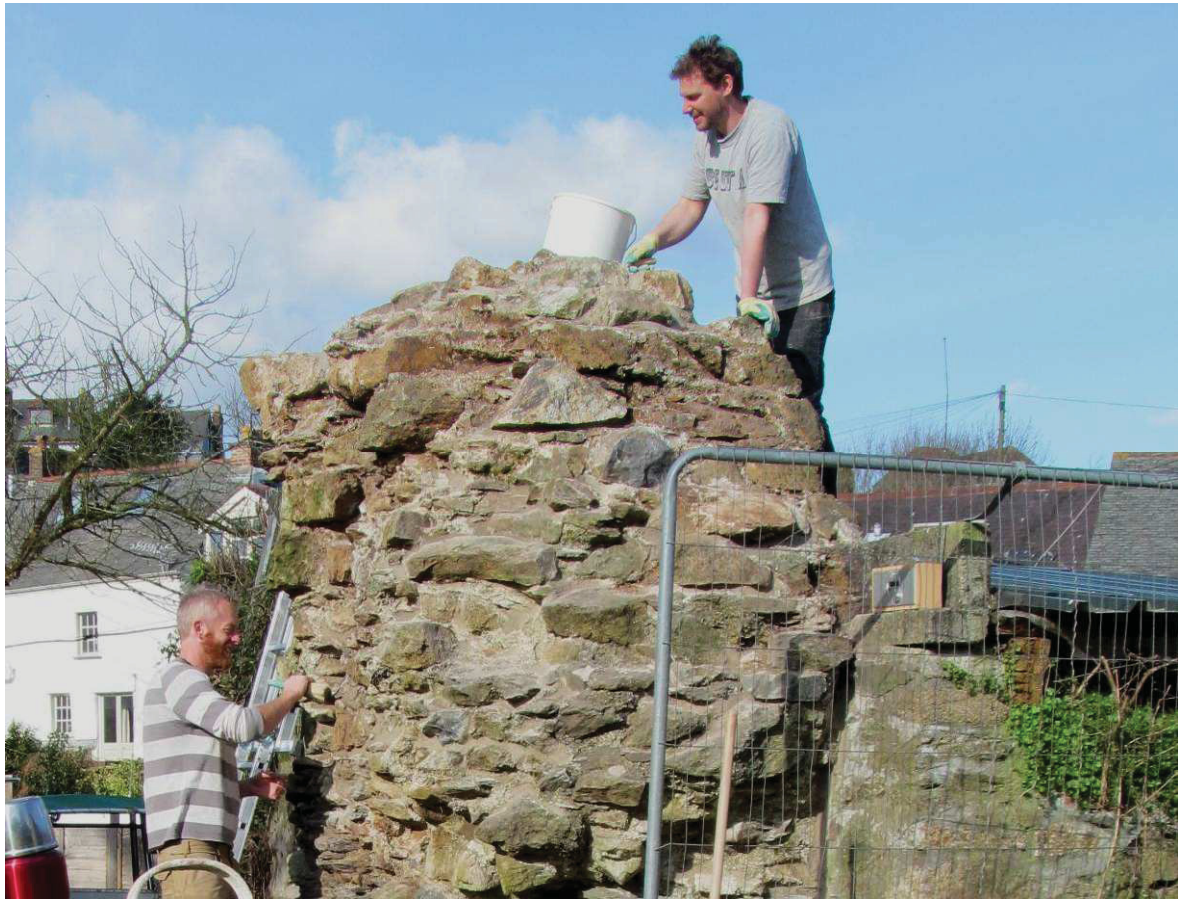
Fig 11 Tim Lake and Joe Morris conserving the Glasney ruin in March 2013

Working with owners of the wall and a range of other partners and volunteers, this project sought to conserve the ruin by pointing in lime mortar, securing vulnerable stones and stitching together a large crack which had developed as a result of ivy growth. At the same time, the Heras fencing was replaced with a new, bespoke, fence to protect the boundary.

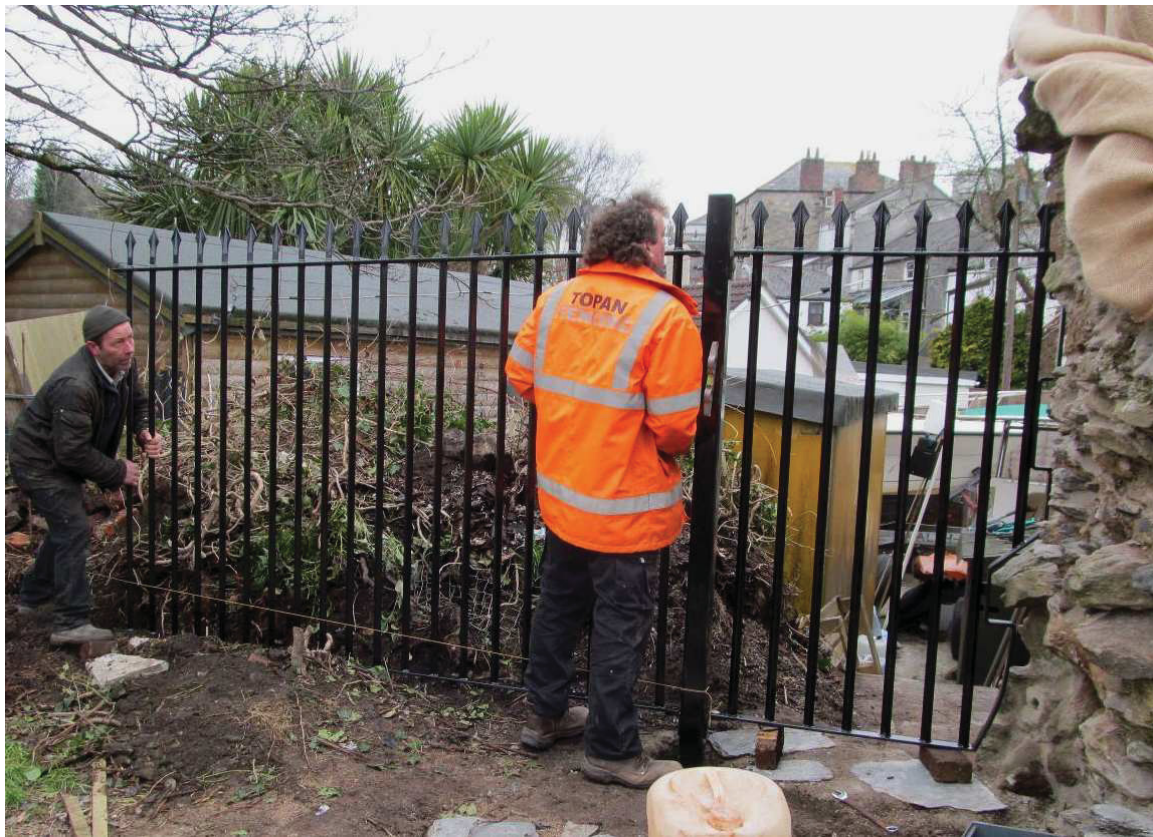
Fig 16 Ian Wilton and Fred Hooper installing the new fence in March 2013

The new fence was installed by Ian Wilton and Fred Hooper of Topan Fencing on Monday 25th March 2013 (Fig 16).

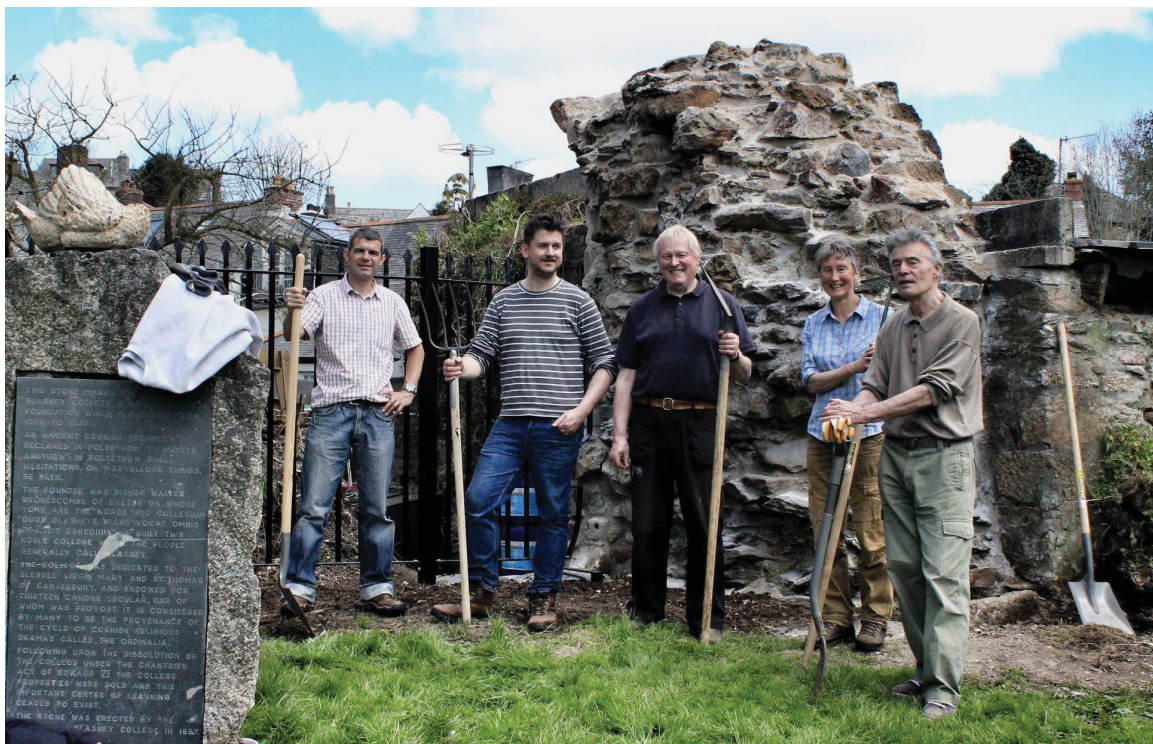
Fig 17 The final tidy-up: from left to right: Alan Jeffrey, Rupert Ellis, John Kirby, APJ, Alex Hooper

On Tuesday 30th April, a final day of vegetation and rubbish clearance was undertaken by the volunteers under the leadership of Alan Jeffrey, to tidy up the site after works (Fig 17).
