Trelill holy well, Helston, Cornwall

Conservation and restoration

Trelill holy well final APJ July 2014

Client	English Heritage, Cornwall Heritage Trust
Report Number	2014R039
Date	July 2014
Status	Final
Report author(s)	Ann Preston-Jones
Checked by	Jacky Nowakowski
Approved by	Andrew Young

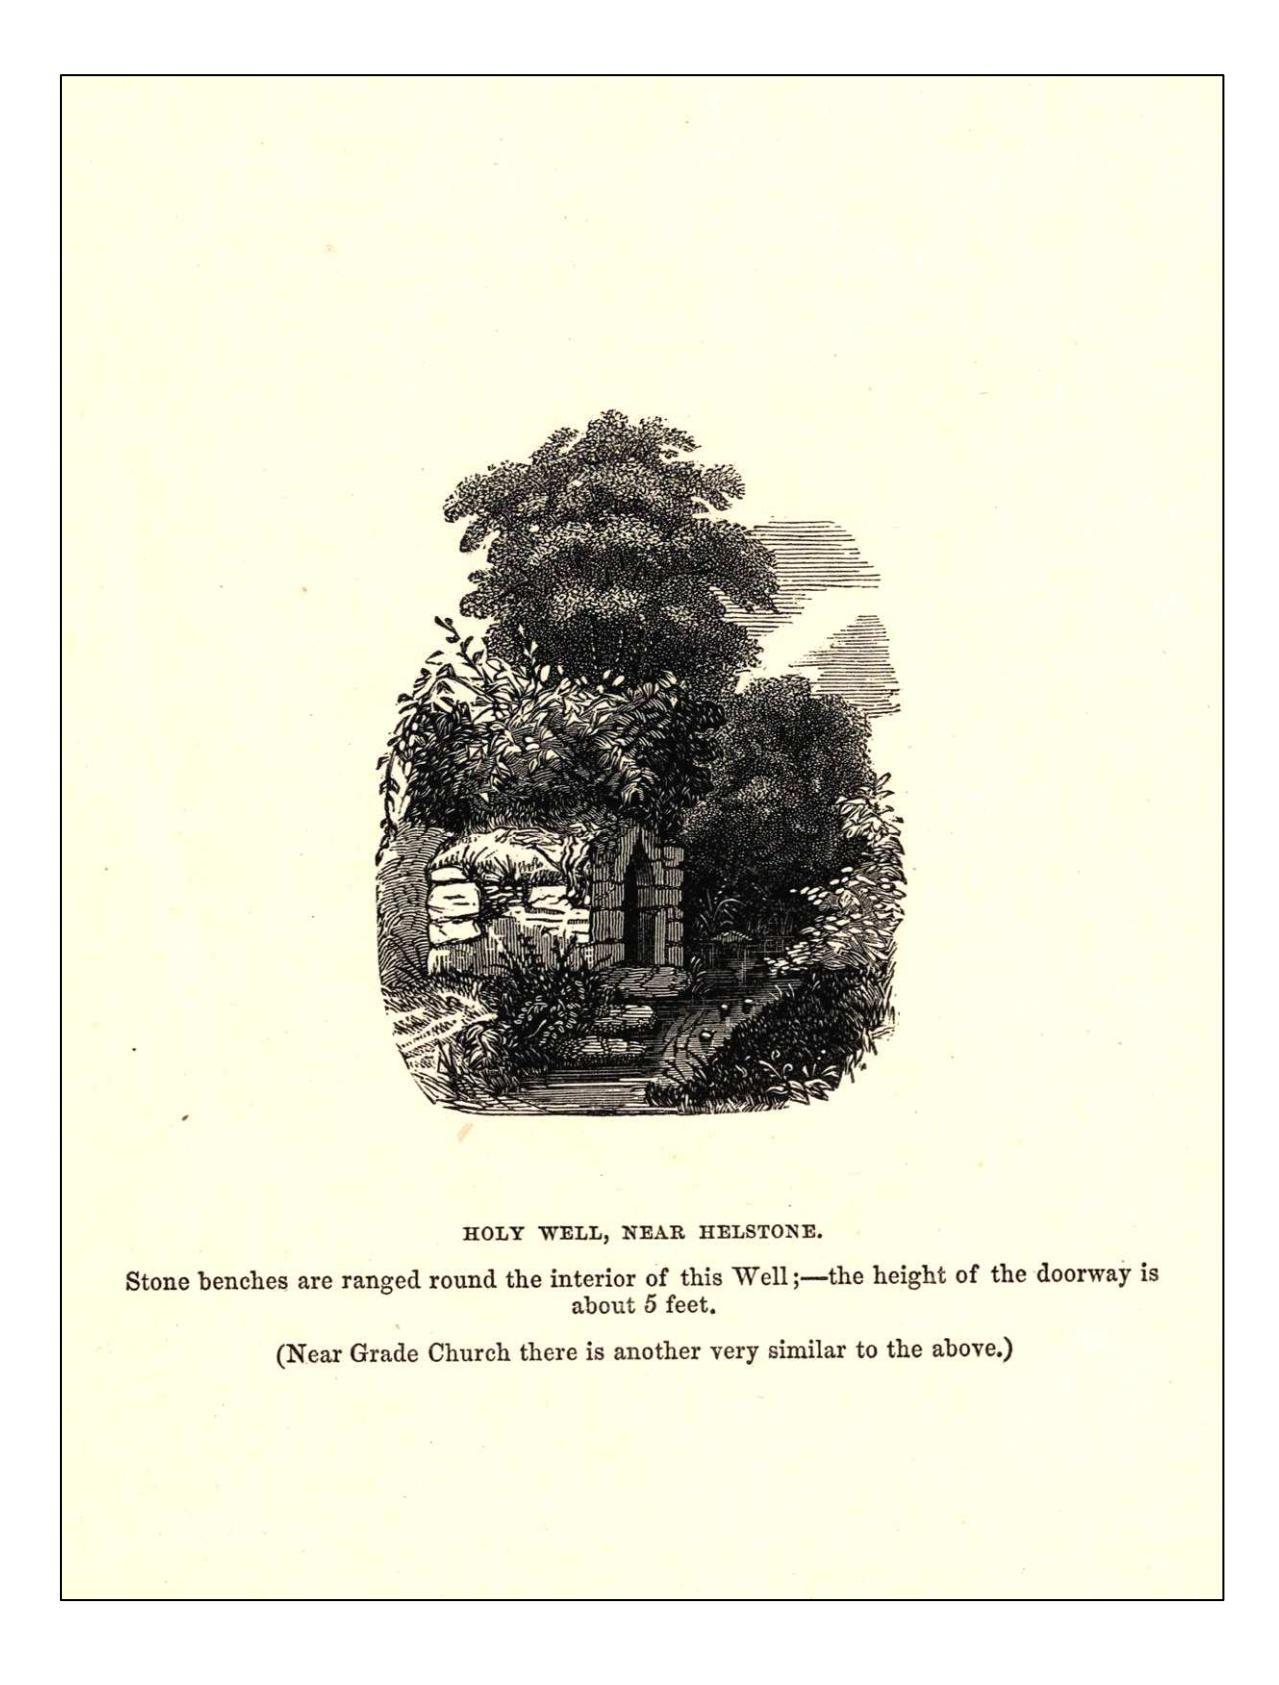
Fig 6 Blight's 1856 illustration of Trelill holy well

In the first known depiction of the holy well by Blight in his *Crosses ... of West Cornwall*, published in 1856 (Fig 6), the roof is shown heavily overgrown with ivy. Otherwise, it looks much as it does now with the same large stones framing the doorway although, as noted above, the hedges running up to the sides of the well had not been built at that date. In 1894, Quiller Couch observed that the building was dry and paved with stone – a contrast with its present state with the floor of the well-house waterlogged and roughly stony: if the paving survives, its presence is not immediately obvious. Ivy not only overwhelmed the roof but was also growing inside. A photograph of the front elevation, taken by Thurstan Peter in 1914 (Peter 1914, opp 312; also reproduced in Preston-Jones, Sturgess *et al* 2003, 10, fig 5) also shows the roof rather overgrown and likewise suggests that few changes have occurred to the structure, other than the possible rearrangement of a few stones above the door arch.

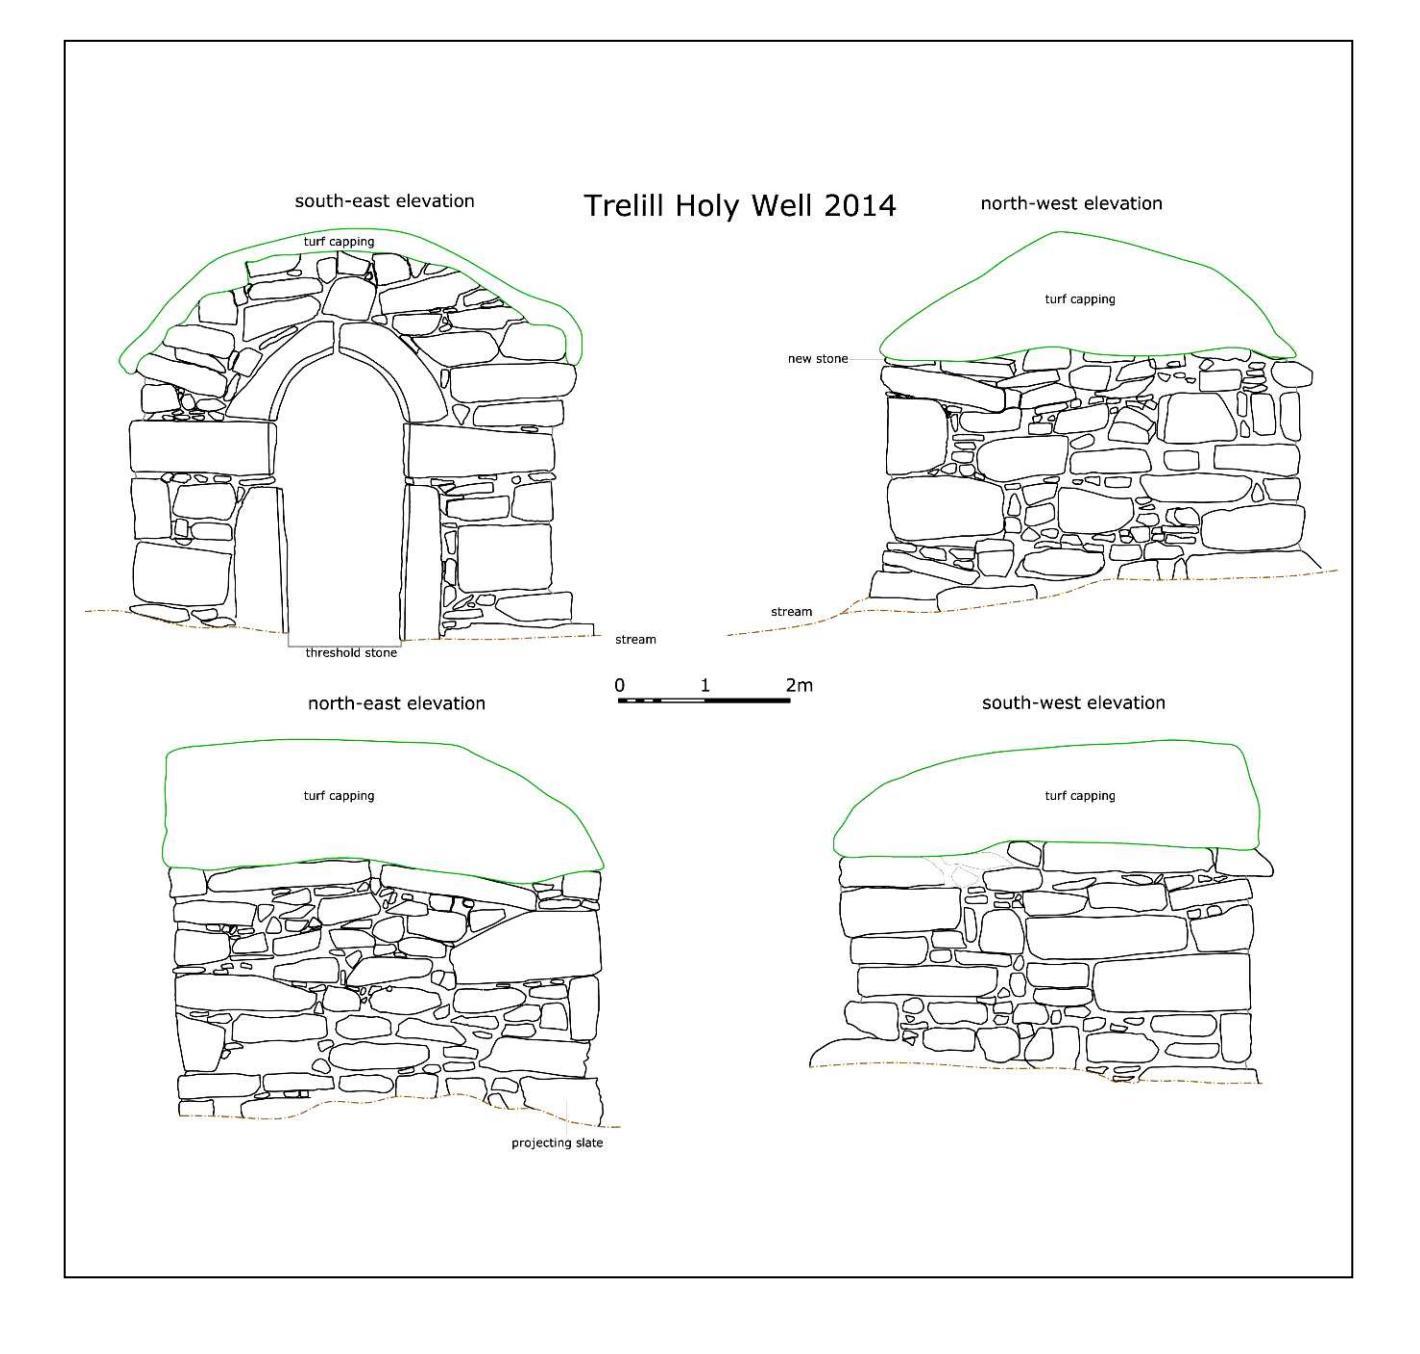
Fig 18 Elevations of the restored building, drawn by James Gossip

All work was recorded with photos and notes. The newly-revealed sections of the building were hand-drawn on the original elevations and then digitally plotted to produce the updated elevations seen in Fig 18.
