# **Penmadow House, St Germans, Cornwall**

## **Historic building record**

<b>Client</b>	Mr Jon Elwell
<b>Report Number</b>	2015R013
<b>Date</b>	January 2015
<b>Status</b>	Final
<b>Report author(s)</b>	Eric Berry, with contributions by Nigel Thomas
<b>Checked by</b>	Jacky Nowakowski
<b>Approved by</b>	Andrew Young

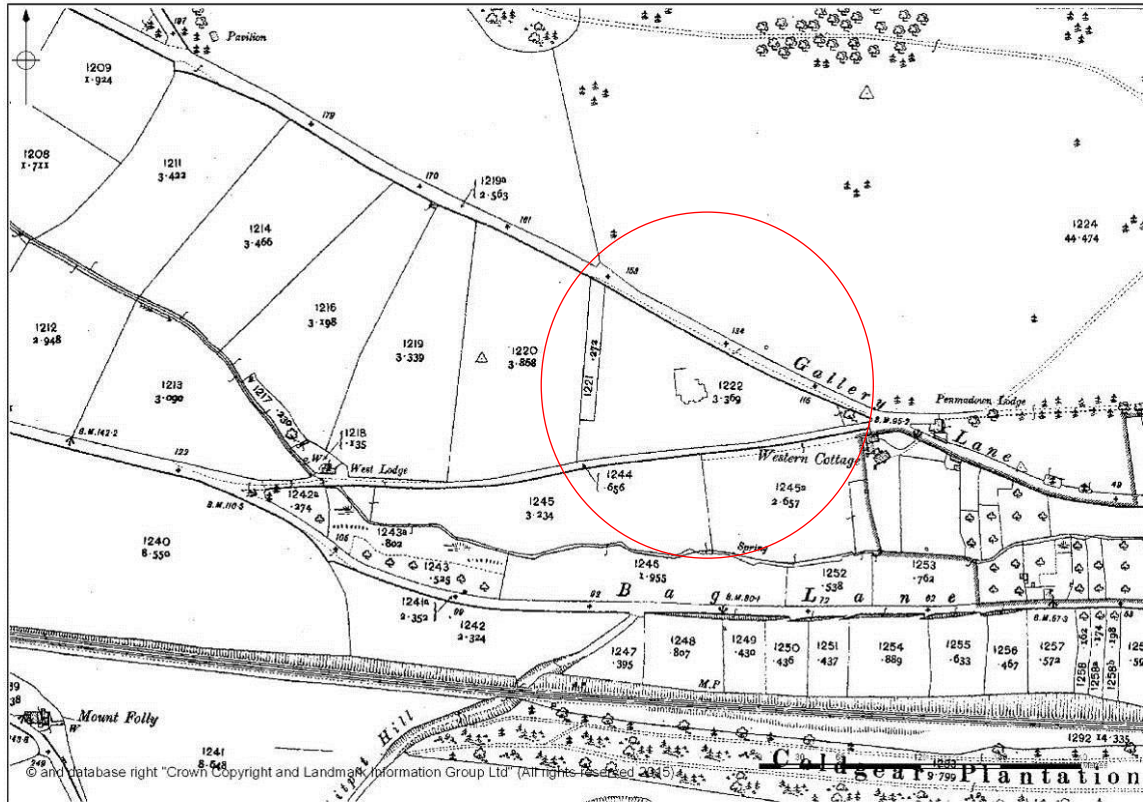
Construction of the house was commenced in 1905 and its origin is commemorated by an elaborately carved date plaque over the principal entrance porch (Figs 9 and 31). The building of this large house is likely to have taken a few years and the house is partly shown as an outline (i.e. under construction) when the area was mapped at large scale by the OS c1907 (Fig 5).

Fig 5 Second Edition of the Ordnance Survey 25 Inch Map, published c1907.  
Construction of Penmadow House had started by this time.

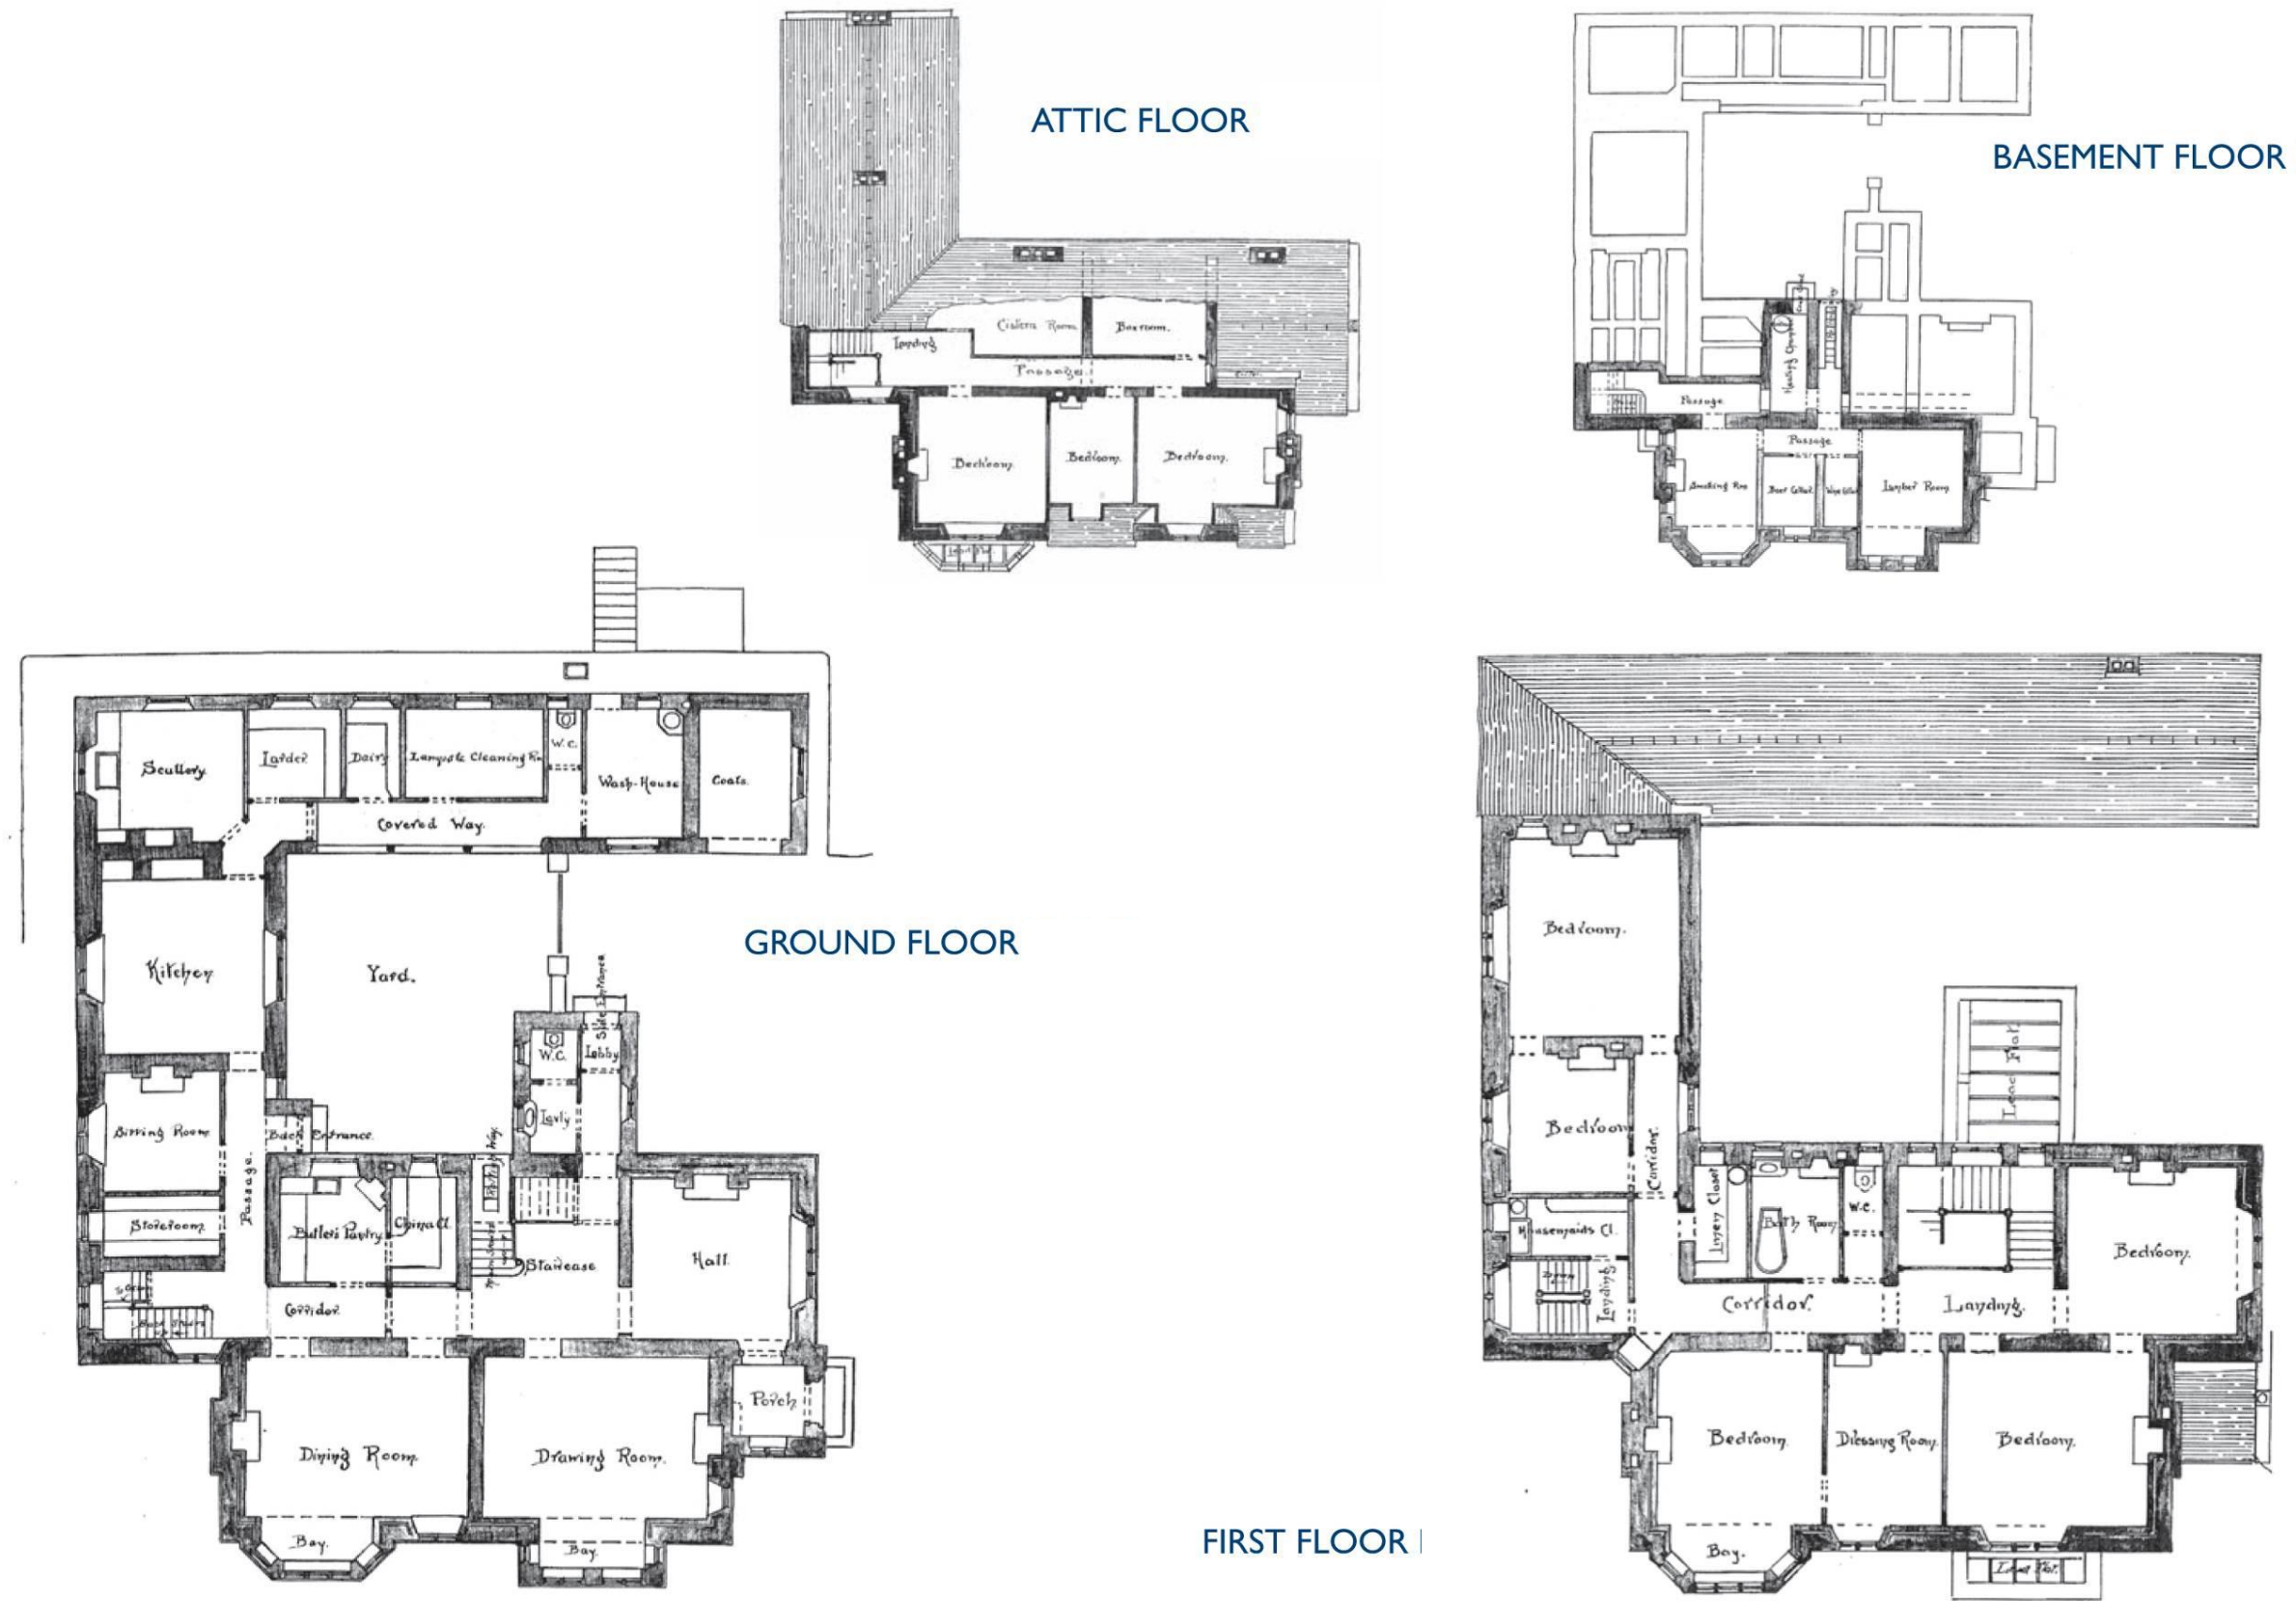
Fig 7 As built plans, c1905.

Penmadow House was originally intended as a land agent's house, built to the design of John Samson FRIBA, an architect from Liskeard, on behalf of the Port Eliot Estate. A series of proposed plans, elevations and detailed drawings were made and these documents are now retained at CRO (ref EL/465). The drawings show the evolution of the design to that which was eventually built. The earliest design shows a house with a longer front elevation with three principal gables. Proposed service rooms to the rear were to be ranged around a yard with the principal and service yard entrances facing west. This is reversed when compared with the 'as built' house, which has east entrances. Slightly later drawings show the plan evolving with a less ambitious layout of rooms but still with a 'reversed' yard scheme. Drawings that emerged before the final versions show the plan significantly revised with the east entrances included and with smaller plan areas for the dining room and principal bedroom above. The plans are labelled with the functions of all the original rooms and also show the divisions between the family rooms and service spaces (Fig 7).

Penmadow House is built to a bespoke plan that combines 'upstairs-downstairs' requirements with efficient layout that comprises the essential room spaces appropriate for a house of its social status of its time. It has an overall U-plan (Figs 7, 10-13) ranged around a service court or 'yard' with a double gateway to the east. The principal entrance porch is also to the east side.

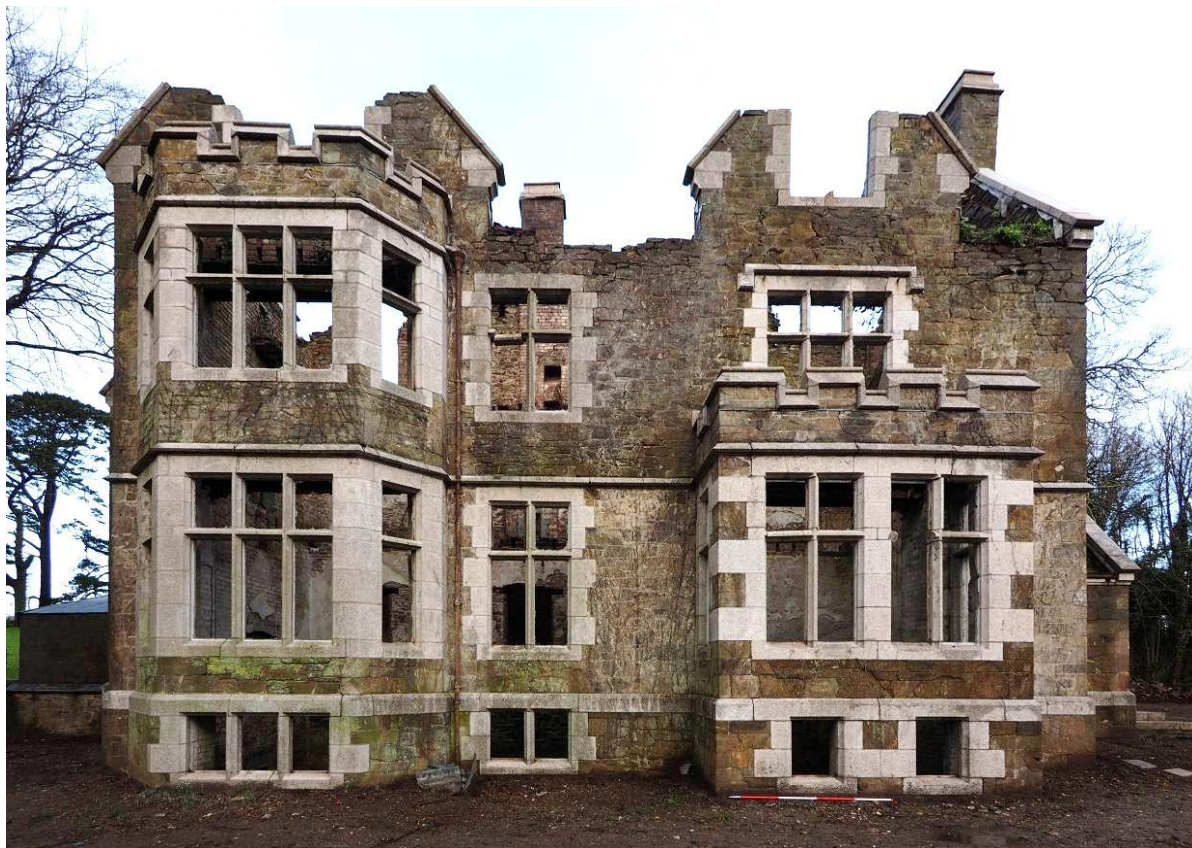
The front part of the south range projects forward and has bay windows facing south, a canted bay in front of the west rooms and a rectangular bay in front of the east rooms (Figs 14 and 21). At ground-floor level this range contains a dining room on the left (west) and a drawing room on the right.

*Fig 21 South front, facing garden.*

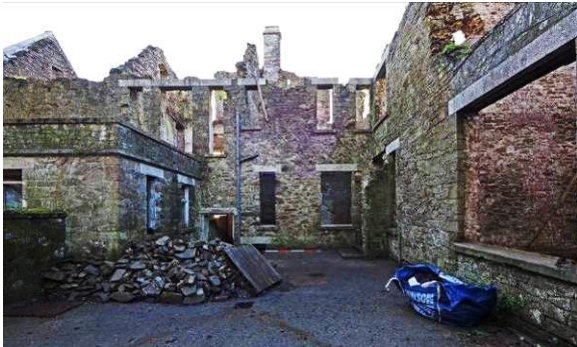
Fig 27 House rear from service yard.

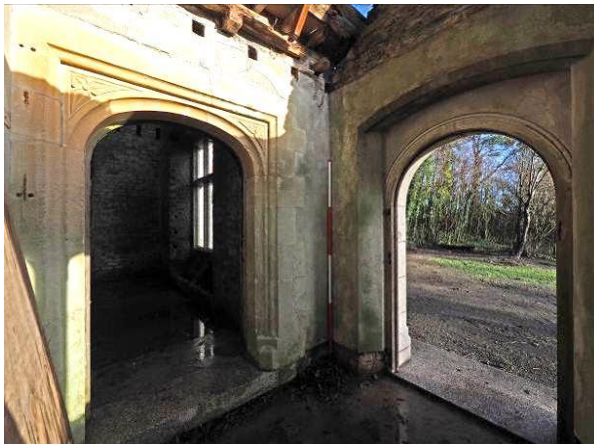
- Moulded arched door frames with diagnostic features (Figs 35 and 58).

Fig 35 E porch doorways.

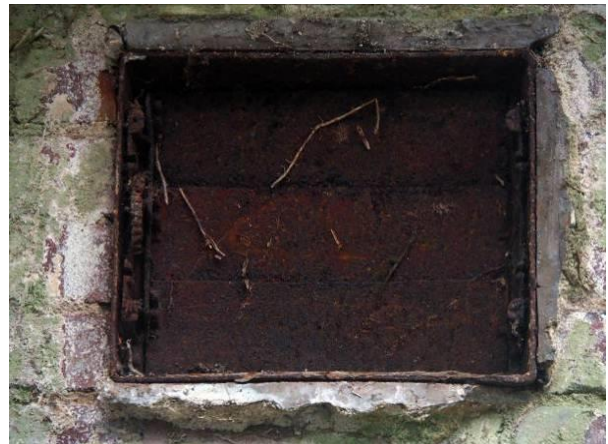
Fig 36 Hall chimney (adjustable flue vent).

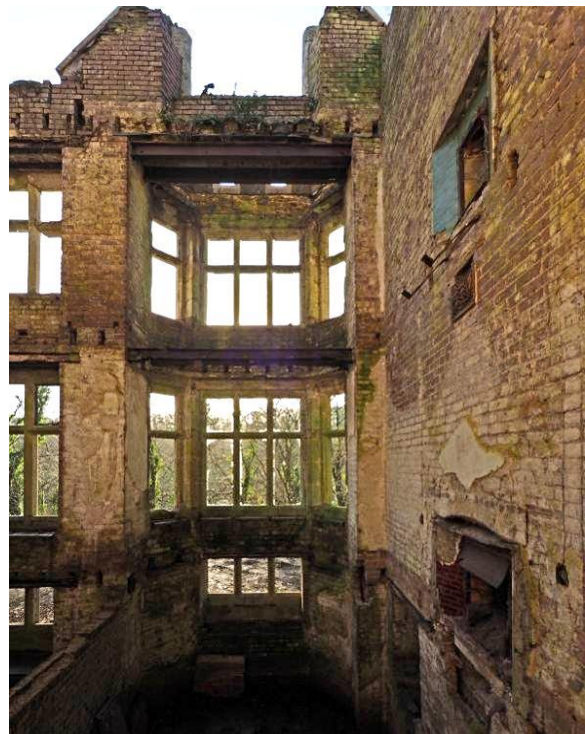
- East wall: remains of 3 fireplaces (Fig 45)
- Remains of service bells and electrical conduit (ground and first floors)
- South wall (Fig 43)
  - Bay windows and remains of iron lintels
  - North wall: doorways to other rooms or passages
  - West side of basement: brick cross wall dividing lumber room from wine cellar

Fig 43 Drawing room, chambers + basement to S.

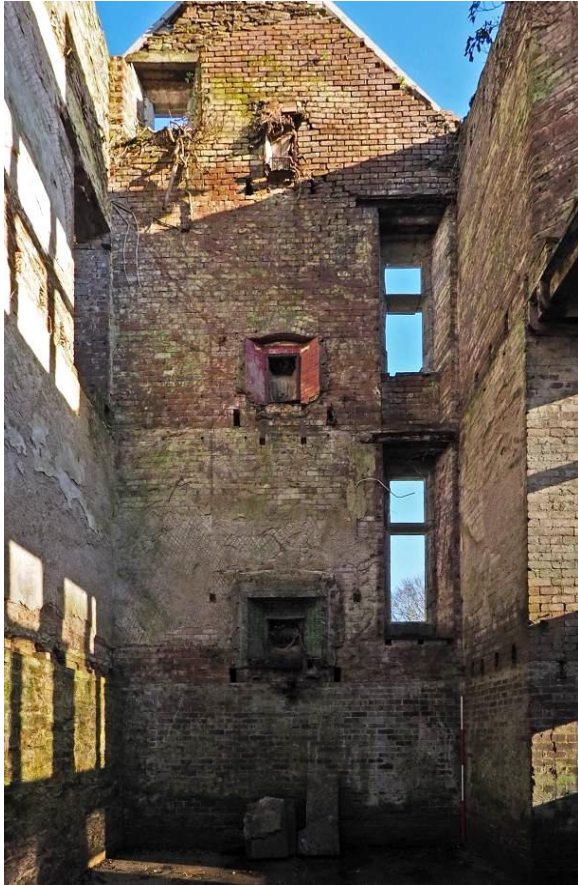
- West wall (Figs 46 and 73): remains of 4 fireplaces
- Remains of service bells and electrical conduit (basement, ground and first floors)
- Cast-iron flue vent (dining room)
- South wall (Fig 44)
  - Bay windows and remains of iron lintels
- North wall:
  - Doorways to passages
  - Remains of first-floor dressing room fireplace
  - Remains of attic fireplace to servant's bedroom

Fig 44 Dining room, chambers + basement to S.

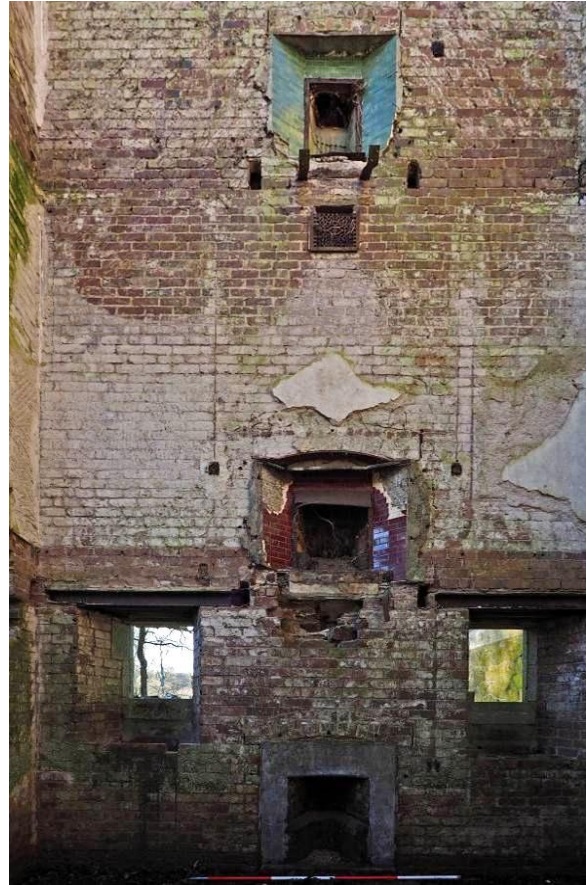
Fig 45 E wall with fireplaces to 3 floors.

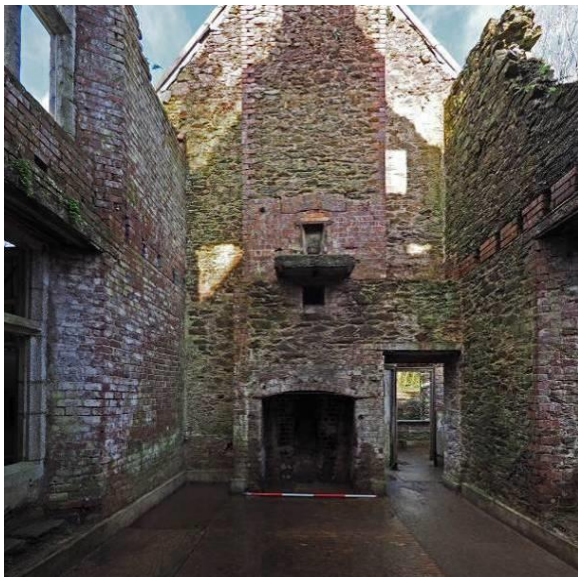
Fig 46 W wall with fireplace to 4 floors.

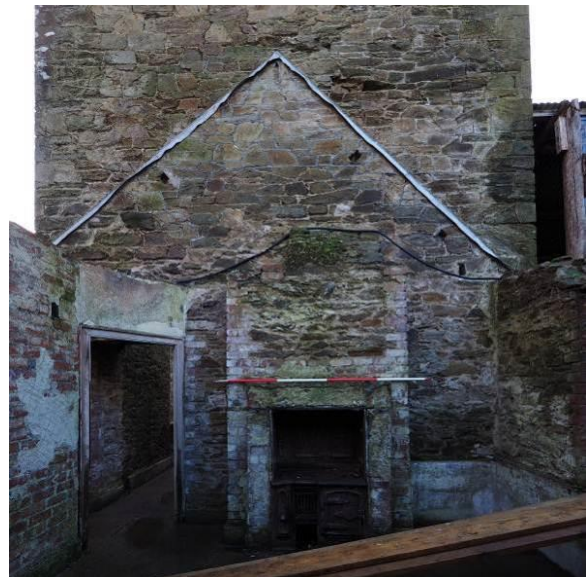
- North wall (Fig 47):
- Large kitchen fireplace opening with oven
- Smoke vent above kitchen fireplace
- Hearth in front of bedroom fireplace
- Tiled floor
- Bedroom fireplace

Fig 47 Kitchen and chamber above from S.

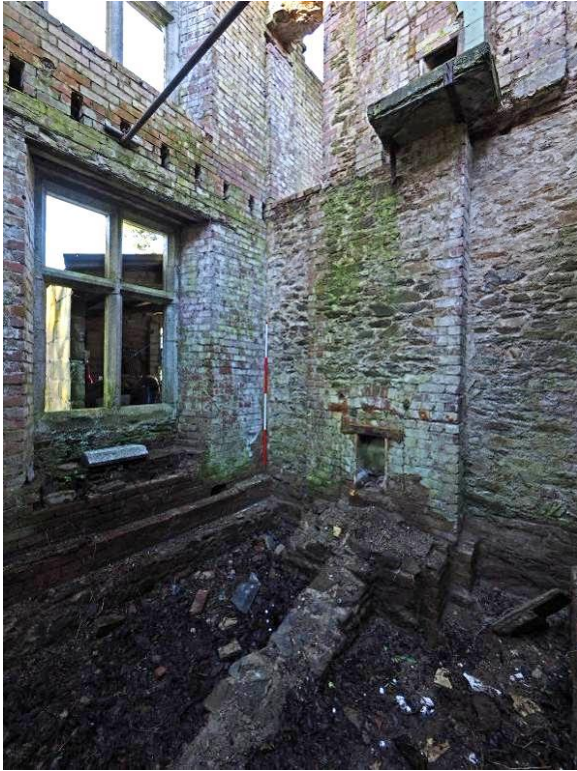
- Tiled floor
- South wall:
- Fireplace fitted with complete C19 cast-iron range (Fig 72 left)
- Evidence for roof weathering in gable end (Fig 48)
- Evidence for location of sink/drain and extant water tap
- Examples of cement pointing

Fig 48 Scullery from N.

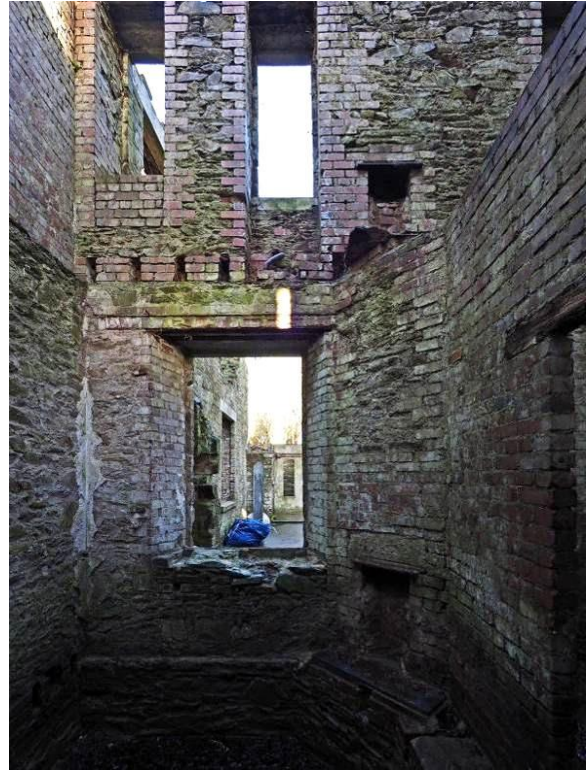
- Evidence for suspended wooden floor (Fig 49)
- Fireplace openings

Fig 49 Servants' hall/'sitting room' and chamber above from SE.

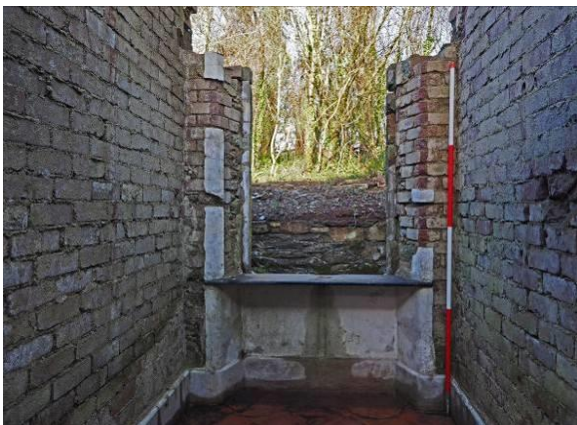
- Tiled floor (Fig 52)
- Good plaster details

Fig 52 Wash-house from S.

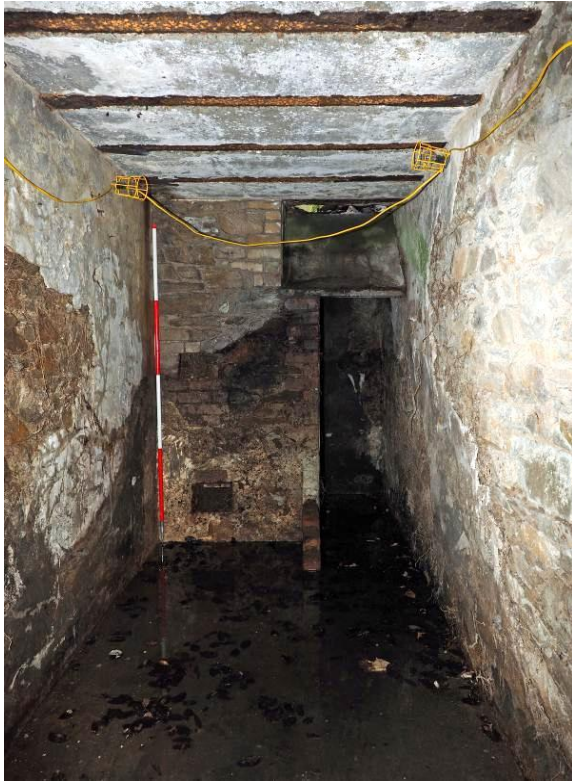
- Tiled floor (Fig 54)

Fig 54 Dairy floor from S.

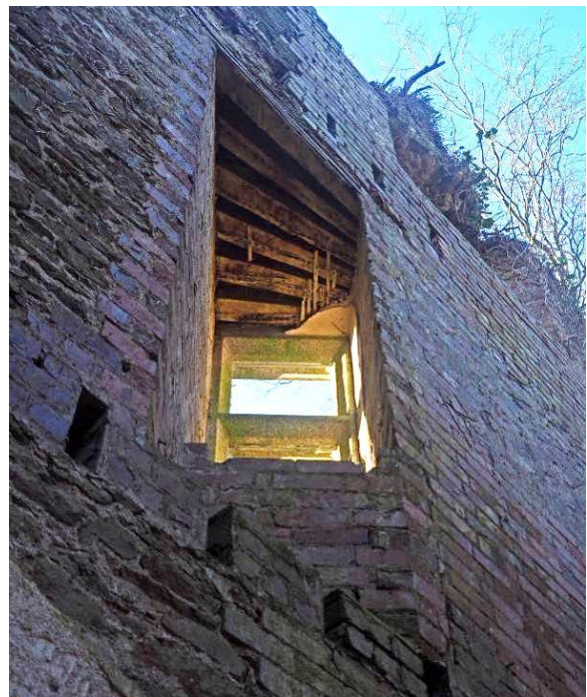
Set back on the left is the 2-storeys plus attic coped gable end of the west range. At ground-floor level is a 2-light mullioned window that lights the passage ('corridor') east of the back-stair well. The window has a square hood-mould that continues as a string course across the west gable end of the south-range. At far right to the first floor is the most interesting window of the whole building. This is a single-light transomed squint window that is oriented to the south-west. The window is carried on oversailing granite corbels and there is a stepped granite roof (Fig 63). The attic gable has a 2-light mullioned window with a string course above.

- Squint window (Figs 63 exterior and 64 interior)
- Doorways between bedrooms and corridors
- Remains of (heavily charred) oak herringbone parquet floor (ground floor) (Fig 61)

Fig 63 Squint window in SW corner.

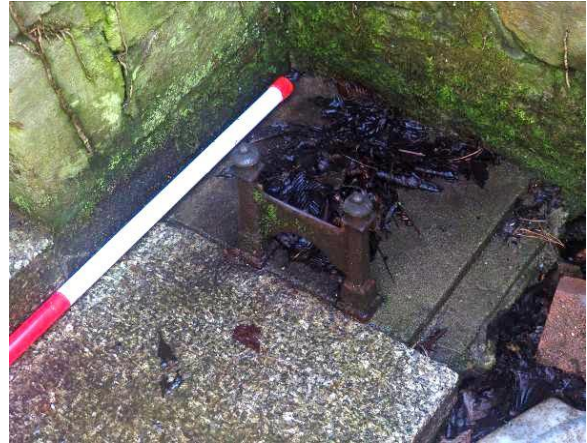
This irregular elevation (Figs 19 and 27) is the back wall of the south-range (facing the 'yard') plus a projecting flat-roofed porch (Fig 67) on the left with plan parapet with parapet string. The porch has a doorway on the left still with its original panelled door and boot scraper to the right of the doorway. The right-hand return (west) wall of the porch has two small windows, the right-hand window with remains of its transomed frame. The left-hand return wall is described with the east elevation.

Fig 67 N porch.
