Trease, Pendeen, Cornwall
The results of an archaeological watching brief during a
second phase of conservation works

Client	The National Trust
Report Number	2016R005
Date	19 May 2016
Status	Final
Report author	Adam Sharpe BA MCIfA
Checked by	Dr. Andy Jones MCIfA
Approved by	Andrew Young MCIfA

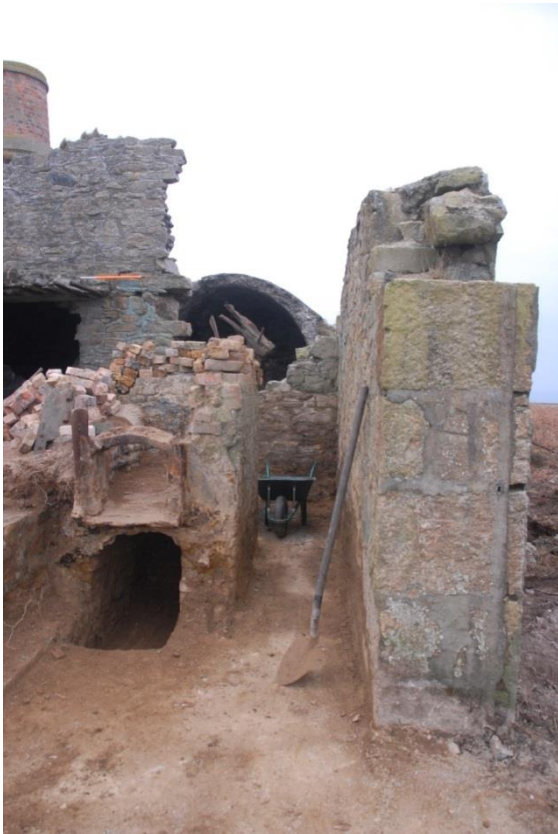
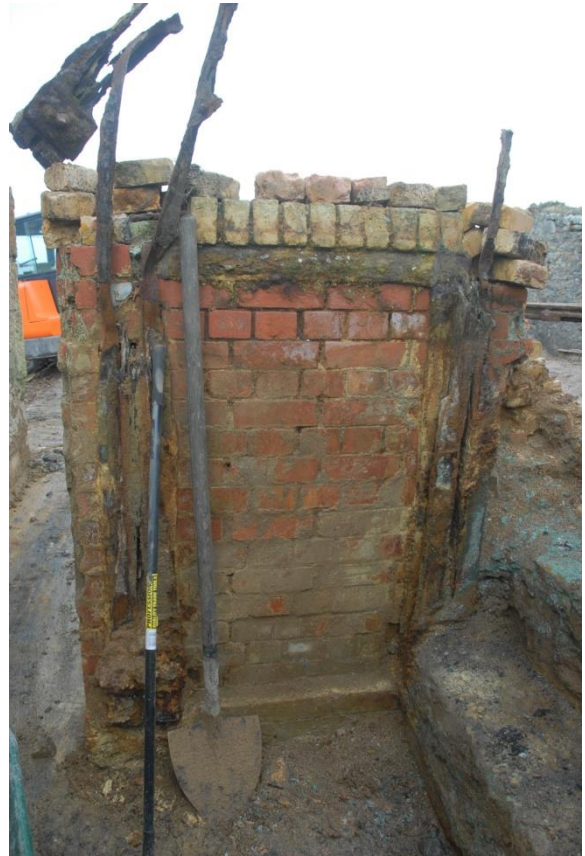
Figs 8 and 9. The eastern and western sides of the calciner furnace, showing the iron surround to the fire door (left) and the remains of the steel joists which had clamped the brickwork together to resist heat expansion forces (right).

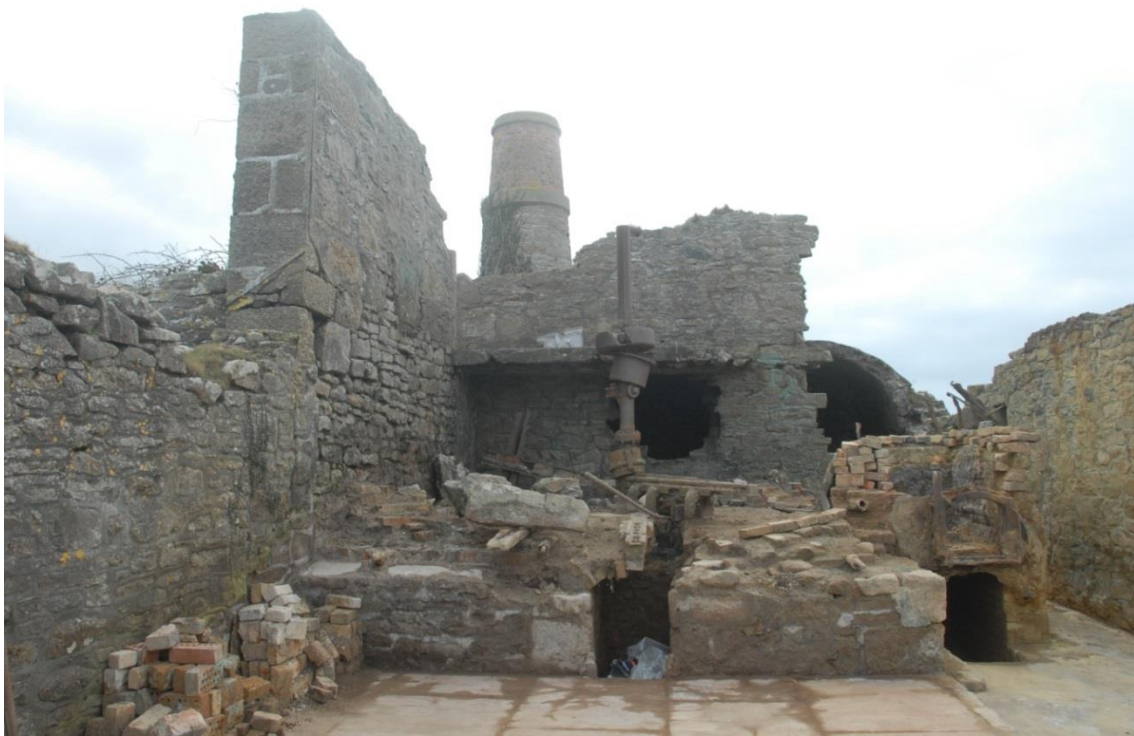
Fig 10. The calciner from the west following rubble clearance in 2015. The whole of its original brick superstructure of the calciner had been removed following the closure of the mine and the scrapping of its components.

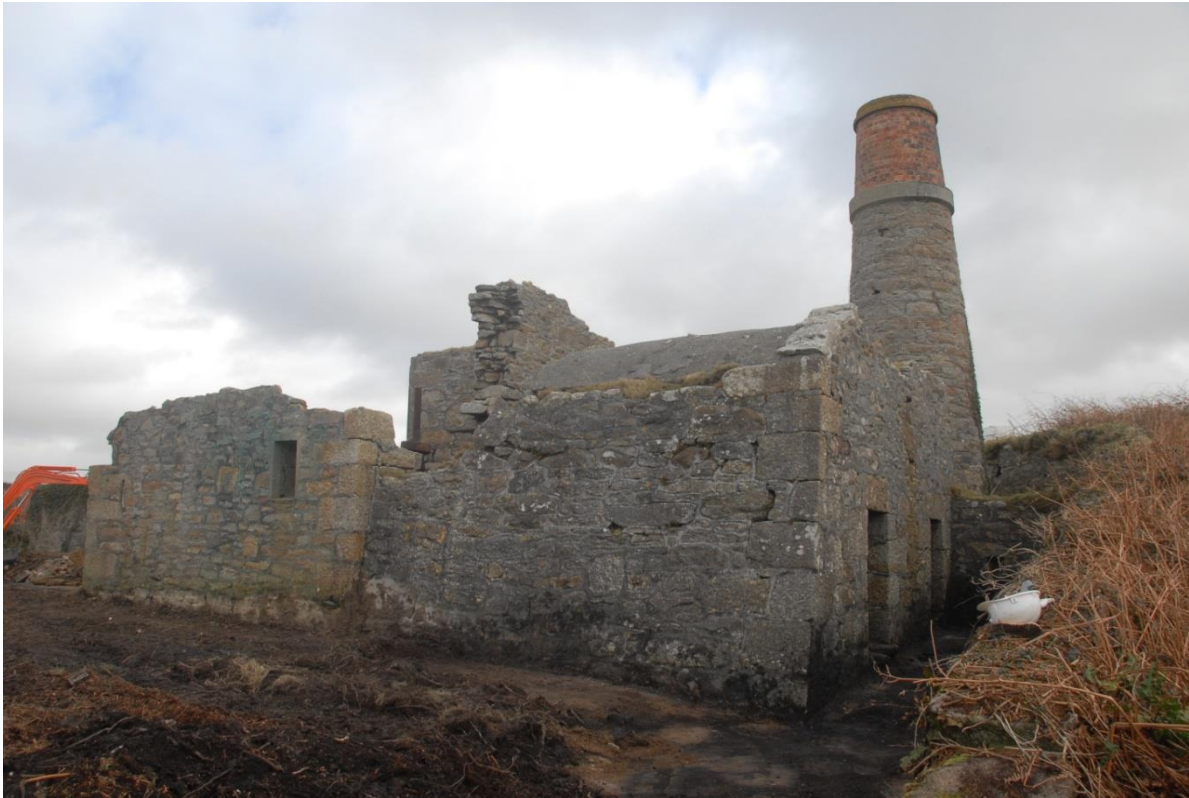
Fig 11. The calciner building (left) and dust chambers (right) showing the losses of original fabric from the western wall of the calciner and the eastern end of the northern dust chamber roof.

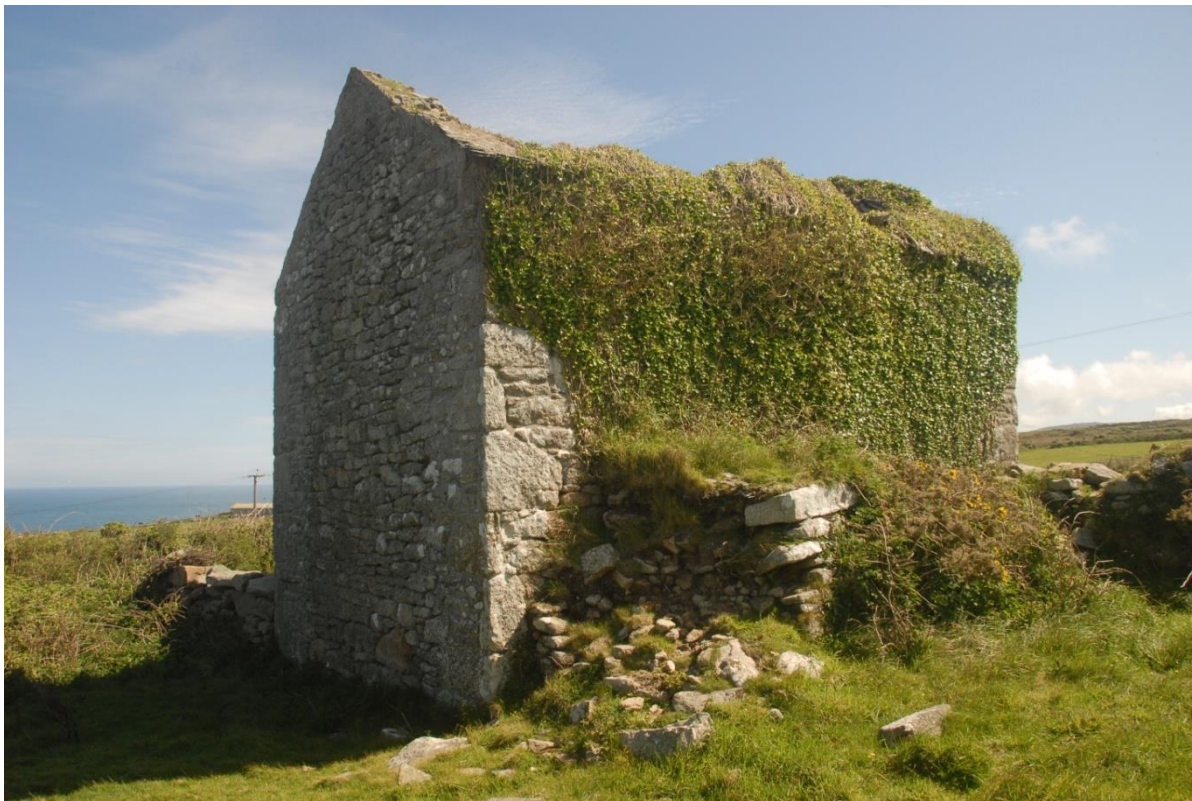
Fig 14. Trease field barn from the south-west, showing the remains of the ramp/steps to the first floor door and the ivy which covered the southern elevation of the building.

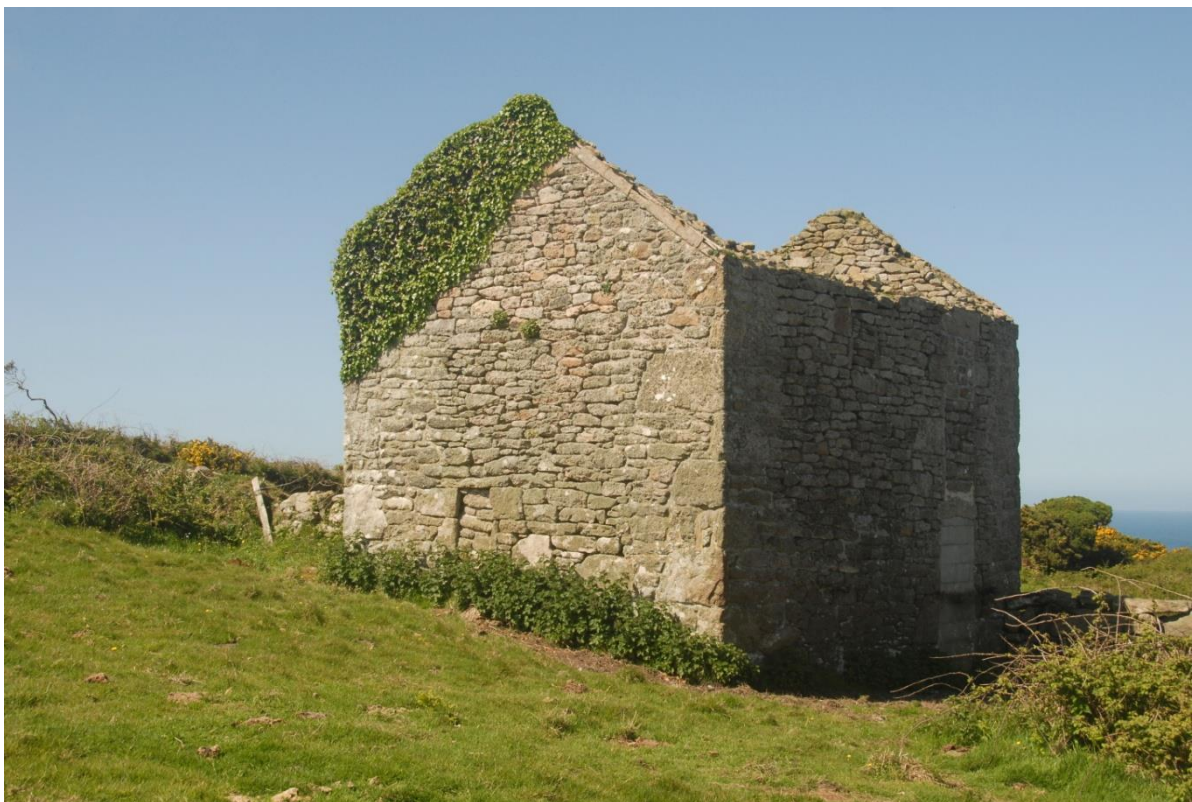
Fig 15. Trease field barn from the north-east, showing the blocked windows and door in these elevations.

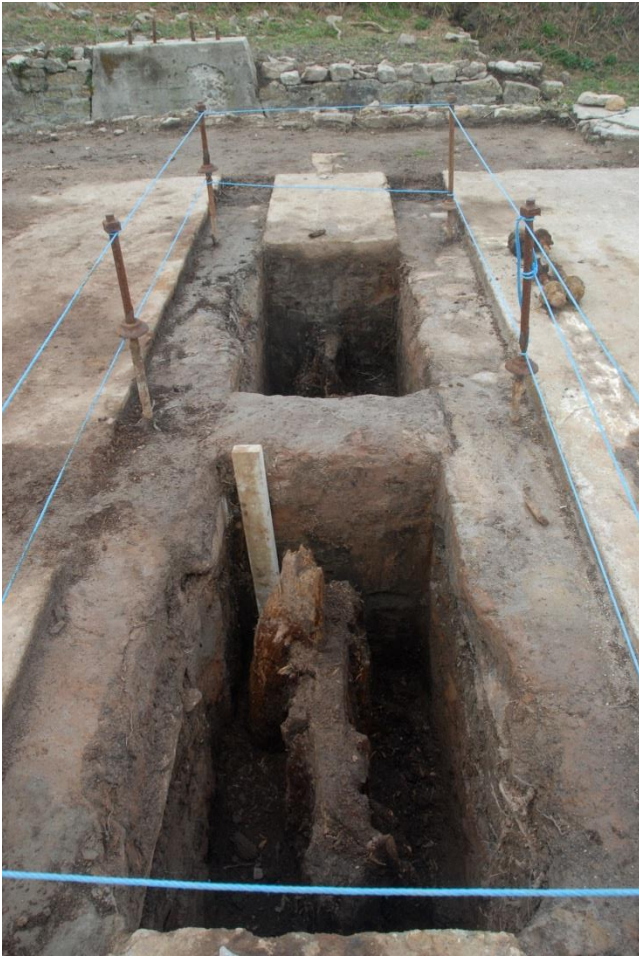
Fig 48. The excavated stamps anvil sockets, showing the remnant timberwork in their bases.

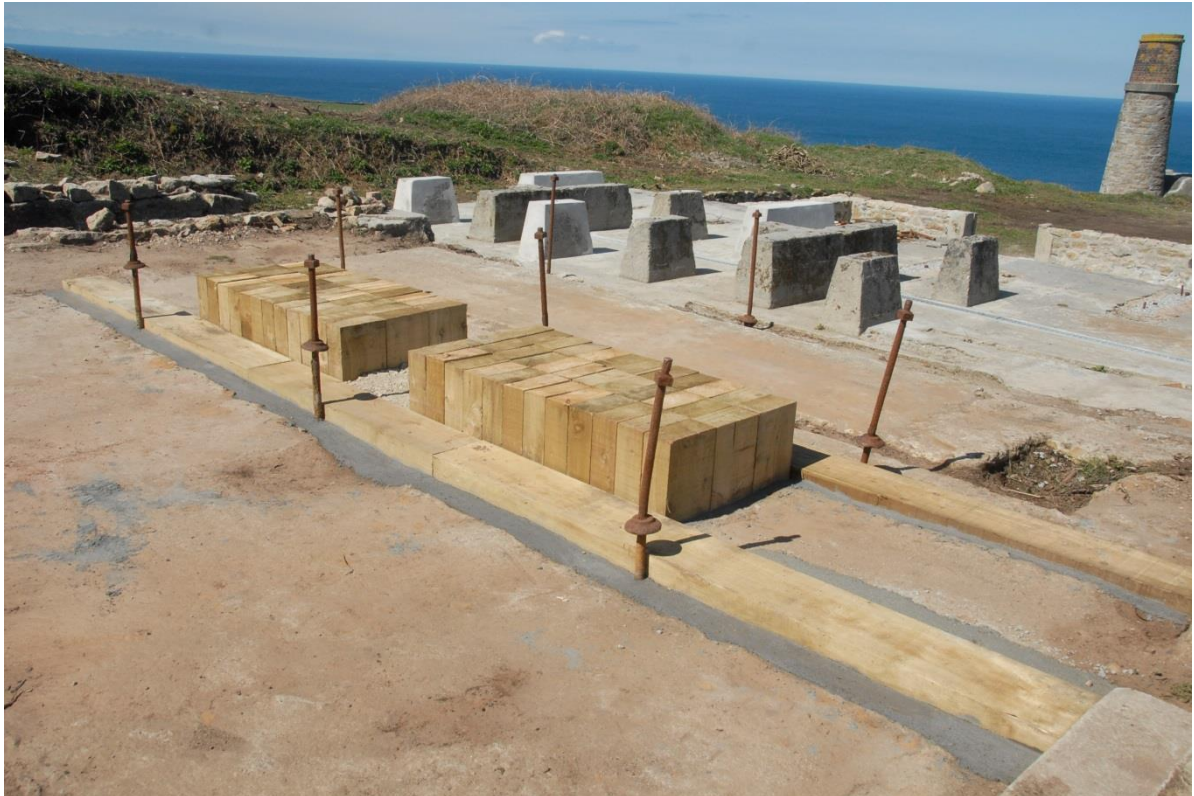
Fig 50. The completed reproduction anvil support timbers and mud cills. The infill concrete next to the mud cills is deliberately darker than the original to distinguish the new work from the old.

anvil supports showed these timbers to originally have been over two metres in length, the lower portions of these surviving *in situ* (Fig 48). The pits were cleaned of all rotten wood and partly backfilled with coarse gravel, on top of which were set 1.2m long sections of replacement treated timber, these being set in the pits so that 0.3m of their top sections protruded above floor level (Fig 49). Hidden fixings into the pit walls and to one another were used to prevent any risk of subsequent theft of the timbers. The replacement mud cills were narrower than the originals, as timbers of the original large size would have to have been cut to order. The 100mm gap left next to the new timbers in the original floor slots was infilled with mortar to prevent water accumulating in them. A colourant was added to this mortar to distinguish the new work from the old (Fig 50).

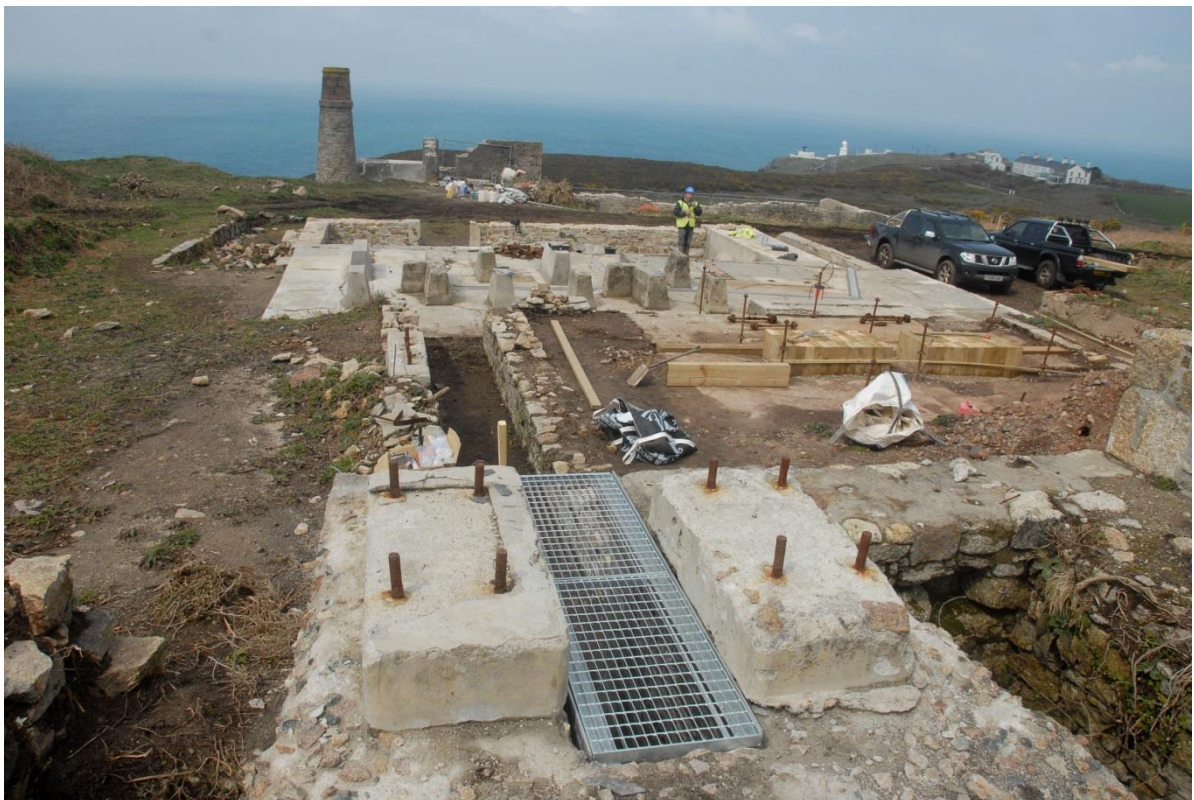
Fig 51. The grille set between the mill engine loadings.

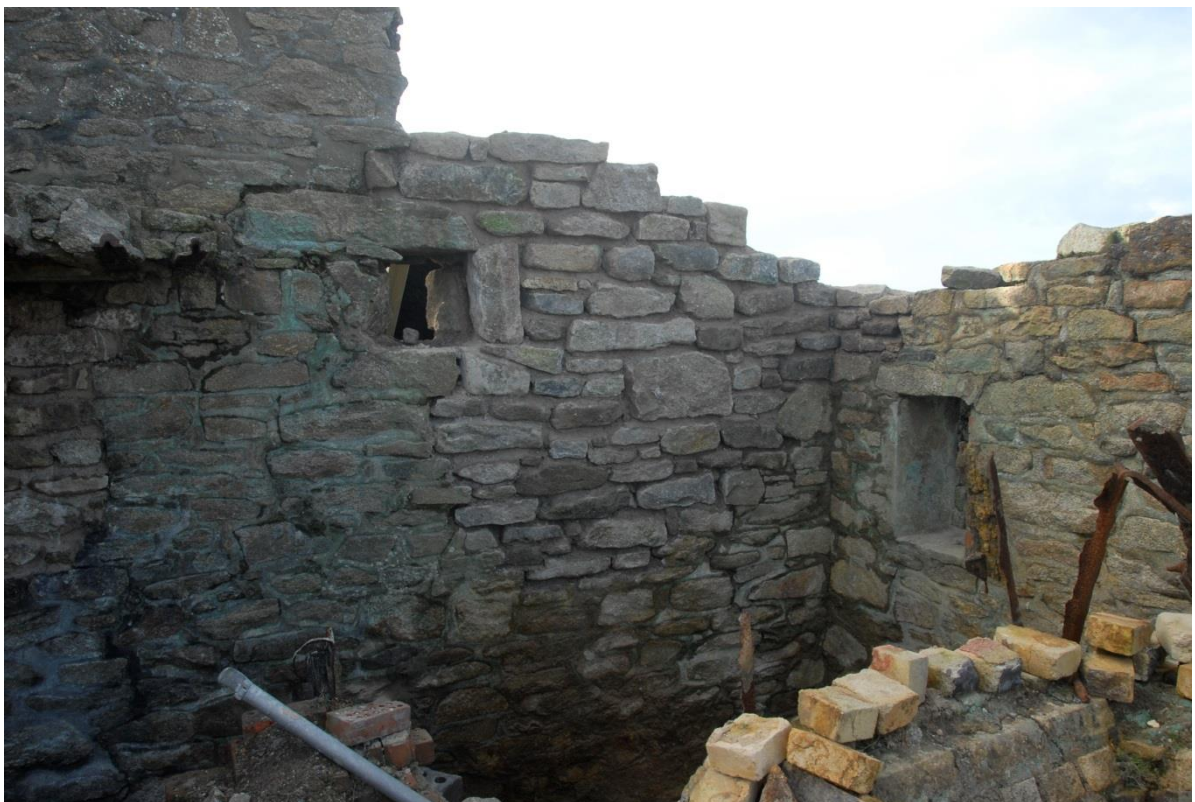
Fig 55. The reinstated masonry forming the eastern wall of the northern dust chamber, incorporating the reconstructed flue opening.

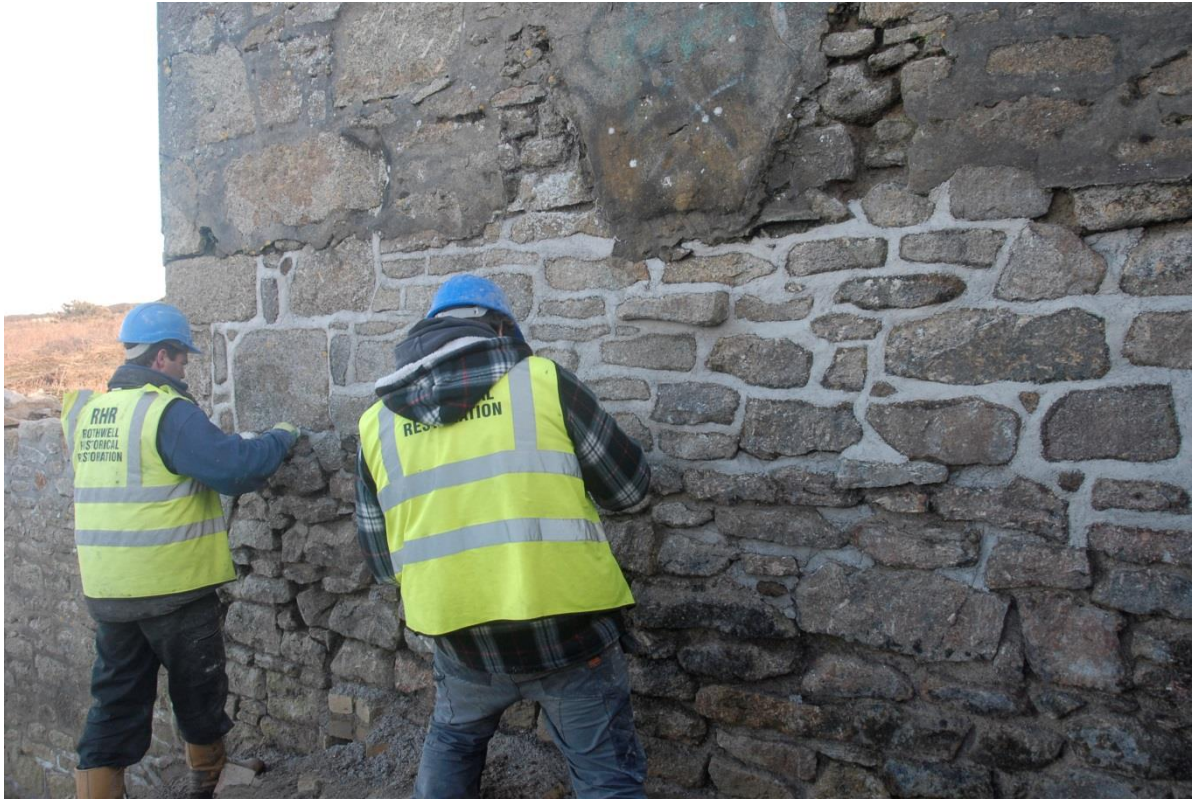
Fig 56. Repointing the lower section of the southern wall of the calciner enclosure in lime mortar. The upper section of the wall, which includes the location of the end of a feed hopper (top centre), was repointed in a cement mix to match the surrounding mortar.

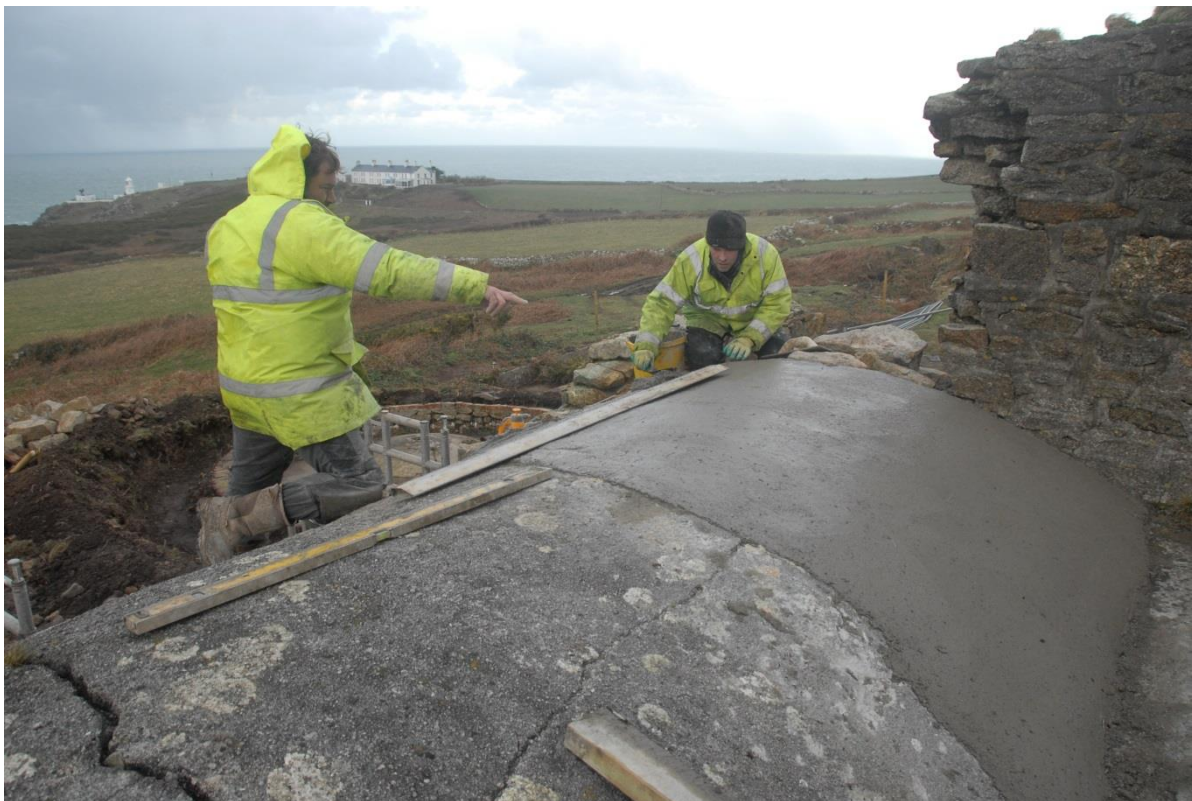
Fig 59. Forming the new section of concrete roof over the northern dust chamber.

The NT Buildings Department was concerned about the cracking and probable destabilisation of the northern and western walls of the northern dust chamber, it being considered that this had been caused by unconstrained side thrusts imposed by the arched concrete roof of this building on the heads of these walls. Although no active movement cracks were evident, it was decided that a long term solution would be required to strengthen these walls, and as a result a specialist company based in Bodmin was contracted to install Cintec reinforcing bars in grout-filled oversized drill holes through the cores of these walls over their full heights (Figs 62 – 64). In addition, one 5m long horizontal bar was to be installed along the length of the northern wall of the northern dust chamber to tie its masonry together. The outer sections of the cores from the drilling works were retained to disguise the drilled entry points for the Cintec bars.

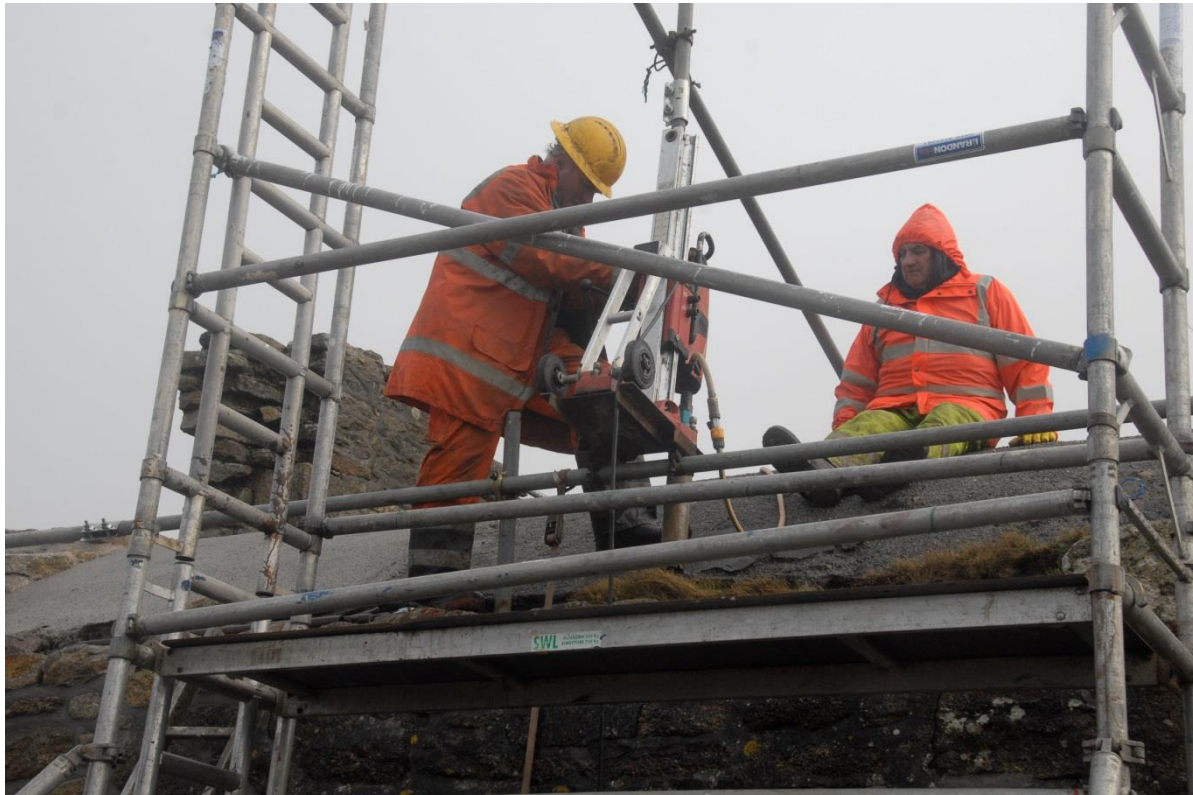
Fig 63. Drilling one of the vertical drill holes for the Cintec reinforcing bars to be installed within the northern wall of the dust chambers.

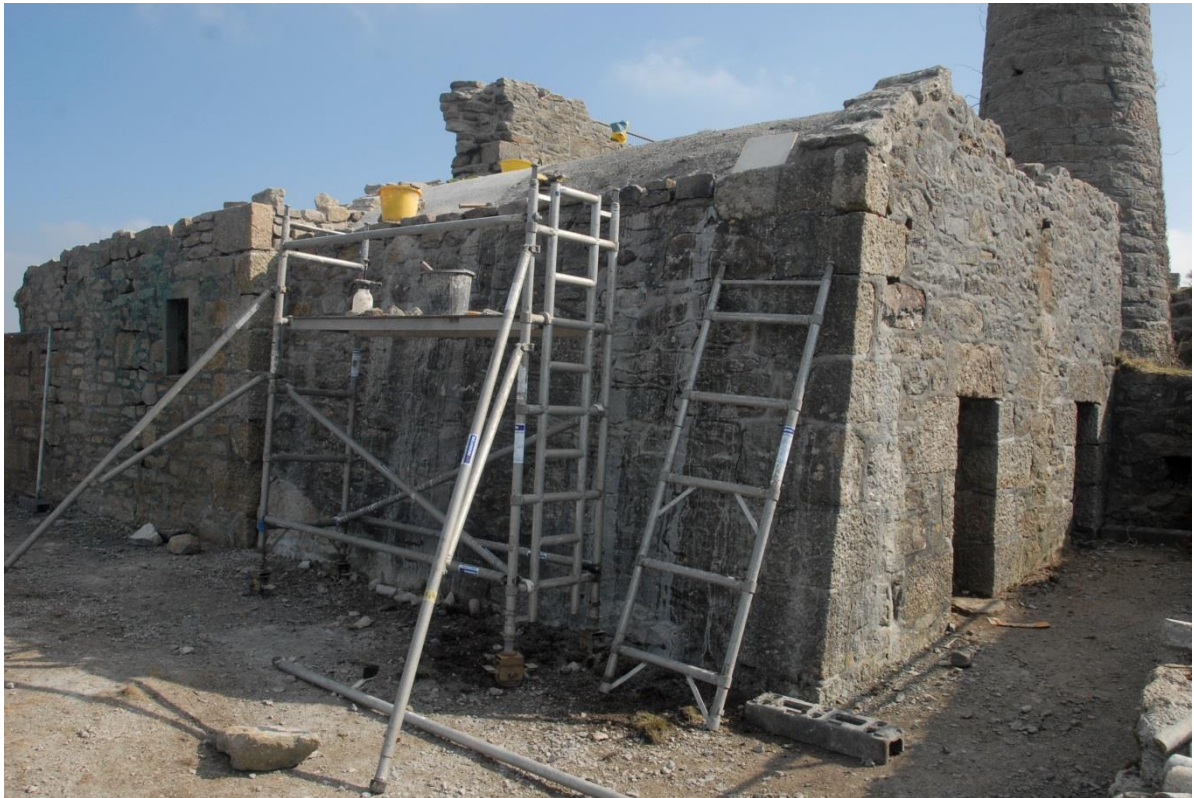
Fig 66. A general view of the dust chambers during the later stages of conservation work to them.

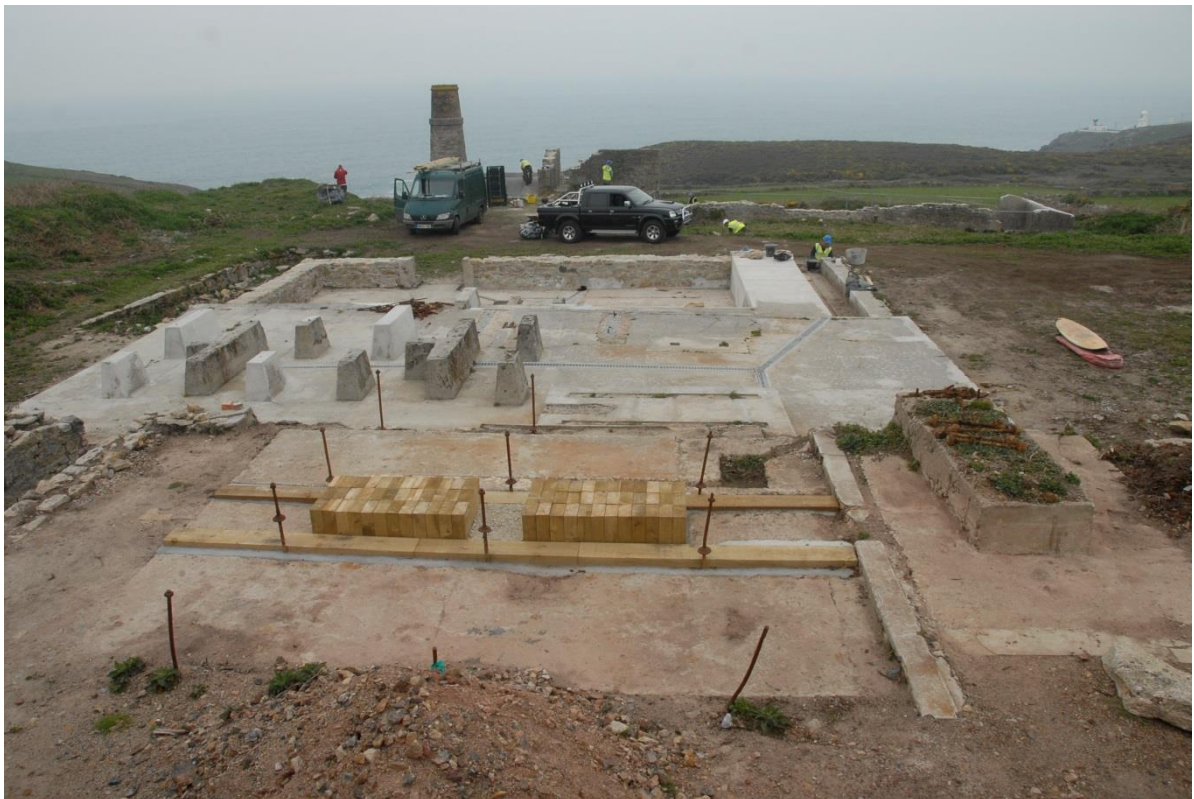
Fig 67. The completed works to the lower section of North Boscawell mill.

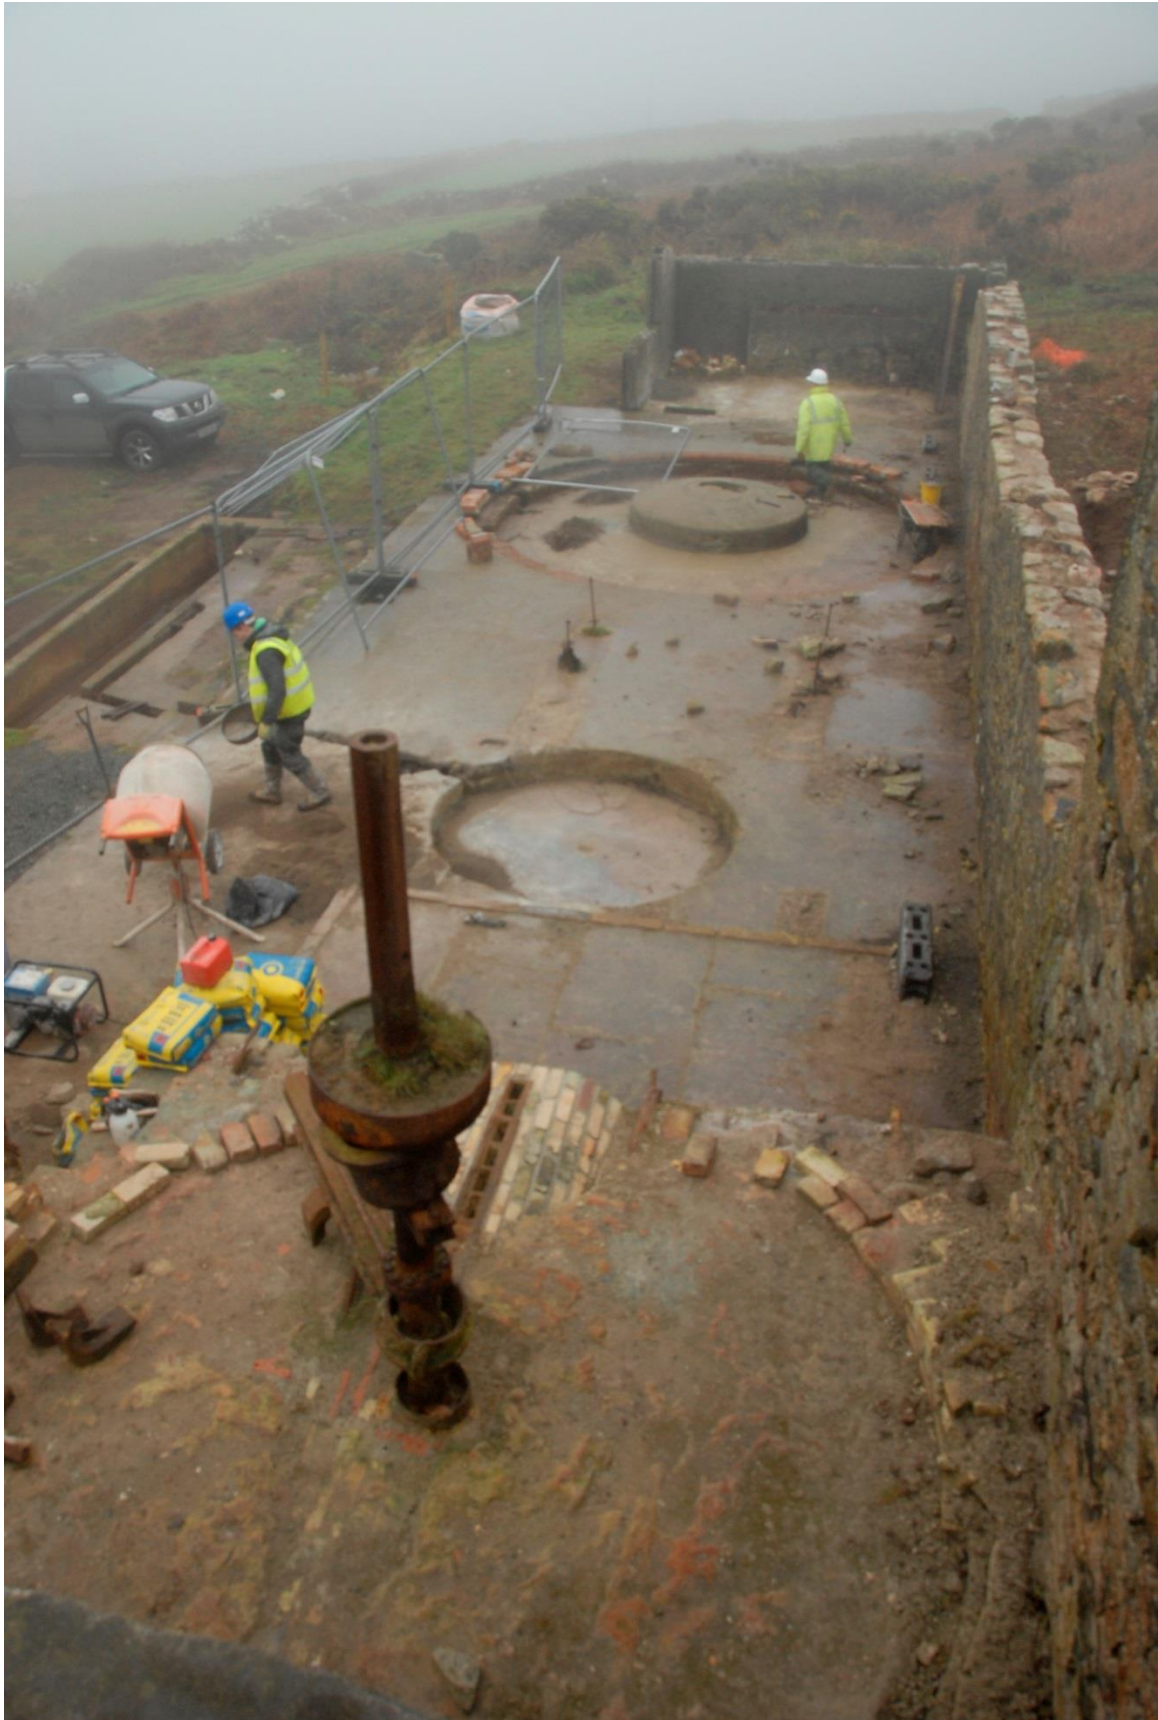
Fig 68. An overview of the tin floors at an early stage of the project showing (foreground) the calciner bed prior to reconstruction works.

The reinstatement of some sections of the lost brickwork of the lower walling of the calciner bed was undertaken in order to help to reform its outer skin and to protect critical detail of the low remains of the circular calcining bed from any foot-induced erosion of the heat-affected mortars backing it and the resultant exposure of the hearth brickwork to destabilisation and damage. The bricks making up the lowest courses of the lower circular calcining hearth were re-set where they were found to be loose – wherever possible at least two courses were reinstated to allow for the resurfacing of the hearth bed concrete where it had become badly eroded (Fig 69). This did not prove possible at the eastern and western sides of the hearth – to the west, remediating the partial collapse of the brick power vault running beneath the hearth would have required a substantial amount of preliminary rebuilding of this feature, whilst to the east large portions of the material making up the core of the hearth base had been lost. As a result, two long arcs of brickwork were reconstructed – these being felt sufficient to indicate the original plan of the hearth. Minor repairs were made in recovered stone, brick and lime concrete to the outer edges of the calciner bed as these areas were felt to be vulnerable to foot erosion.

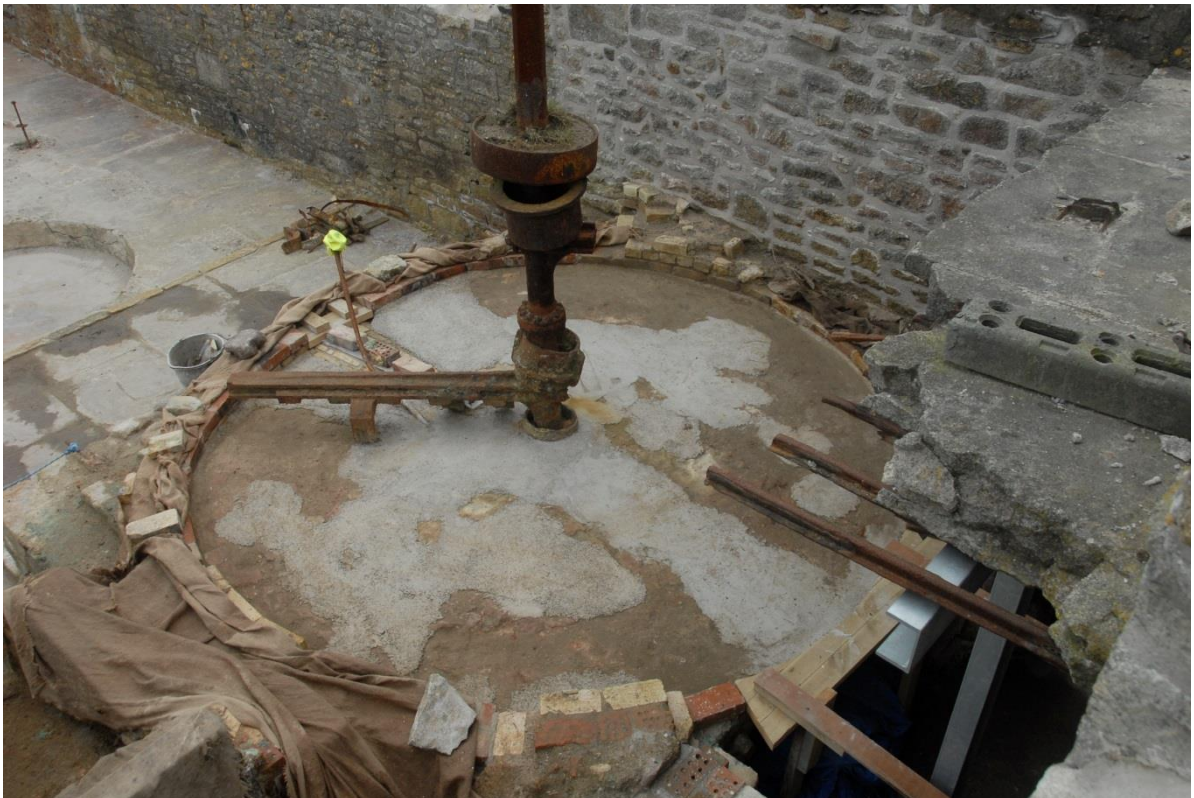
Fig 70. The calciner bed prepared for its re-screeding.

In order to protect the underlying power vault from the effects of further water penetration damage, a specialised concrete screed (Fosroc Paverok) was laid over the original eroded brickwork calciner bed once this had been cleaned of loose material, significant hollows in it had been backfilled with lime concrete and the whole surface of the bed treated with Fosroc Nitobond EP as a primer (Figs 71 – 73). The surface of the new screed was feathered off at its junction with the discharge casting on the eastern side of the calciner bed, whilst to the west where damage to the underlying brick power vault had occurred, the screed was cast up against temporary formwork.

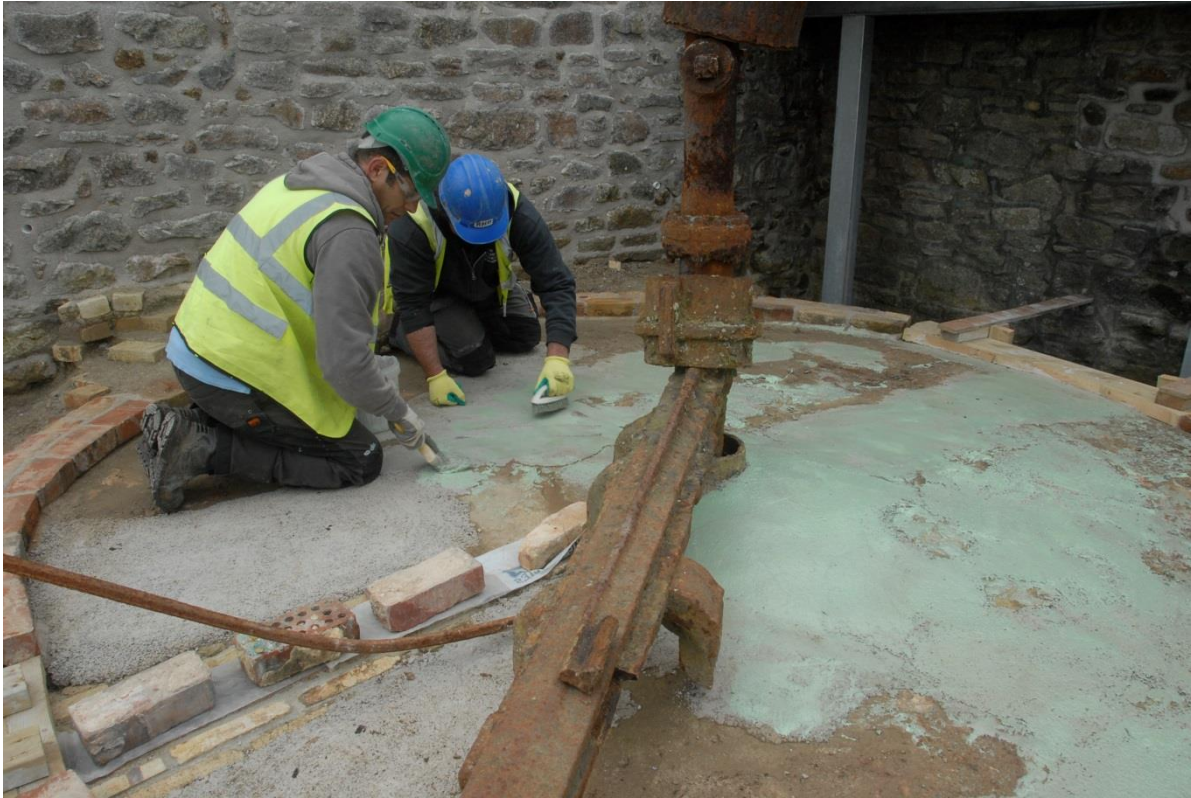
Fig 71. Applying the Nitocote bonding primer to the calciner bed.

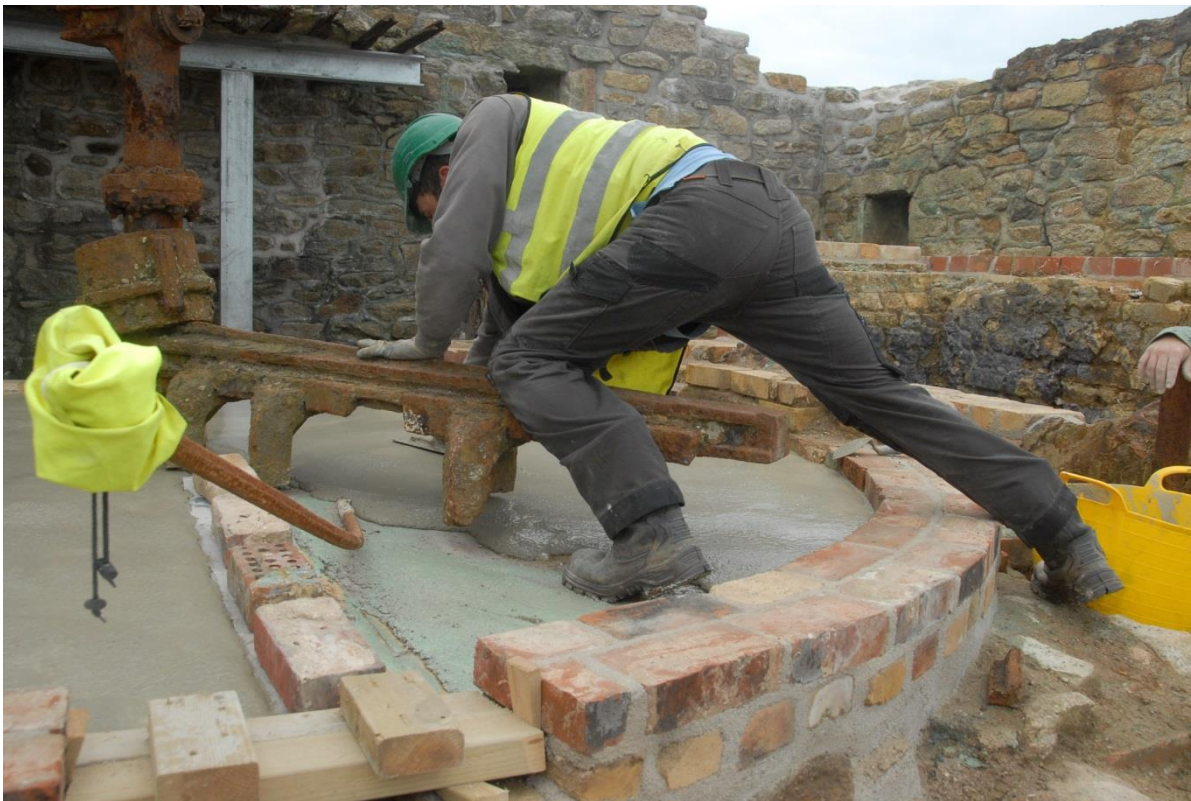
Fig 72. Laying the Paverok screed on the calciner bed.

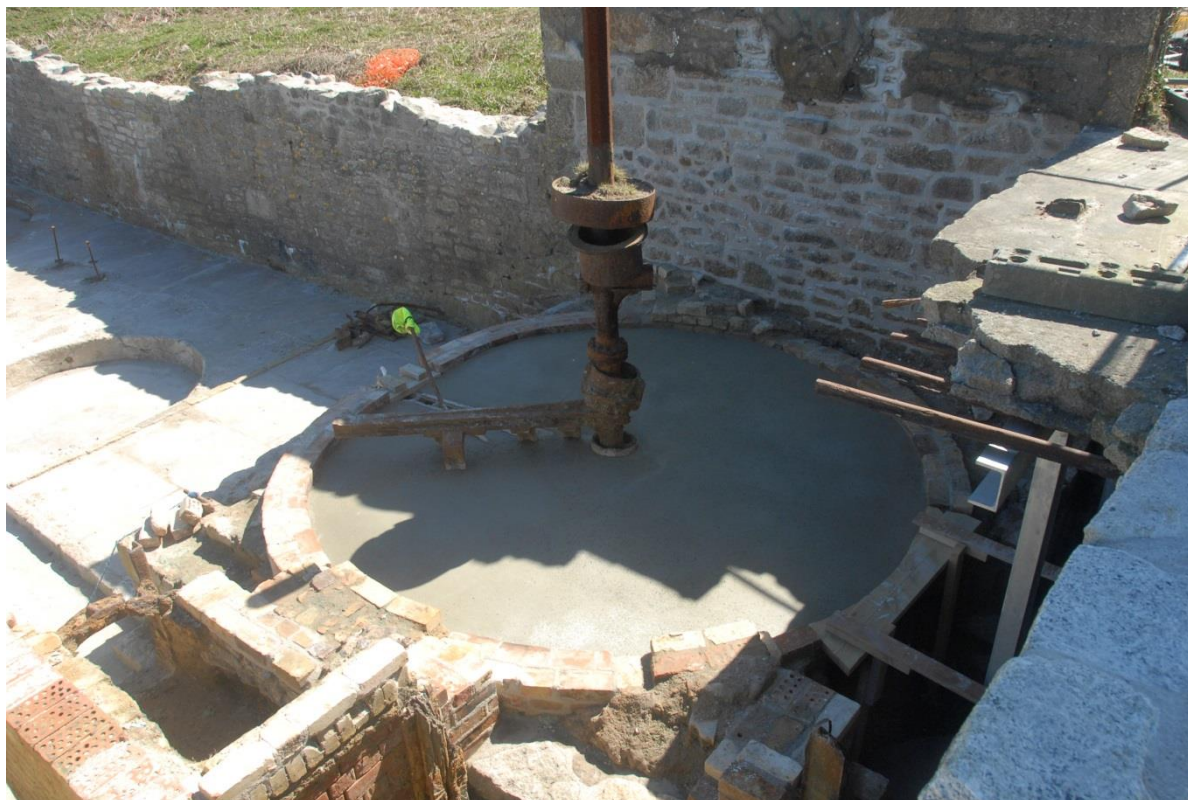
Fig 73. The completed Paverok screed to the calciner bed.

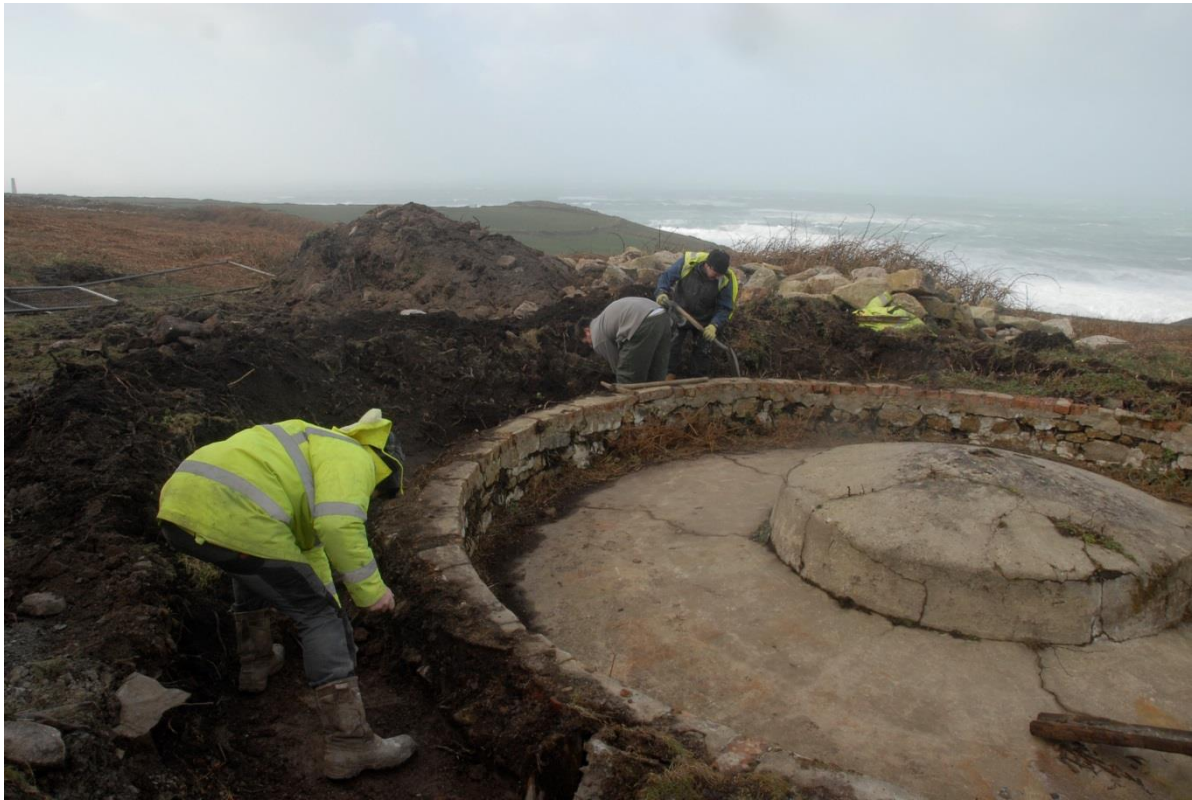
Fig 75. Hand excavation under way around the northern buddle.

To the north of the tin floors, the ground around the external buddle was machine trenched down around its external brick and stone walls, the trench was cleaned by hand down to the top of the rab and any remaining bracken rhizomes within the masonry of the buddle walling were treated with Glyphosate (Fig 75). A woven geotextile fabric barrier was then installed in the trench to prevent future root infiltration, something which had, in the past, caused very significant damage to the rendered inner facing of this structure (Fig 76). The trench between the folded fabric was backfilled with granular material, which was covered to surface on its southern side by A803 mixed size granular material to match the path constructed along the adjacent northern face of the dust chambers and with excavated soil from which bramble roots and bracken rhizomes had been removed by hand around the remainder of its circuit. Bramble roots and bracken rhizomes were dug out from cracked sections of the inner face of the structure, together with any other organic material, the joints were re-packed with bedding mortar and the inner face of the buddle brickwork was re-pointed in a cement mortar to match the existing. Minor repairs were also undertaken to the central cone of the buddle where this had become damaged by cracking and subsequent root infiltration. The paired concrete sockets for the buddle's original timber superstructure were revealed during these works and were left exposed on its completion.
