Trease, Pendeen, Cornwall
The results of an archaeological watching brief during a
second phase of conservation works

Client	The National Trust
Report Number	2016R005
Date	19 May 2016
Status	Final
Report author	Adam Sharpe BA MCIfA
Checked by	Dr. Andy Jones MCIfA
Approved by	Andrew Young MCIfA

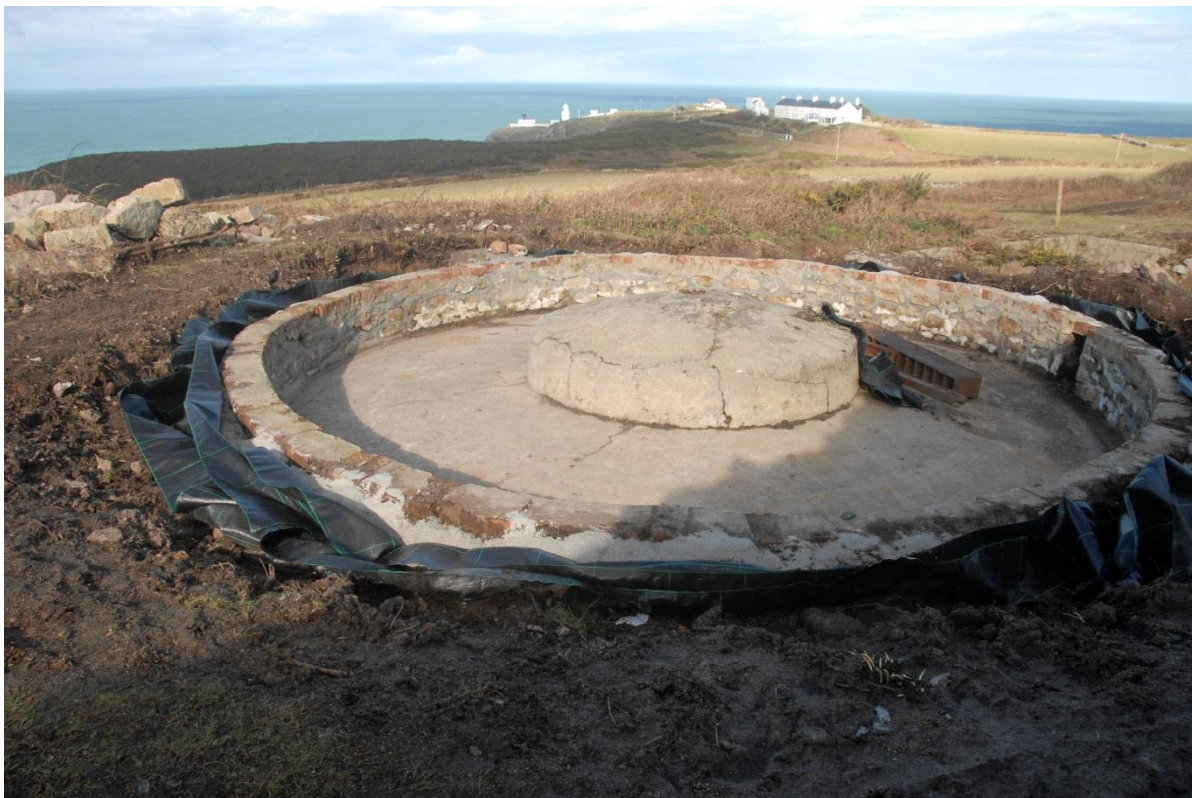
Fig 76. The geotextile root barrier in place in the trench around the northern buddle. This was subsequently backfilled with an inert gravelly material.

To the north of the tin floors, the ground around the external buddle was machine trenched down around its external brick and stone walls, the trench was cleaned by hand down to the top of the rab and any remaining bracken rhizomes within the masonry of the buddle walling were treated with Glyphosate (Fig 75). A woven geotextile fabric barrier was then installed in the trench to prevent future root infiltration, something which had, in the past, caused very significant damage to the rendered inner facing of this structure (Fig 76). The trench between the folded fabric was backfilled with granular material, which was covered to surface on its southern side by A803 mixed size granular material to match the path constructed along the adjacent northern face of the dust chambers and with excavated soil from which bramble roots and bracken rhizomes had been removed by hand around the remainder of its circuit. Bramble roots and bracken rhizomes were dug out from cracked sections of the inner face of the structure, together with any other organic material, the joints were re-packed with bedding mortar and the inner face of the buddle brickwork was re-pointed in a cement mortar to match the existing. Minor repairs were also undertaken to the central cone of the buddle where this had become damaged by cracking and subsequent root infiltration. The paired concrete sockets for the buddle's original timber superstructure were revealed during these works and were left exposed on its completion.

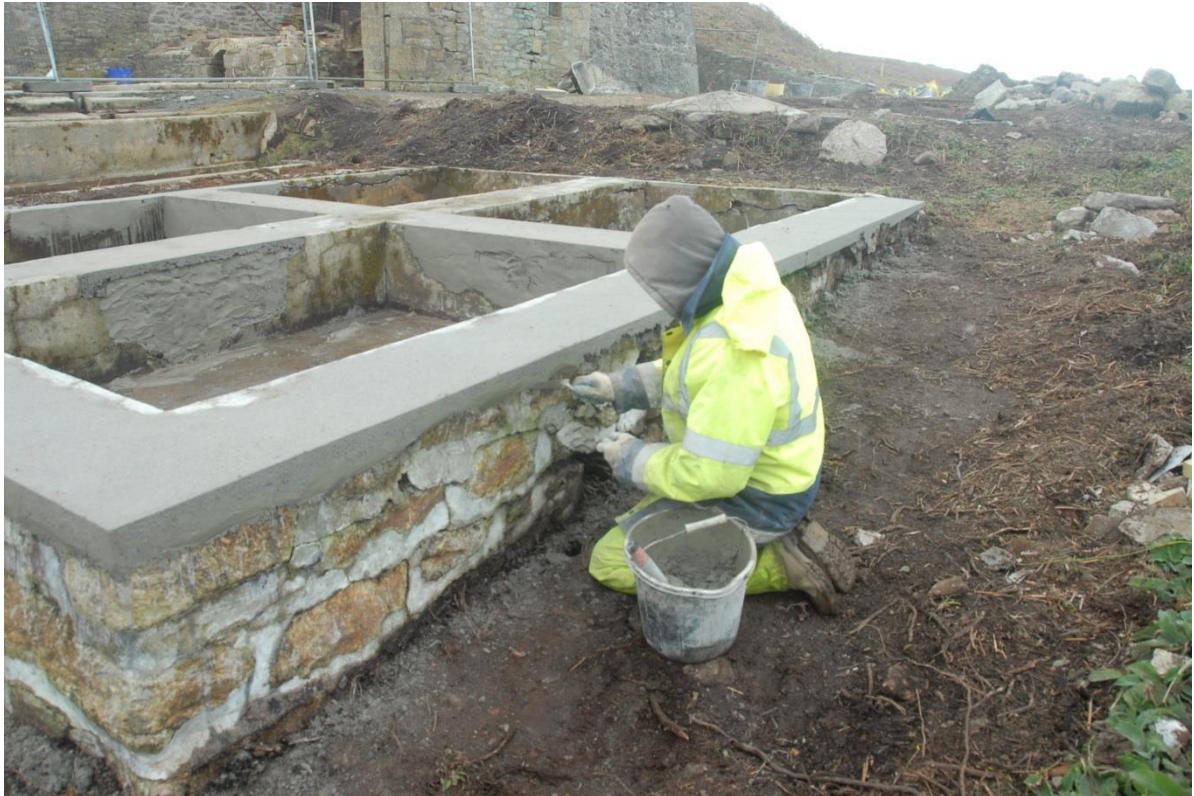
Fig 77. The completion of the works to the precipitation tanks to the north of the tin floors.

Repairs were also undertaken to the mass concrete settling and precipitation tanks to the north of the tin floors (Fig 77). In the case of the latter this entailed the removal of some substantial gorse and bramble roots and the re-forming of major sections of the badly damaged (and in some cases lost) sections of its subdividing rubble and concrete walls. These were reconstructed on a like for like basis, then skimmed over with a cement mortar to reform their heads and faces, matching the originals. Only minor repairs were required to the heads of the walls of the adjacent settling tanks.

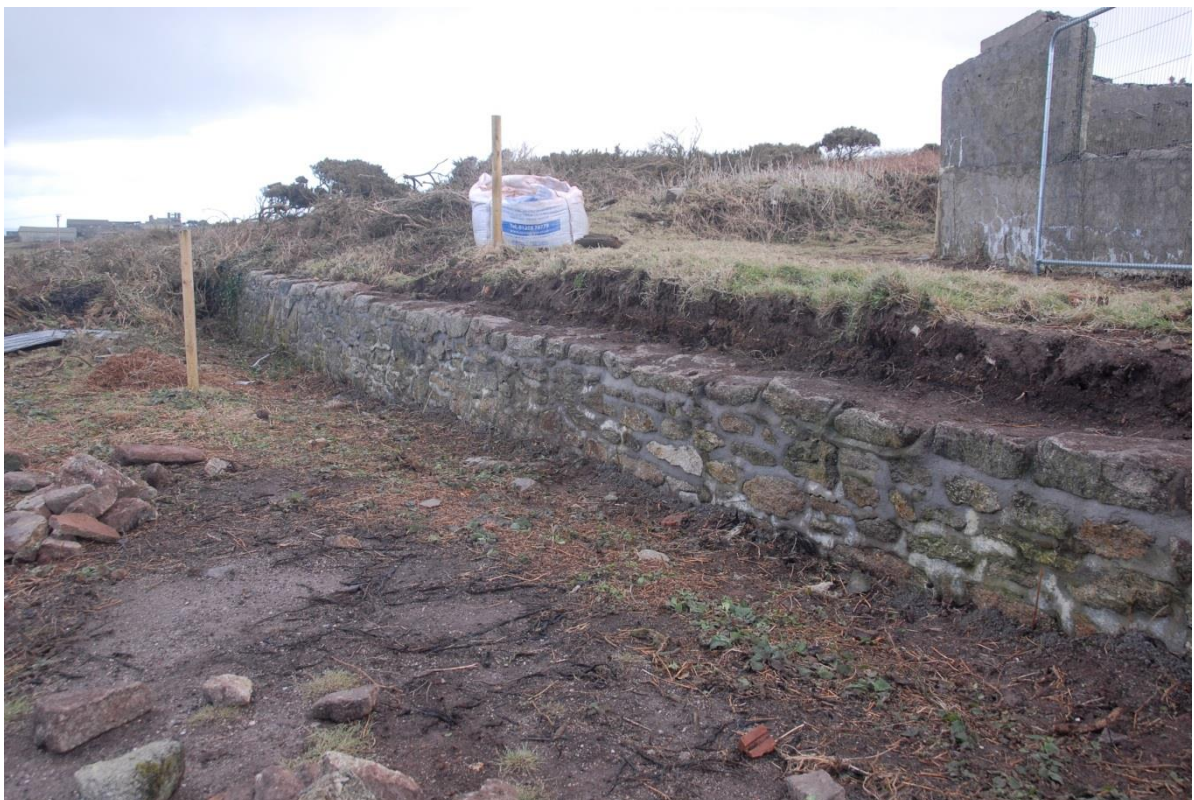
Fig 78. Completed works to the revetment wall linking the tin floors to the probable powder house.

The elongated revetting wall stretching to the east of the tin floors was cleared of vegetation on its northern side, and scrub and infiltrating roots were removed from its head and face, ground levels were reduced to an extent on its southern side (this material represented slimes and soil cleared out of the settling tanks which had been spread in this area during 2015), the joints were repointed in cement mortar where required and its capping stones were re-bedded where they were found to be loose (Fig 78). Two sections of broken wall end were partially rebuilt and repointed to prevent any further collapse. At the wall's eastern end, the small building which might have formed the site's powder house was cleared of rubble and vegetation, minor repairs undertaken where destabilising wall collapses had occurred, its wall top stones were reset and its walls were repointed where required using a cement-based mortar to match the original (Figs 79 – 80).

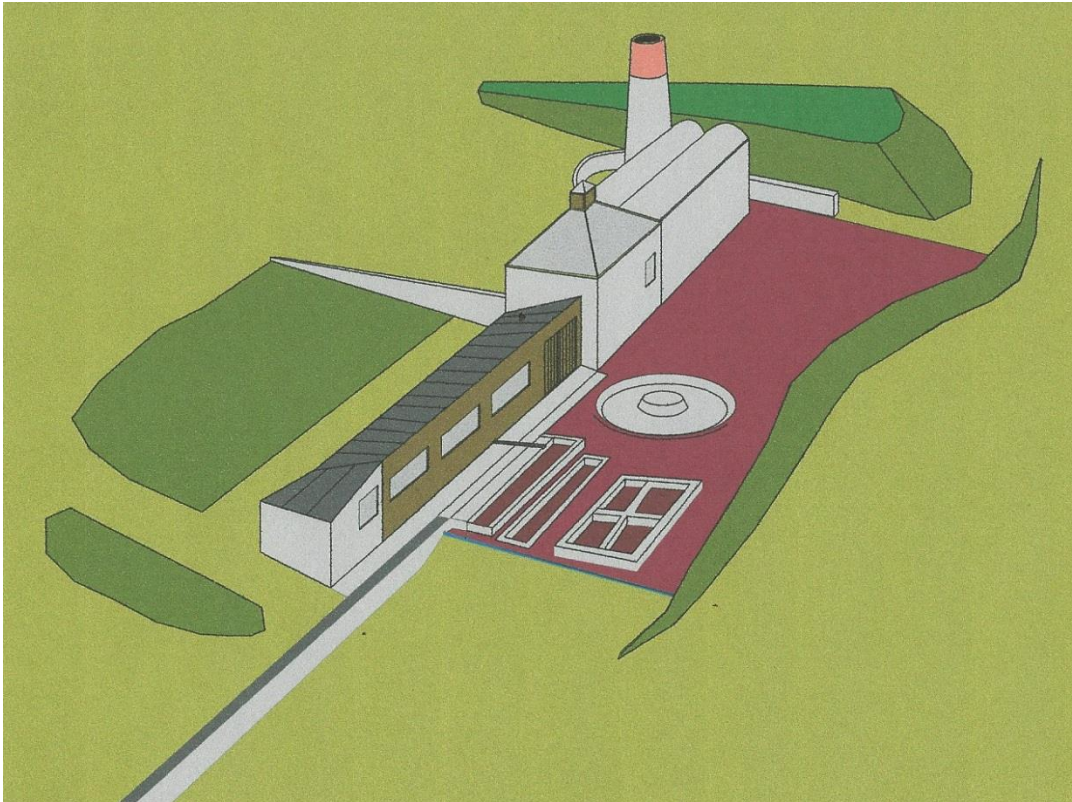
Fig 81. A simplified and hypothetical reconstruction of the original appearance of the tin floors at North Boscawell.

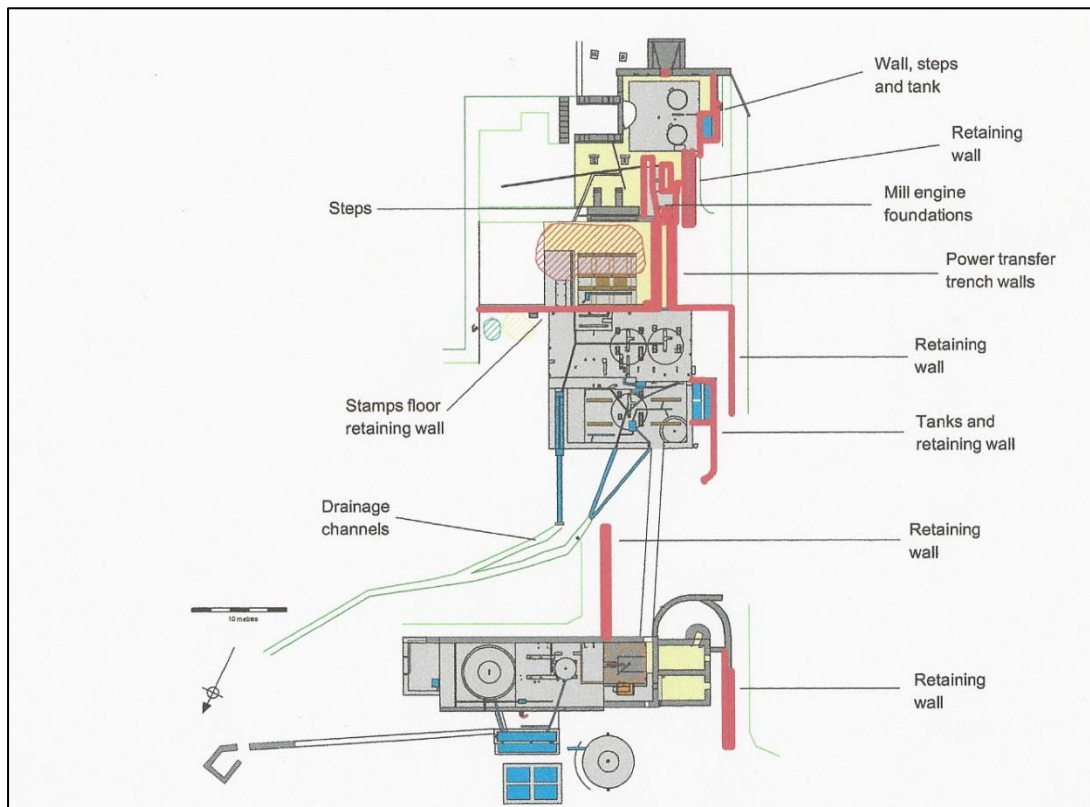
Fig 82. Outstanding conservation works at North Boscawell dressing floors (highlighted in red).

See Fig 82.

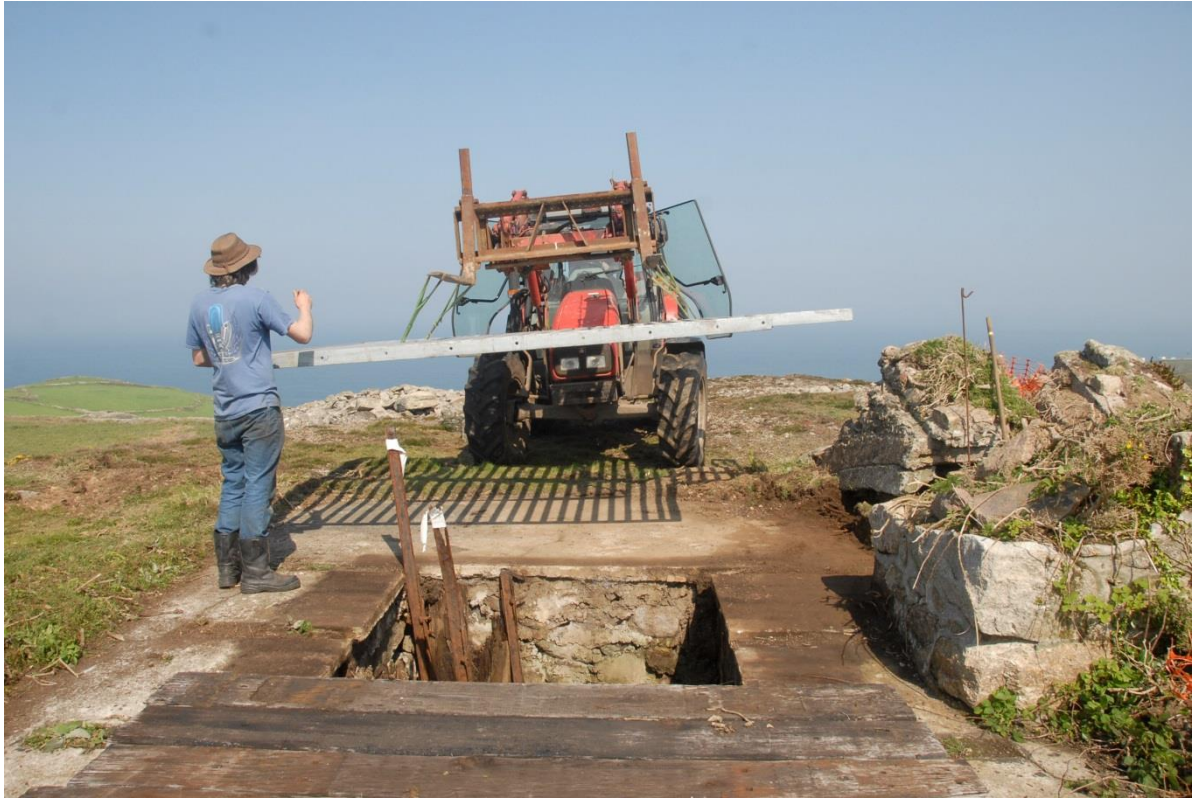
Fig 84. Manoeuvring the first section of the new steel grille onto Trease Shaft once the sleeper cap had been partly removed.

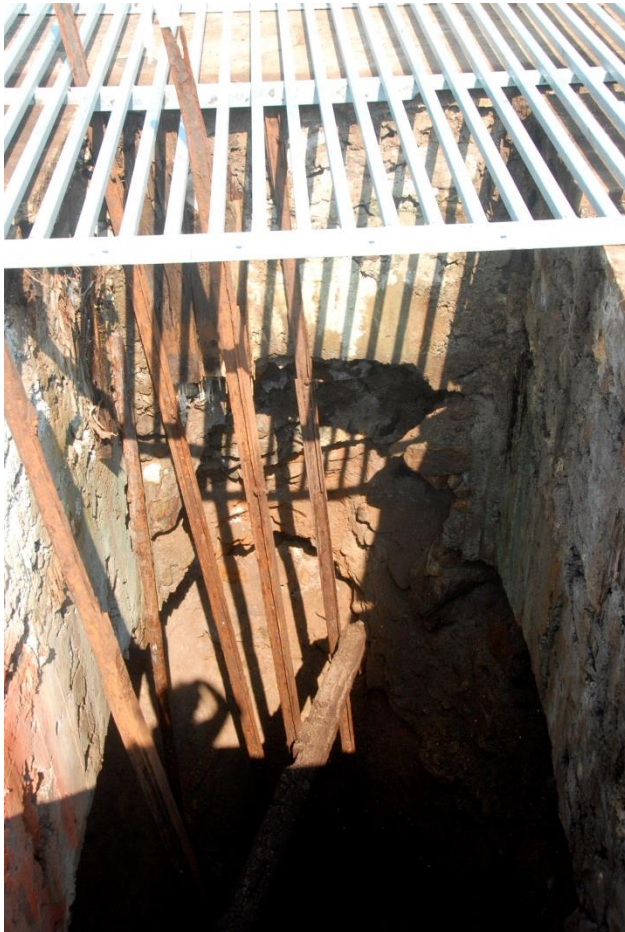
Fig 85. The northern elevation of the upper section of Trease Shaft during the installation of the new grille, showing the displaced tramway rail skip guides and the upper section of shallow workings behind them.
