Poltesco Mill House, Cornwall Historic building record

2015R036

The National Trust

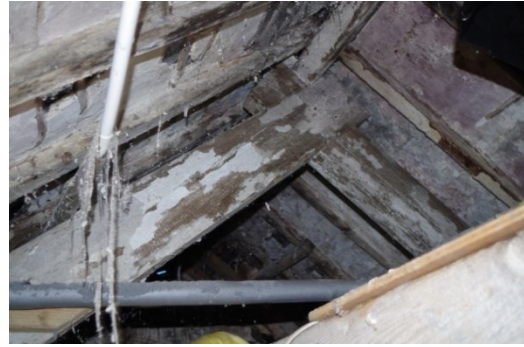
Fig 36 wash house roof structure looking west

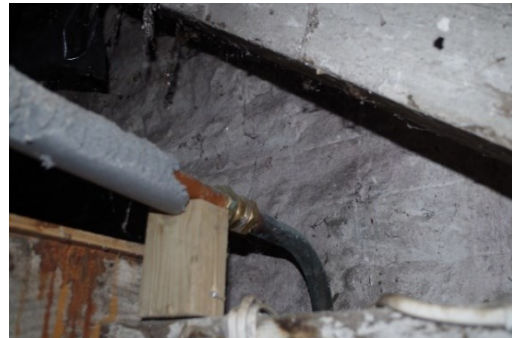
Fig 37 wash house roof space looking east

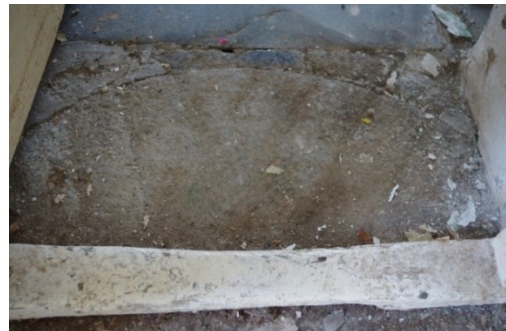
Fig 38 Half 19th century millstone reused as threshold between wash house and kitchen

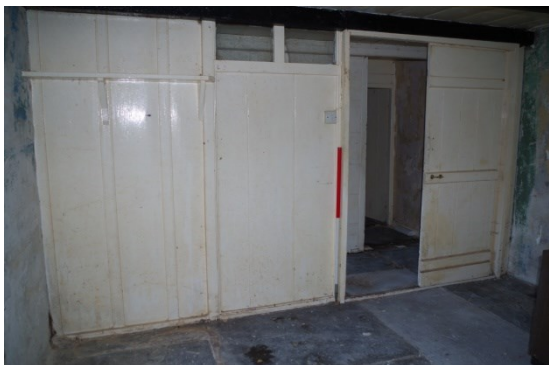
Fig 42 Interior kitchen looking south showing 18th or early 19th century planked wall
