Dodman Point, St Goran, Cornwall Archaeological Assessment and Management Plan

Archaeological Assessment and Management Plan

Client	Miss E Letcher
Report Number	2014R086
Date	June 2015
Status	Final
Report author	Dr Fiona Fleming ACIfA
Checked by	Charlie Johns
Approved by

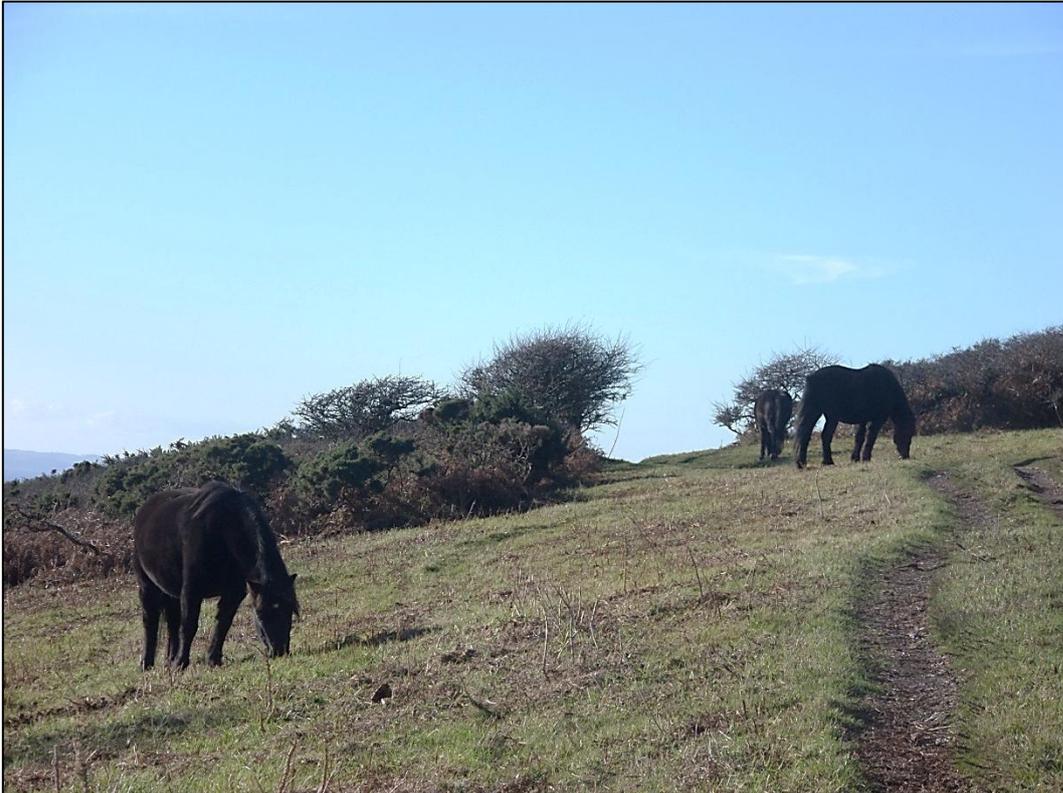
Bracken and scrub on the cliff slopes has been under a programme of clearance by the National Trust, supported by the current grazing regime by Shetland ponies (Fig 15). It is the intention to put the Penare Dexter herd onto the coastal slopes and the further grazing of this area will assist the gradual clearance and maintenance; it has been agreed that stock fencing could be introduced along the western end of The Bulwarks to make this possible. Some further clearance may be required to bring it within the prescriptions of the HLS Agreement for Penare Farm (AG00462831 part 2a; part 3) but once the expanded grazing regime is in place scrub clearance in this area could take place bi-annually, freeing up time and manpower for other areas.

Fig 15 Shetland ponies grazing on areas of cleared coastal slope on the west side of Dodman point, looking north. Stands of gorse, blackthorn and bracken remain in uncleared areas
