Report No: 2015R029

St Agnes mine buildings, Cornwall Archaeological monitoring during repair and consolidation works 2014

Client	National Trust
Report Number	2015R029
Date	August 2015
Status	Final
Report authors	Nigel Thomas (CAU), Adam Sharpe (CAU)
Checked by	Dr Andy Jones
Approved by	Andrew Young

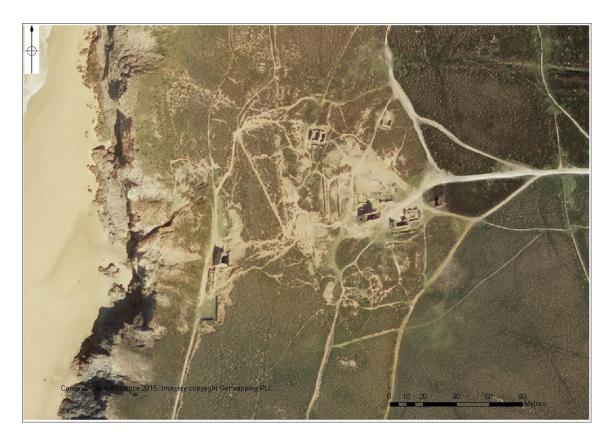
Fig 5. Wheal Coates as it appeared on a 2005 Cornwall County Council aerial photograph. Note the significant level of path erosion visible on this source.

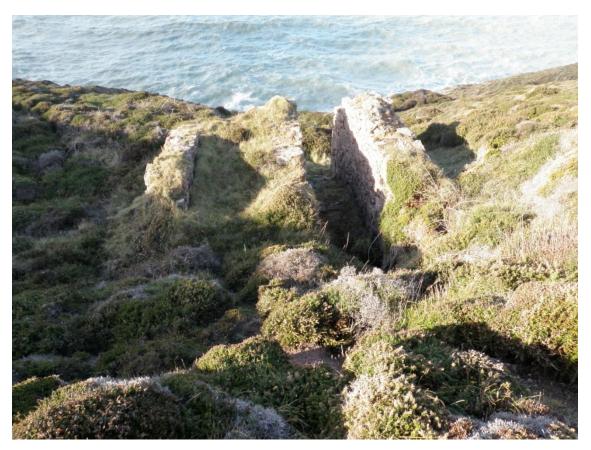
Fig 30. The tributers' stamps wheelpit (right) and gearing platform (left) prior to works.

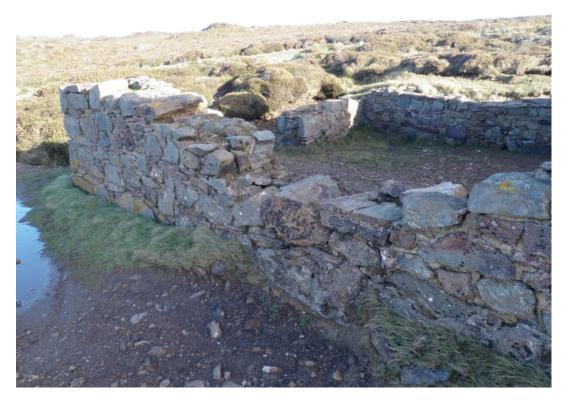
Fig 44. The northern end of the Wheal Coates mine smithy showing the low surviving walling.

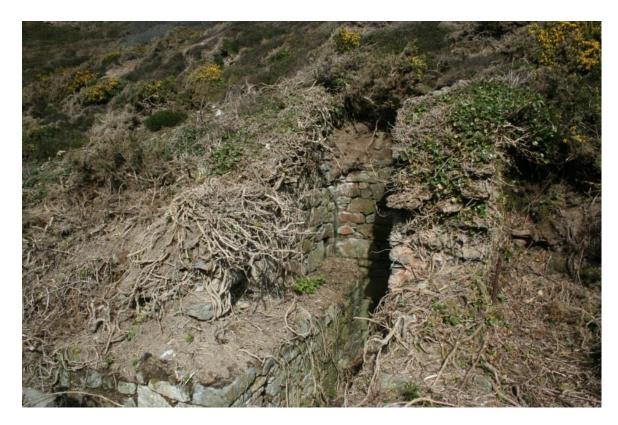
Fig 46. The Old Century Works stamps wheelpit prior to vegetation clearance and stabilisation.

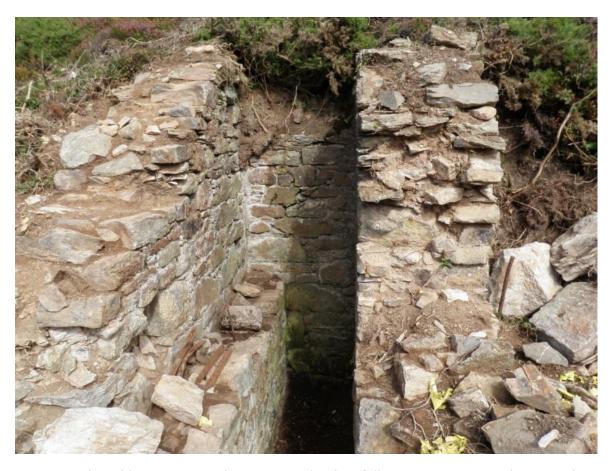
Fig 47. The Old Century Works stamps wheelpit following vegetation clearance but prior to its stabilisation.

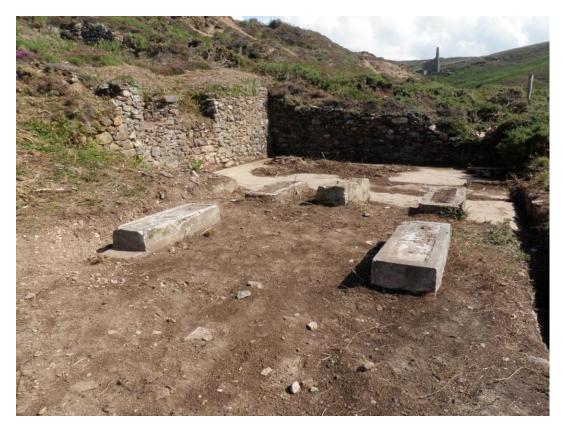
Fig 48. The eastern end of the Old Century Works dressing floors following the clearance of scrub and rubble. The concrete plinths would have supported vanning tables.

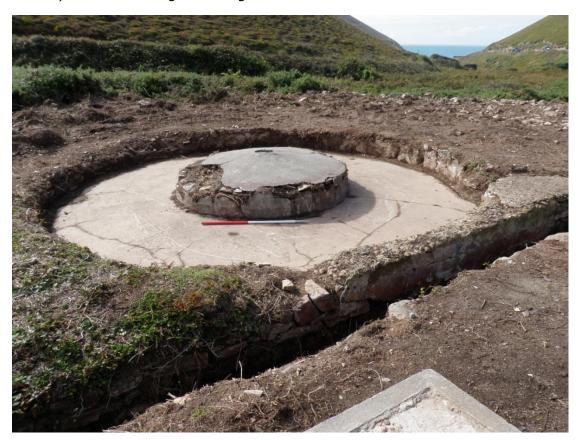
Fig 51. The convex buddle at the Old Century Works following the final removal of vegetation and rubble but prior to its consolidation.

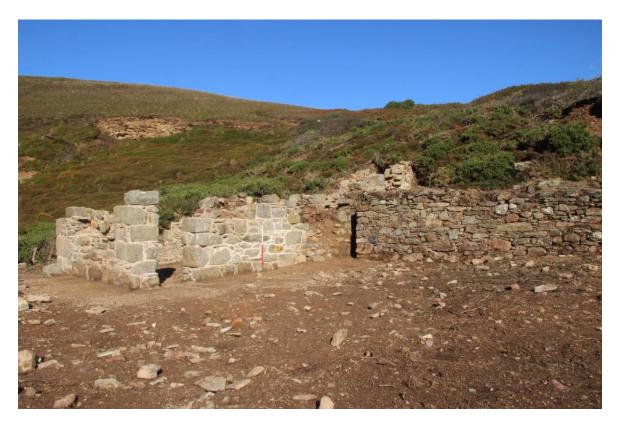
Fig 53. A general view of the structures at the western end of the Old Century Works following vegetation clearance and masonry conservation works.

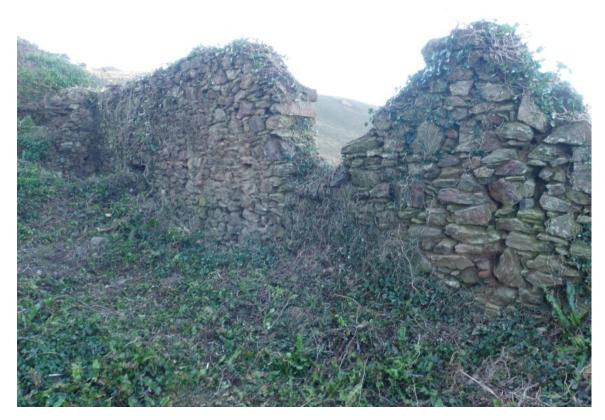
Fig 54. The boiler house at Charlotte United prior to its conservation.

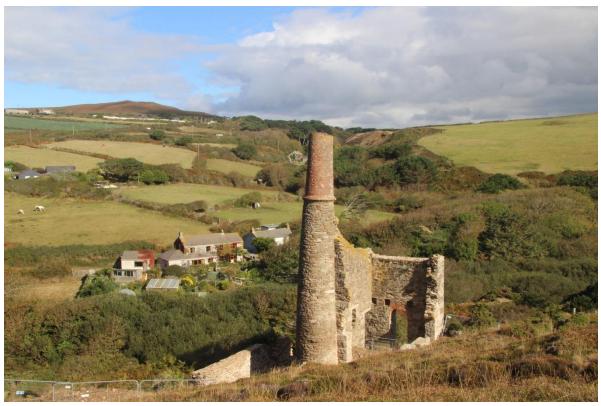
Fig 59. The engine house and boiler house at Charlotte United on completion of the conservation works undertaken to them.
