Tregargus China Stone Mills

St. Stephens, Cornwall

Archaeological recording

Client	Tregargus Valley Trust
Report Number	2015R065
Date	September 2015
Status	Final
Report author	Colin Buck
Checked by	Andy Jones
Approved by	Andrew Young

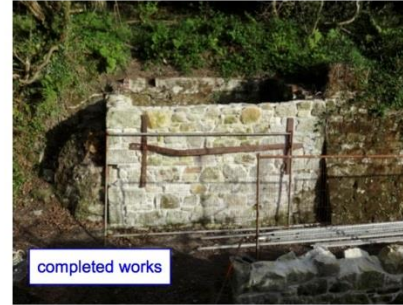
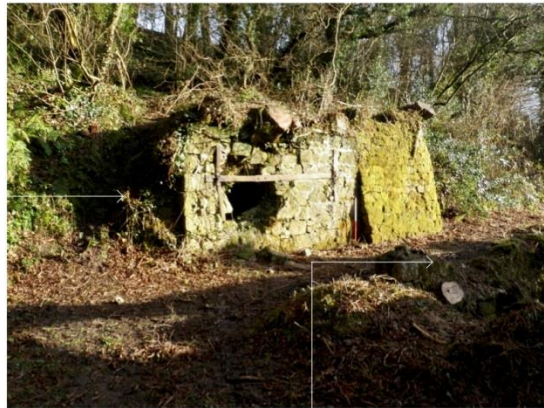
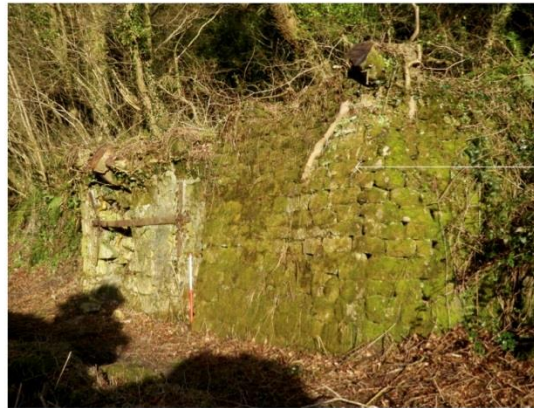
Figure 19 Trevar Mill water tank conservation specifications and images (© Pdp Green Dwg. No. J13037-4013P, 14/9/15).

tree roots
take down unstable section of wall, remove trunk and root system, rebuild wall to tank to stabilise, consolidate wall head

area of collapse to wall, old steel brace remains in-situ, tree growing from wall has been removed but trunk and roots remain
cut away bolts of existing brace to remove from wall, fold back metal work whilst wall rebuilt then re-fix back brace.

Detail view of Tank

steps covered in debris
expose steps and stabilise wall edges

General view of tank

missing area of wall, potential H&S improvement opportunity to re-build wall to provide screen from wheel pit
re-build section of wall with masonry salvaged from site, consolidate wall head to provide rapid water run-off

Retaining wall adjoining tank

existing retaining wall
no work proposed

Site work proceeded from late July to remove further vegetation (especially from the water tank and the wheelpit masonry sides), where stumps were further cut back and treated with root killer. Consolidation works started on the water tank whilst the cottage was being scaffolded (see section 5.5 below). Following careful removal of the large tree trunk, and its associated roots (a difficult exercise), stone was sourced from the site (and within the tank which was cleared out), to rebuild the outer west wall of the tank – keeping the wrought iron strap *in situ*. Mortar panels had previously been assessed and CLS No. 32 was chosen with variable amounts of coal dust to darken the mortar as necessary to match with existing – the same sand aggregate was used for all consolidation works at the Trevear complex. The wall tops were also repointed and ‘capped’. Figure 19 shows images and specifications for these works ‘as constructed’.

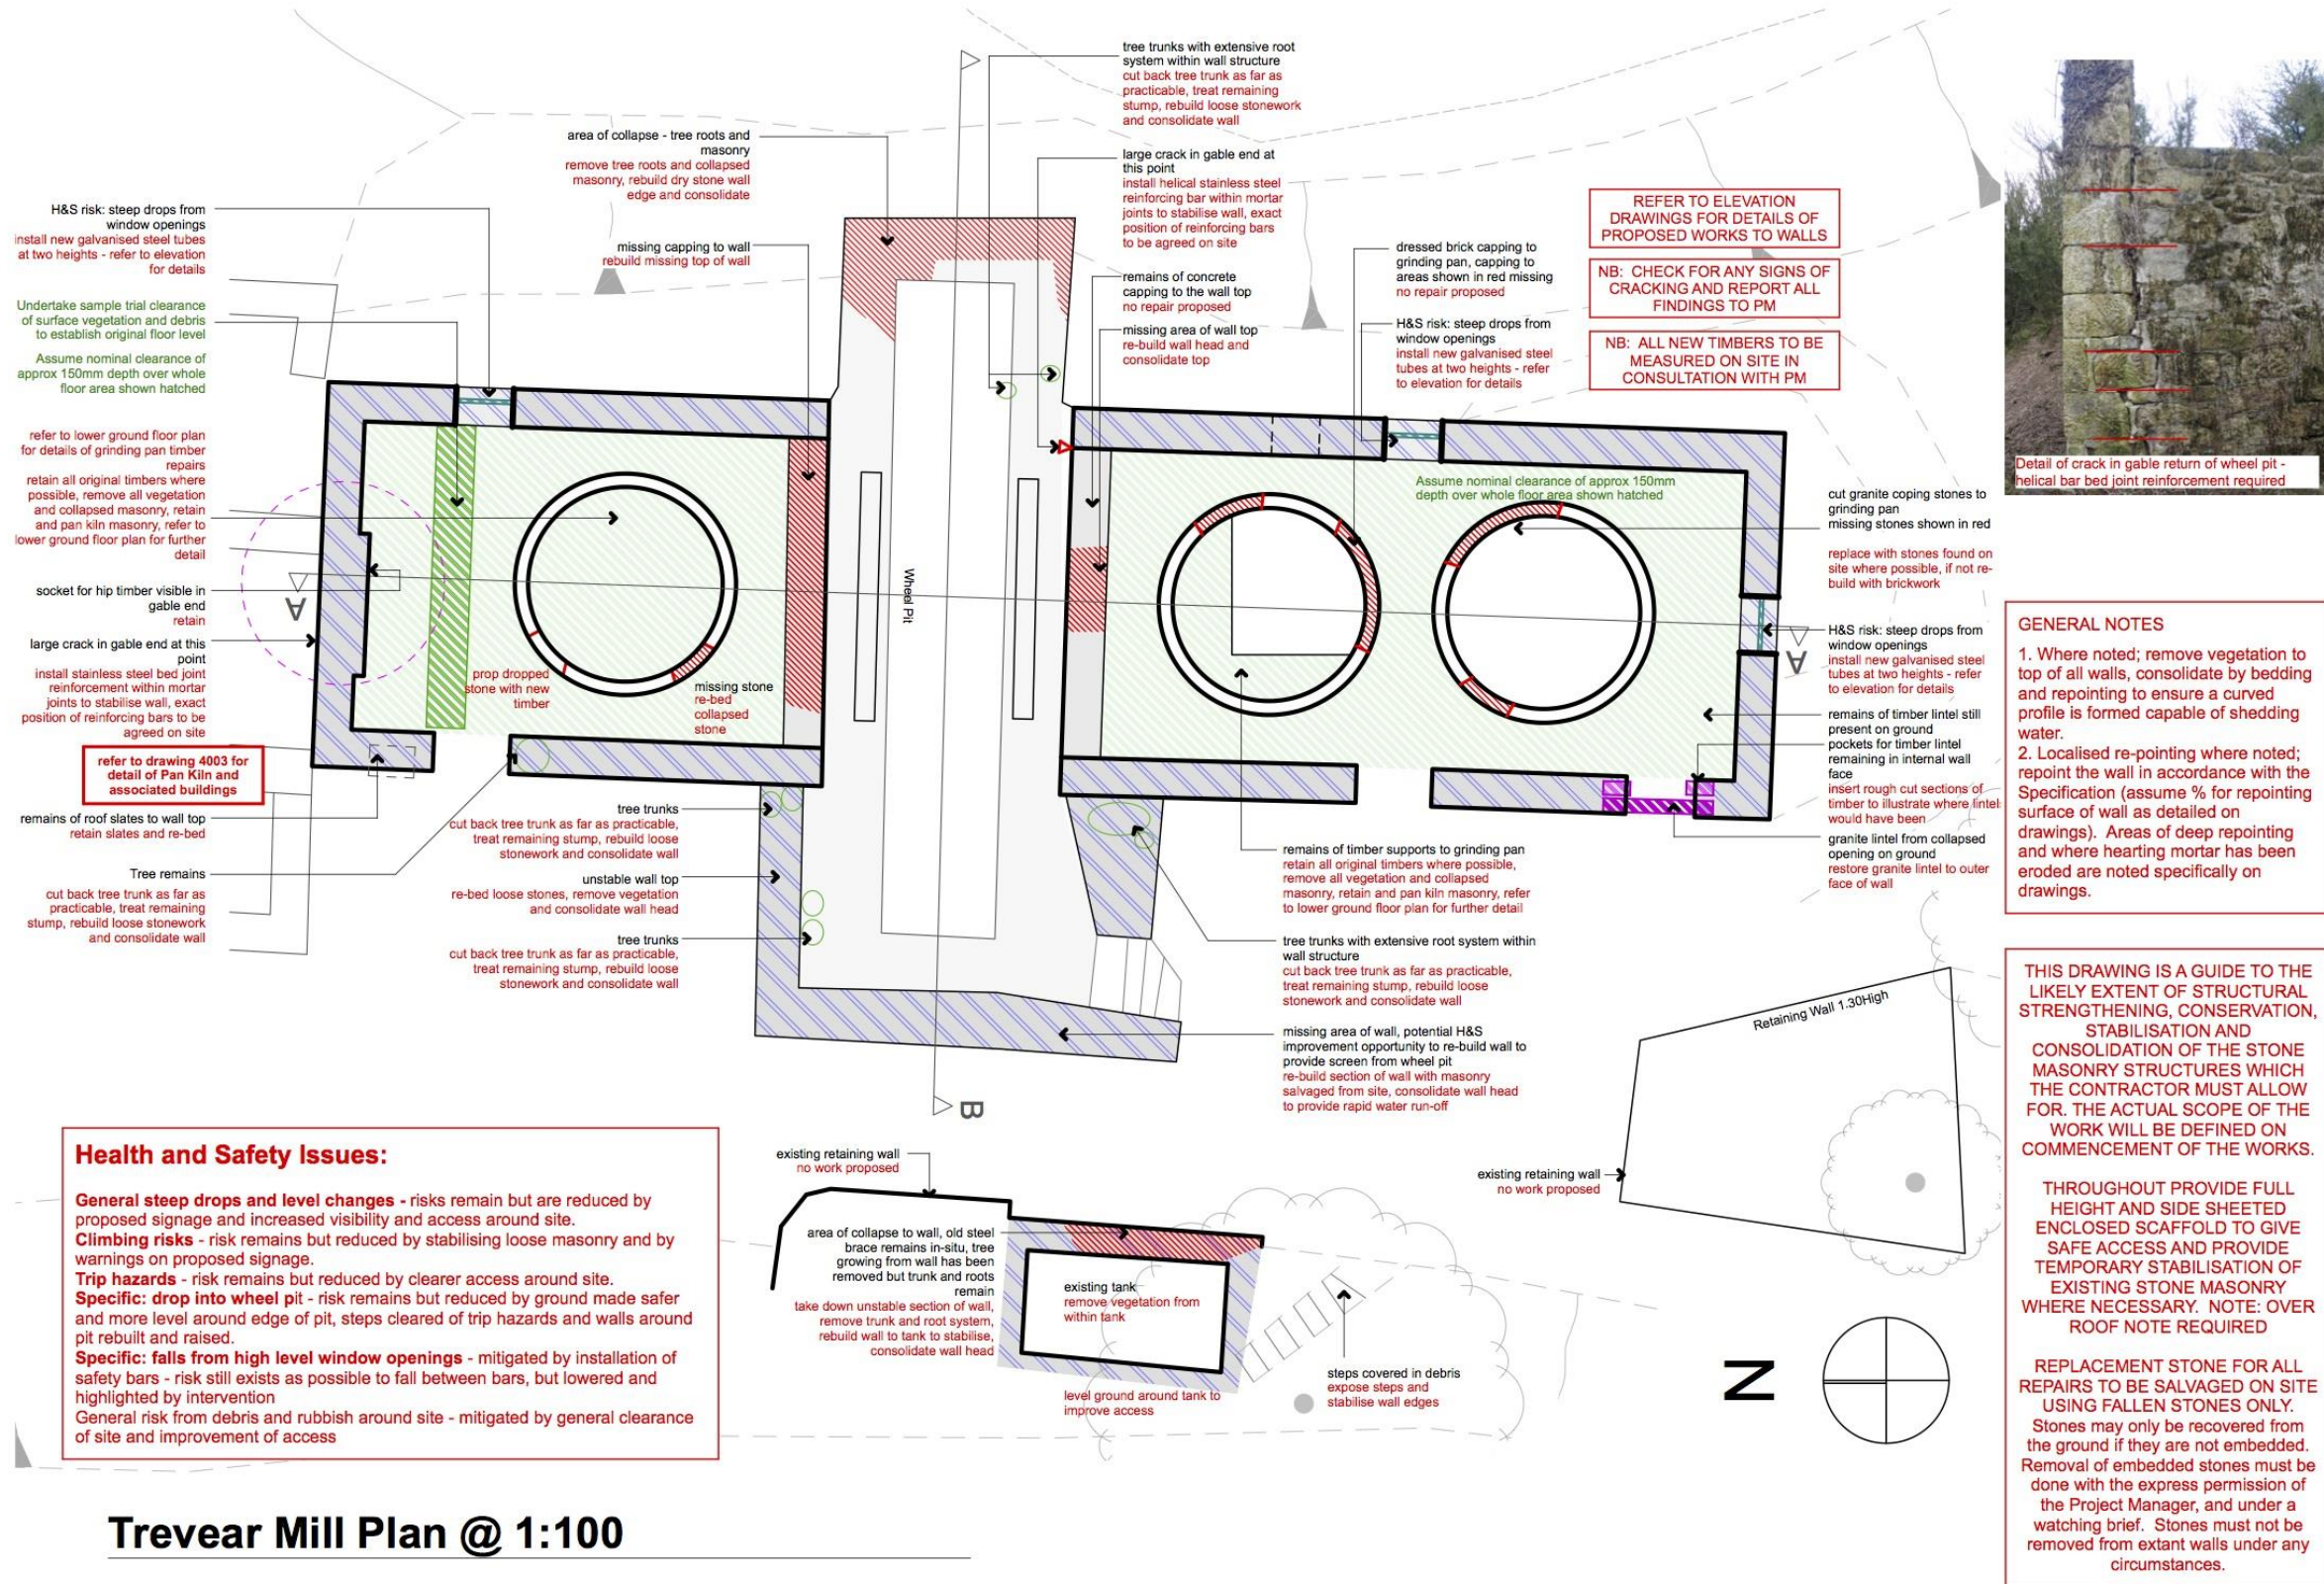
Figure 21 Trevear china stone mill 'as constructed' specifications upper level plan (© Pdp Green Dwg. No. J13037-4002P'B', 14/9/15).

The first floor grinding pans and floor were cleared of vegetation build up and rubble (a build-up of approximately 0.1m in height – compare Figs 24 and 33). The stone floors were then left following clearance. The walls were patch repointed internally and externally where necessary after root and vegetation clearance, and the walls ‘capped’ by rebuilding and re-setting the top of the masonry to a depth of 0.3m (see Figs 25, 34 and 36). A granite lintel was replaced on its original site at the north east corner of the north side of the mill (see Figs 21, 23, 24 and 36), following its collapse onto the adjacent floor. The parapet walls overlooking the wheelpit had deteriorated (see Fig 32), so these were consolidated and a new layer of lime mortar placed on the top surface – copying the original style (compare Figs 24, 32 and 33). These will darken in time. New galvanised tubes were inserted horizontally into three window openings to minimise the possibility of falls to the ground below (see Fig 21 (as built’ survey drawing), and Figures 34 and 36 for site images).

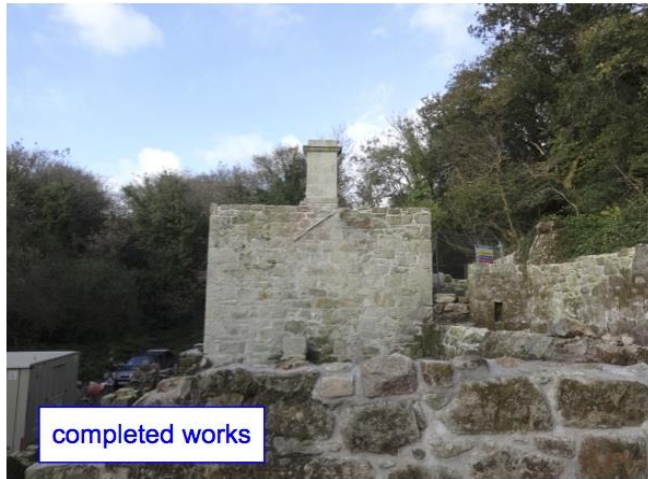
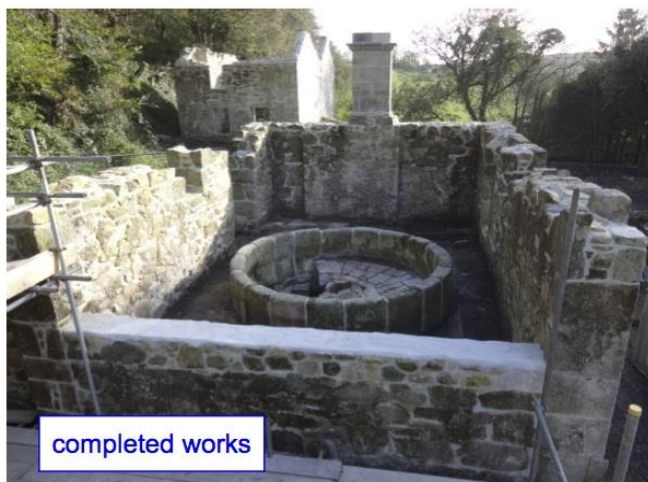
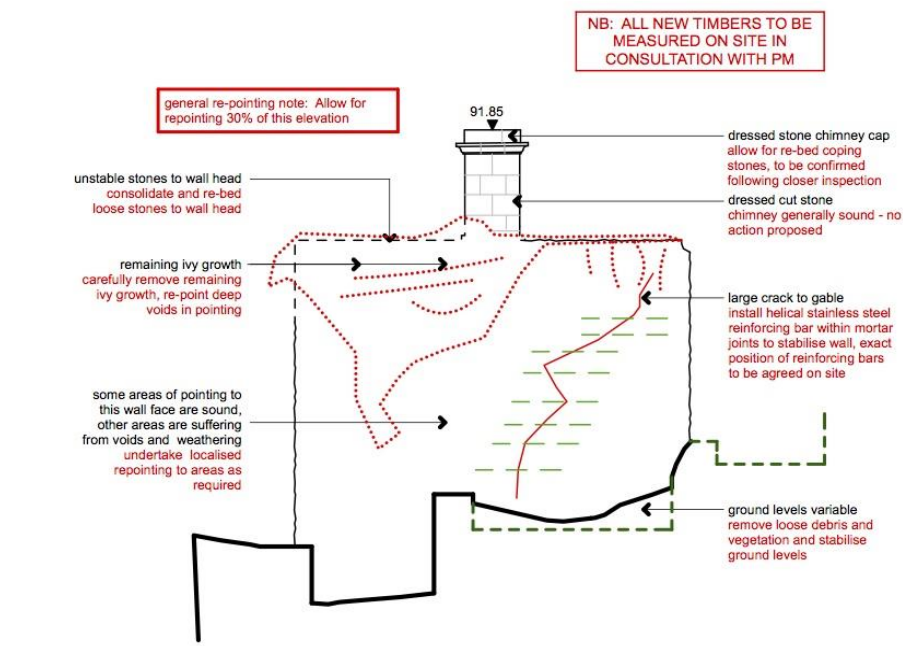
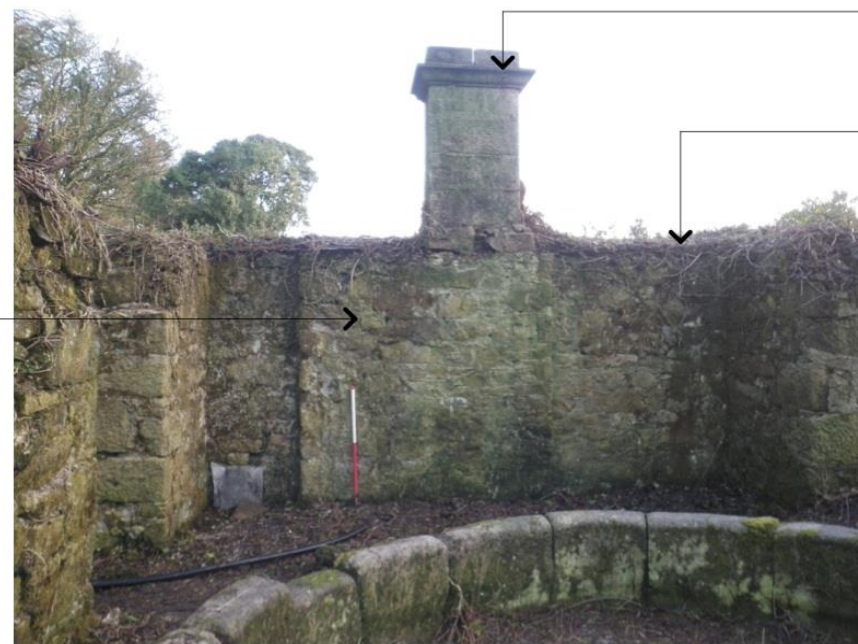
Figure 24 Trevear china stone mill 'as constructed' south elevation (© Pdp Green Dwg. No. J13037-4006P'B', 14/9/15).

pointing to this wall face generally sound, no large voids or extensive weathering no general re-pointing required, some localised re-pointing to areas behind ivy growth as required

consolidate wall heads, remove vegetation and re-bed loose stones. allow for re-pointing 10% of internal face of wall, retain pointing where sound

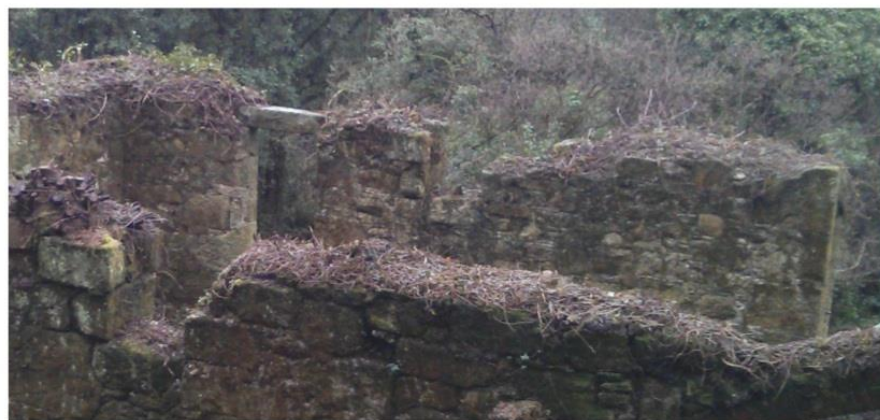
View of internal face of west elevation (south side)

consolidate wall heads, remove vegetation and re-bed loose stones. allow for repointing 50% of internal face of wall, retain pointing where sound

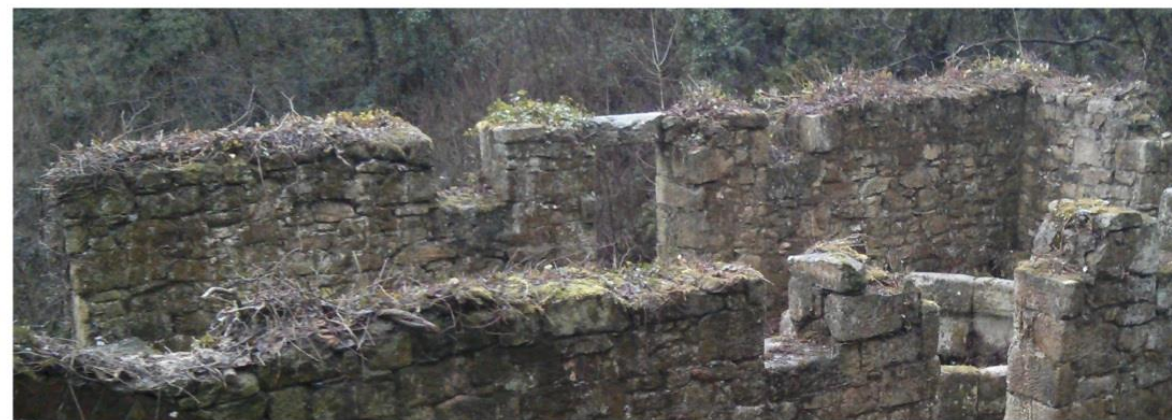
View of internal face of west elevation (north side)

consolidate wall heads, remove vegetation and re-bed loose stones. allow for repointing 50% of internal face of wall, retain pointing where sound

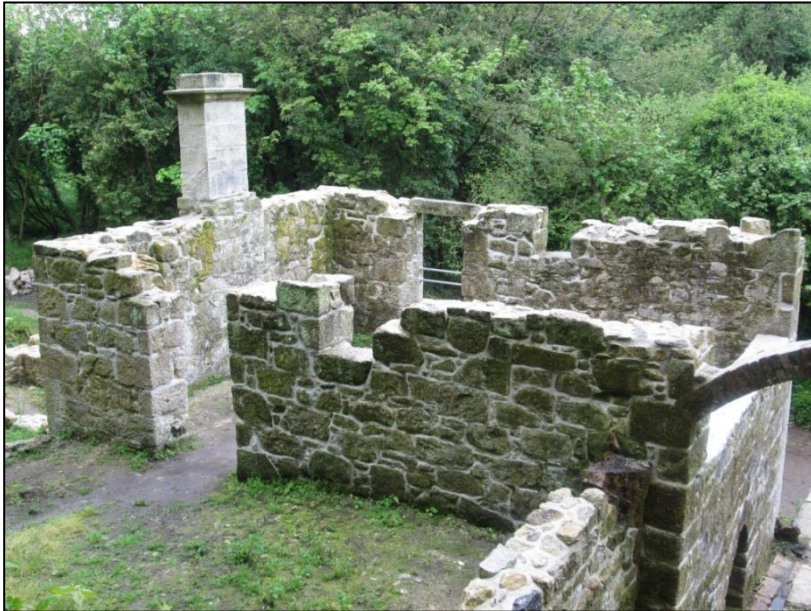
Figure 34 View of Trevear mill first floor south side (from the east) after works © CAU, CC 14/5/2015.

The fallen/vandalised upper chimney masonry at the south end of the south section of the mill was found on-site. This was replaced into its original position and attached firmly with steel pins and re-mortared *in situ* (compare front cover images and Fig 34).

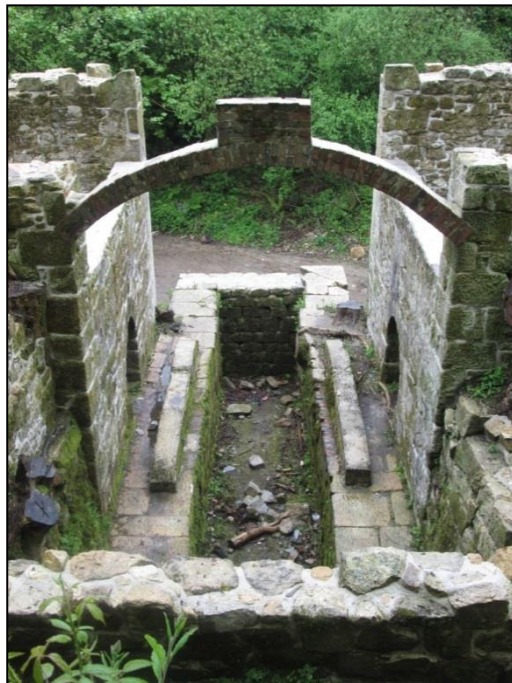
Figure 35 View of Trevear mill wheelpit (from the east) after works © CAU, CC 14/5/2015.

The general site plan of this complex is shown on Figure 20. Works to the other Trevear Mill buildings started in earnest in late August – following scaffolding erection after removal from the cottage. Following the earlier clearance of the wheelpit of fly tipped debris and vegetation, the masonry collapse to the west was rebuilt, and the west end of the wheelpit surround surface consolidated (compare Figs 28 and 29). Trees had been growing out of the east upper side of the wheelpit surround, which were also further cut back with a chainsaw and treated (see Figs 35 and 36). The internal sides of the wheelpit were also patch repointed where necessary.

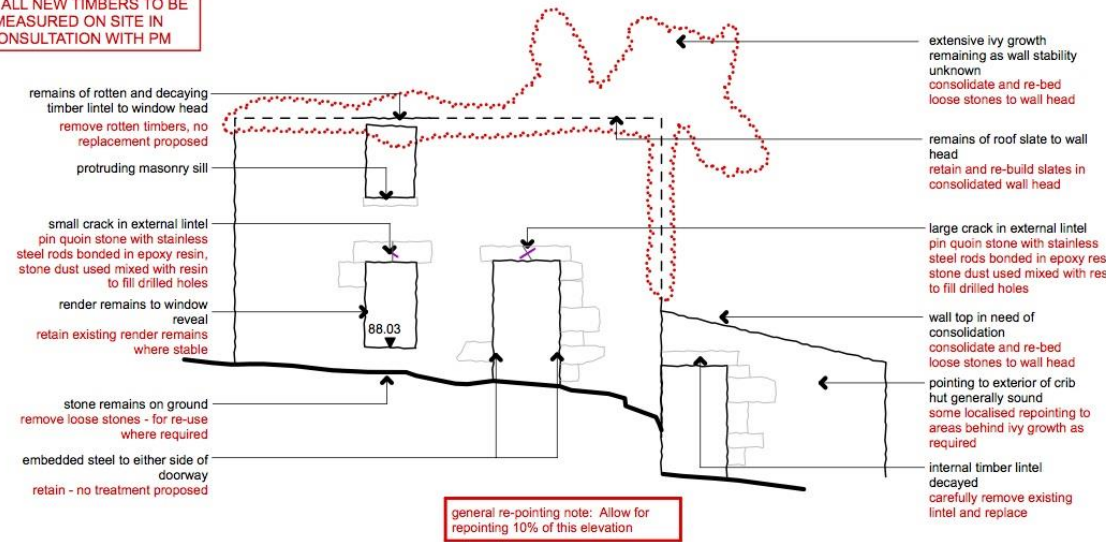
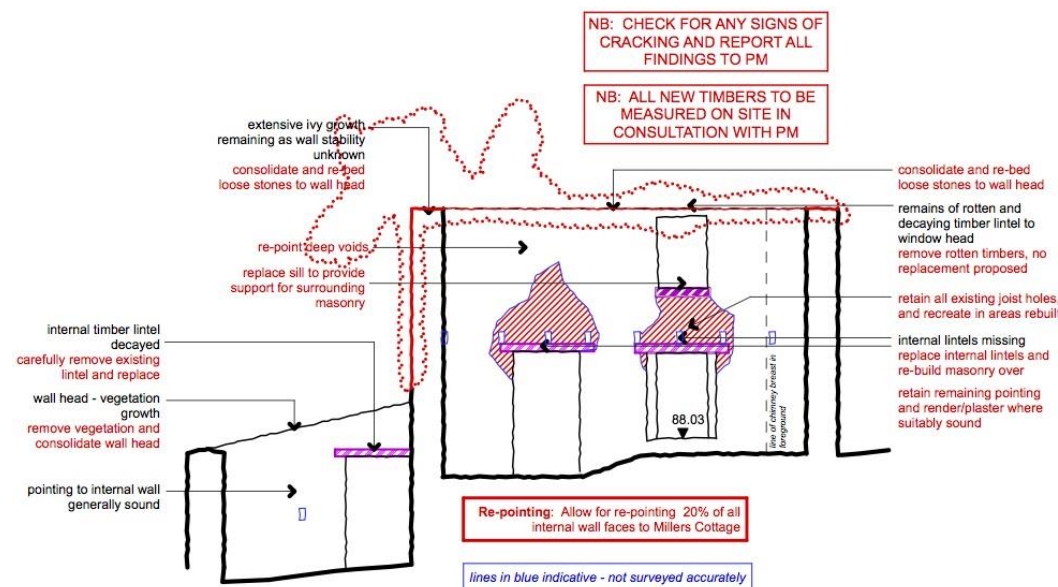
Figure 40 Trevear cottage 'as constructed' internal and external north elevations (© Pdp Green Dwg. No. J13037-4021P'B', 14/9/15).

The north wall (see Figs 40, 42, 48 and 49), had the common structural issue of timber components failing through old age and weathering following collapse/removal of the roof; namely the internal timber lintels. New Douglas fir lintels were installed and the masonry above rebuilt from site-won reclaimed stone. In addition, both of the granite lintels had vertical cracks in their centre – both of which were strengthened by using stainless steel pins. Figures 42 and 43 demonstrate 'before' and 'after' views of the north (exterior) wall, whilst Figures 48 and 49 show the internal north wall.
