Helman Tor, Lanlivery, Cornwall,
Archaeological Watching Brief

Report No: 2017R37

Client	Cornwall Wildlife Trust
Report Number	2017R037
Date	June 2017
Status	Final report
Report author(s)	Catherine Parkes BA MCIfA
Checked by	Ann Preston-Jones
Approved by	Andy Jones

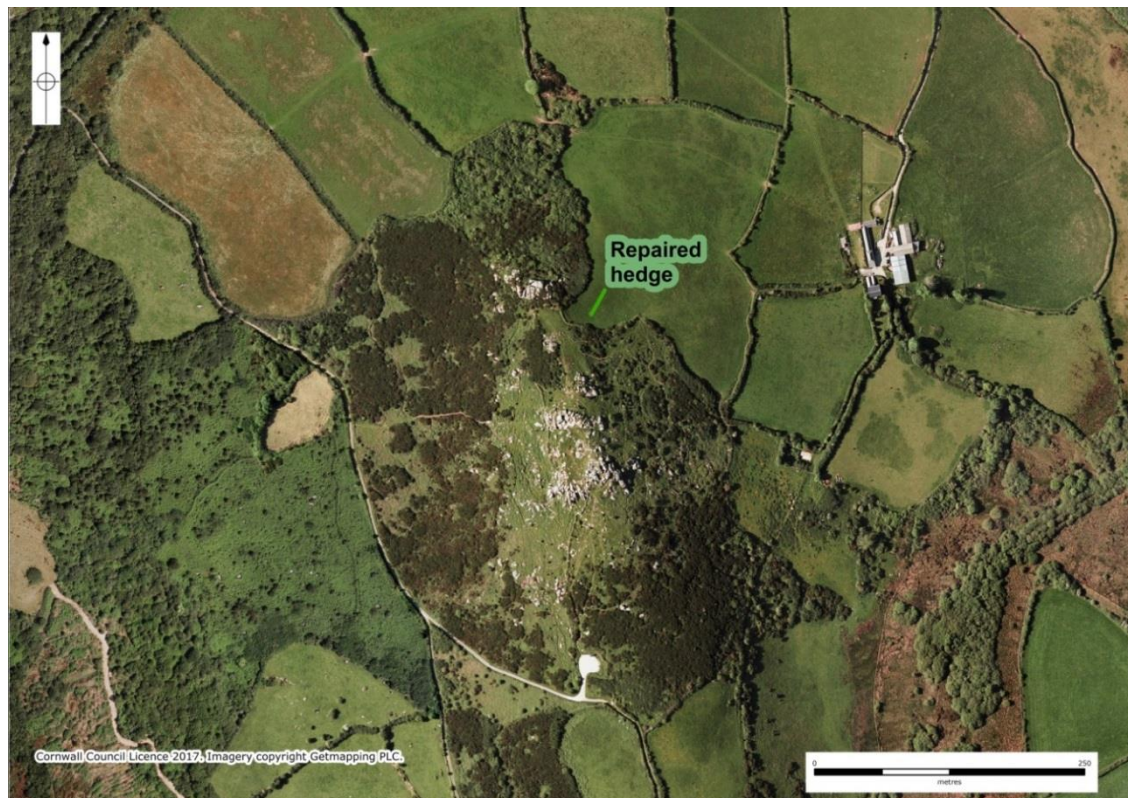
Fig 3 Aerial photograph of 2005 showing the site at the edge of the rough hilltop.

The repaired hedge separates rough ground on upper Helman Tor, on its south and west, from an improved field to the north and east (Fig 3). It should be noted, though, that alongside and beneath the westernmost part of the hedge, roughly parallel to this, the improved field incorporates a substantial linear earthwork (Figs 4 and 5). This is interpreted as part of the rampart of the tor enclosure which continues along the contour south of the affected hedge as recorded on the 1984 survey (Fig 28), and is included in the Scheduling. Here the rampart is a stony bank c4m-5m wide and 1.6m high on the east, with an uneven surface supporting the hedge on its west, and a scarp forming its outer side against the rest of the field on its east. It is unimproved, bearing bluebells and other rough vegetation, unlike the remainder of the field incorporating it.

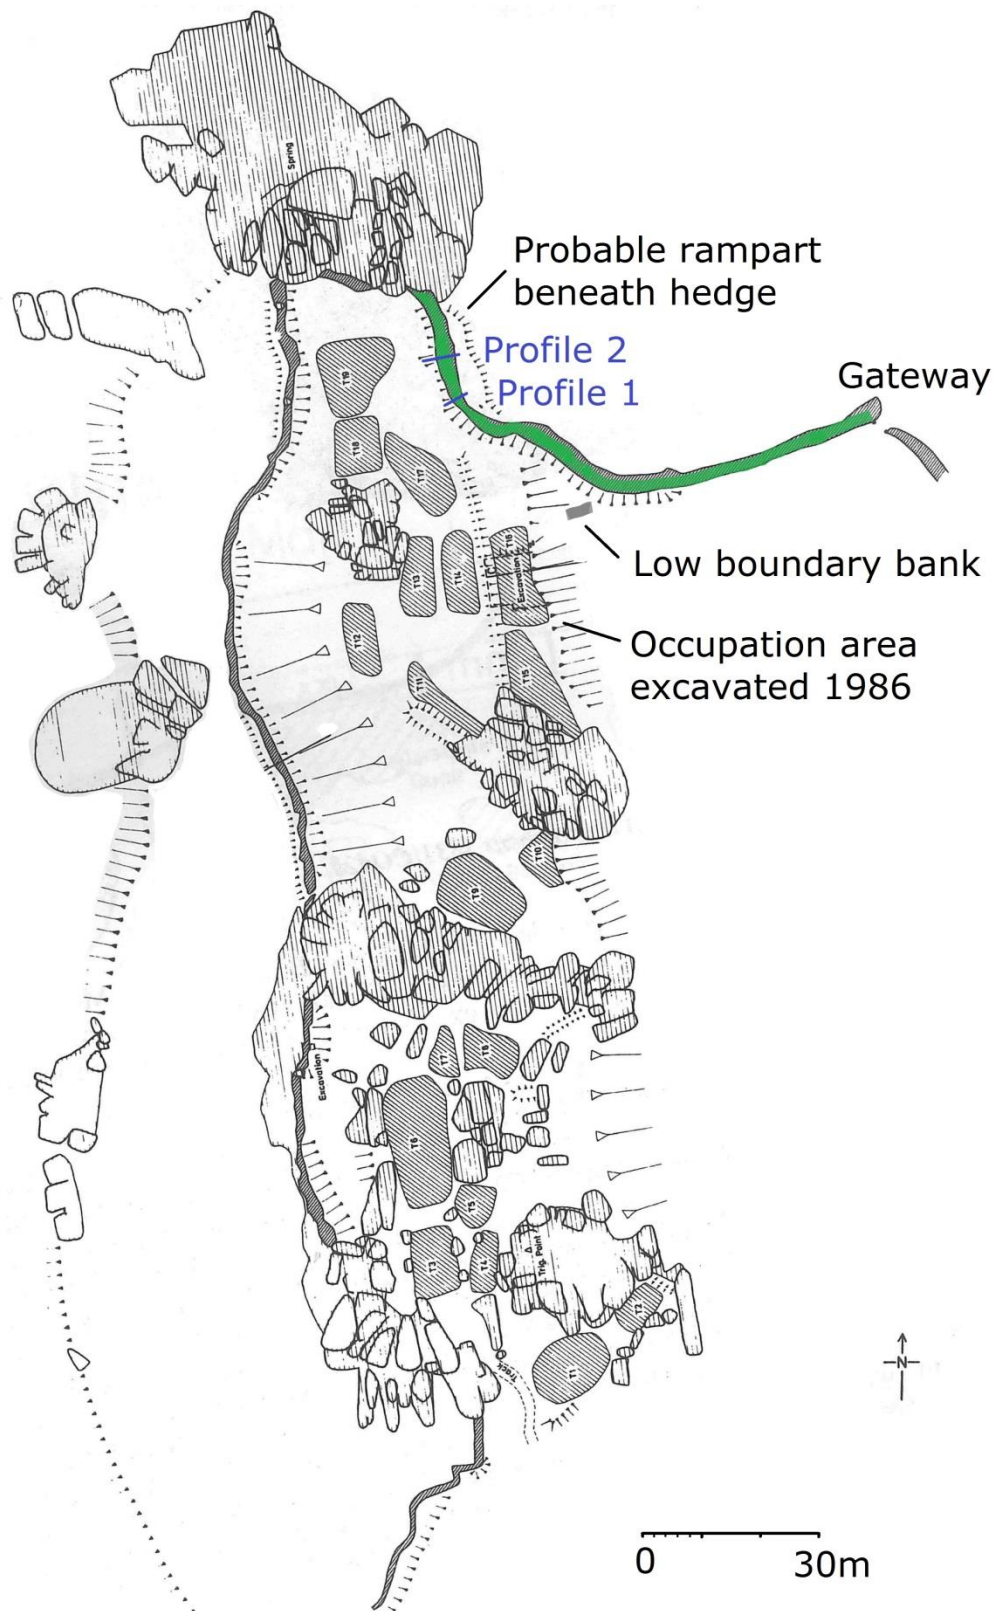
As Figure 28 shows, the hedge bank at Helman Tor repaired in 2017 stands partly on the tor enclosure's 'enceinte of massively built, boulder-constructed wall....certainly present on the eastern side of the summit of the hill and at the southern extremity' (Mercer 1997, 9, 12). It is close to Terrace T16, a well-defined platform between the massive boulder-built enclosure wall on its forward (eastern) side and a 'clear bank of upcast material on its rearward side', c15m to the south at its nearest point. Excavations at T16 in 1986 revealed Neolithic structural and cultural activity - midden debris, 'substantial ground-fast evidence for timber supports for structures', relatively large quantities of pottery and lithic debris (*op cit*, 5, 12-13, 56).

Fig 28 Plan of the tor enclosure, with natural rock piles and outcrops shaded pale grey: showing the low boundary bank south of the centre of the repaired hedge; the hedge itself in green; and hedge profile lines in blue (after CCRA 1984, and Mercer 1997).

The darker grey areas labelled T1, etc, are potential levelled occupation areas (Mercer).
