# Dupath Holy Well, Cornwall

## Archaeological investigation

<b>Client</b>	<b>English Heritage Trust</b>
<b>Report Number</b>	2017R070
<b>Date</b>	<b>January 2018</b>
<b>Status</b>	Final
<b>Report author(s)</b>	<b>Ann Preston-Jones</b>
<b>Checked by</b>	<b>Adam Sharpe</b>
<b>Approved by</b>	<b>Andy Jones</b>

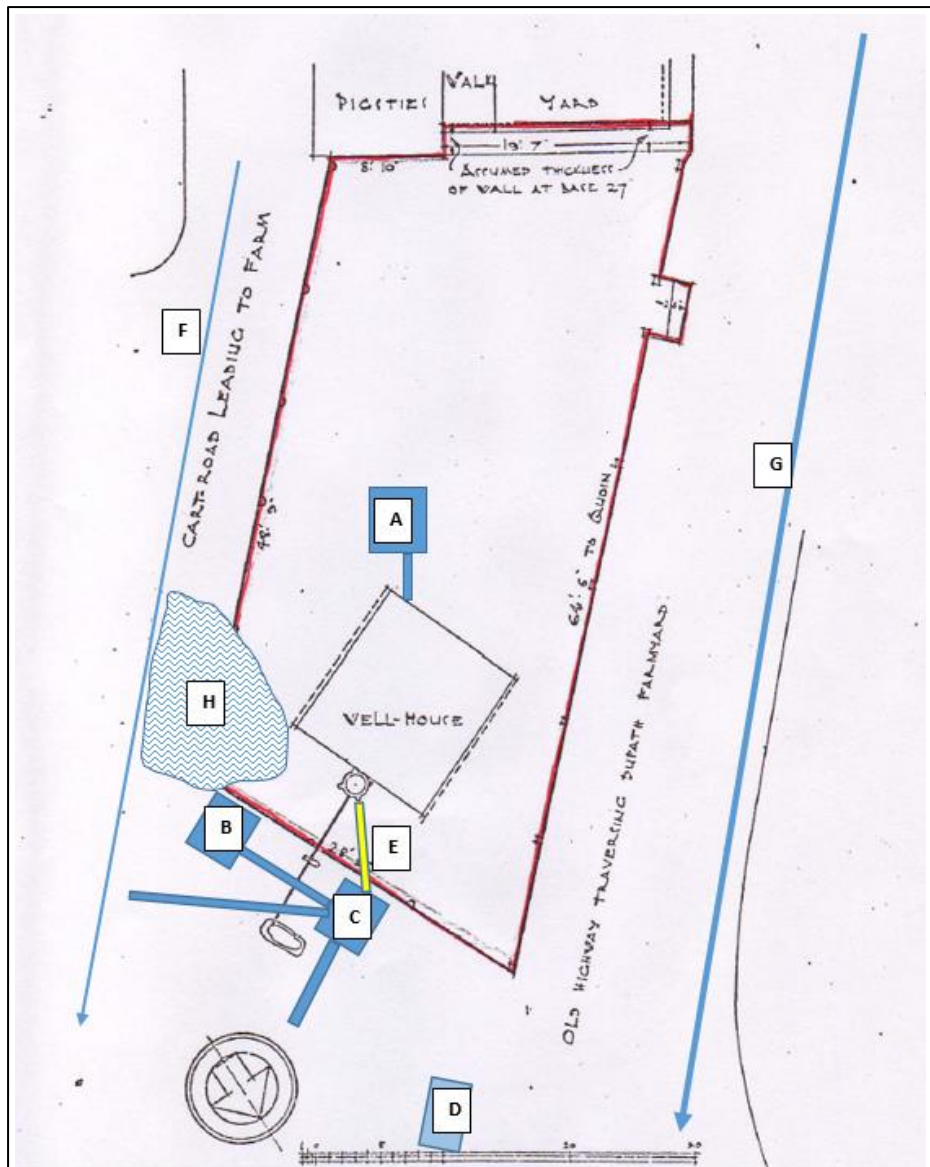
Fig 6. Plan of the drainage pattern at Dupath Holy Well.

The water flow at Dupath Holy Well is not well understood and our understanding at the outset of this project was based on information from Peter Coombe, the owner of Dupath Farm, as described to David Attwell of the Cornwall Heritage Trust (CHT). It is summarised in Figure 6, a map owned by English Heritage but annotated by David Attwell.

- A Drainage chamber with stone drain to well house
- B Drainage chamber with pipe linking to Chamber C
- C Drainage Chamber with in and out clay pipes – running
- D Site of Trough
- E Suggested new pipe linking overflow to drainage chamber
- F Drain emanating from Farmhouse direction
- G Highways drain (15") draining from road above and issuing near bottom field gateway
- H Area of very wet waterlogged ground inside and outside SAM area

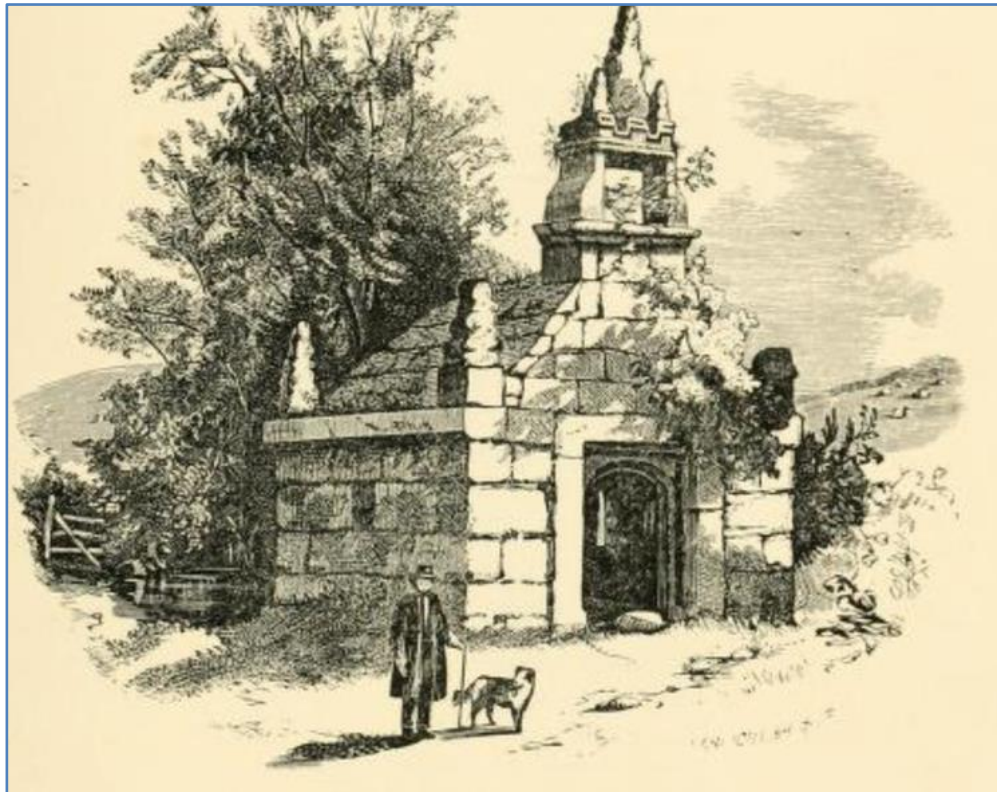
‘A portion of the front is overrun with ivy; grass and weeds grow in clusters from the chinks on the roof. The water from the spring, unconfined by any regular channel, flows through the doorway and falls out at the east end, inundating in its course much of the surrounding soil and rugged pathway. The spot has a deserted and neglected appearance...’ (Blight 1858, 97).

Fig 8. Blight’s illustration of Dupath Holy Well, published in 1858.

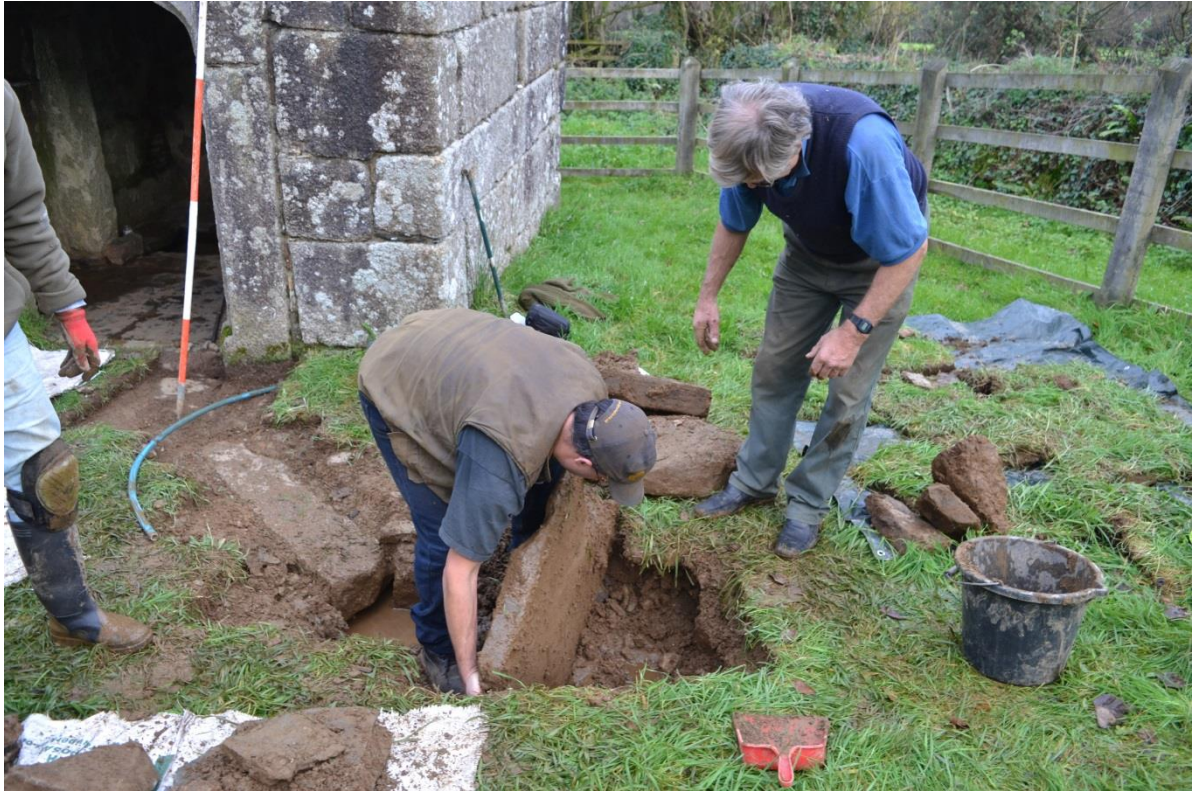
Further investigation in the area of the slight hollow, thought to be the site of the suspected chamber, revealed two substantial slate slabs (Figs 16 and 17). These were lifted, resulting in the discovery that spring water was trickling into the back of the resultant hole but also that the alleged chamber consisted of no more than the two slate slabs set on rough pieces of stone. There was no formally-built chamber and with rough earthen sides it was very easy for silt and smaller stones to collapse into the water. It appears likely that there may in the past have been some sort of small chamber where the water collected (as Peter said) which may have collapsed or been disturbed and was put back very roughly – with the slate cap-stones at the bottom and other stones which may have originally formed the sides, back on top, all very loosely. This disturbance to the chamber cannot be dated as there were no finds but the loose and unconsolidated nature of the backfilling, plus the very poor construction, suggested that this was all relatively recent work.

Fig 17. Removing the second of the slate slabs covering the 'chamber'.

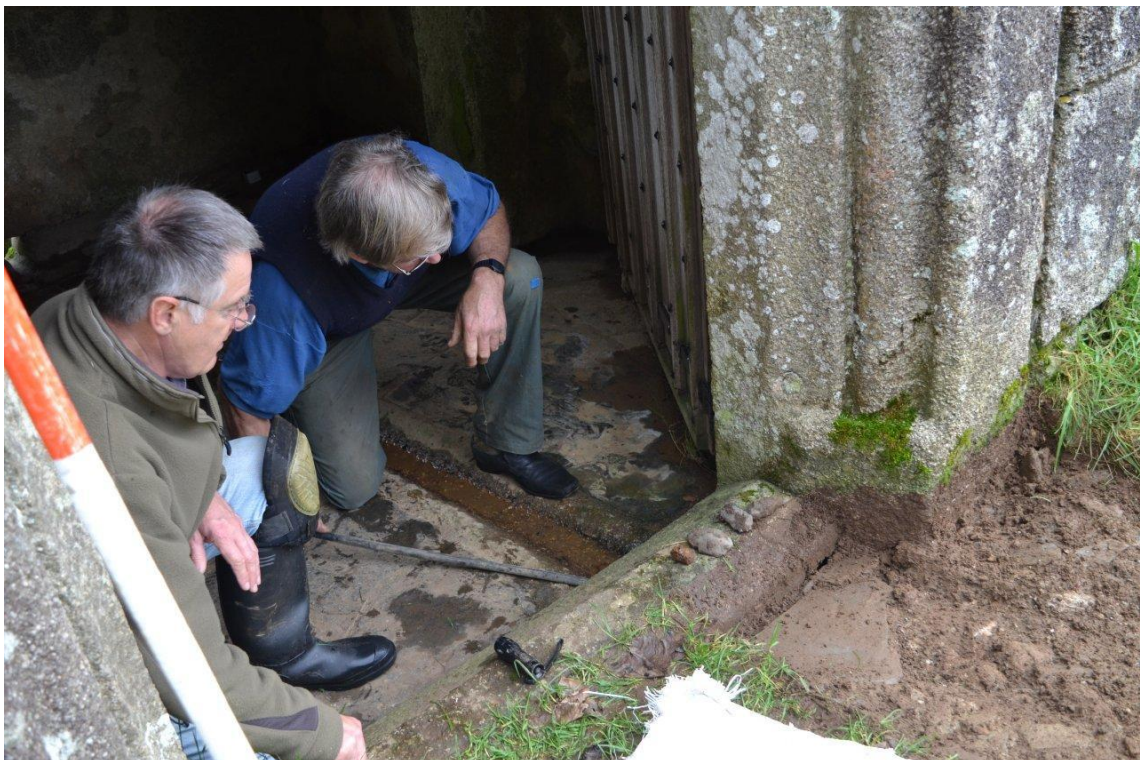
Initially, the culvert from the well-house to the chamber was rodded (Fig 18) and a few largish stones were pulled out from underneath the large piece of granite on the line of the assumed culvert. However, there remained some sort of blockage preventing a free-flow of water from the site of the chamber and under the long piece of granite, so in order to alleviate that, it was decided that the granite would need to be lifted and re-set.

Fig 18. Peter Coombe and Andrew Langdon, attempting to rod the culvert.

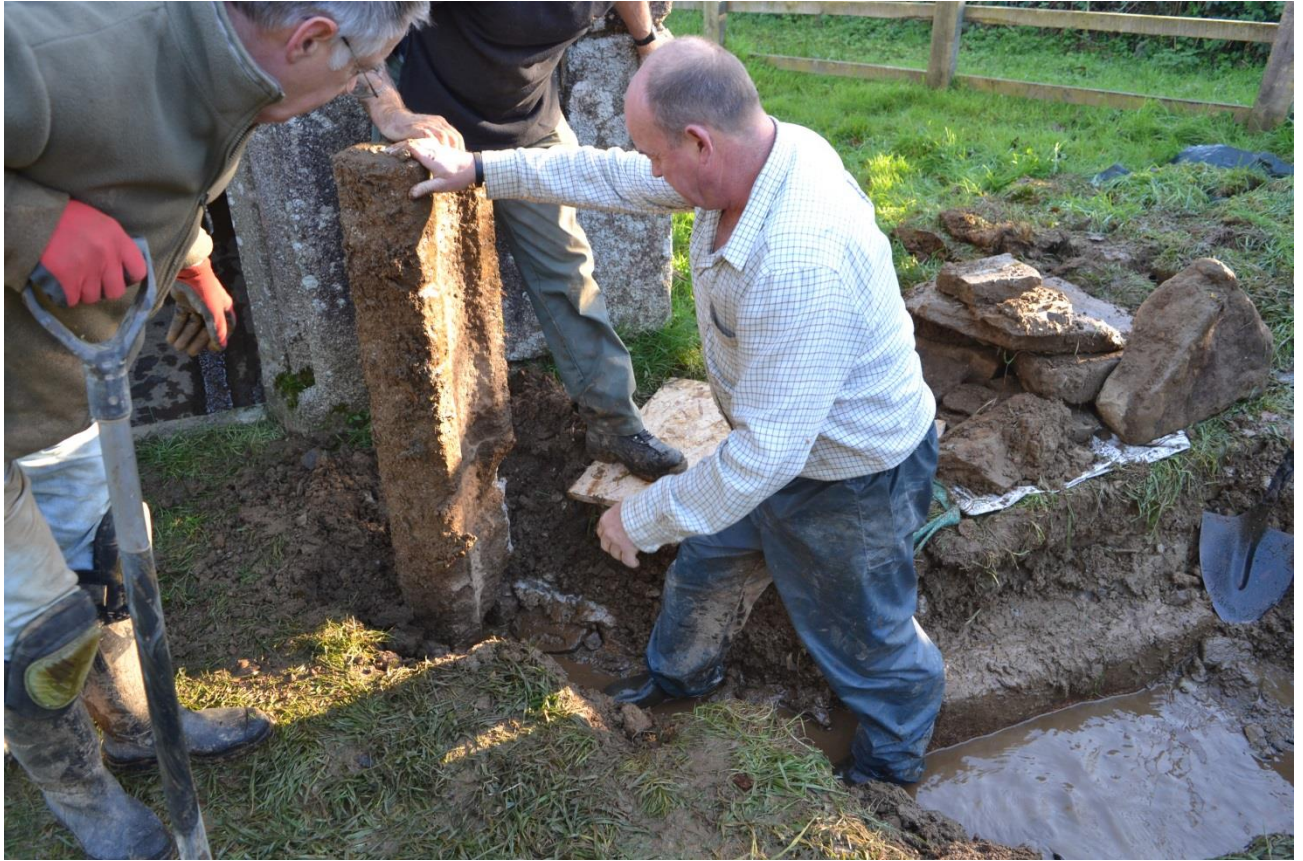
When the granite was lifted, it was found to be a granite launder, similar to those used to conduct water across the floor of the well-house and into the trough or pool. This had been inverted for re-use as a capstone, but as it had been set on only a few small stones, the available channel beneath it was no more than 10cm high. The granite launder measured overall 1.2m long by 15cm deep and 0.15 to 0.25cm wide. Cut into its upper surface (which was facing down when in use) was a curved channel, 12cm wide and approximately 1.5cm deep (Figs 19 and 20). Along one long edge, a series of half-round linear hollows 2cm wide and approximately 17cm apart were noted: the remains of drill marks, indicating that the launder is of 19th century origin. It had been damaged on one side, which may explain why it was re-used in this way.

Fig 19. Lifting the granite launder.
