Cornwall Archaeological Unit Report No: 2021R090

Gwynearth, Rosudgeon, Cornwall

Historic Building Record and Archaeological watching brief

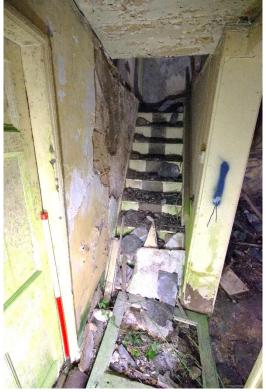
Fig 20 Room 3 staircase looking north from entrance hallway (former cross passage).

In the northern half of the room a phase 2 timber staircase (Fig 20) climbs to a landing at first floor level to the north; the landing is small and shorter than the widths of the doors in the east and west walls.

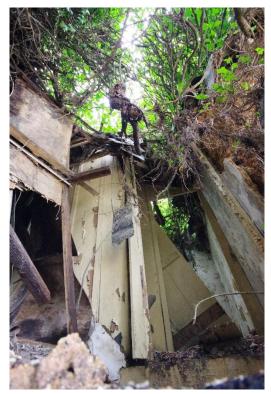
Fig 30 Room 8 west wall.

The west wall (Fig 30) is an 18th or early 19th century (phase 2) plank and beaded muntin partition wall which steps into the room around the stairwell and landing area (room 3). At the north end of the partition there is a phase 2 door opening. The detached, contemporary ledged door has H hinges and is constructed from two wide planks.

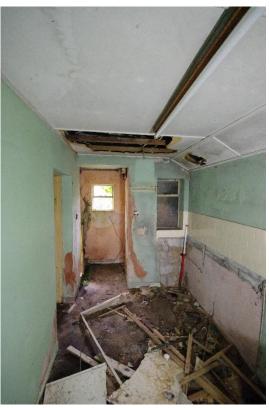
Fig 33 Room 6 looking north.

The western half of the north wall (Fig 33) steps outwards to form a small entrance lobby to the rear of the building. In the north wall of this lobby there is a small Crittall casement window and in the eastern half of the wall there is another, slightly larger Crittall window.

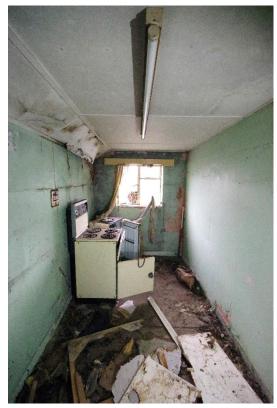
Fig 34 Room 6 looking south.

In the south wall (Fig 34) there is a wide Crittall casement window.

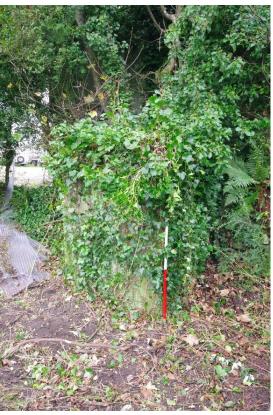
Fig 37 Early-mid 20th century concrete block-built outhouse to south of house.

Clearance of the garden plot revealed an early-mid 20th century outhouse (W.C.) located in the garden to the south of the house against the western boundary, and also two repurposed early 20th century tram carriages along the eastern boundary to the north of the house.
