Storm Tower, Compass Point, Bude, Cornwall, Historic Building Record

Client	Donald Martin Countryside Team Cornwall Council
Report Number	2021R077
Date	22/07/2021
Status	Final
Report author(s)	Jo Sturgess
Checked by	Jo Sturgess
Approved by	Andy Jones
Project number	147137
Data location	\\CAU\Archive\Sites\B\Bude Storm Tower Preservation by Record HBR 2021
Historic England / ADS OASIS online reference	cornwall2-426593
Planning reference	N/A

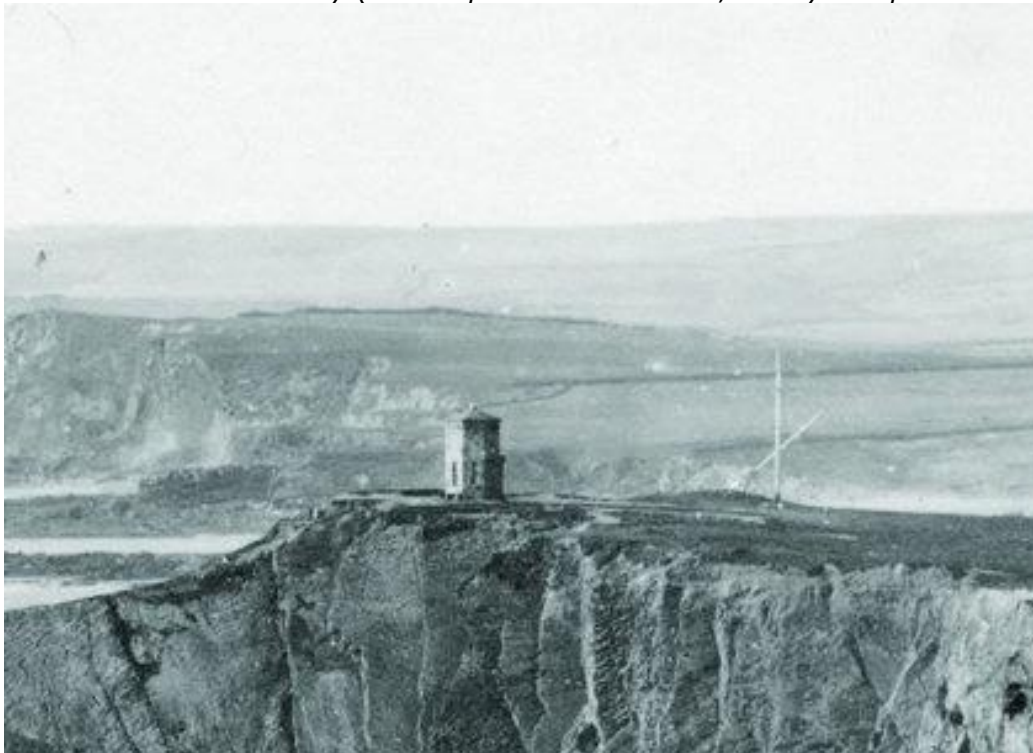
Fig 8 Cropped photograph of the first Storm Tower, taken between 1850-1879 by local photographer Harry Thorn, © Thorn and Thorn. It shows the tower without a plinth at the base or a cross on the roof but does show the signalling flagstaff close by.

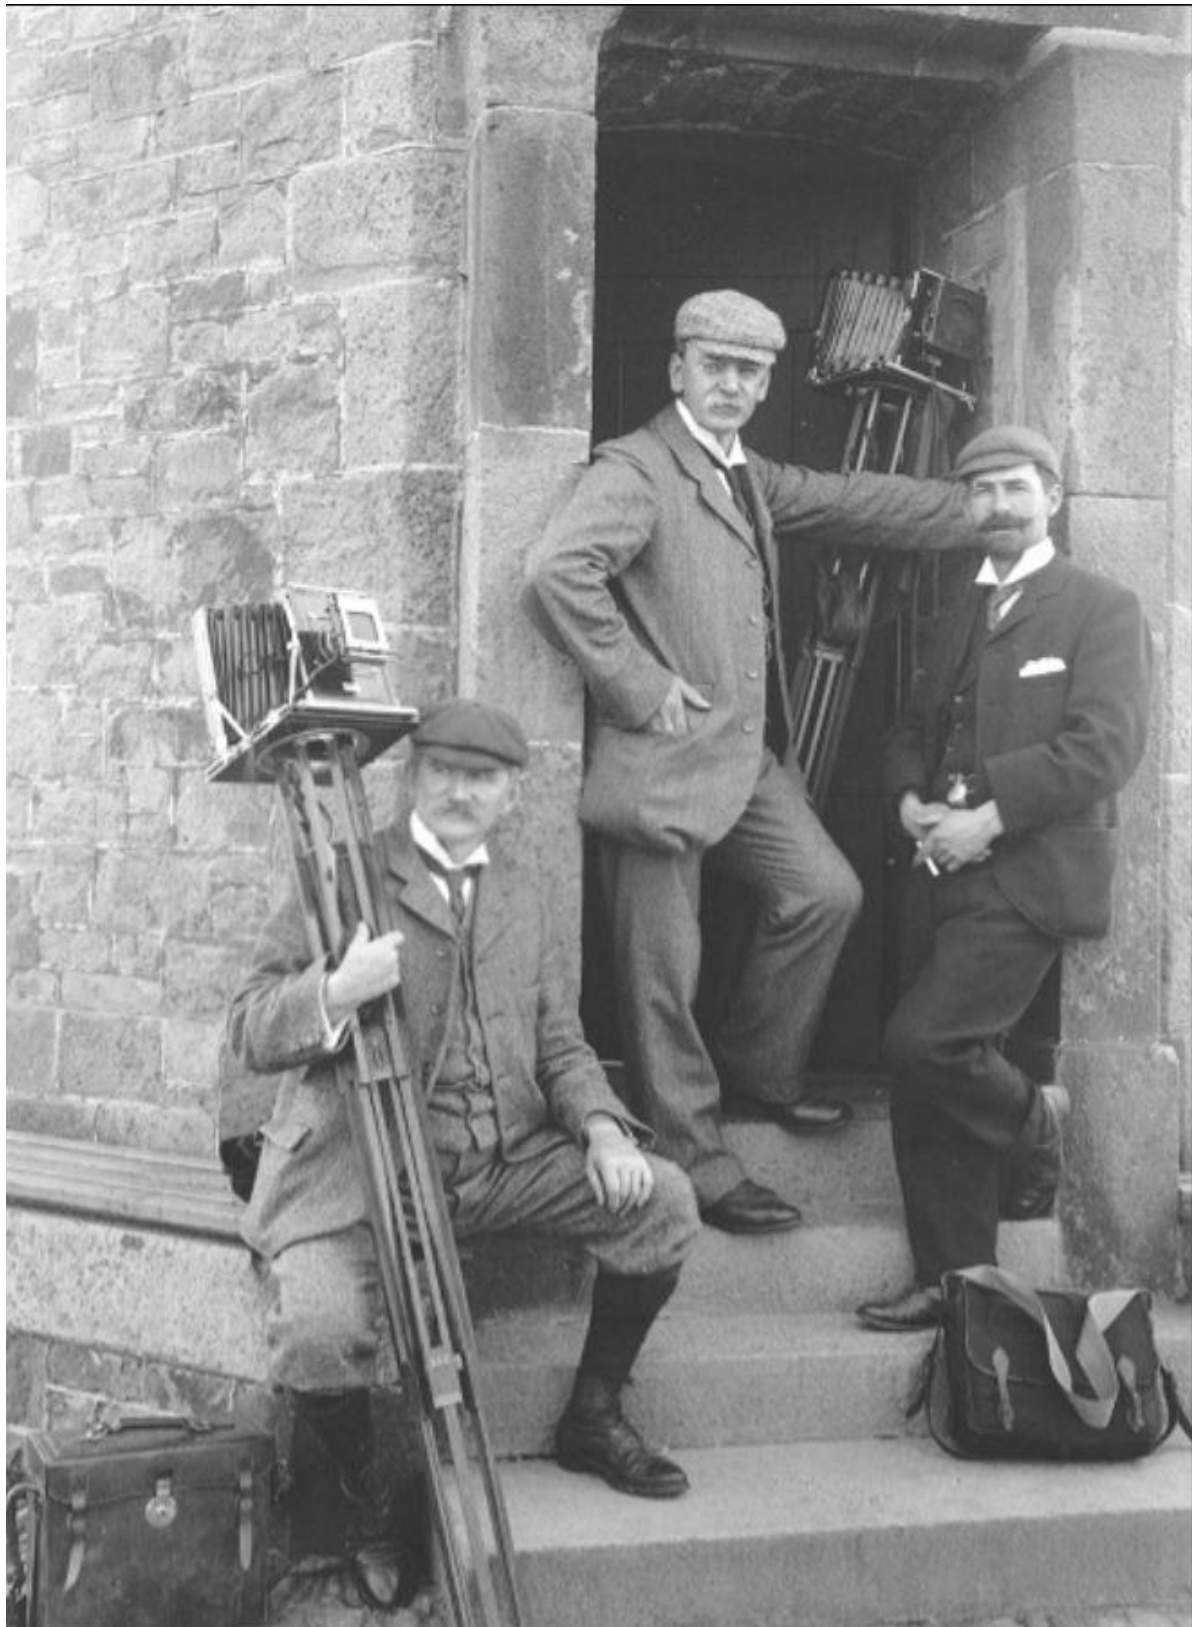
A photograph of the tower taken in 1905 (Fig 9) shows the building with its 1881 door still *in situ*.

Fig 9 Photograph of photographers (centre J C Burrow right H Hughes) taken in 1905 in the doorway of the tower (© Kresen Kernow Ref: corn03883). It shows the door still in situ.

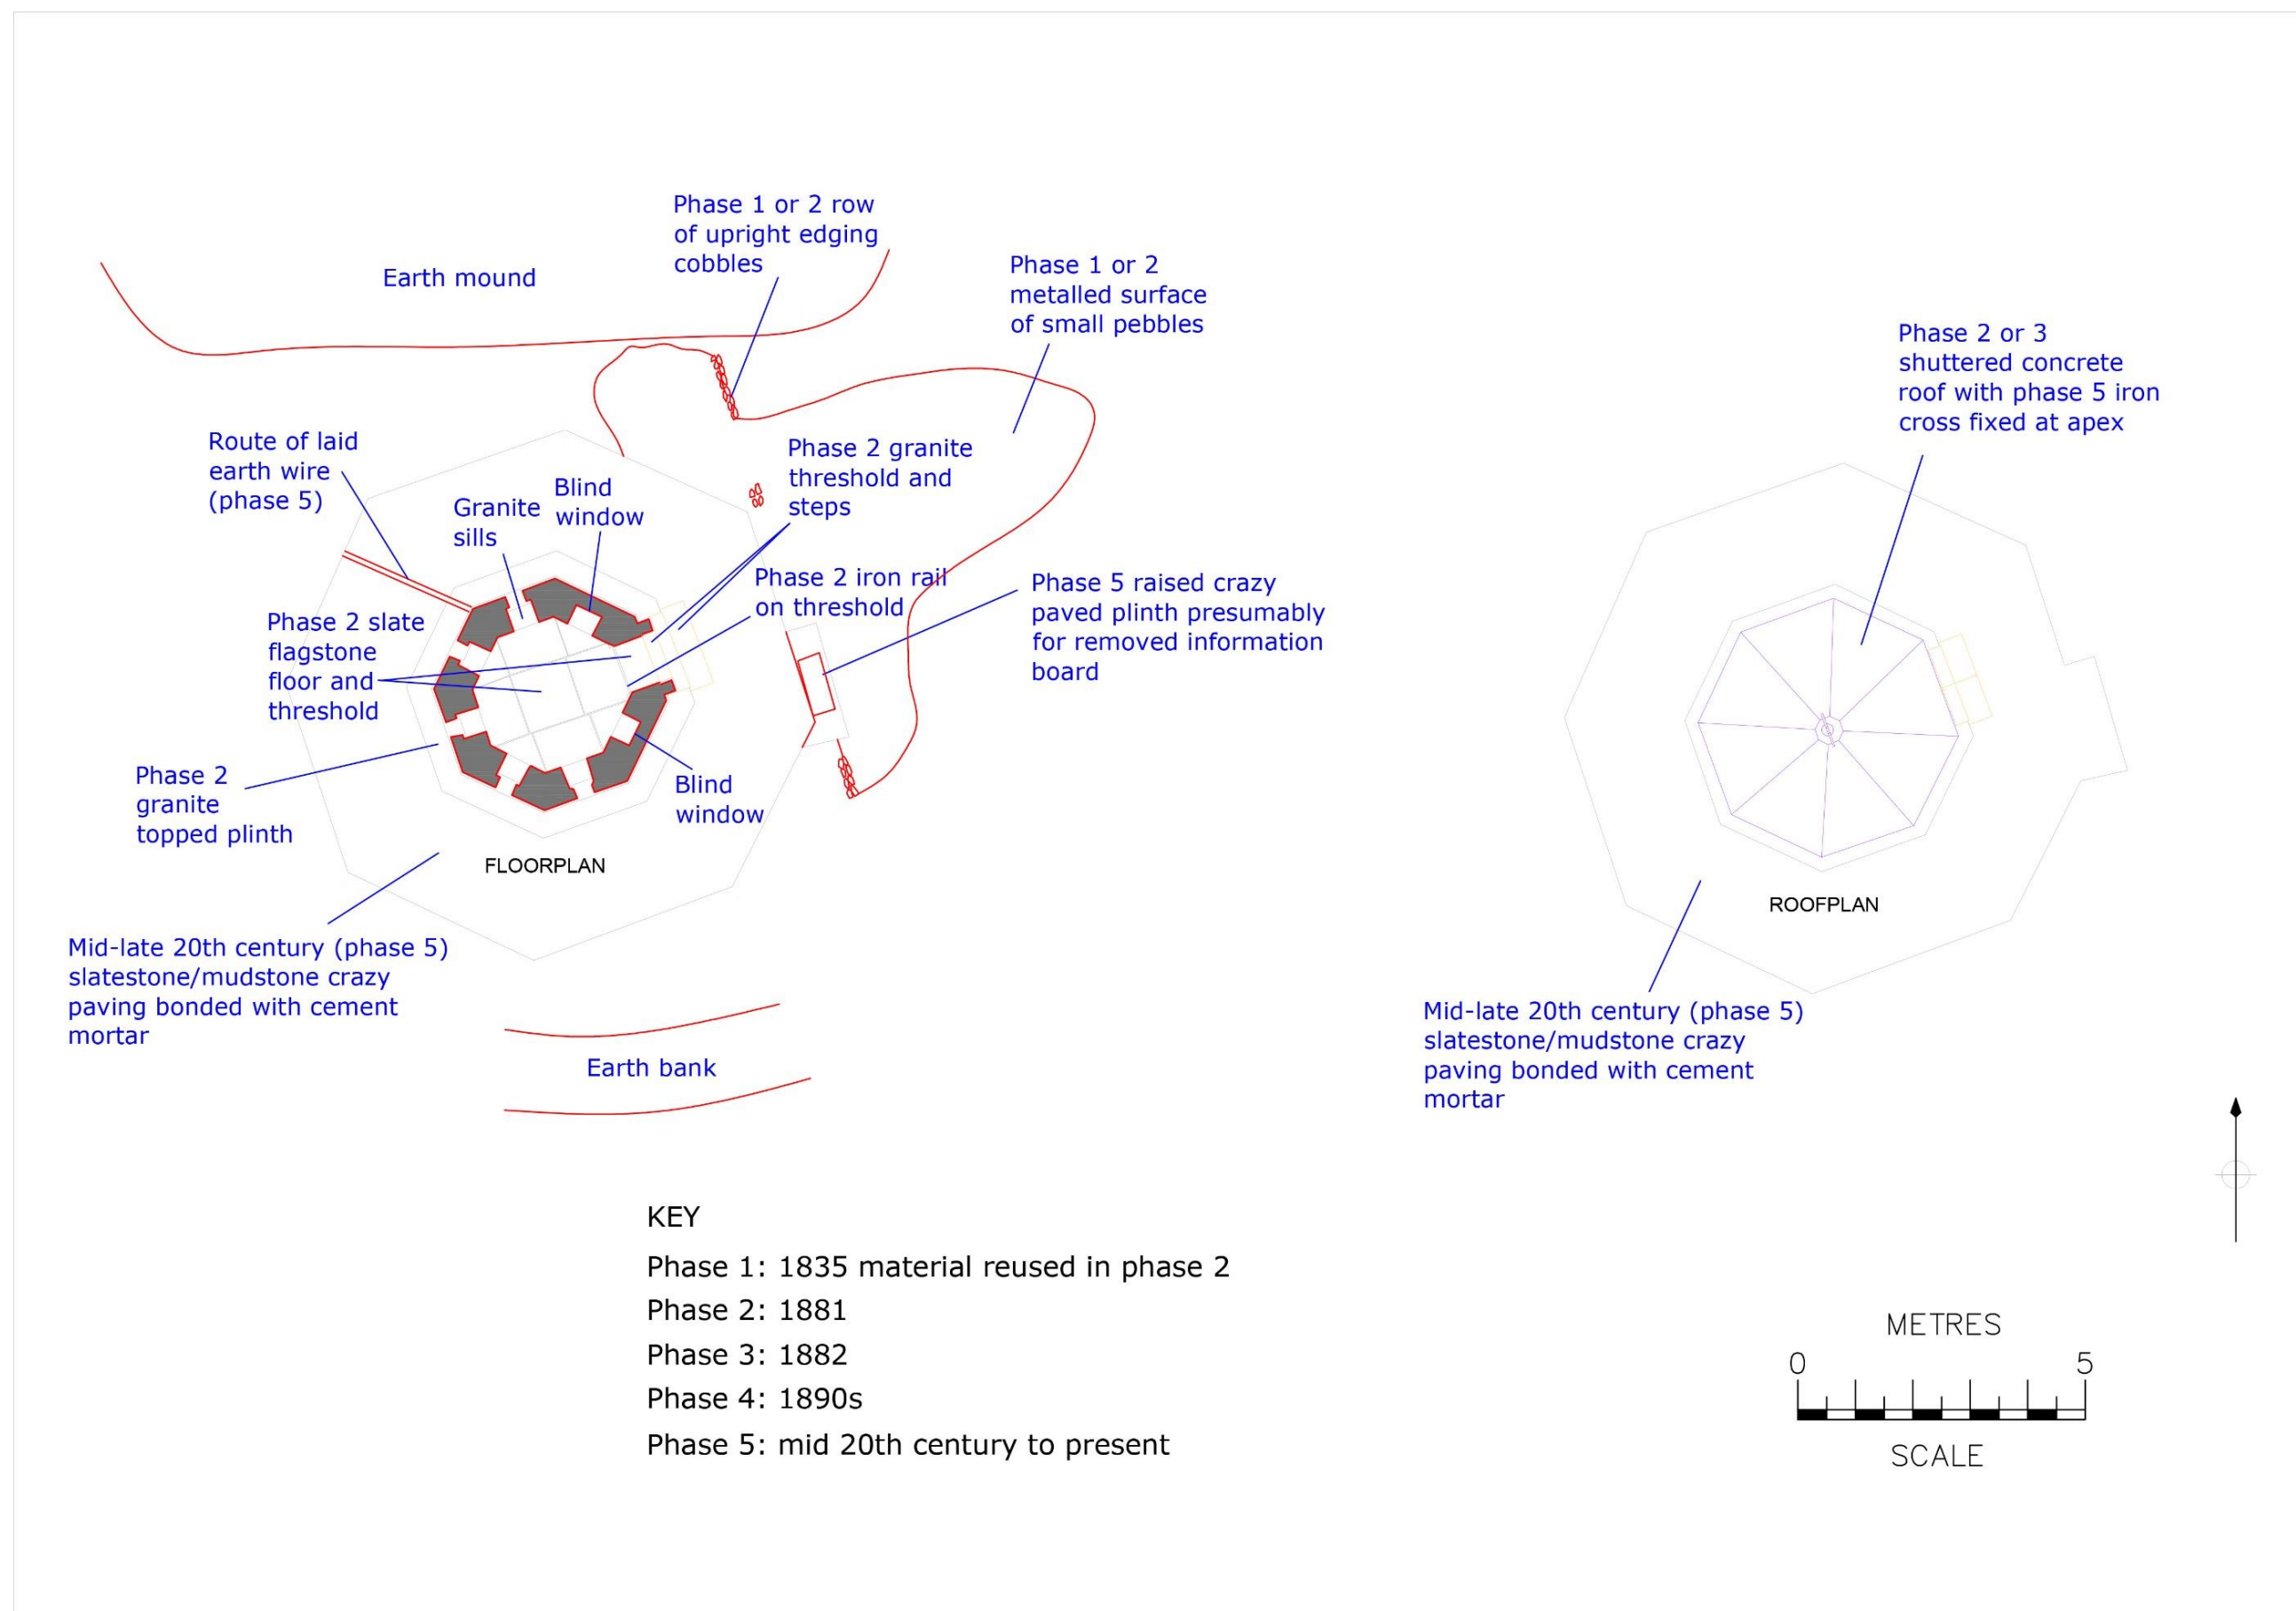
Fig 45 Floor plan and roof plan.

(See phase plans and elevations Figs 45–47).
