Miners' Dry, South Wheal Frances,
Piece, Cornwall
Historic Building Record

Report No: 2022R010

Client	Cormac Solutions Ltd
Report Number	2022R010
Date	24/03/22
Status	Final
Report author(s)	Connor Motley and Jo Sturgess
Checked by	Jo Sturgess
Approved by	Andy Jones
Project number	147146
Data location	\\CAU\Archive\Sites\R\Redruth Miners Dry South Wheal Frances HBR 2021
Historic England / ADS OASIS online reference	cornwall2-504956
Planning reference	PA20/09145

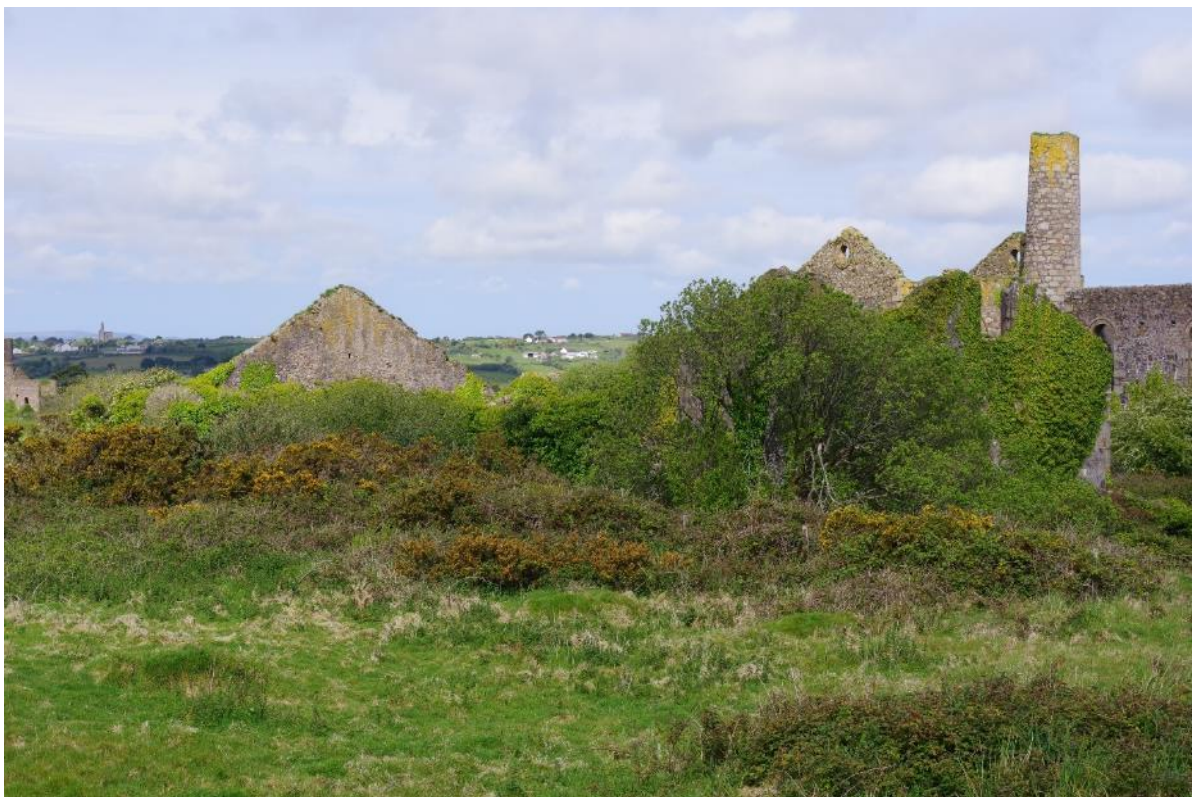
Most of the south elevation is no longer visible or accessible due to dense vegetation and ivy growth (Fig 19). However, the eastern part of it associated with rooms 7, 9 and 10 was visible and accessible at the time of the survey (Fig 18). The wall here is constructed from randomly coursed slatestone and granite rubble with a cement wash over and there is a dressed granite quoin at the east end. The ground floor contains three window openings and a door opening giving access through to room 7. All the openings have round brick arches with three courses of brick voussoirs and dressed granite jambs. At first floor level there is a centrally set window opening lighting room 10 which matches those at ground floor level.

Fig 19 South elevation which is mainly inaccessible and heavily overgrown.

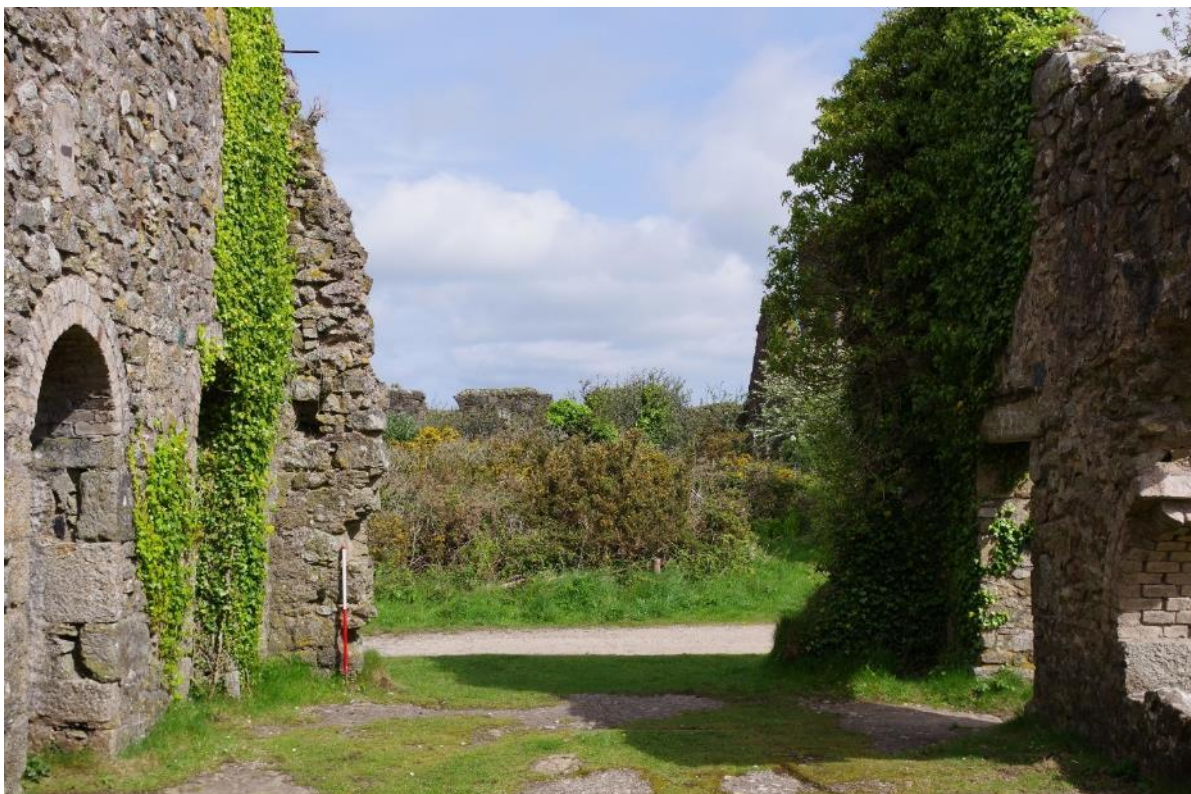
The walls are all constructed from granite and slatestone rubble bonded with earth and lime mortar and have remnants of a cement wash render. The north wall has almost entirely been removed (Fig 41).

Fig 41 Room 4 remains of north wall (now mostly missing).

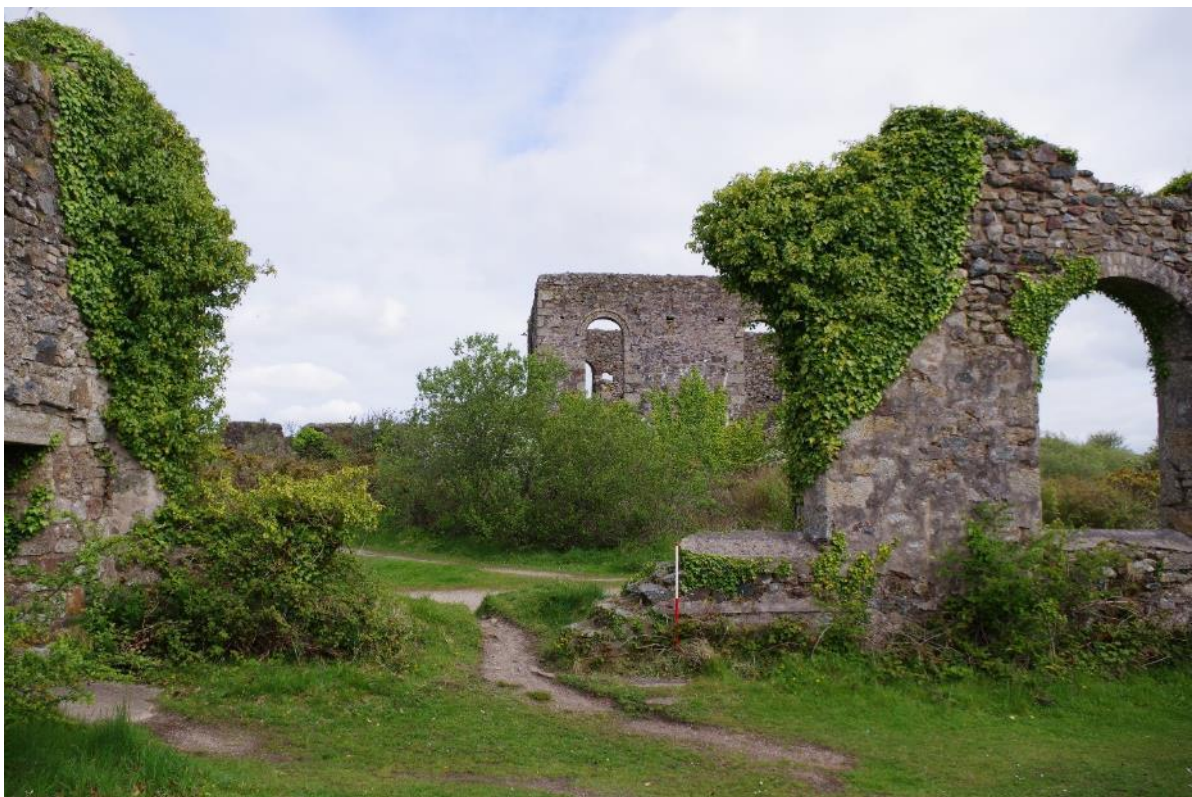
Fig 51 Room 5 north wall, missing section at west end.

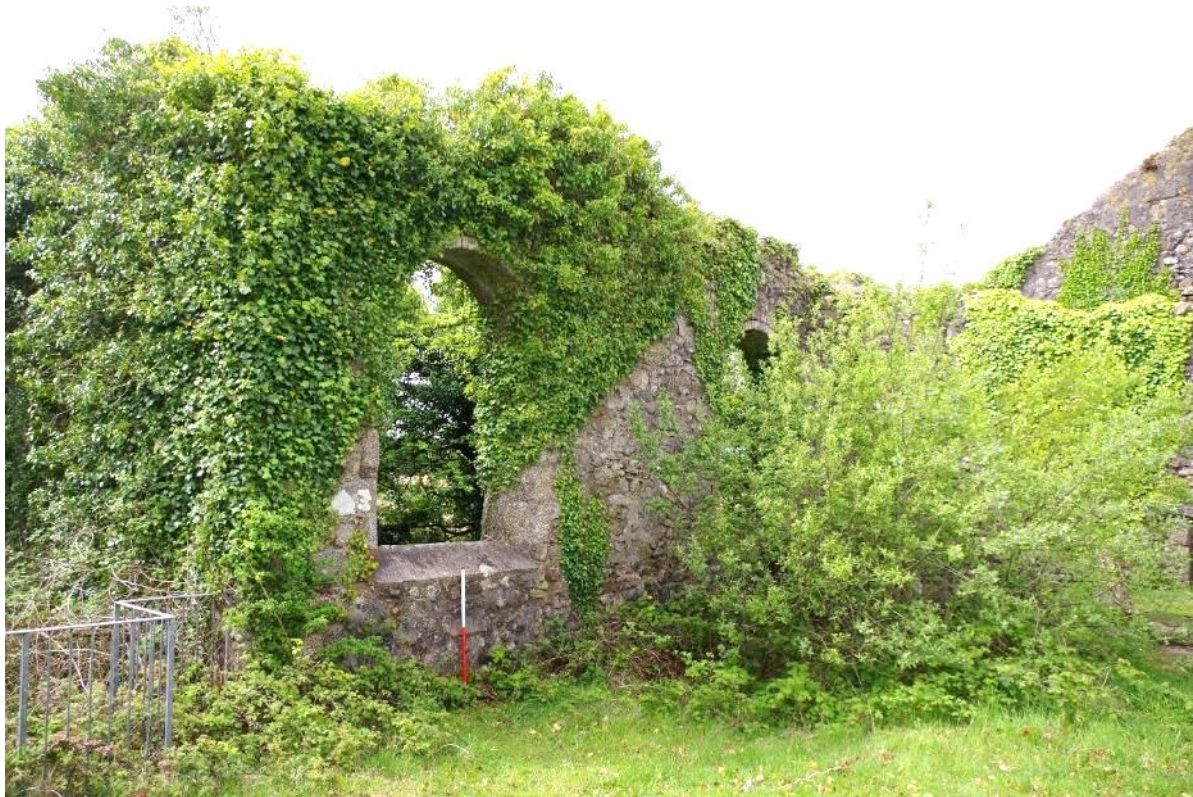
Fig 57 Room 5 south wall, western half.

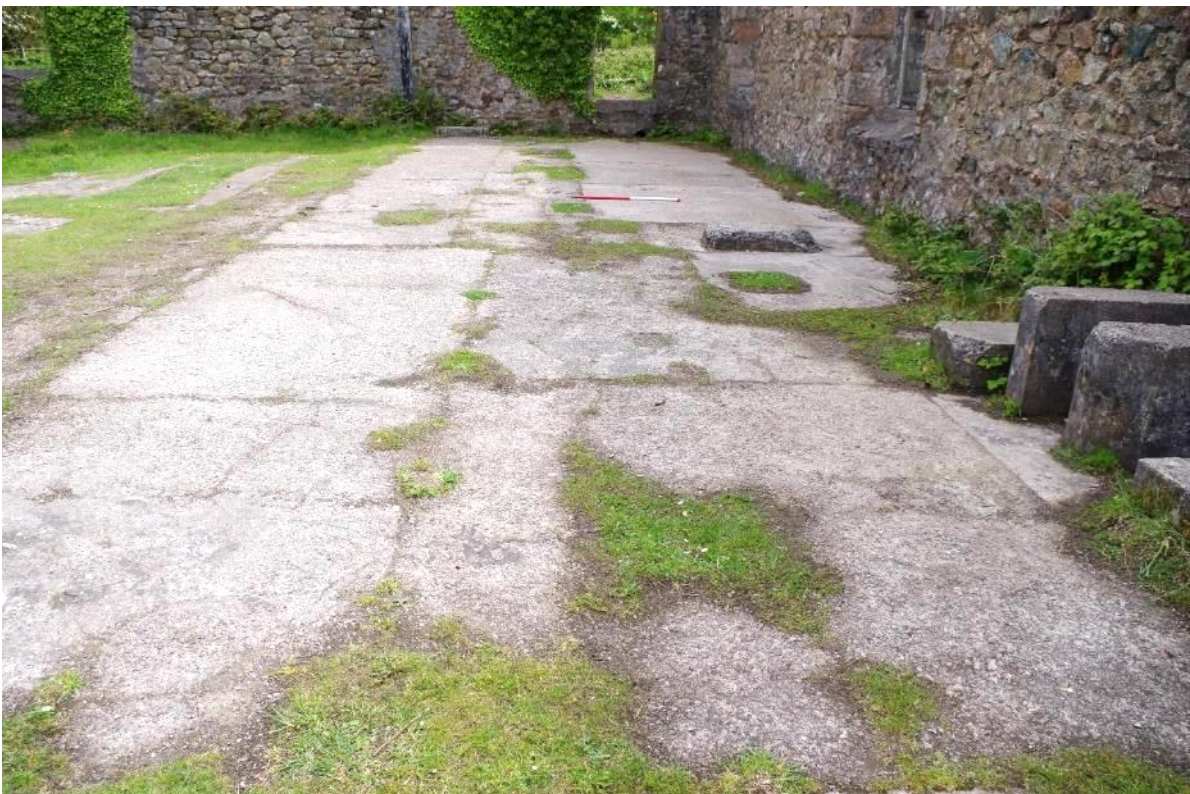
The floor of the room is now mainly grassed over, however, there are areas where the original cobbled floor set in cement is visible. In the southeast part of the room there is an inserted concrete floor within the footprint of the former 1950s lean-to associated with the concrete block manufacturing works (Fig 61). In the southwest corner of the former lean-to there is a concrete machine base and concrete block associated with the 1950s works (Fig 62). To the north of the former lean-to there is a rectangular concrete base set in the original cobbled floor which contains several iron bolts. It seems likely that this is associated with the original building and may have been a base for securing the large heating pipes (Fig 63).

Fig 61 Room 5 inserted phase 3 concrete floor in southeast quarter of the room, looking east.

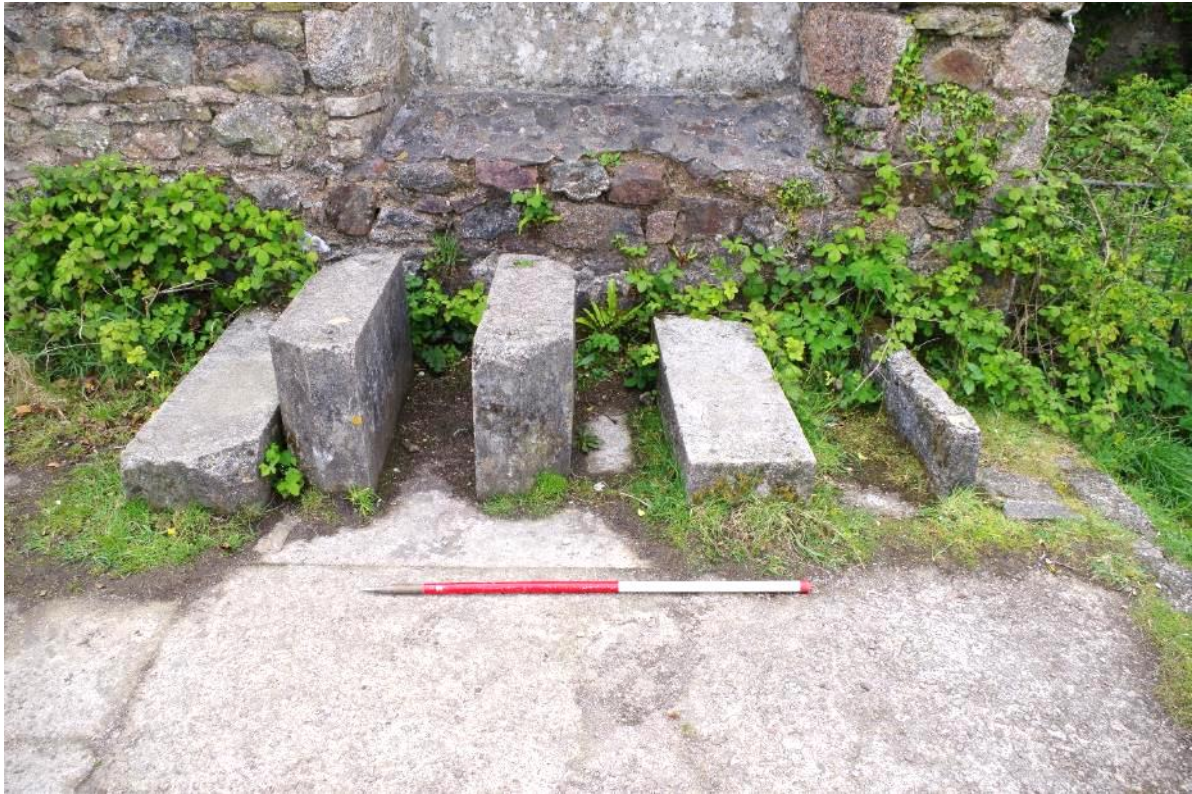
Fig 62 Room 5, phase 3 concrete machine base against south wall.

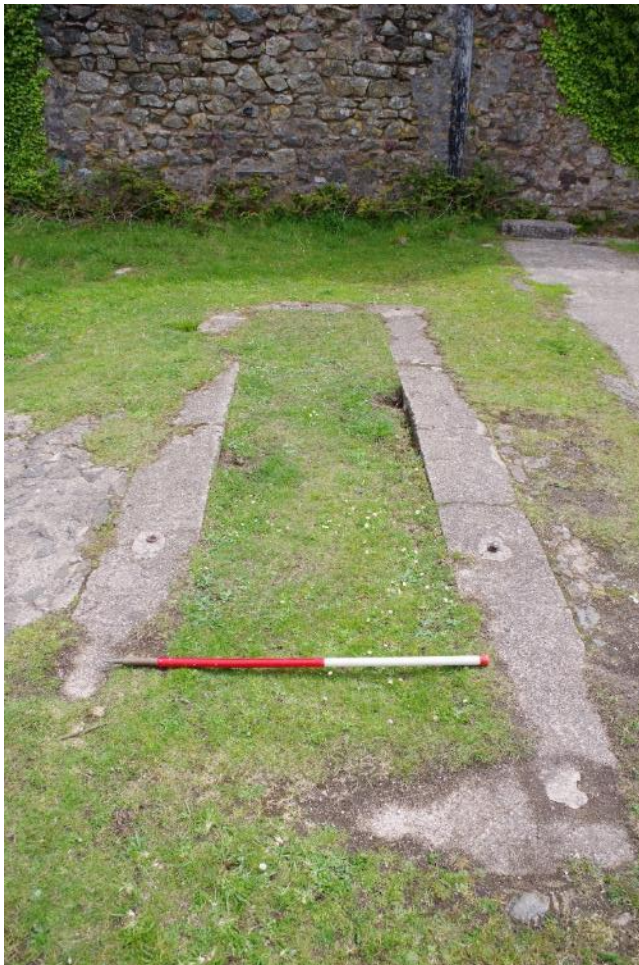
Fig 63 Room 5, machine base at east end of floor.

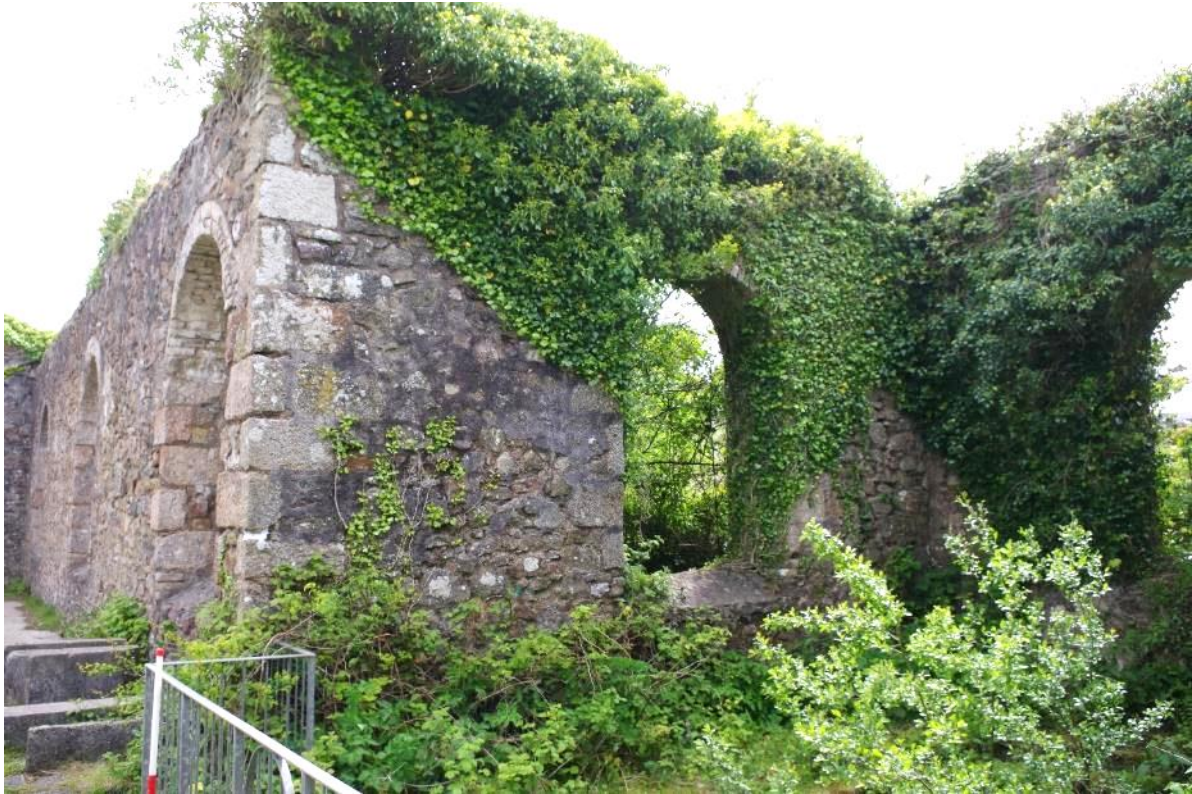
Fig 64 Room 6 east wall.

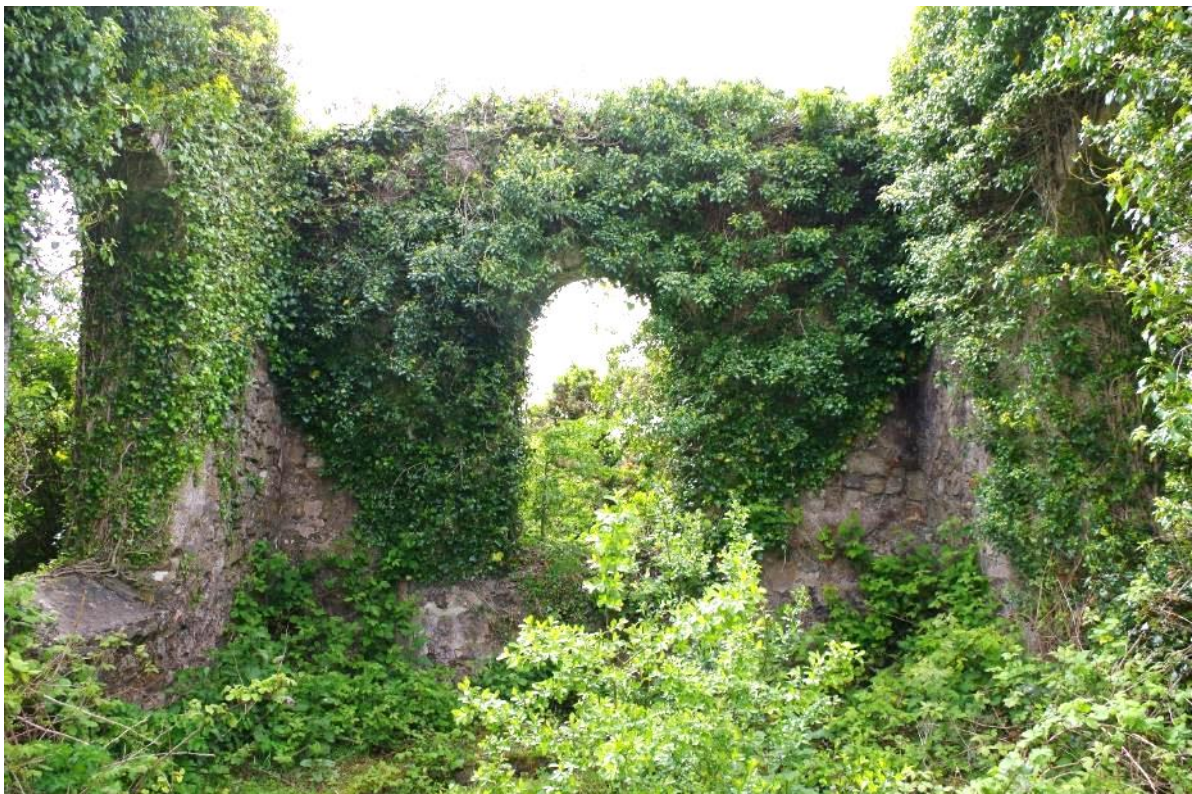
Fig 65 Room 6 south wall.

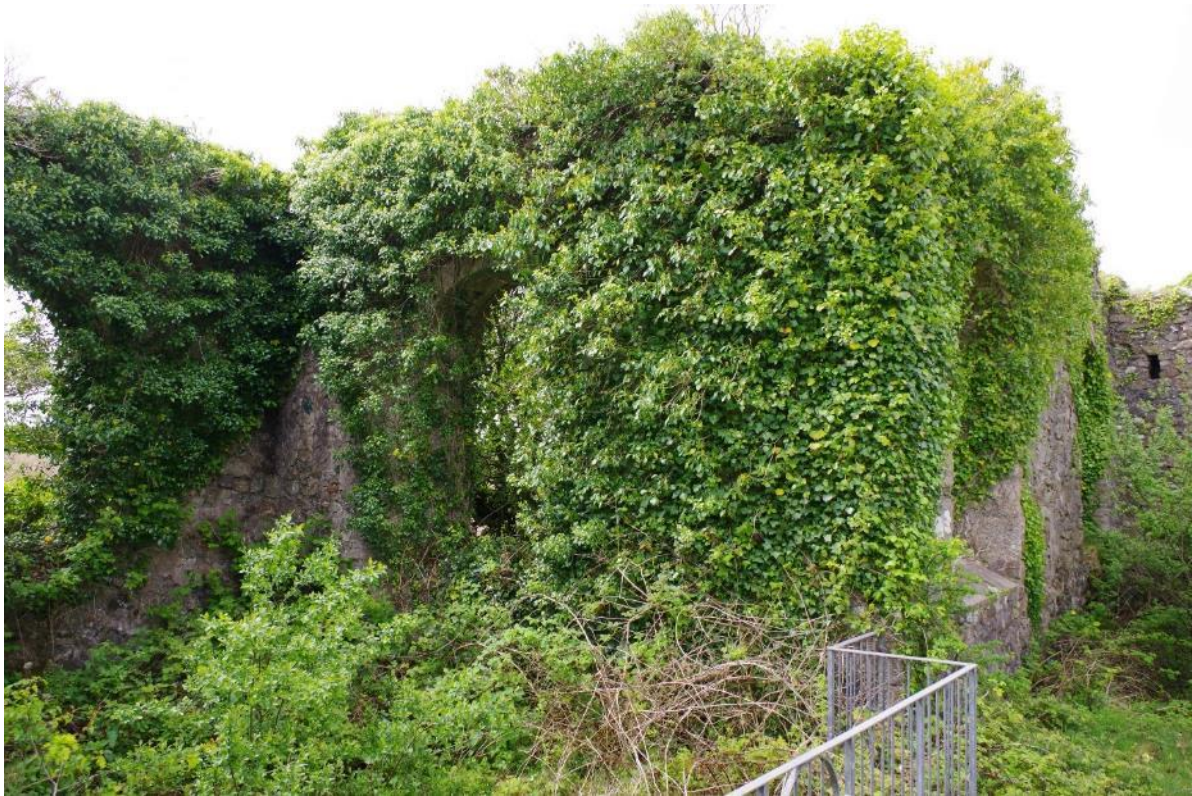
Fig 66 Room 6 west wall.

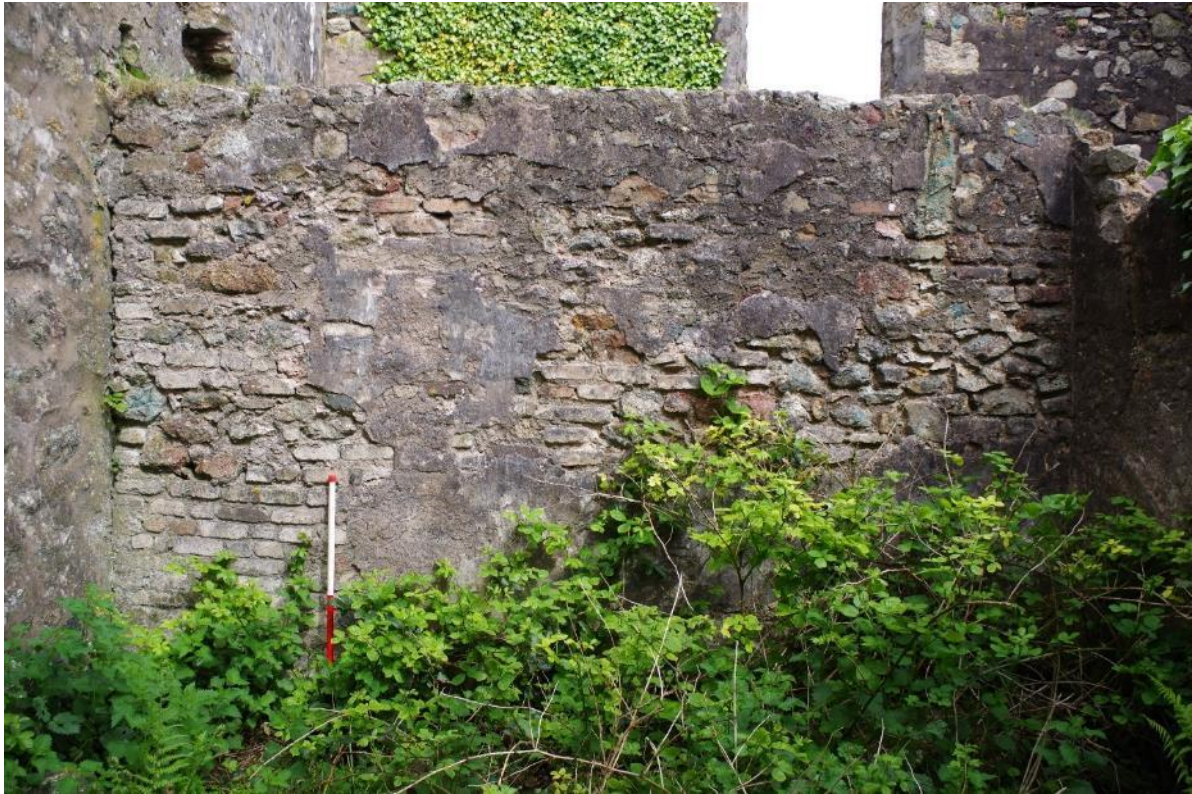
Fig 68 Room 7 north wall.

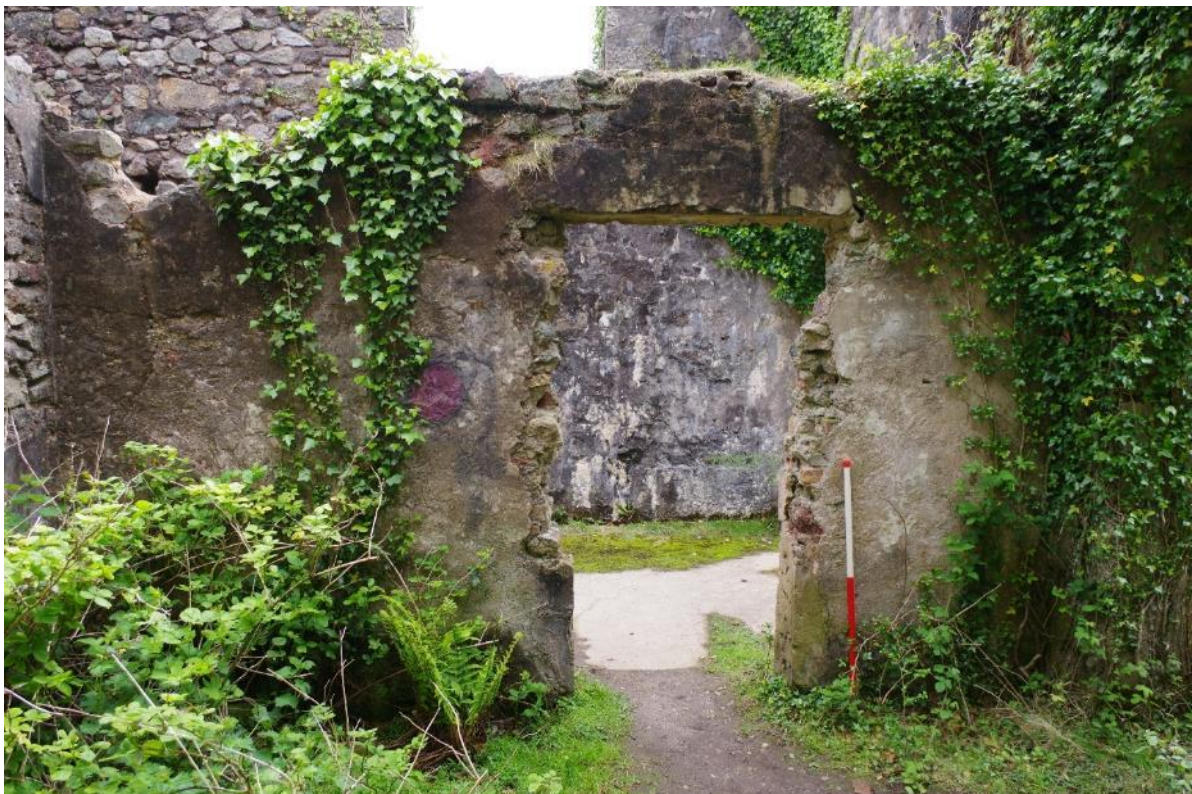
Fig 69 Room 7 east wall.

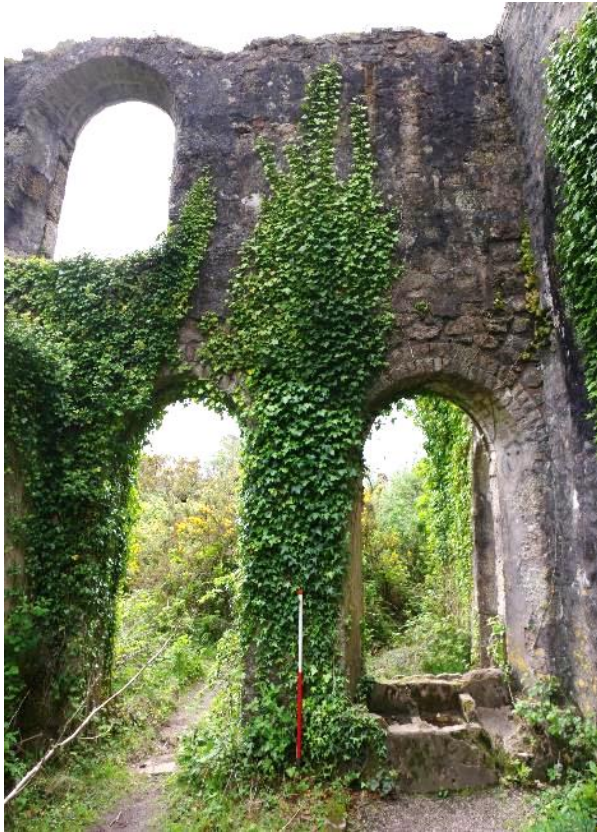
Fig 70 Rooms 7 and 10 south wall.

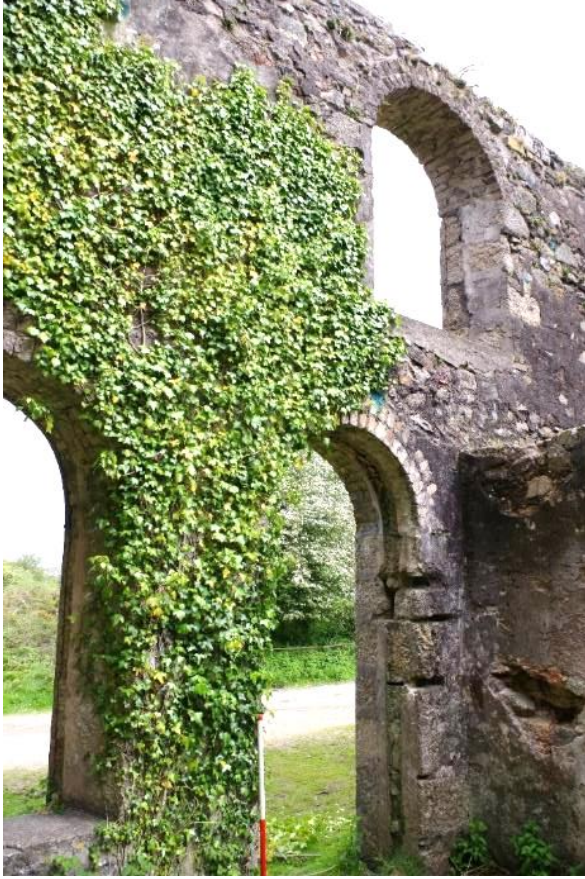
Fig 72 Rooms 8 and 10 north wall (east half) with room 10 at first floor level.

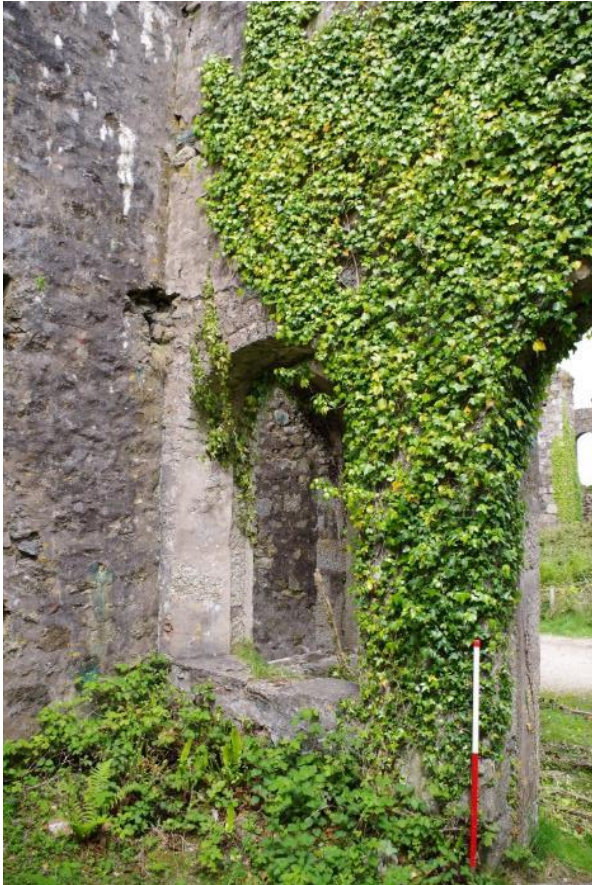
Fig 73 Room 8 north wall (west half) with room 10 at first floor level.

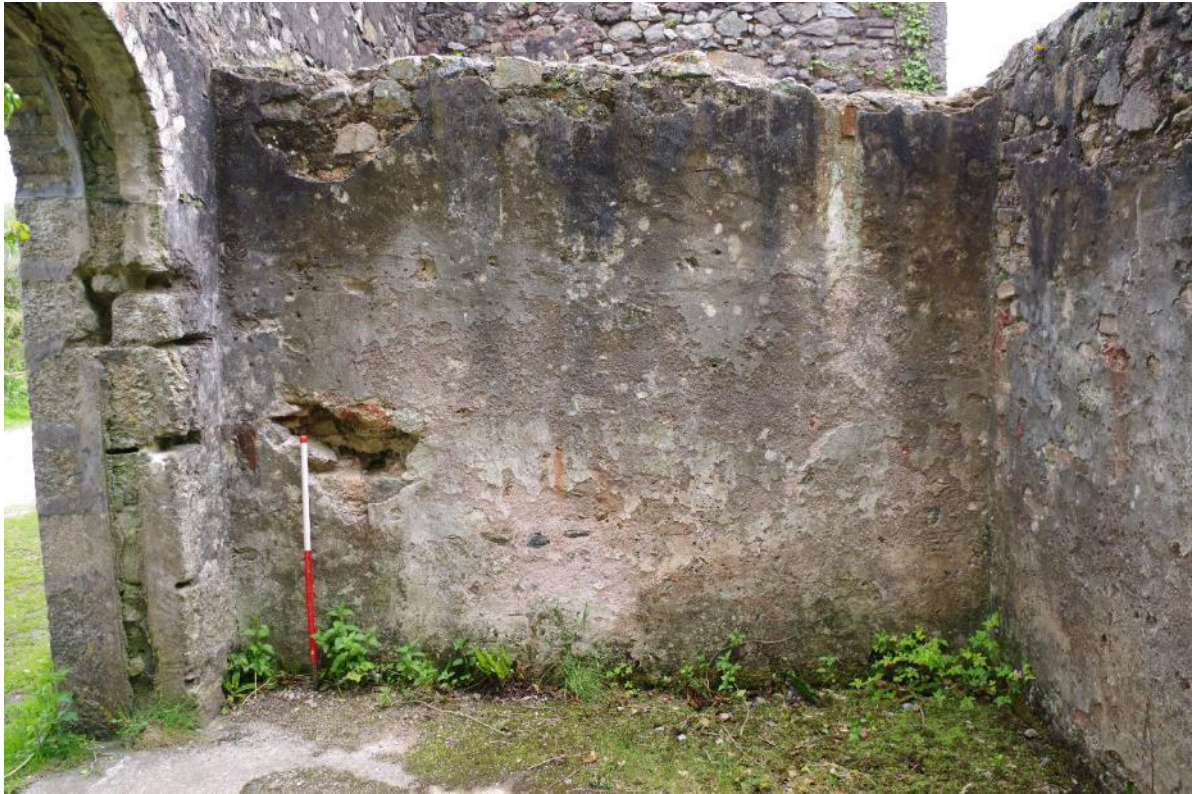
Fig 74 Room 8 east wall.

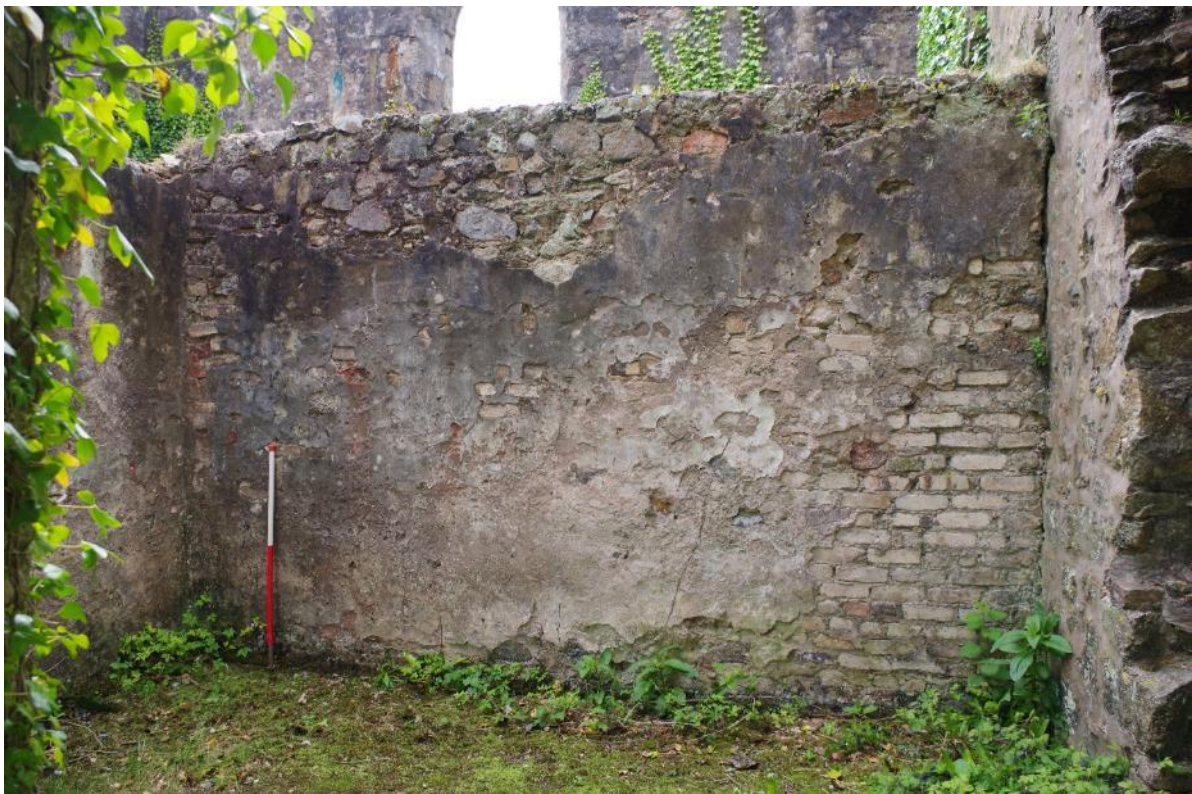
Fig 75 Room 8 south wall.

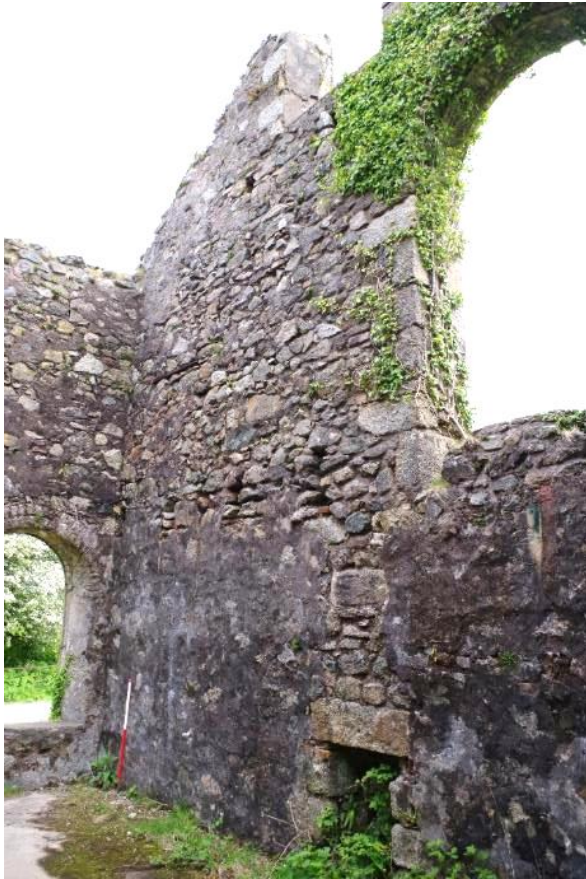
Fig 78 Room 9 east wall looking northeast, with room 10 at first floor level.

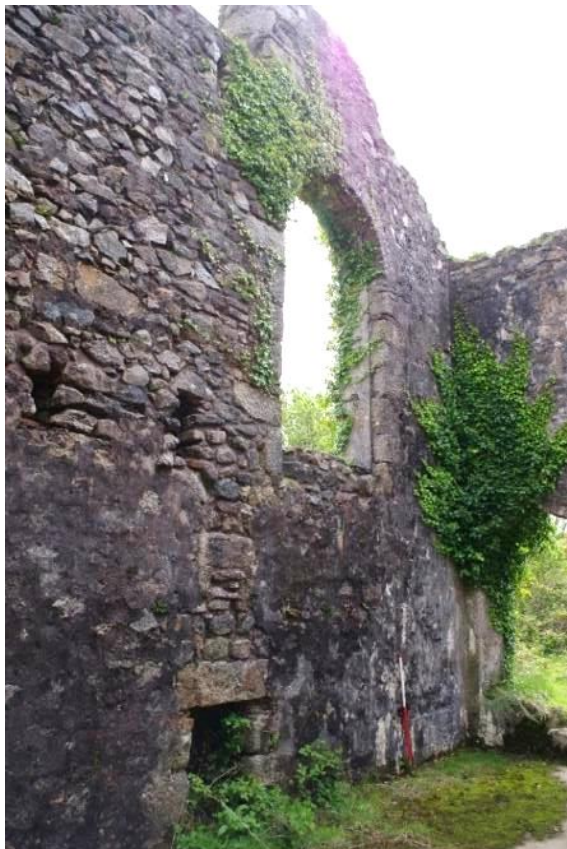
Fig 79 Room 9 east wall looking southeast, with loading door opening into room 10 at first floor level.

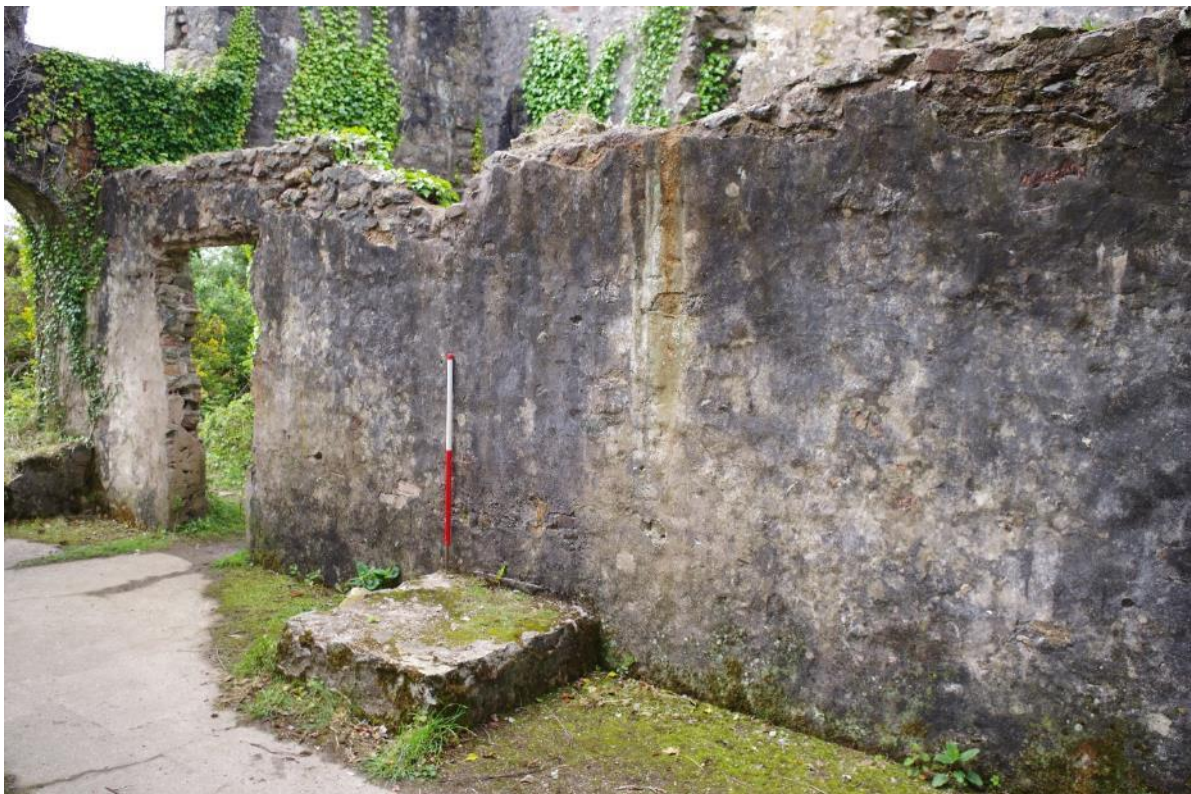
Fig 83 Room 9 west wall.
