Helland Bridge, Cornwall
Archaeological recording and
watching brief

Archaeological recording and watching brief

Client	Cormac Solutions Ltd
Report Number	2022R047
Date	October 2022
Status	Final
Report author(s)	Jo Sturgess and Connor Motley
Checked by	Jo Sturgess
Approved by	Andy Jones
Project number	147188
Site code	N/A
Data location	\\CAU\Archive\Sites\H\Helland Bridge recording and WB 2022
Historic England / ADS OASIS online reference	cornwall2-509550
Planning reference	PA22/05523

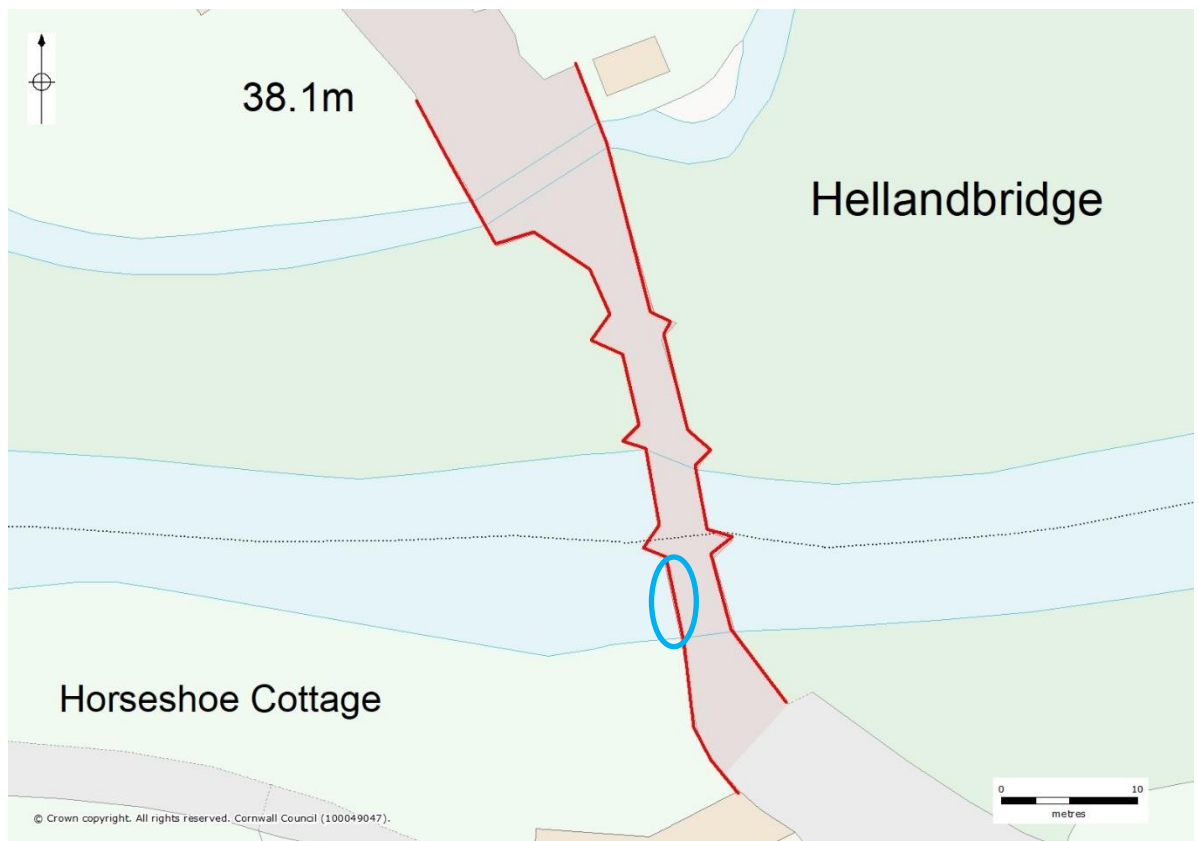
Fig 2 Grade I Listed bridge in red with area of repair circled in blue.

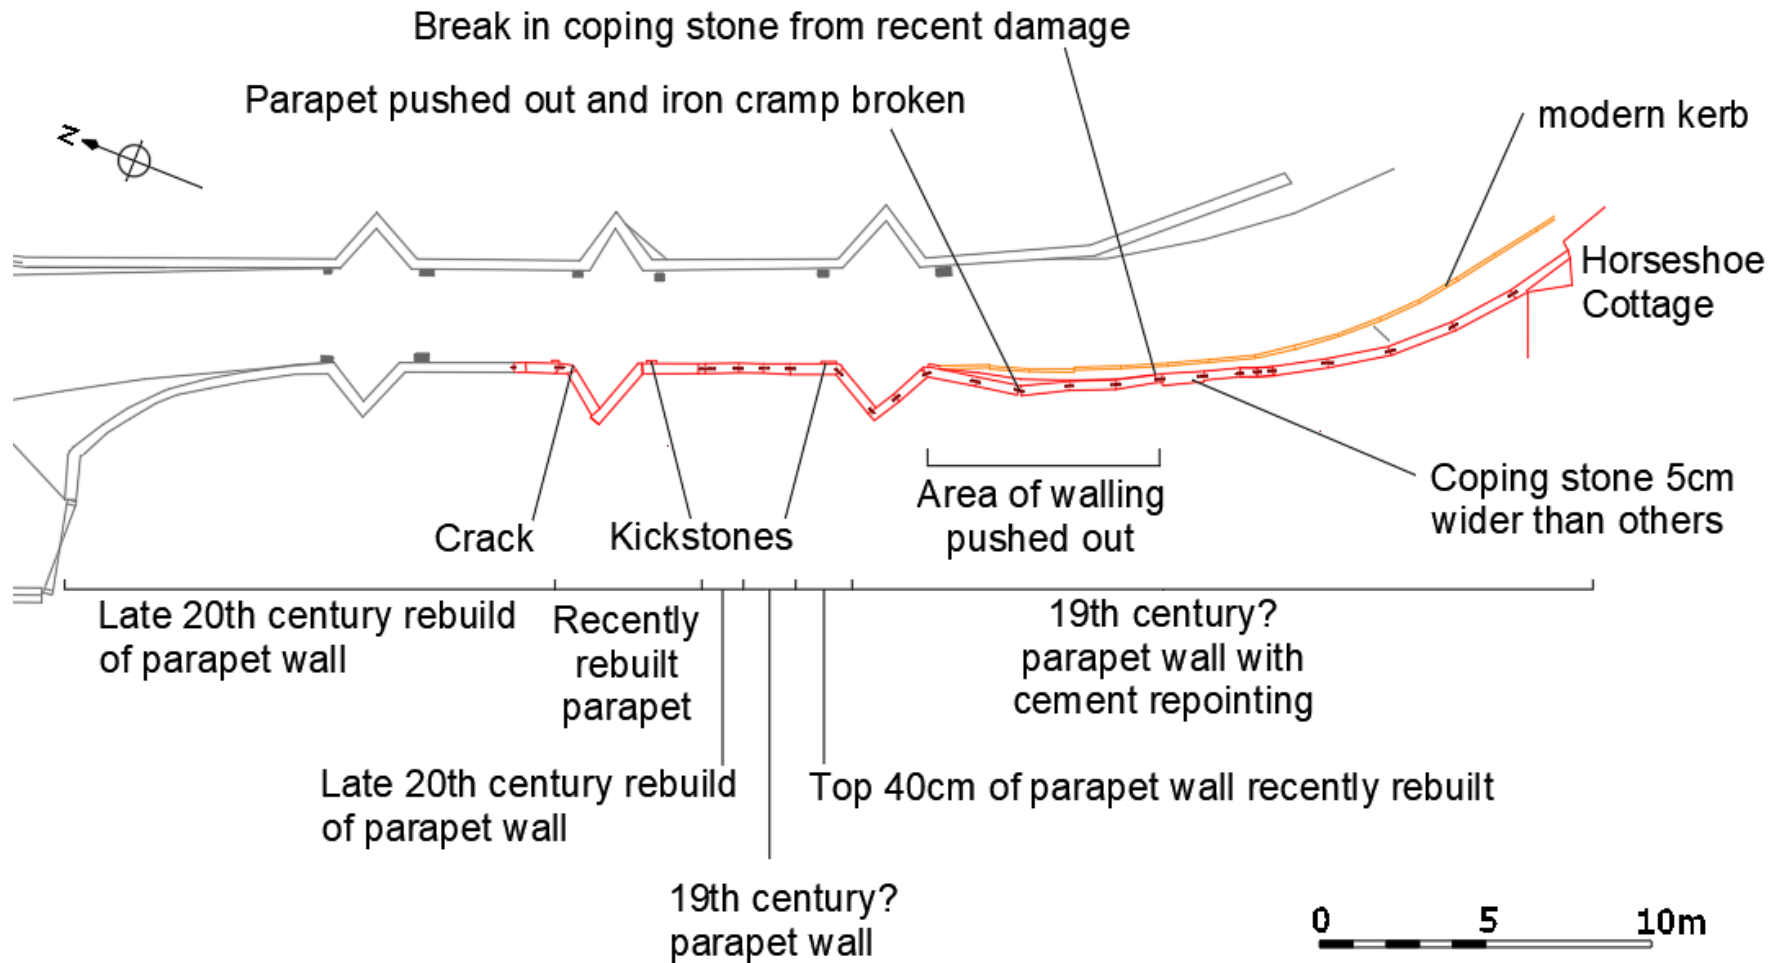
Prior to dismantling the damaged section of walling a photographic record was made along with descriptive notes to record the damage as well as the style of construction and materials used in the existing build in order to guide the reconstruction. A measured plan was also created of the granite coping stones and iron cramps along the southern half of the western parapet wall so that it could be used to ensure that these would be replaced in the same positions during reconstruction (Fig 9).

Fig 9 Plan of bridge prior to works with coping stones shown within and either side of the damaged area of wall.

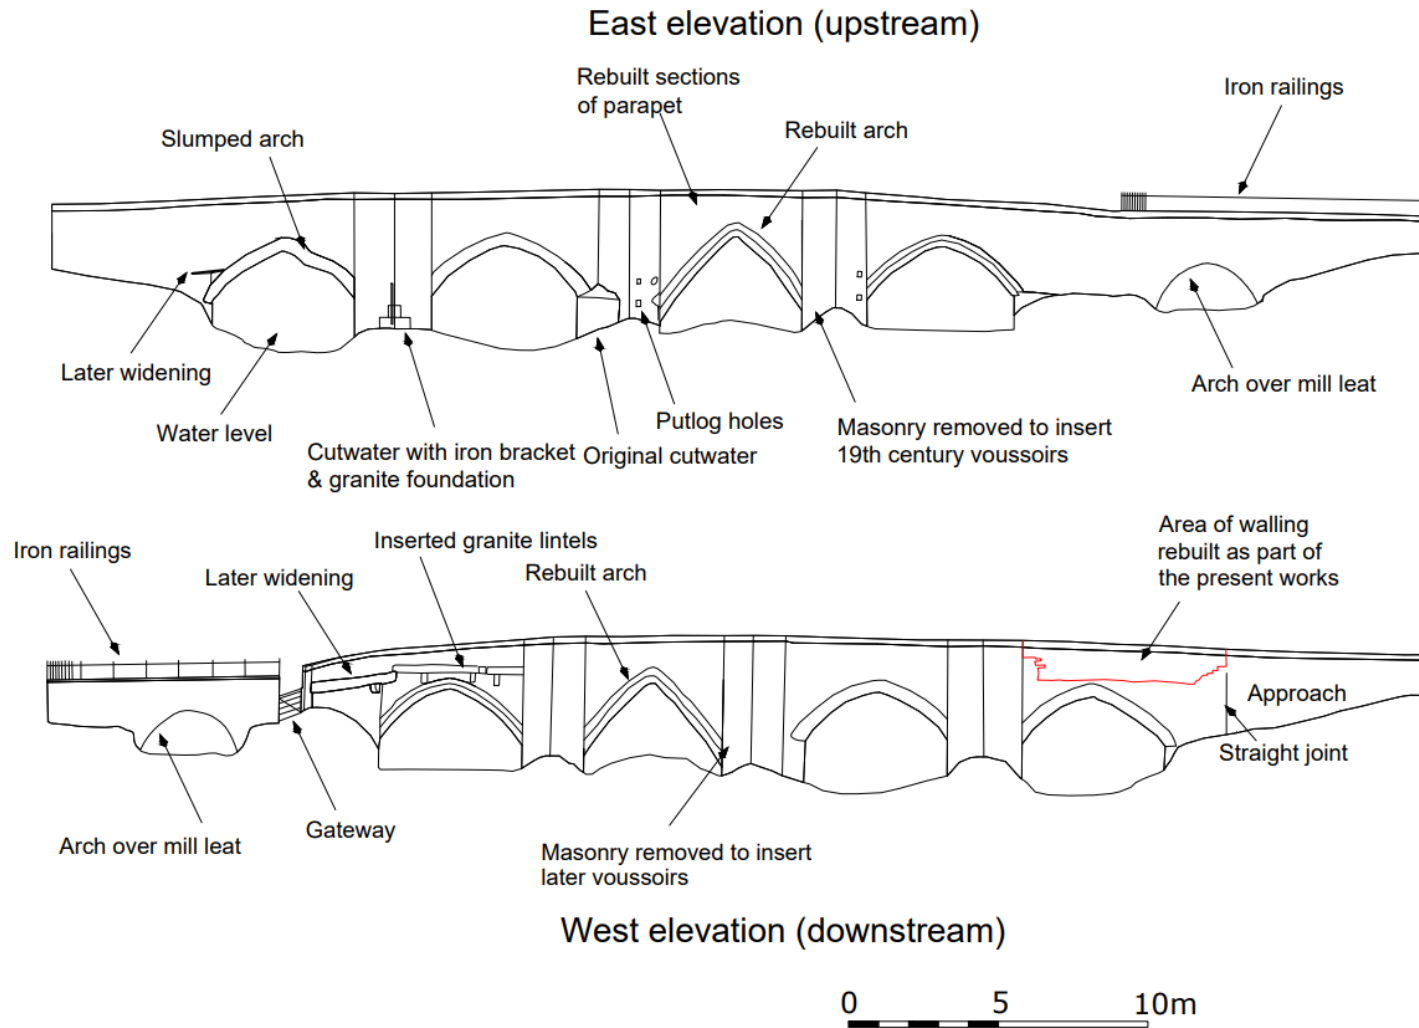
The area of walling removed measured approximately 5.2m in length by 1.2m in height. It was taken down to a level of approximately 0.45m below the present road surface reaching a level at the top of the keystone of the arch below. The removed area stretched from the southern end of the southernmost refuge, southwards to a straight joint in the bridge walling directly above the edge of the river bank (see Figs 9 and 10).

Fig 10 Elevation drawings of the bridge after Thomas, N, 2000 showing area of damaged walling.

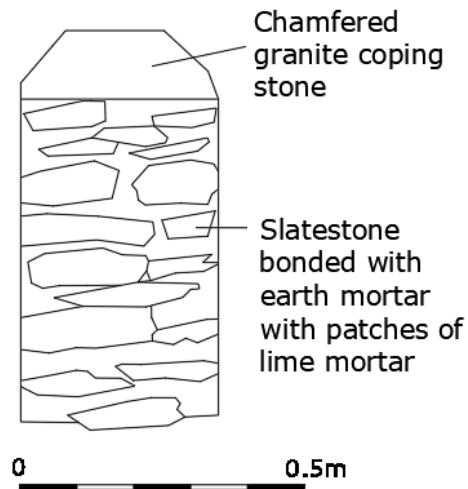
Fig 28 North facing section of parapet wall down to road surface level.

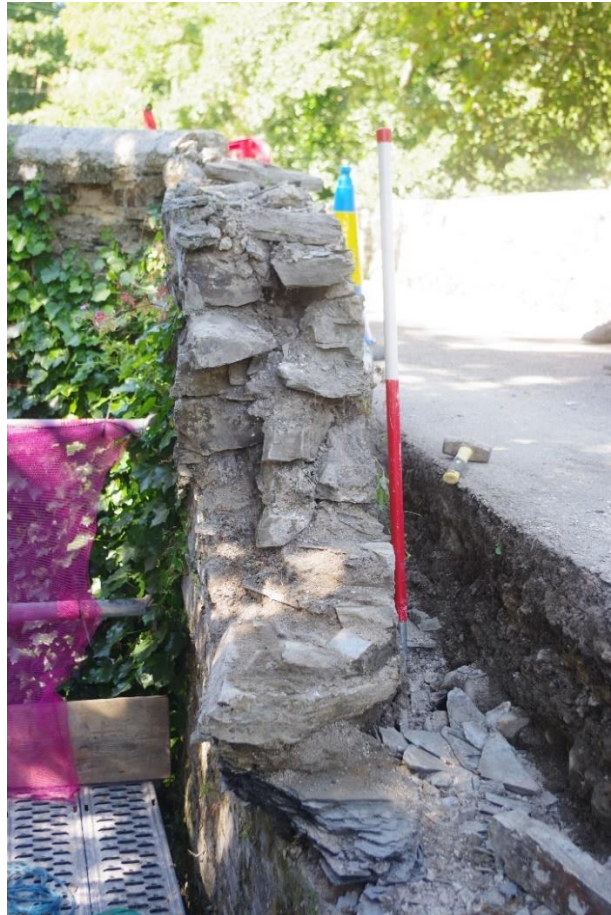
Dismantling of the parapet wall here showed that much of it was likely to be a 19th century rebuild, constructed from randomly coursed slatestone rubble bonded with lime mortar in the northern half and a mix of earth mortar with patches of lime mortar in the southern half. The parapet wall here measured 0.35m wide by 0.7m high down to the present road surface (Fig 28). However, it was clear that the parapet wall extended below the present road surface by a further 0.35m where it had been constructed on top of the bridge arch and spandrel walls (Figs 29 and 33). The spandrel walls had a greater width of 0.45m and comprised much larger blocks of slatestone than the parapet wall which were randomly coursed and bonded with a mid yellowish brown silty clay earth mortar (Compare Figs 29 and 30).

Fig 29 (36) South facing section of parapet wall.

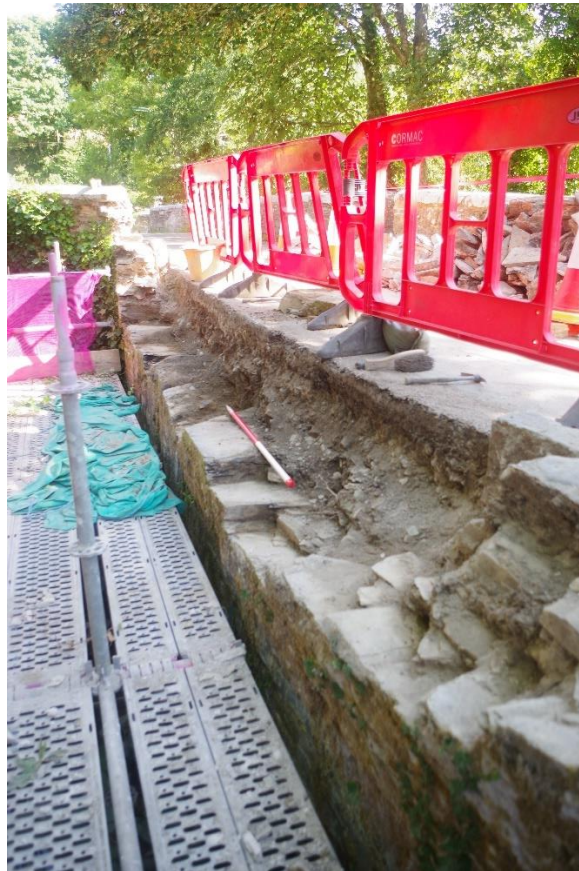
Fig 32 (39) Area of removed walling looking north.

Following the dismantling of the damaged area of walling, a section was exposed showing the make-up below the modern Tarmac road surface (see Figs 27, 30, 31 and 32). In the exposed, west facing section the modern Tarmac road (101) was seen to be approximately 0.1m deep and overlay a compact layer of crushed slatestone fragments in a dark grey silt matrix containing occasional patches of lime (102) approximately 0.09m deep. This in turn overlay a layer of mid greyish brown

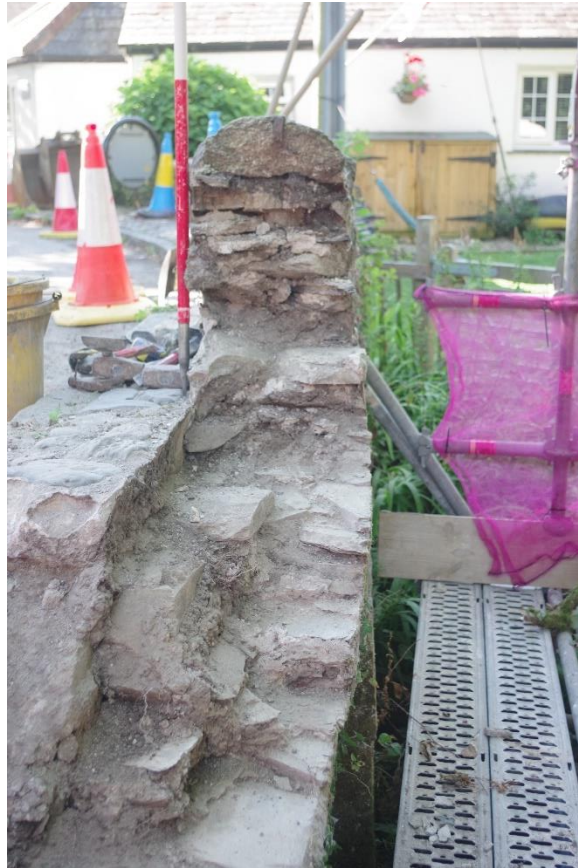
Fig 33 (40) North facing section through parapet wall.

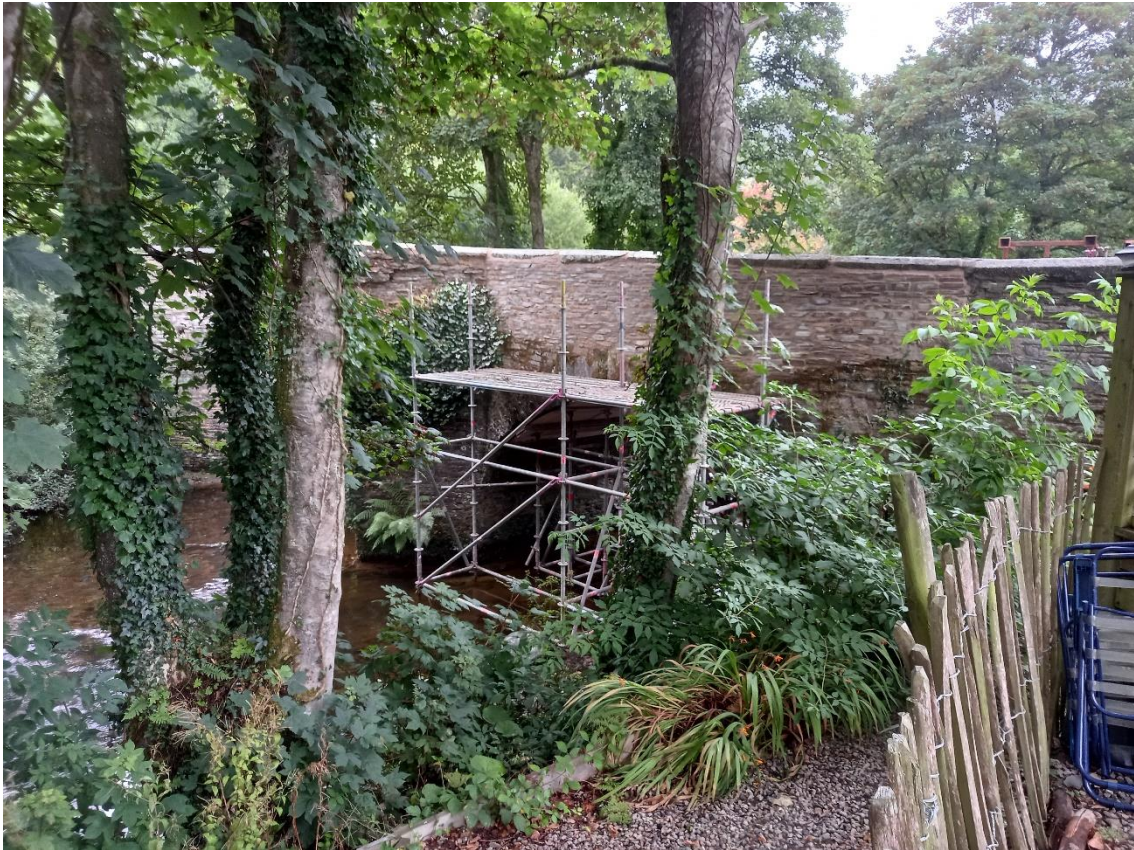
Fig 37 West elevation of new parapet and spandrel wall following reconstruction.
