Pascoe's Shaft Pumping and Winding
Engine Houses, South Wheal Frances,
Piece, Cornwall
Historic Building Record

Cornwall Archaeological Unit

Report No: 2022R022

Historic Building Record

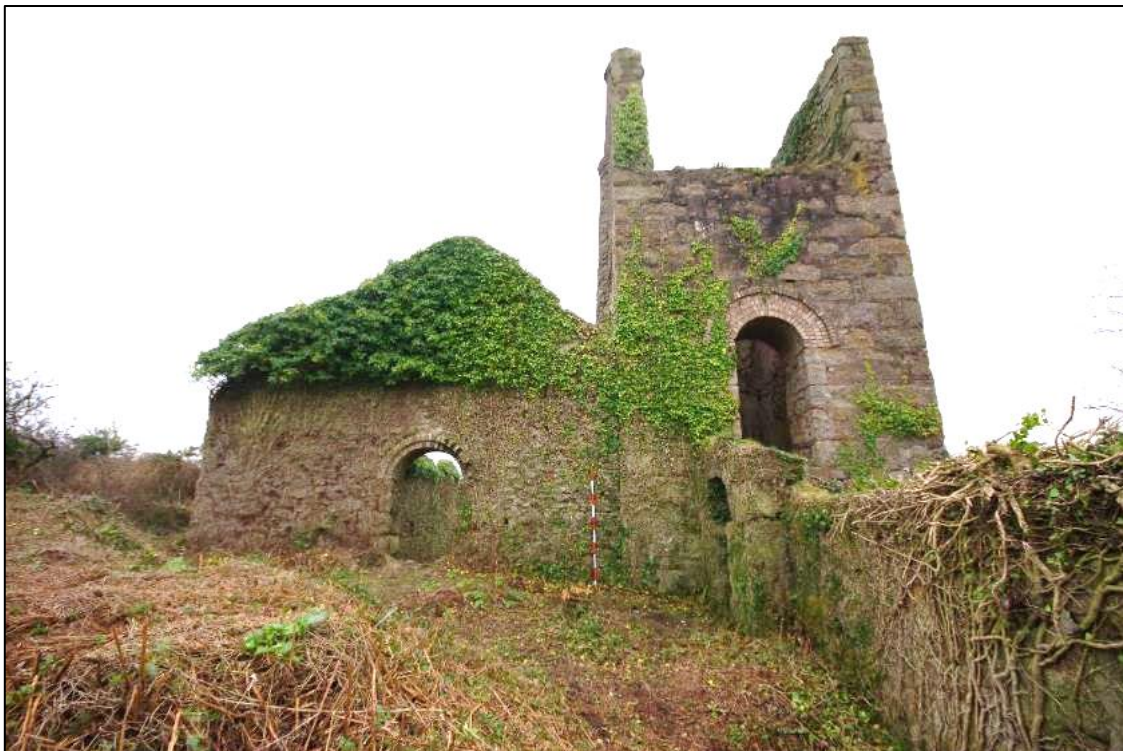
Fig 10 North-east elevation before remedial works.

(see Figs 10, 16, 59 and 60 for before and after repairs).

(see Figs 10, 19 and 20 for before and after repairs).

(see Figs 10, 11 and 14 for before and after repairs).

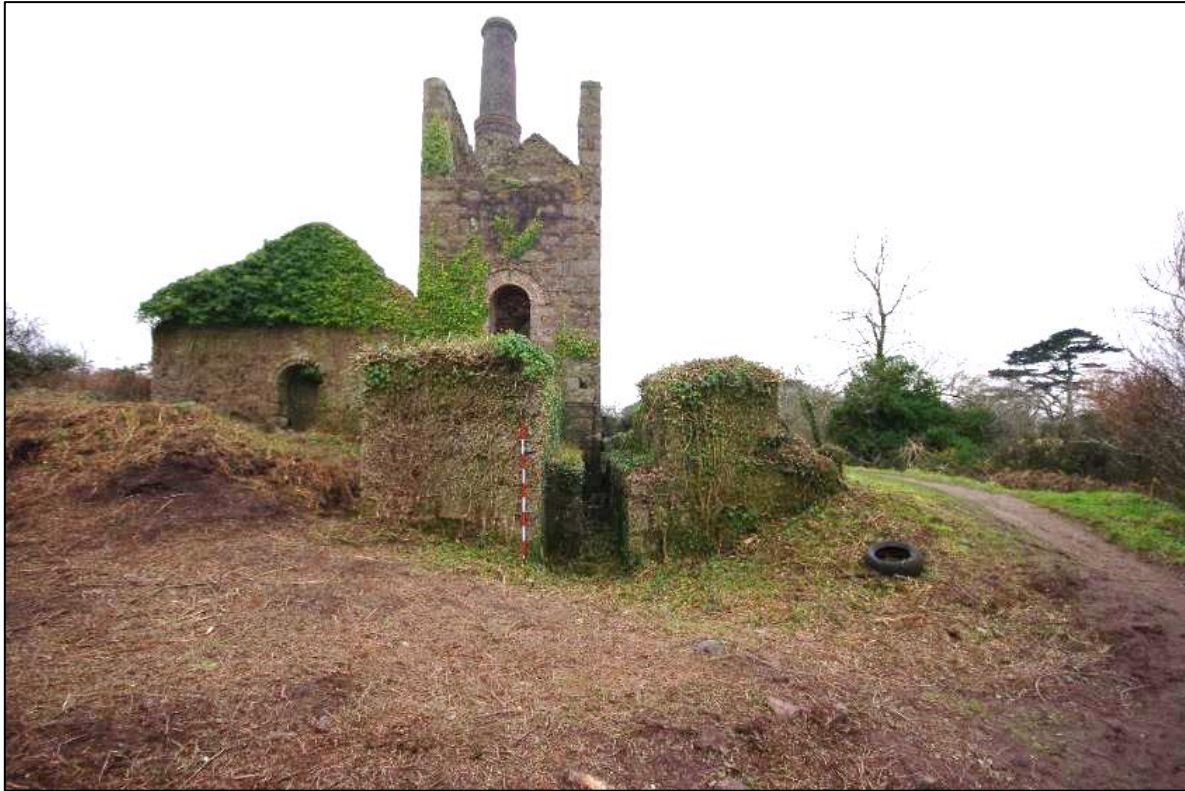
Fig 11 North-east elevation before remedial works.

(see Figs 11 and 14 for before and after repairs).

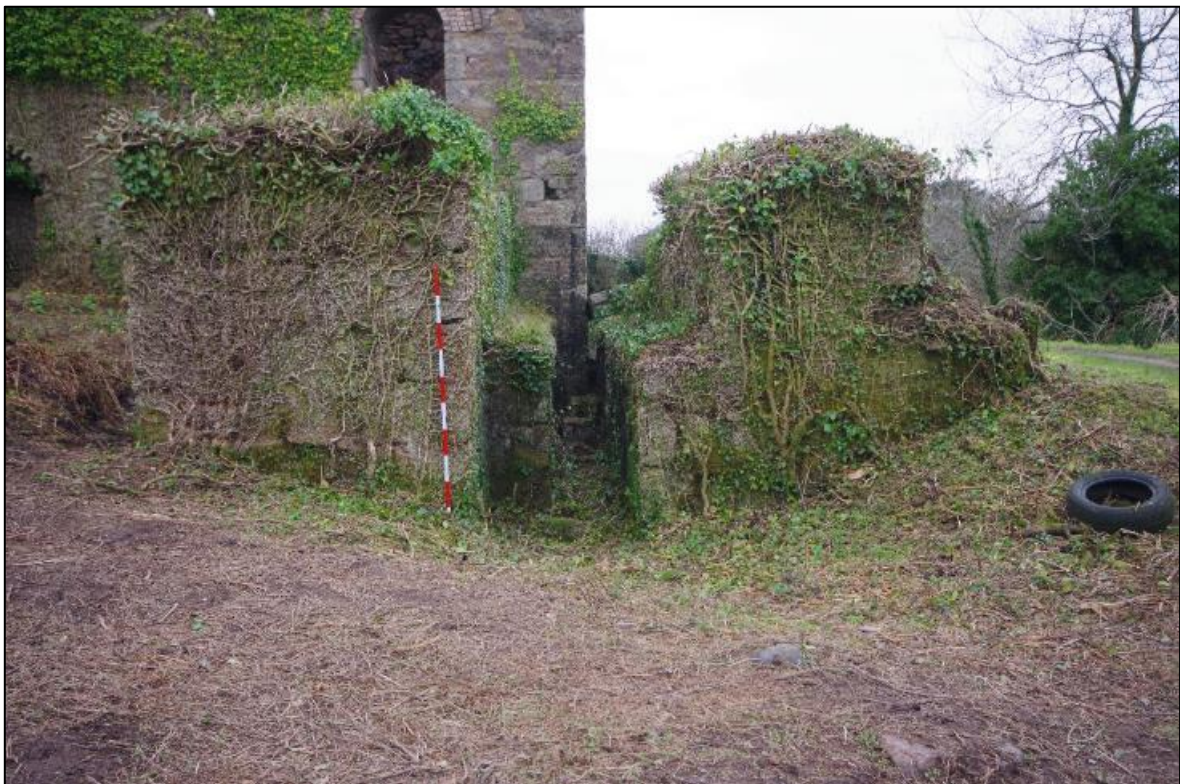
Fig 12 North-east elevation of loadings and flywheel slot before remedial works.

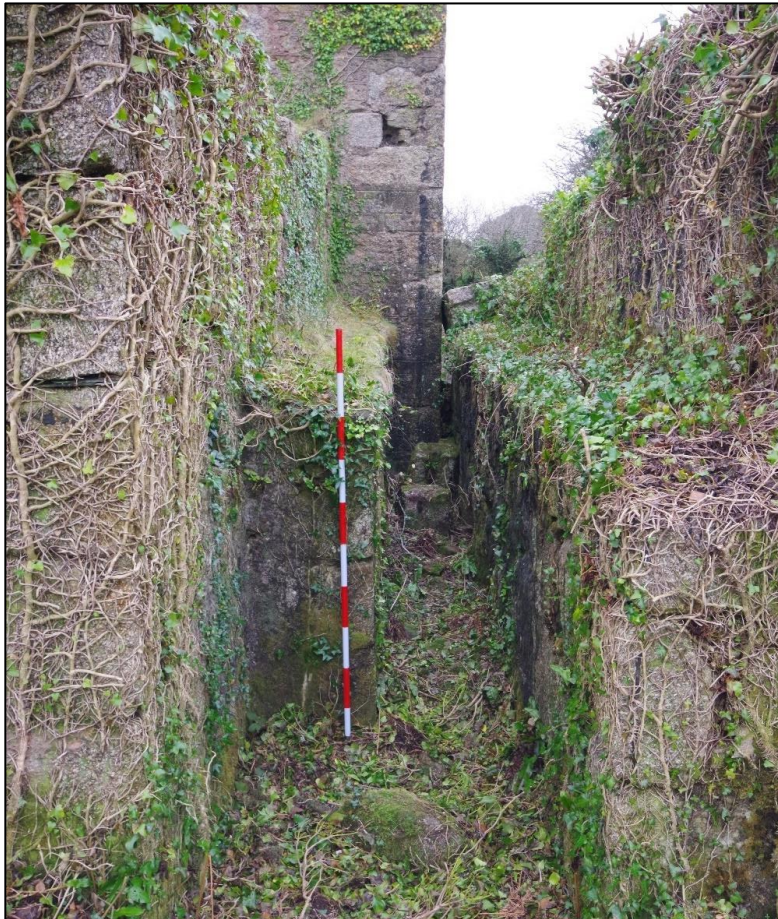
Fig 13 View of flywheel slot in loadings before remedial works.

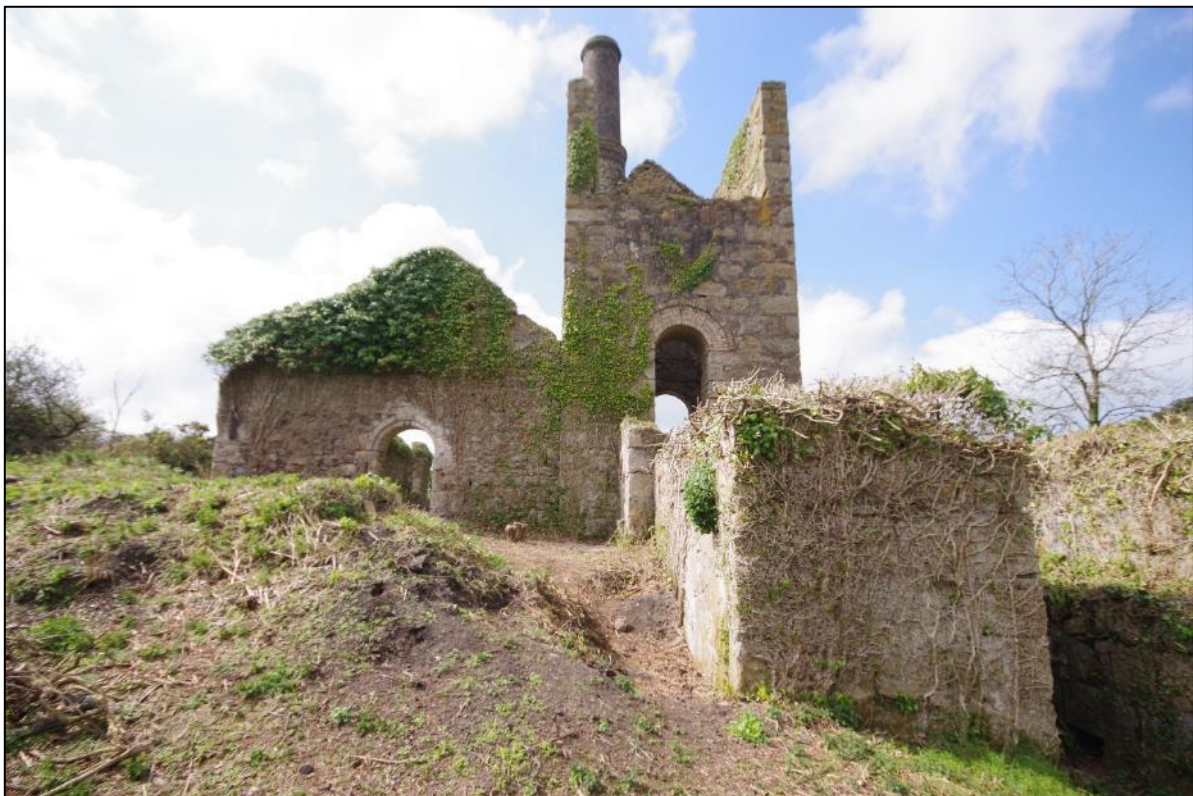
Fig 14 North-east elevation following vegetation clearance and repair work to the boiler house window opening.

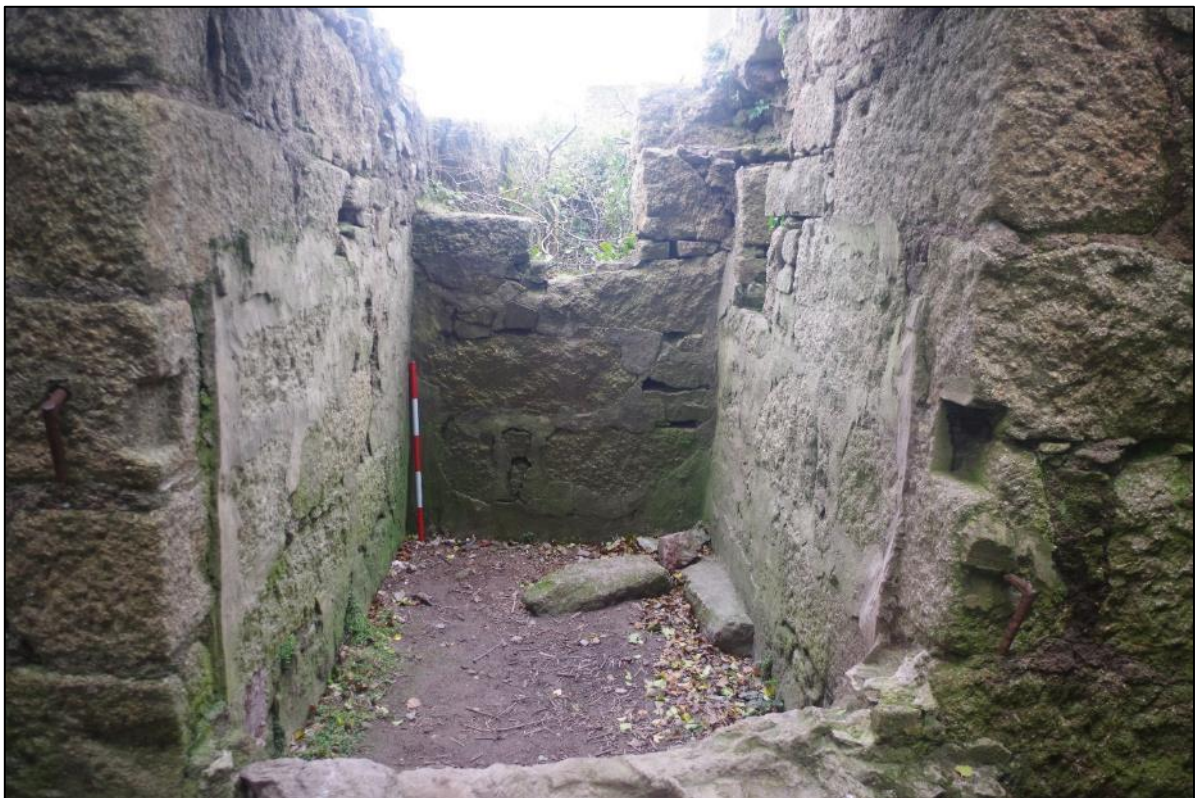
Fig 18 Interior looking north-east into condenser pit before remedial works.

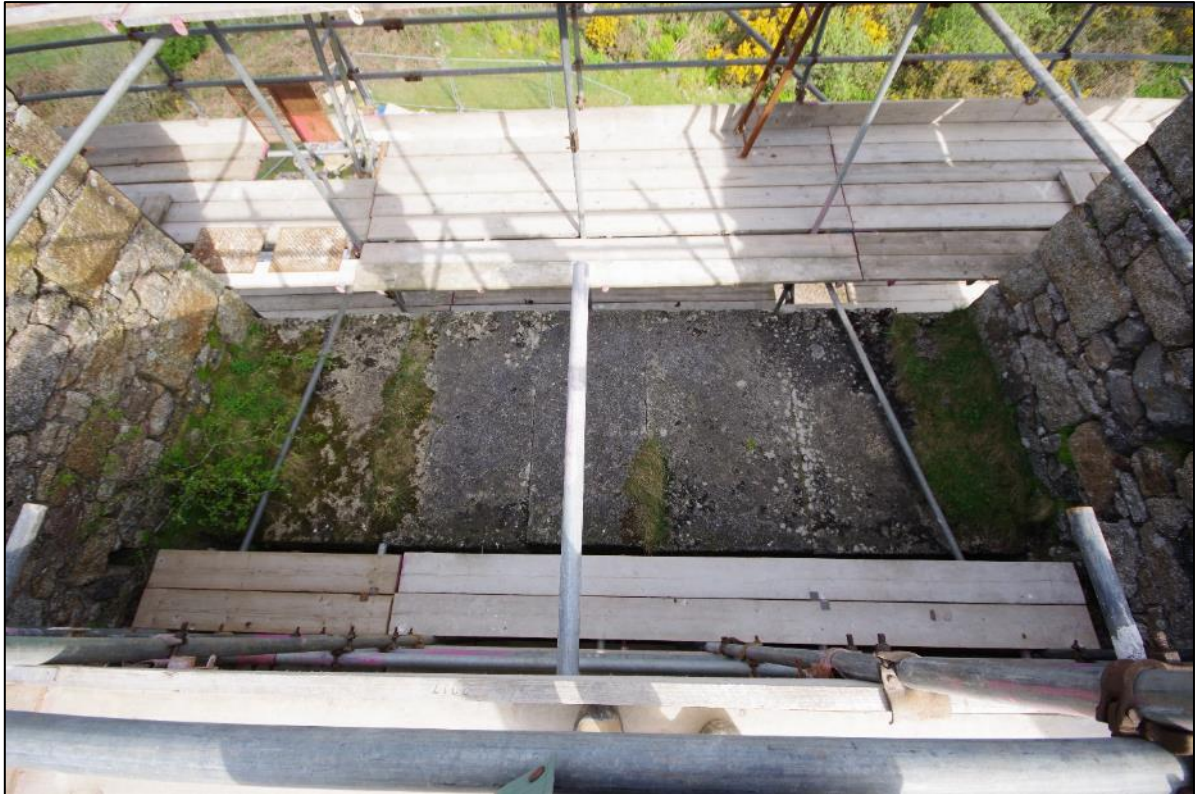
Fig 19 Top of bob wall before remedial works.

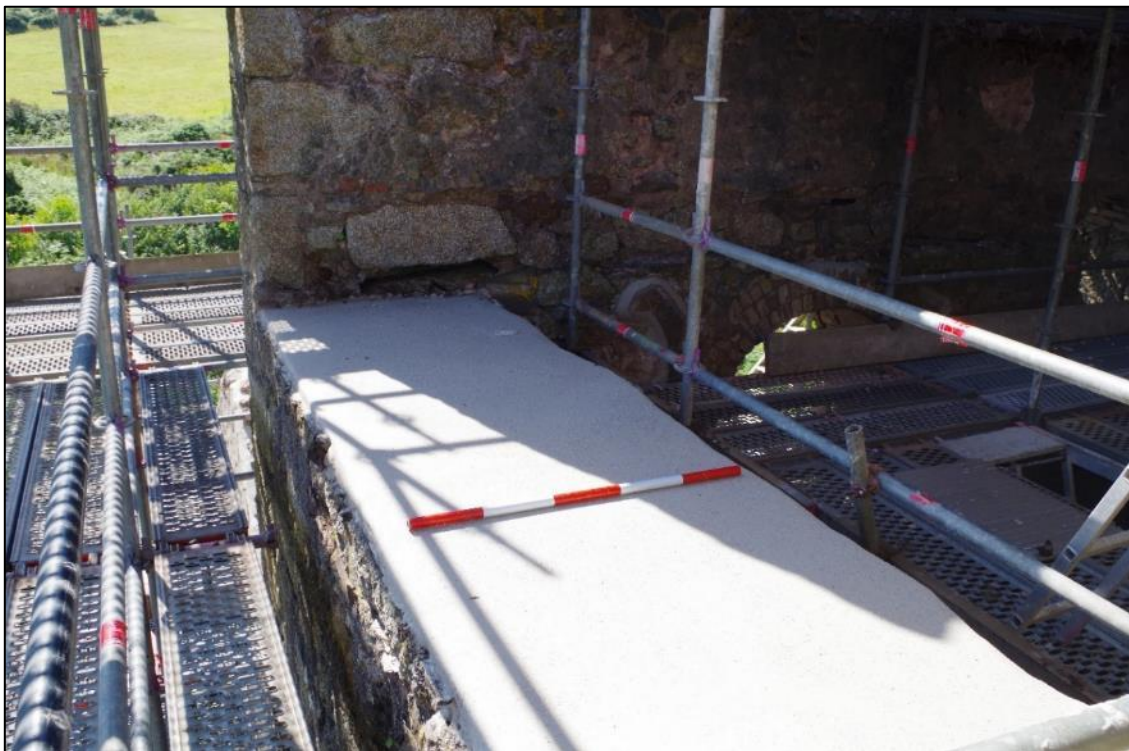
Fig 20 Top of bob wall following lime mortar capping.

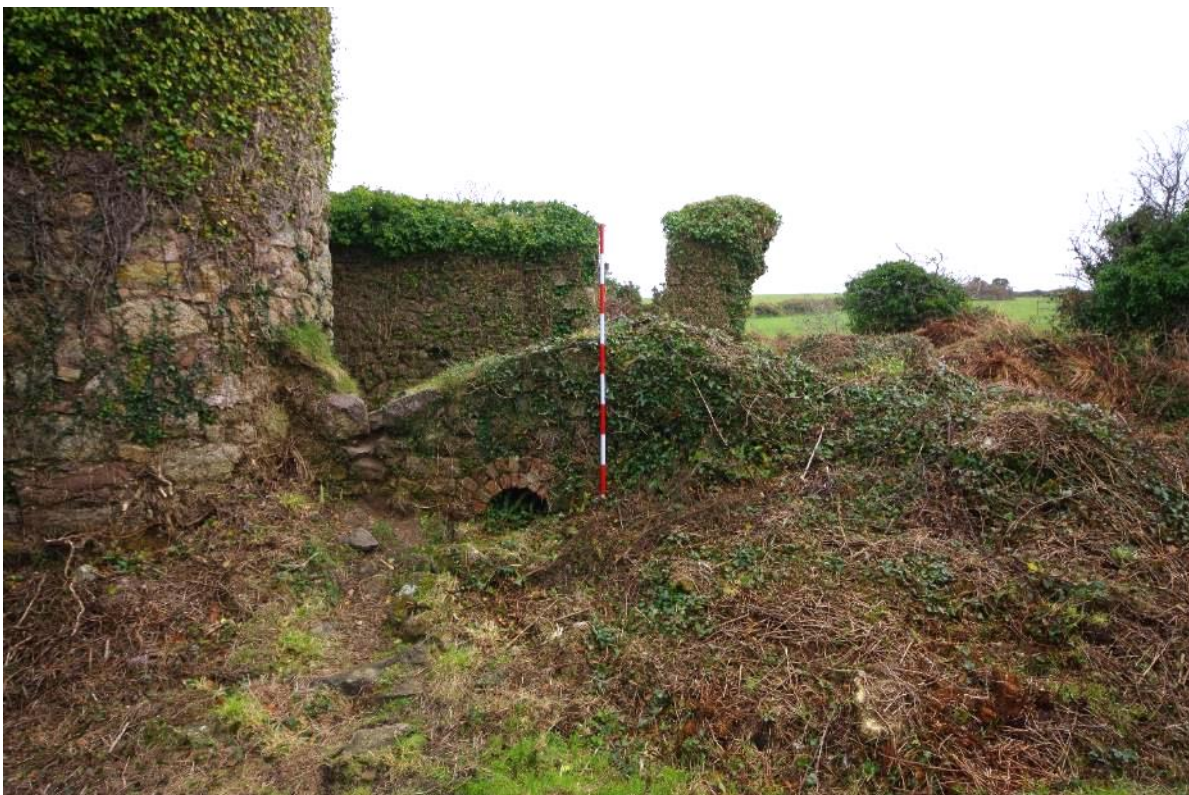
To the south-west of the engine house a low, short section of the north-west elevation of the boiler house survives (Fig 22). Within the randomly coursed granite rubble masonry there is a low arched opening with two courses of brick voussoirs at ground level, presumably for pipework.

Fig 22 North-west elevation of remains of boiler house wall before remedial works.

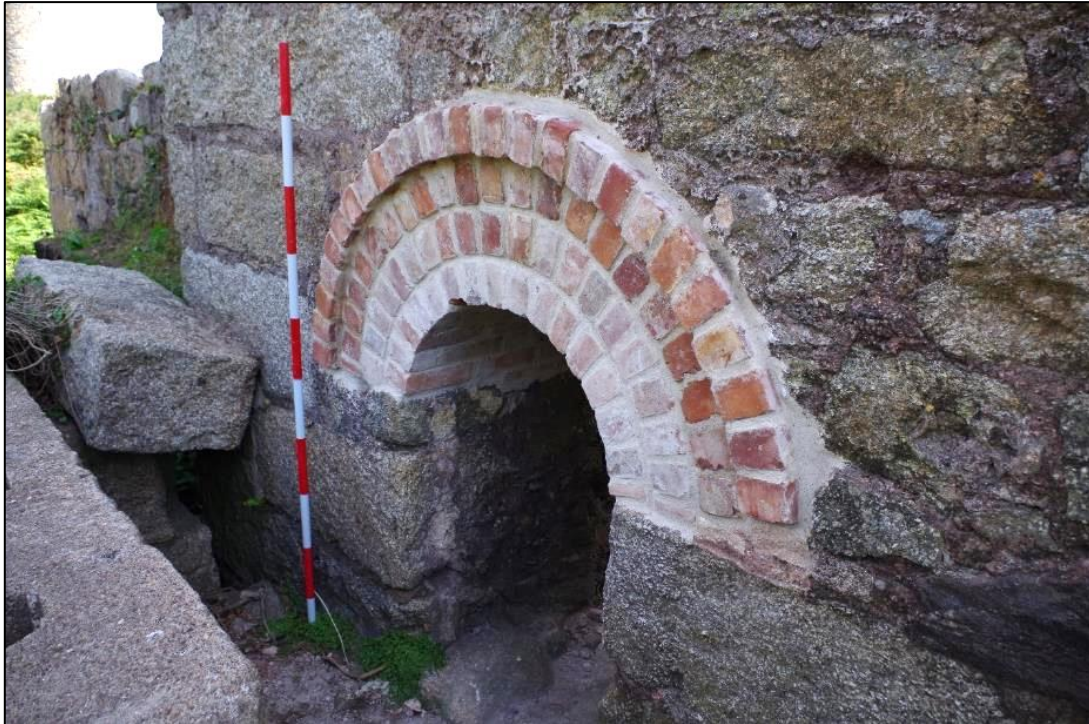
Fig 23 North-west elevation of engine house: arch leading to cataract pit following repair work.

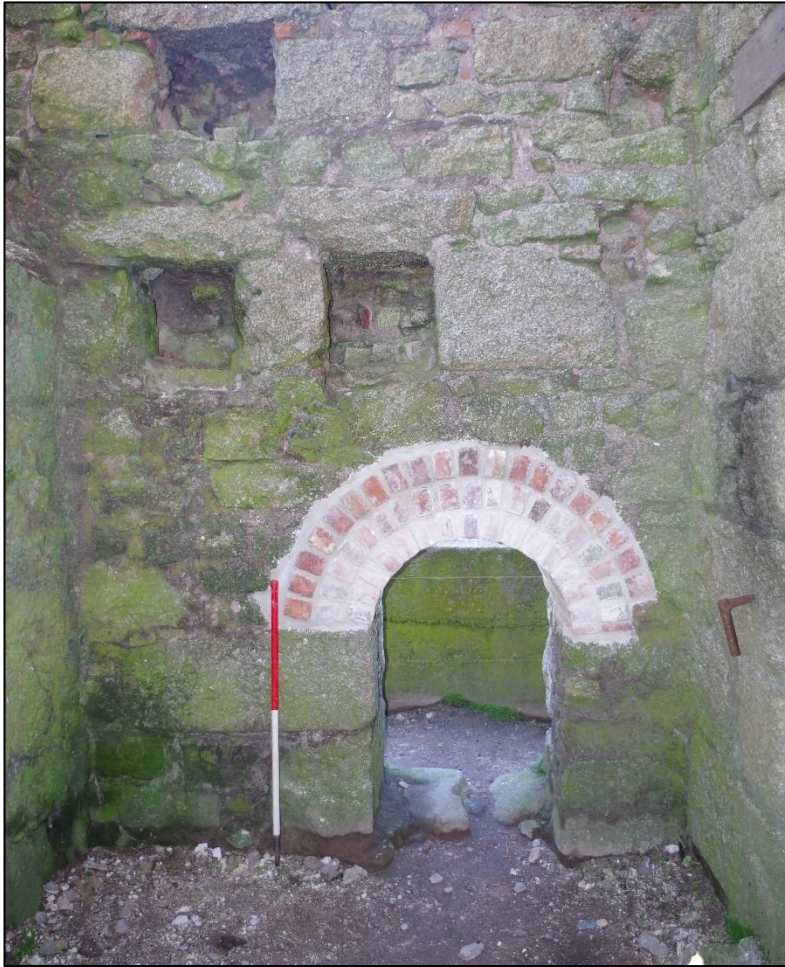
Fig 25 Interior north-west cataract pit wall following reconstruction of brick arch.

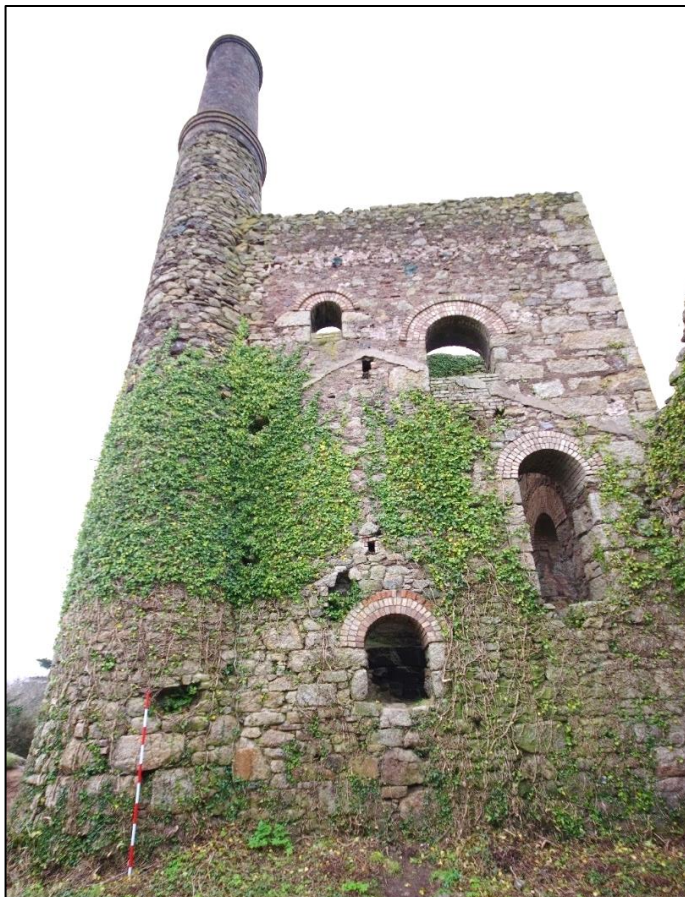
Fig 28 South-east elevation of engine house before remedial works.

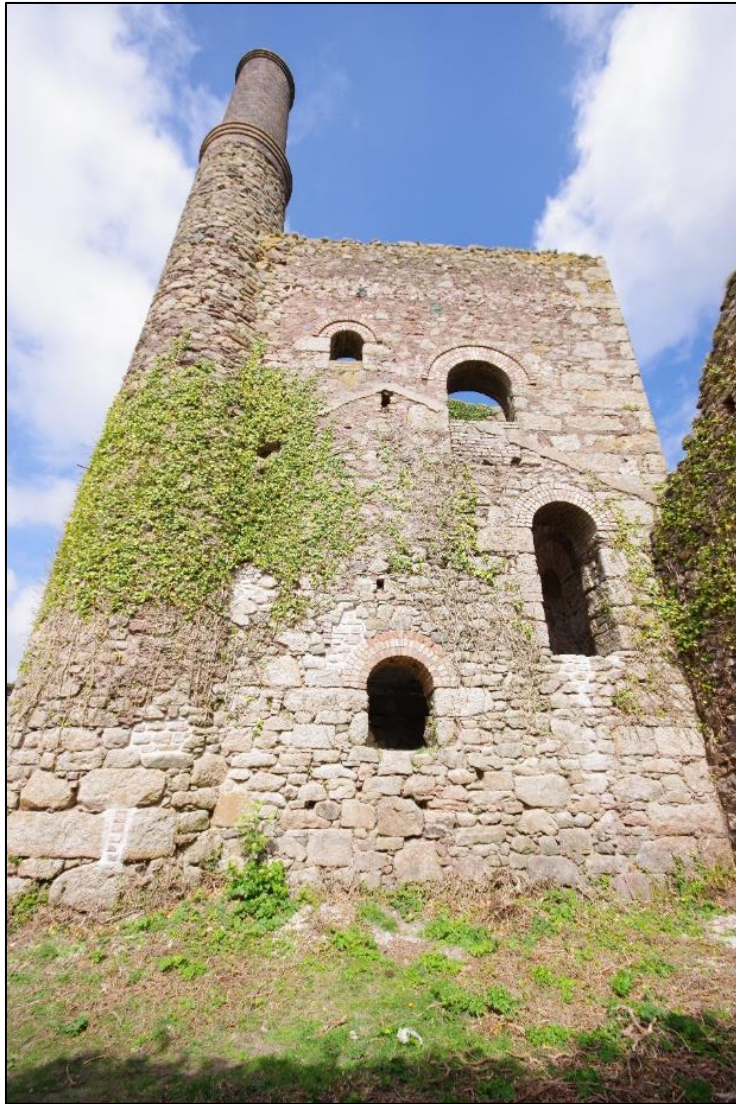
During this period, alterations appear to have been undertaken to the boiler house roof. This is indicated by the scar of a former pitched roof with associated sockets for roof timbers on the south-east elevation of the winding house (see Fig 29). This pitched roof cuts across the upper floor window of the winding house, indicating that it was clearly a later alteration. Photographs taken in c1890 and c1910 (Figs 8 and 9) show a simple gable roof over the boiler house. However, the pitched roof scar on the external south-east elevation of the winding house wall suggests that the roof was altered after the photographs were taken in to create an 'L' shaped roof.

Fig 29 South-east elevation of engine house following patch repairs and some ivy clearance.

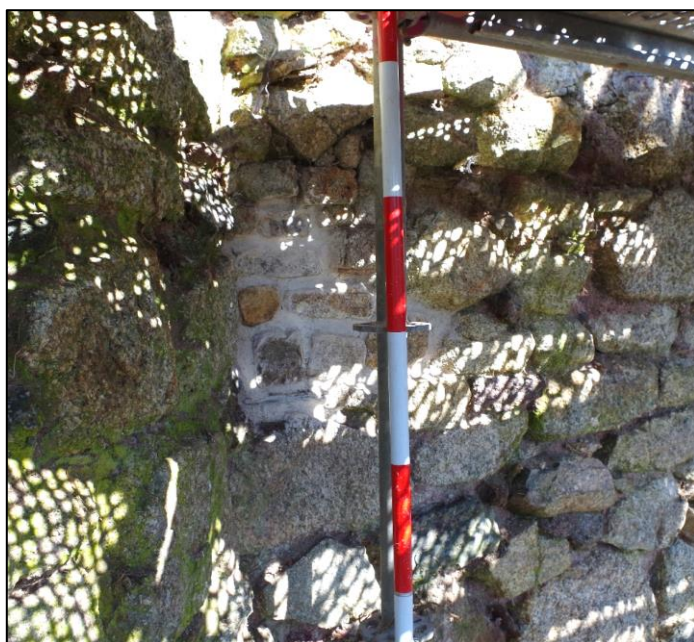
Fig 30 South-east elevation following patch repairs.

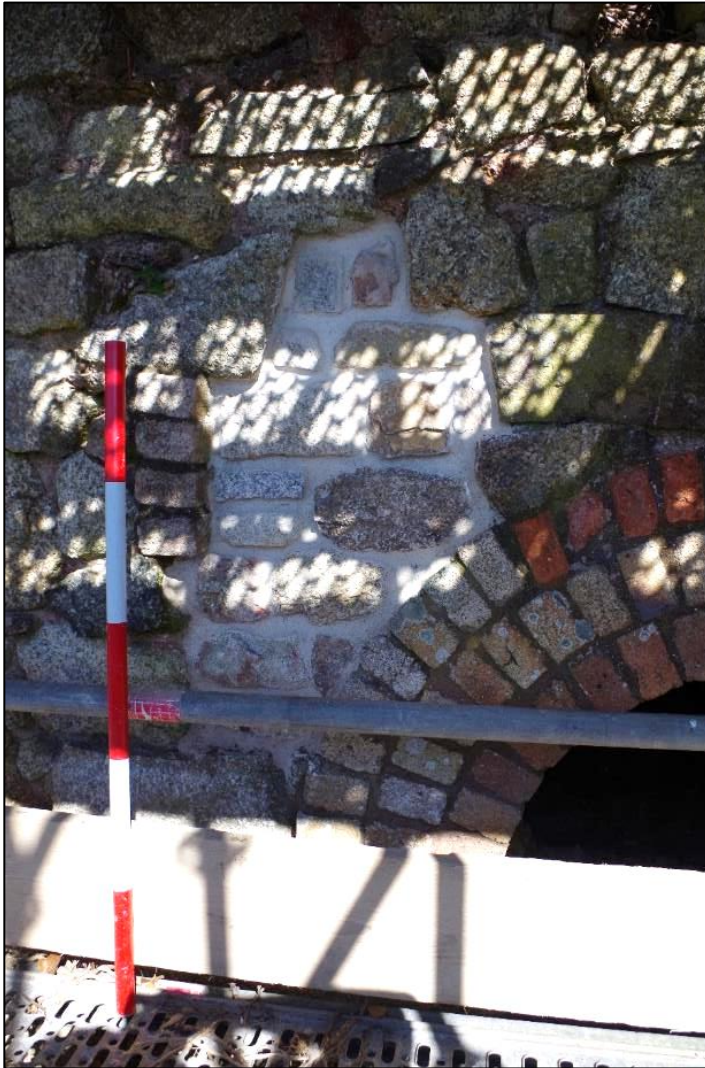
Fig 31 South-east elevation following patch repairs.

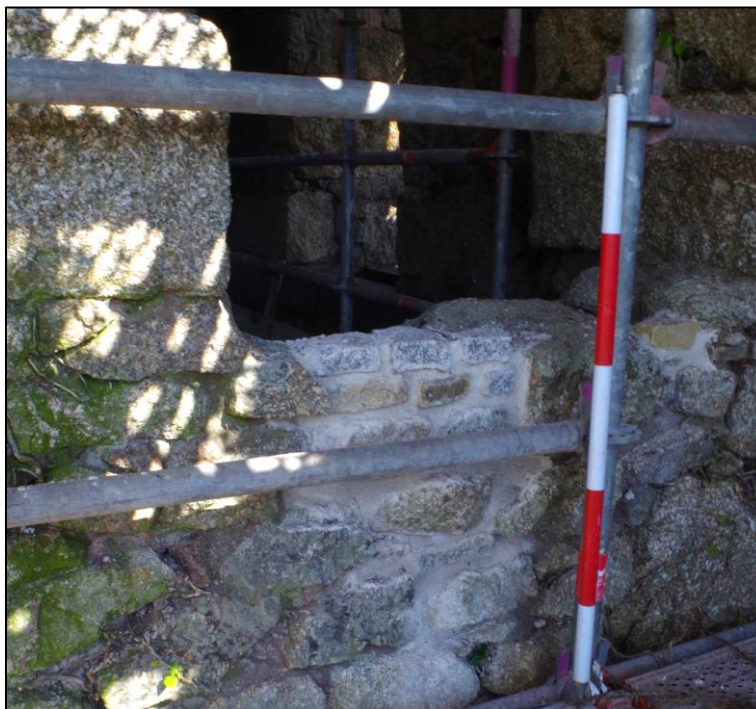
Fig 32 South-east elevation following patch repairs.

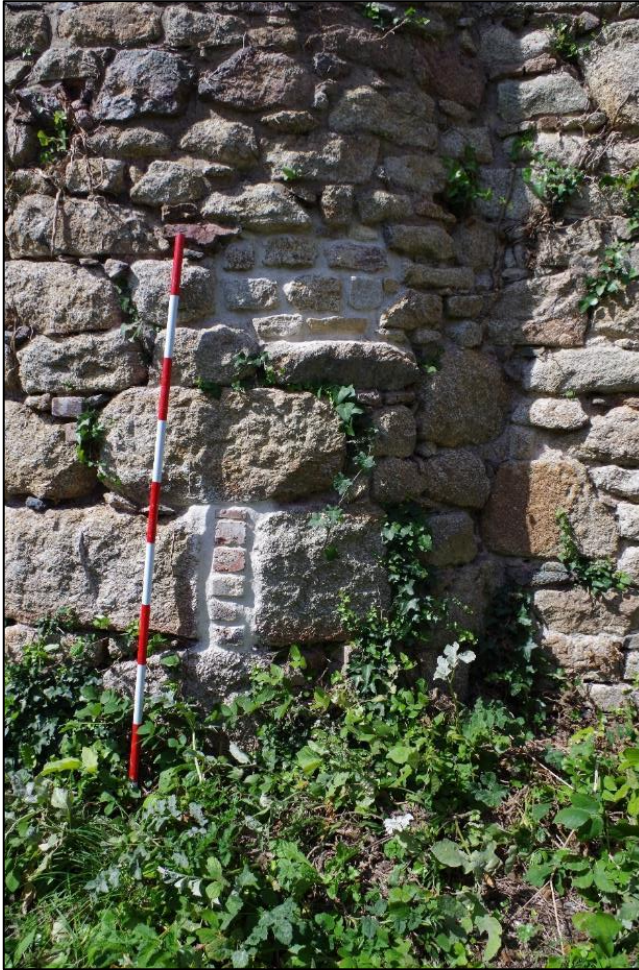
Fig 33 South-east elevation following patch repairs to chimney stack.

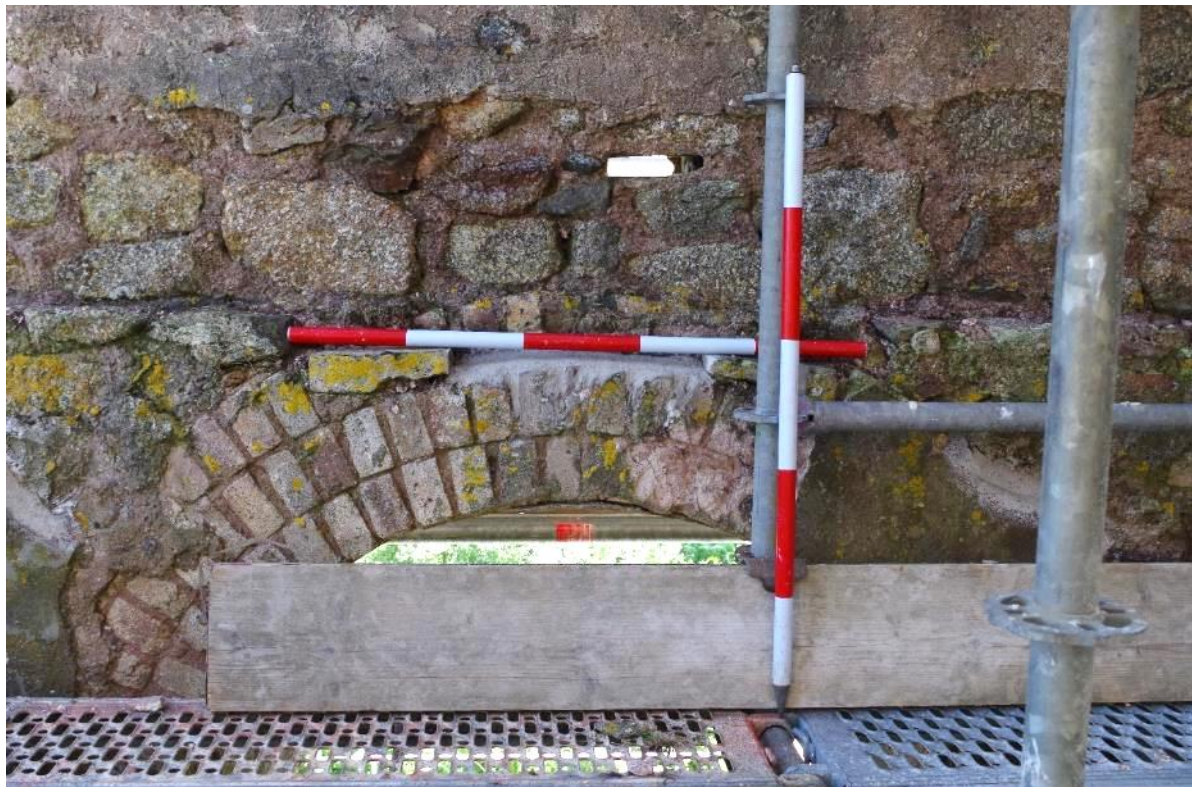
Fig 40 Interior south-east wall following patch repairs.

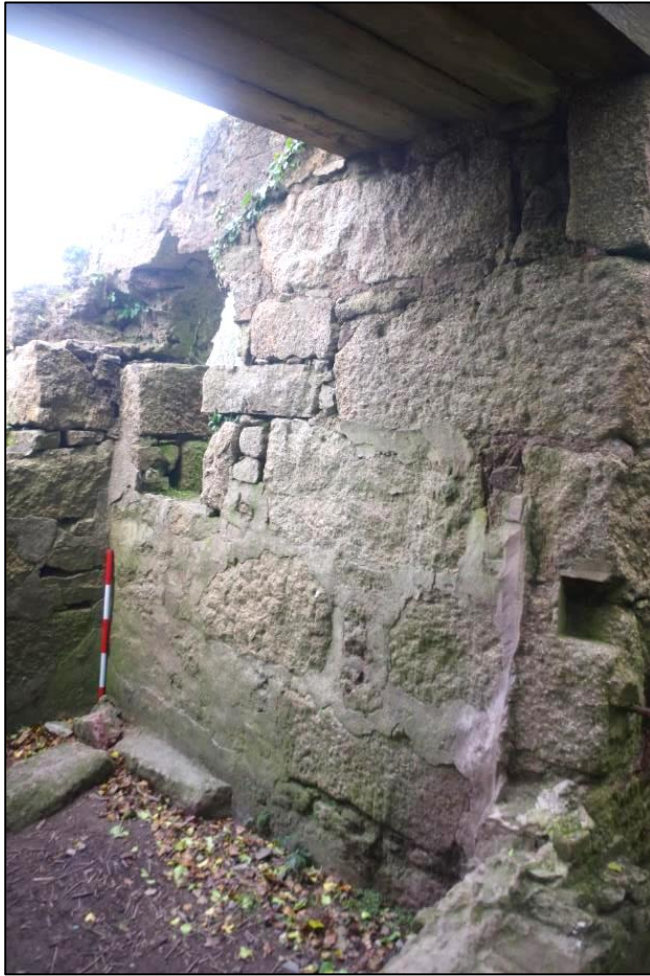
Fig 41 Interior south-east wall of the condenser pit before remedial works.

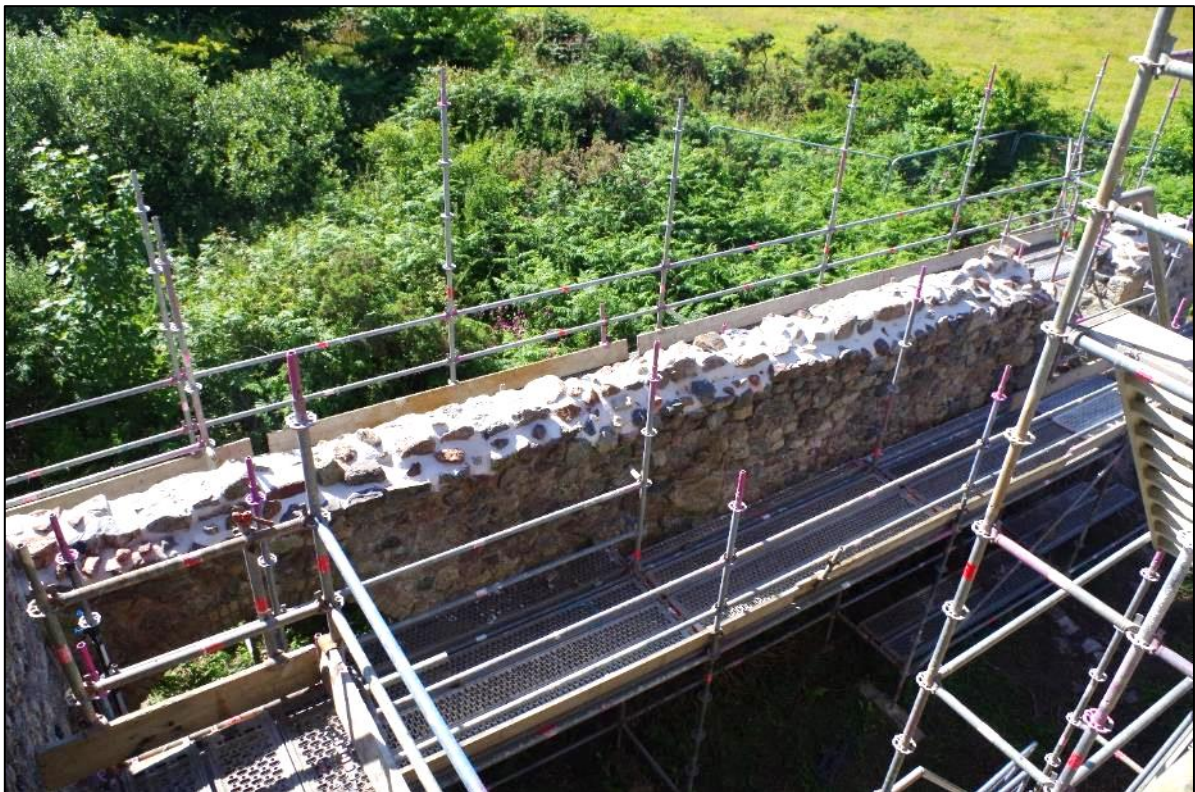
Fig 44 South-east wall of the boiler house following lime mortar capping.

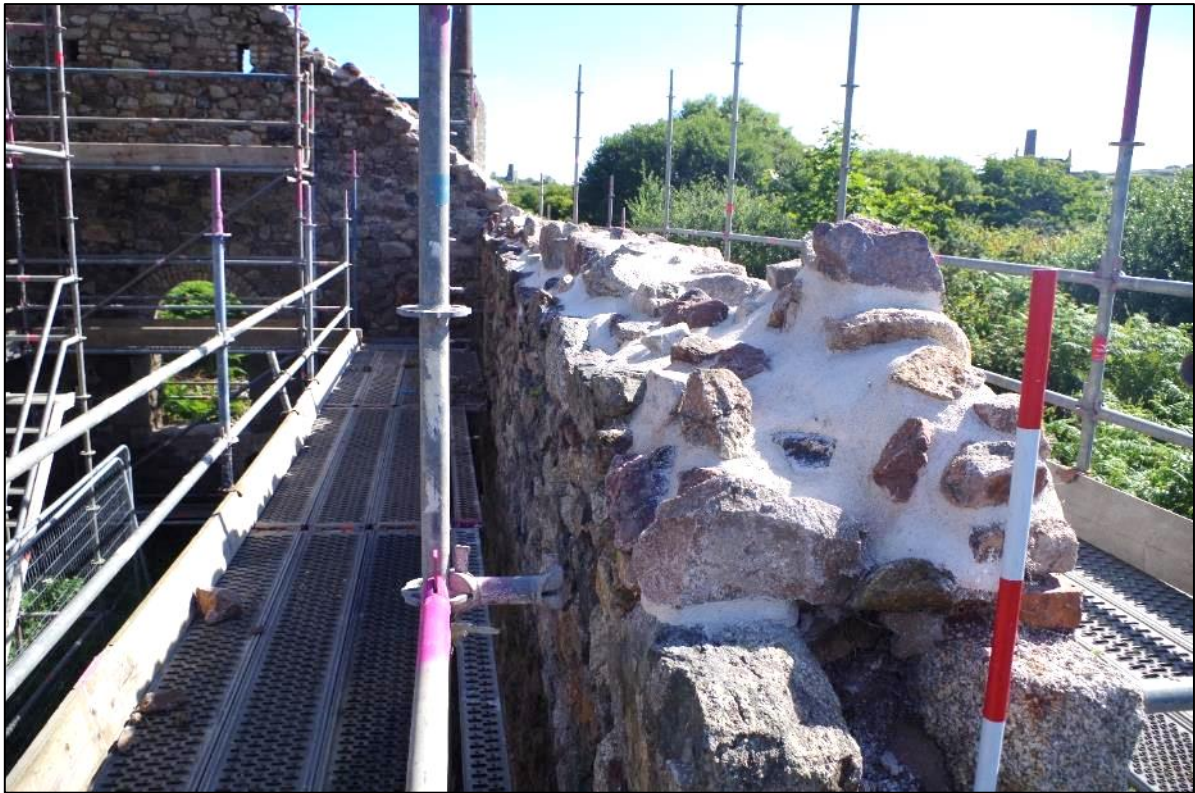
Fig 45 South-east wall of the boiler house following lime mortar capping.

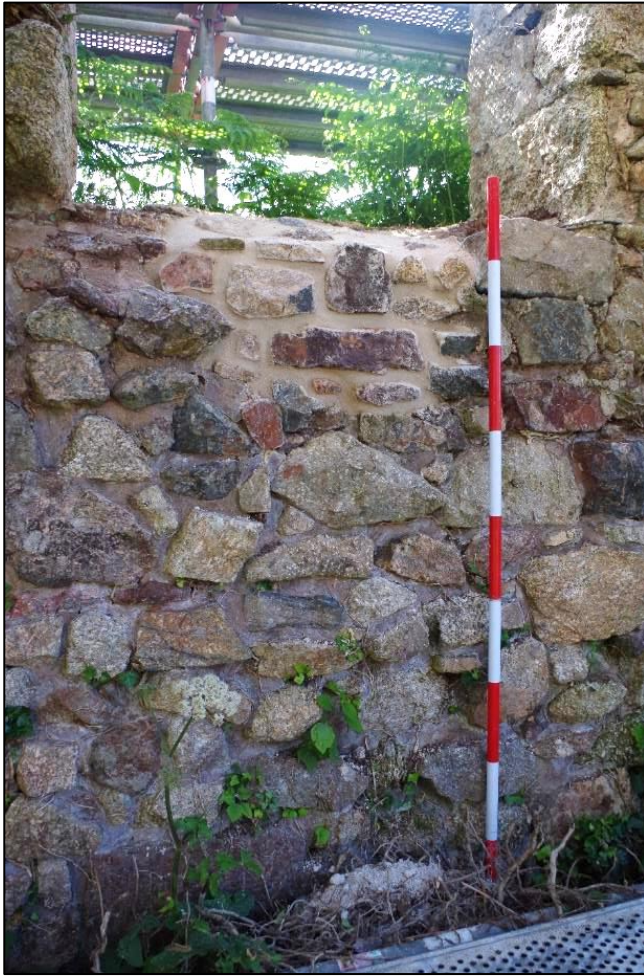
Fig 47 Interior south-east wall of the boiler house following patch repair.

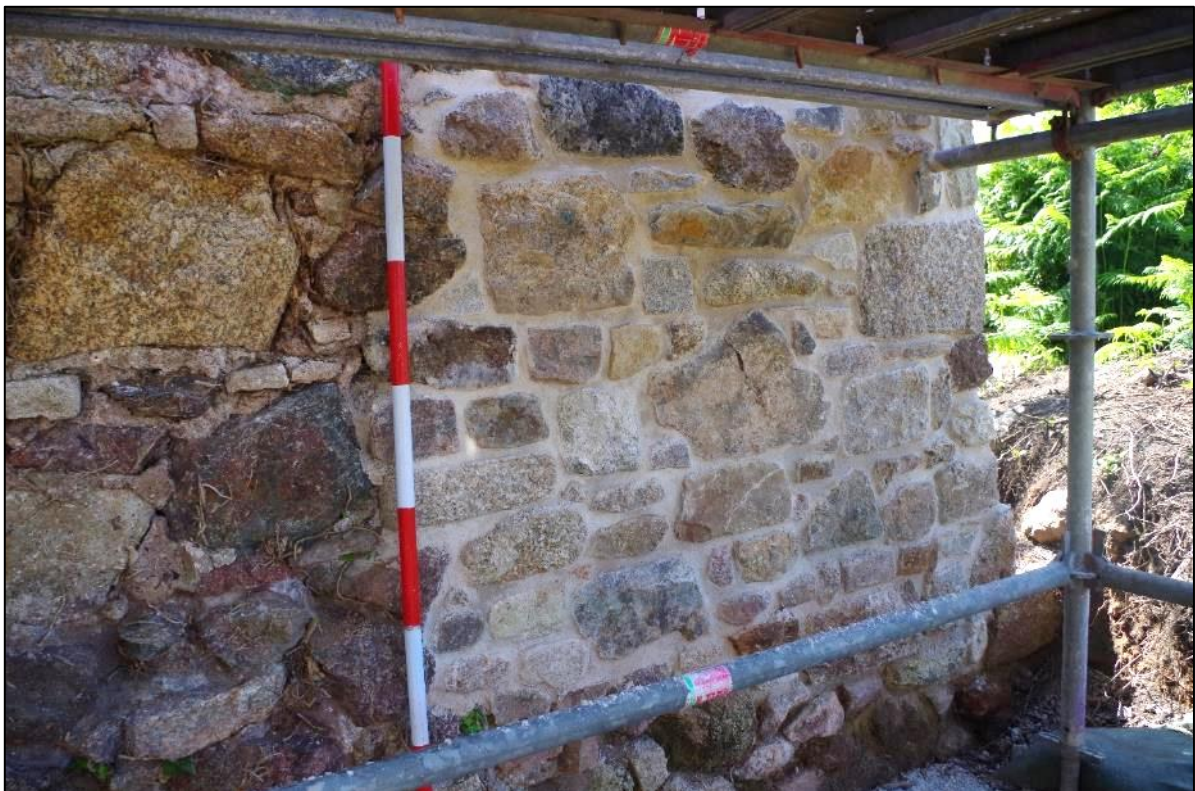
Fig 48 Interior south-east wall of the boiler house following patch repair.

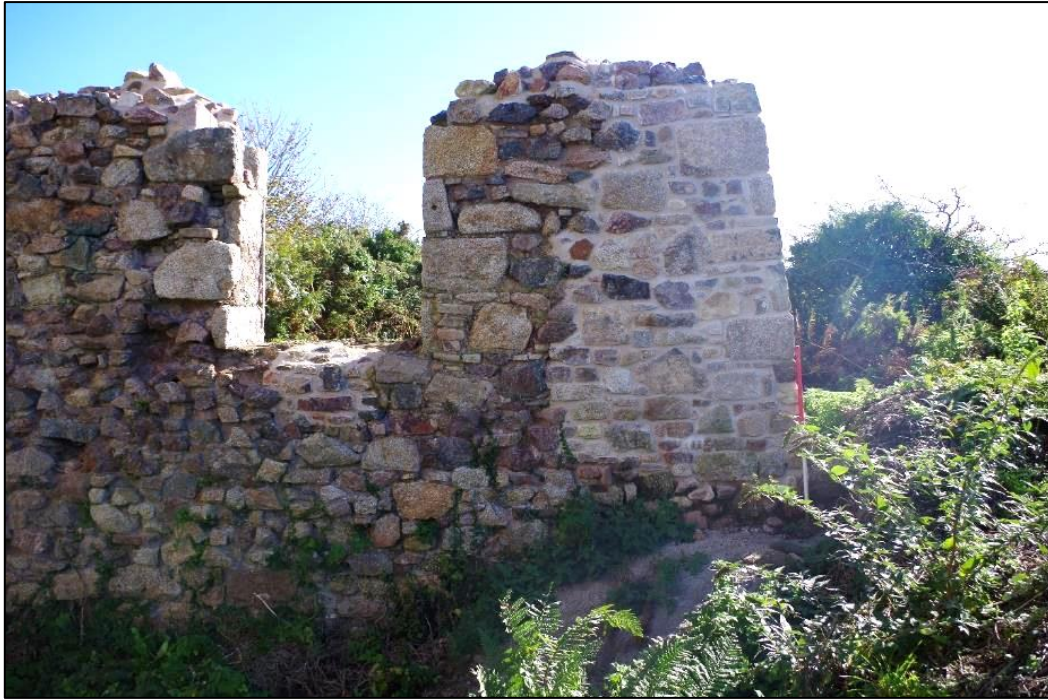
Fig 49 Interior south-east wall of the boiler house following patch repairs.

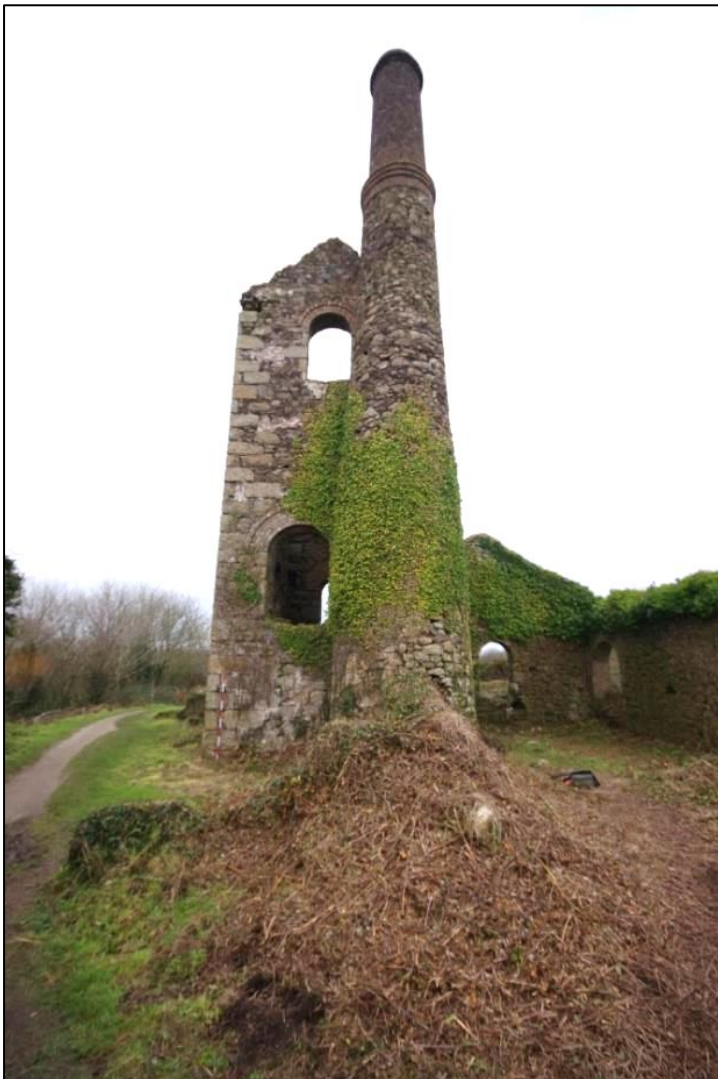
Fig 50 South-west elevation of the engine house before remedial works.

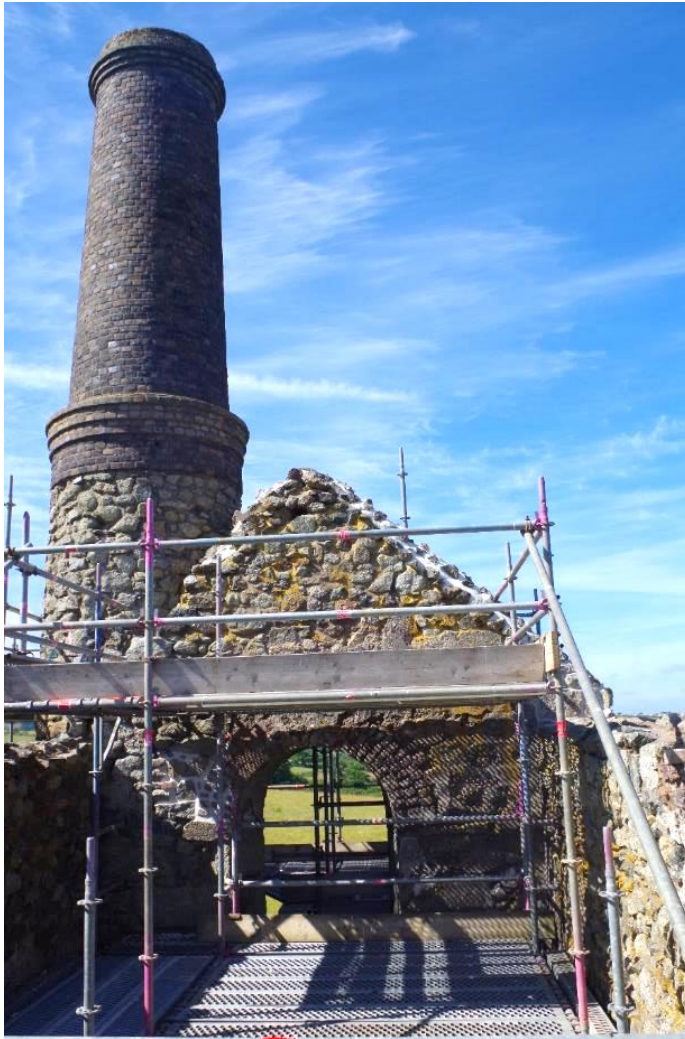
Fig 53 Interior south-west engine house wall following patch repairs and gable end capping.

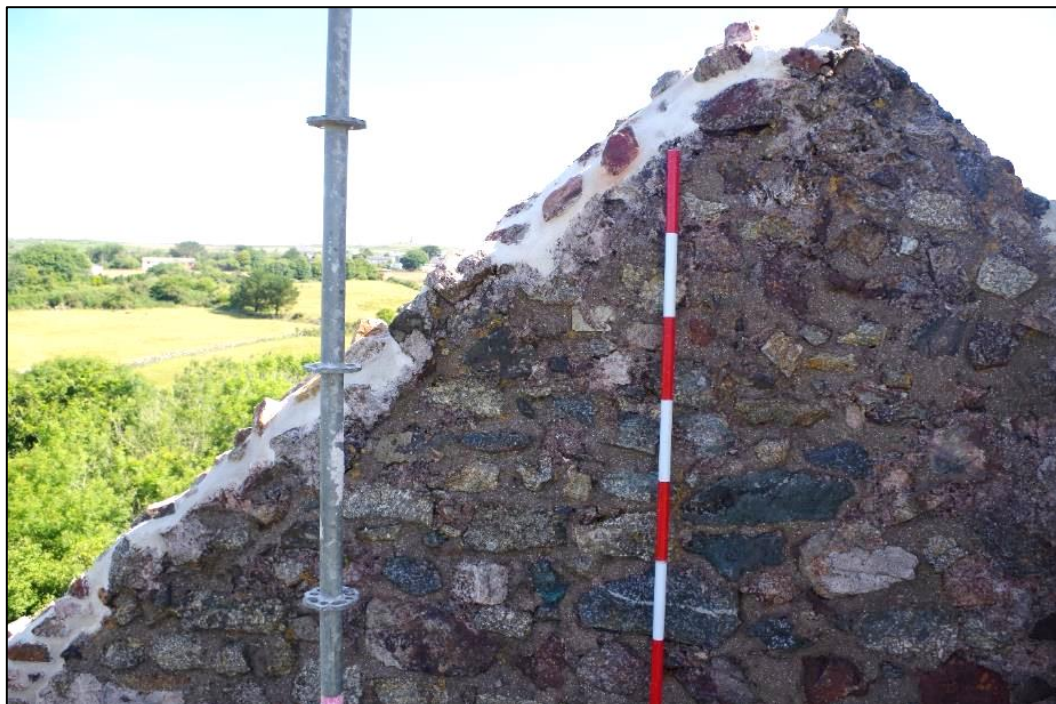
Fig 54 South-west engine house wall following gable end capping.

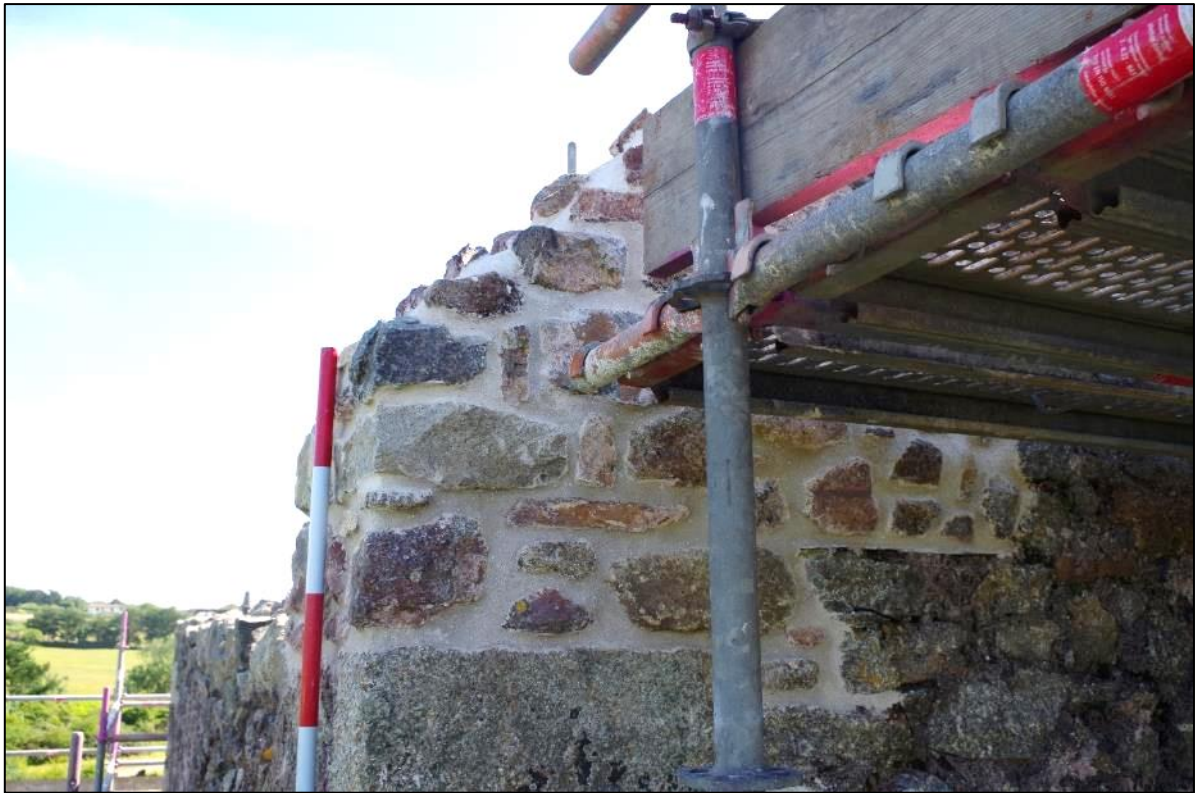
Fig 55 South-west gable end wall of engine house following patch repair.
