Pascoe's Shaft Pumping and Winding
Engine Houses, South Wheal Frances,
Piece, Cornwall
Historic Building Record

Cornwall Archaeological Unit

Report No: 2022R022

Historic Building Record

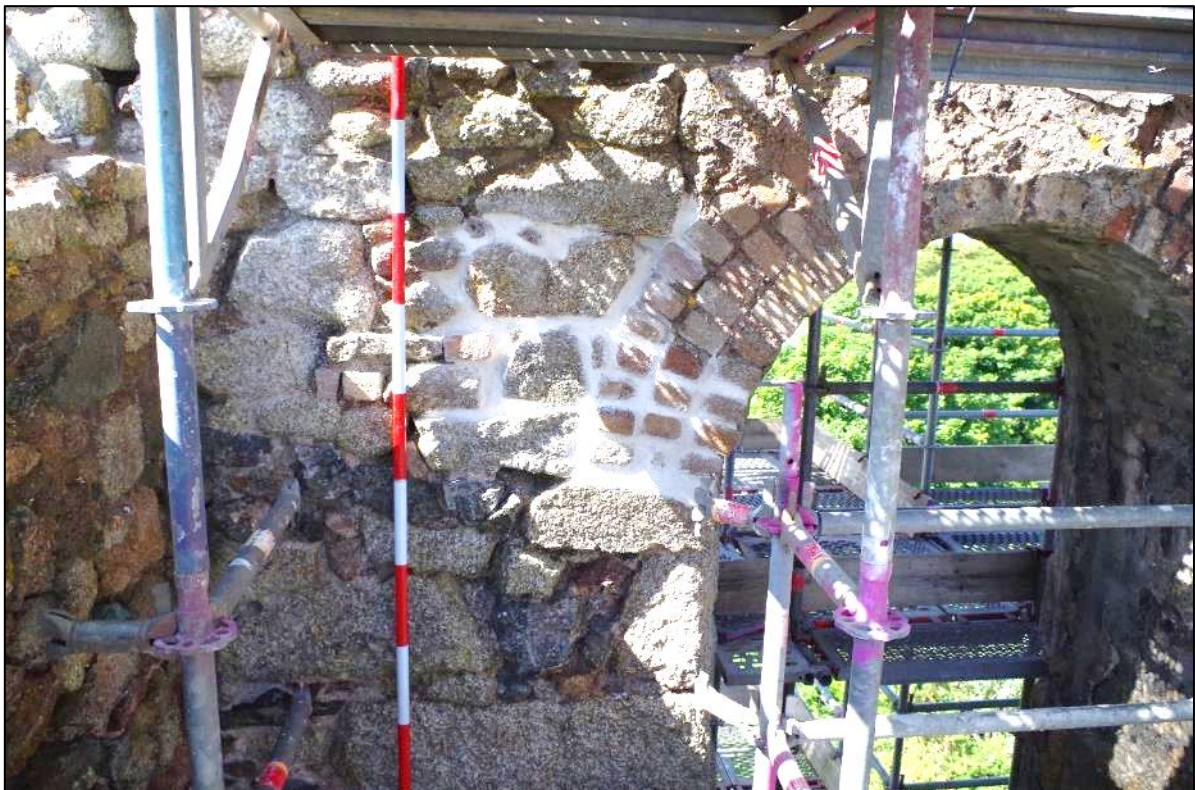
Fig 56 Interior south-west engine house wall following patch repairs.

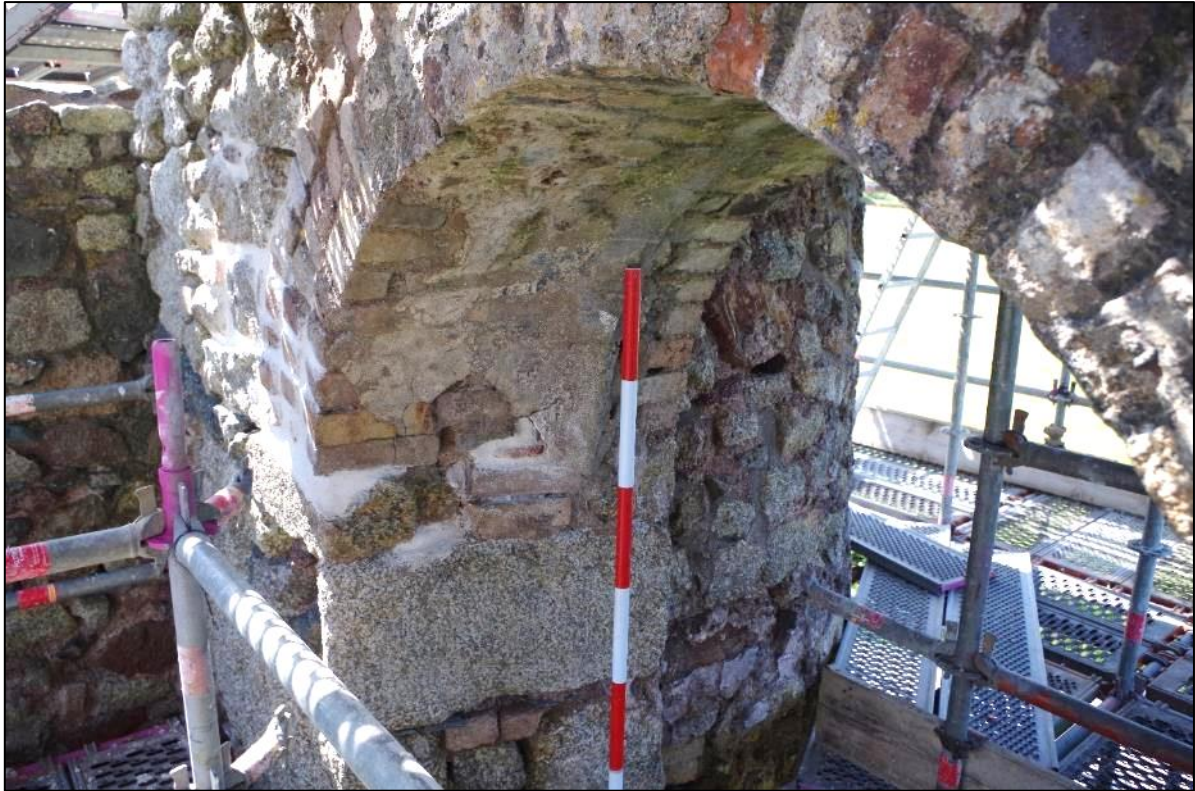
Fig 57 Interior south-west engine house wall following patch repair to arch.

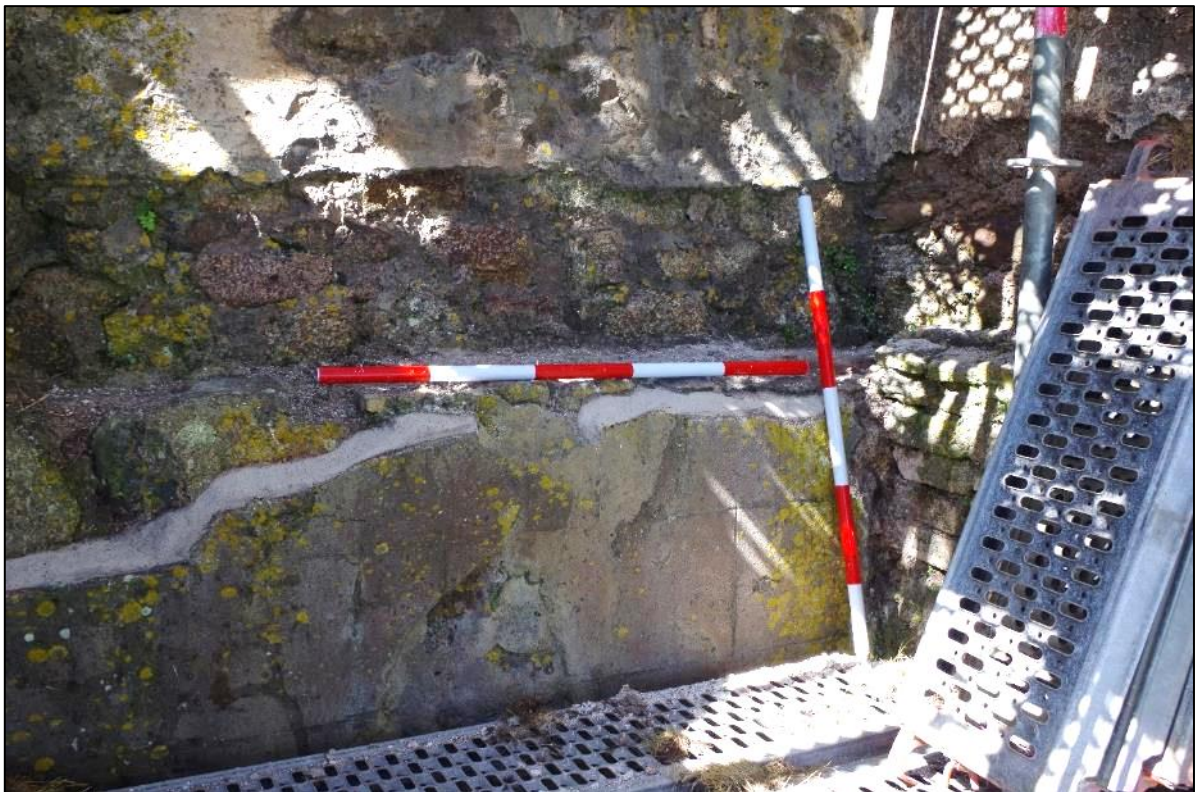
Fig 58 Interior south-west wall following small patch repair to incised plaster.

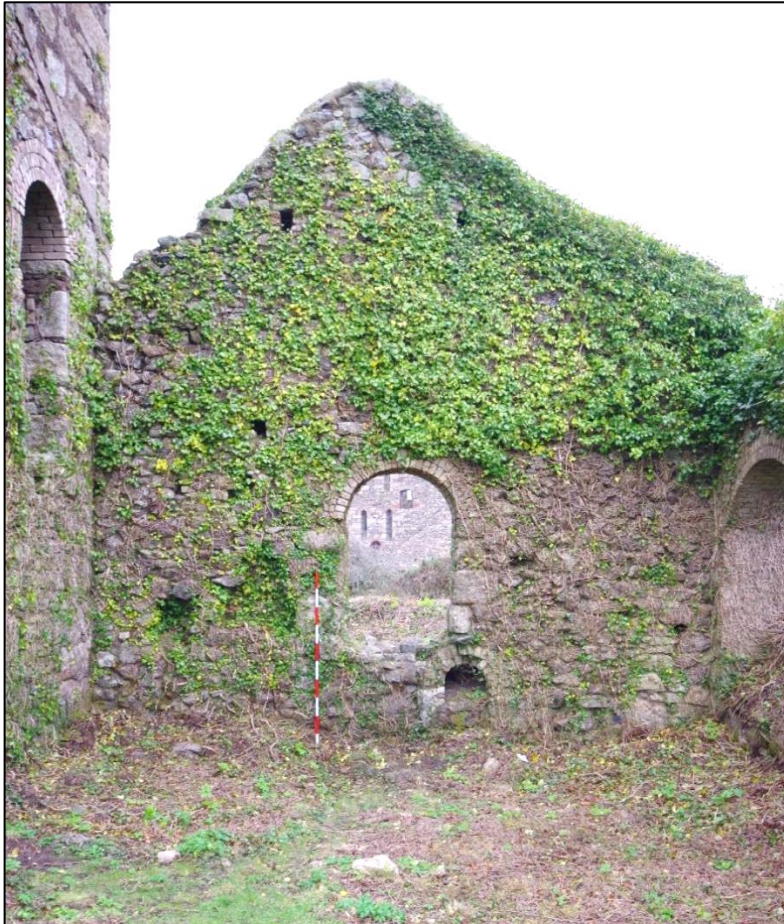
Fig 59 Interior south-west wall of boiler house before remedial works.

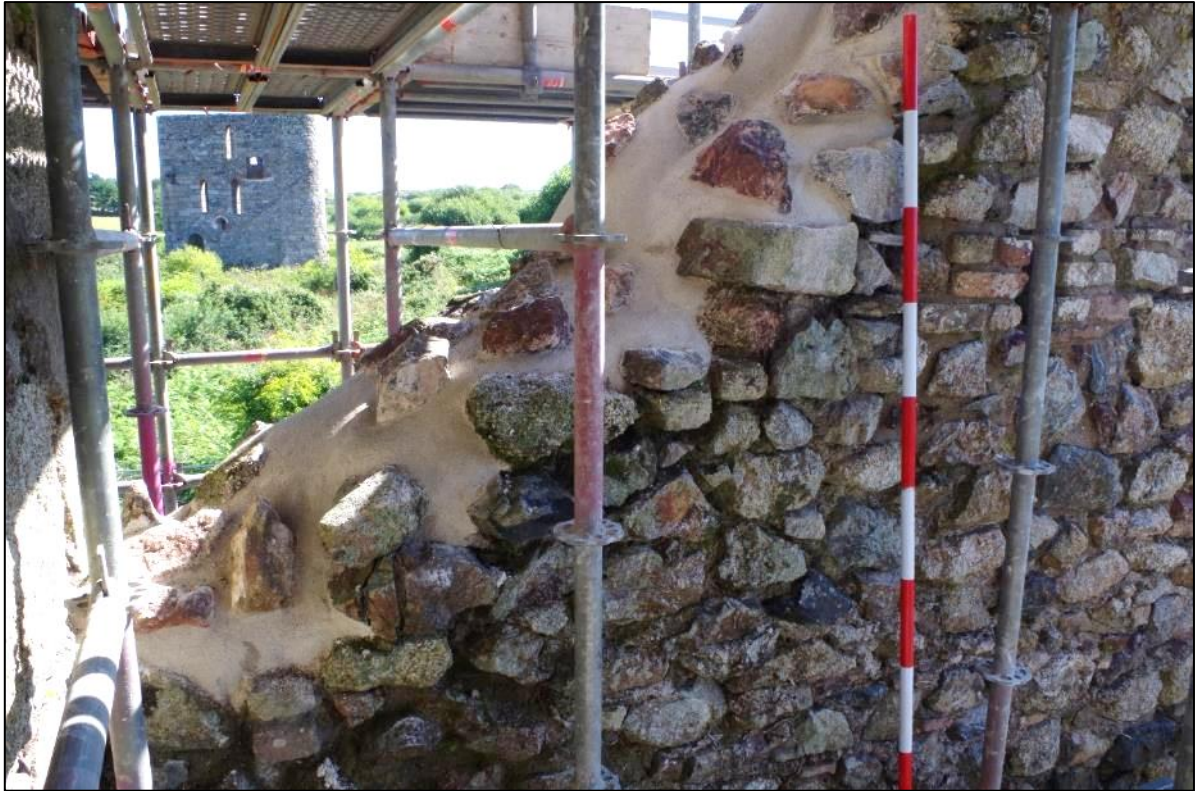
Fig 61 Interior south-west wall of boiler house following repairs to gable end.

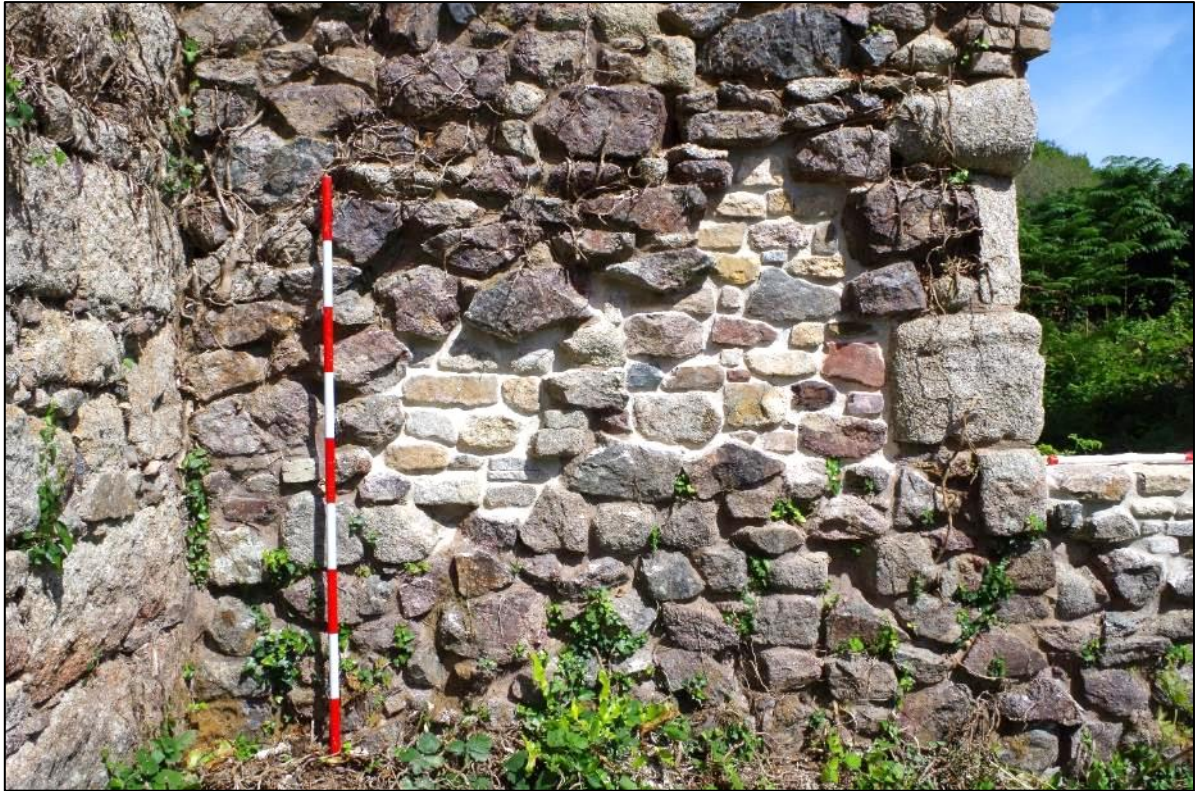
Fig 65 Interior south-west wall of boiler house following patch repairs.

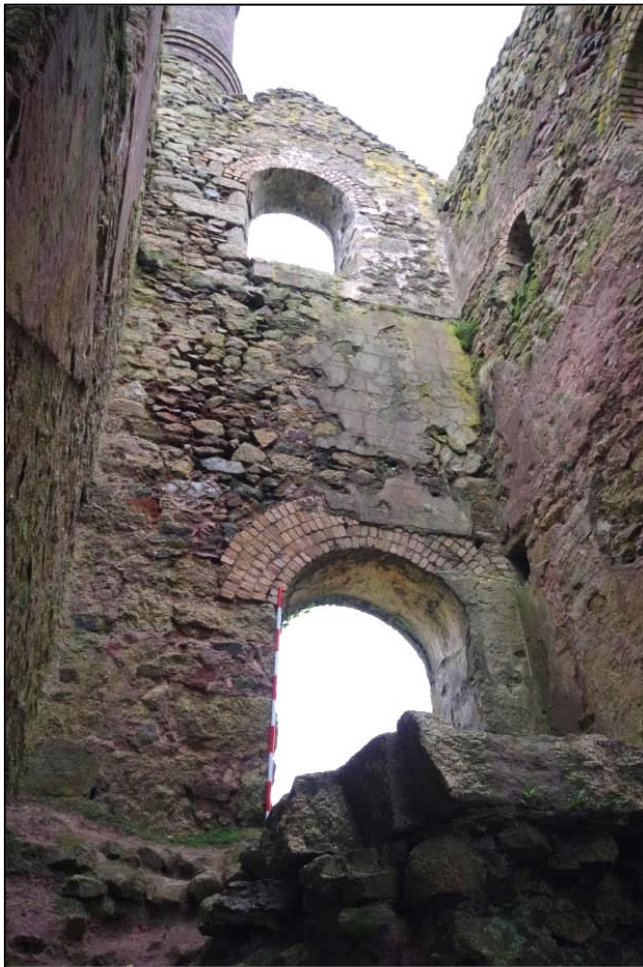
Fig 66 Interior south-west wall of engine house before remedial works.

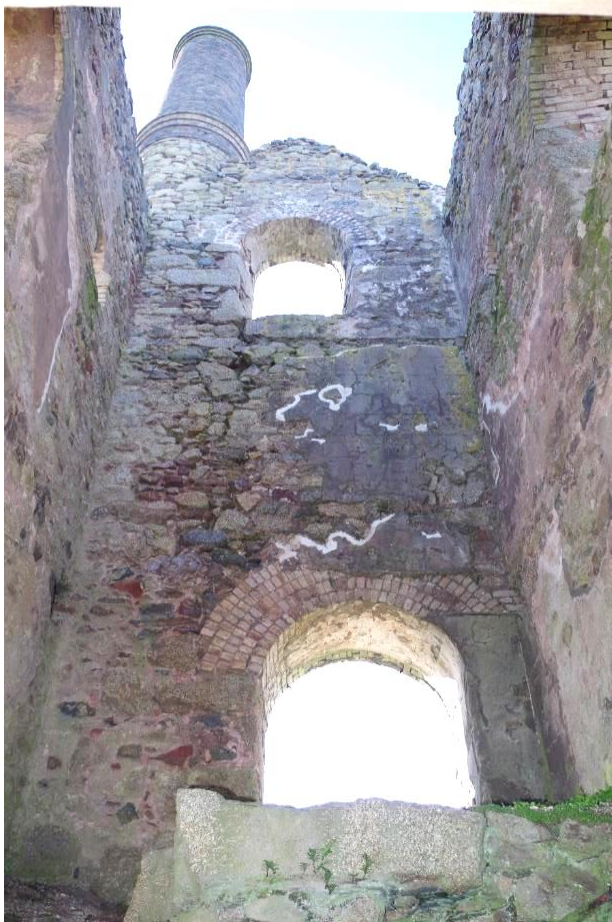
Fig 67 Interior south-west wall of engine house following small patch repairs to incised plaster.

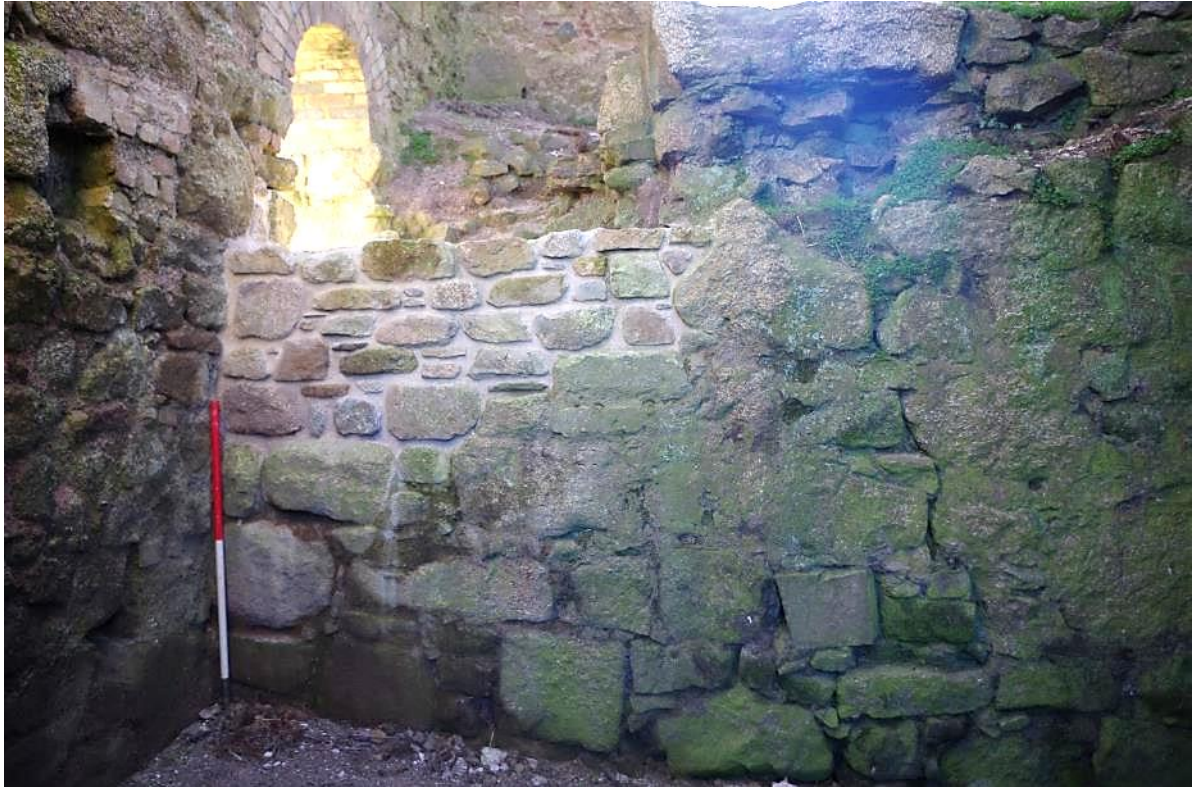
Fig 69 Interior cylinder bed following remedial works.

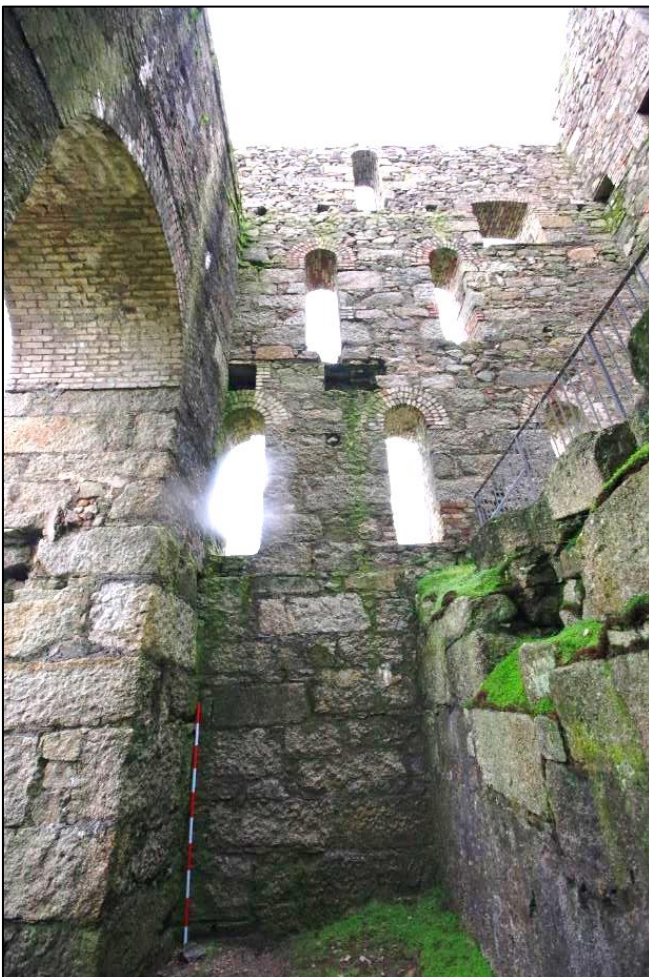
Fig 74 Interior north-east wall from the cataract pit before remedial works.

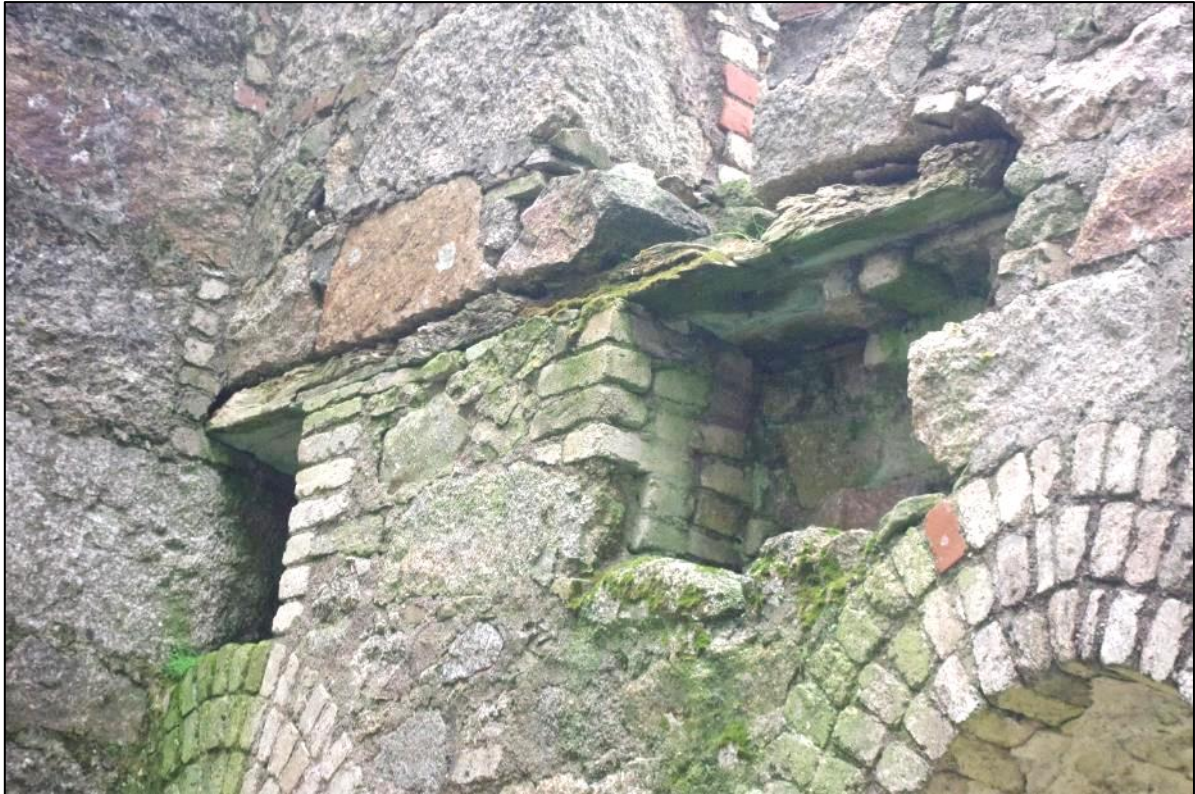
Fig 75 Interior north-east wall jost sockets and lintel before remedial works.

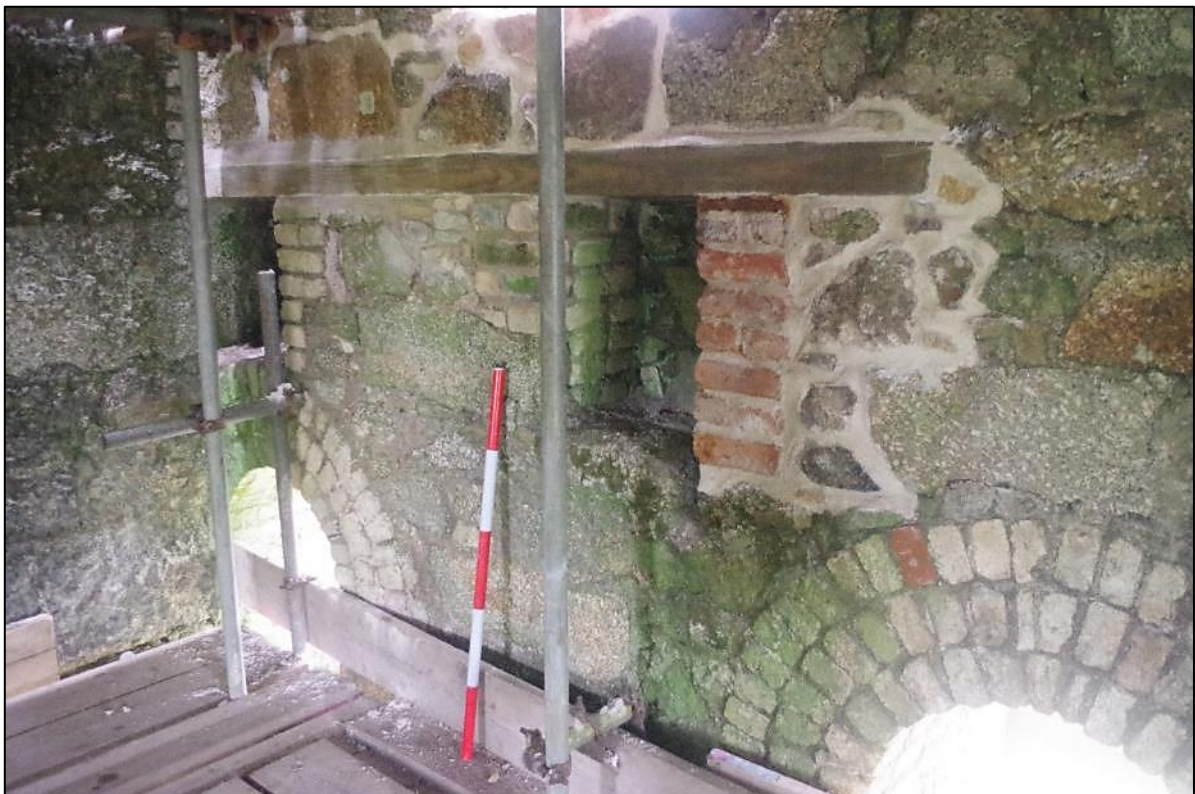
Fig 76 Interior north-east wall, jost sockets and lintel following remedial works.

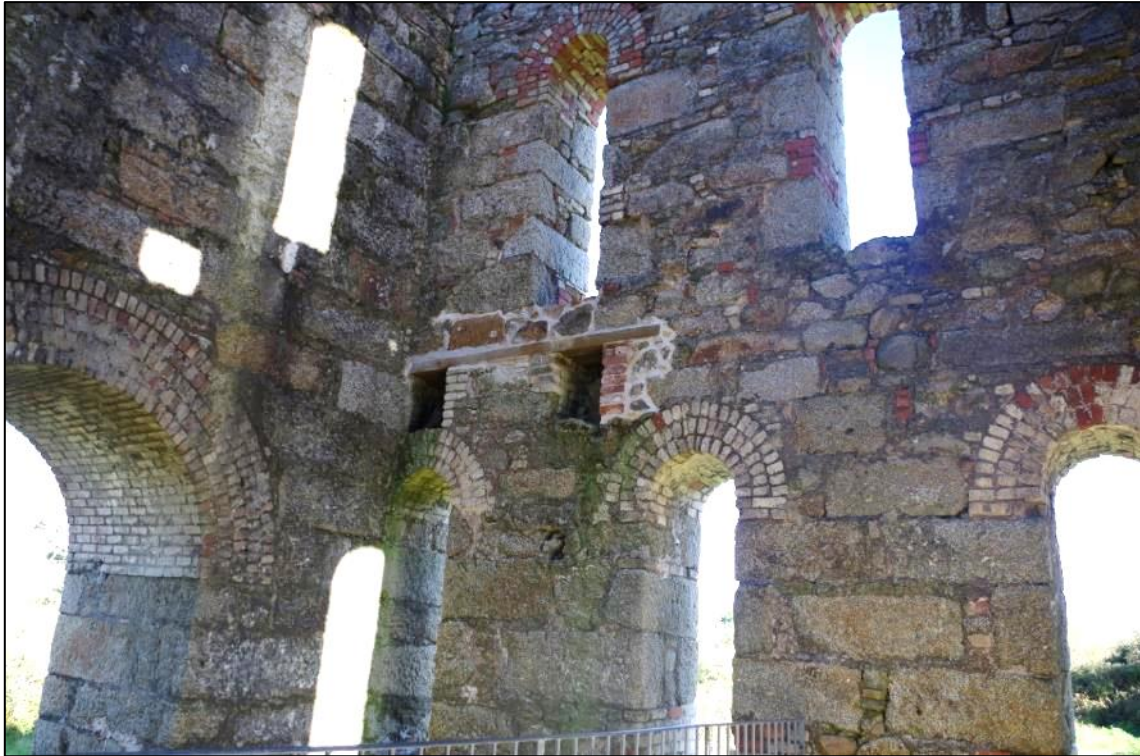
Fig 77 Interior north-east wall following remedial works.

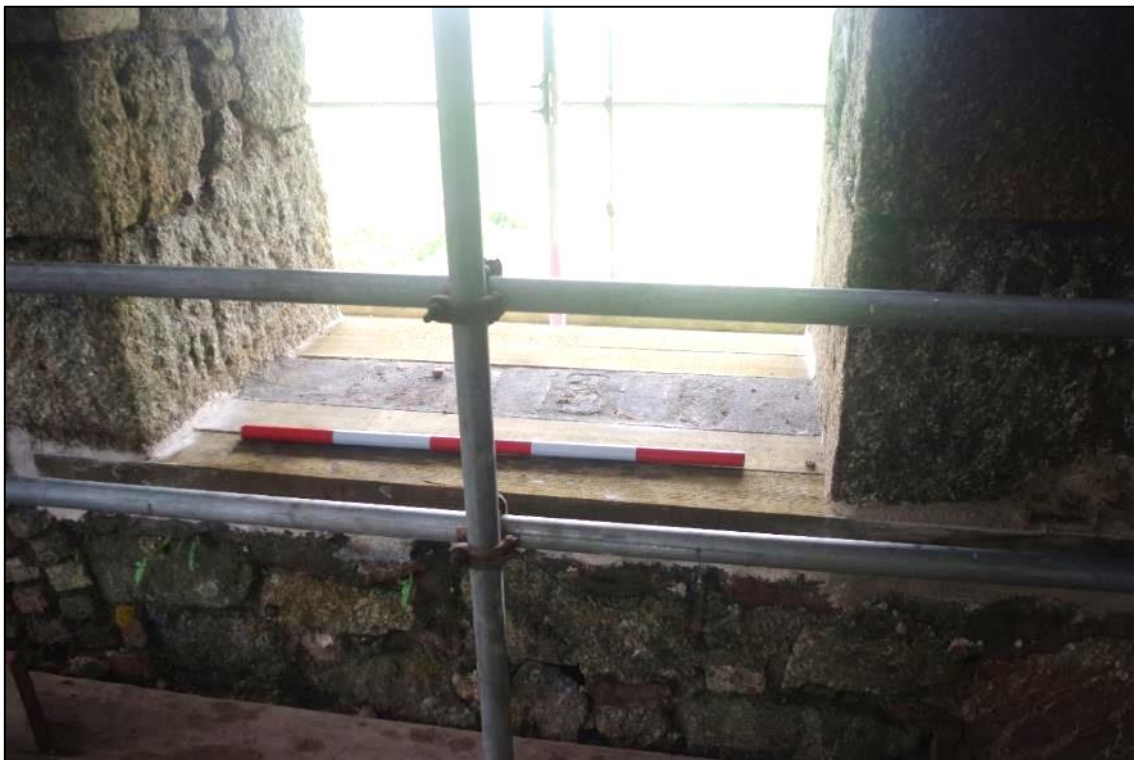
Fig 78 Interior north-east wall, repairs to main girder slot sill.

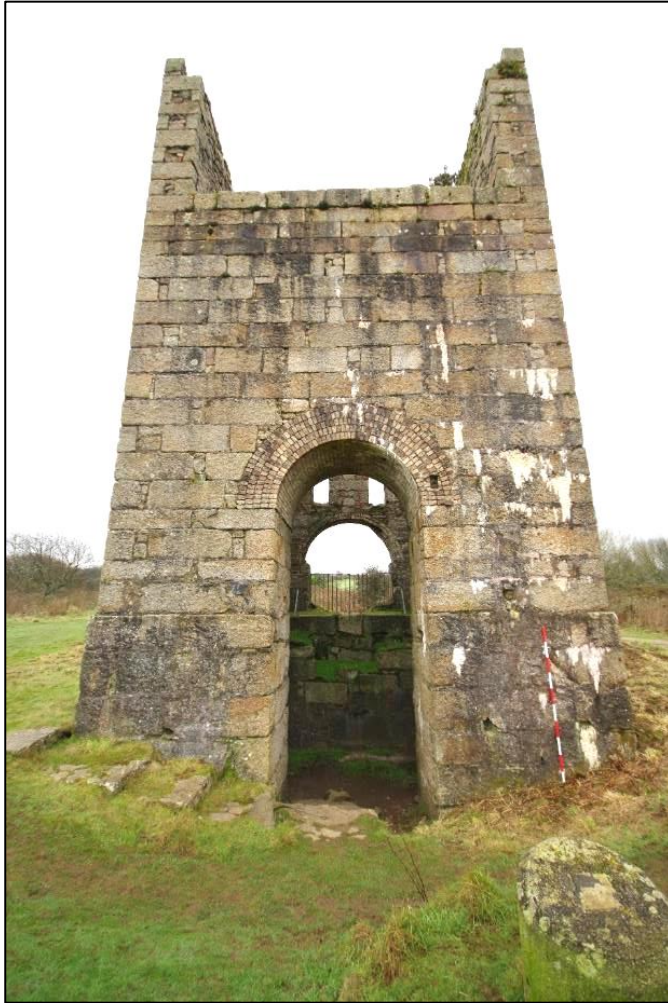
Fig 81 North-west elevation, bob wall.

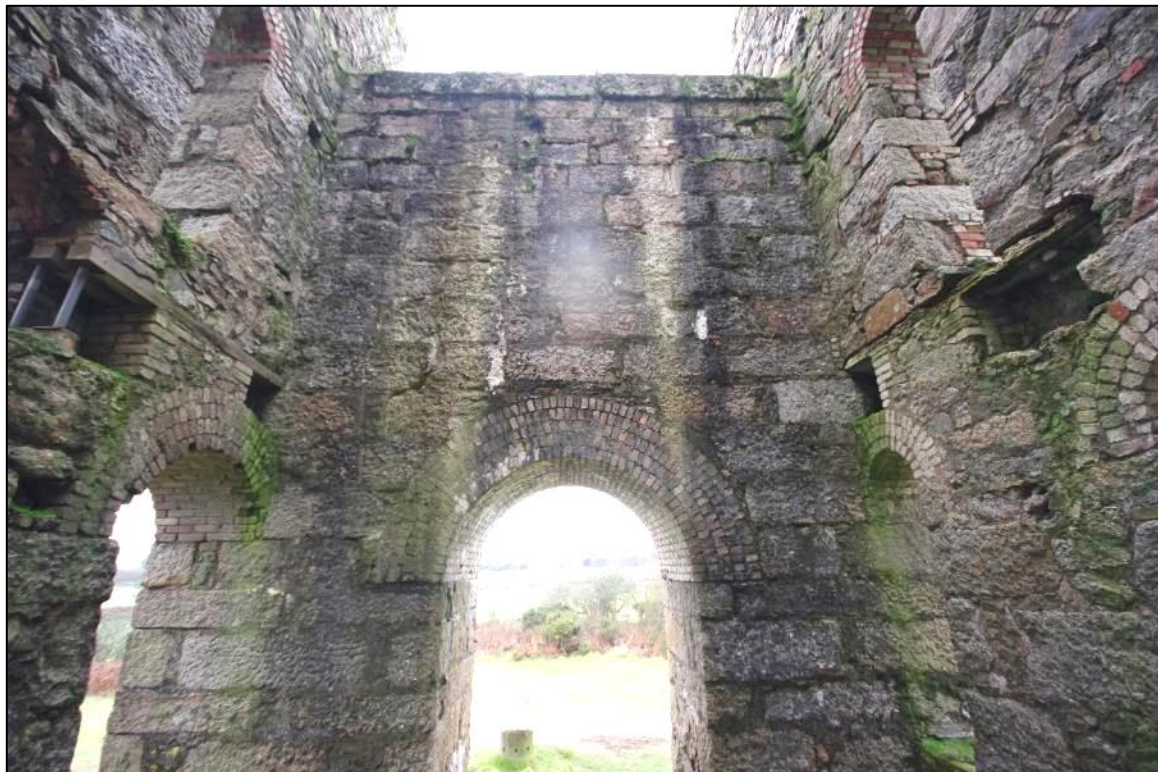
Fig 82 Interior north-west bob wall.

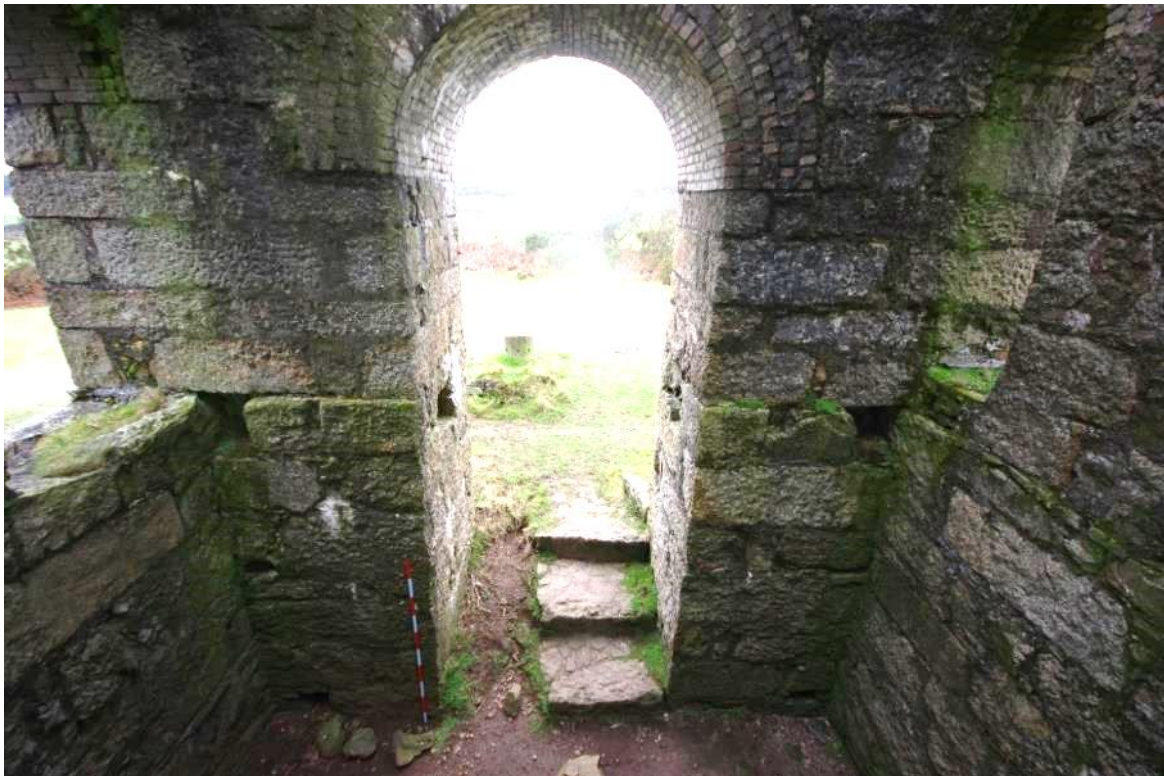
Fig 83 Interior north-west bob wall.

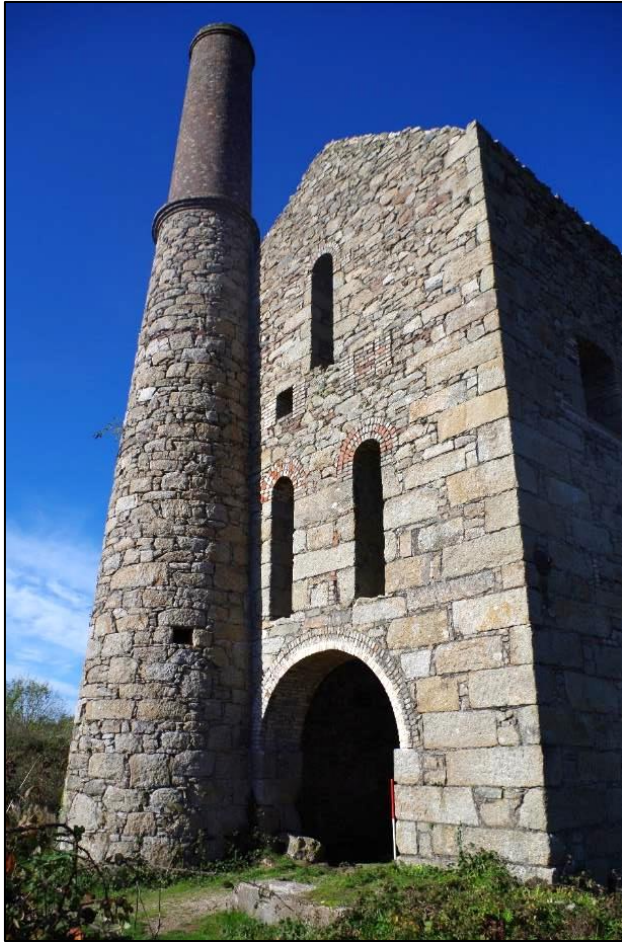
Fig 85 South-east elevation following repairs to cylinder arch, small patch repairs and capping of the top of the gable.

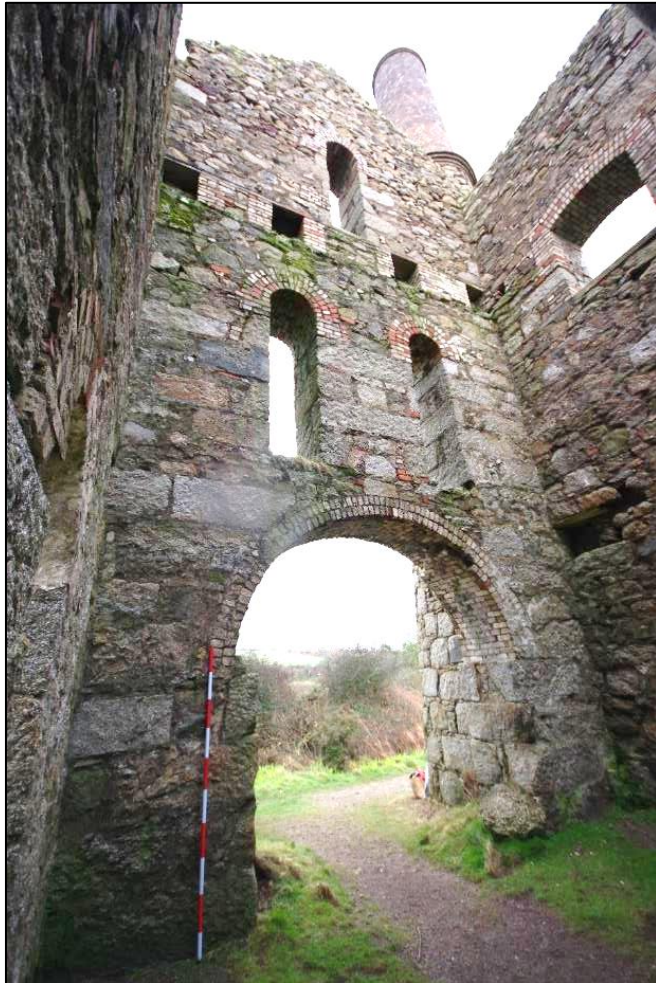
Fig 87 Interior south-east wall and cylinder arch before remedial works.

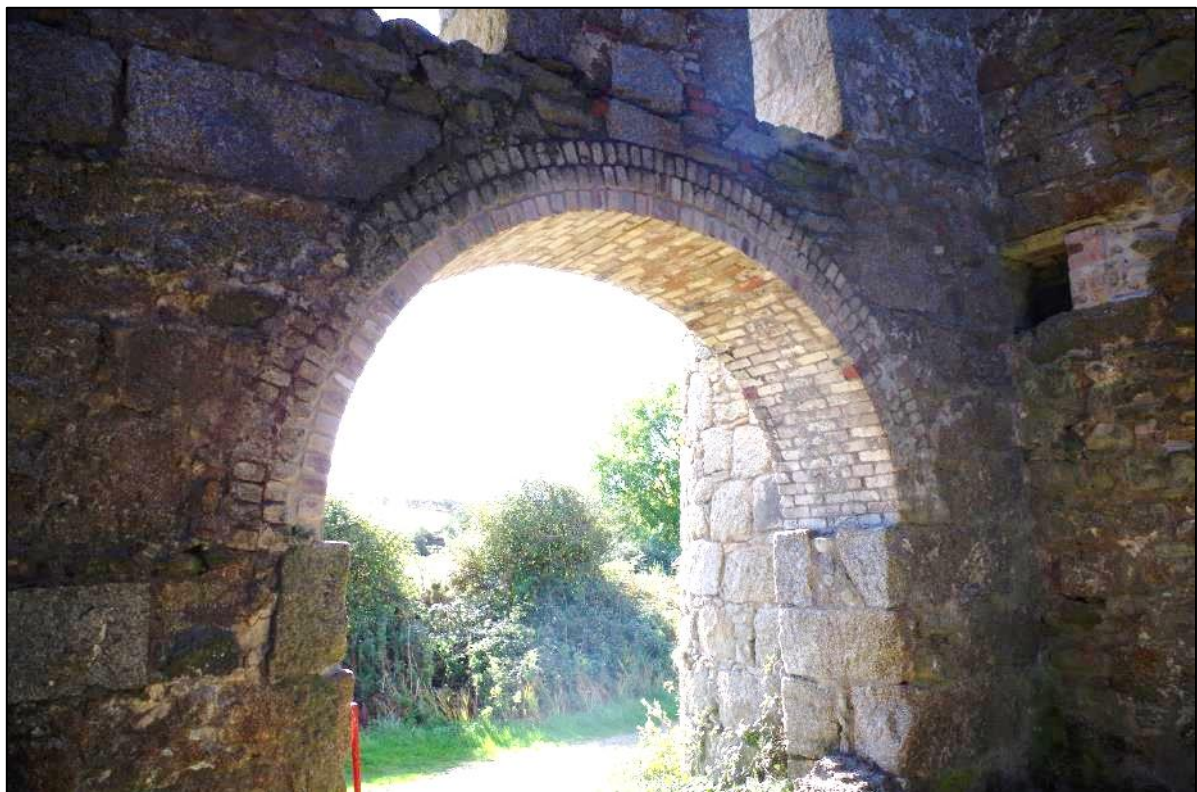
Fig 88 Interior south-east cylinder arch following repairs.

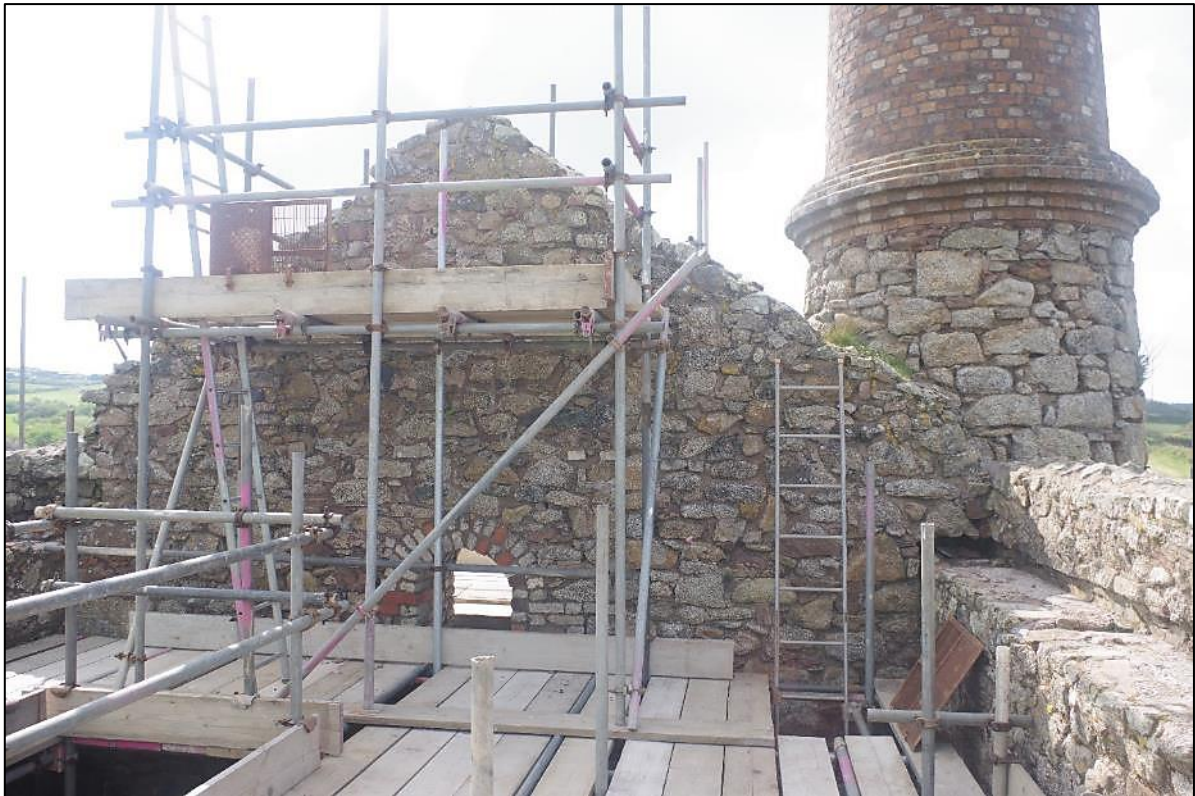
Fig 89 Interior south-east gable end before remedial works.

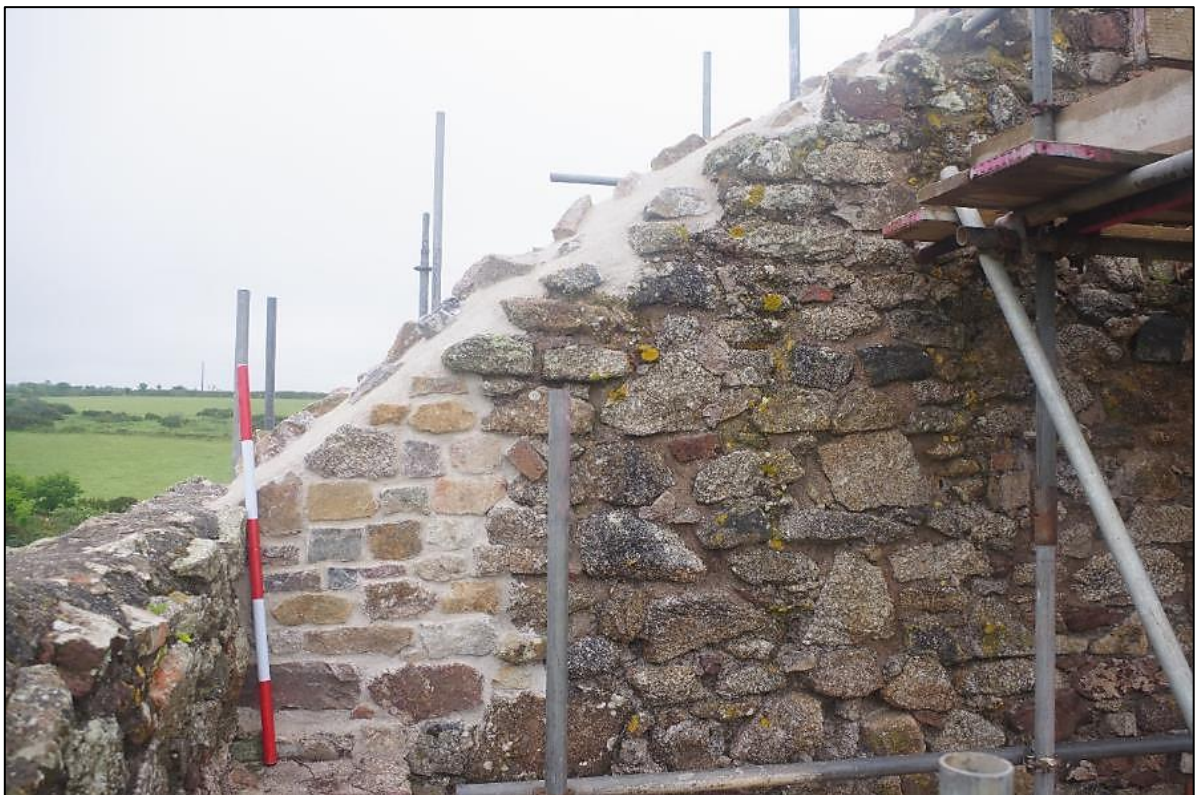
Fig 90 Interior south-east gable wall following patch repair and capping.

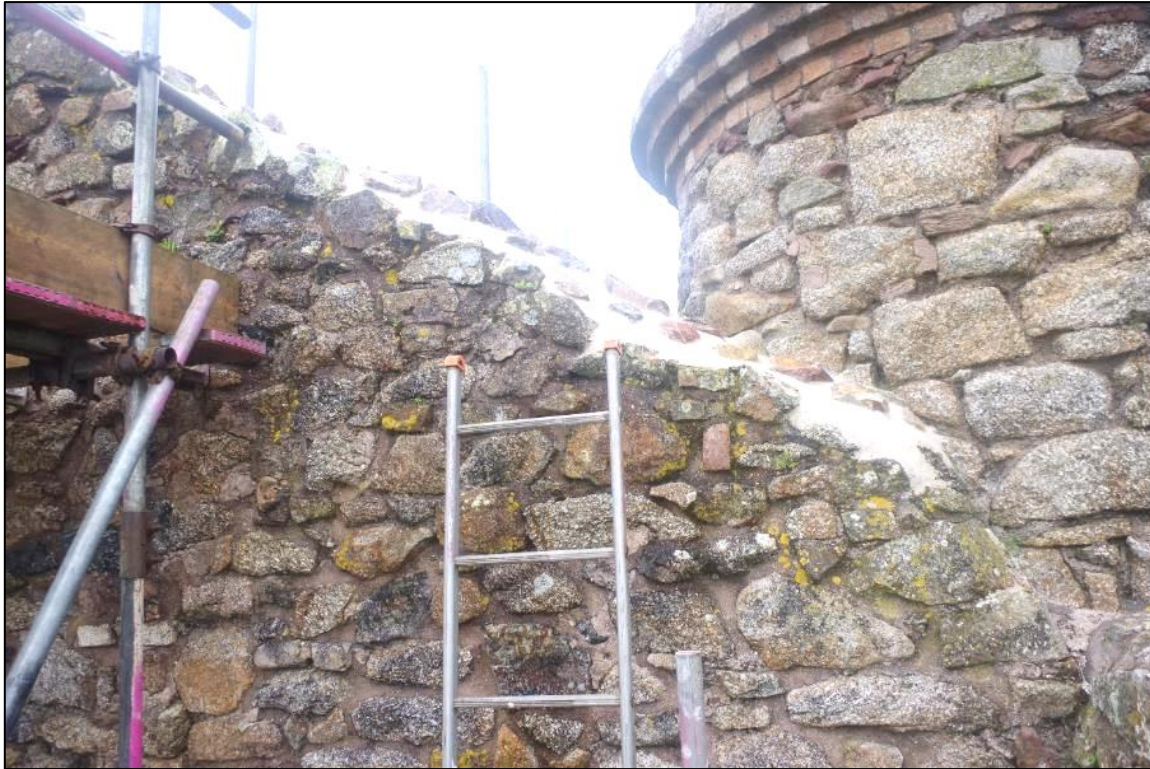
Fig 91 Interior south-east gable wall following capping.

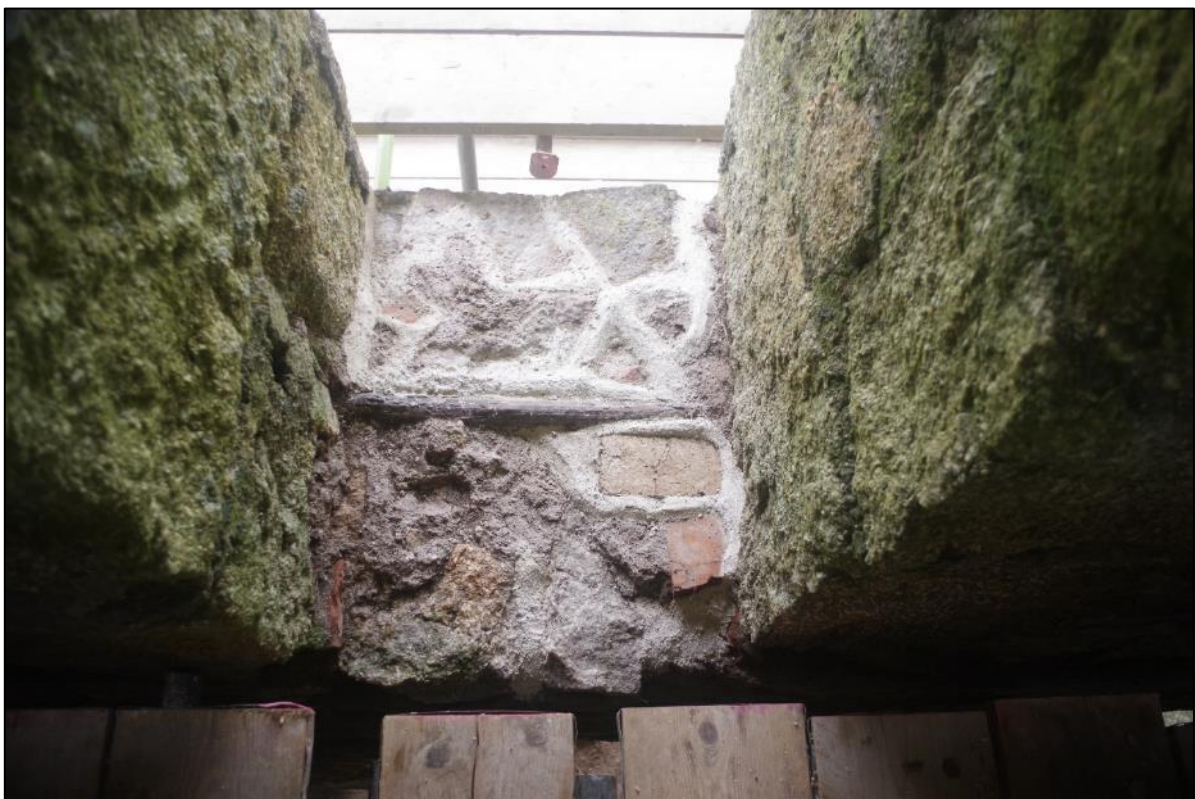
Fig 94 Interior south-east gable wall following small patch repair to window sill.

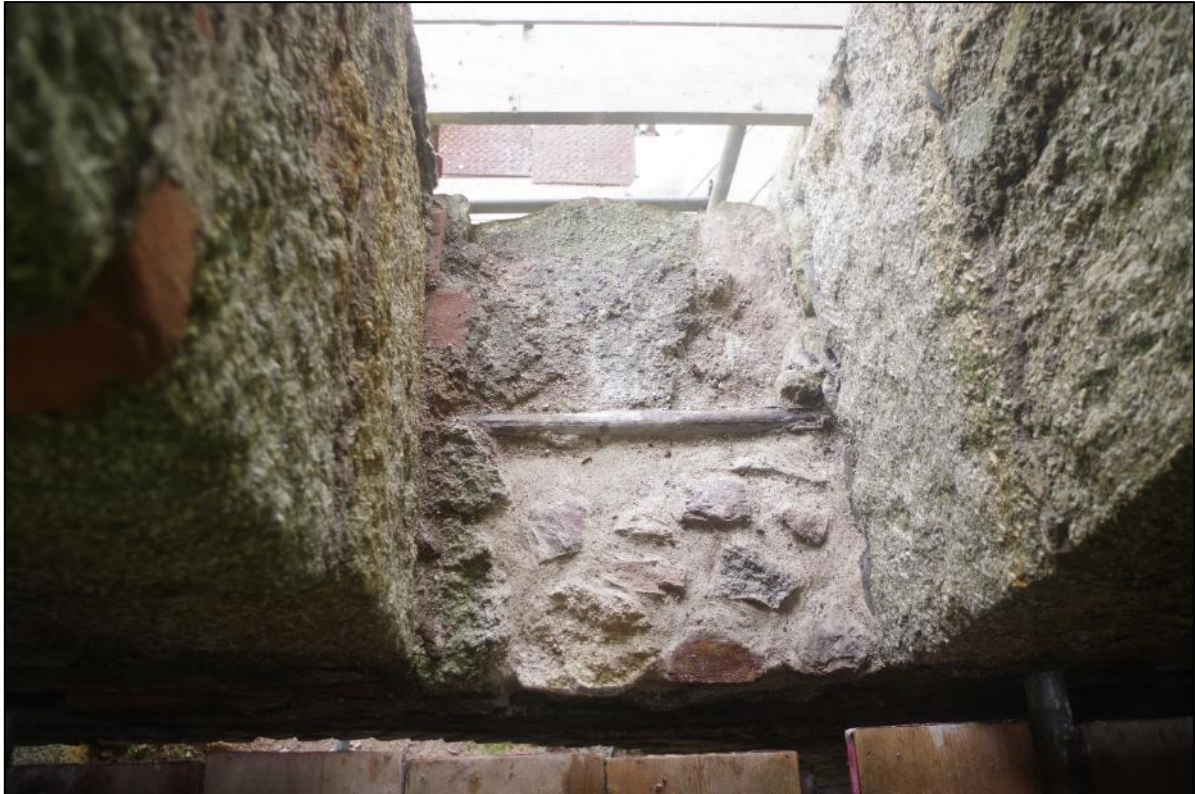
Fig 95 Interior south-east gable wall following small patch repair to window sill.

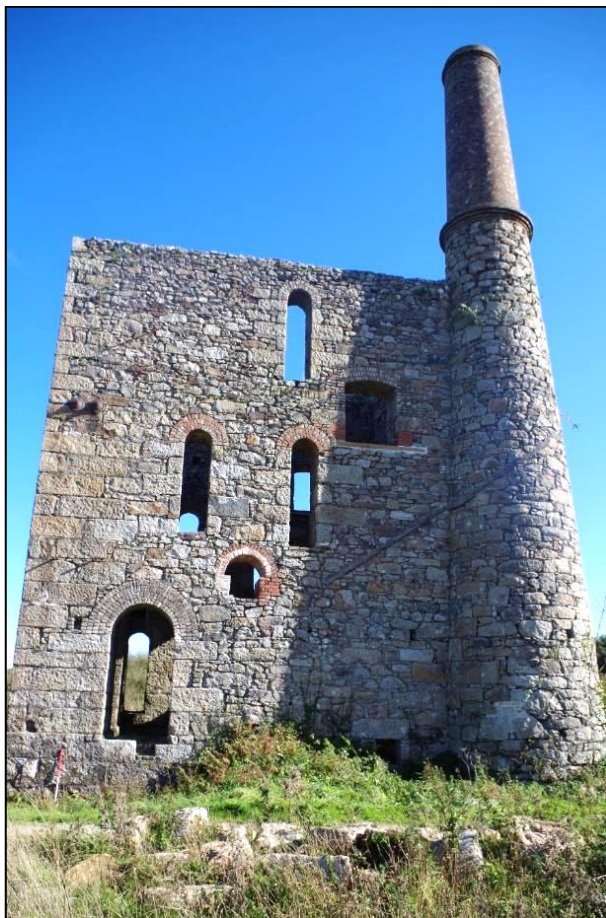
Fig 98 South-west elevation following remedial works.

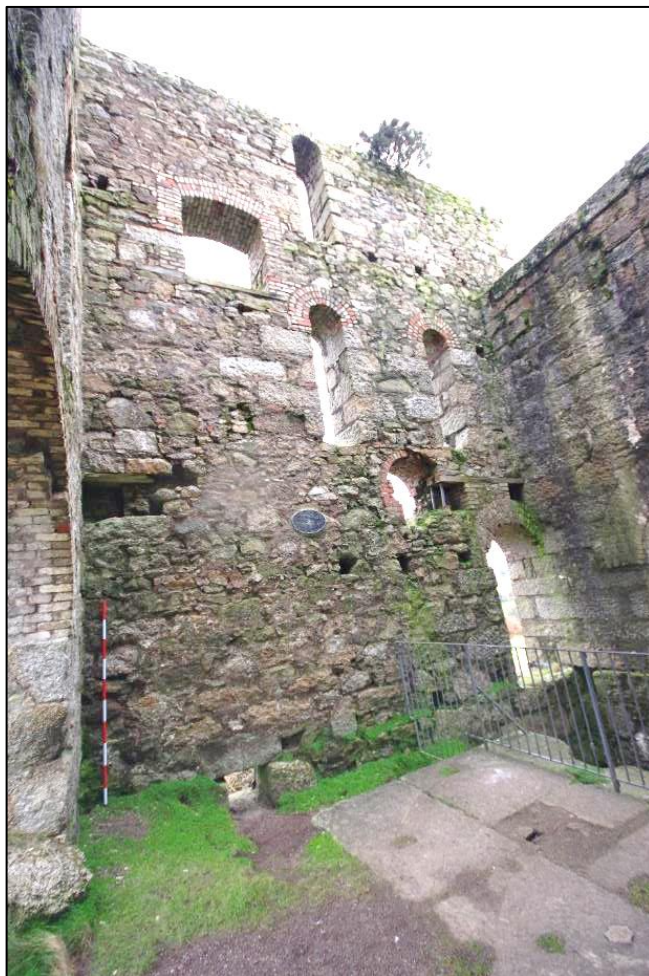
Fig 100 Interior south-west wall before remedial works.
